Before the Independent Hearings Panel  
at Waimakariri District Council

*in the matter of:* Proposed private plan change RCP31 to the Operative  
Waimakariri District Plan

Supplementary evidence of Laura Drummond

Dated: 4 September 2023

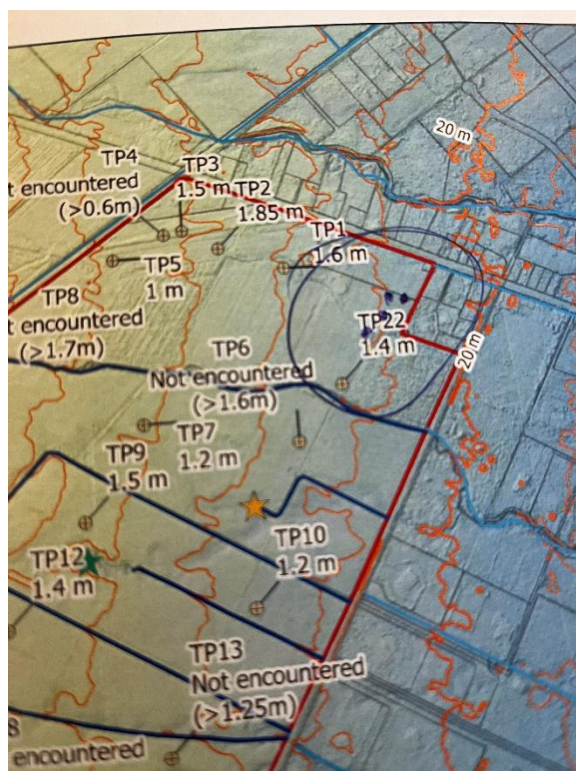
- 3 During the hearing, a submitter (#105, Ms L Joris) raised concerns about the potential for spring presence on the PC31 site, which was not captured in the aquatic ecology technical report<sup>1</sup>, Outline Development Plan (ODP) or the aquatic ecology evidence (Mark Taylor and Laura Drummond). The areas of concern were located in the northeastern side of the site, where a submitter had observed areas of water (shown in **Figure 1**).

**Figure 1: Submitter mark-up showing areas of potential spring presence (dots in circled area).**

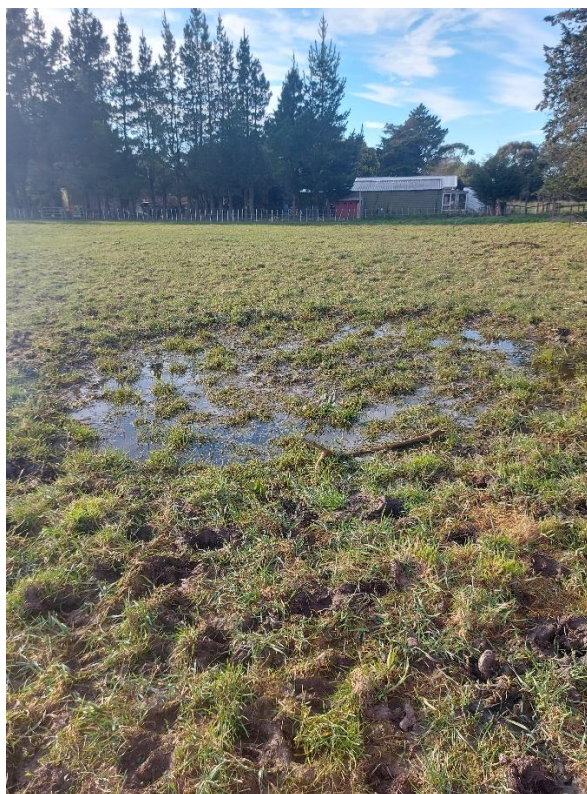
- 4 On 8 August 2023, I undertook a site walkover of the area raised as having potential spring presence. I observed several areas of ponded water in depressions in the general area identified, which can be expected with the recent rainfall from July 22 to 24. However, none of the areas are considered 'springs' as there was no signs of flow rising from groundwater (bubbling, sediment movement, flow channels) and the dominant vegetation was pasture grasses.

- 5 Discussion on site with the landowner indicates that during dry conditions, these areas have no standing water. This was confirmed through review of aerial imagery. However, when it rains heavily water will sit in depressions in the land due to the clay layer reducing infiltration to ground. In addition, two of the areas (shown in **Figures 2 and 3**) are likely to be depression areas caused by the placement of past feed racks for stock in this paddock. These racks are placed in the paddock and stock movement around them can lead to depressional areas.

**Figure 2: Surface water ponding in a depression area.**

- 7 As these wetted areas are not considered springs, they do not require the protection of spring setbacks at this stage under the ODP. The PC31 area will require field surveys during the subdivision consent stage to confirm the presence and extent of natural inland wetlands on site. Any natural wetlands delineated on site will then

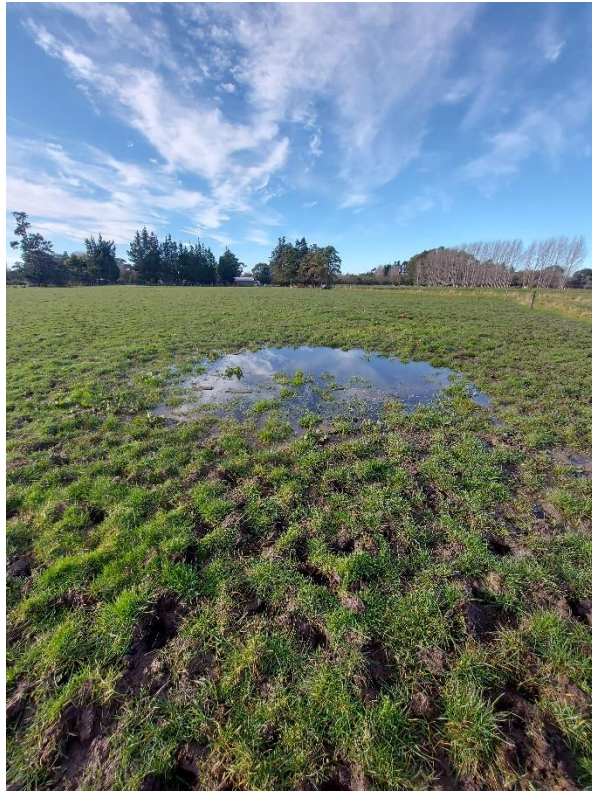
**Figure 3: Surface water ponding in a depression area.**

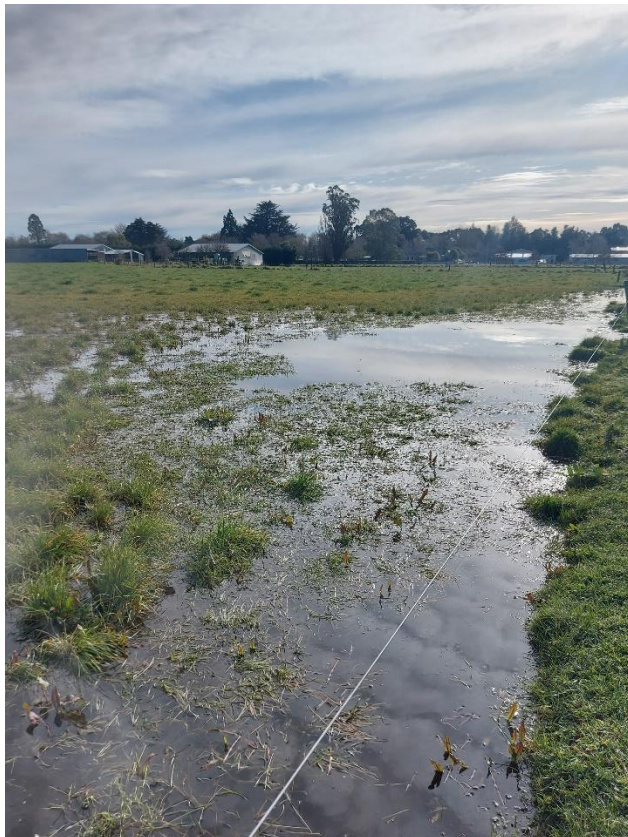
- 6 There is also a larger area of ponding near an internal farm road (shown in **Figures 4 and 5**). This area of ponding has likely resulted from the farm track intercepting overland flow runoff through an old stream braid towards Whites Road.

**Figure 4: Surface water ponding associated with farm track.**

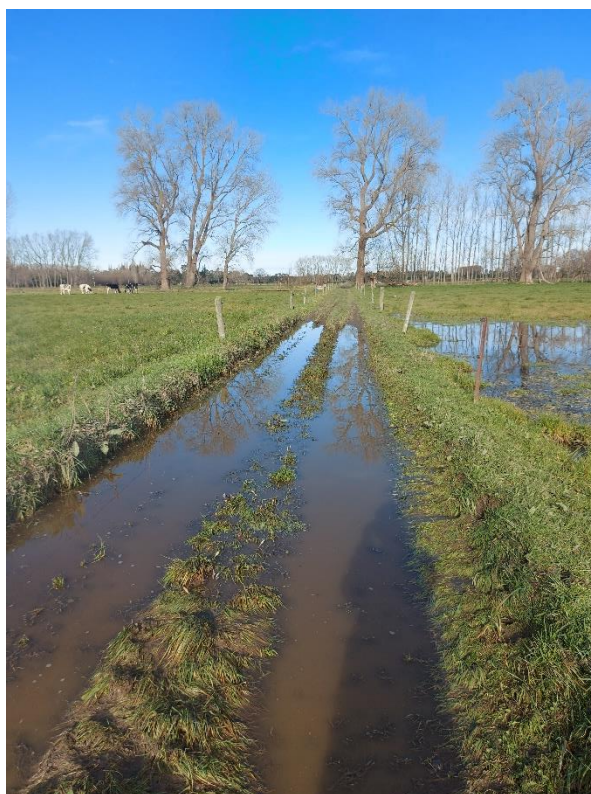
**Figure 5: Surface water ponding within the farm track.**
