## **Geotechnical Investigation by Geoscience Consulting**

## **GEOTECHNICAL INVESTIGATION**

**474 BRADLEYS ROAD, OHOKA,  
CANTERBURY**

4 April 2012

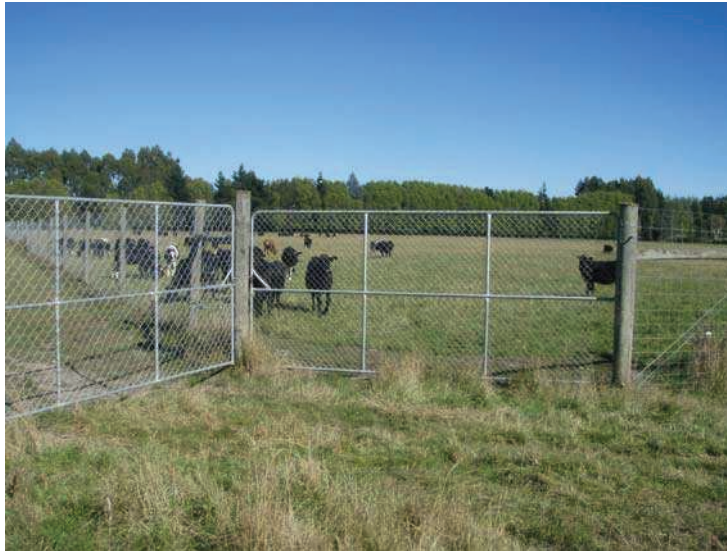
**Photo 1: View of the paddocks along the western boundary of the site**

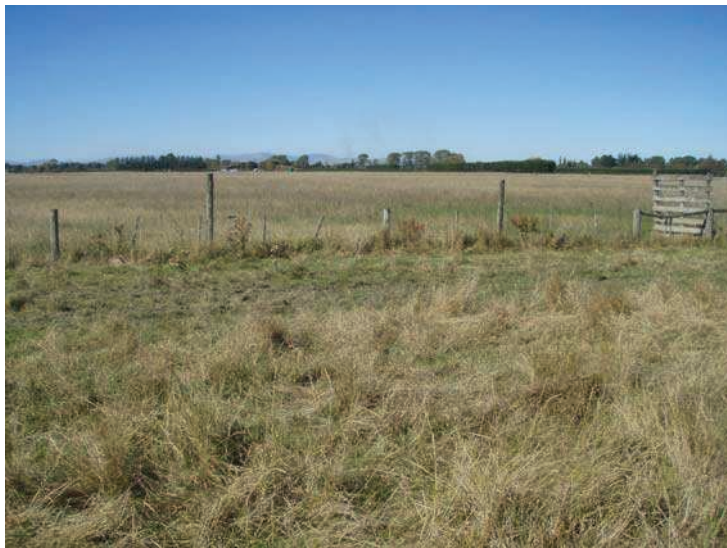
**Photo 2: View of the paddocks in the southern portion of the site**

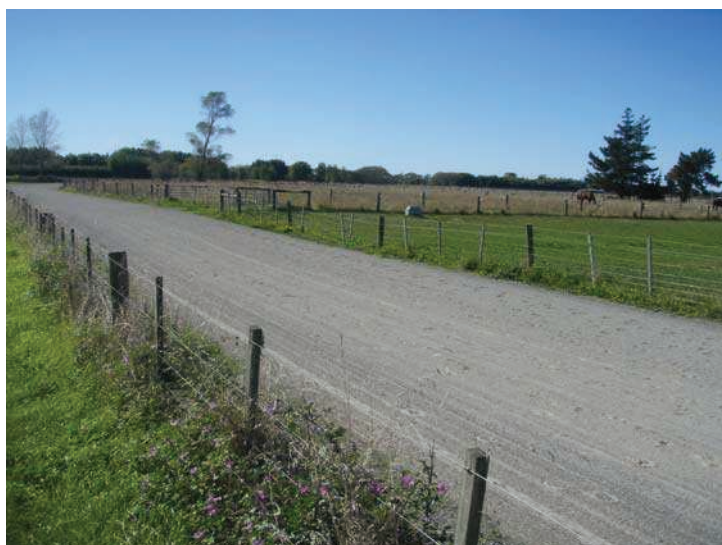
**Photo 3: View of the horse training track near the centre of the site**

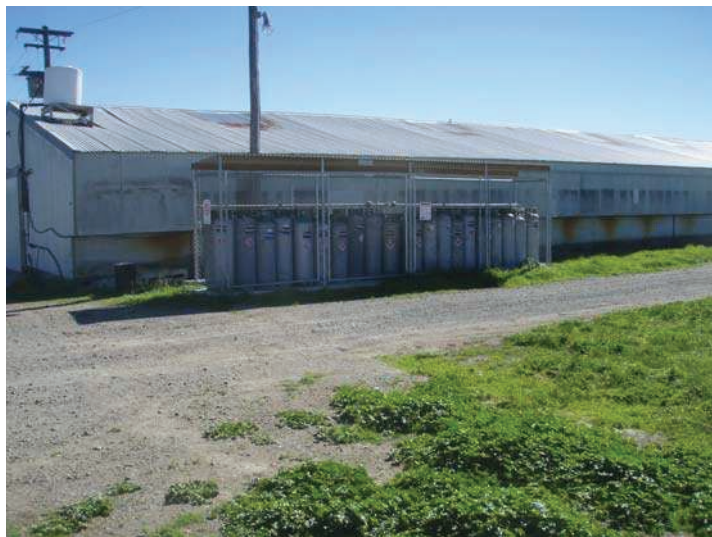
**Photo 4: View of one of the chicken sheds**

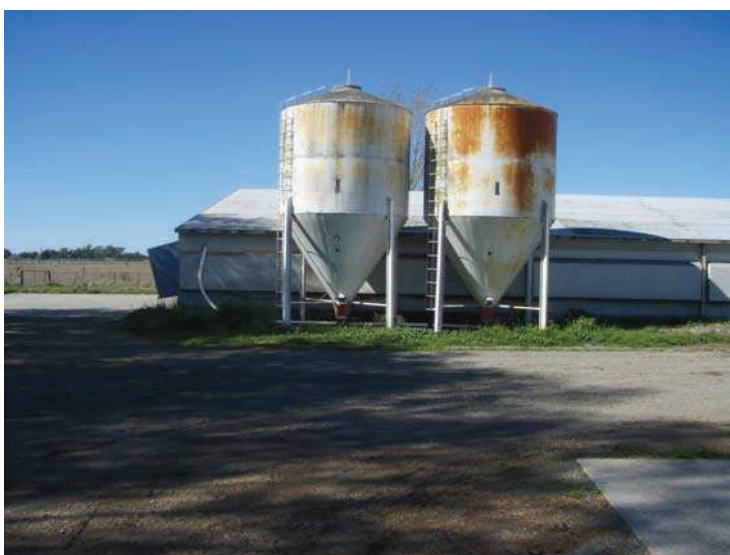
**Photo 5: View of one of the chicken sheds**

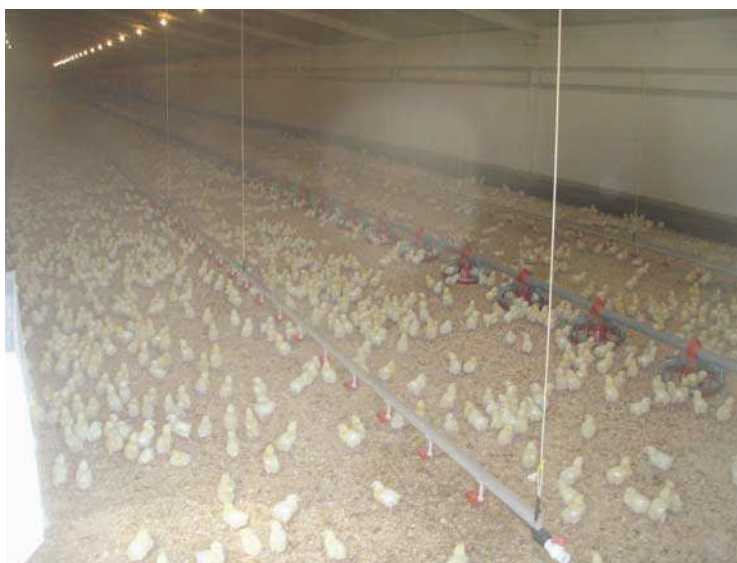
**Photo 6: View inside the chicken sheds**

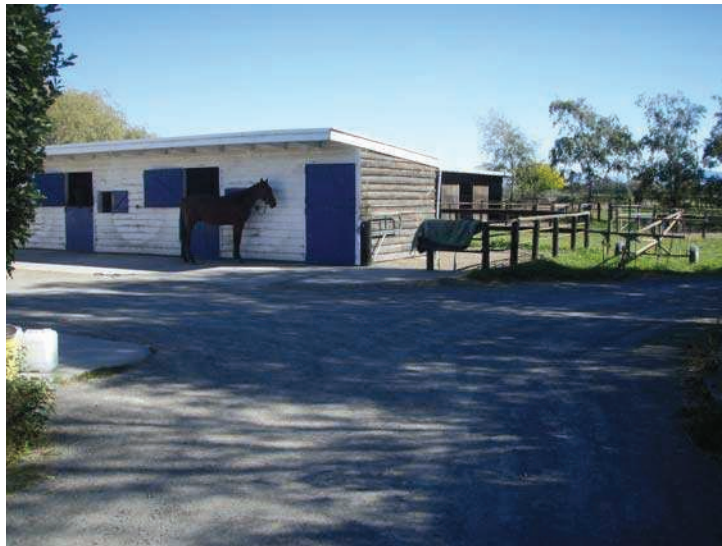
**Photo 7: View of the horse stables**

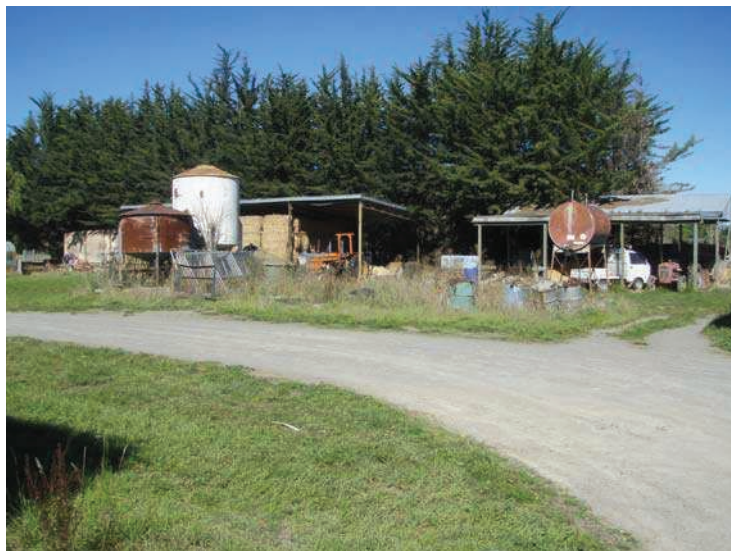
**Photo 8: View of the general farm storage area (showing the above ground fuel tank)**

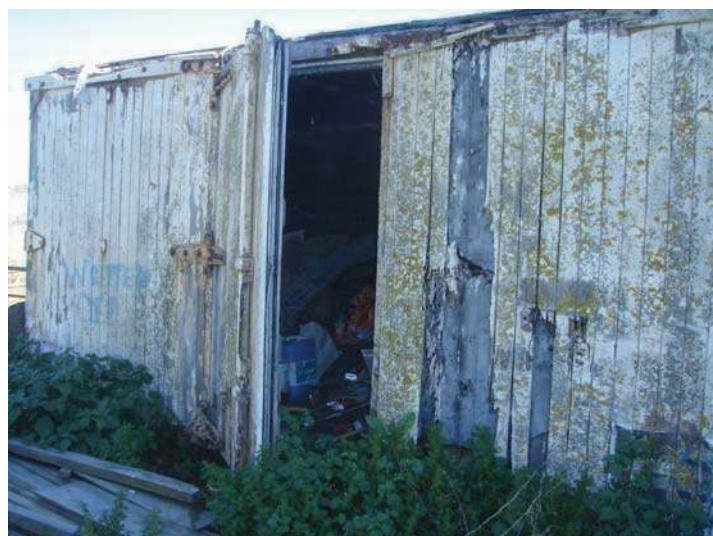
**Photo 9: View of the implement shed within the general farm storage area**

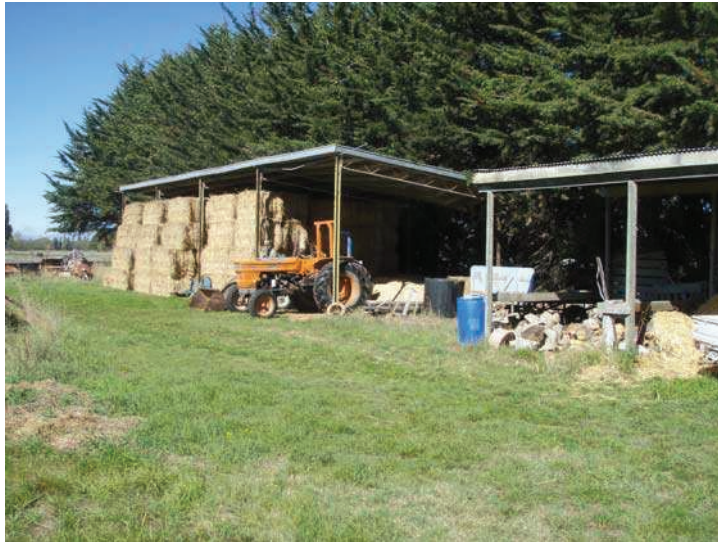
**Photo 10: View of the haybarn within the general farming storage area**

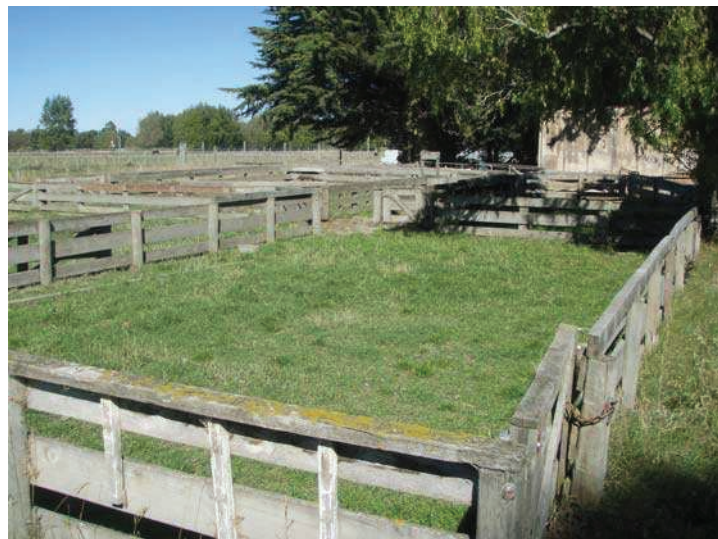
**Photo 11: The sheep yard area located between the general farm storage area and the horse track**

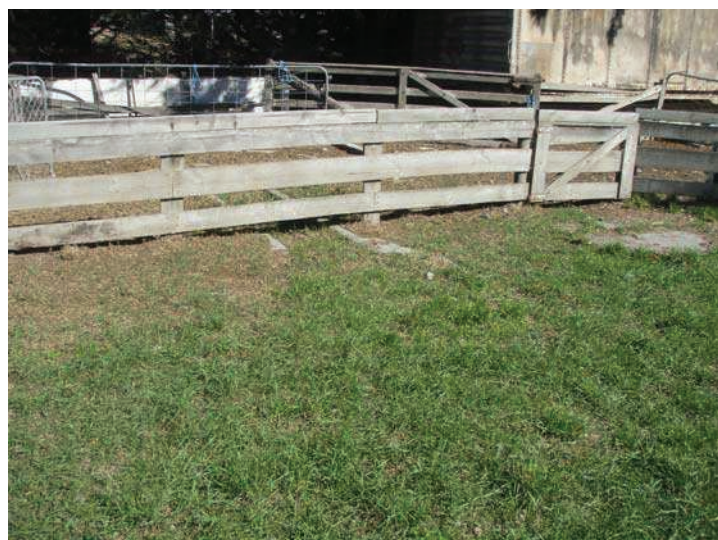
**Photo 12: The possible foot rot trough / sheep dip within the sheep yard area**

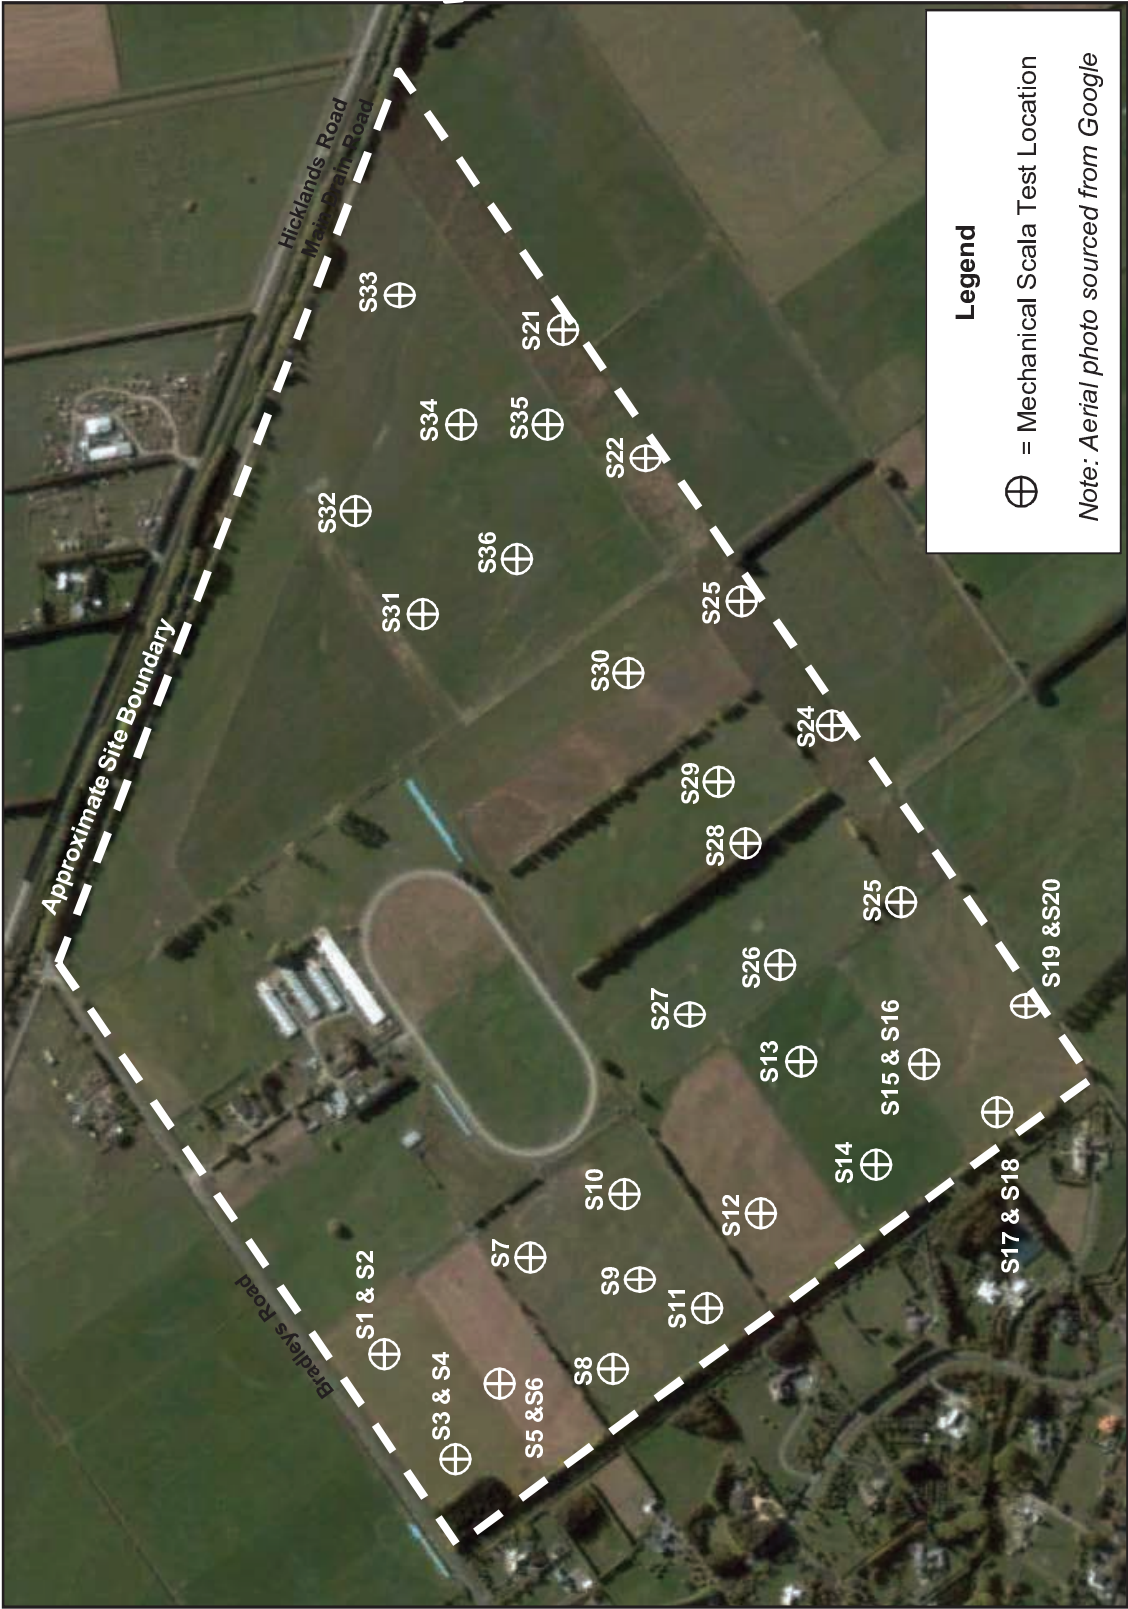
Date	March-12	Client	Survus Consultants Limited		
Drawn by	CM	Project	474 Bradleys Road, Ohoka		
Approved by	MW	Description	AutoScala Test Locations		
Scale	NTS	Figure Number	2	Project Number	12034_2

Test Number	Depth to Refusal (m)	Approx. Depth to “good ground” (m)	Test Number	Depth to Refusal (m)	Approx. Depth to “good ground” (m)
1	0.82	0.5	19	0.56	0.0
2	1.11	0.5	20	0.94	0.0
3	0.81	0.5	21	0.65	0.0
4	0.78	0.4	22	1.22	0.2
5	0.76	0.1	23	1.45	0.9
6	1.43	0.2	24	0.58	0.1
7	1.13	0.5	25	0.66	0.1
8	1.11	0.5	26	0.83	0.2
9	1.10	0.3	27	1.05	0.5
10	1.36	0.3	28	1.08	0.2
11	0.92	0.5	29	0.83	0.6
12	0.79	0.1	30	0.99	0.8
13	1.09	0.1	31	0.95	0.5
14	0.84	0.3	32	1.14	0.6
15	0.56	0.1	33	0.50	0.1
16	0.53	0.0	34	1.71	1.0
17	0.67	0.0	35	0.63	0.0
18	0.52	0.0	36	0.98	0.6

- AutoScala testing results indicate that the gravels encountered typically meet the requirements for “good ground” as defined by NZS3604:2011<sup>9</sup>.
- There is no evidence of any liquefaction having occurred at or near the site during recent large earthquakes. We consider the likelihood of liquefaction or lateral spreading occurring at the site to be very low based on the nature of the sub-surface materials (namely gravel).
