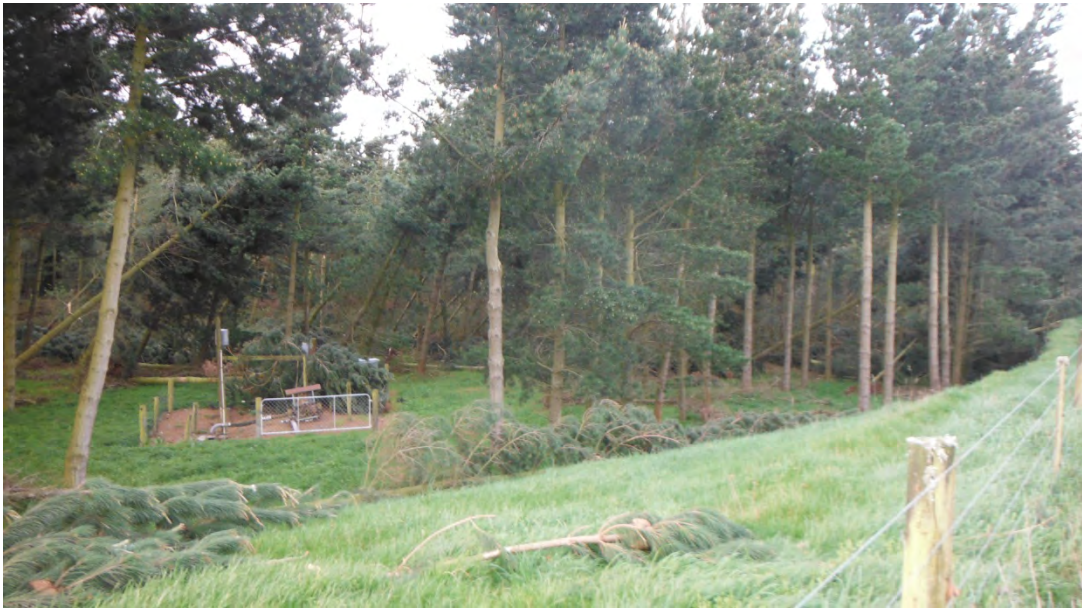
*Figure 3: Photo taken looking into the southwest corner of proposed Lot 1. Photo taken September 2013.*

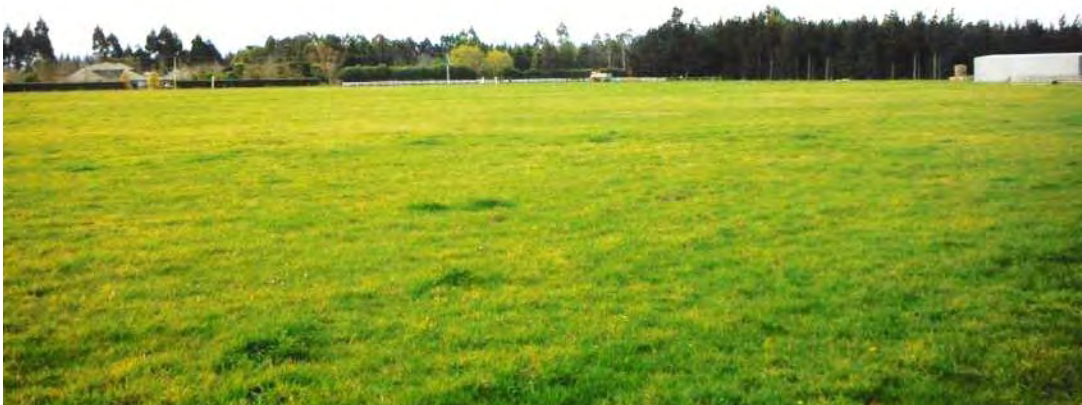
*Figure 4 : Photo taken on the southwest part of the site, looking east. Photo taken September 2013.*

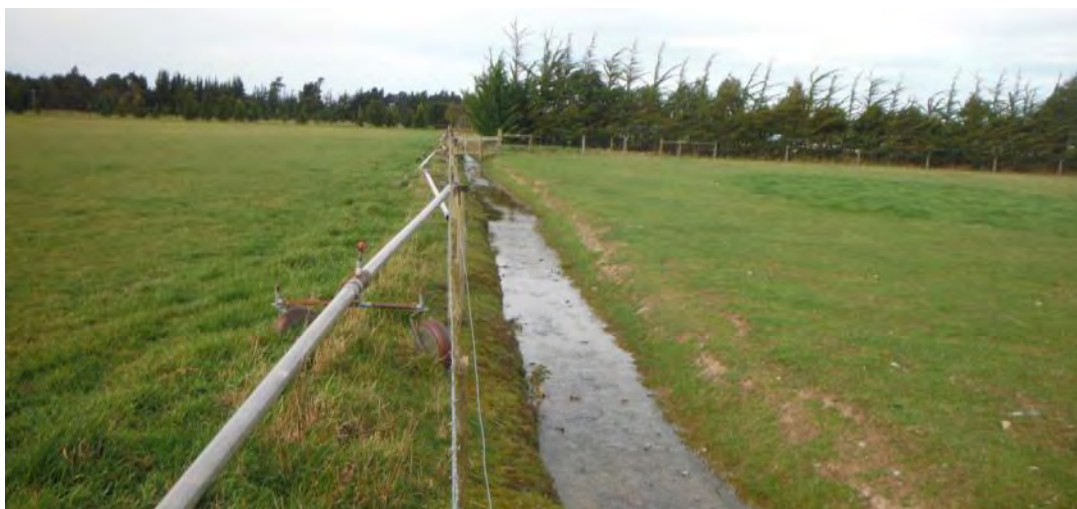
Figure 5 : Photo looking east along water race located at the south boundary of Lot 2. Photo taken September 2013.

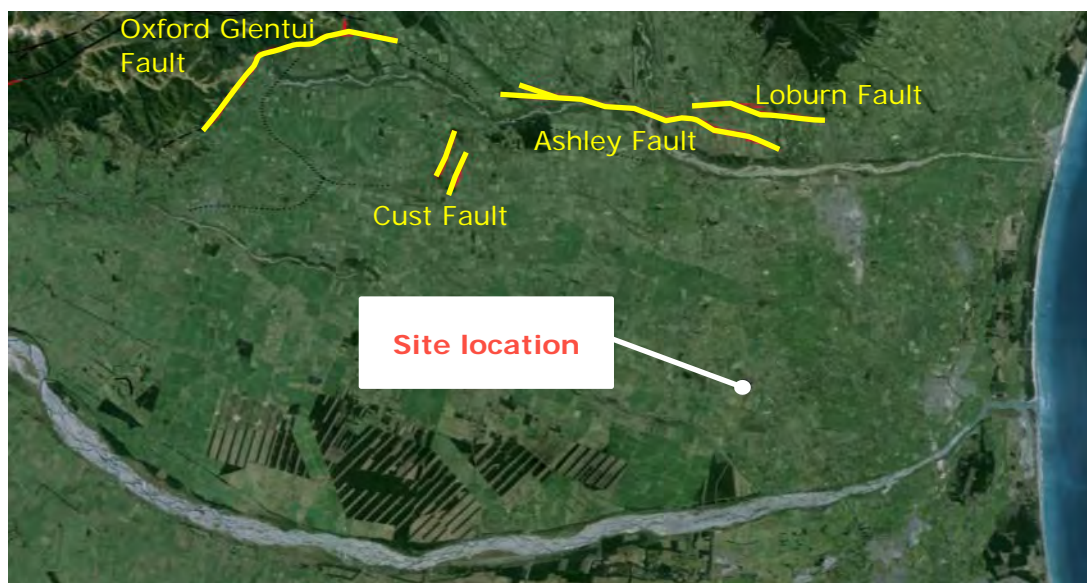
Figure 7 : Aerial photo of showing faults in the surrounding area. Source: CGD 2013

Geological & Nuclear Science's (GNS) Active Faults Database<sup>2</sup> notes the Ashley Fault is located approximately 12.5km northwest of the site and has an east-west orientation, and the Loburn Fault is located approximately 14kms northwest of the site and has an east-west orientation.

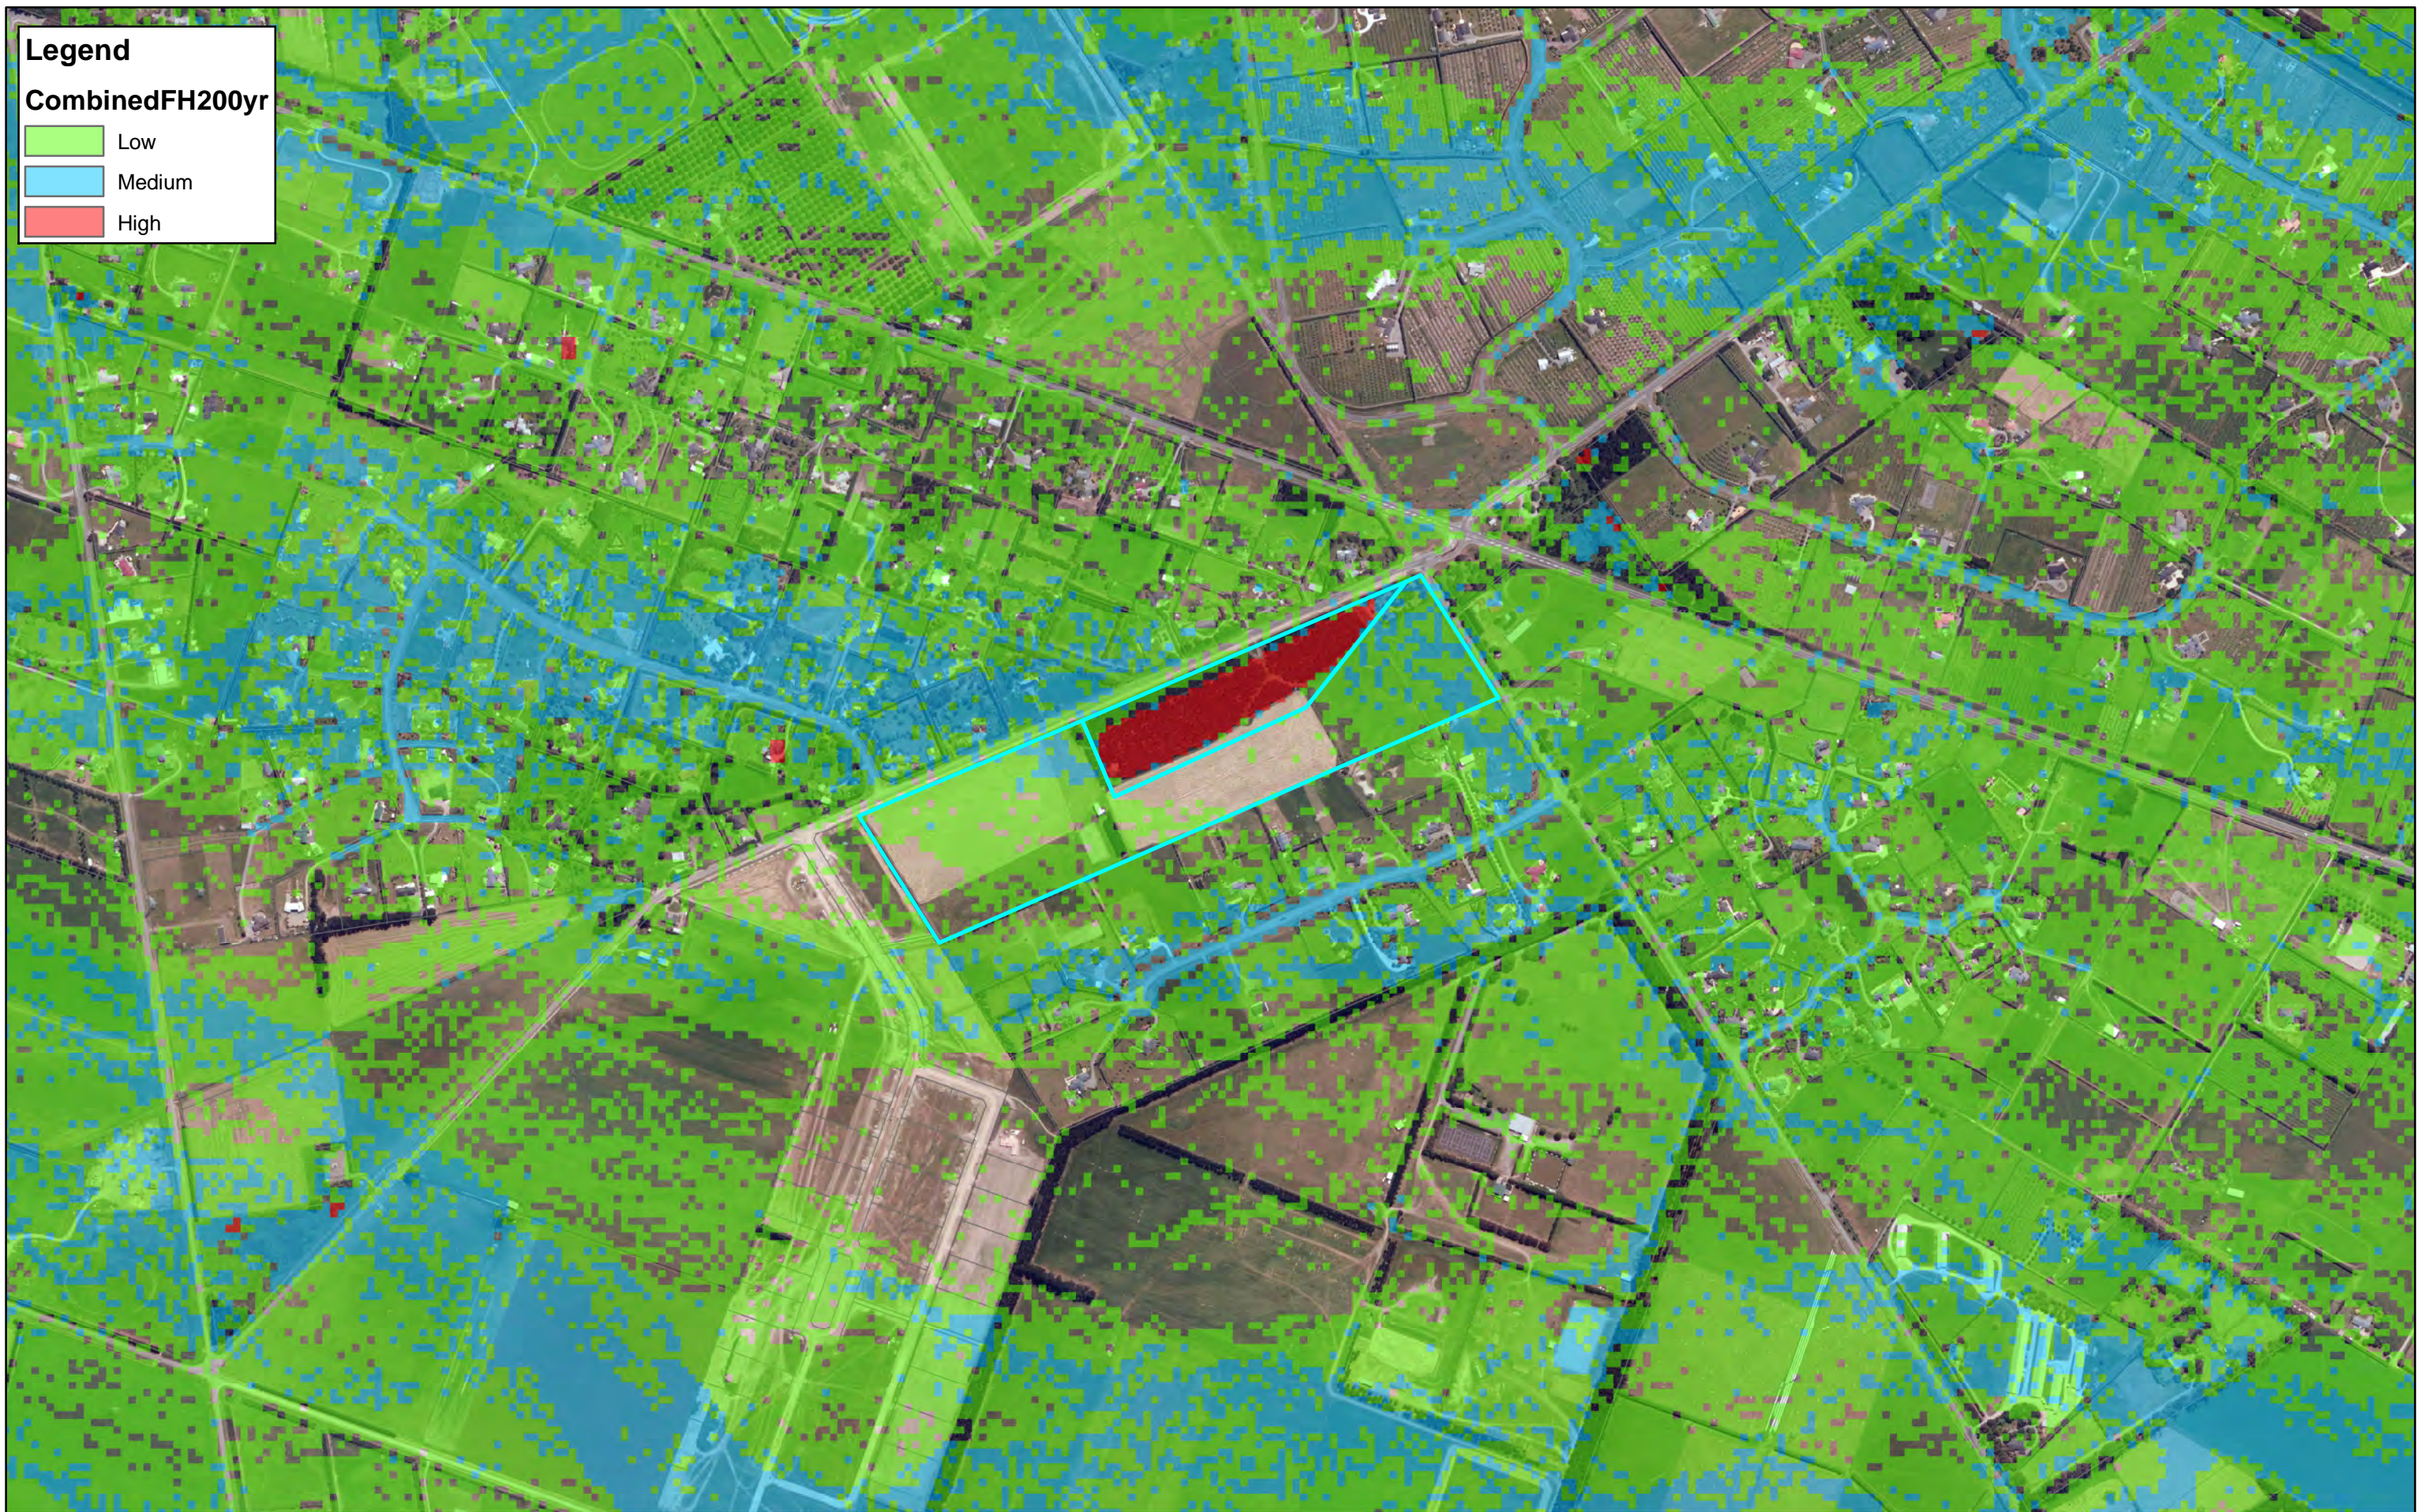
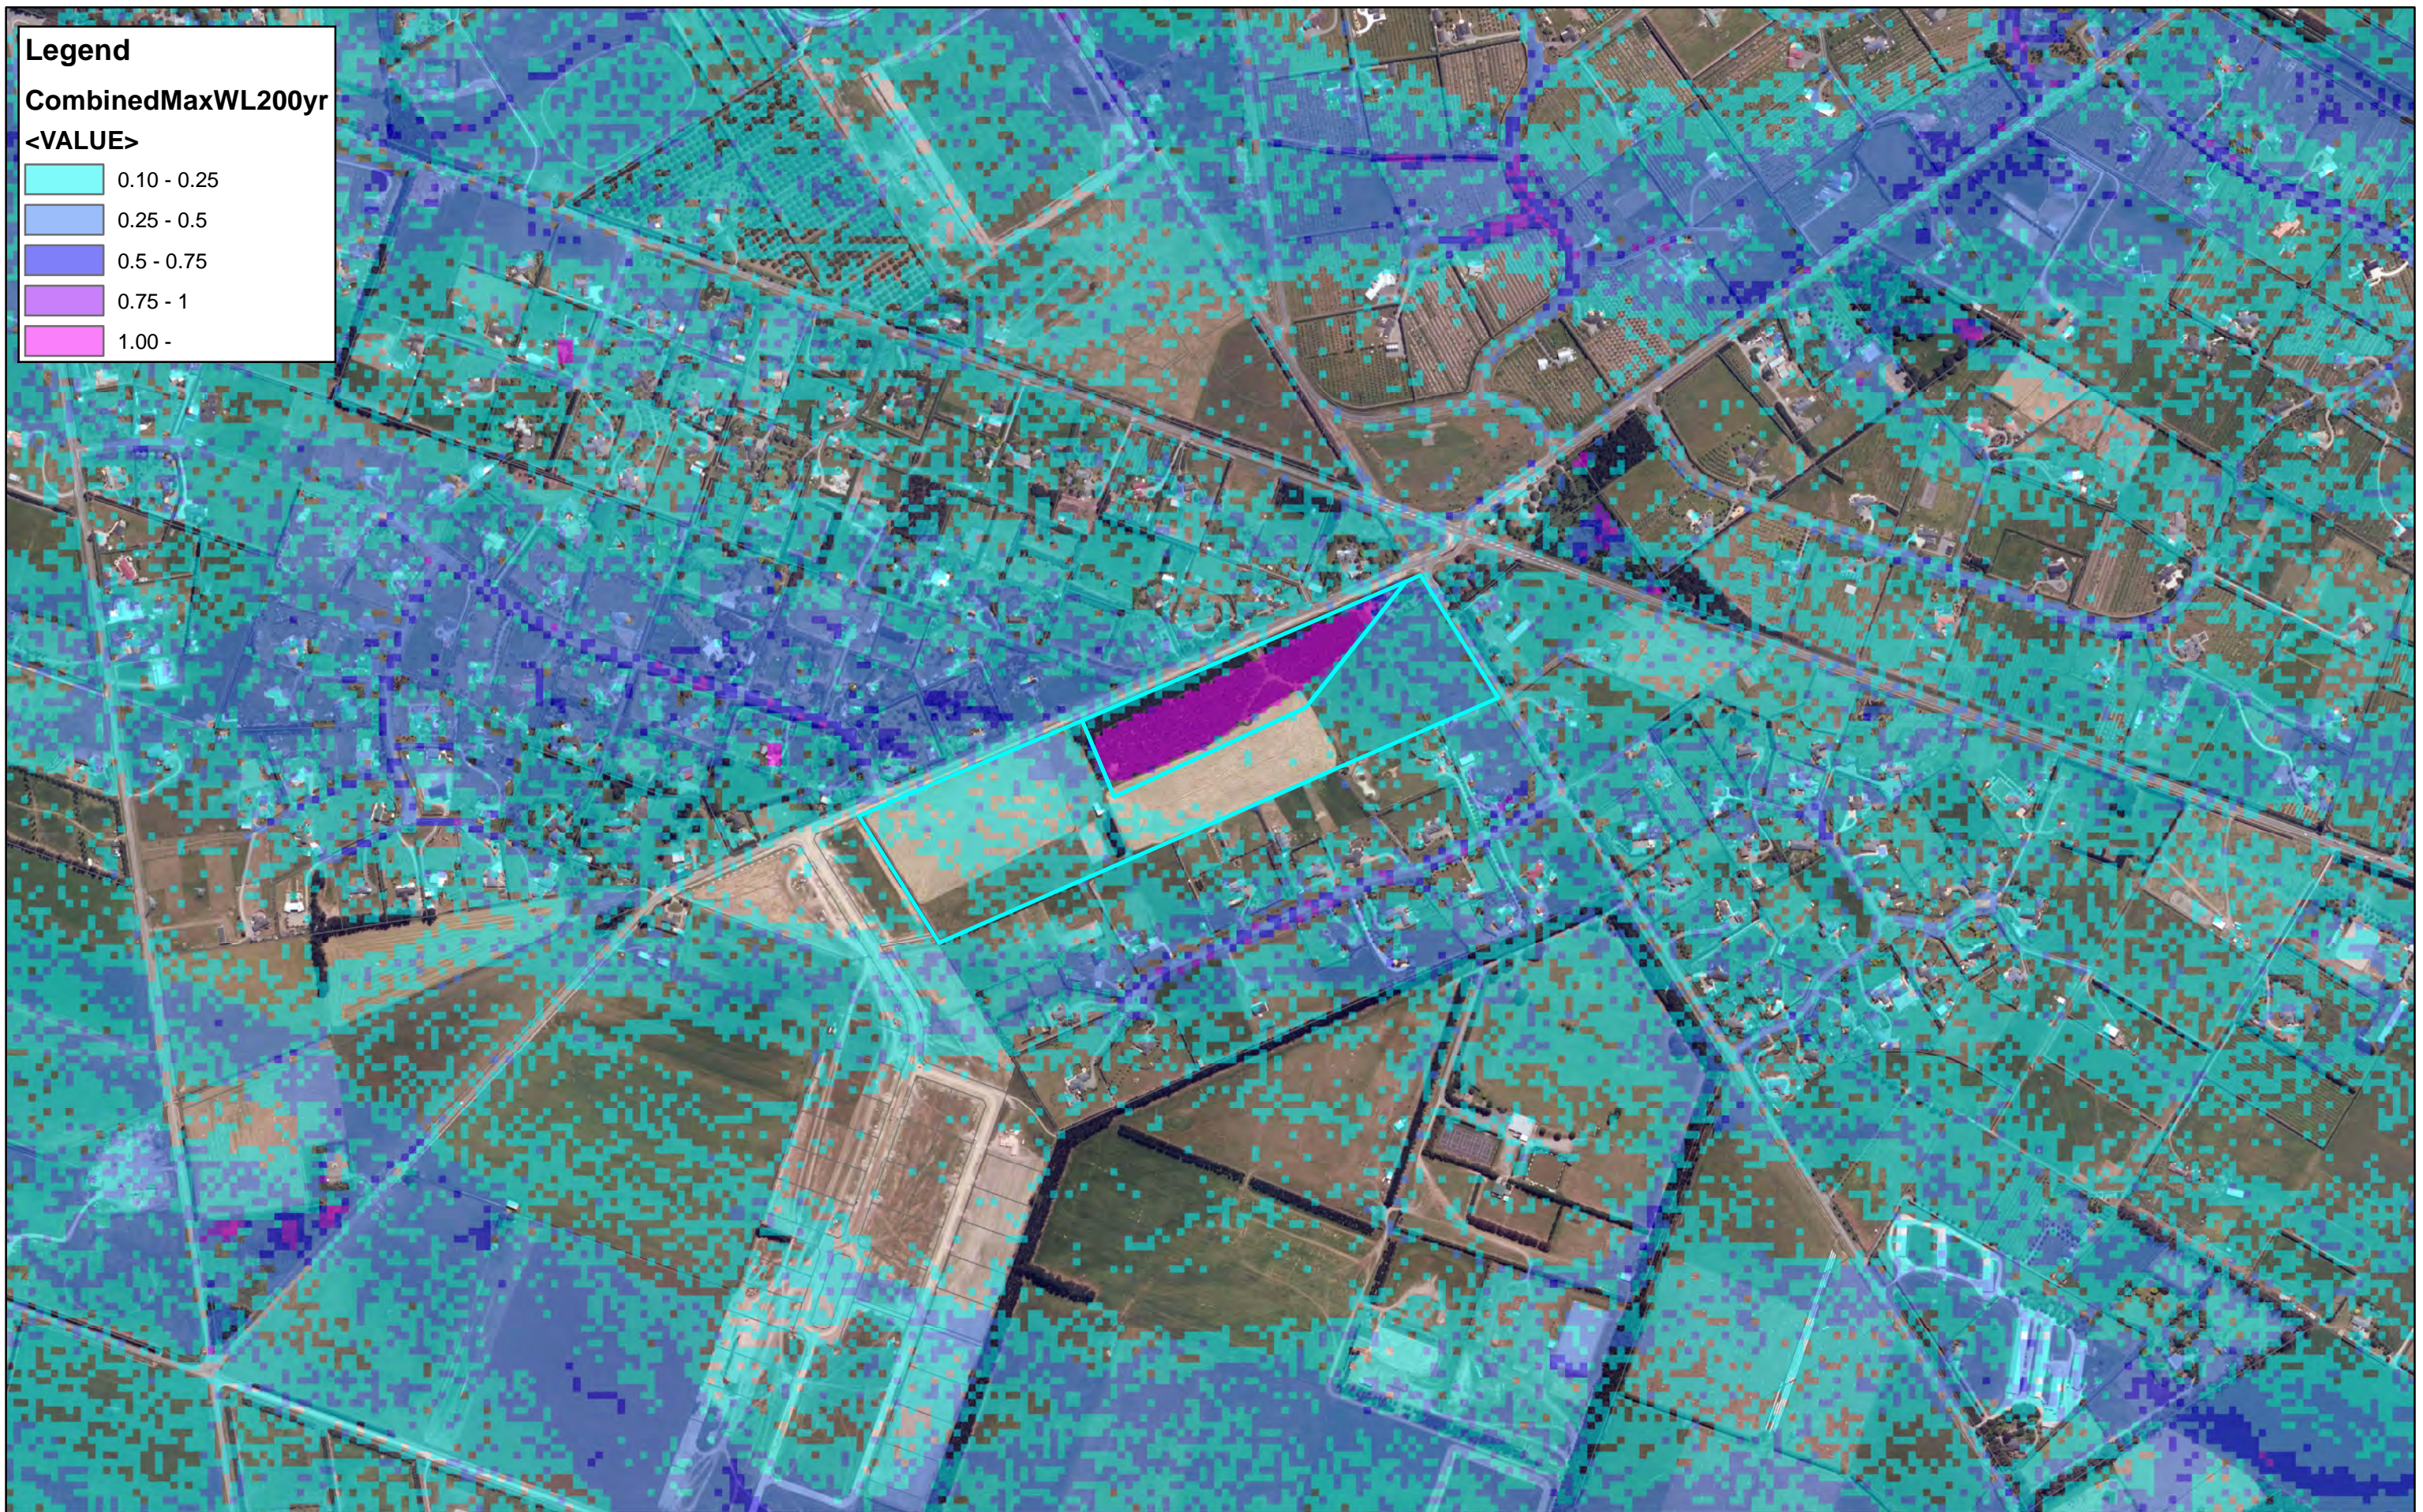
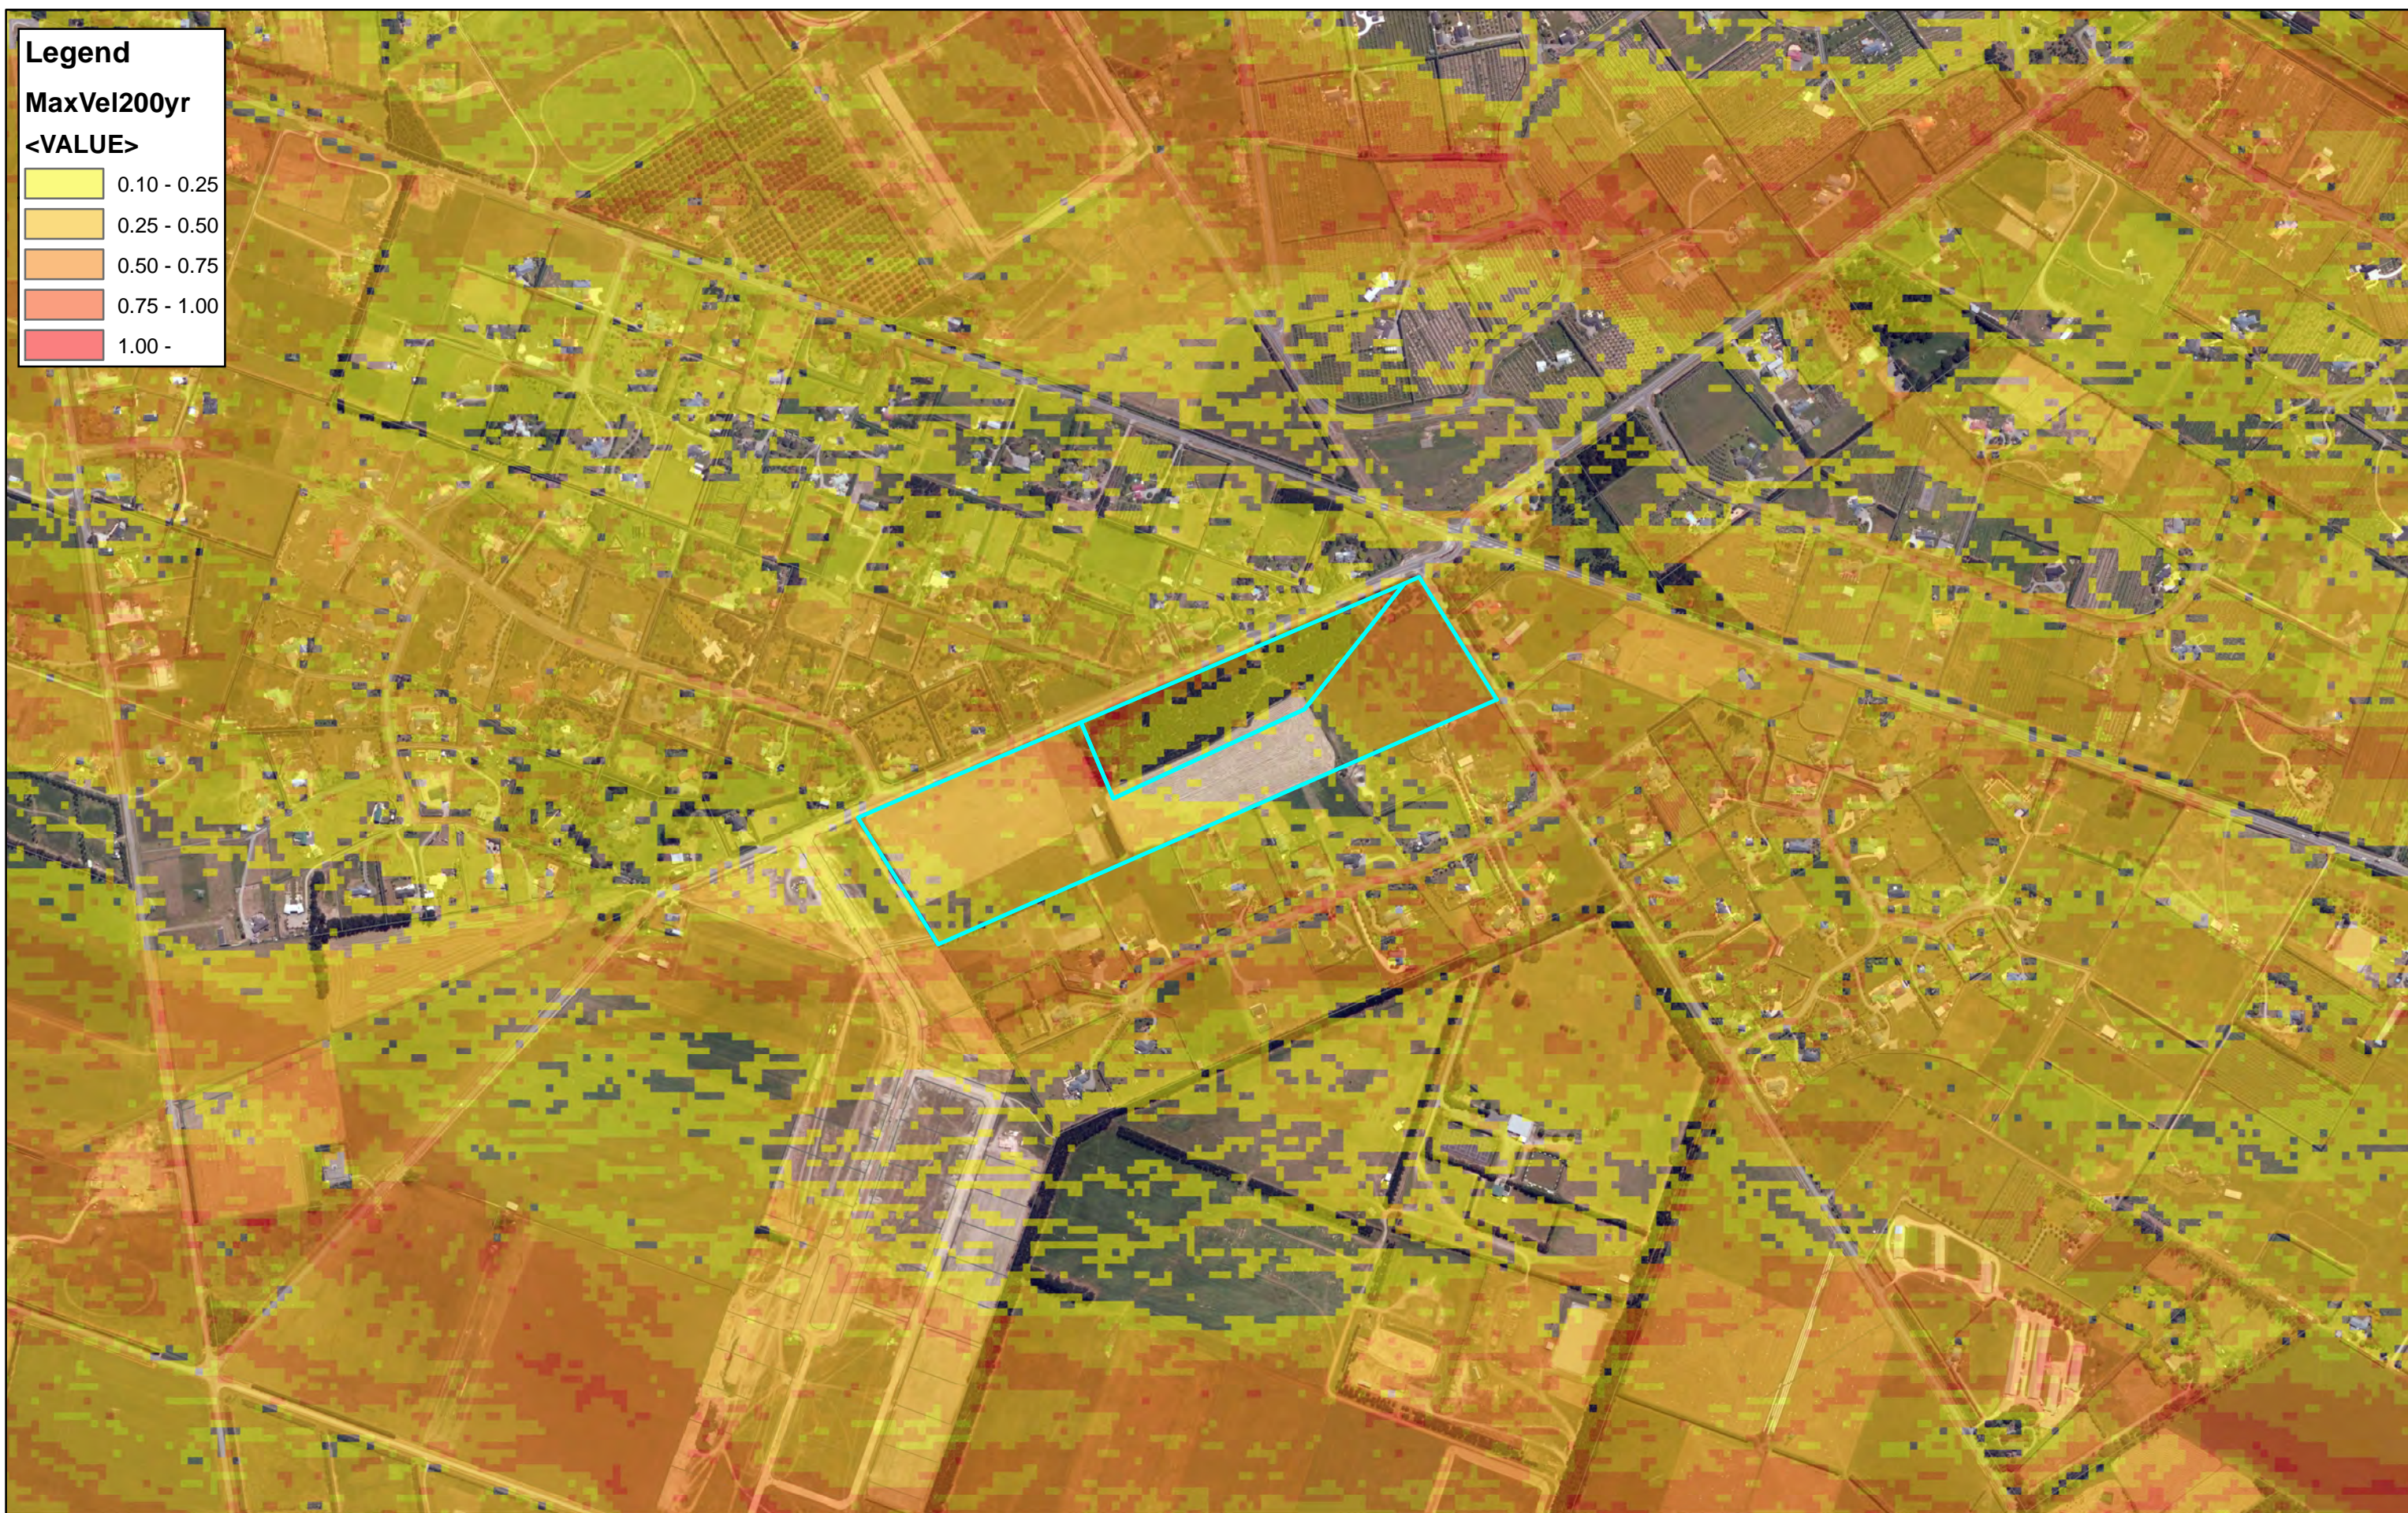
## Appendix B : FLOOD HAZARD MAPPING

Flood hazard data provided by the Waimakariri District Council titled '*116 and 148 McHughs Road*' indicates Lots 2 and 3 are generally at a '*low*' risk from flood hazard. The northeast parts of Lot 2 are indicated to be at '*medium*' risk of flooding in a 200 year event and estimates flood depths of up to 0.5m could occur in these areas.

There are areas on Lot 2 and Lot 3 which are shown to have no risk of flooding in a 200 year event.

The majority of Lot 1 is located below the surrounding ground level, and is estimated to be at '*high*' risk of flooding in a 200 year event with flood depths of greater than 1m in this area. There is a small area at the northeast corner of Lot 1 that is estimated to be at '*low*' and '*medium*' risk of flooding in a 200 year event, with much lower estimated flood depths up to 0.5m above existing ground level.

A large part of Lot 1 has previously been quarried and is now around 2 to 3m below the surrounding land and the Waimakariri District Council 200 Year ARI Flood Level Map indicates that most parts of proposed Lot 1 are at 'high' risk of flooding, other than the northeast corner where the depth of flooding is typically around 0.5m above ground level.

There are areas on Lot 2 and Lot 3 which are not at risk of flooding in a 1:200 year event, however this does not prevent other parts of the site that are at risk being used for building providing floor levels are set at an appropriate level to avoid a likely risk of inundation.

The flood height at the building platform of proposed Lot 1 can not be easily determined from the modelling, and therefore specific engineering investigation at the time of building consent should be undertaken. Alternatively, a pragmatic level would be to adopt the nearest crown of McHughs Road as a minimum floor level for the proposed Lot 1 building platform.

- All new foundations shall be subjected to specific engineering design and investigations.
- All foundation excavations shall be inspected by an experienced engineer to ensure there is no historic uncontrolled fill present.
- The ground levels in the area of the Lot 1 building platform should be raised by control filling in order to mitigate the existing risk of inundation to the Lot 1 building platform.
- Any new dwellings on Lot 1 shall be located within the nominated building platform and shall have a minimum finished floor level at, or above, the crown level of McHughs Road, nearest to the building platform, unless a lower level is determined appropriate by a future specific engineering investigation.

- All new foundations shall be subjected to specific engineering investigation and design.
- Any new building shall be located within the nominated building platform.
- Minimum floor levels shall be specified by the Council at time of Building Consent.
