Preliminary Site Investigation

518 Rangiora Woodend Road & 4 Golf Links Road, Rangiora, Canterbury

Prepared for CVI Projects Ltd

511185

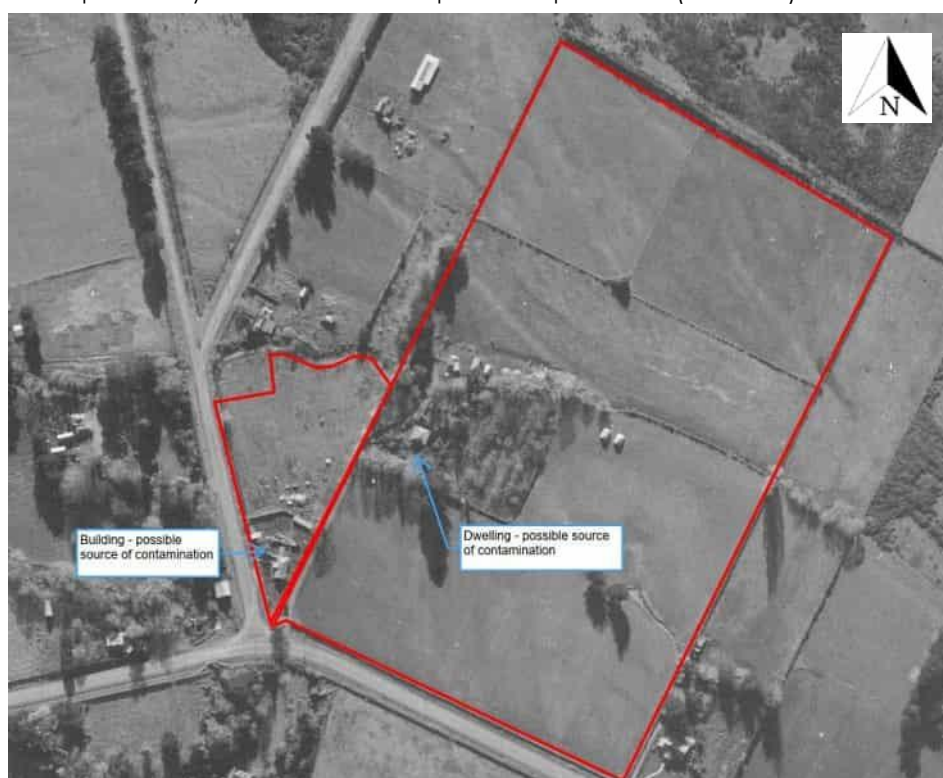
Figure 3. Site between 1940-1944 (Retrolens).

Figure 3 shows the first appearance of a dwelling on 518 Rangiora Woodend Road and a building on 4 Golf Links Road. Due to the date of its construction – prior to 1944, the risks of soil contamination by asbestos and lead-based paint (**HAIL I**) exist. Although this cannot be confirmed, the likelihood of that building to have been a “shearing” shed or a building used for an activity related to sheep/cattle treatment cannot be ruled out, particularly the structures on the north side of the building which could have been part of a sheep treatment/management. This activity would be related to **HAIL A8** : Livestock dip or spray race operations. The entire site seems to be used for agricultural/pastoral activities which potentially involved the use of persistent pesticides (**HAIL A10**).

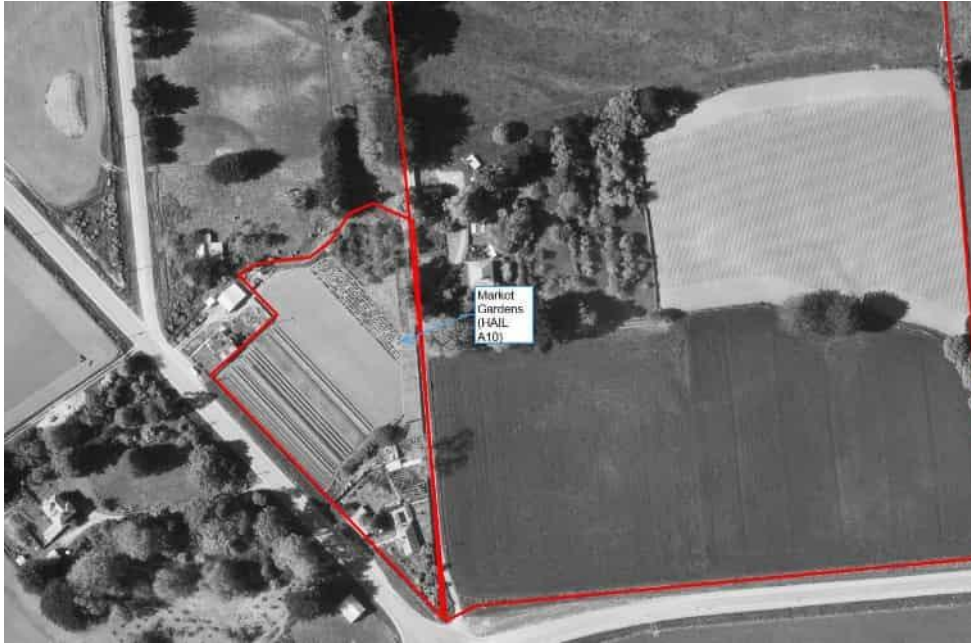
Figure 5. Site between 1960-1970 (Retrolens).

Figure 5 clearly shows market gardens on 4 Golf Links Road, indicating the likely Hail A1 0 of persistent pesticide bulk storage and use. This activity carried on for many years with its first appearance in 1963 and carrying on through till the 1990's.

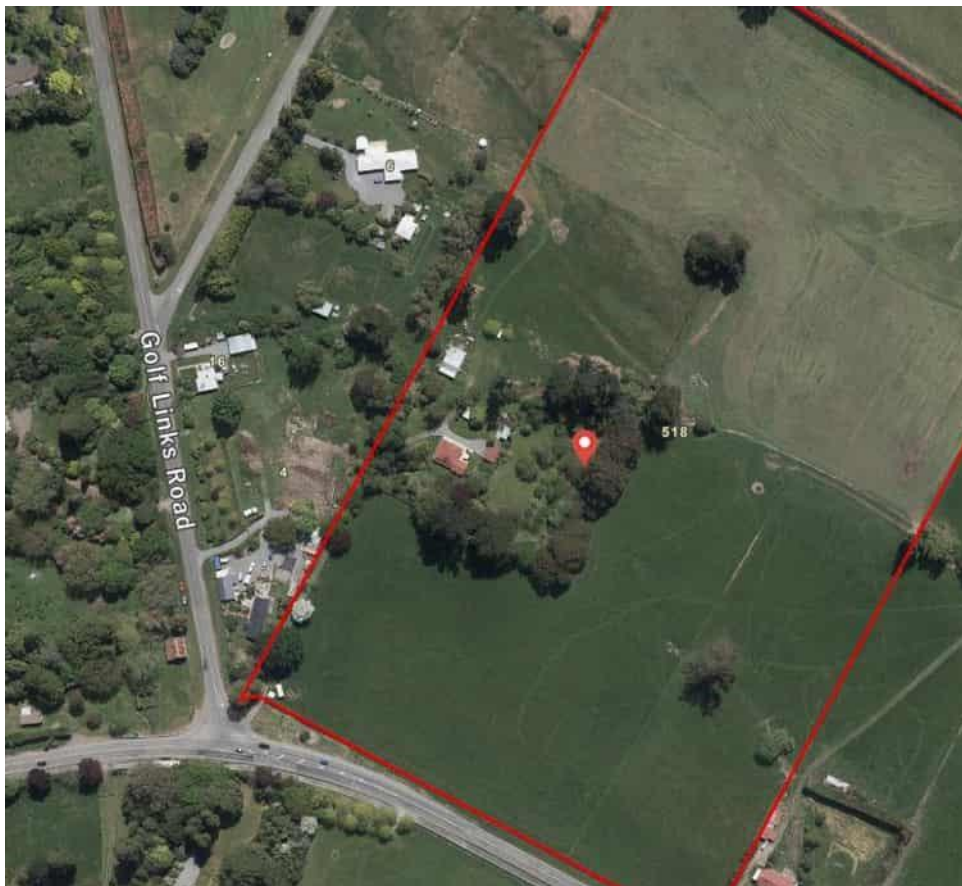
Figure 6. Site between 2015 – 2019 (Canterbury Maps)

Figure 6 shows stockpiles near the shed on 51 8 Rangiora Woodend Road. Exposed soil in around the trees and to the northeast of the dwelling.

New driveway being developed and buildings on 4 Golf Links Road. Exposed soil where garden was.

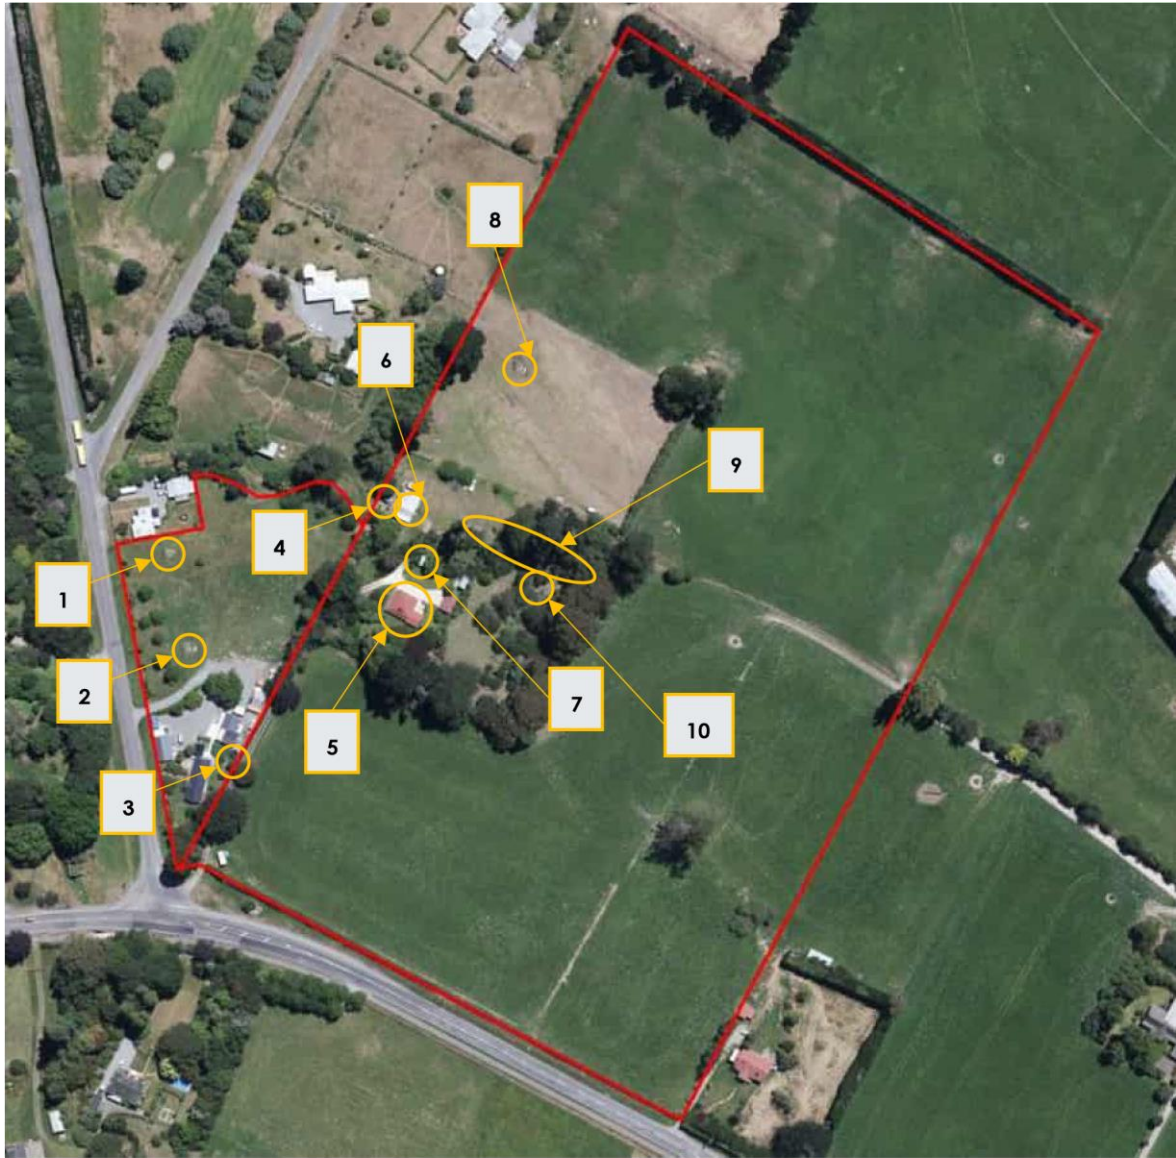
Figure 7. Locations of Interest at 518 Rangiora Woodend Road and 4 Golf Links Road (Eliot Sinclair Maps, 2023).

1. Mound of deposited fill (**HAIL G3**).
2. Burn pad with evidence of household rubbish being burned (**HAIL I**).
3. Septic waste system. Unsure of the nature of the wastewater disposal system.
- 4 Storage of empty and rusted drums. It is not known what these may have used to hold but the risk of chemicals being lost to ground cannot be ruled out (**HAIL I**).
5. Residential dwelling from 1940's. The presence of asbestos and lead based paint in a degraded condition cannot be ruled out (**HAIL I**).
6. Farm sheds/workshops that contain a variety of commercial/industry grade products (herbicide/pesticides, oils, paints, etc) on bare ground. **HAIL I** and **HAIL A10** cannot be ruled out.

7. Farm sheds/workshops that contain a variety of commercial/industry grade products (herbicide/pesticides, oils, paints, etc). **HAIL I** and **HAIL A10** cannot be ruled out.
8. Burn pad with evidence of household rubbish being burned (**HAIL I**).
9. Treated timber posts stored on ground along with a variety of farm incidentals (**HAIL A18**)
10. Long drop toilet.

- c) **However**, we recommend that the areas outlined as potential HAIL areas undergo additional detailed site investigation (DSI) in terms of the Ministry for the Environment's Contaminated Land Management Guidelines to establish the nature, degree, and extent of contaminants distribution.
