25 November 2021

## Risk of Natural Hazards & Soil Contamination at 163 ~ 203 Johns Rd, Rangiora

Eliot Sinclair were engaged to undertake a desktop review of the geotechnical conditions, and to comment on any obvious risk of natural hazards for 163 Johns Road, Rangiora.

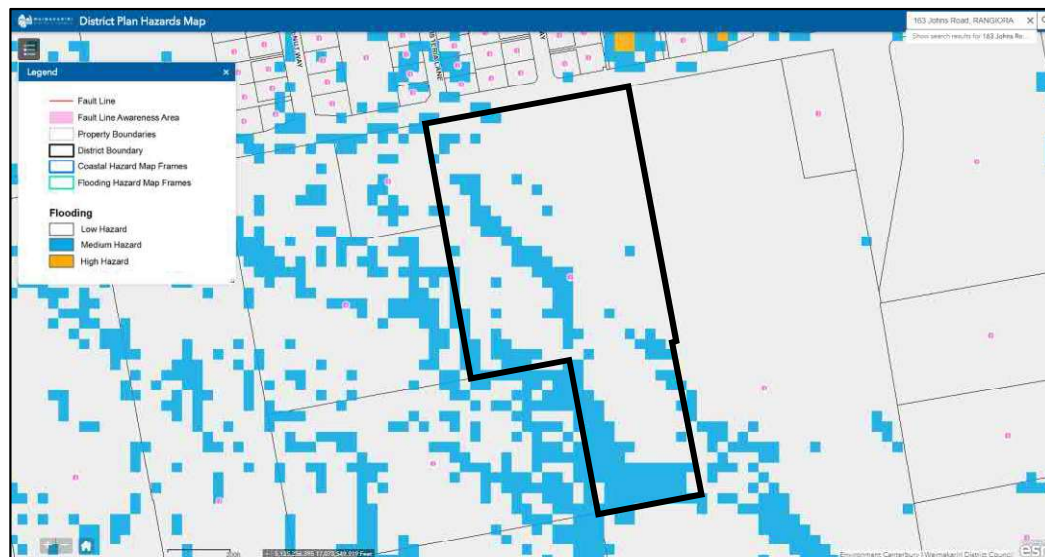
Figure 9: Waimakariri District Plan's Hazards Map, February 2018.

The Waimakariri District Plan's Hazards Map<sup>8</sup> indicates there is a 'medium hazard' of flooding across the central to south parts of the site, along what may be a shallow surface depression. Refer to Figure 9.

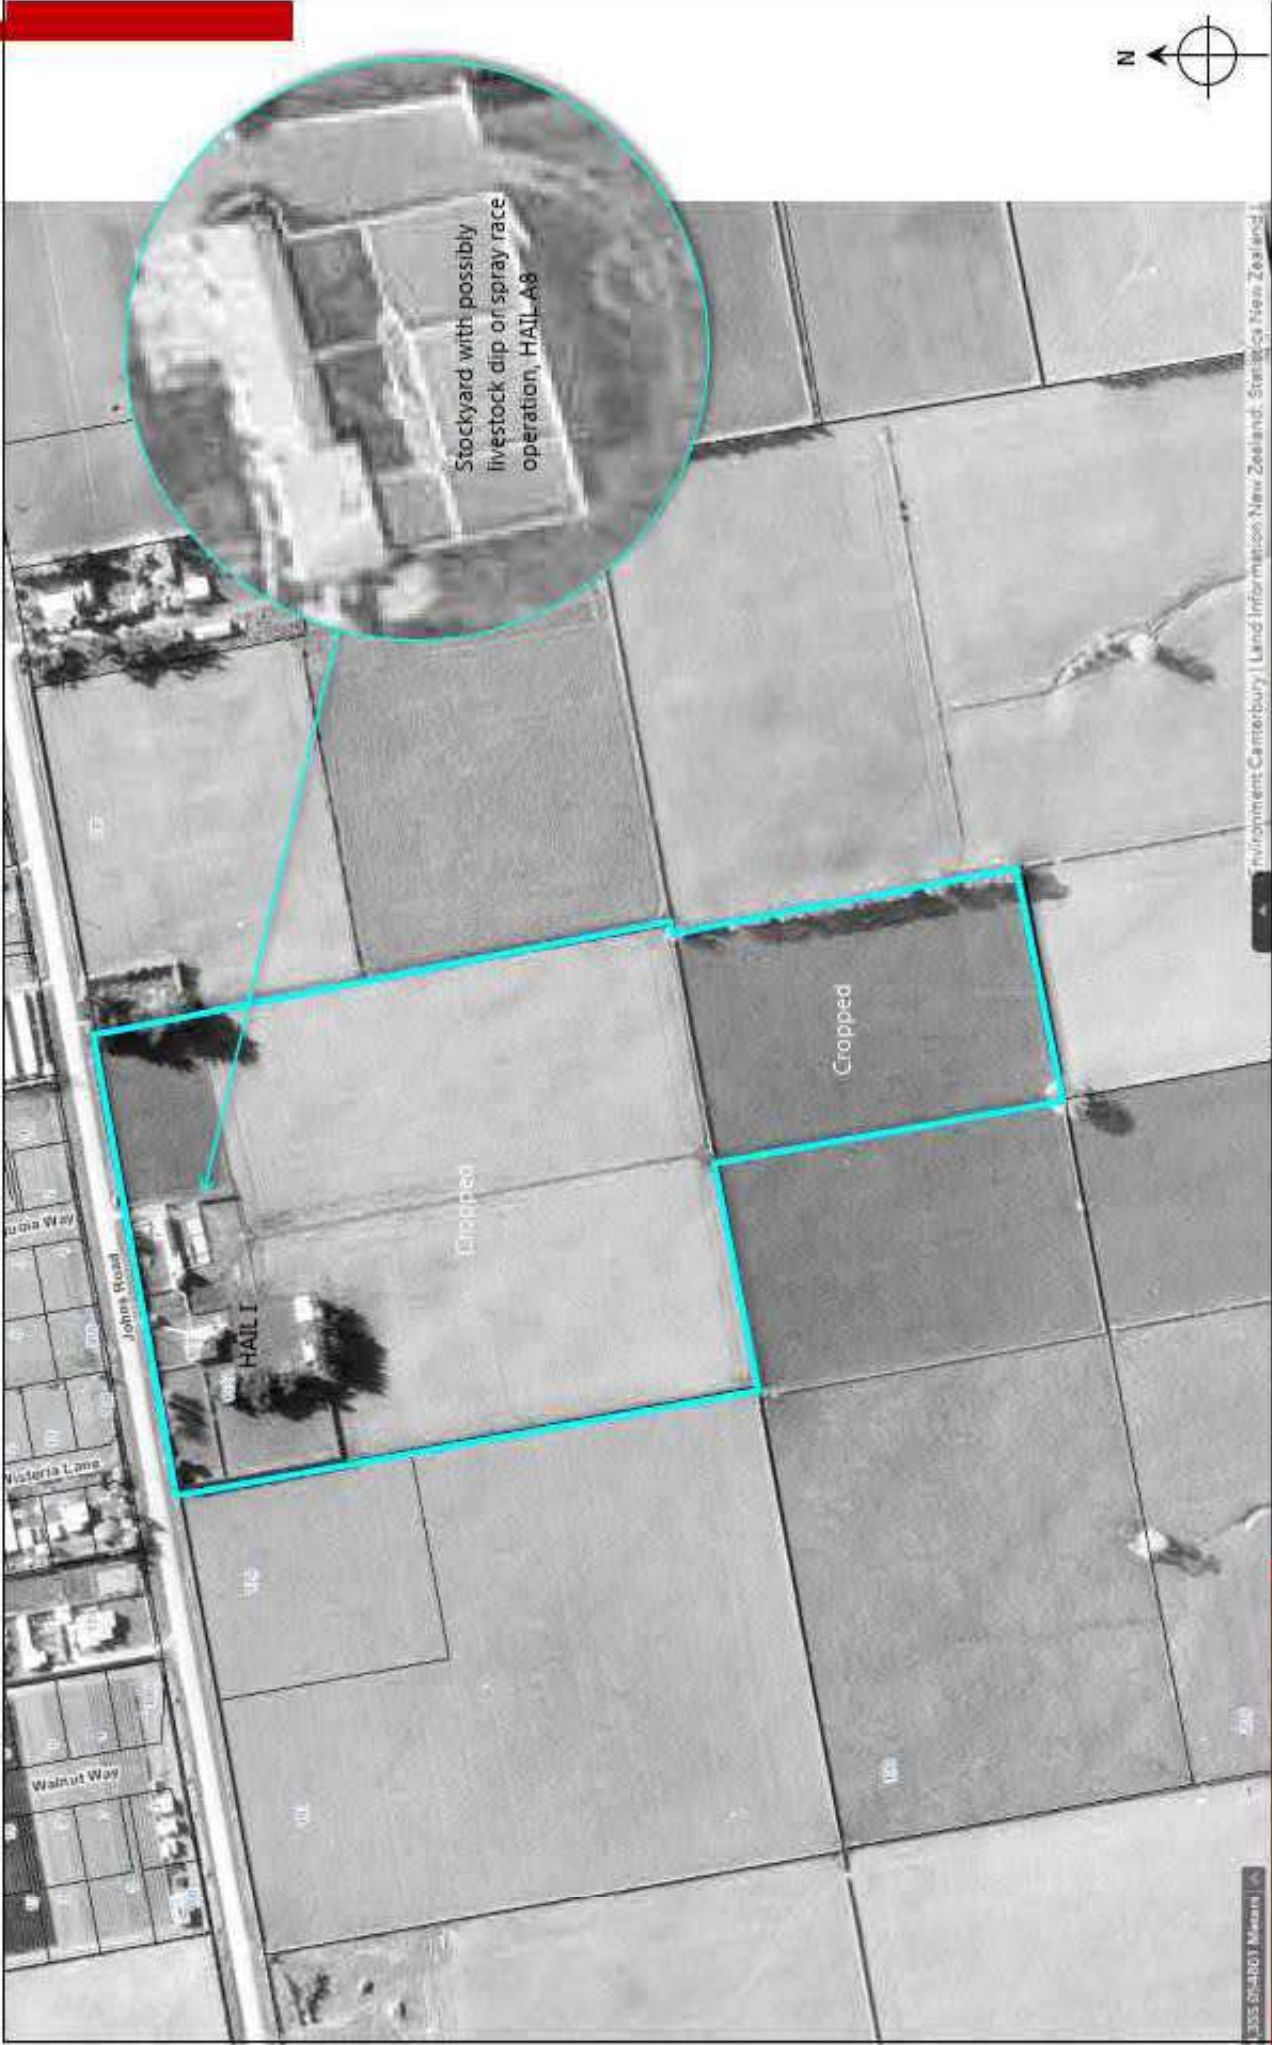
Stockyard with possibly livestock dip or spray race operation, HAIL A8

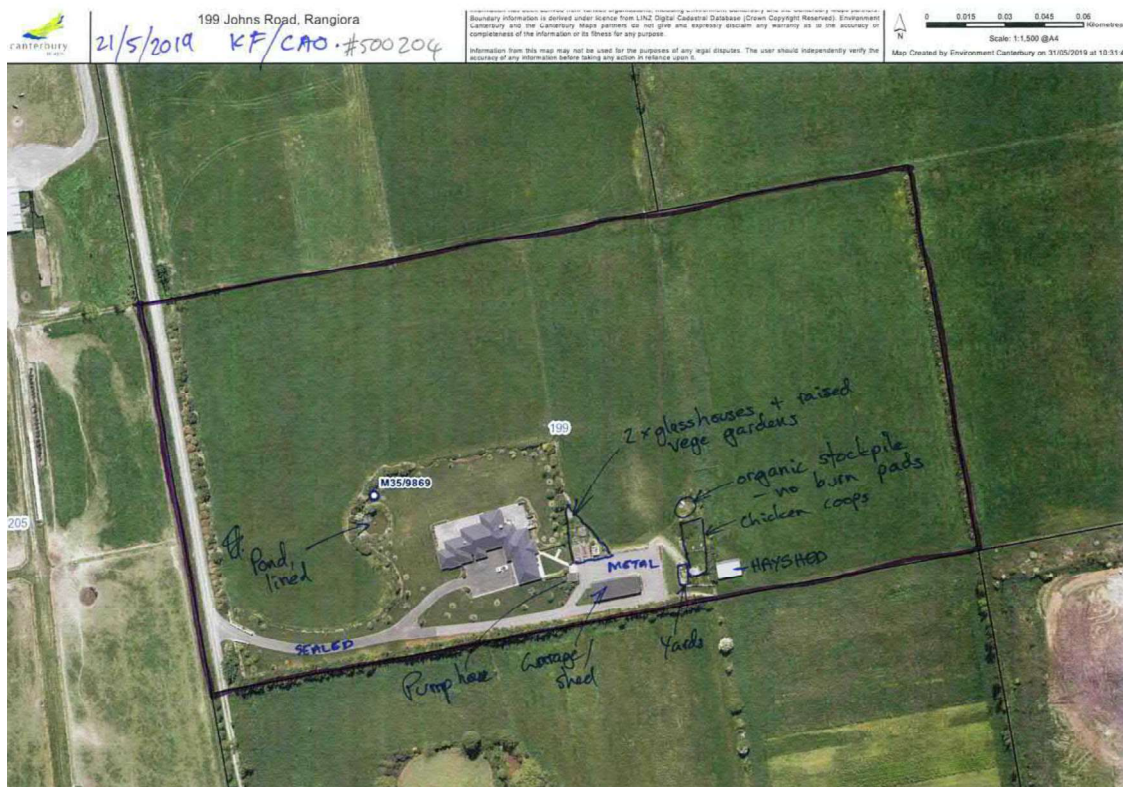
Figure 2: Land-uses identified during the site inspection.

A site walkover by an Eliot Sinclair environmental scientist was undertaken on 21 May 2019. Field notes with observations are summarised in Figure 2. Two residential-size glasshouses were established post year 2000 and are not considered a HAIL activity. The organic stockpile to the north of the chicken coop did not show signs of burning activities. No further HAIL activities have been identified during the walkover. Photographs from the site inspection are attached in Appendix C.

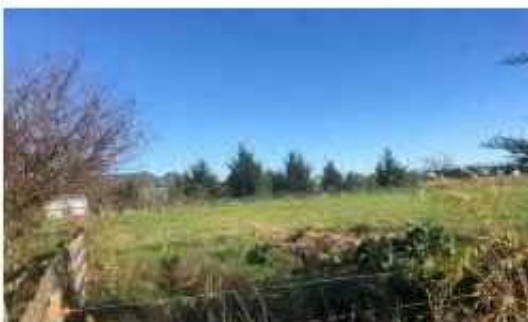
Photo 5. Compost (no signs of burning activities)

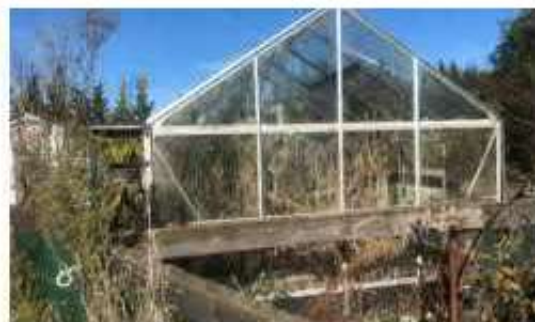
Photo 6. Disused domestic glasshouse
