Project Number #25142.000.001

Geotechnical Investigation

Judsons Road and Petries Road, Woodend,
Canterbury

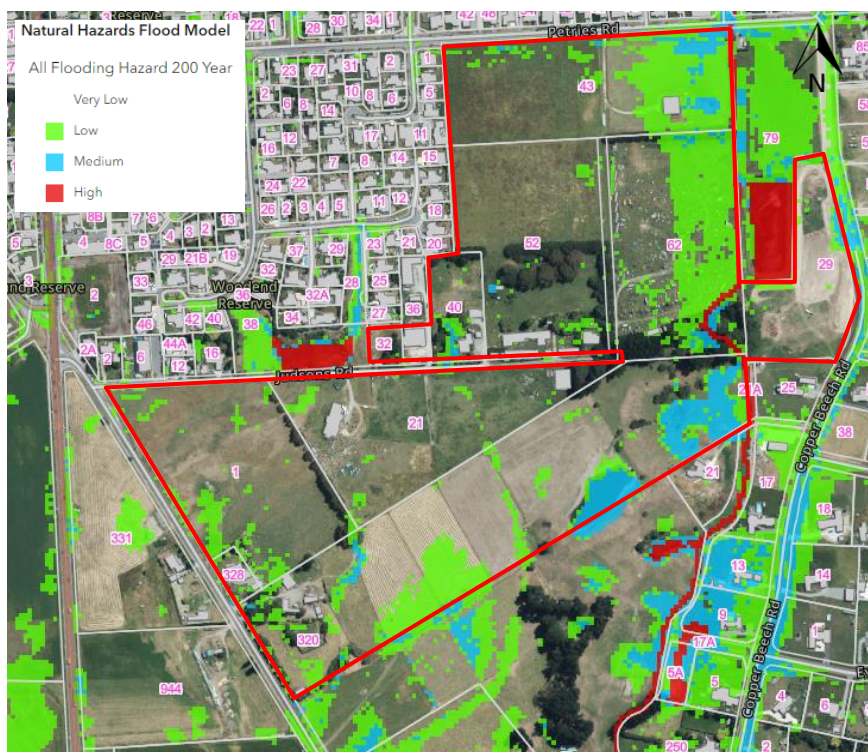
Figure 1: Flood Hazard Mapping

We have reviewed the Waimakariri District Council GIS database and have presented a snapshot of the map with the approximate site boundary overlain (Figure 1). The mapping indicates that parts of the eastern and southern sides of the site may be subject to a medium flood hazard (defined as inundation depth of greater than 0.3 m) during a 1 in 200 year flood event. A high flood hazard has been associated with the current stream channel for the 1 in 200 year flood event.

Image sourced from the Waimakariri District council Hazard Maps.

We also recommend that the flooding hazard (noted in Section 3.2.4) is considered during civil engineering subdivision design.

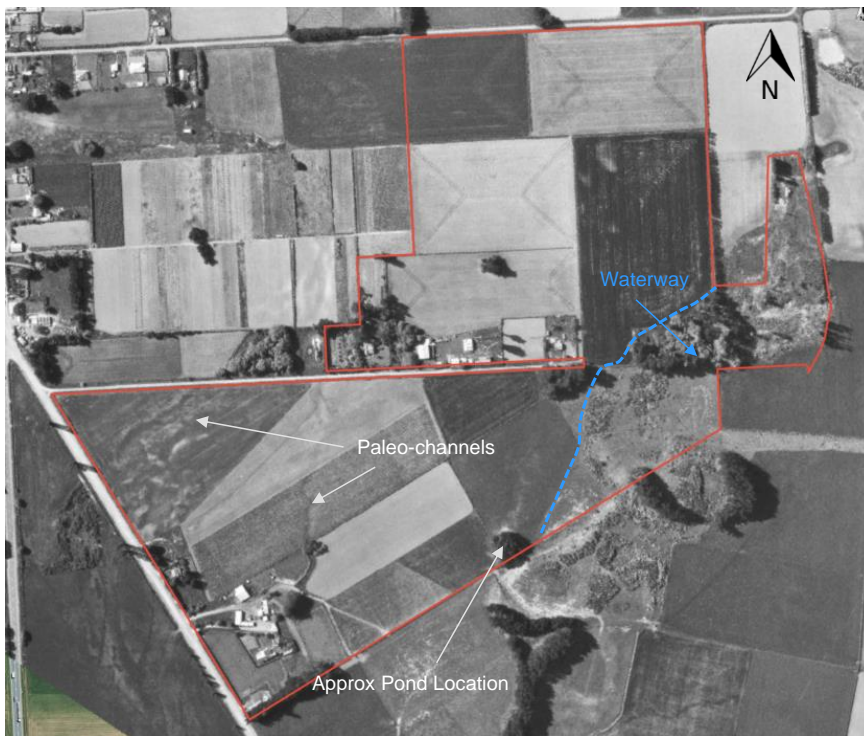
Figure 2: 1965-1969 Historic Aerial

The site appears to have been used as agricultural grazing land since the earliest available photograph in 1940. In this photograph a stream channel and associated drainage basin is present in the east of the site, generally running northeast to southwest. The channel enters the site to the northeast of the wooded area at the end of Judsons Road. Paleo channels were also noted on the western side of the site in the 1965-1969 aerial photograph. These are generally orientated north to south. We have highlighted these significant features in Figure 2.

The waterway on the eastern side of the site appears to have been partially infilled between the 1965-1969 and the 1970-1974 aerial photograph. A pond is also noted to the southeast of the site (west of the waterway) in the 1970-1974 aerial photograph. This pond appears to periodically dry out and is still present in the current aerial photograph.

Image sourced from Canterbury Maps.
