PROJECT **Westpark Rangiora  
Rangiora**

# DYNAMIC CONE (SCALA) PENETROMETER TEST RECORD

**Environmental Site Assessment**

100 Oxford Road and 198 Lehmans Road,  
Rangiora

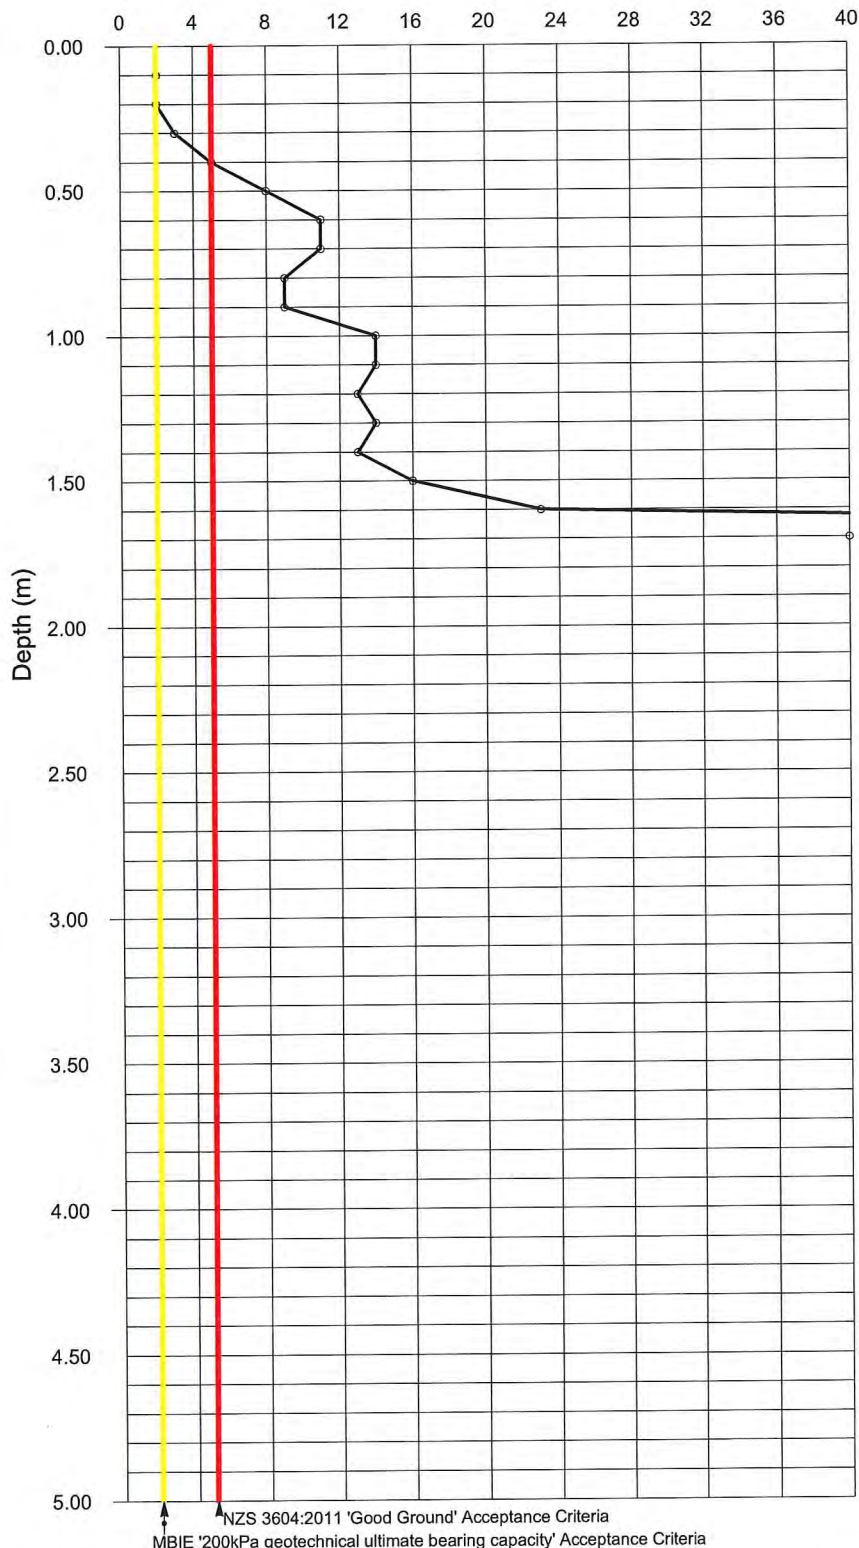
**Number of blows per 100mm**

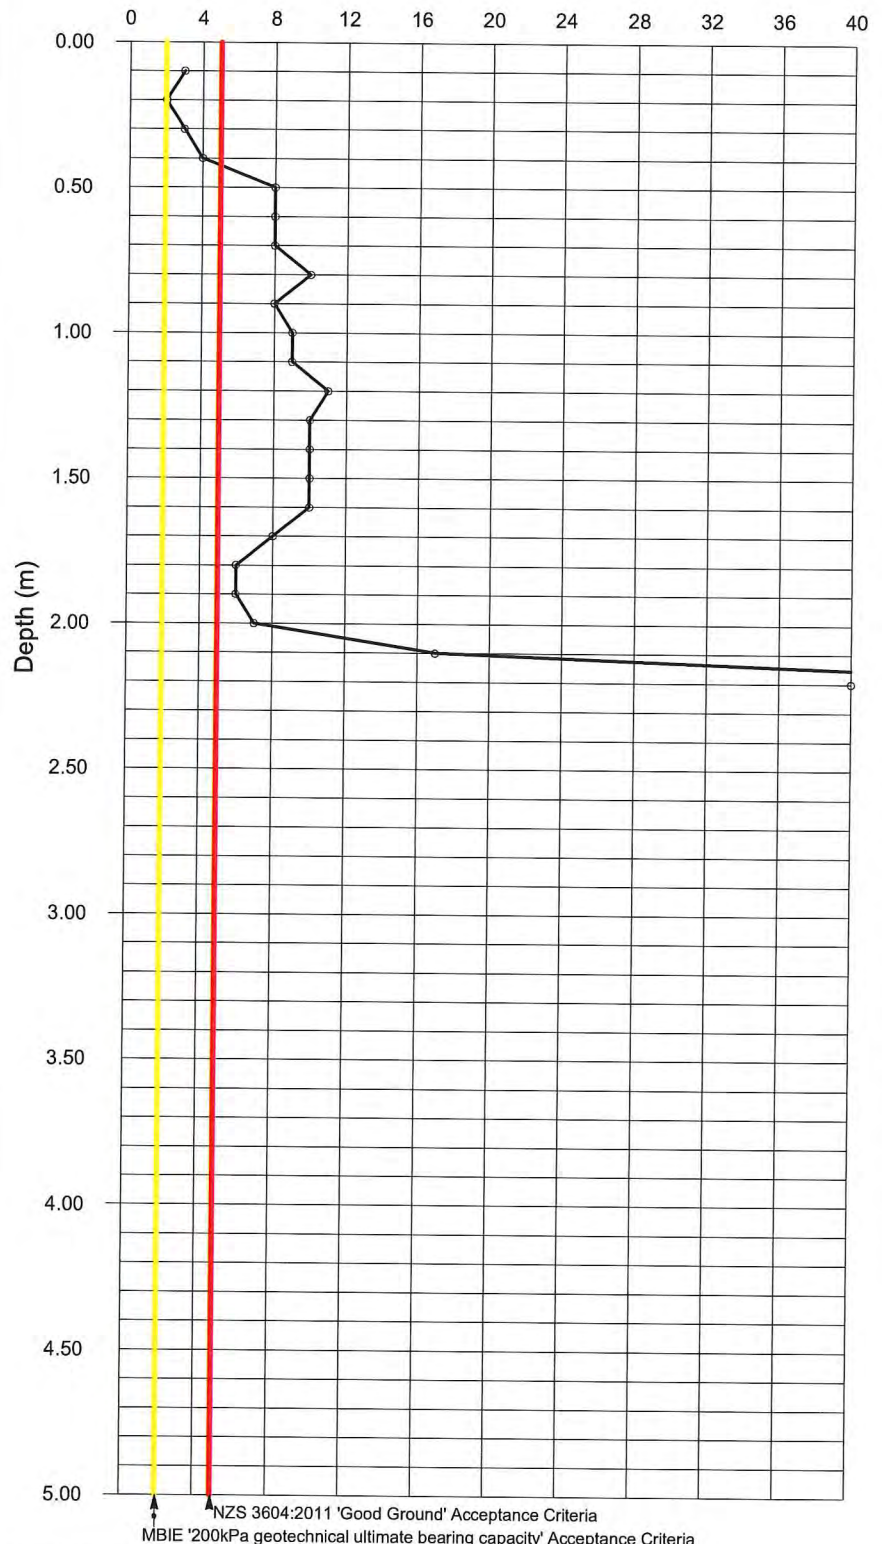
**Remarks:**

30 blows for 50mm in the last increment.

Effective refusal; 20+ blows per 100mm penetration.

**Number of blows per 100mm**

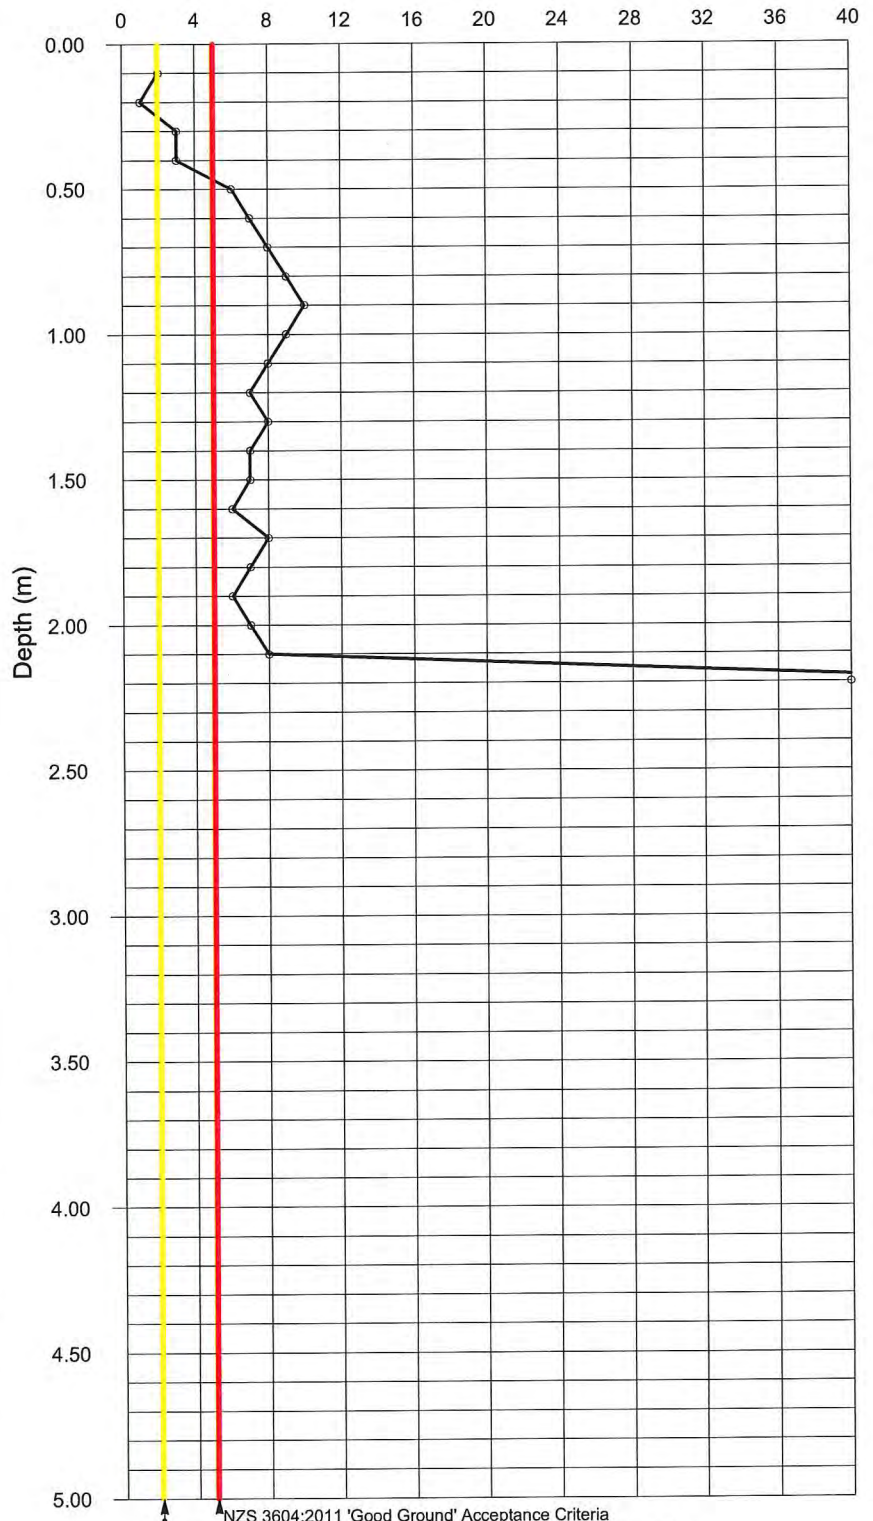
SCALA PENETROMETER NO.  
**DCP 5**

## Number of blows per 100mm

25 blows for 50mm in the last increment.

Effective refusal; 20+ blows per 100mm penetration.

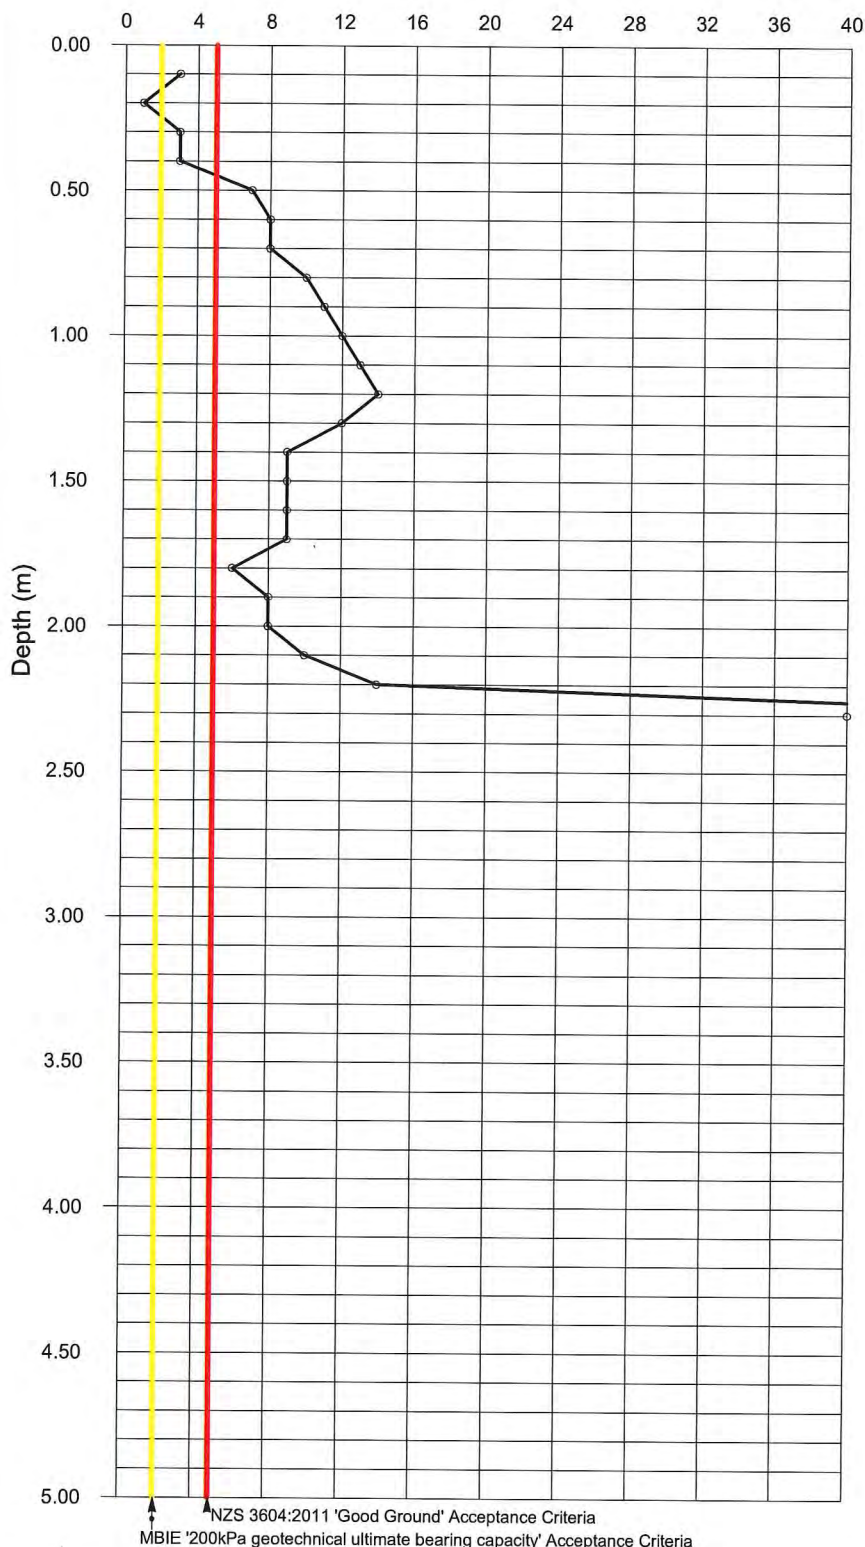
30 blows for 50mm in the last increment.

Effective refusal; 20+ blows per 100mm penetration.

**Number of blows per 100mm**

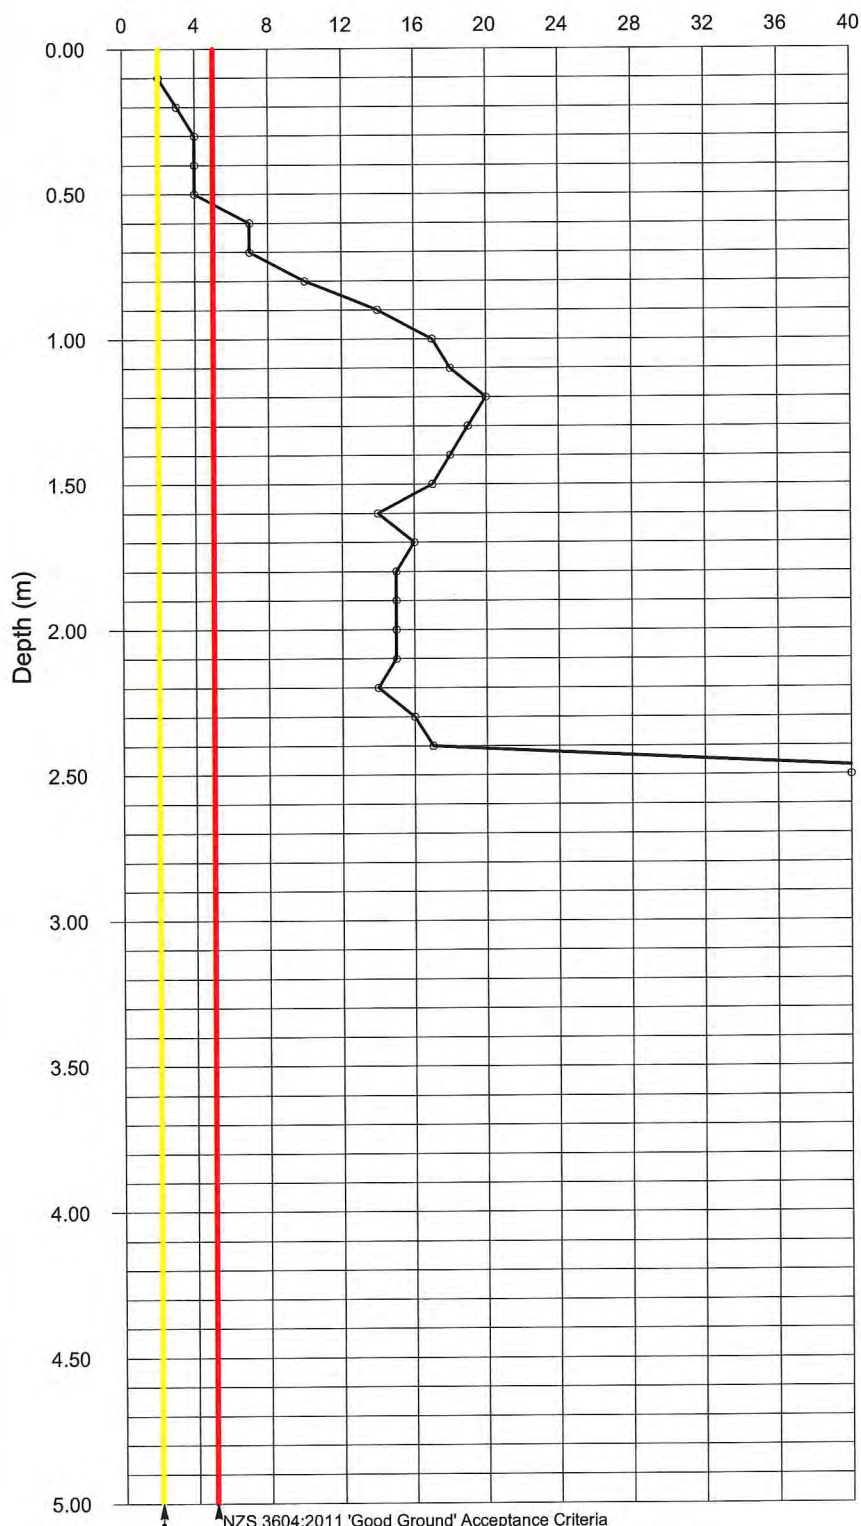
25 blows for 50mm in the last increment.

Effective refusal; 20+ blows per 100mm penetration.

## Number of blows per 100mm

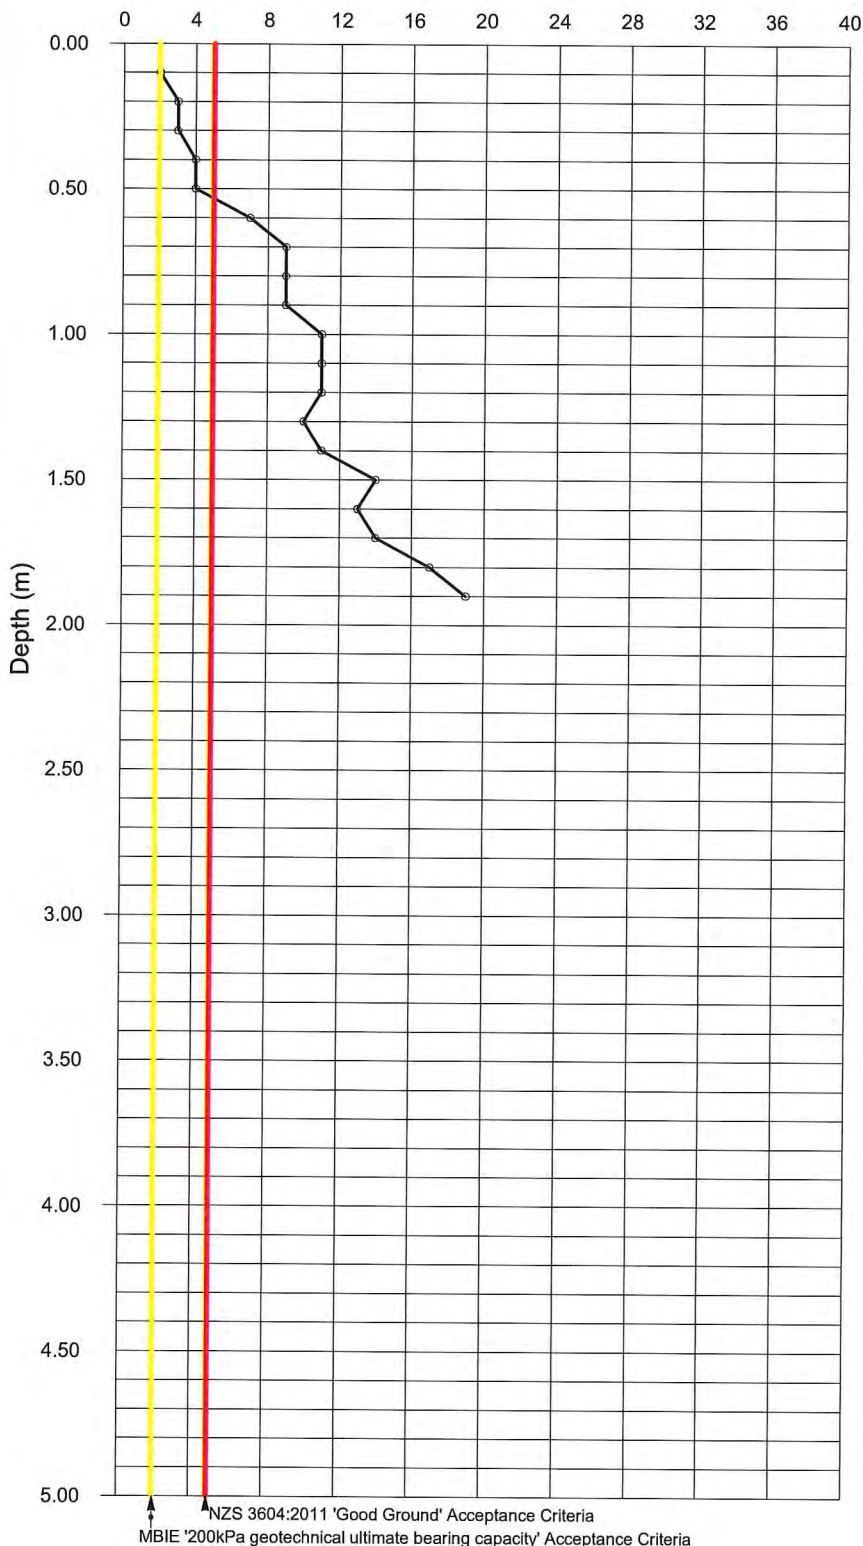
19 blows for 100mm in the last increment.

Effective refusal; 20+ blows per 100mm penetration.

**Number of blows per 100mm**

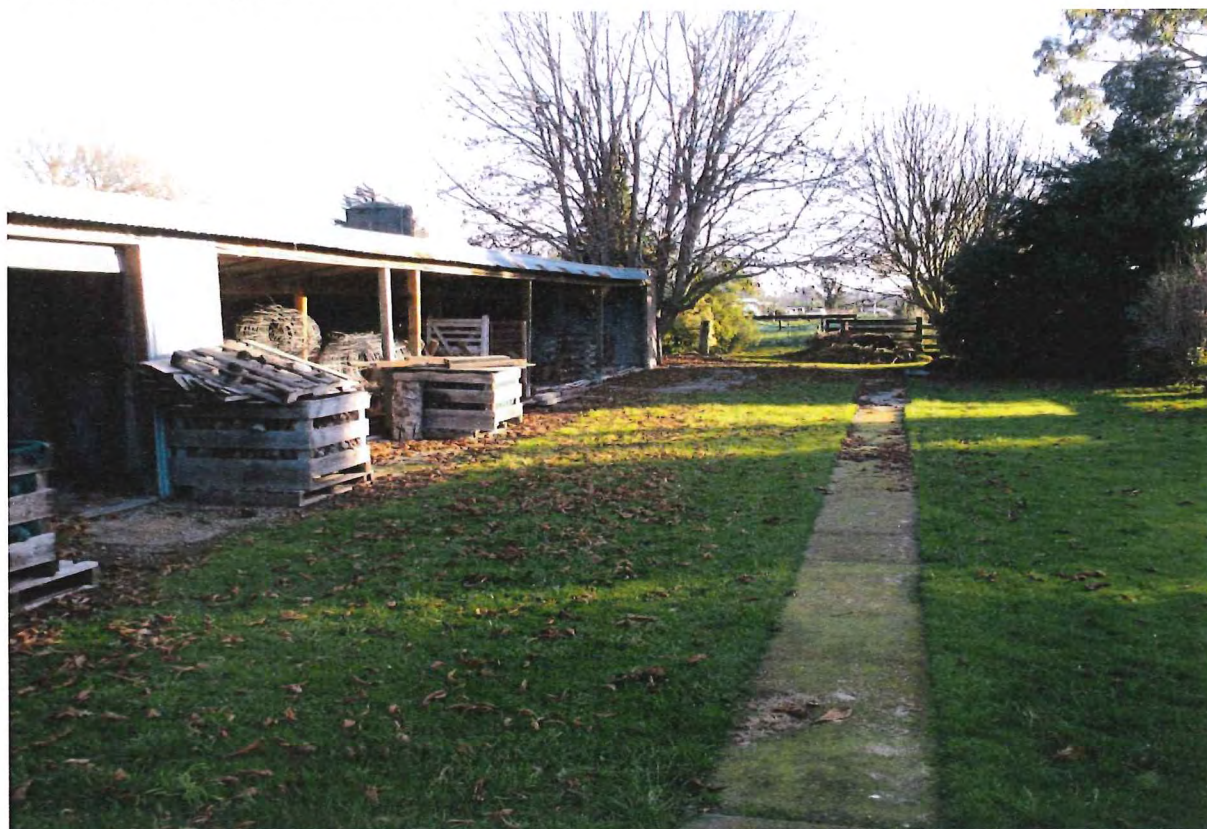
Photograph 4: Old storage shed located near the main dwelling at 100 Oxford Road.

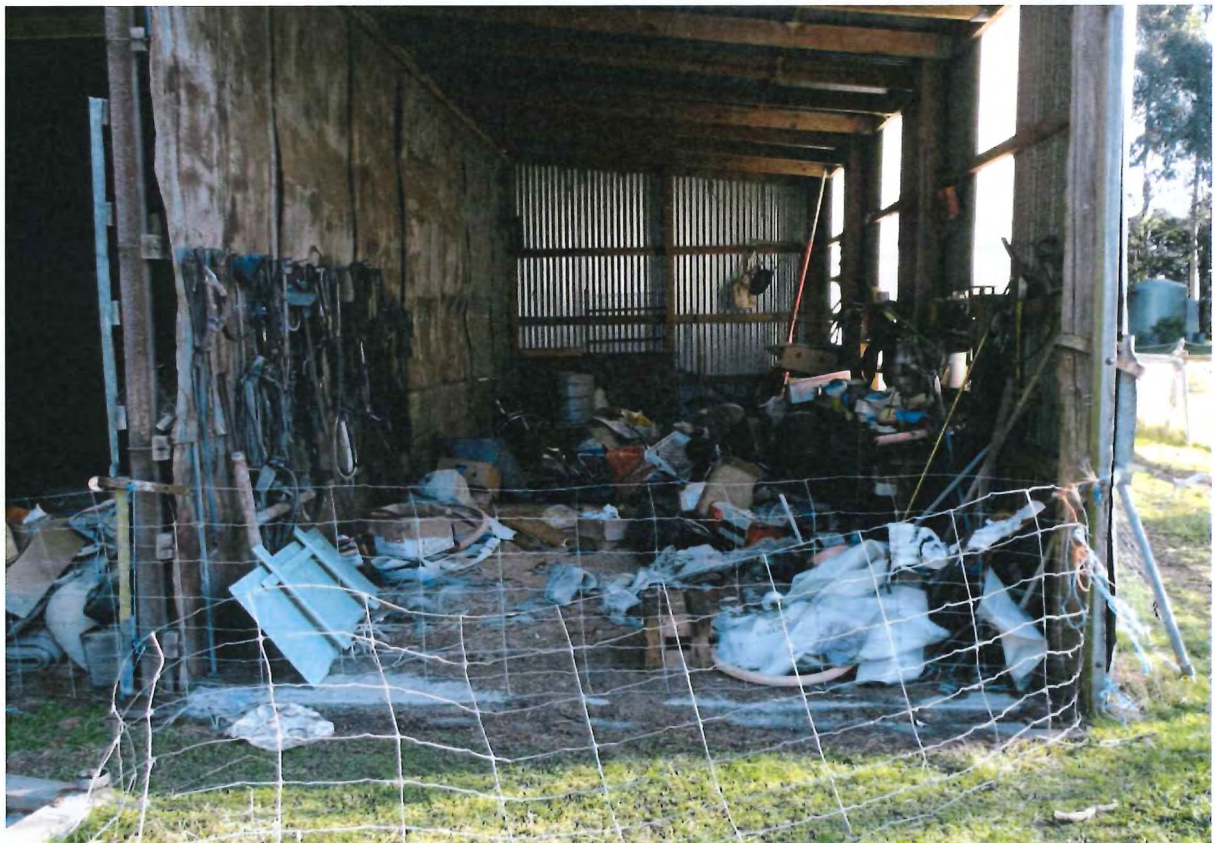
Photograph 6: Old working shed found at the western end of the horse stables on the southern boundry of 198 Lehmans

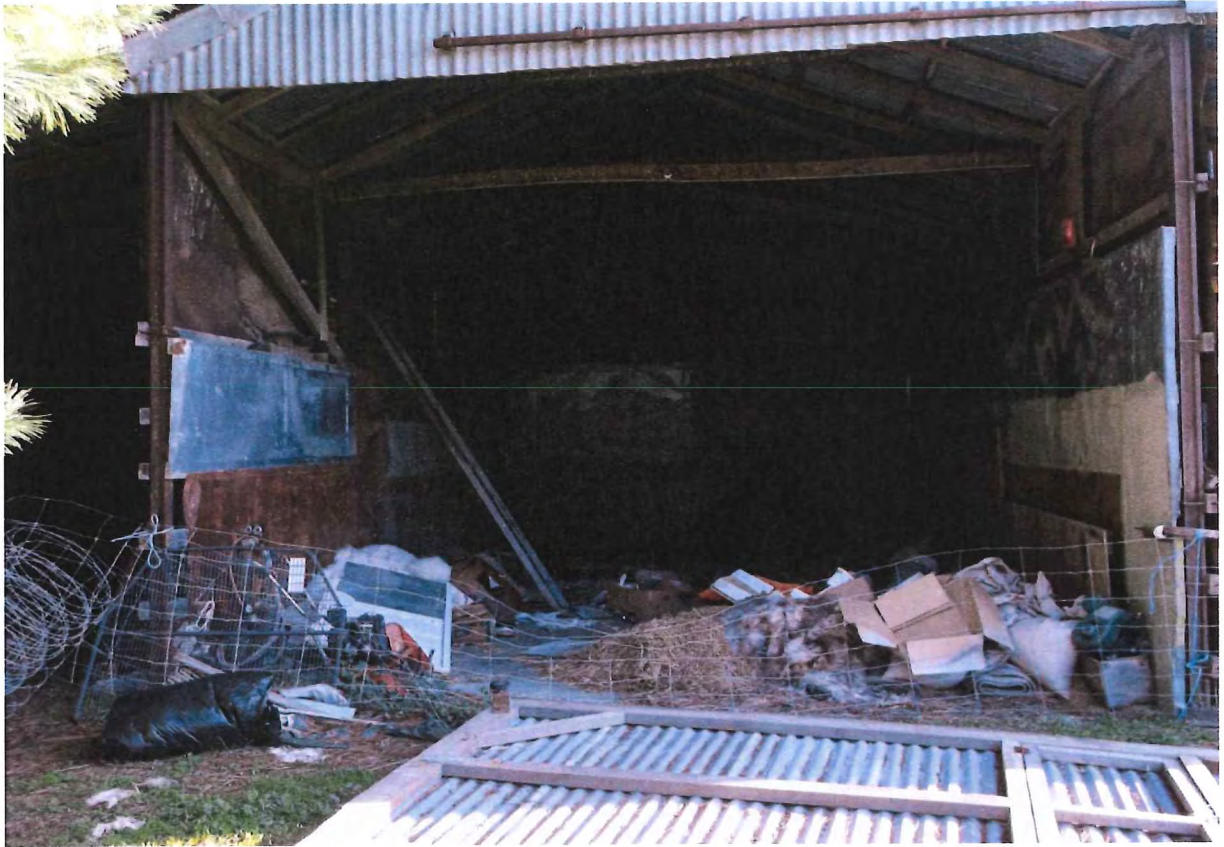
Photograph 7: One of the two old stable currently fill of rubbish, found at the western end of the horse stables on the southwestern corner of 198 Lehmans Road.

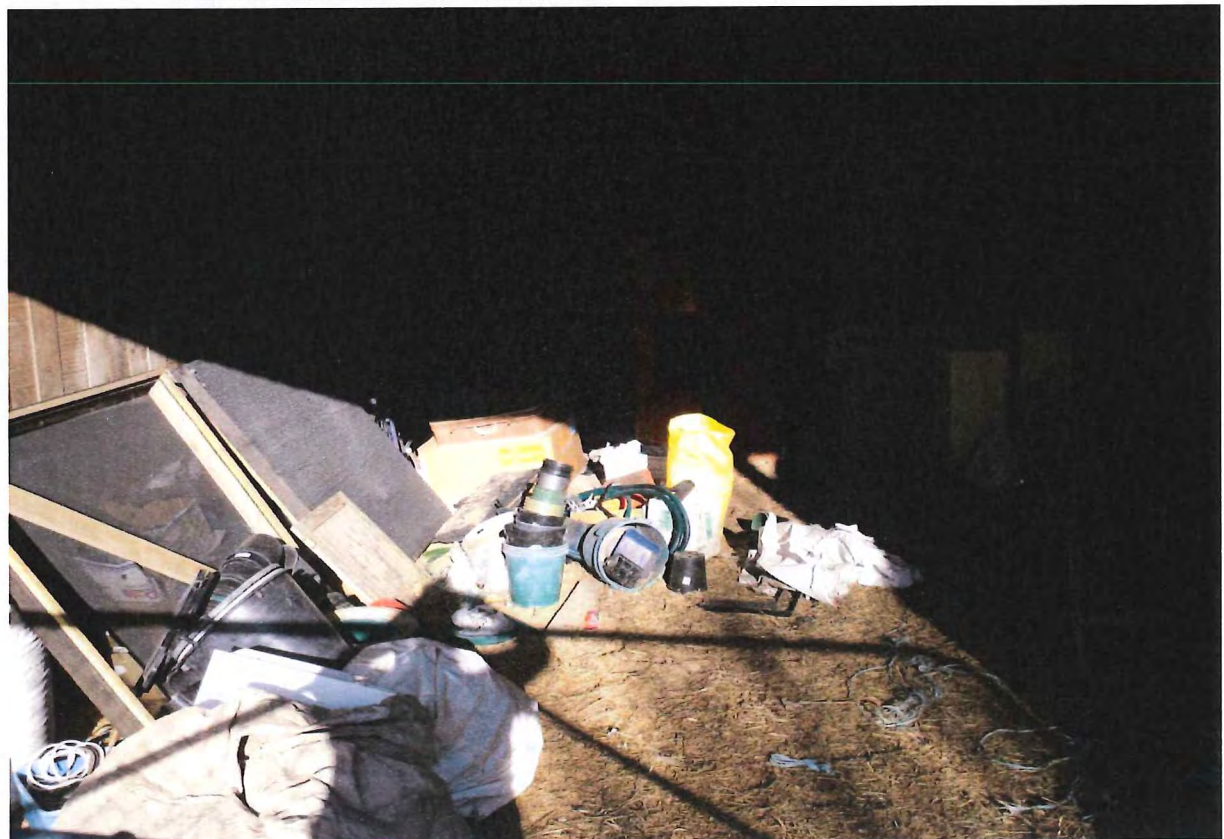
Photograph 8: One of the two old stable currently fill of rubbish, found at the western end of the horse stables on the southwestern corner of 198 Lehmans Road.

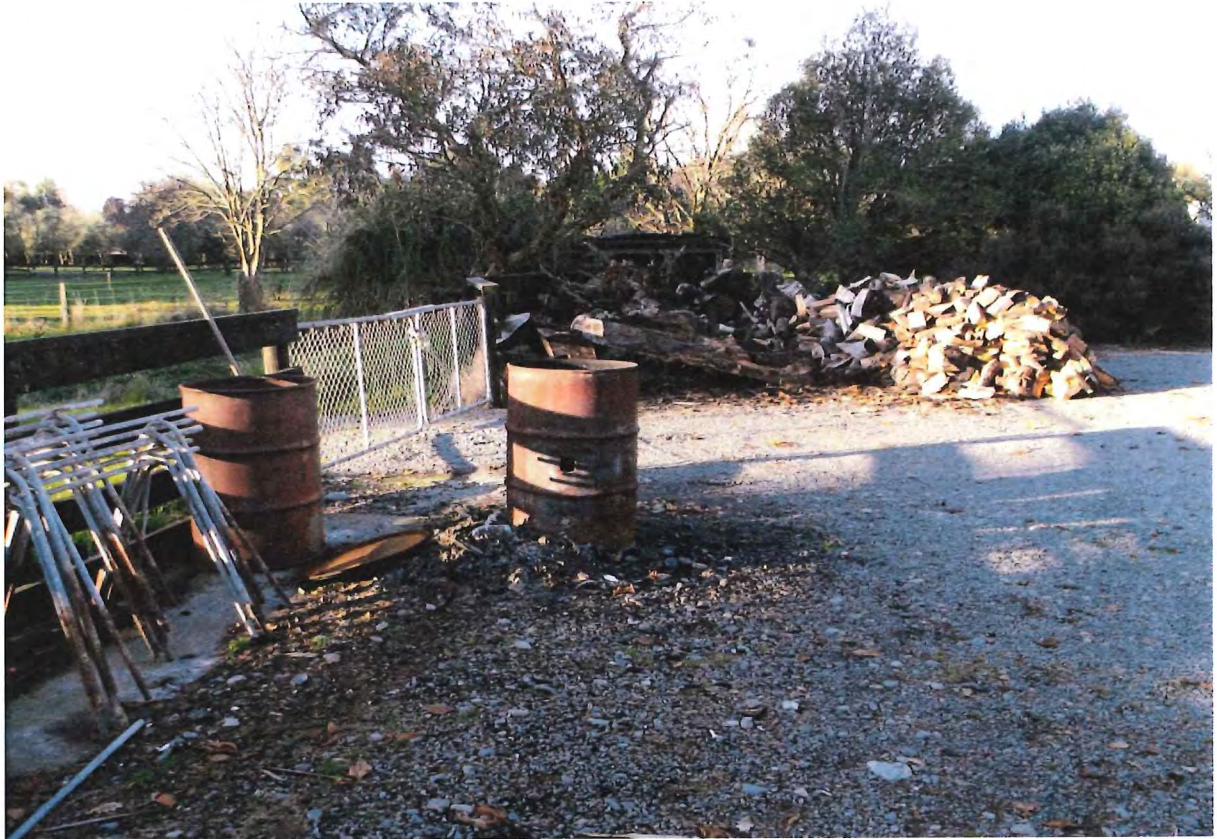
Photograph 11: Active burning of wood and waste in a barrel located near the dwelling at 100 Oxford Road.
