Re: Asbestos Identification Analysis – Mandeville Plan Change

Waimakariri District Council
Mandeville North Plan Change
Geotechnical Assessment
7 January 2015

**Appendix A - CH2M Beca's Ohoka Meadows and
Mandeville WWTP soil sampling test locations and
engineer's logs (933 Tram Road)**

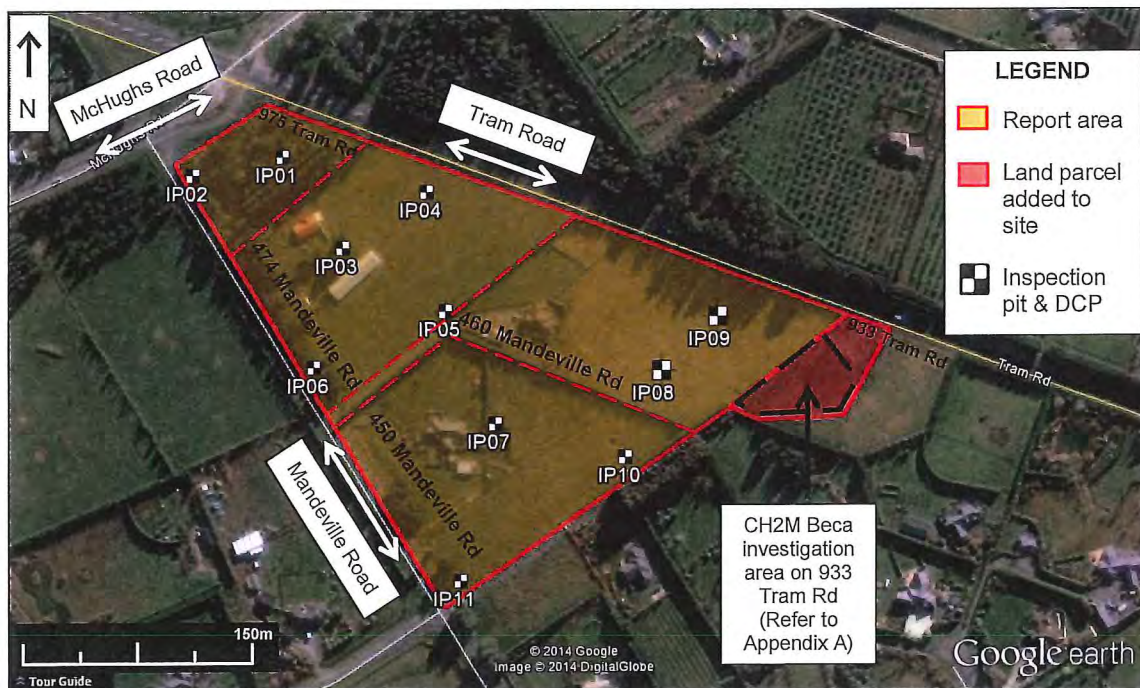
Figure 2: Testing location plan (scale as shown)

Test locations are shown on Figure 2 and the field test results are attached in Appendix C for reference.

Council has since added a portion (approximately 0.3ha) of 933 Tram Road (Lot 31 DP77464) into the plan change area, which is situated adjacent to 460 Mandeville Road⁹ (refer to "red" shaded area on Figure 2).
