Date taken	8/02/12	Client	Survus Consultants Ltd		
Taken by	JK	Project	474 Bradleys Road, Ohoka, Canterbury		
Approved by	MW	Description	Site Photographs		
Scale	N/A	Photo No.	1 to 6	Project Number	12034_2

APPENDIX 3

Test Pit Logs

Engineering Log - Test Pit

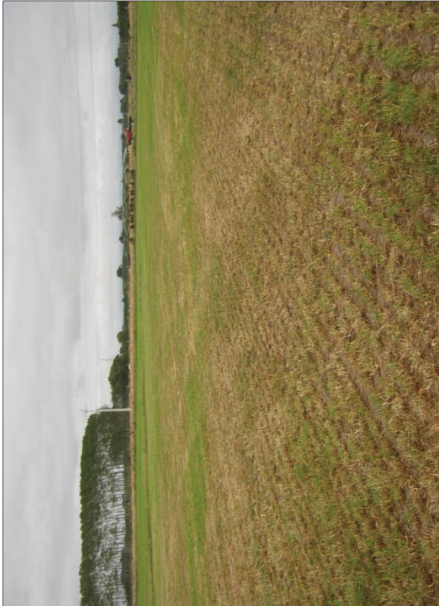
Photo 1: Western corner of property

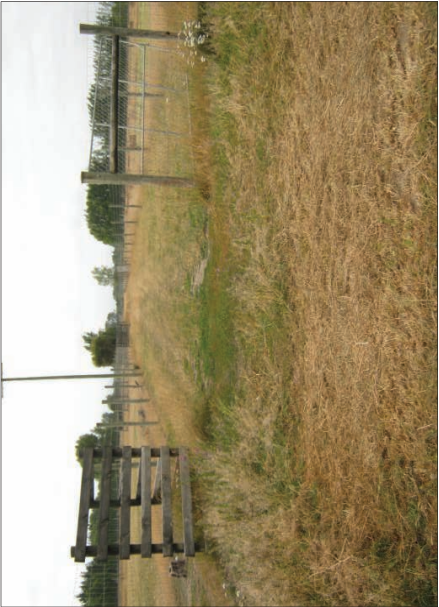
Photo 2: View looking towards South East (Western half of property)

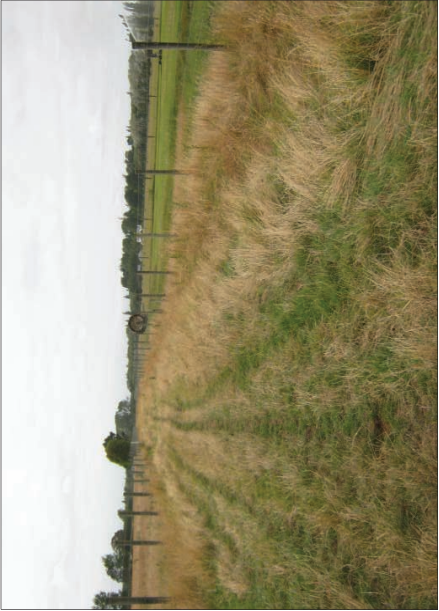
Photo 3: View towards South and neighbouring properties

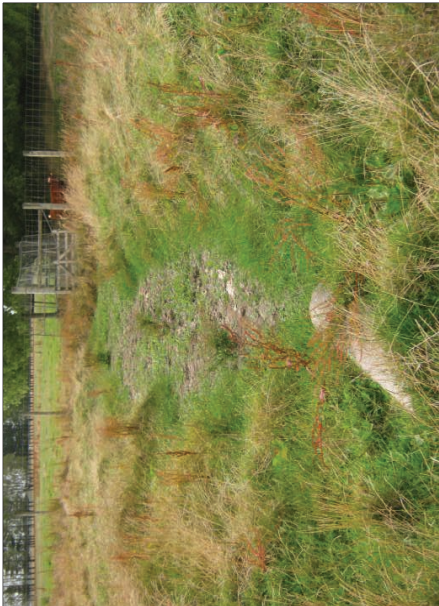
Photo 4: Drainage channel flowing towards South East boundary

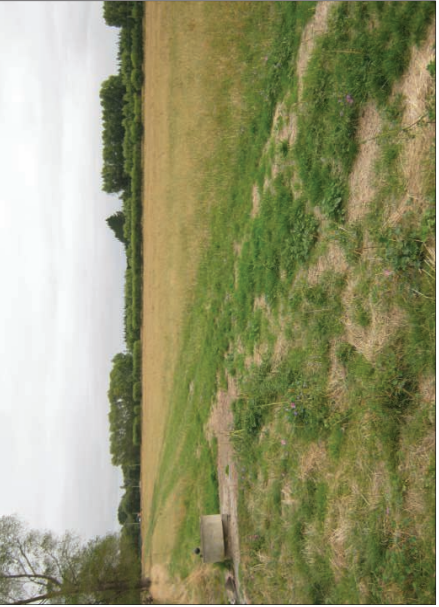
Photo 5: View of Northern extent of property

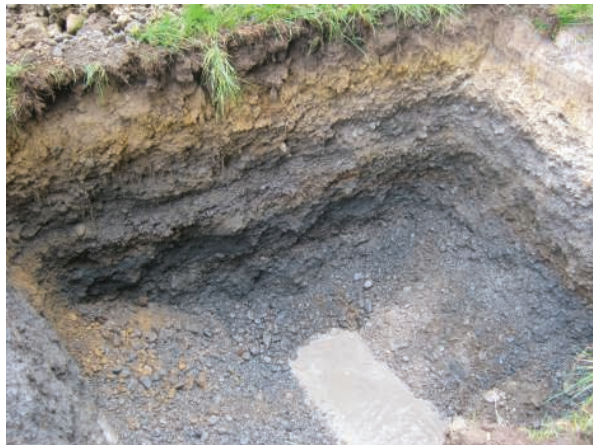
Test Pit No. **TP01**
 Sheet **1 of 1**
 Project No. **12034**

Machine Type: 21 Tonne Excavator				Survey Method: Handheld GPS				Northing: 5,761,007.00						
Excavation Dimensions: 2.00 by 3.00								Easting: 2,475,831.00						
Vane No.: N/A														
Excavation Information				Material Substance										
Material	Water	Notes, samples, tests etc	Depth (m)	Graphic Log	Classification Symbol	Material	Moisture Condition	Consistency / Density Index	Shear Vane (Dial Readings kPa)	Scala (Blows/100mm)				
						Soil - soil type, colour, structure, grading, bedding, plasticity, sensitivity; Secondary and minor components Rock - colour, fabric, rock type; discontinuities; additional information								
TOPSOIL			0.2		ML	SILT; dark brown. Low plasticity. [TOPSOIL]	M	F

0.4		ML	SILT; light brown with orange and grey mottles. Low plasticity.	M	St						
			0.6		GP	Sandy fine to medium GRAVEL; brown, rounded. Sand is coarse.	M-W	D

0.8											
			1		GP	Sandy fine GRAVEL; grey, rounded, poorly graded. Sand is coarse.	W	D						
			1.2											
			1.4											
			1.6

1.8											
			2		GP	Sandy fine to coarse GRAVEL; bluish grey, rounded, well graded. Sand is coarse.	S	VD						
			2.2											
			2.4											
			2.6

EOH: 2.7 m
Termination: Practical refusal
Notes:
 Test pit terminated at 2.7 m due to hole collapsing.
 Groundwater encountered at 1.4 m.

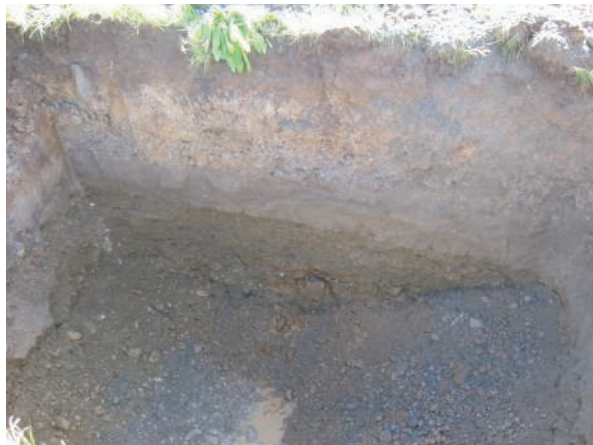
Test Pit No. **TP02**
Sheet **1 of 1**
Project No. **12034**

Machine Type: 21 Tonne Excavator				Survey Method: Handheld GPS				Northing: 5,760,876.00						
Excavation Dimensions: 2.00 by 3.00								Easting: 2,476,017.00						
Vane No.: N/A														
Excavation Information				Material Substance										
Material	Water	Notes, samples, tests etc	Depth (m)	Graphic Log	Classification Symbol	Material Soil - soil type, colour, structure, grading, bedding, plasticity, sensitivity; Secondary and minor components Rock - colour, fabric, rock type; discontinuities; additional information	Moisture Condition	Consistency / Density Index	Shear Vane (Dial Readings kPa)	Scala (Blows/100mm)				
										2	4	6	8	
DPSO			0.2		ML	SILT; dark brown. Low plasticity. [TOPSOIL]	D	F

0.4		ML	SILT; light brown with orange and grey mottles. Low plasticity.	D	St						
			0.6		GP	Sandy fine to coarse GRAVEL; brown, rounded, well graded. Sand is medium.	M	MD

0.8											
			1		SP	Fine to medium SAND; grey. Poorly graded.	W	MD						
			1.2		GW	Sandy fine to coarse GRAVEL; grey, rounded, well graded.	W-S	D

1.4											
			1.6		GW	Sandy fine to coarse GRAVEL; bluish grey, rounded, well graded.	S	VD						
			1.8											
			2											
			2.2

Test pit terminated at 2.2 m due to hole collapsing.

Groundwater encountered at 1.3 m.

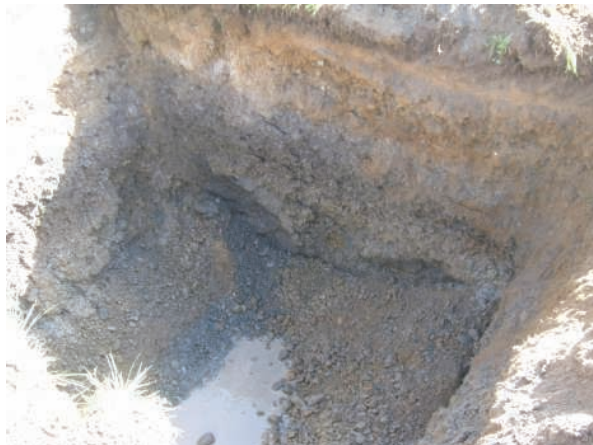
Test Pit No. **TP03**
 Sheet **1 of 1**
 Project No. **12034**

ML	SILT with trace fine sand; dark brown. Low plasticity. [TOPSOIL]	D	F		
			0.4

ML	SILT; light brown with orange and grey mottles. Low plasticity.	M	St		
			0.6

GW	Sandy fine to medium GRAVEL; grey, rounded, poorly graded. Sand is coarse.	M	D		
		0.8								
		1								
		1.2								
		1.4								
			1.6							
			1.8							
			2		GW	Sandy fine to coarse GRAVEL; bluish grey, rounded, well graded. Sand is coarse.	S	VD		
			2.2

EOH: 2.3 m
Termination: Practical refusal
Notes:
 Test pit terminated at 2.3 m due to hole collapsing.
 Groundwater encountered at 1.1 m.

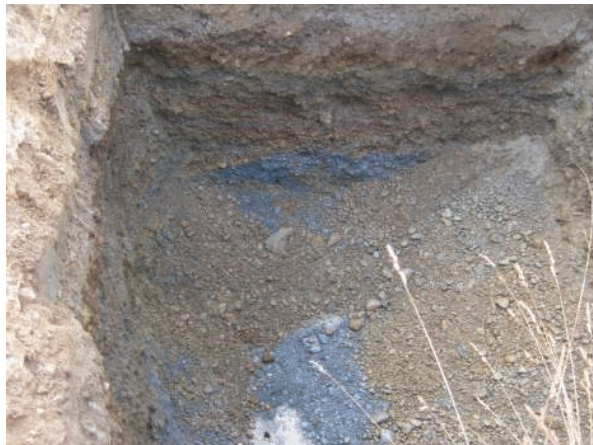
Test Pit No. **TP04**
Sheet **1 of 1**
Project No. **12034**

Machine Type: 21 Tonne Excavator				Survey Method: Handheld GPS				Northing: 5,761,462.00					
Excavation Dimensions: 2.00 by 3.00								Easting: 2,476,366.00					
Vane No.: N/A													
Excavation Information				Material Substance									
Material	Water	Notes, samples, tests etc	Depth (m)	Graphic Log	Classification Symbol	Material	Moisture Condition	Consistency / Density Index	Shear Vane (Dial Readings kPa)	Scala (Blows/100mm)			
						Soil - soil type, colour, structure, grading, bedding, plasticity, sensitivity; Secondary and minor components Rock - colour, fabric, rock type; discontinuities; additional information				2	4	6	8
DPSO			0.2		ML	SILT; dark brown. Low plasticity. [TOPSOIL]	M	F

0.4		ML	SILT; yellowish brown with orange mottles. Low plasticity.	D	St					
			0.6		GP	Sandy fine to medium GRAVEL; brown, rounded, poorly graded. Sand is coarse.	M	D

0.8										
			1			Sandy fine to medium GRAVEL; grey, rounded, poorly graded.	W	D					
			1.2										
			1.4		GP								
			1.6										
			1.8										
			2

2.2										
			2.4										
			2.6										
					GW	Sandy fine to coarse GRAVEL; bluish grey, rounded, well graded. Sand is coarse.	S	VD

EOH: 2.8 m
Termination: Practical refusal
Notes:
Test pit terminated at 2.8 m due to hole collapsing.
Groundwater encountered at 1.4 m.

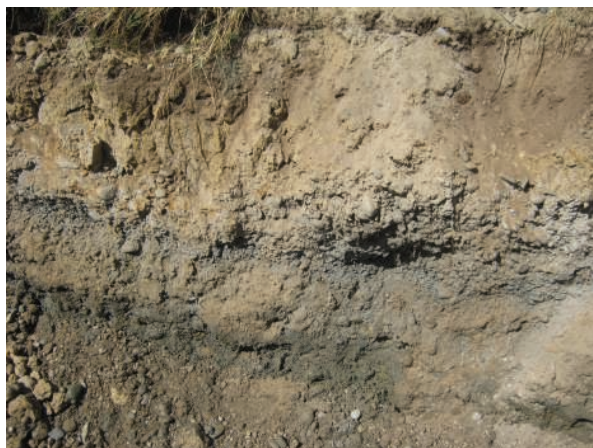
Test Pit No. **TP05**
Sheet **1 of 1**
Project No. **12034**

EOH: 2.5 m
Termination: Practical refusal
Notes:
Test pit terminated at 2.5 m due to hole collapsing.
Groundwater encountered at 1.9 m.

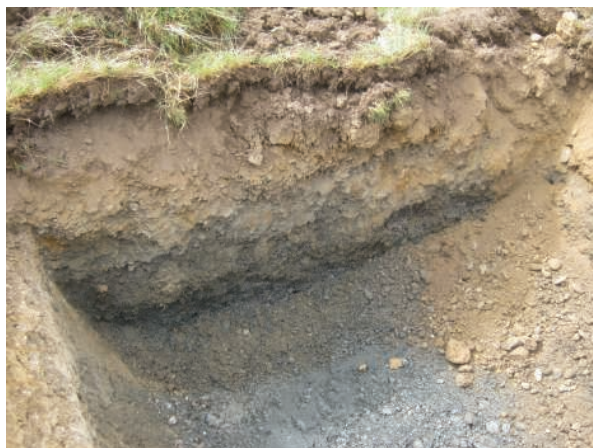
Test Pit No. **TP07**
 Sheet **1 of 1**
 Project No. **12034**

ML	SILT; dark brown. Low plasticity. [TOPSOIL]	D	S-F

ML	SILT; light brown with orange and grey mottles. Low plasticity.	D	St					
			0.6

GW	Sandy fine to coarse GRAVEL; grey, rounded, well graded. Sand is coarse.	M	D

Becomes wet.	W						
			1

Turns bluish grey and becomes saturated.	S	VD					
			1.4

EOH: 2.4 m
Termination: Practical refusal
Notes:
 Test pit terminated at 2.4 m due to hole collapsing.
 Groundwater encountered at 1.2 m.

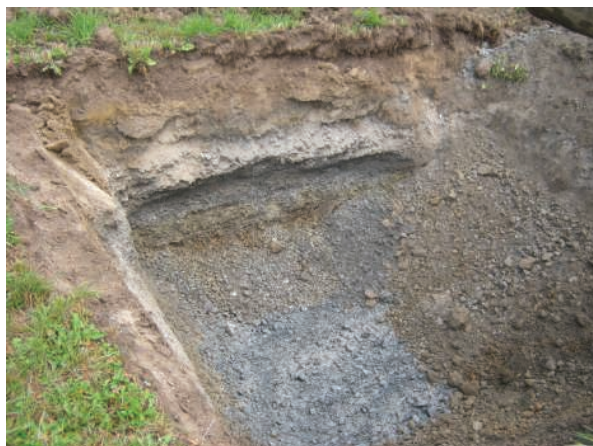
Test Pit No. **TP08**
 Sheet **1 of 1**
 Project No. **12034**

Machine Type: 21 Tonne Excavator				Survey Method: Handheld GPS				Northing: 5,760,916.00					
Excavation Dimensions: 2.00 by 3.00								Easting: 2,476,536.00					
Vane No.: N/A													
Excavation Information				Material Substance									
Material	Water	Notes, samples, tests etc	Depth (m)	Graphic Log	Classification Symbol	Material	Moisture Condition	Consistency / Density Index	Shear Vane (Dial Readings kPa)	Scala (Blows/100mm)			
						Soil - soil type, colour, structure, grading, bedding, plasticity, sensitivity; Secondary and minor components							
						Rock - colour, fabric, rock type; discontinuities; additional information							
										2	4	6	8
DPSO			0.2		ML	SILT; dark brown. Low plasticity. [TOPSOIL]	D	F

0.4		ML	SILT; light brown with orange and grey mottles. Low plasticity.	D	St					
			0.6		GW	Sandy fine to medium GRAVEL; grey with brown layers, rounded, well graded. Sand is coarse.	D	D

EOH: 2.4 m
Termination: Practical refusal
Notes:
 Test pit terminated at 2.4 m due to hole collapsing.
 Groundwater encountered at 1.1 m.

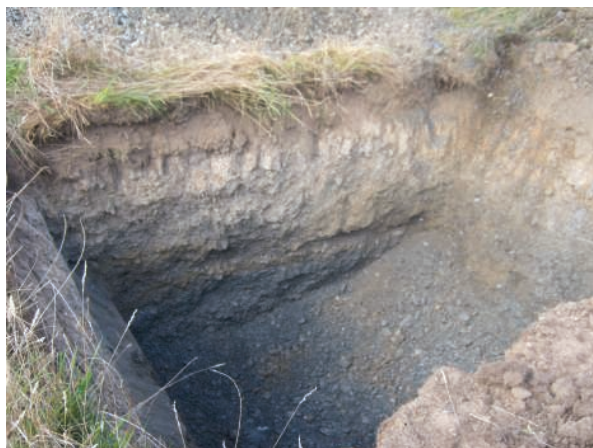
Test Pit No. **TP09**
 Sheet **1 of 1**
 Project No. **12034**

Machine Type: 21 Tonne Excavator				Survey Method: Handheld GPS				Northing: 5,760,808.00					
Excavation Dimensions: 2.00 by 3.00								Easting: 2,476,765.00					
Vane No.: N/A													
Excavation Information				Material Substance									
Material	Water	Notes, samples, tests etc	Depth (m)	Graphic Log	Classification Symbol	Material	Moisture Condition	Consistency / Density Index	Shear Vane (Dial Readings kPa)	Scala (Blows/100mm)			
						Soil - soil type, colour, structure, grading, bedding, plasticity, sensitivity; Secondary and minor components							
						Rock - colour, fabric, rock type; discontinuities; additional information							
DPSO			0.2	TS	ML	SILT; dark brown. Low plasticity. [TOPSOIL]	D	F-St

0.4		GW	Sandy fine to coarse GRAVEL; grey, rounded, well graded. Sand is coarse.	D	D-VD					
			0.6										
			0.8										
			1										
			1.2				M

1.4			Becomes wet.	W						
			1.6			Becomes saturated.	S						
			1.8										
			2										
			2.2										
			2.4										
			2.6										
			2.8										
			3

EOH: 3 m
Termination: Practical refusal
Notes:
 Test pit terminated at 3.0 m due to hole collapsing.
 Groundwater encountered at 1.3 m.

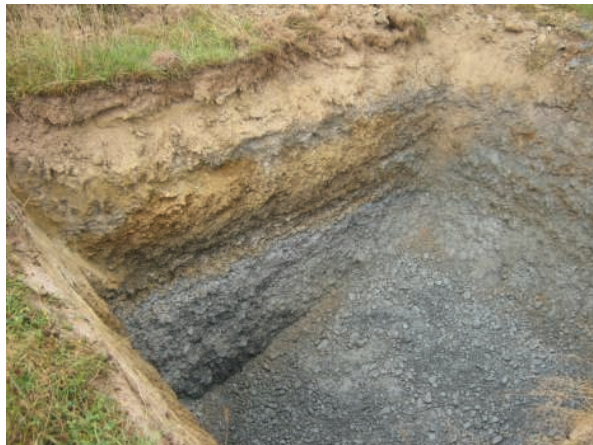
Test Pit No. **TP10**
Sheet **1 of 1**
Project No. **12034**

Machine Type: 21 Tonne Excavator				Survey Method: Handheld GPS				Northing: 5,761,043.00					
Excavation Dimensions: 2.00 by 3.00								Easting: 2,476,845.00					
Vane No.: N/A													
Excavation Information				Material Substance									
Material	Water	Notes, samples, tests etc	Depth (m)	Graphic Log	Classification Symbol	Material	Moisture Condition	Consistency / Density Index	Shear Vane (Dial Readings kPa)	Scala (Blows/100mm)			
						Soil - soil type, colour, structure, grading, bedding, plasticity, sensitivity; Secondary and minor components Rock - colour, fabric, rock type; discontinuities; additional information				2	4	6	8
DPSO			0.2		ML	SILT; dark brown. Low plasticity. [TOPSOIL]	D	F

0.4		ML	SILT; light brown with orange mottles. Low plasticity.	D	St					
			0.6		GW	Sandy fine to medium GRAVEL; brown, rounded, well graded. Sand is gravel.	M-W	D

0.8										
			1										
			1.2										
			1.4			Becomes saturated.	S						
			1.6										
			1.8										
			2		GW	Sandy fine to coarse GRAVEL; bluish grey, rounded, well graded. Sand is coarse.	S	VD

EOH: 3.4 m
Termination: Practical refusal
Notes:
Test pit terminated at 3.4 m due to hole collapsing.
Groundwater encountered at 1.3 m.

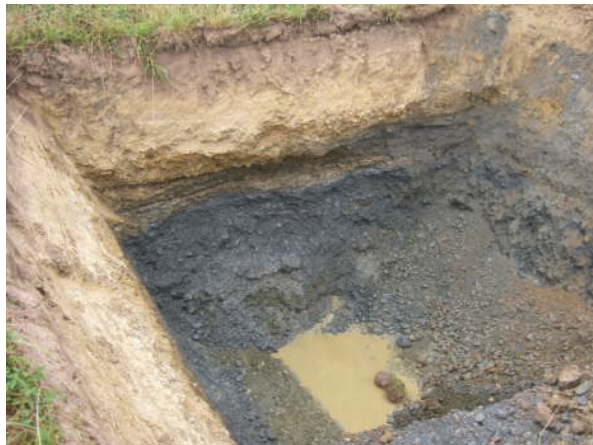
Test Pit No. **TP11**
Sheet **1 of 1**
Project No. **12034**

ML	SILT; dark brown. Low plasticity. [TOPSOIL]	D	F

ML	SILT; light brown with orange and grey mottles. Low plasticity.	D	St					
			0.6										
			0.8										
			1.0										
			1.2

EOH: 3.3 m
Termination: Practical refusal
Notes:
 Test pit terminated at 3.3 m due to hole collapsing.
 Groundwater encountered at 1.7 m.

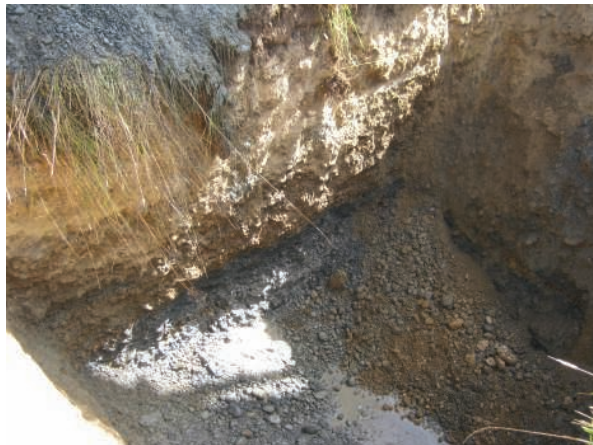
Test Pit No. **TP12**
 Sheet **1 of 1**
 Project No. **12034**

Machine Type: 21 Tonne Excavator				Survey Method: Handheld GPS				Northing: 5,761,113.00					
Excavation Dimensions: 2.00 by 3.00								Easting: 2,477,195.00					
Vane No.: N/A													
Excavation Information				Material Substance									
Material	Water	Notes, samples, tests etc	Depth (m)	Graphic Log	Classification Symbol	Material	Moisture Condition	Consistency / Density Index	Shear Vane (Dial Readings kPa)	Scala (Blows/100mm)			
						Soil - soil type, colour, structure, grading, bedding, plasticity, sensitivity; Secondary and minor components							
						Rock - colour, fabric, rock type; discontinuities; additional information							
										2	4	6	8
TOPSOIL			0.2		ML	SILT; dark brown. Low plasticity. [TOPSOIL]	D	F

0.4		ML	SILT; light brown with orange and grey mottles. Low plasticity.	D	St					
			0.6										
			0.8		GW	Sandy fine to coarse GRAVEL; brown, rounded, well graded. Sand is coarse.	D	D					
			1

1.2				M						
			1.4										
			1.6										
			1.8										
			2			Sandy fine to coarse GRAVEL; bluish grey, rounded, well graded. Sand is coarse.	S	VD

EOH: 3 m
Termination: Practical refusal
Notes:
 Test pit terminated at 3.0 m due to hole collapsing.
 Groundwater encountered at 1.7 m.
