SITE INVESTIGATION RECORD

Site **141 South Belt (Lot 3 DP73557) &
104 Townsend Rd (Lot 1 DP 45826), Rangiora**

GROUND CONTAMINATION ASSESSMENT

141 South Belt & 104 Townsend Road, Rangiora, Canterbury

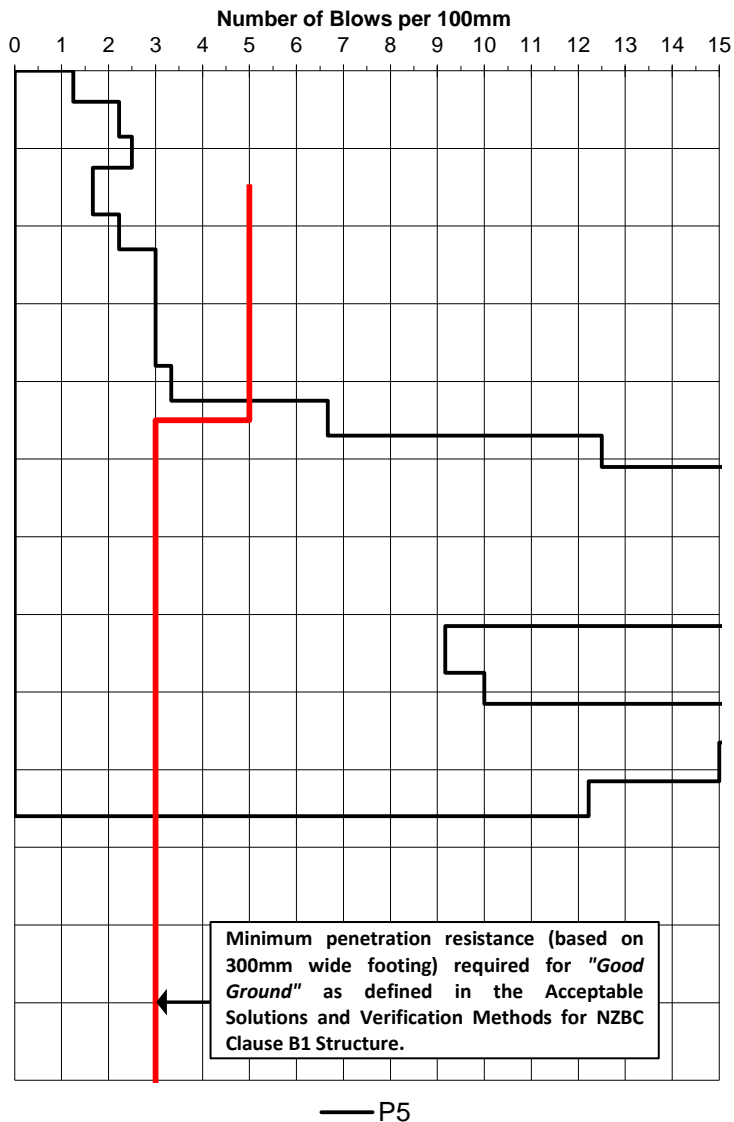
[m]	Hand Auger	Machine Auger	Test Pit
G.L.	<input checked="" type="checkbox"/>	<input type="checkbox"/>	<input type="checkbox"/>
0.2	(Borehole @ 5)		
0.4	Dark brown silty TOPSOIL with rootlets <2mm Ø		
0.6	Grey clayey SILT, iron staining, with minor		
0.8	Grey clayey SILT, moist, iron staining		
1.0	Grey sandy clayey SILT, moist, iron staining		
1.2	STOP - Stones		
1.4			
1.6			
1.8			
2.0			
2.2			
2.4			
2.6			
2.8			
3.0			
3.2			
3.4

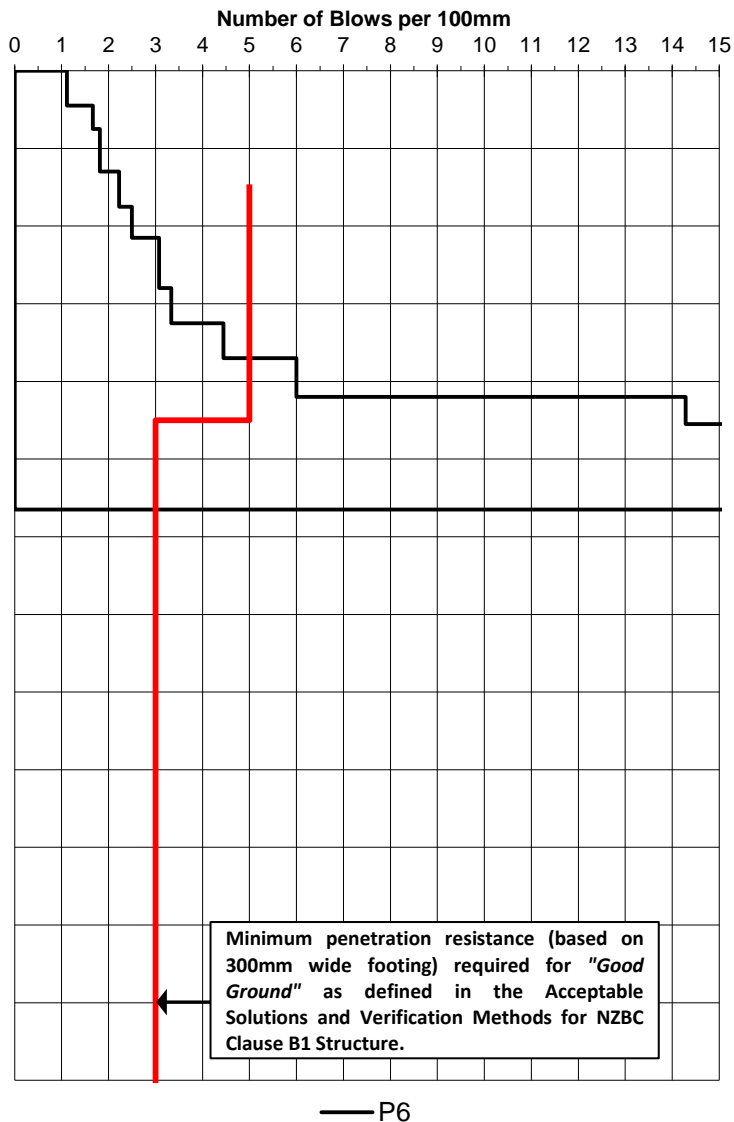
DEPTH [m]	Hand Auger	Machine Auger	Test Pit
G.L.	<input checked="" type="checkbox"/>	<input type="checkbox"/>	<input type="checkbox"/>
0.2	(Borehole @ 6) Dark brown silty TOPSOIL, moist, with rootlets <2mm Ø		
0.4	Grey clayey SILT, moist, iron staining		
0.6			
0.8	Grey clayey sandy SILT, moist, iron staining		
1.0	STOP - Stones		
1.2			
1.4			
1.6			
1.8			
2.0			
2.2			
2.4			
2.6			
2.8			
3.0			
3.2			
3.4

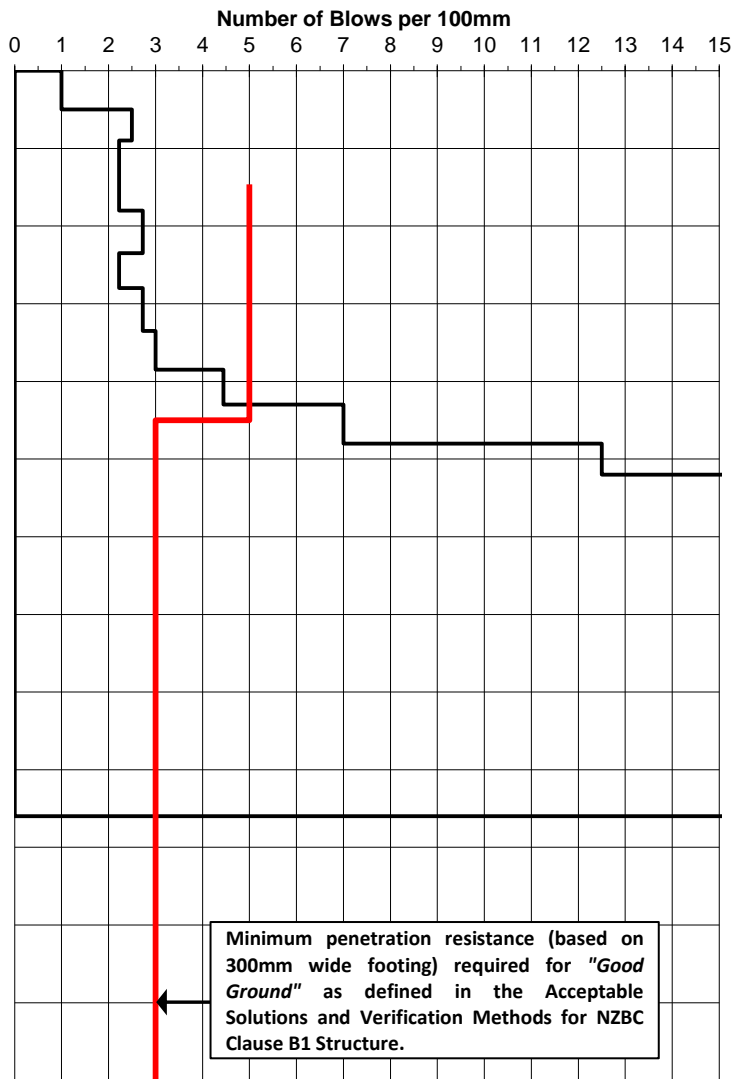
Dark brown silty TOPSOIL, moist, with rootlets <2mm Ø

Grey clayey SILT, moist, iron staining

Grey clayey sandy SILT, moist, iron staining
STOP - Stones

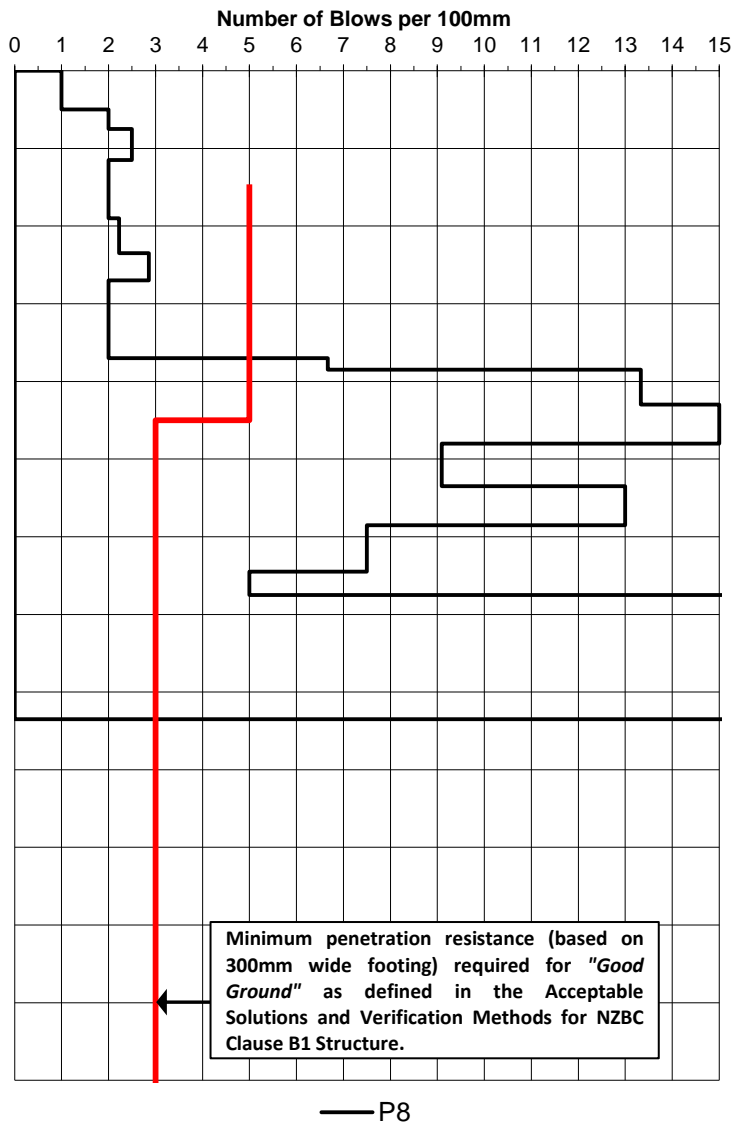
DEPTH [m]	Hand Auger	Machine Auger	Test Pit
G.L.	<input checked="" type="checkbox"/>	<input type="checkbox"/>	<input type="checkbox"/>
0.2	(Borehole @ 8) Dark brown silty TOPSOIL, moist, with minor rootlets		
0.4	Grey clayey SILT, damp, iron staining		
0.6	Grey clayey sandy SILT, damp, iron staining		
0.8	STOP - Stones		
1.0			
1.2			
1.4			
1.6			
1.8			
2.0			
2.2			
2.4			
2.6			
2.8			
3.0			
3.2			
3.4

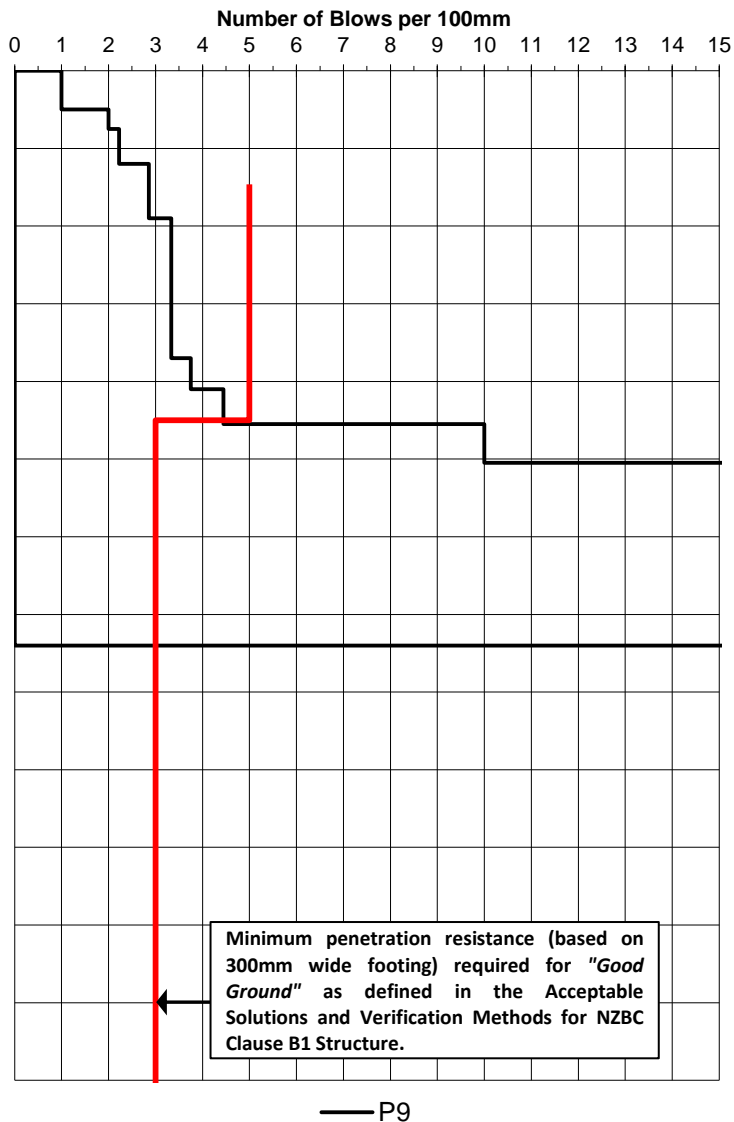
[m]	Hand Auger	Machine Auger	Test Pit
G.L.	<input checked="" type="checkbox"/>	<input type="checkbox"/>	<input type="checkbox"/>
0.2	(Borehole @ 9) Dark brown silty TOPSOIL, moist, with minor rootlets		
0.4			
0.6	Grey clayey SILT, damp, iron staining, with minor rootlets		
0.8			
1.0	Grey clayey sandy SILT, damp, iron staining STOP - Stones		
1.2			
1.4			
1.6			
1.8			
2.0			
2.2			
2.4			
2.6			
2.8			
3.0			
3.2			
3.4

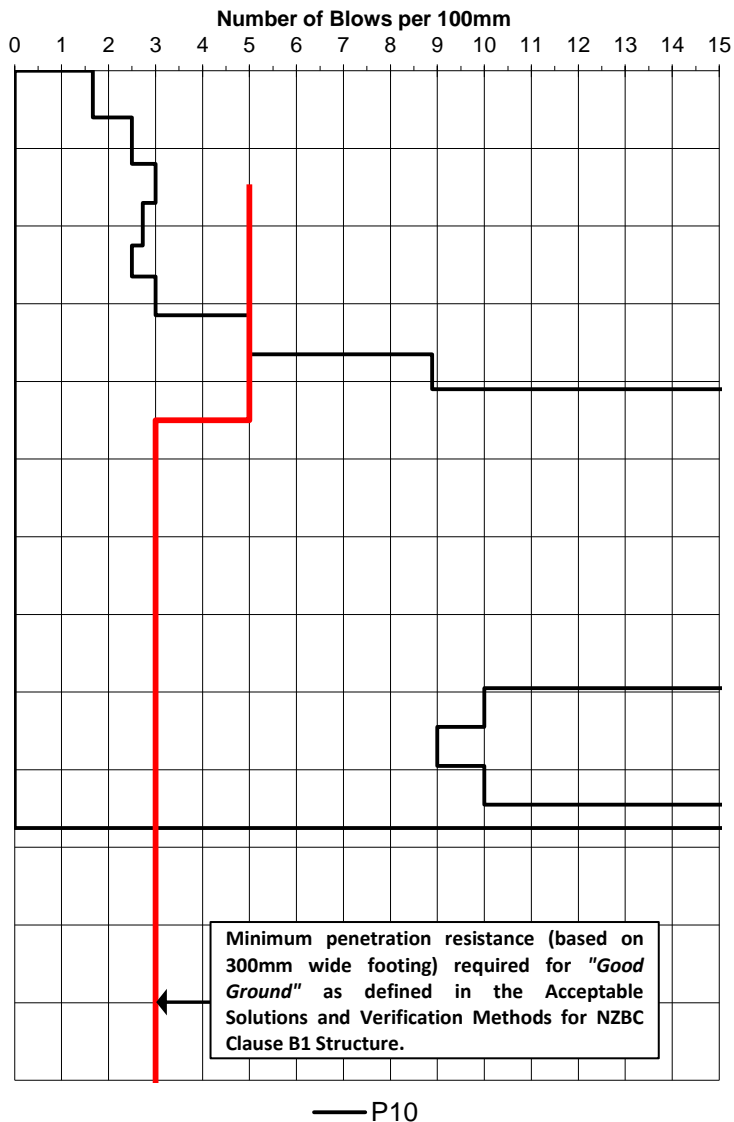
Grey clayey SILT, damp, iron staining, with traces of rootlets

Grey clayey sandy SILT, moist, iron staining

STOP - Stones

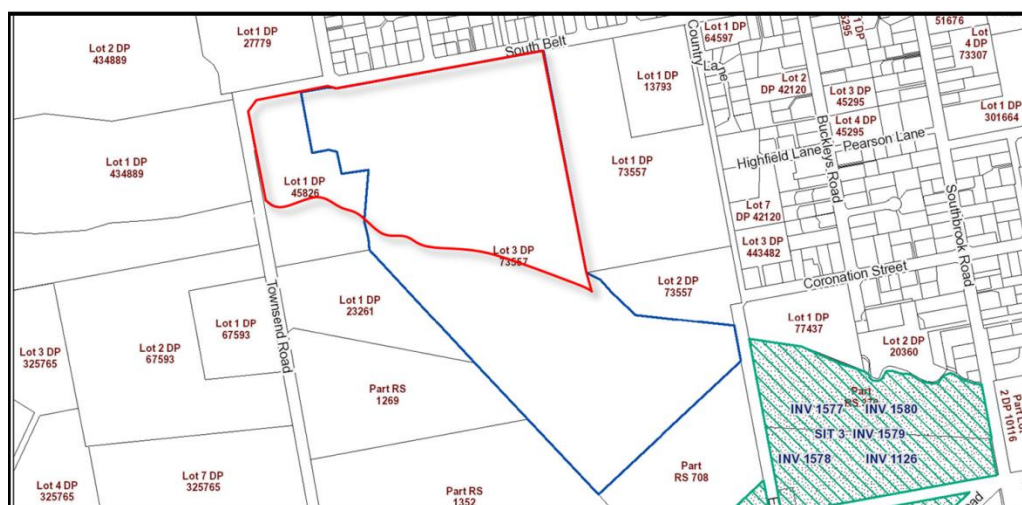
A neighbouring land parcel southeast of the site and on the true right bank of South Brook Stream is recorded on the LLUR as Site ID 3 at 1 Southbrook Road (**Figure 2**). The site comprises historical and current timber treatment or preservation and bulk storage of timber. The LLUR category is 'partially investigated'.

The LLUR record is within 50 metres of the legal boundary of 141 South Belt. The proposed plan change is approximately 300 metres at the nearest point, and the timber treatment area is downgradient of the site in the general direction of surface and groundwater flow.

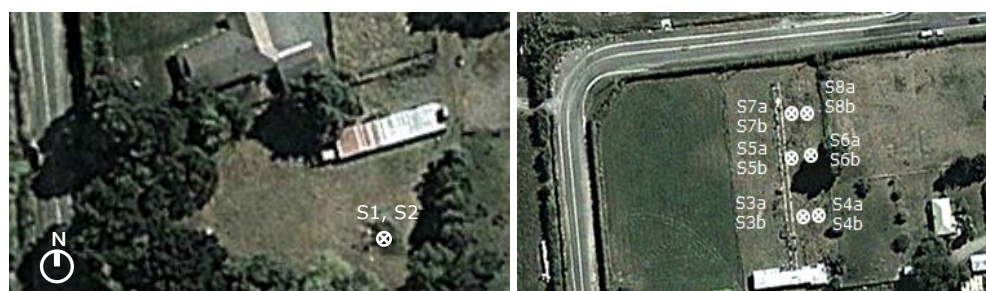
The soil investigation design is based on the findings of the PSI, and comprised 16 soil samples from eight locations (two location at the burn pad and 6 at the former chicken shed), as shown in **Figure 3**. Two samples were collected at each location and 0-50mm bgl and 250-300mm bgl. The soil test results, relevant soil contaminant standards (SCSs) land use scenario (residential, 10% produce consumption), and background concentrations are discussed in Chapter 7 and are summarised in **Table 5**.

The two poultry sheds covered an area of approximately 900m²; therefore, a 95% confidence level is achieved with six sampling points. The chicken sheds were constructed without walls or a sealed floor. Consequently, metals⁵ and/or organochlorine pesticides would be detectable in the topsoil within the footprint of the removed buildings. The two concrete footpaths under each of the roofs provided access to four rows of chicken cages, which itself were over uncovered topsoil. The concrete footpaths of the western shed remained in situ; the concrete from the eastern shed has been removed.

Figure 3. Burn pad (left) and poultry sheds (removed in 2008/09, right). White symbols denote soil-sampling locations.

The test results identified arsenic concentrations above residential standards in the topsoil of the burn pad. As a remediation measure, it was suggested to scrape the top 100mm of topsoil from the burn pad and remove from site. A soil validation sample, taken on 25 July 2014 showed arsenic, 21mg/kg, was still slightly above the NES_{Soil} contamination standards (20mg/kg) for residential land use after remediation. Therefore, it was recommended that more soil be removed to 200mm below ground level. The second validation test confirmed that arsenic concentrations are now at background levels in the area of the burn pad.

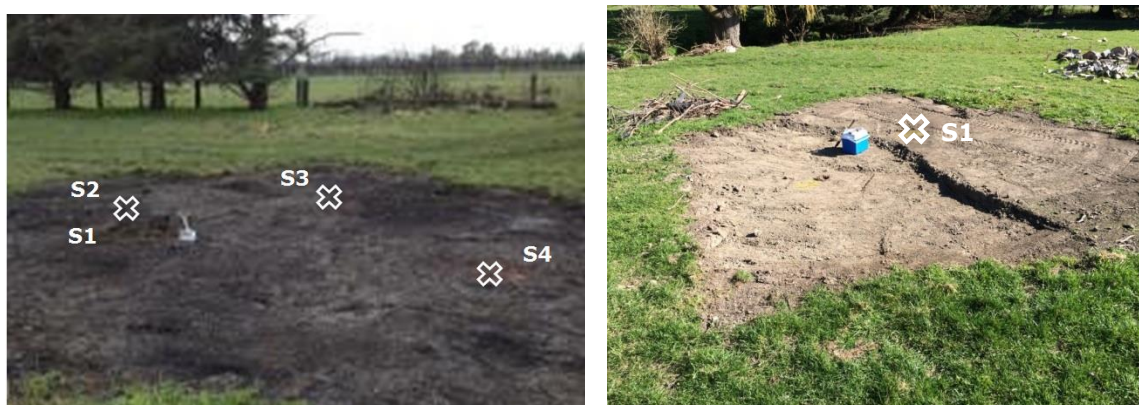
Two site validation tests were carried out on two different dates. The first on 25 July 2014 found arsenic in one out of three samples to be 21mg/kg, slightly over the NES_{Soil} contaminant standard for residential land use (20mg/kg). In the other two samples, arsenic was at background concentrations. More soil was removed from the site and a second validation sample was taken on 2 September 2014. These samples recorded concentrations below NES_{Soil} standards for residential land use (10% produce). Results are summarised in **Table 6**.

Figure 4. Site validation sample locations on 25 July 2014 (left) and 2 September 2014 (right).

The top 200mm of soil was removed from the burn pad and taken to Kate Valley by a certified contractor. The soil validation testing confirms that the concentrations of arsenic and heavy metals are below the NES_{Soil} contaminant standards for residential land use.
