Before the Independent Hearings Panel  
at Waimakariri District Council

*in the matter of:* Proposed private plan change RCP31 to the Operative  
Waimakariri District Plan

Summary of evidence of Ben Throssell

PLAN CHANGE 31: FLOOD HAZARD

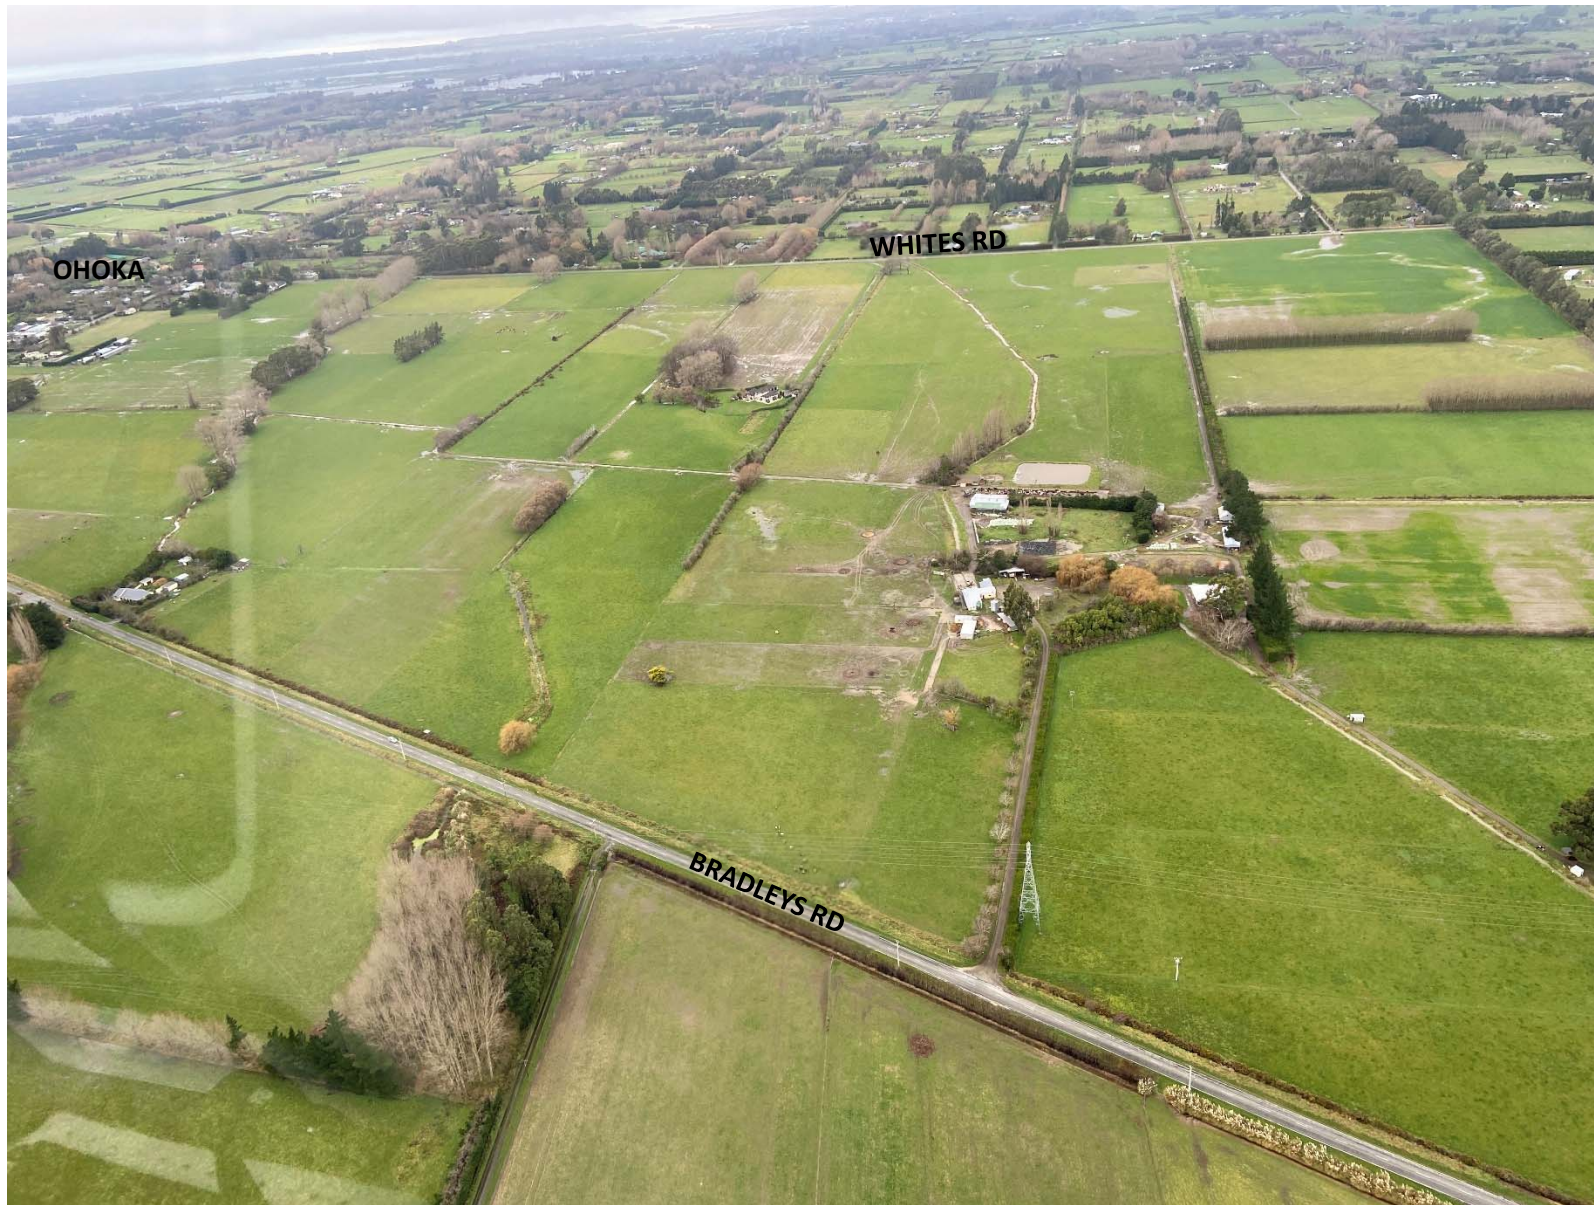
Attachment 4A: Aerial image 2257. Taken looking south-east with much of the proposed plan change site in the foreground

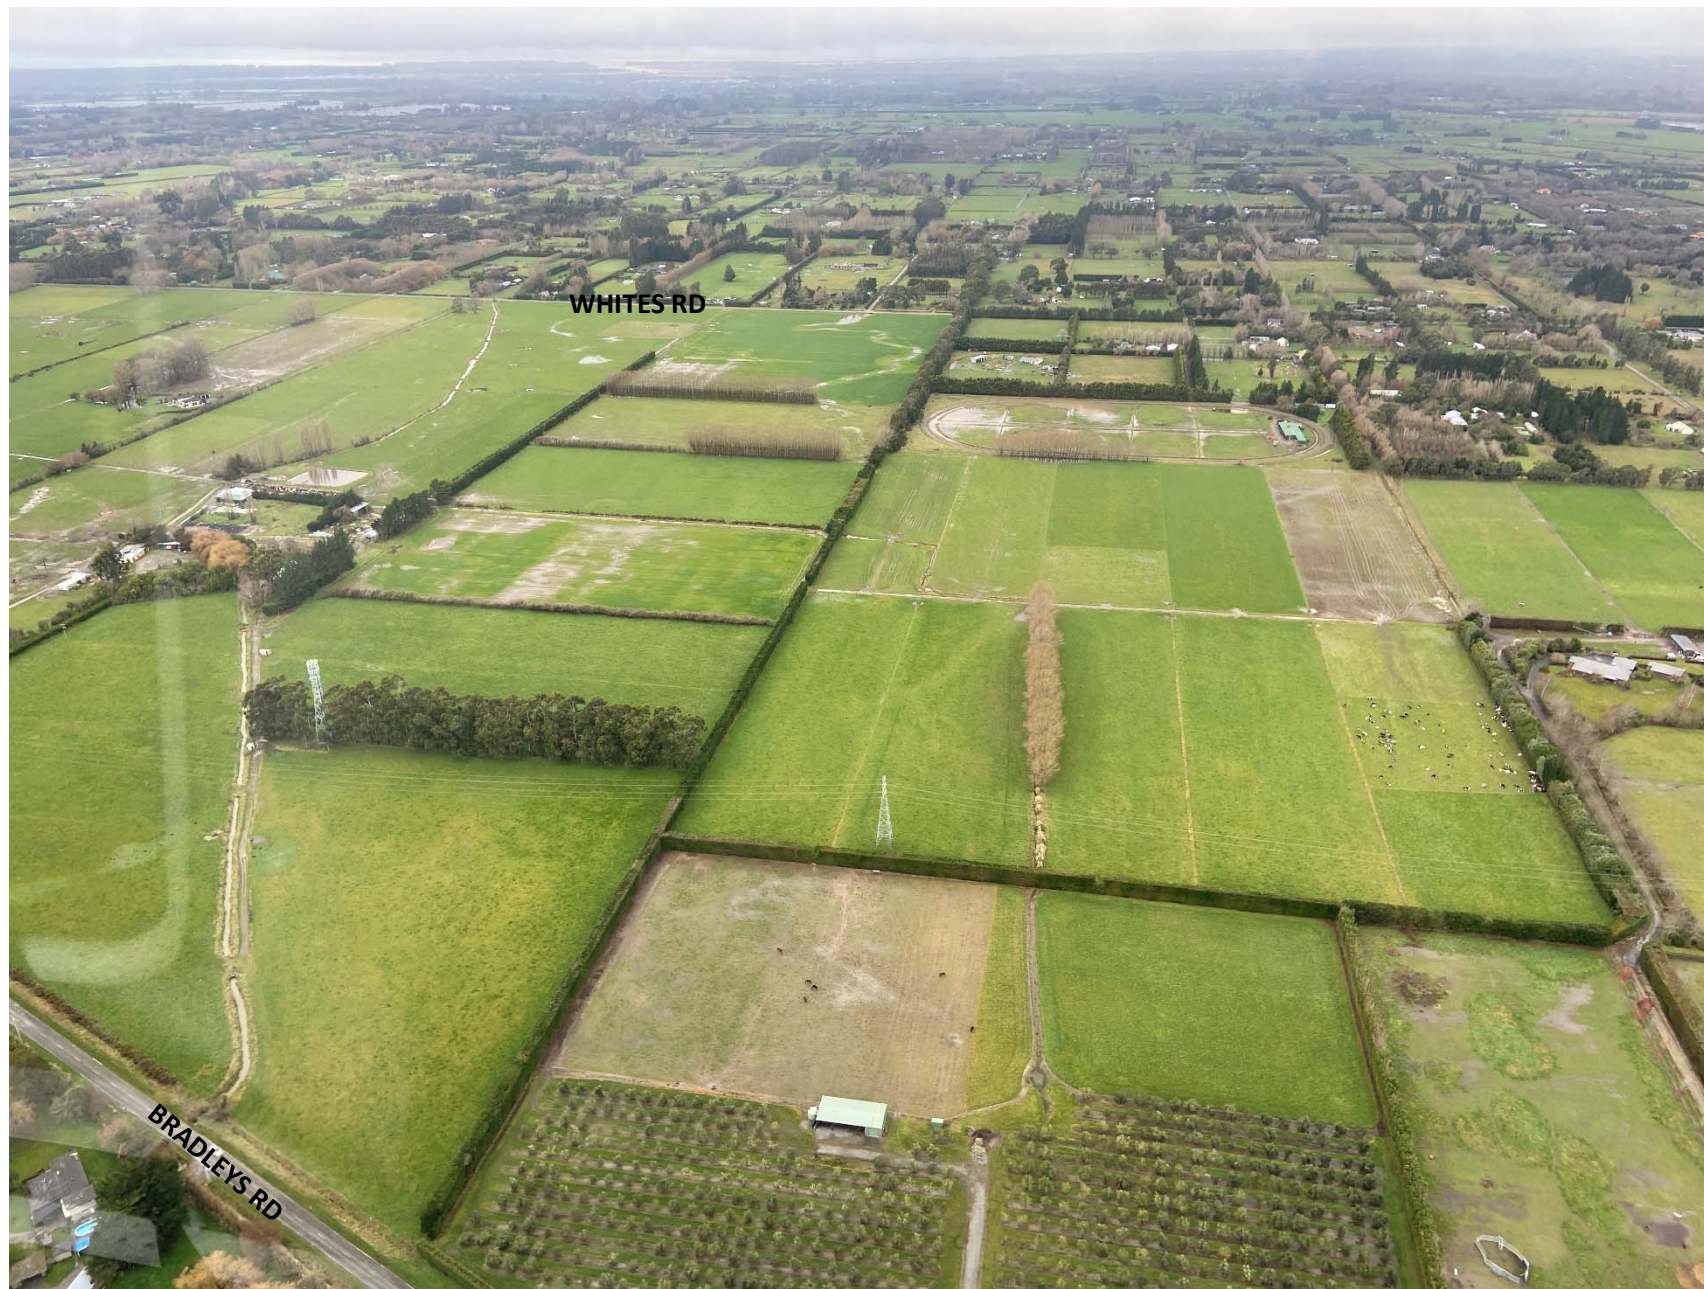
Attachment 4B: Aerial image 2548. Taken looking south-east with southern end of the proposed plan change site in the left foreground. This phot is taken to the south-west of the photo above

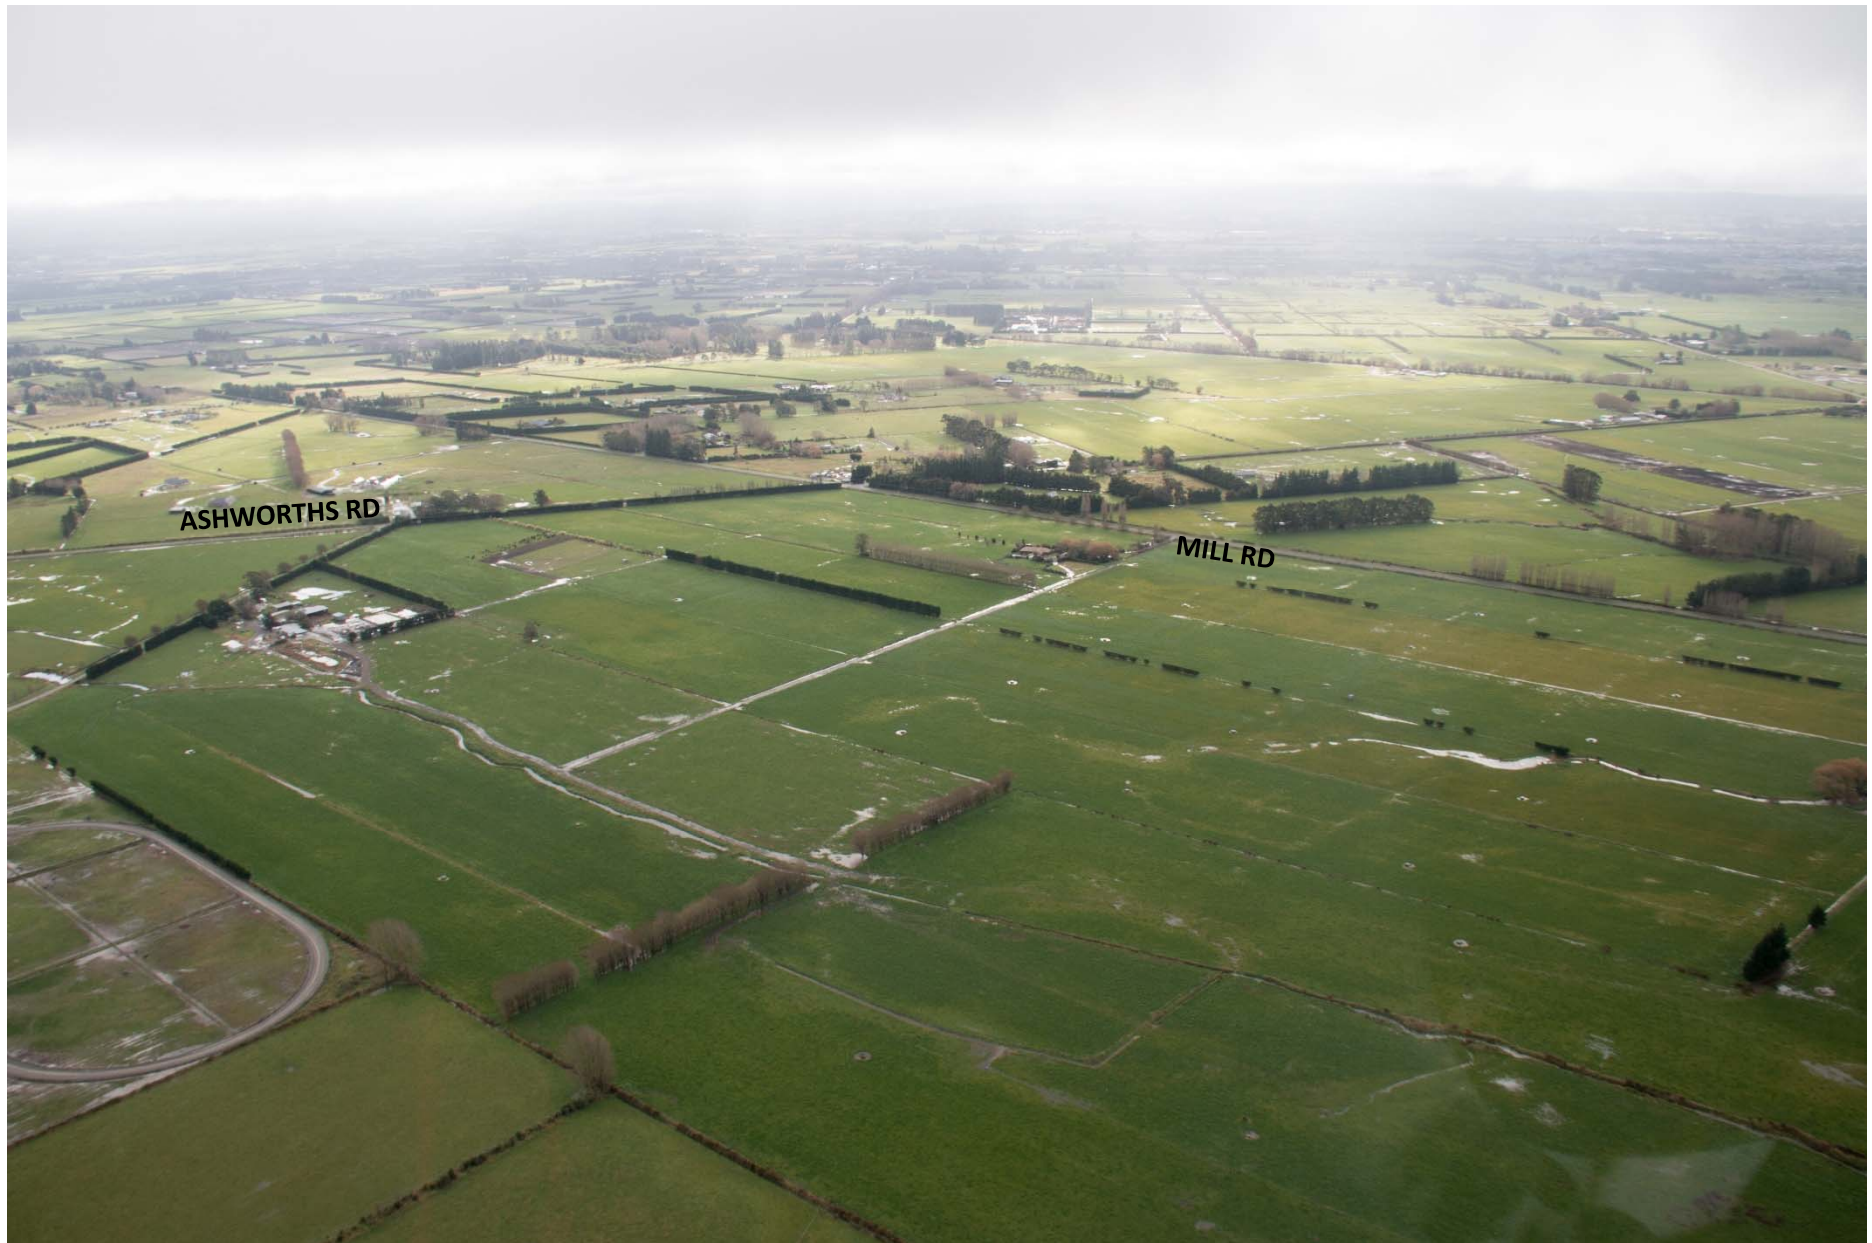
Attachment 4C: Aerial image 2554. Taken from Bradleys Rd looking north. This shows the upstream catchment

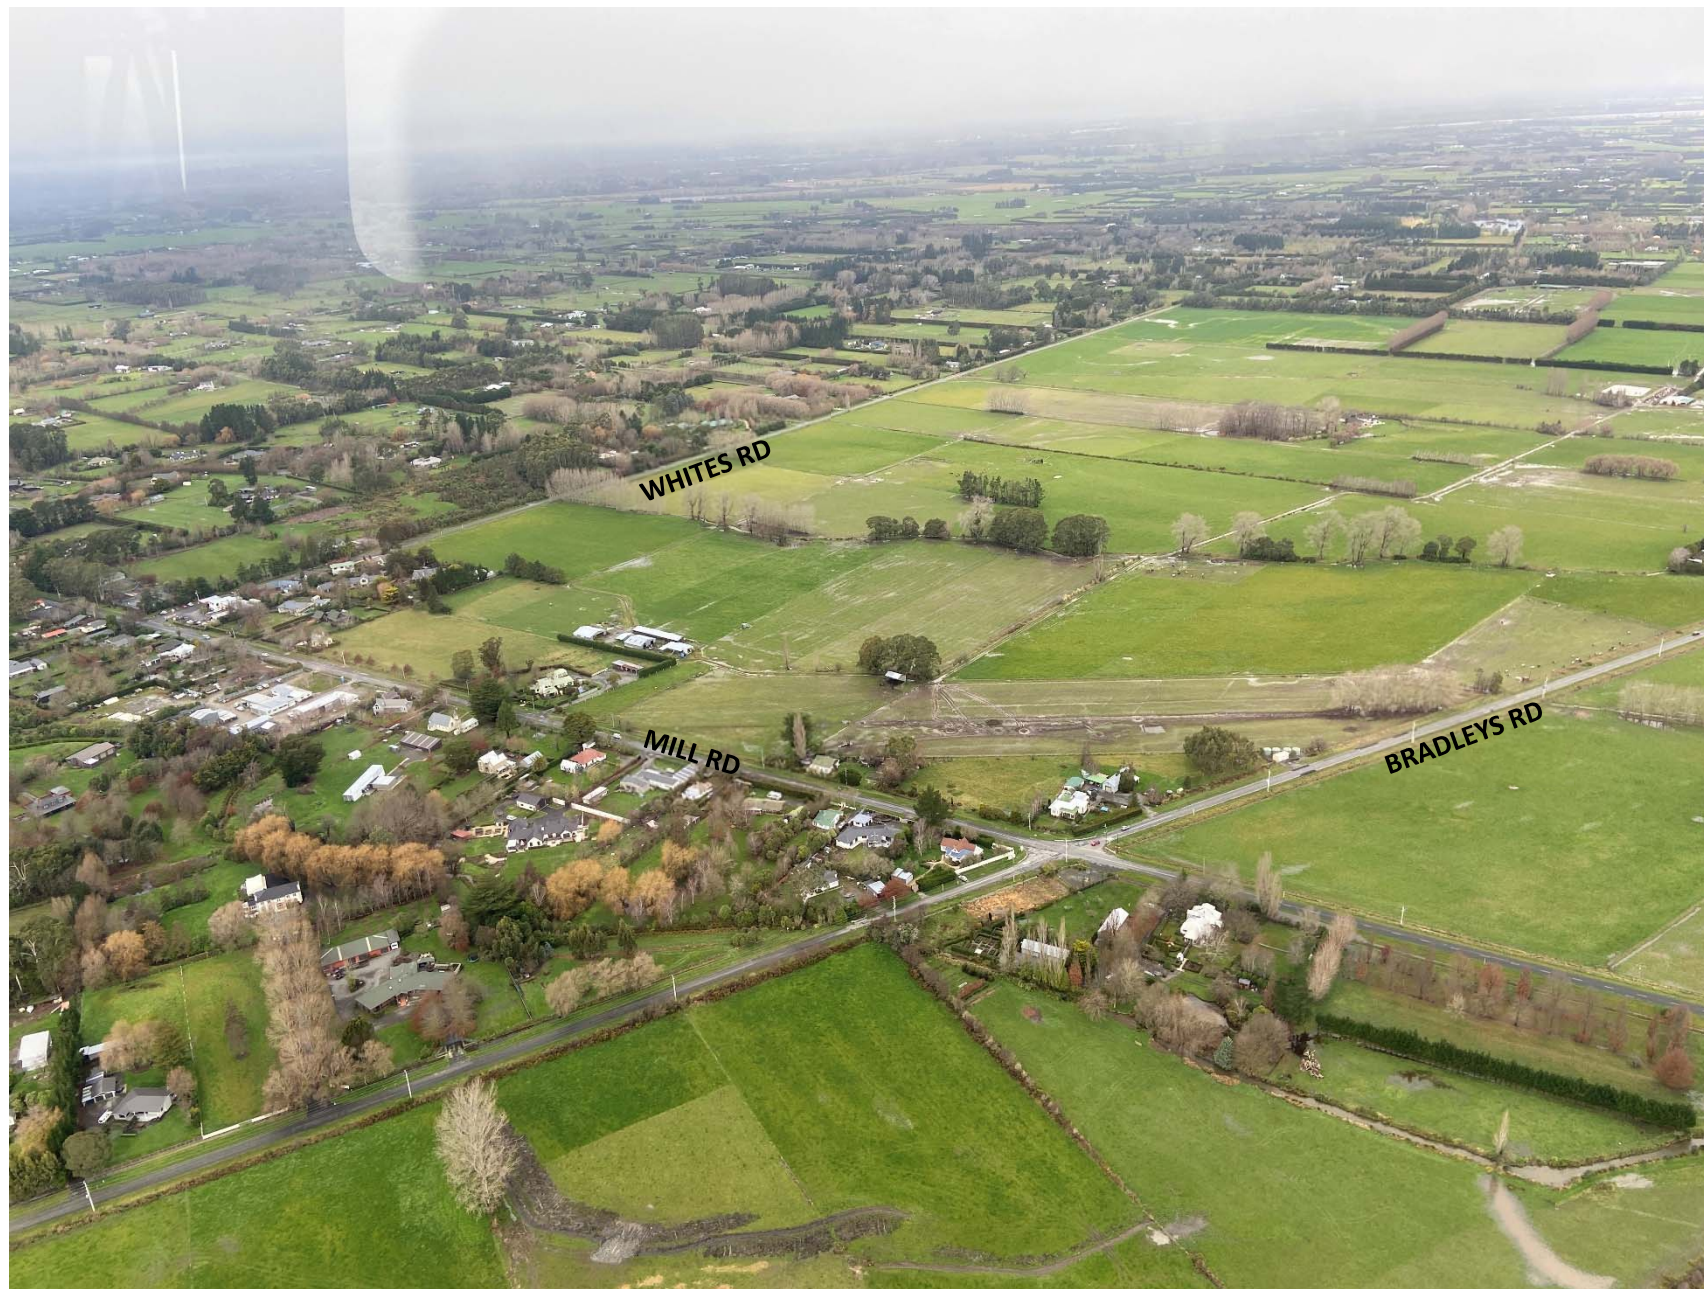
Attachment 4D: Aerial image 2623. Taken from North of Mill Rd looking south over Ohoka and the proposed plan change site

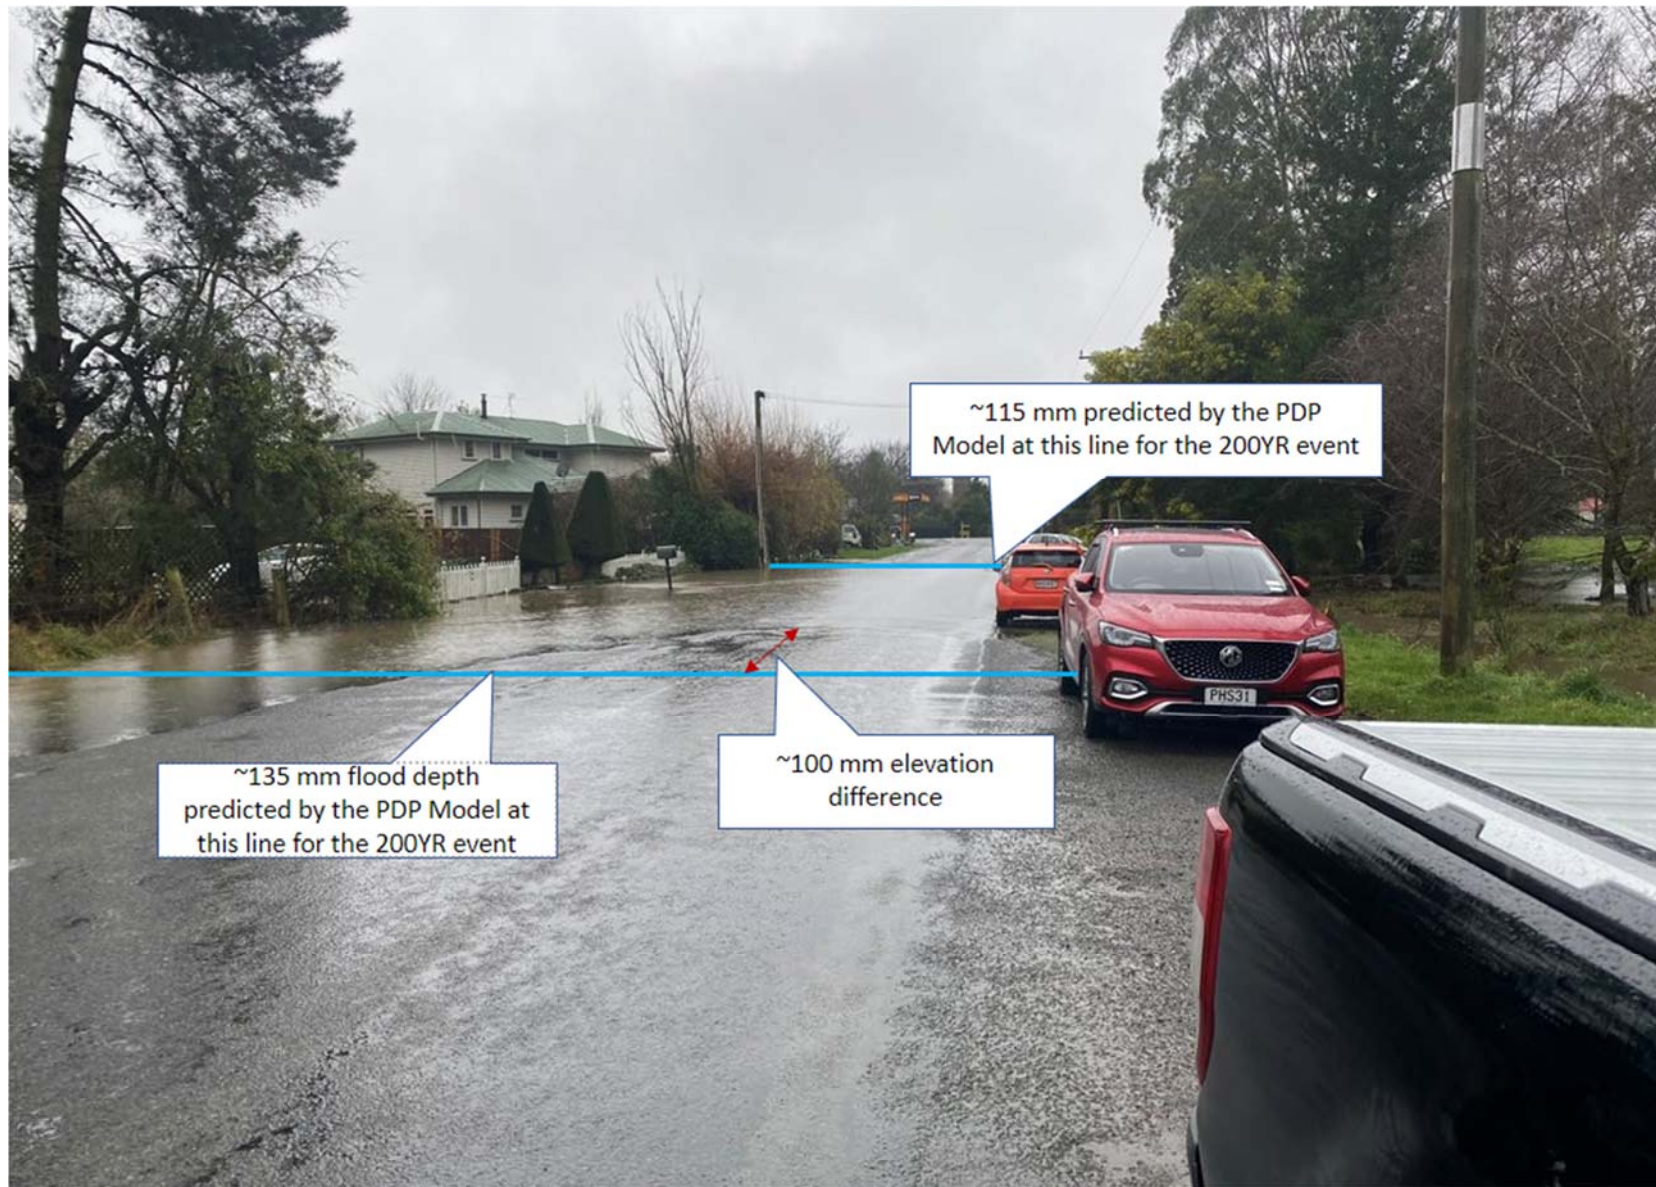
Attachment 5A: Photo 6156 taken on 23 July at 11:30 am, around 6-hours after the peak of the rainfall event and therefore likely close to the maximum flood elevations for this event.

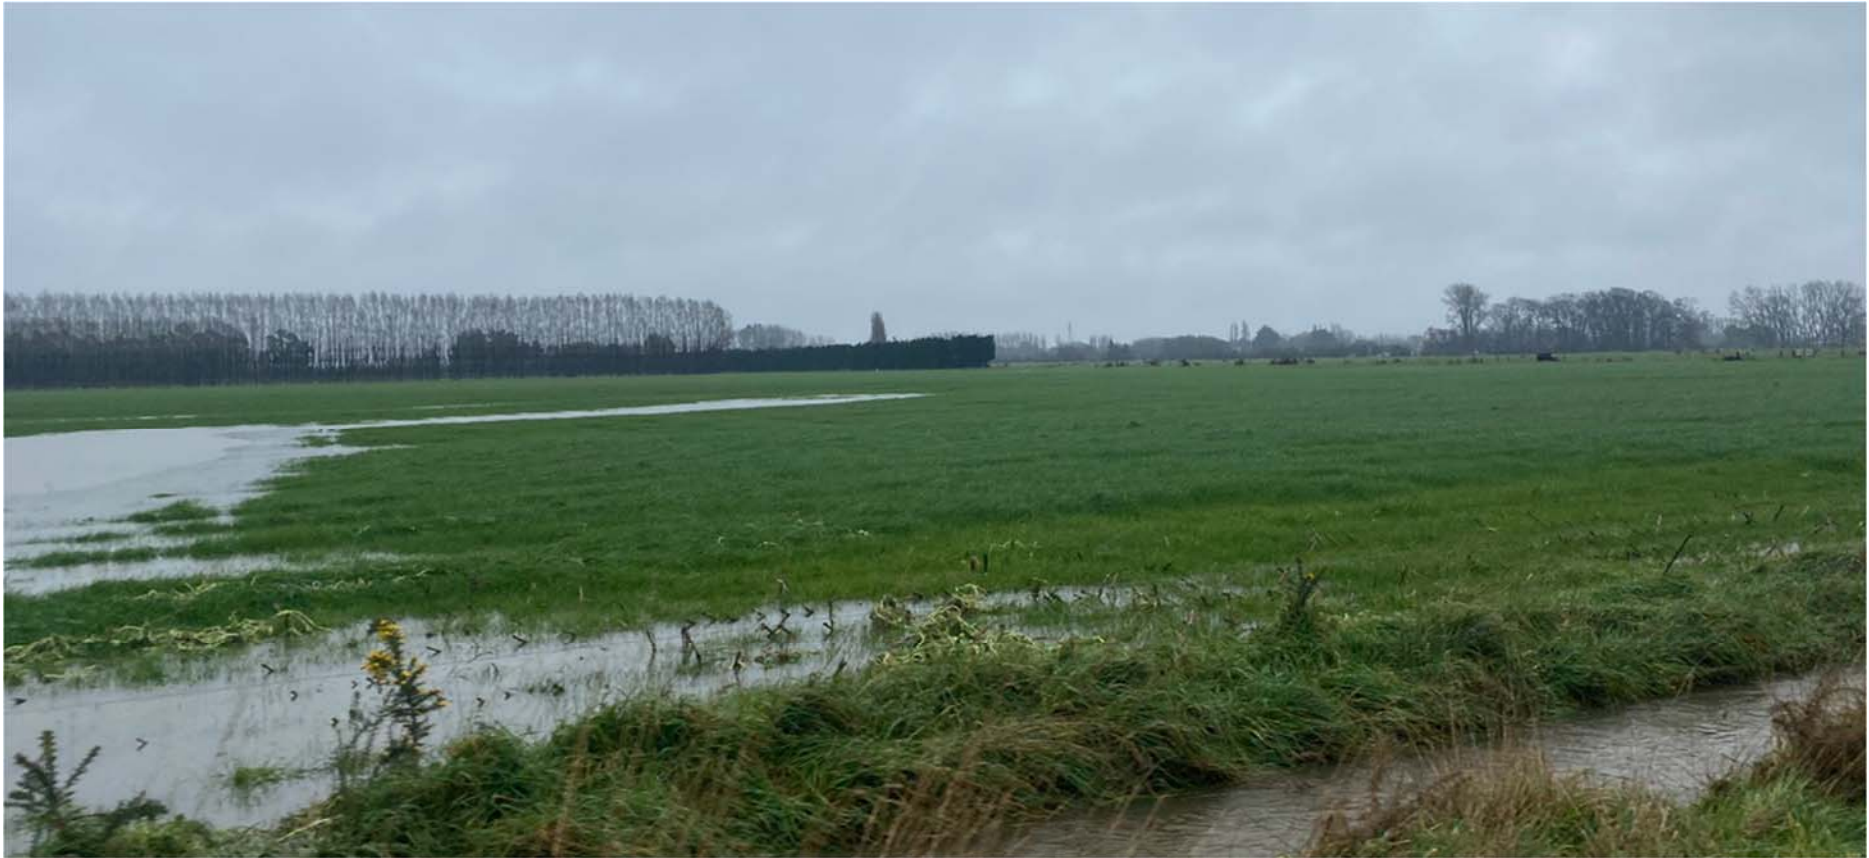
Attachment 5B: Photo 6160 taken on 23 July at 11:30 am. Taken from Whites Rd looking north over the plan change site. Water is close to top of bank in the foreground drain and flooding shown over the plan change site

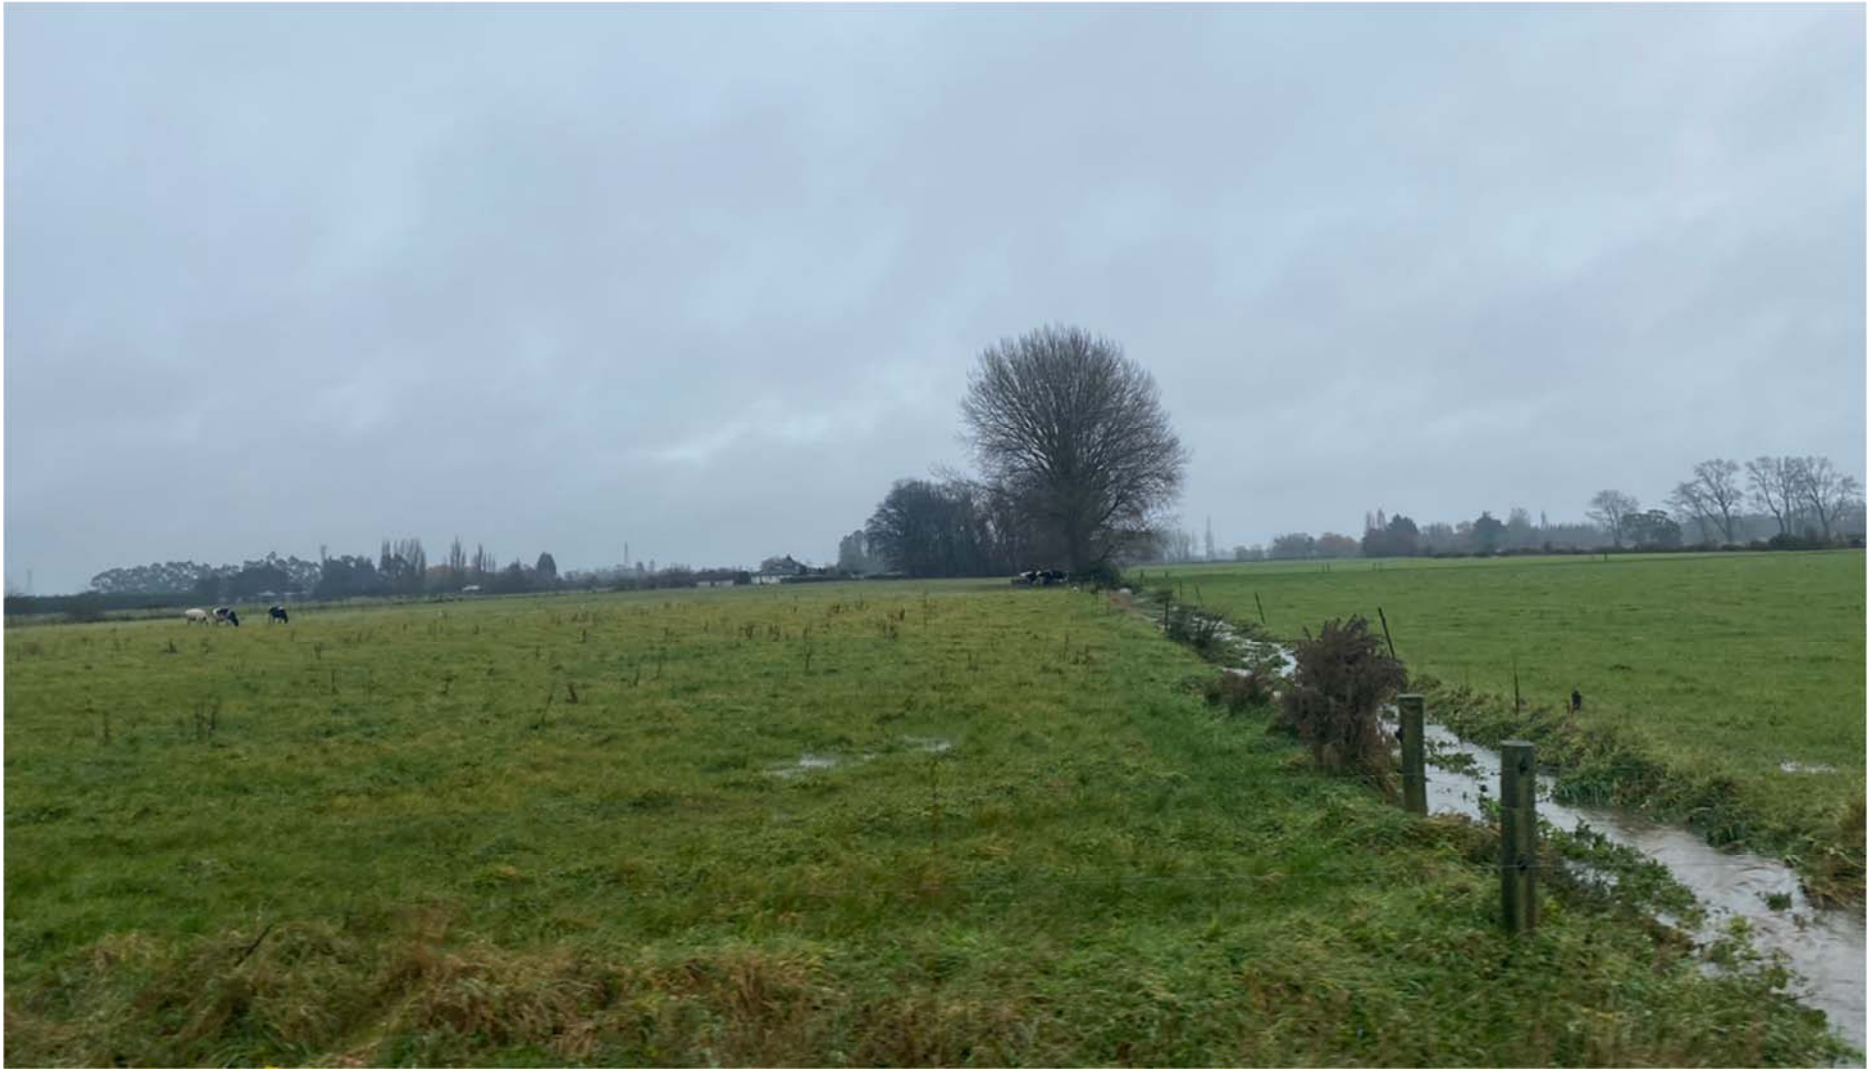
Attachment 5C: Photo 6166 taken on 23 July at 11:30 am. Taken from Whites Rd looking north over the plan change site. Water is within the drain and minimal flooding is shown over the plan change site.

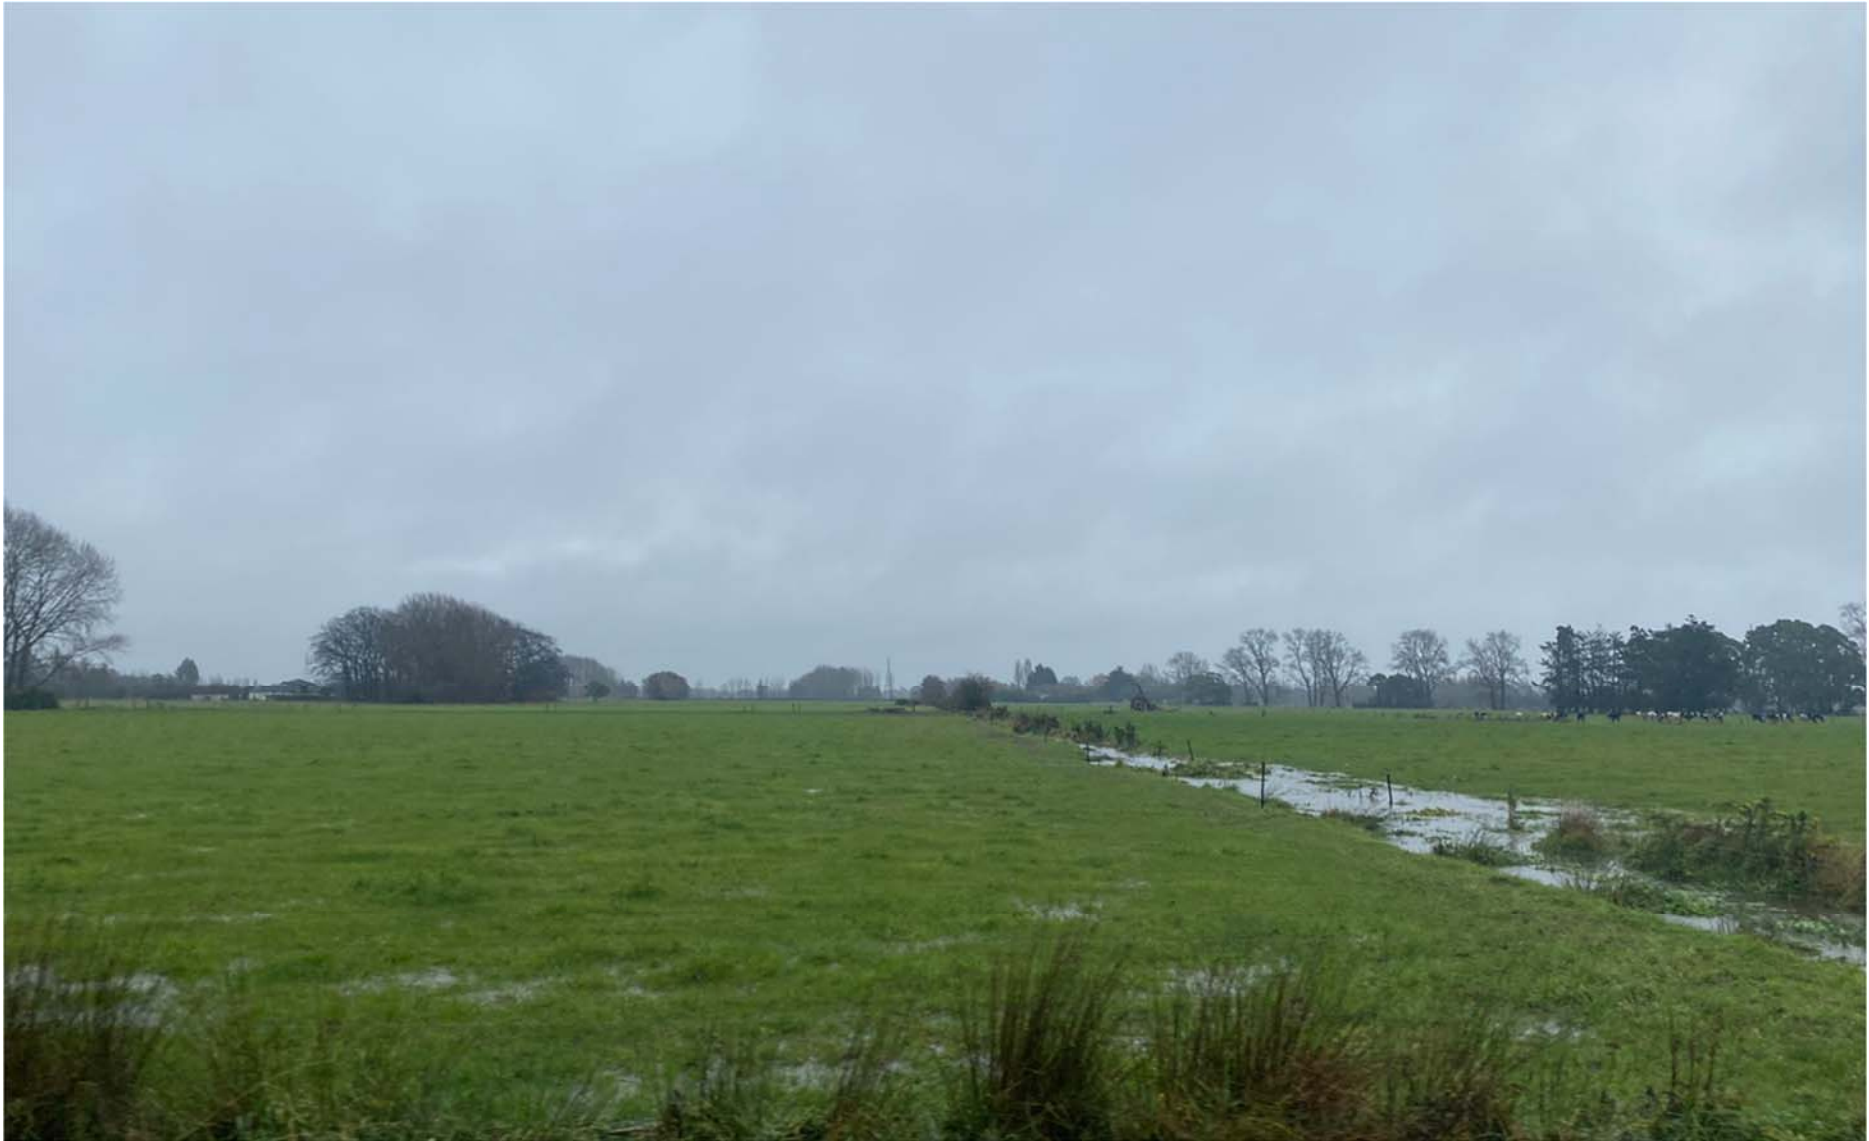
Attachment 5D: Photo 6169 taken on 23 July at 11:30 am. Taken from Whites Rd looking north over the plan change site. Water is spilling out of lower section of drain but contained within the upper section. Minimal flooding is shown over the plan change site.

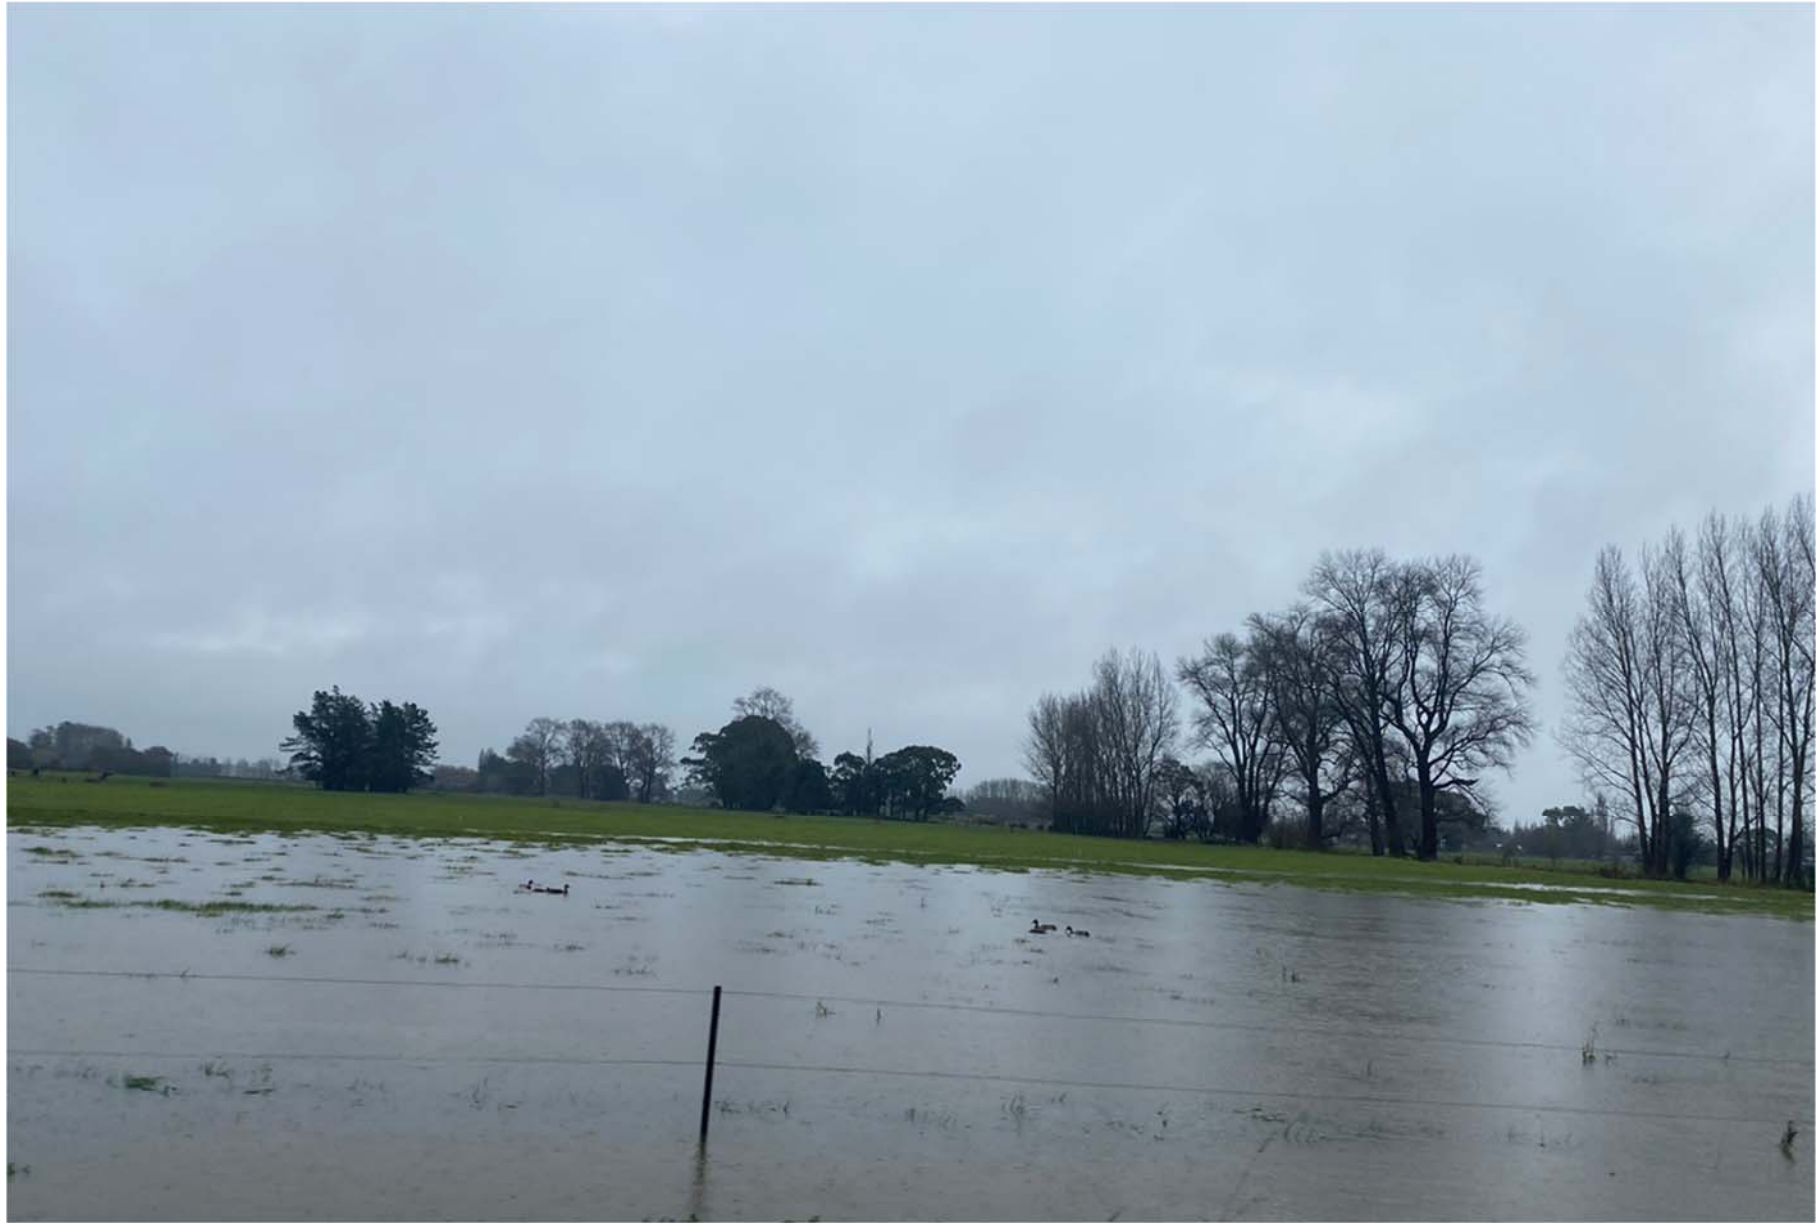
Attachment 5E: Photo 6173 taken on 23 July at 11:30 am. Taken from Whites Rd looking north over the plan change site. Water is ponding over the PC site, and the trees along the Ohoka Stream can be seen in the background. Attachment 1 of my evidence in chief shows that development will be minimised in the flooded location.

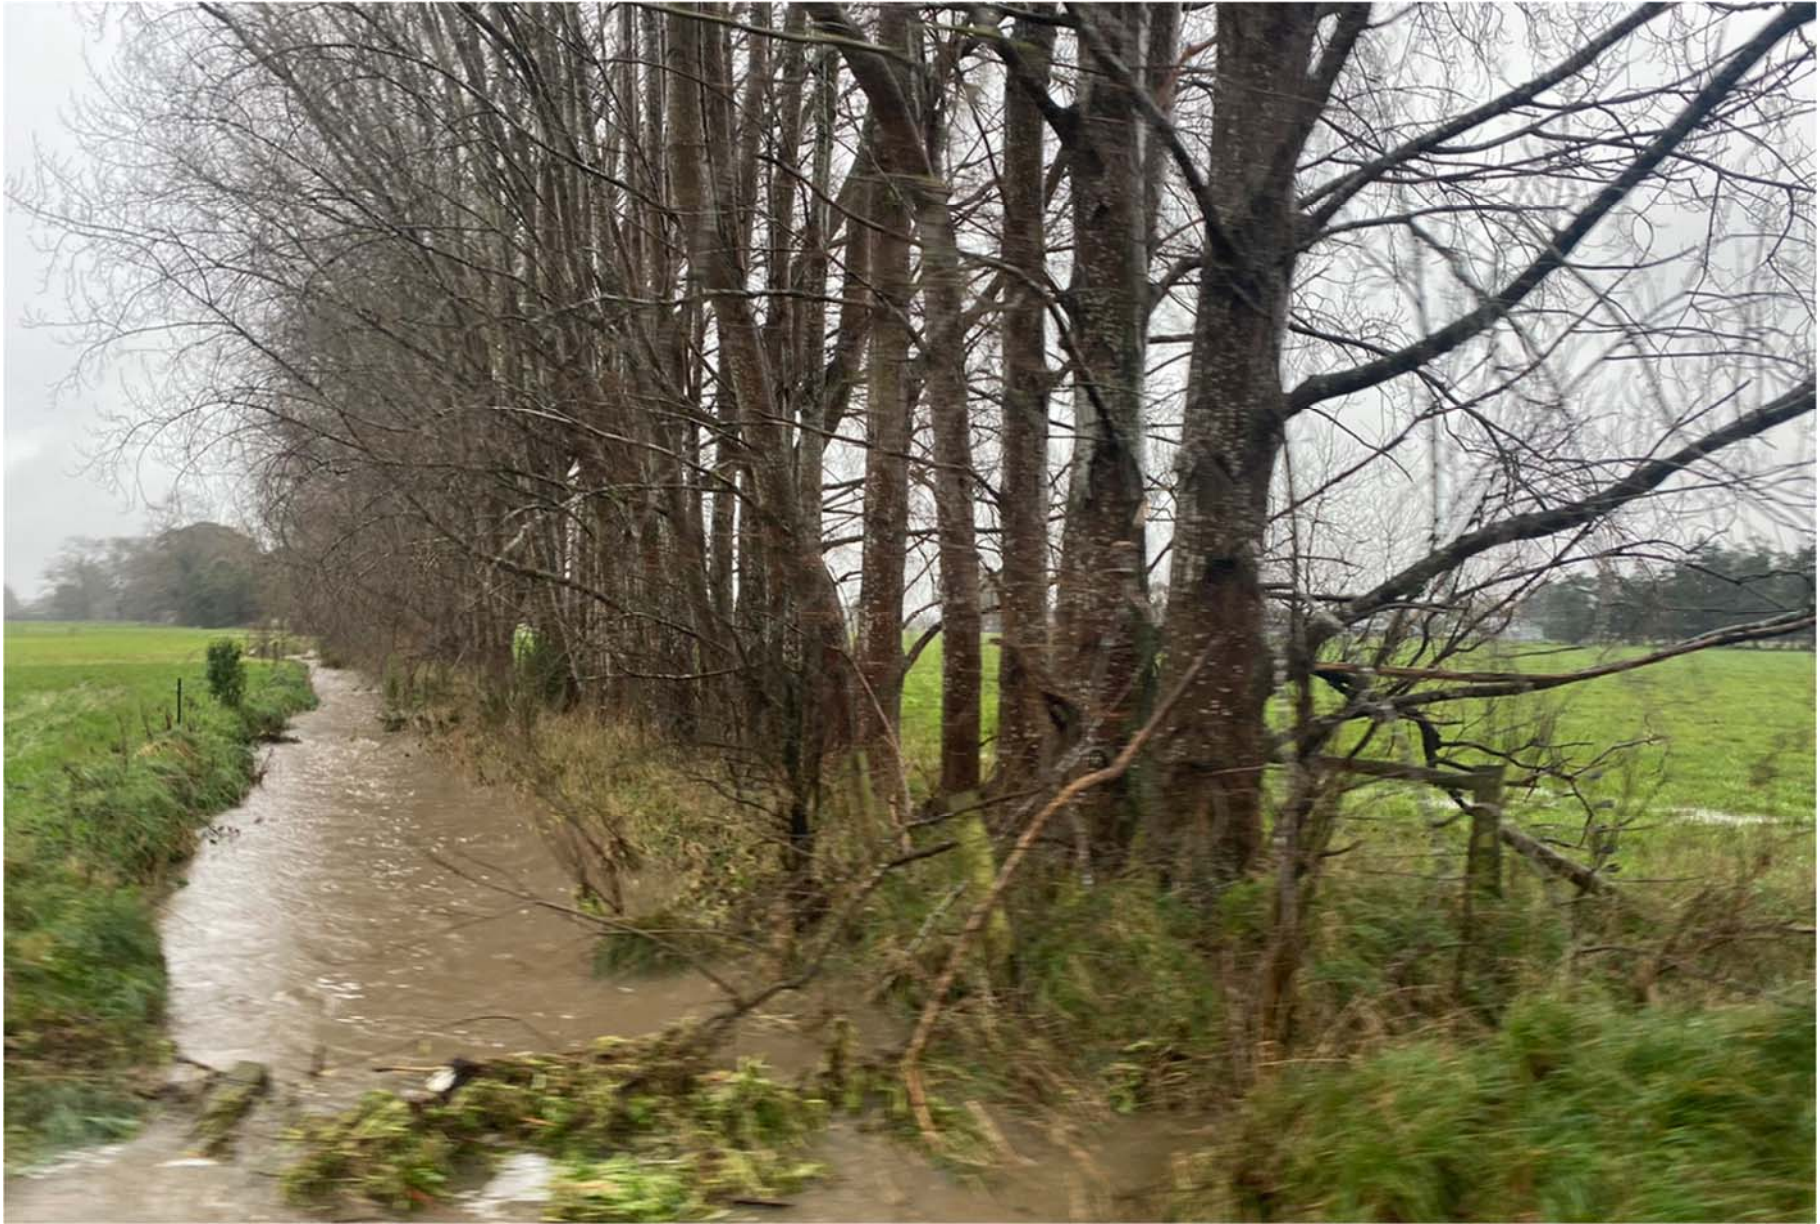
Attachment 5F: Photo 6174 taken on 23 July at 11:30 am. Taken from Whites Rd looking north up the Ohoka Stream. Water is within the stream banks and no out of bank flow is observed.
