Before the Independent Hearings Panel  
at Waimakariri District Council

*in the matter of:* Proposed private plan change RCP31 to the Operative  
Waimakariri District Plan

Summary of evidence of Ben Throssell

PLAN CHANGE 31: FLOOD HAZARD

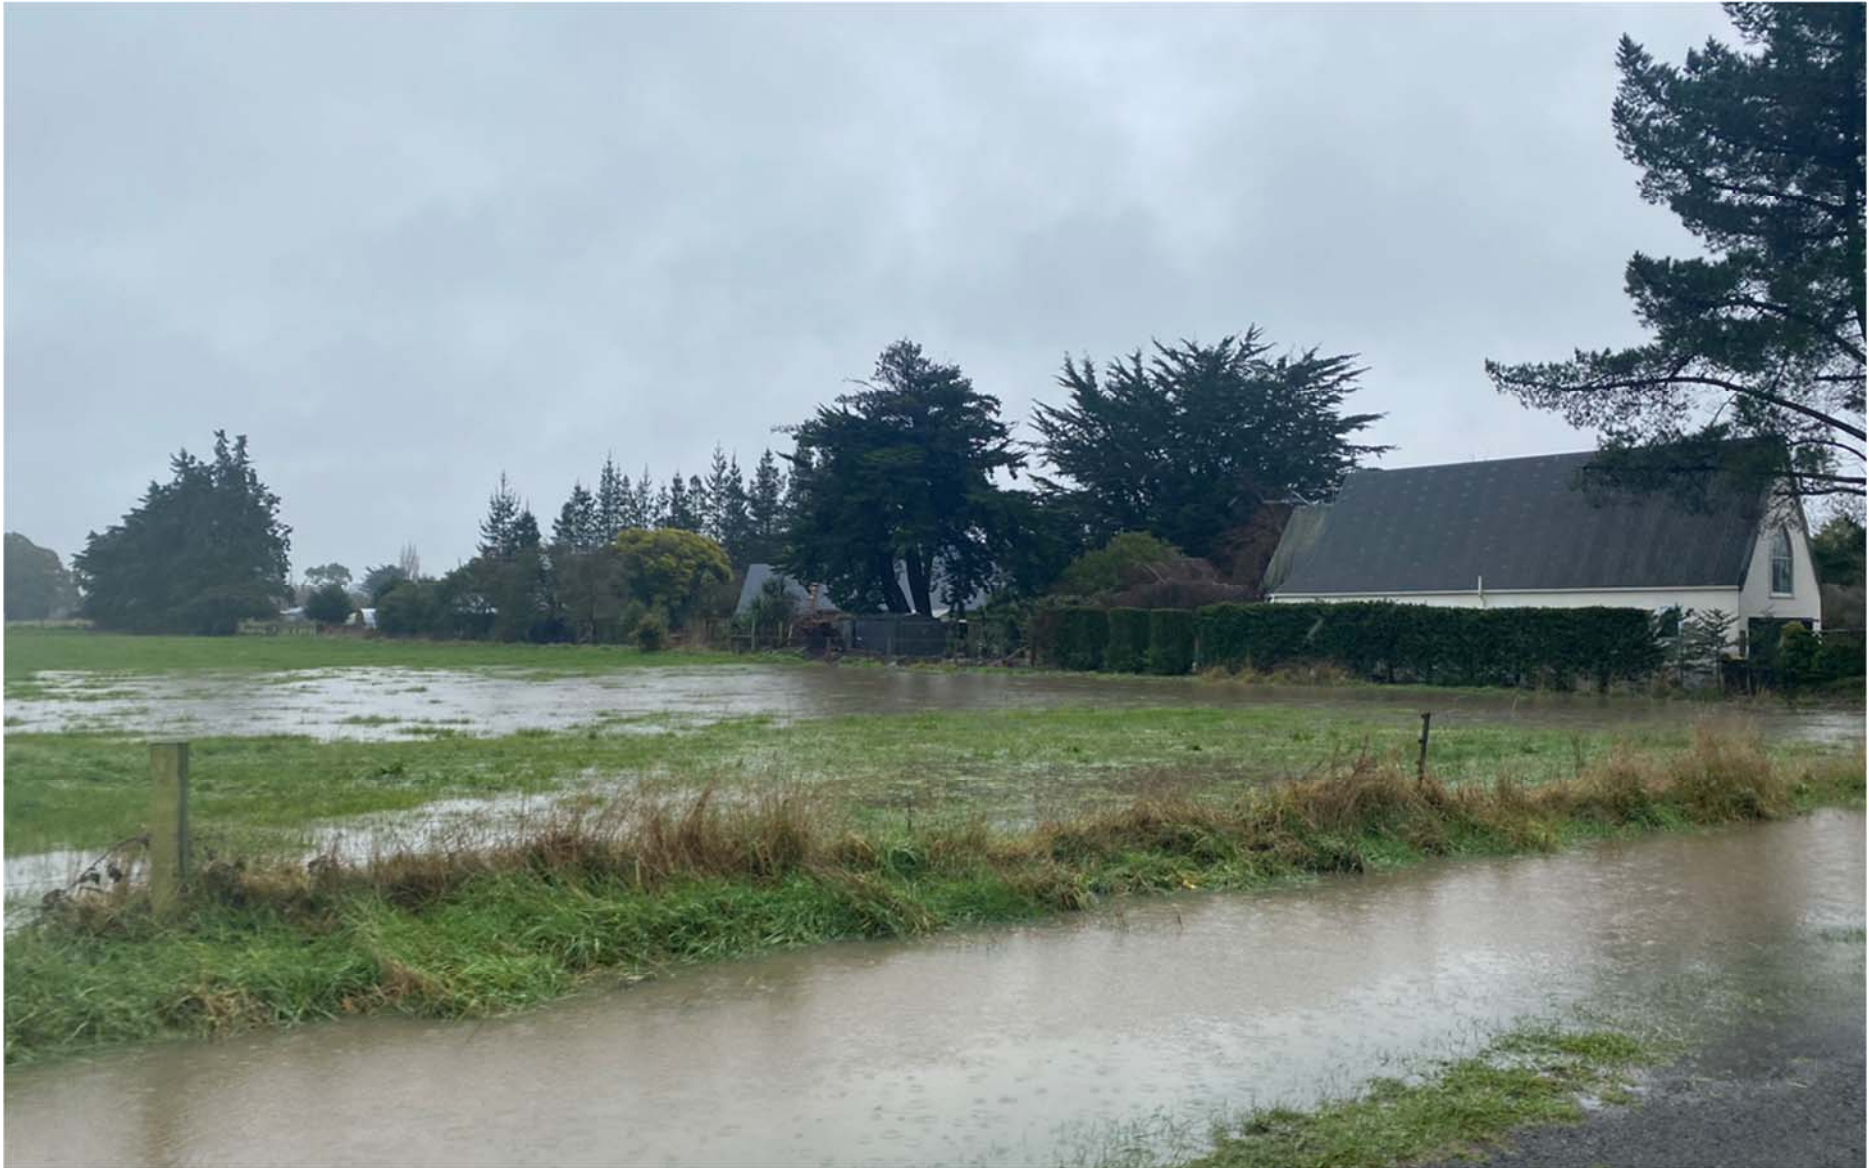
Attachment 5G: Photo 6177 taken on 23 July at 11:30 am. Taken from Whites Rd looking north over the plan change site. Water is ponding over the PC site. Attachment 1 of my evidence in chief shows that development will be minimised in the flooded location.

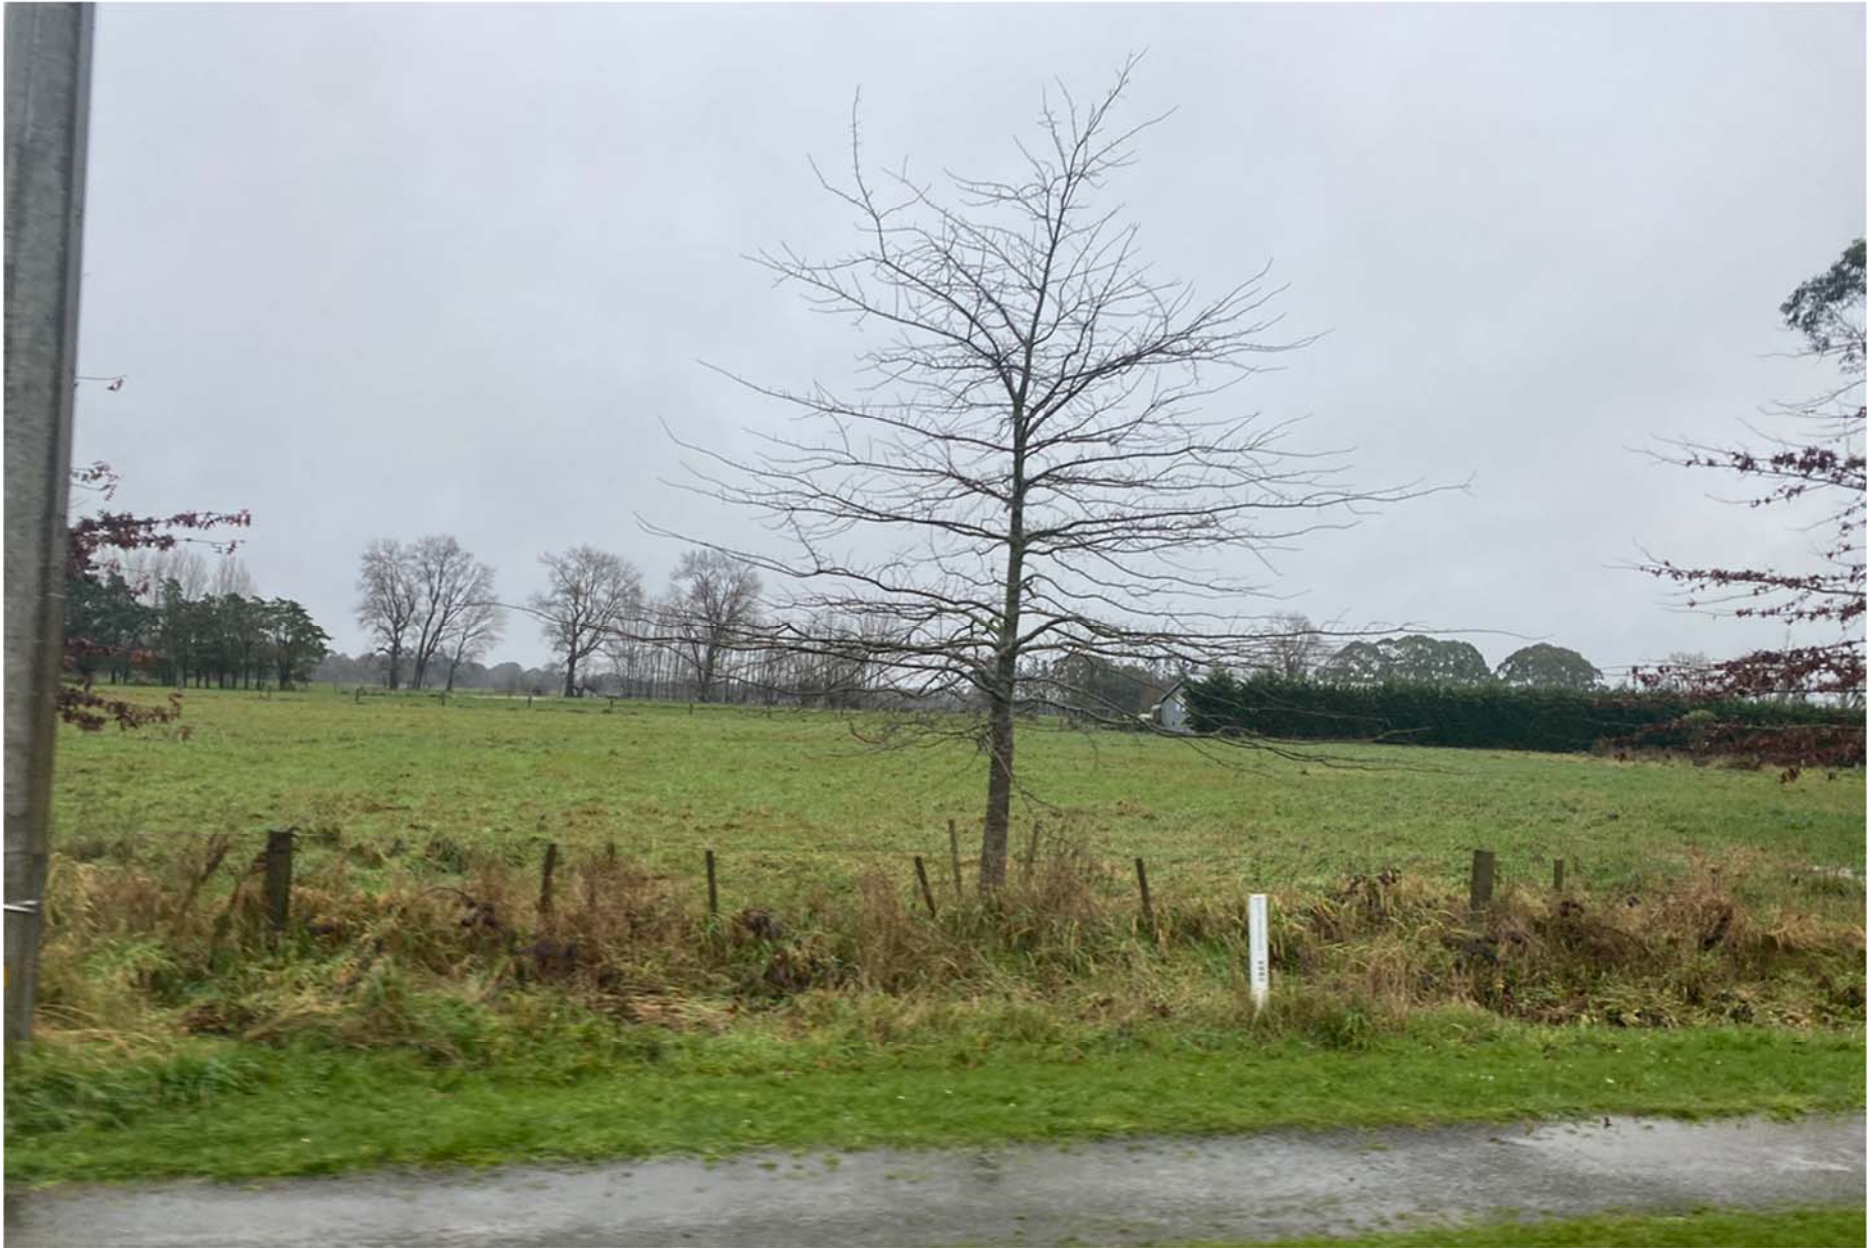
Attachment 5H: Photo 6184 taken on 23 July at 11:30 am. Taken from Mill Rd looking south-west over the plan change site showing minimal flooding

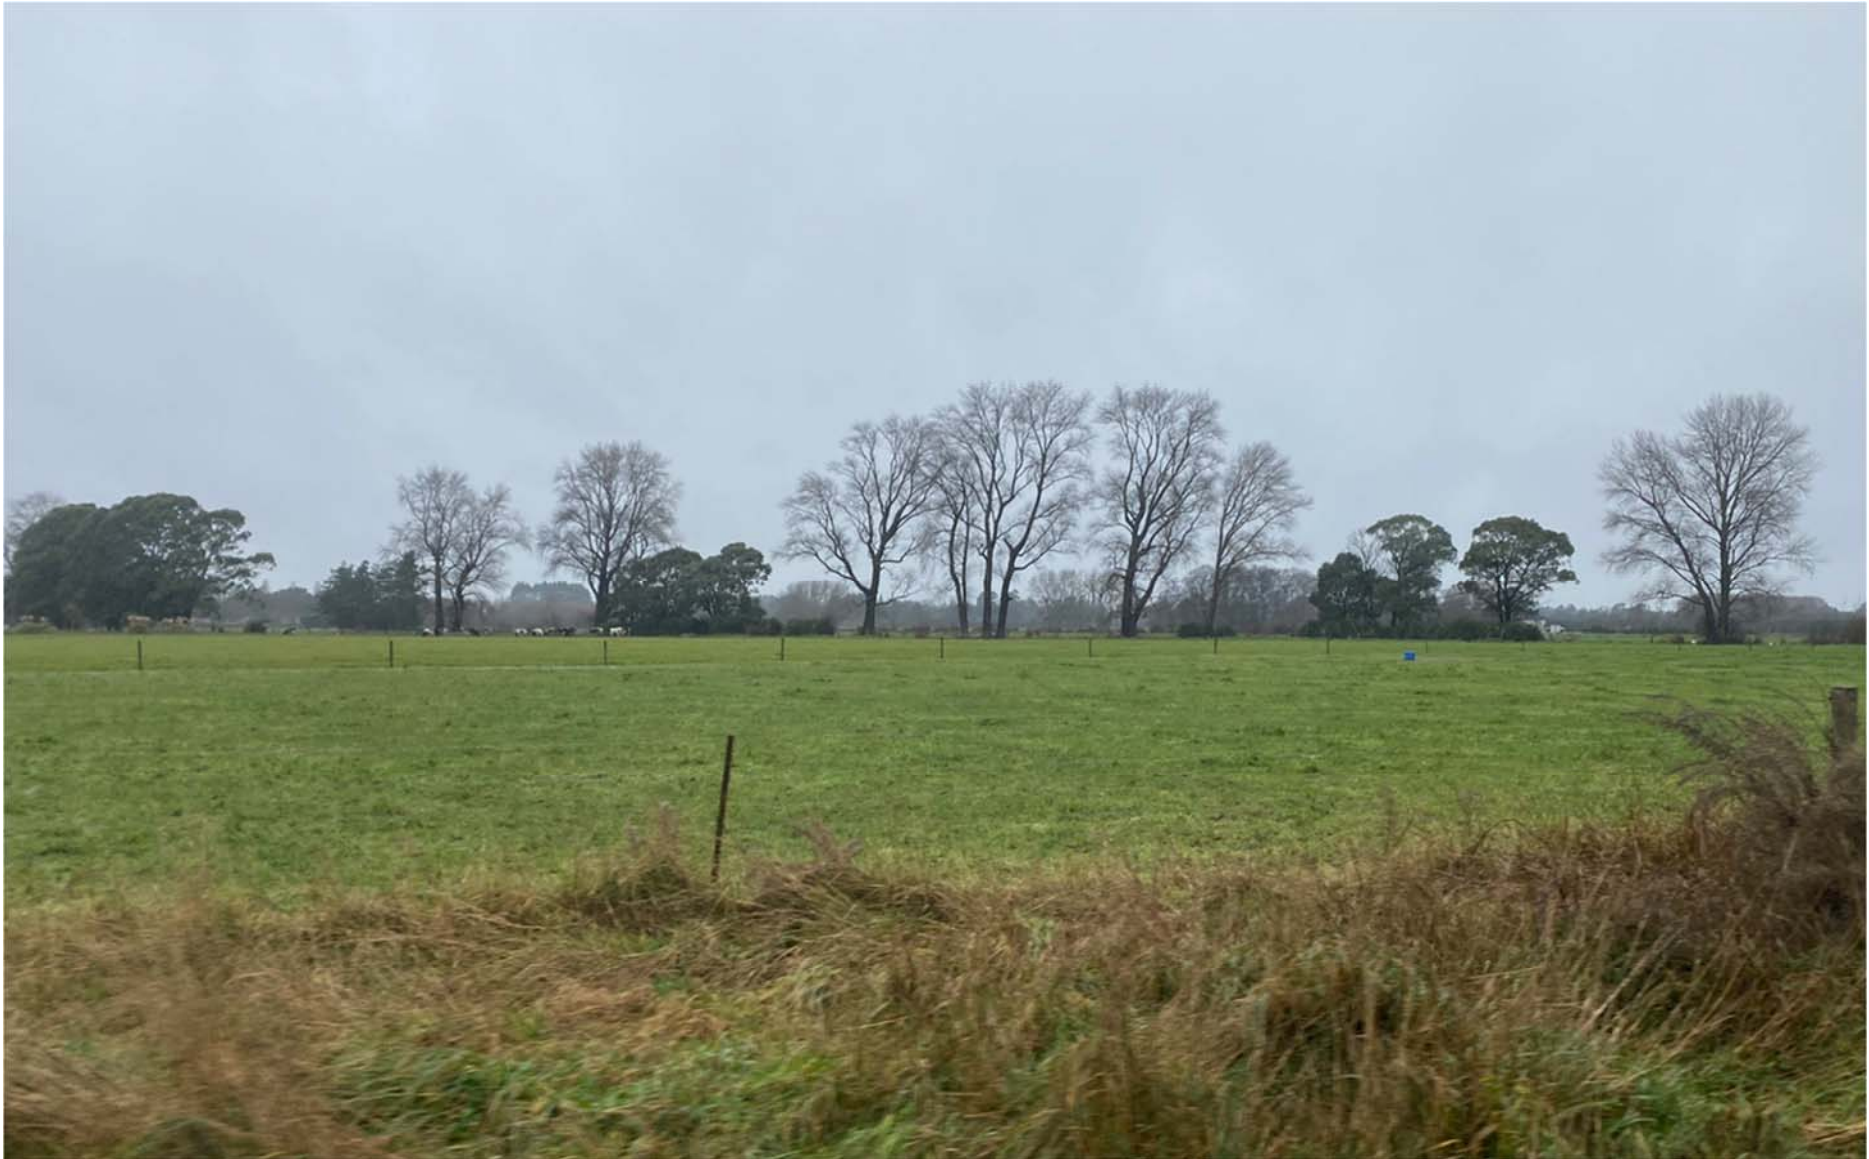
Attachment 5I: Photo 6188 taken on 23 July at 11:30 am. Taken from Bradleys Rd looking south-east over the plan change site showing minimal flooding.

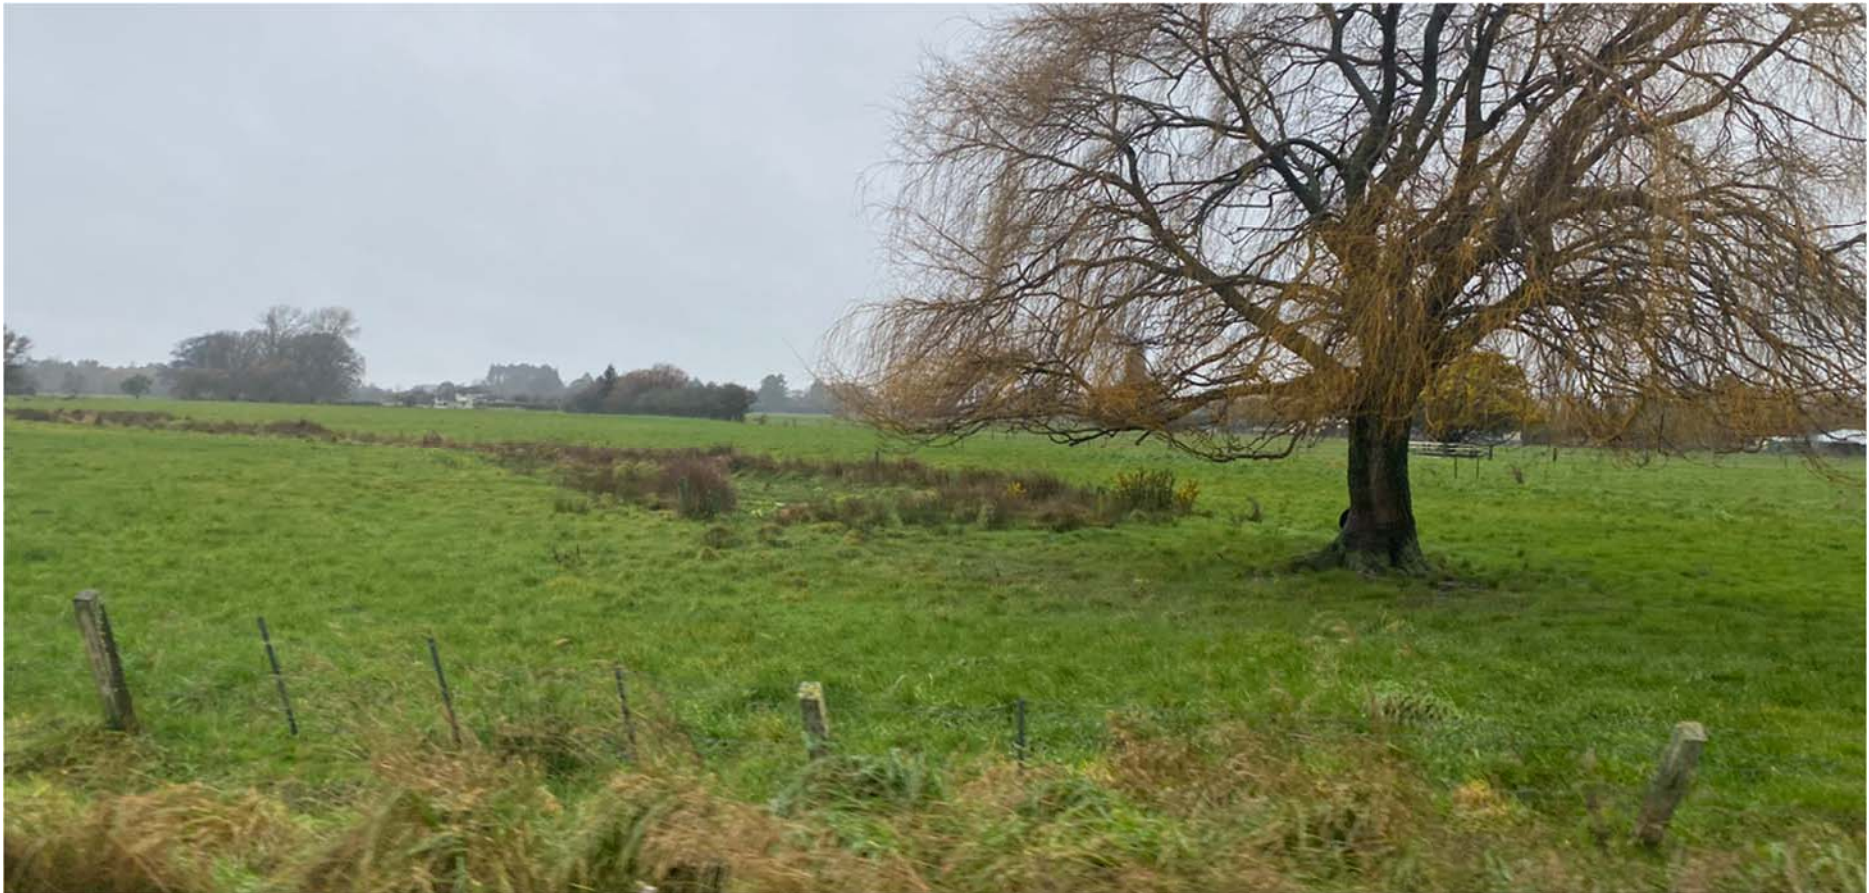
Attachment 5J: Photo 6191 taken on 23 July at 11:30 am. Taken from Bradleys Rd looking south-east over the plan change site showing minimal flooding from northern spring head which is bounded by the rushes.

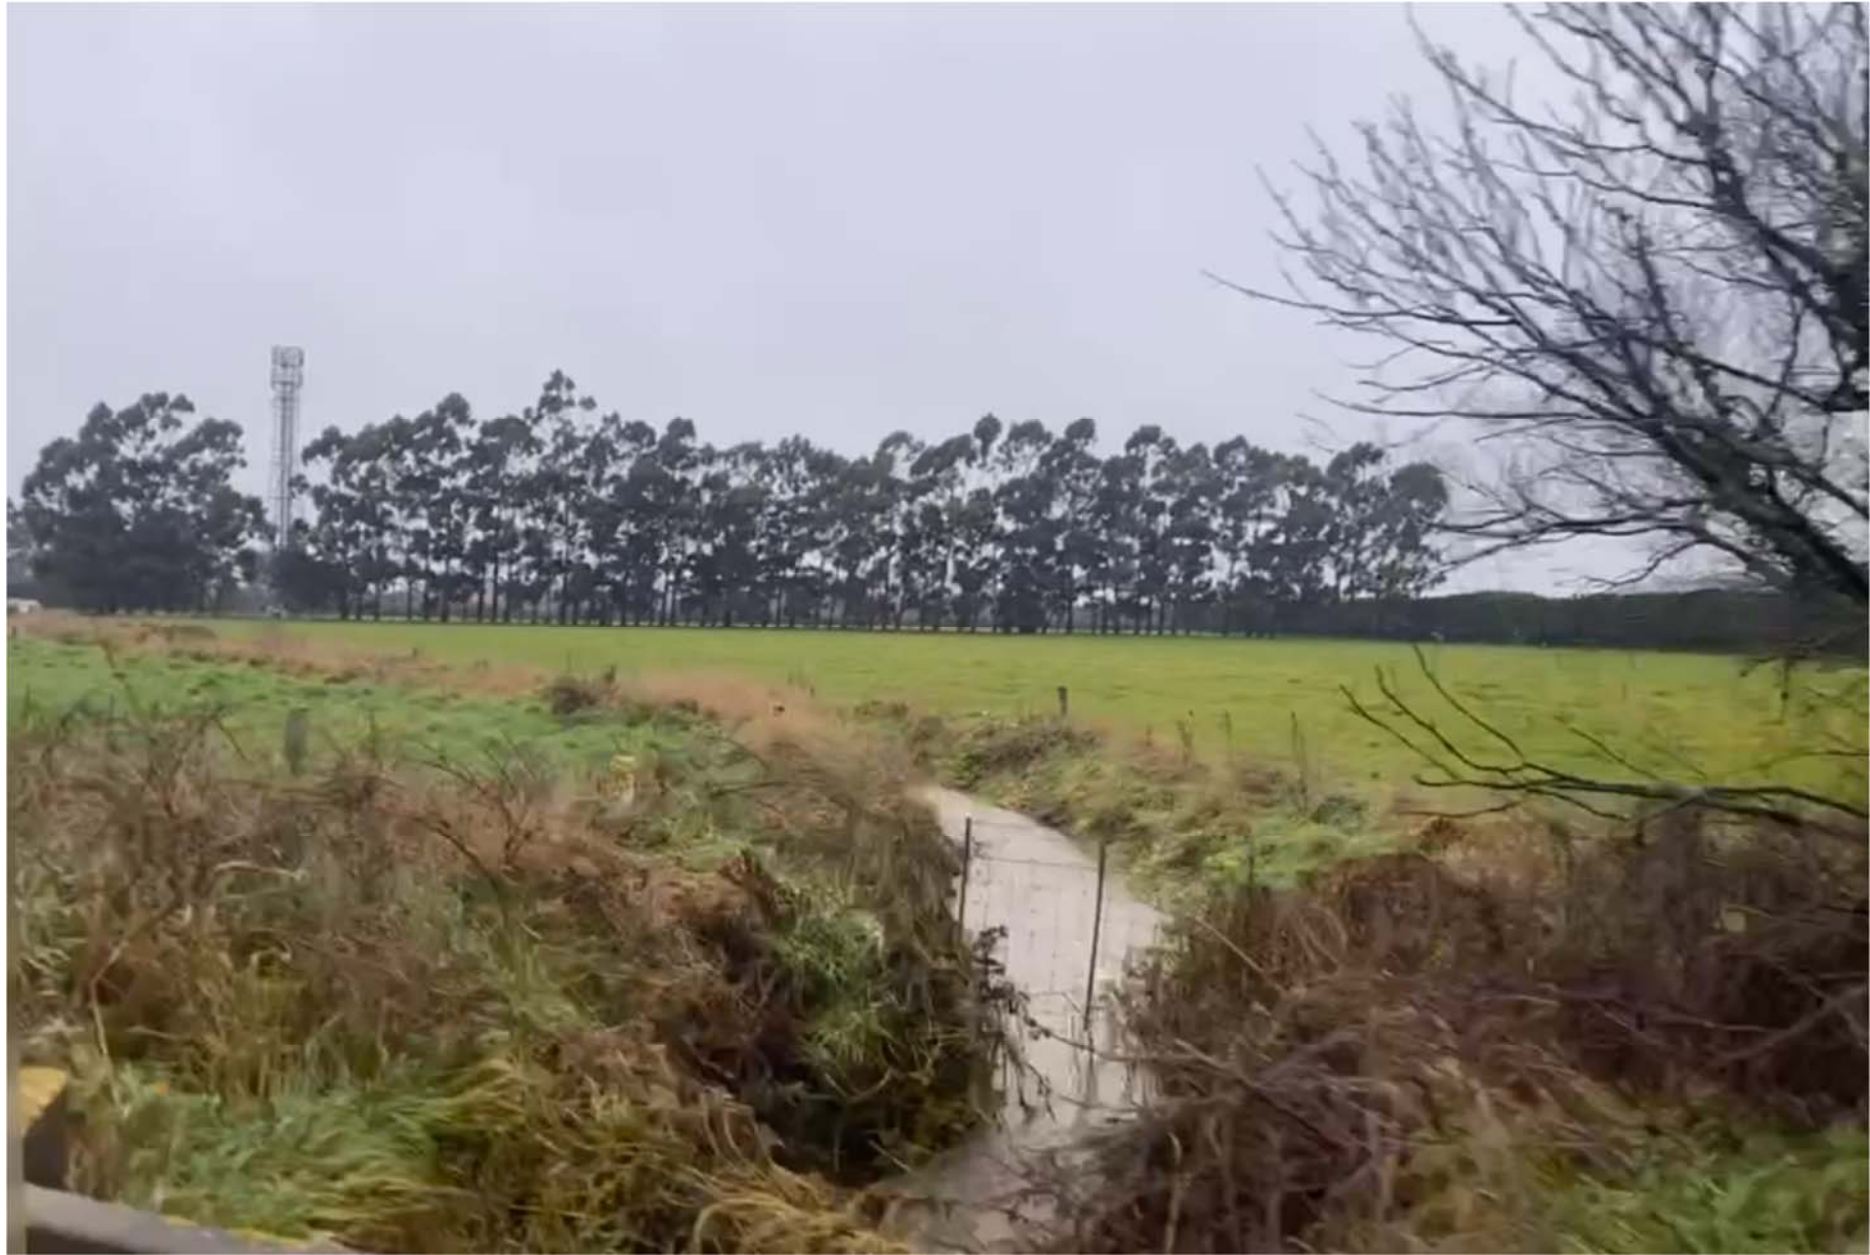
Attachment 5K: Photo 6197 taken on 23 July at 11:30 am. Taken from Bradleys Rd looking south-east over the plan change site showing minimal flooding. Floodwaters are well contained within the drain and there is no out of bank flow.
