Project Number #24496.000.001

Geotechnical Investigation

144 & 170 Main North Road, Kaiapoi,
Canterbury

Submitted to:
Balance Developments Ltd
PO Box 36-732
Merivale
Christchurch 8143

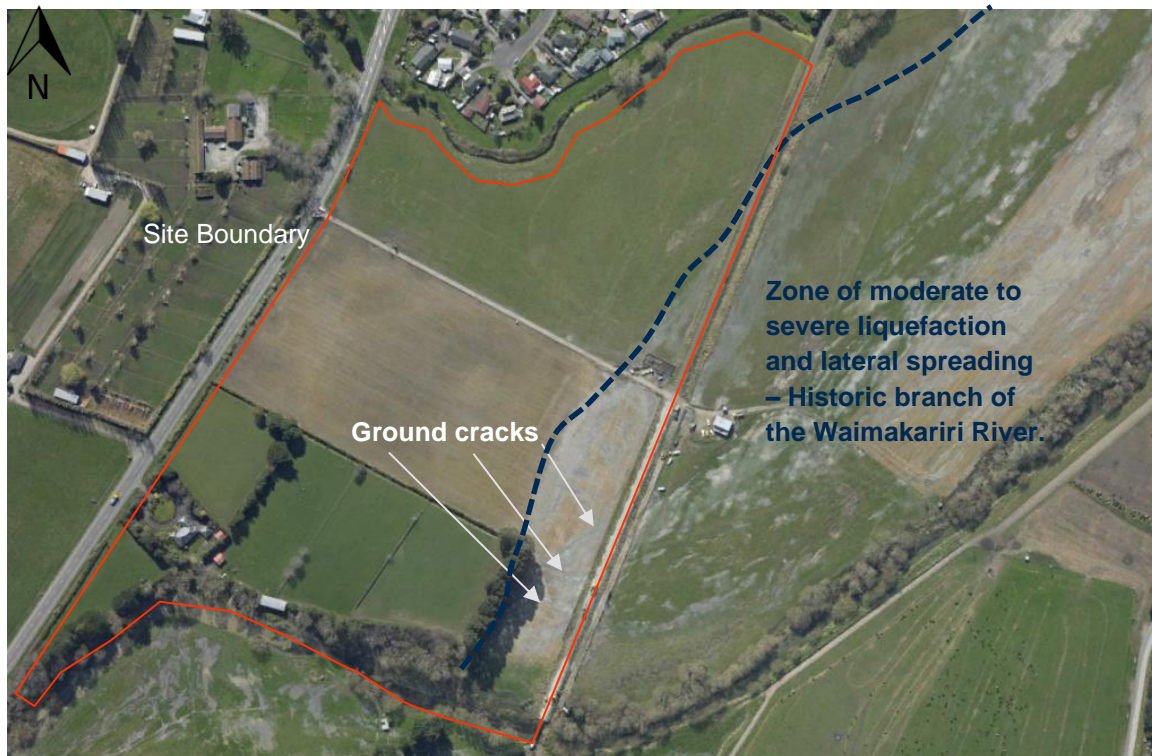
Figure 3: September 2010 Aerial Photograph

- Aerial photographs following the September 2010 earthquake event (Figure 3) show moderate to severe liquefaction ejecta and extensive lateral spread ground cracks in the lower lying portion of the site that extends east of the site (i.e. the historic branch of the Waimakariri River). Large ground cracks are visible running approximately parallel to the Courtenay River and indicate lateral spreading in this direction.

Image sourced from NZGD Canterbury Maps, historic imagery layer.

Following the September 2010 earthquake, the historic branch of the Waimakariri River lying north of Courtenay Stream suffered extensive lateral spread and liquefaction damage, particularly along the north edge of the historic channel boundary (Wotherspoon, 2012). This lower lying area extends into the site along the southeast edge (Zone 2a). Aerial photos taken following the September 2011 earthquake show extensive lateral spread cracks and liquefaction ejecta within this area along the southeast side of the site.

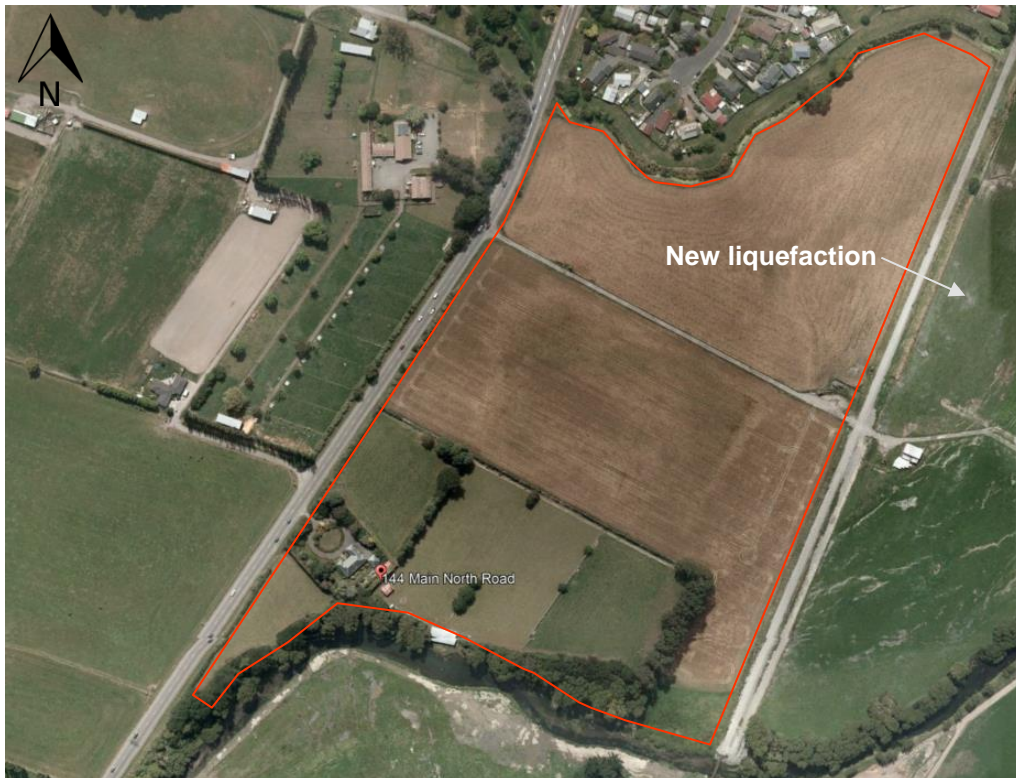
Figure 4: February 2011 Aerial Photograph

- Aerial photographs following the February 2011 earthquake event (Figure 4) show minor to moderate liquefaction ejecta and associated ground cracks on the other side of the railway corridor to the east of the site. No clear liquefaction or ground cracks were noted on the site itself.

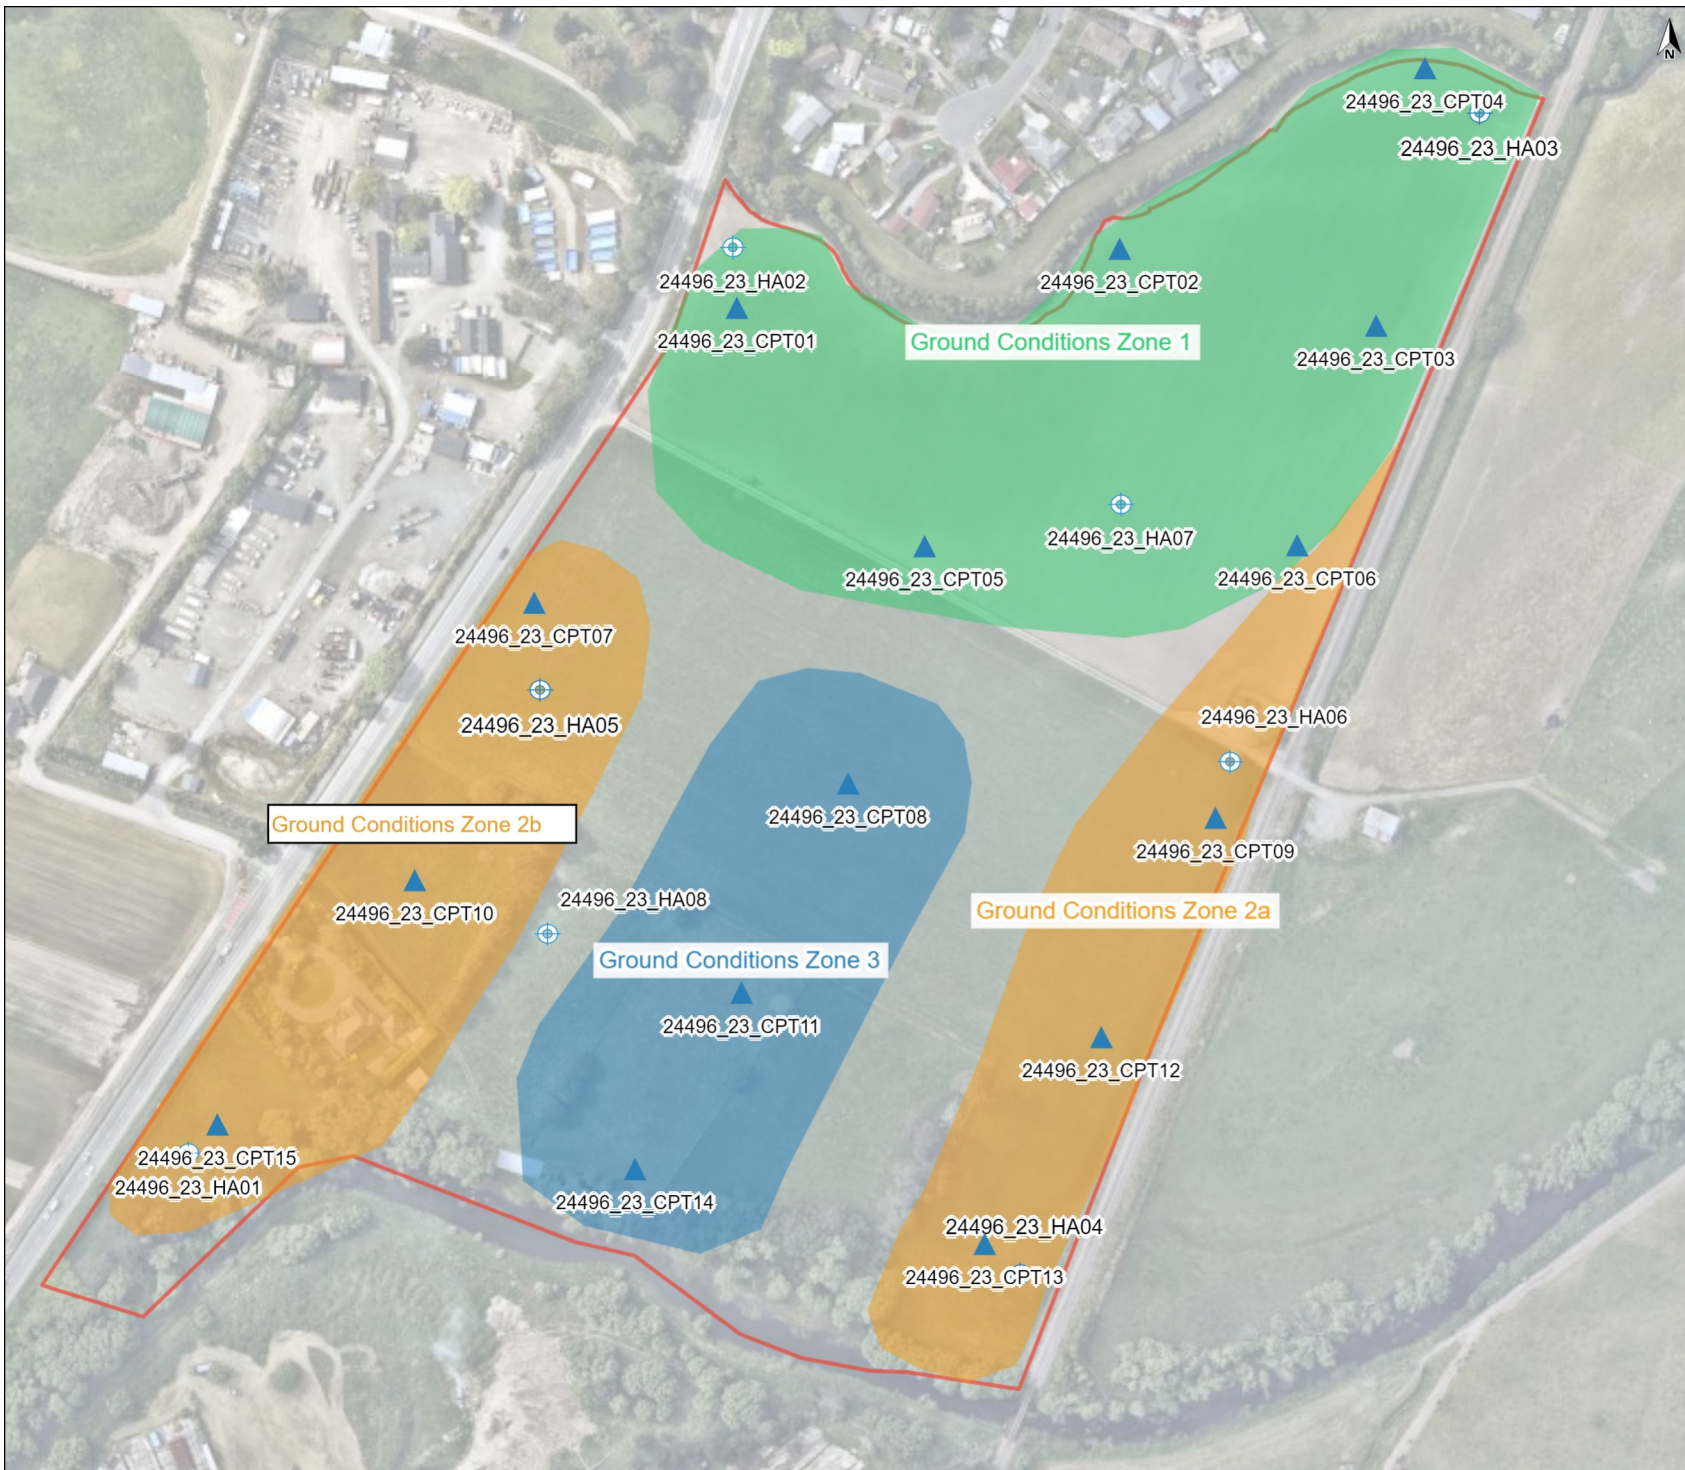
- Legend**
- ▲ ENGEO CPTs 2023
 - ⊕ ENGEO Hand Augers 2023
 - ▭ Ground Conditions Zone 1
 - ▭ Ground Conditions Zone 2a
 - ▭ Ground Conditions Zone 2b
 - ▭ Ground Conditions Zone 3
- Unmarked areas within the site boundary are areas of high uncertainty in ground conditions due to the low density of investigation.

The upper 2.5 m of the soil profile is somewhat consistent across the site and includes interbedded loose sand-silt mixtures (Unit 2) and clay-silt mixtures (Unit 3). Below this depth ground conditions are complex and highly variable but can be broadly categorised into three ground conditions zones. The locations of these zones across the site are shown in Appendix 1- Figure 2 and described below.

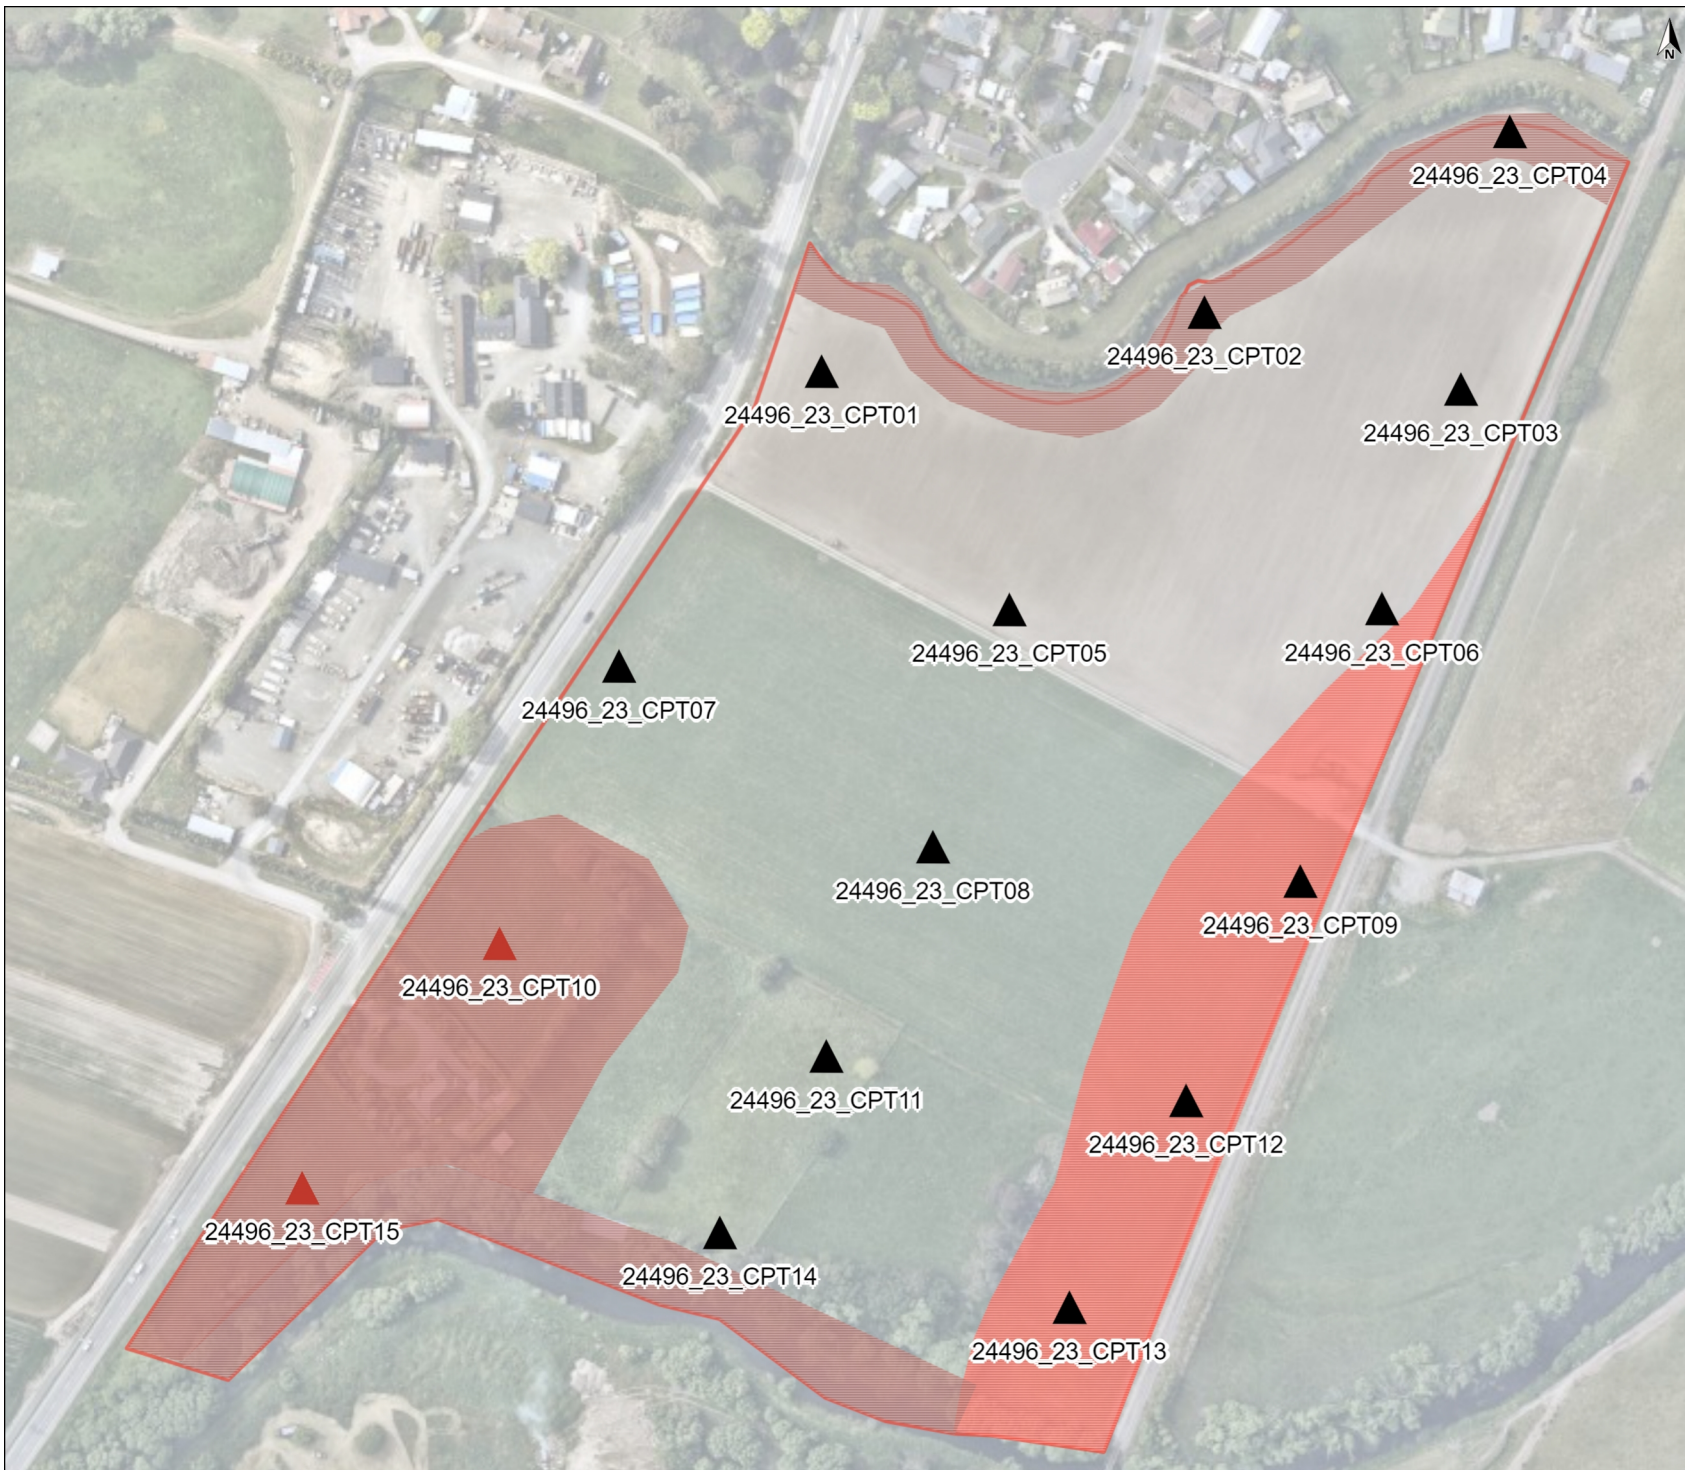
- Legend**
- ▲ Calculated Vertical Settlement \geq 100mm
 - ▲ Calculated Vertical Settlement $<$ 100mm
 - Area of $>$ 100mm of settlement - High Confidence
 - Area of estimated $>$ 100mm settlement or $>$ 250mm of lateral displacement - High Uncertainty

We completed liquefaction analysis for the earthquake scenarios outlined in Table 3. Liquefaction vulnerability varied across the site as expected owing to the variable ground condition. In general, our analysis indicates that Unit 2 and Unit 4 will liquefy to various degrees in ILS and ULS ground shaking. The highest liquefaction vulnerability is expected within Ground Condition Zone 2 where the thickest deposits of these units were encountered. Details of our liquefaction analysis and full results are provided in Appendix 4, and liquefaction vulnerability maps are included in Figures 3 and 4 in Appendix 1.
