MANDEVILLE AND OHOKA
WASTEWATER SCHEME
- PIPELINE CONSTRUCTION

FLOOD RISK – PT RS 2561 & RS 2010 – 474 - 494 BRADLEYS ROAD, OHOKA

PHASE 1 ENVIRONMENTAL SITE ASSESSMENT (SITE HISTORY) FOR 474 BRADLEYS ROAD, OHOKA

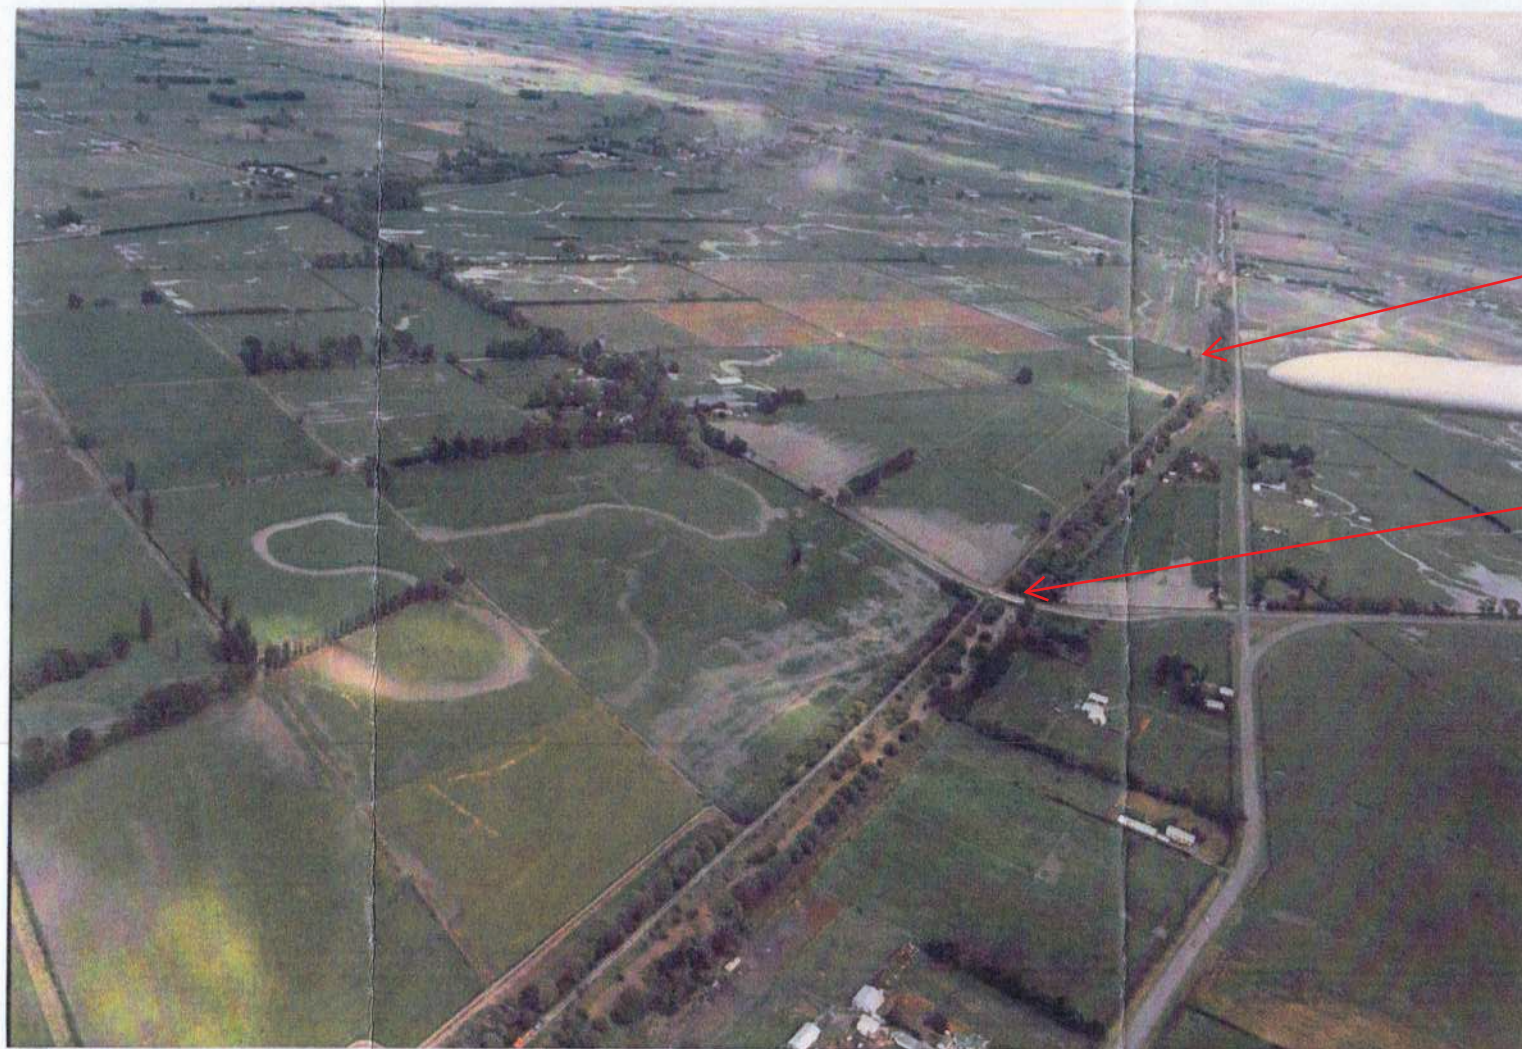
116 Looking upstream (northwest) along Cust Main
Drain, Threlkelds Road Bridge centre right

The enclosed photographs No. **116** (13/03/1986) and No. **119** (11/08/1986) both show runoff following depressions across the property and in some instances ponding behind barriers to overland flow. Note that these photos may not show flooding at its peak.

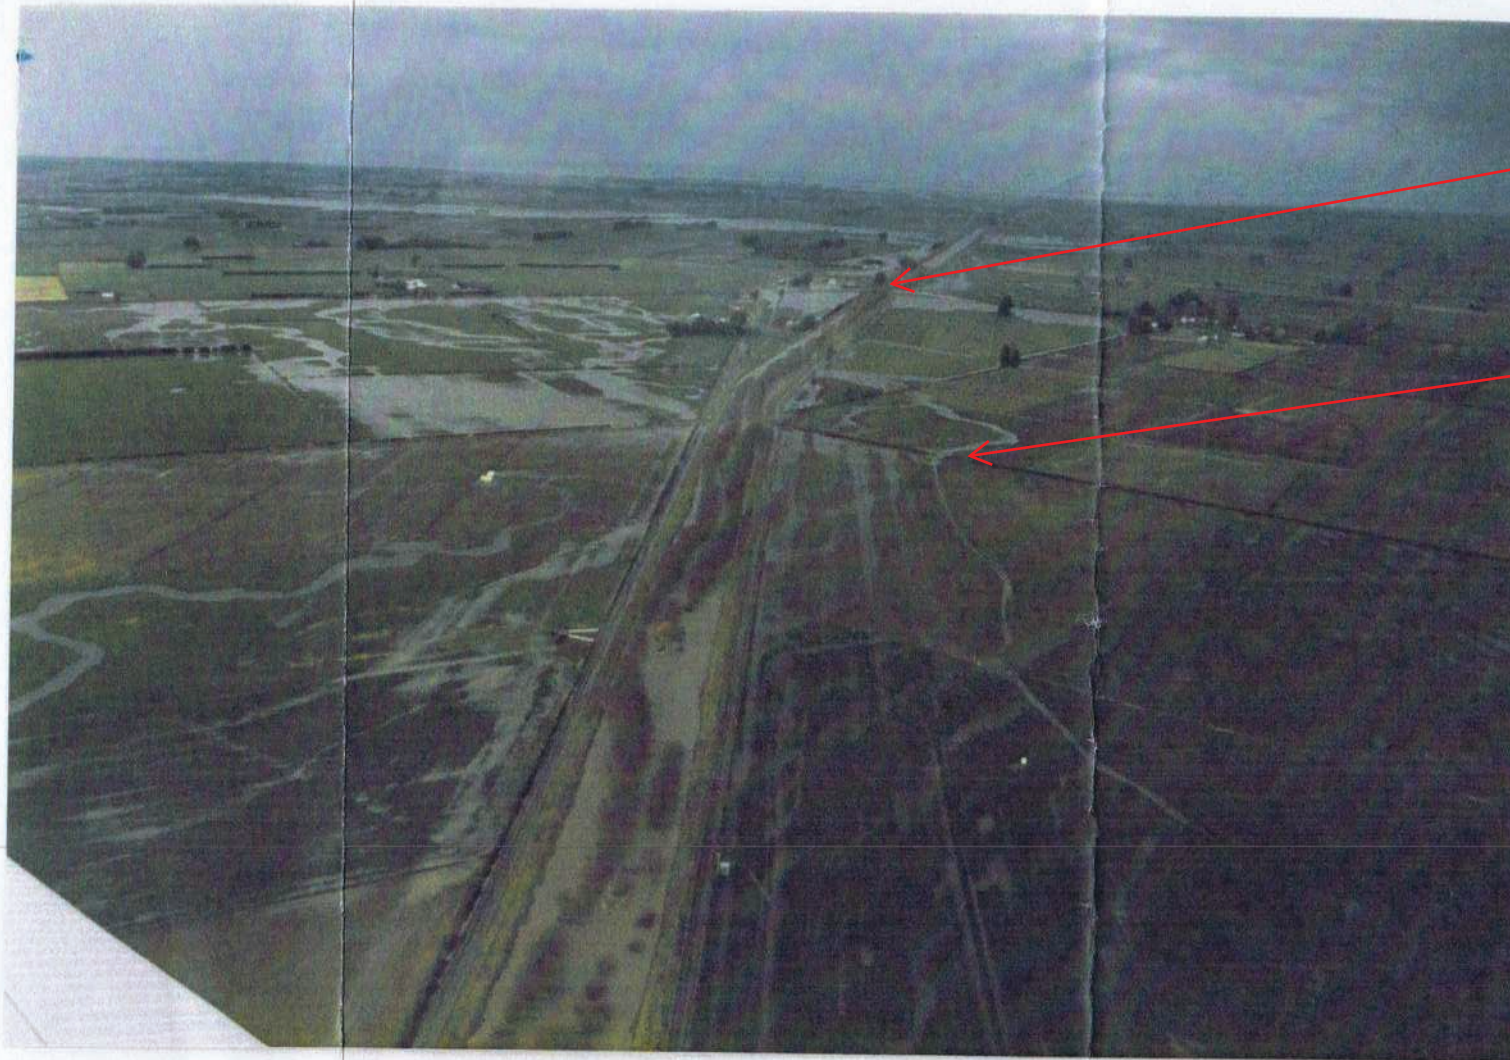
119

Cust Main Drain from downstream of Bradleys Road (east)

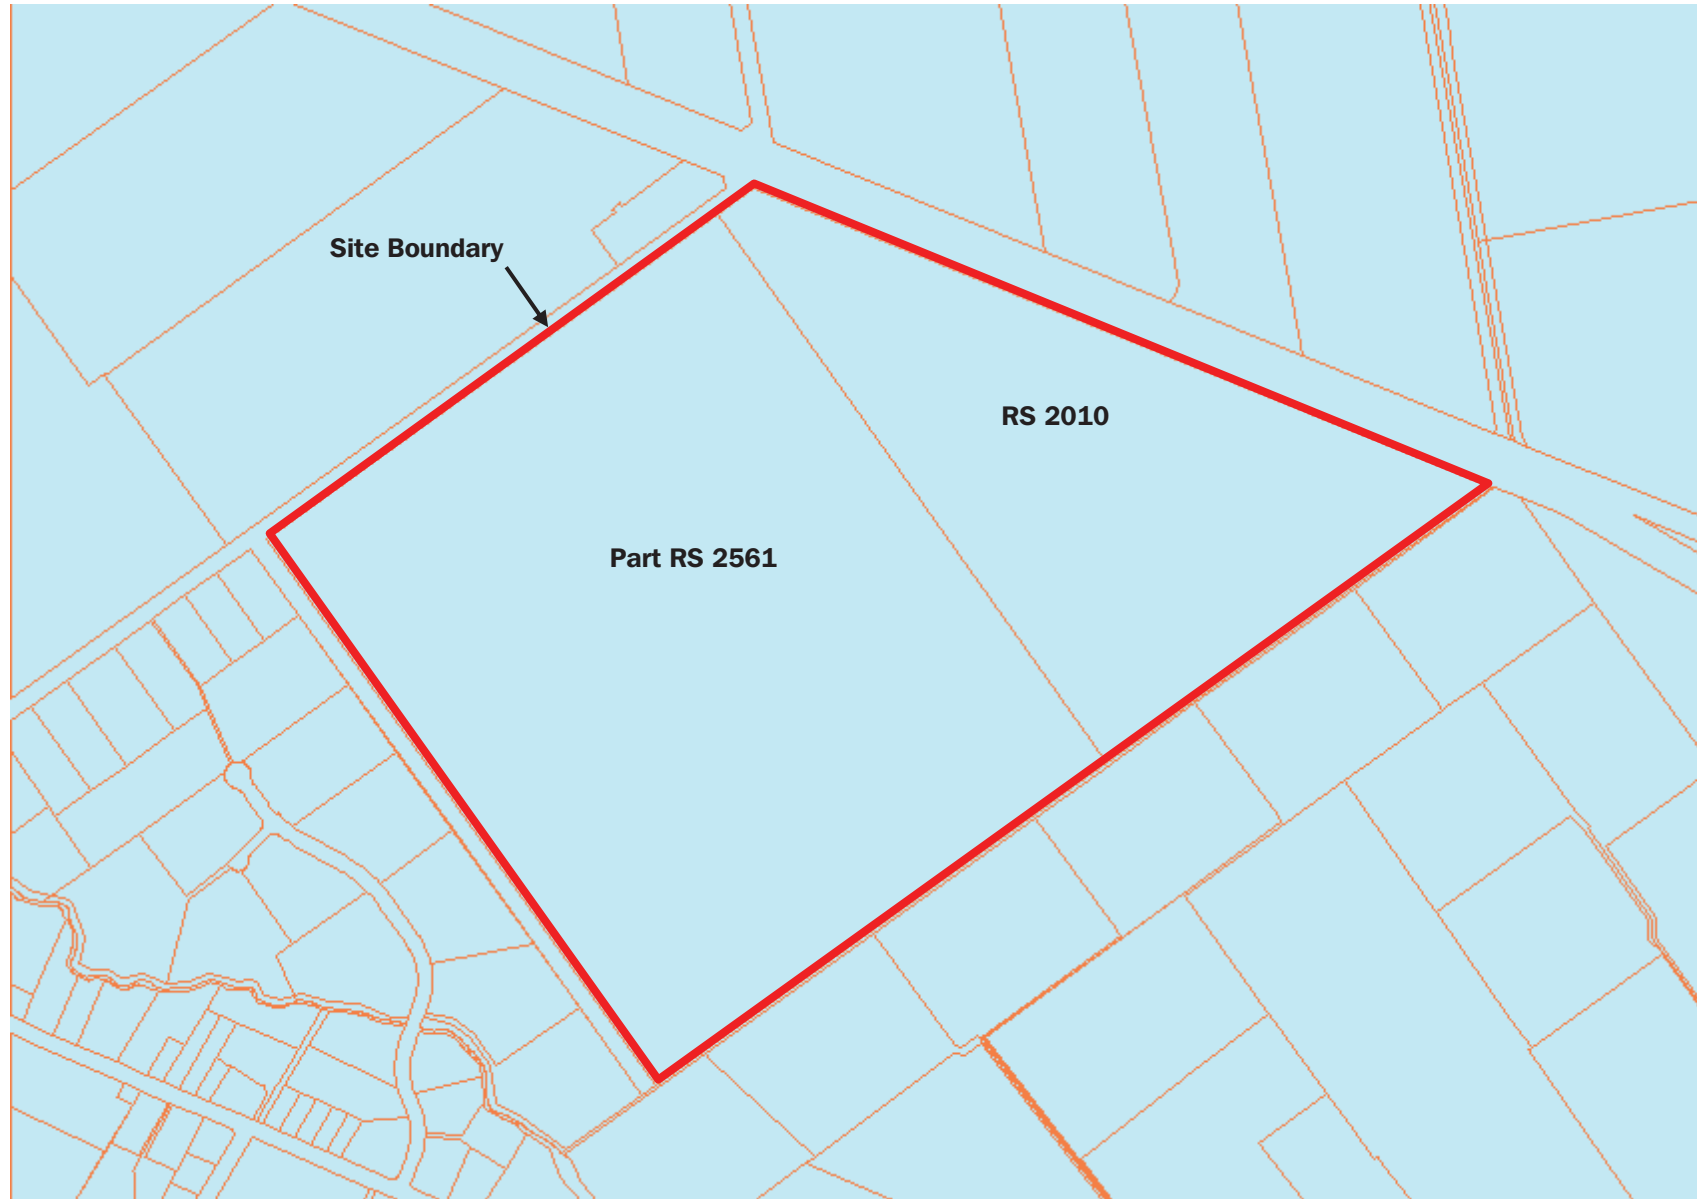
Figure 2 : Layout of Land Parcels

The site is located at 474 Bradleys Road, Ohoka, approximately 20 km north of central Christchurch. The site covers an area of approximately 78.26 ha and is legally described as Part Rural Section 2561 and Rural Section 2010. A plan showing the layout of the two land parcels is appended as Figure 2.

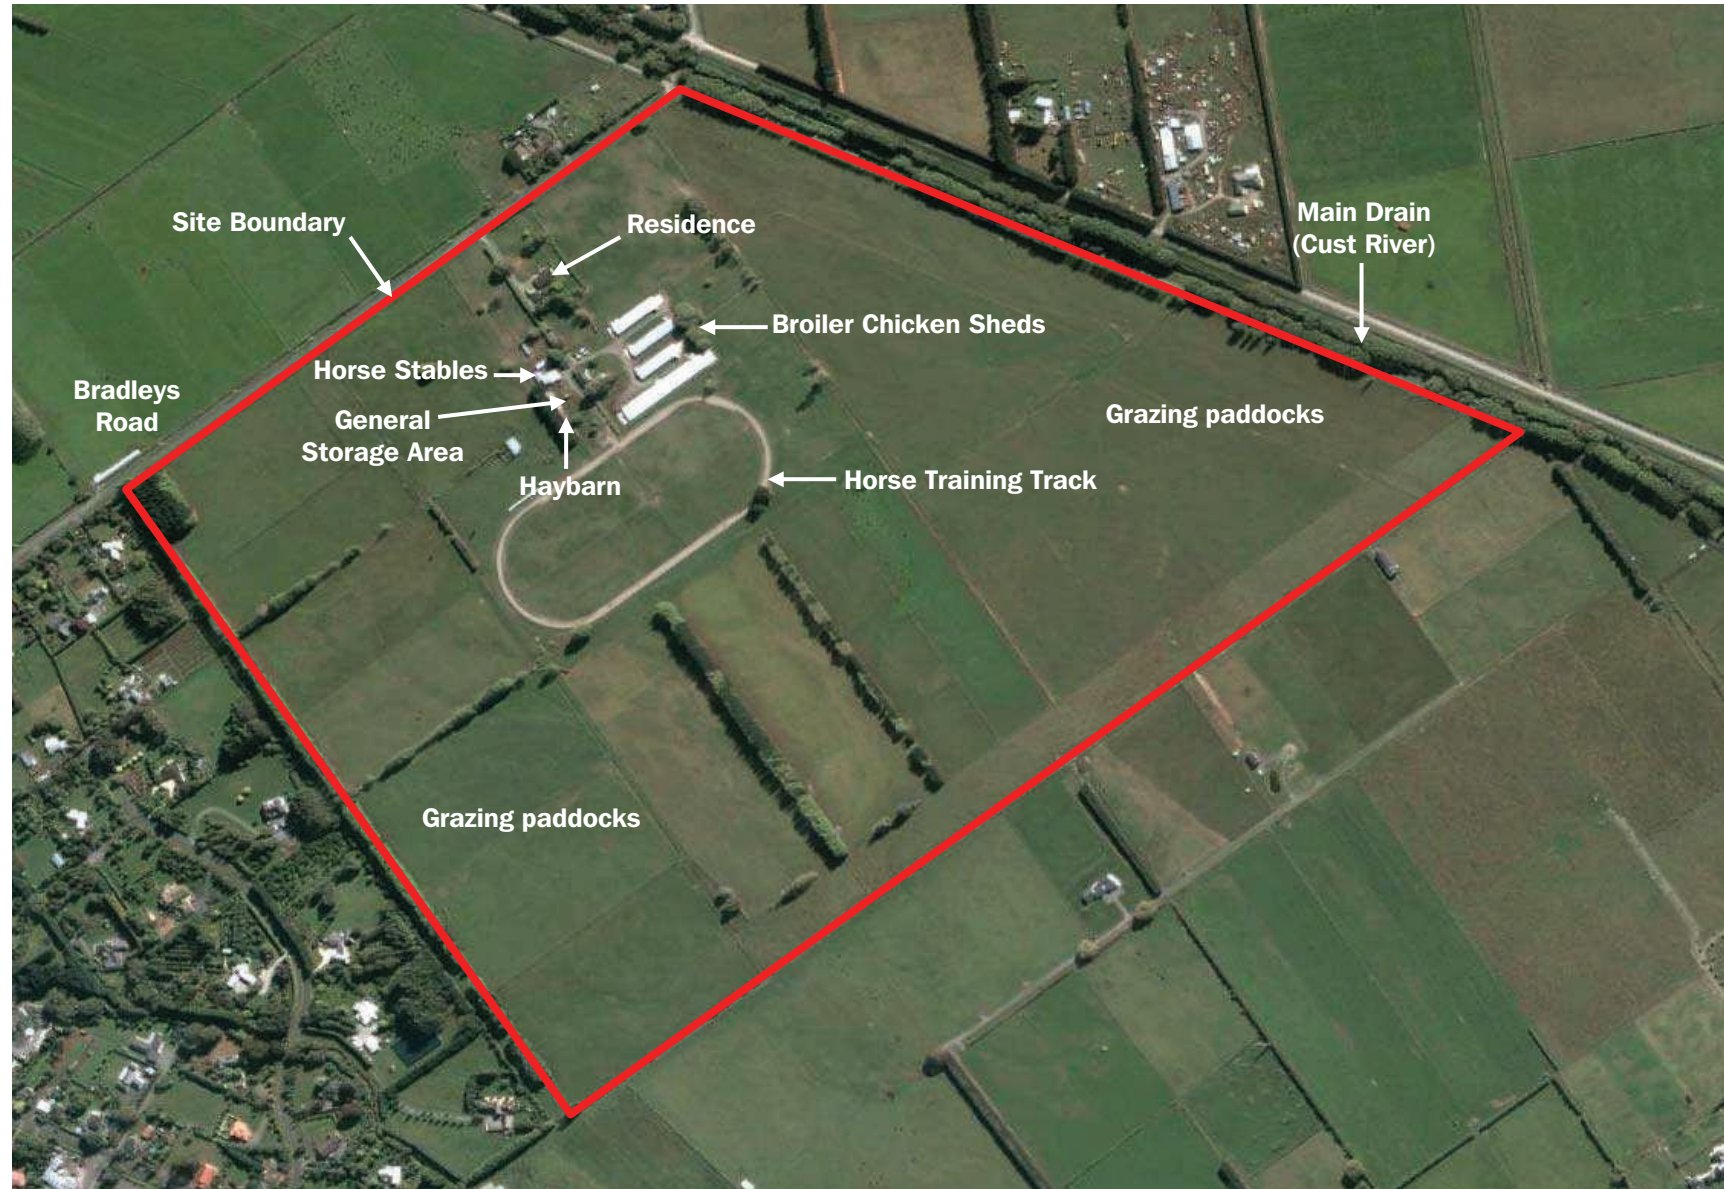
Figure 3 : Site Layout

The site is situated in a rural setting and comprises a residence, buildings associated with a broiler chicken farm (poultry grown for meat consumption), general farming storage sheds and horse stables in the northern portion of the site. The remainder of the site comprises a horse training track and numerous open paddocks used for general cattle, deer and sheep grazing. An aerial photograph showing the existing site layout is presented as Figure 3 while photographs of the site are appended.

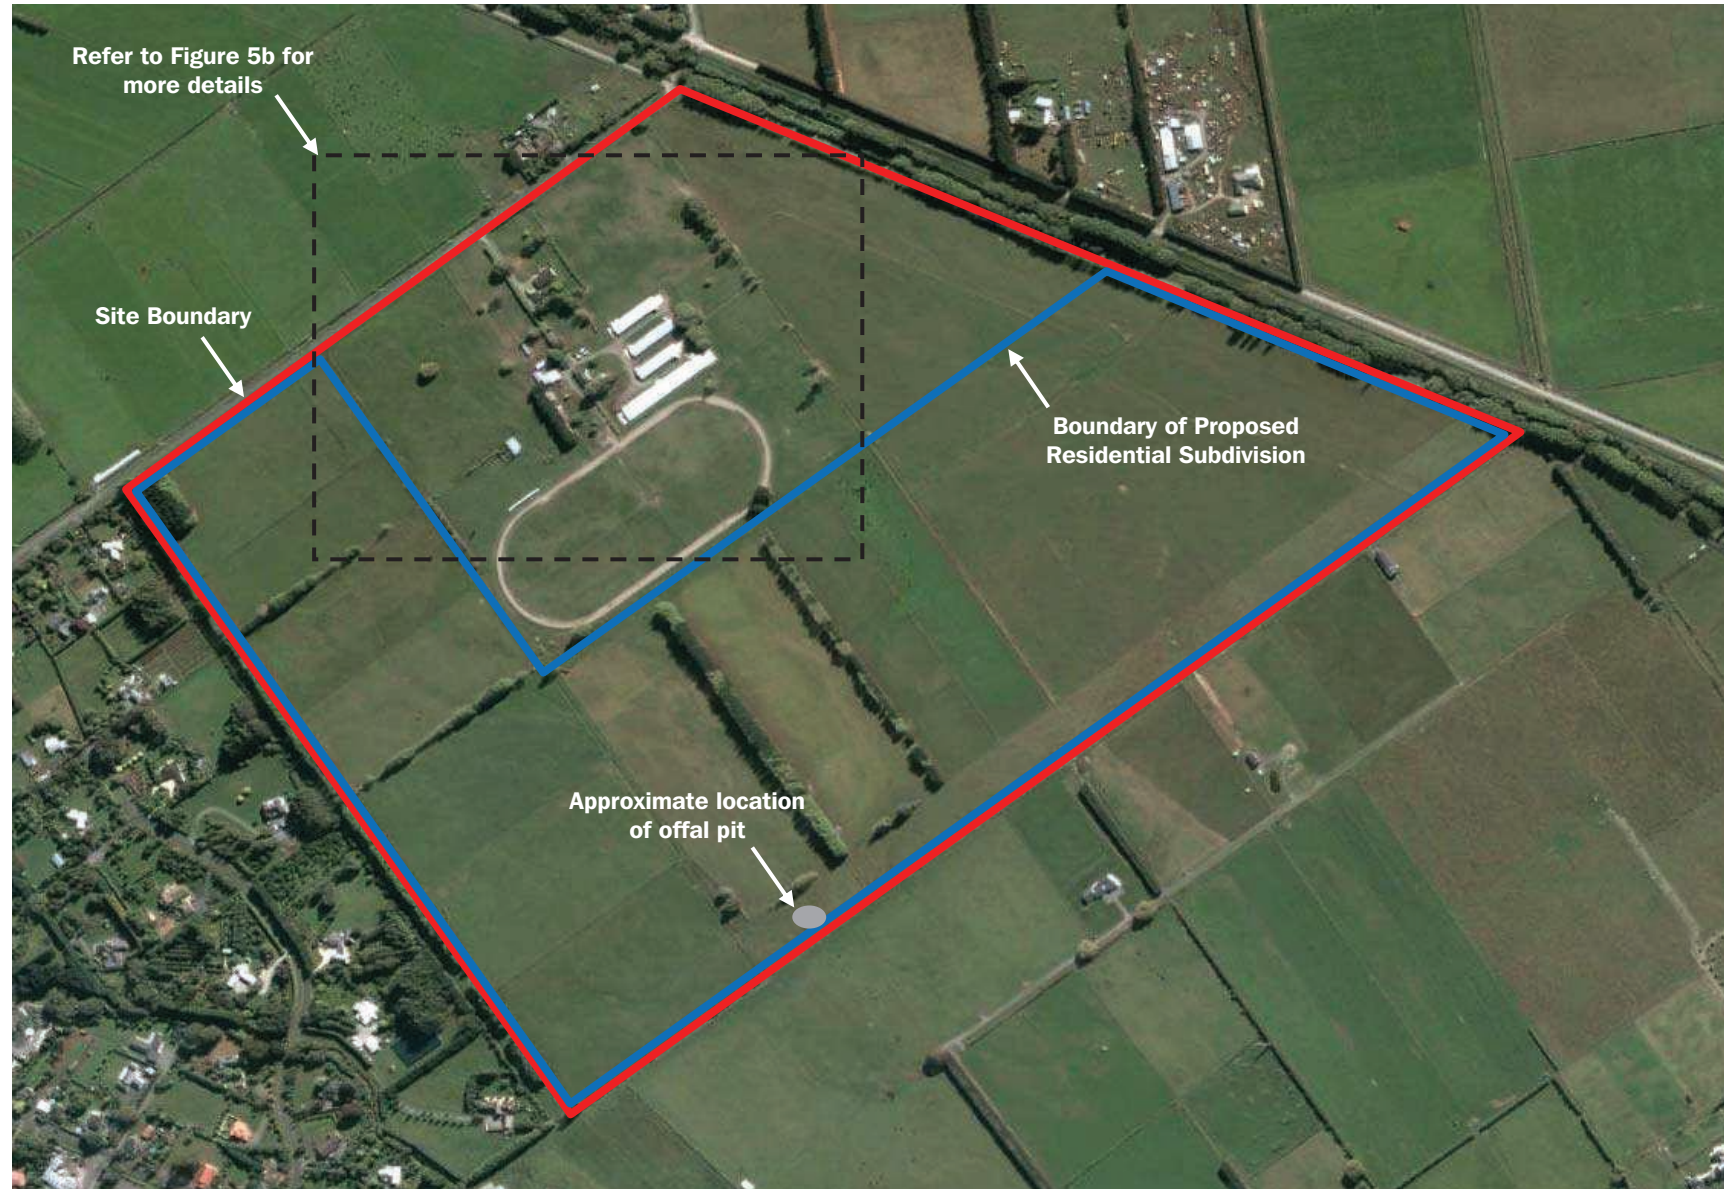
Figure 5a : Potential Sources of Site Contamination

- ✧ The storage of petrol and diesel within an above ground storage tank within the general farming storage area;
- ✧ The storage of small quantities of oils, fuels, pesticides, paints, etc within the general farming storage area;
- ✧ Possible former sheep dip/foot rot trough within the sheep yard area;
- ✧ The burial of animal carcasses in waste/offal pits;
- ✧ Burning of waste (paper from chicken sheds) directly west of the general farming storage area; and
- ✧ The on site waste water disposal system via septic tanks.

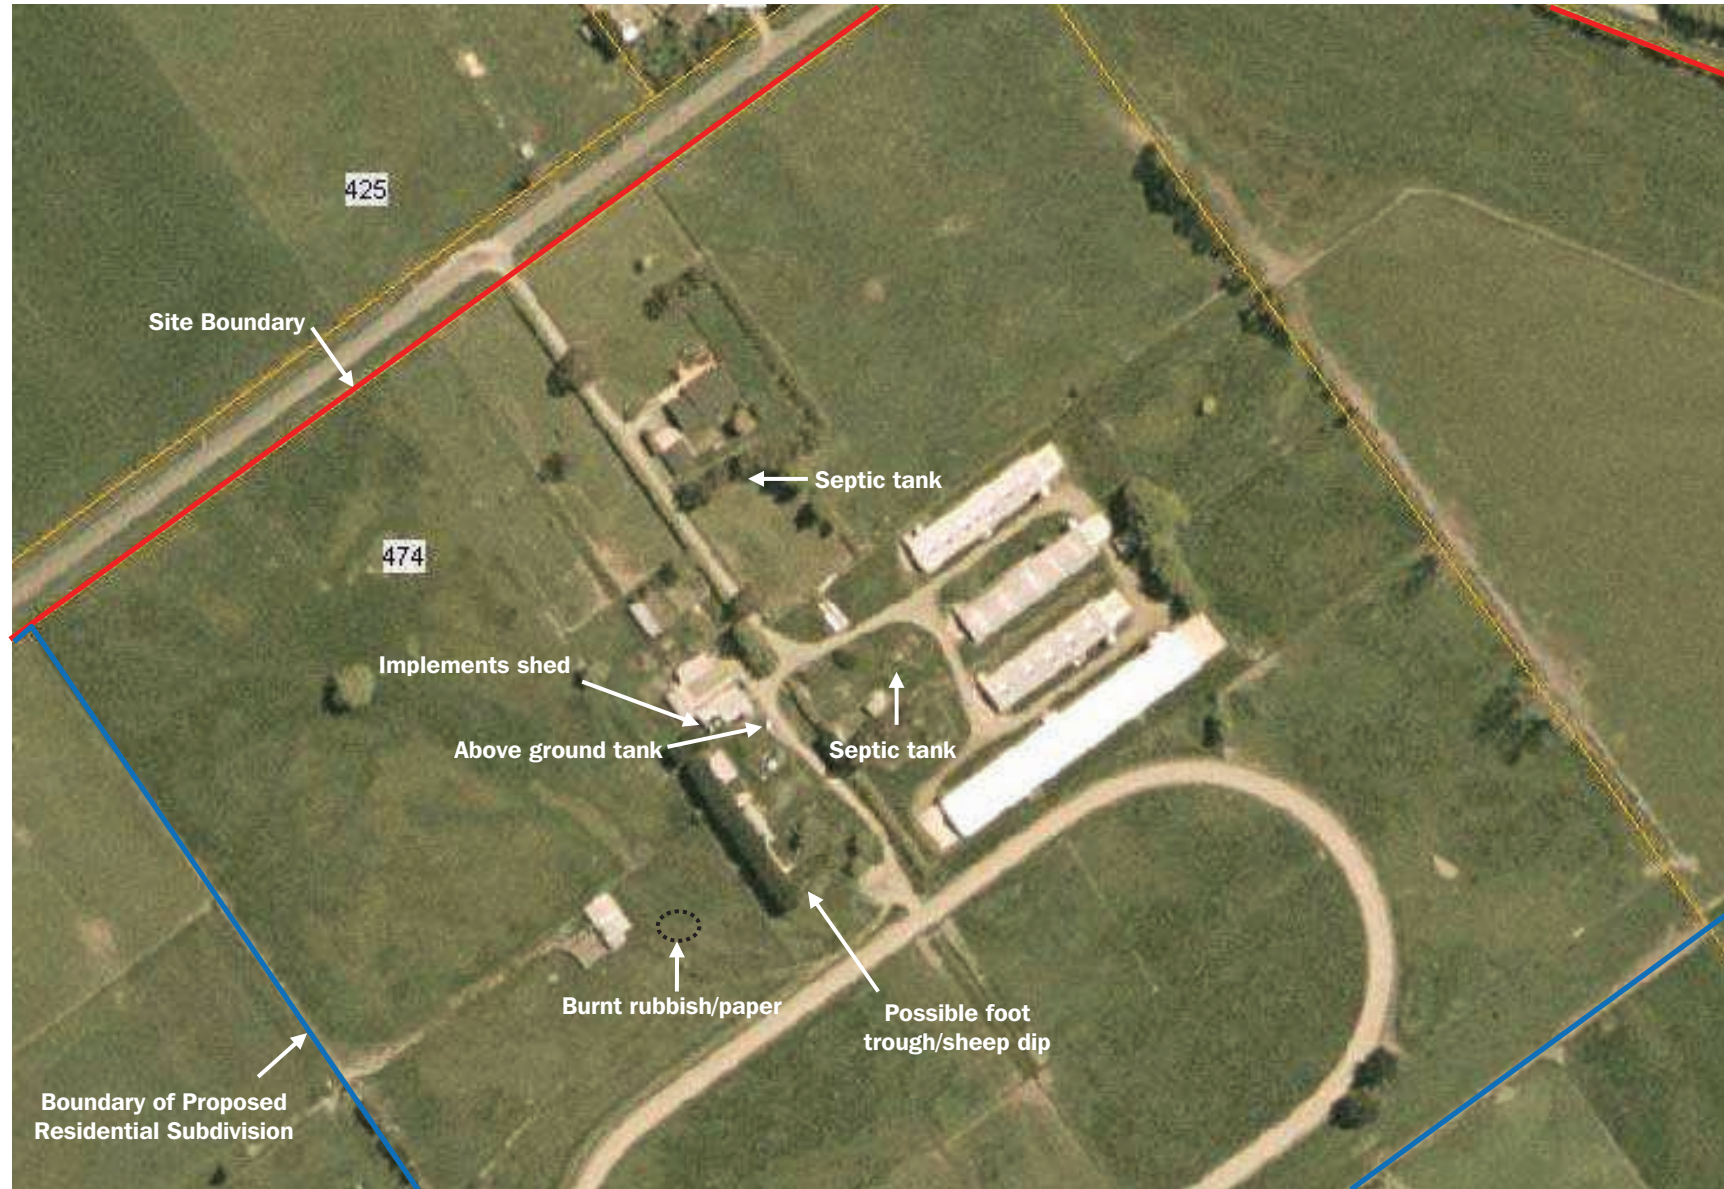
Figure 5b : Potential Contamination Sources
