Before an Independent Hearings Panel
at Waimakariri District Council

in the matter of: Proposed private plan change RCP031 to the Operative
Waimakariri District Plan

Evidence of Dave Compton-Moen

535 MILL ROAD, OHOKA - PLAN CHANGE
FOR ROLLESTON INDUSTRIAL DEVELOPMENTS LIMITED
7 JULY 2023

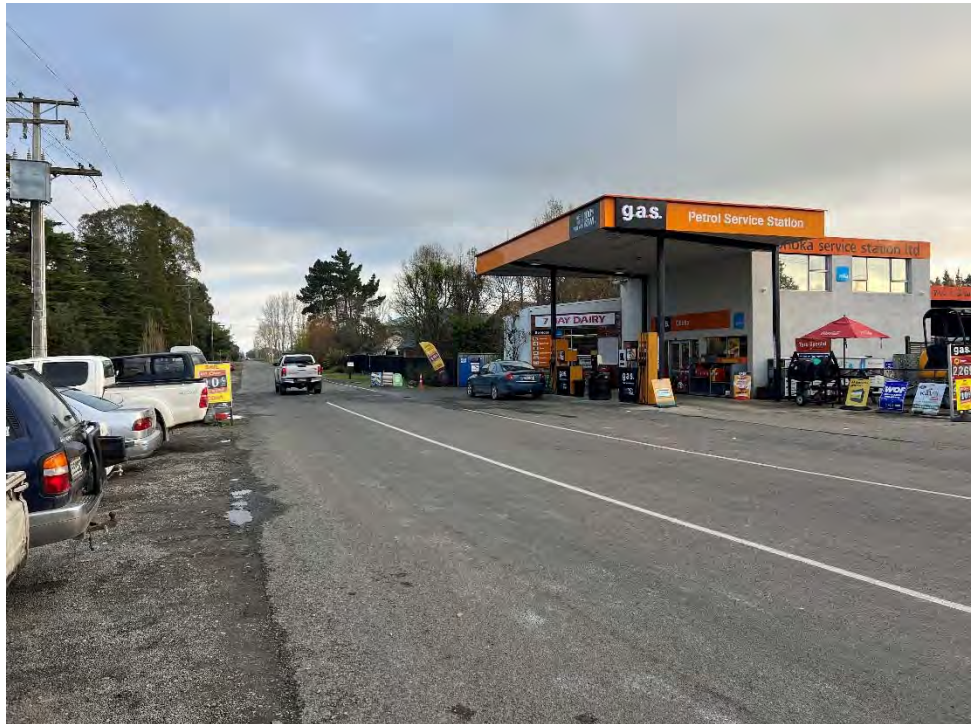
Photo 1 - The existing GAS service station on the corner of Whites and Mill Roads

- 13 Ōhoka is an established settlement in the Waimakariri District with a mix of residential zones (3, 4a and 4b) as well as community facilities which provide the 'bones' to the small settlement. Current development straddles both sides of Mill Road with the centre of village considered to be the intersection of Mill Road and Whites Road, although the current zoned areas tend to be weighted more to the north.
- 14 The roads are typically slow speed through the village, more through side friction (parked cars), a lack of road markings and a narrow carriageway, rather than through posted speed limits.
Photo 1 below shows how the existing GAS service station on has 'spread' across Whites Road.

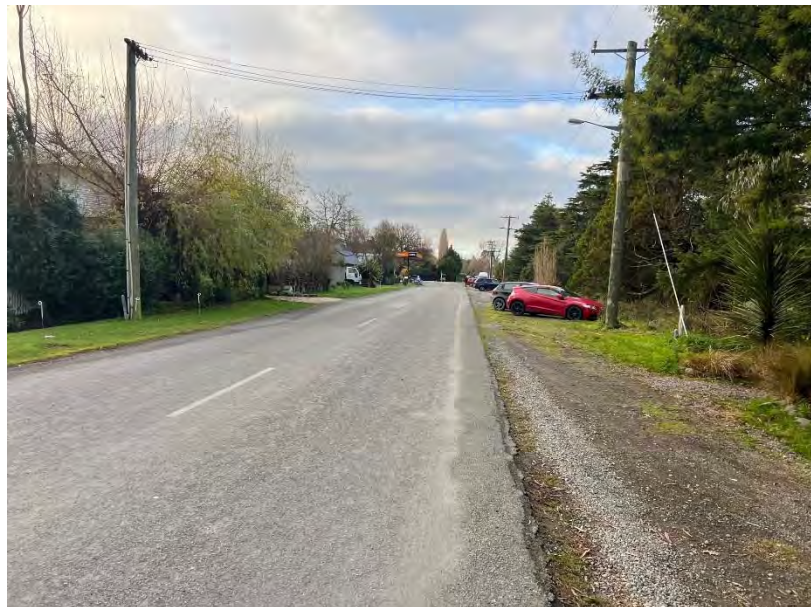
Photo 22 - Photo looking north along Whites Road adjacent to the Domain. Note that the proposal does not seek to change any of the elements in this view which contribute to the rural-village character of Ōhoka, where people stand and talk close to the edge of the carriageway.

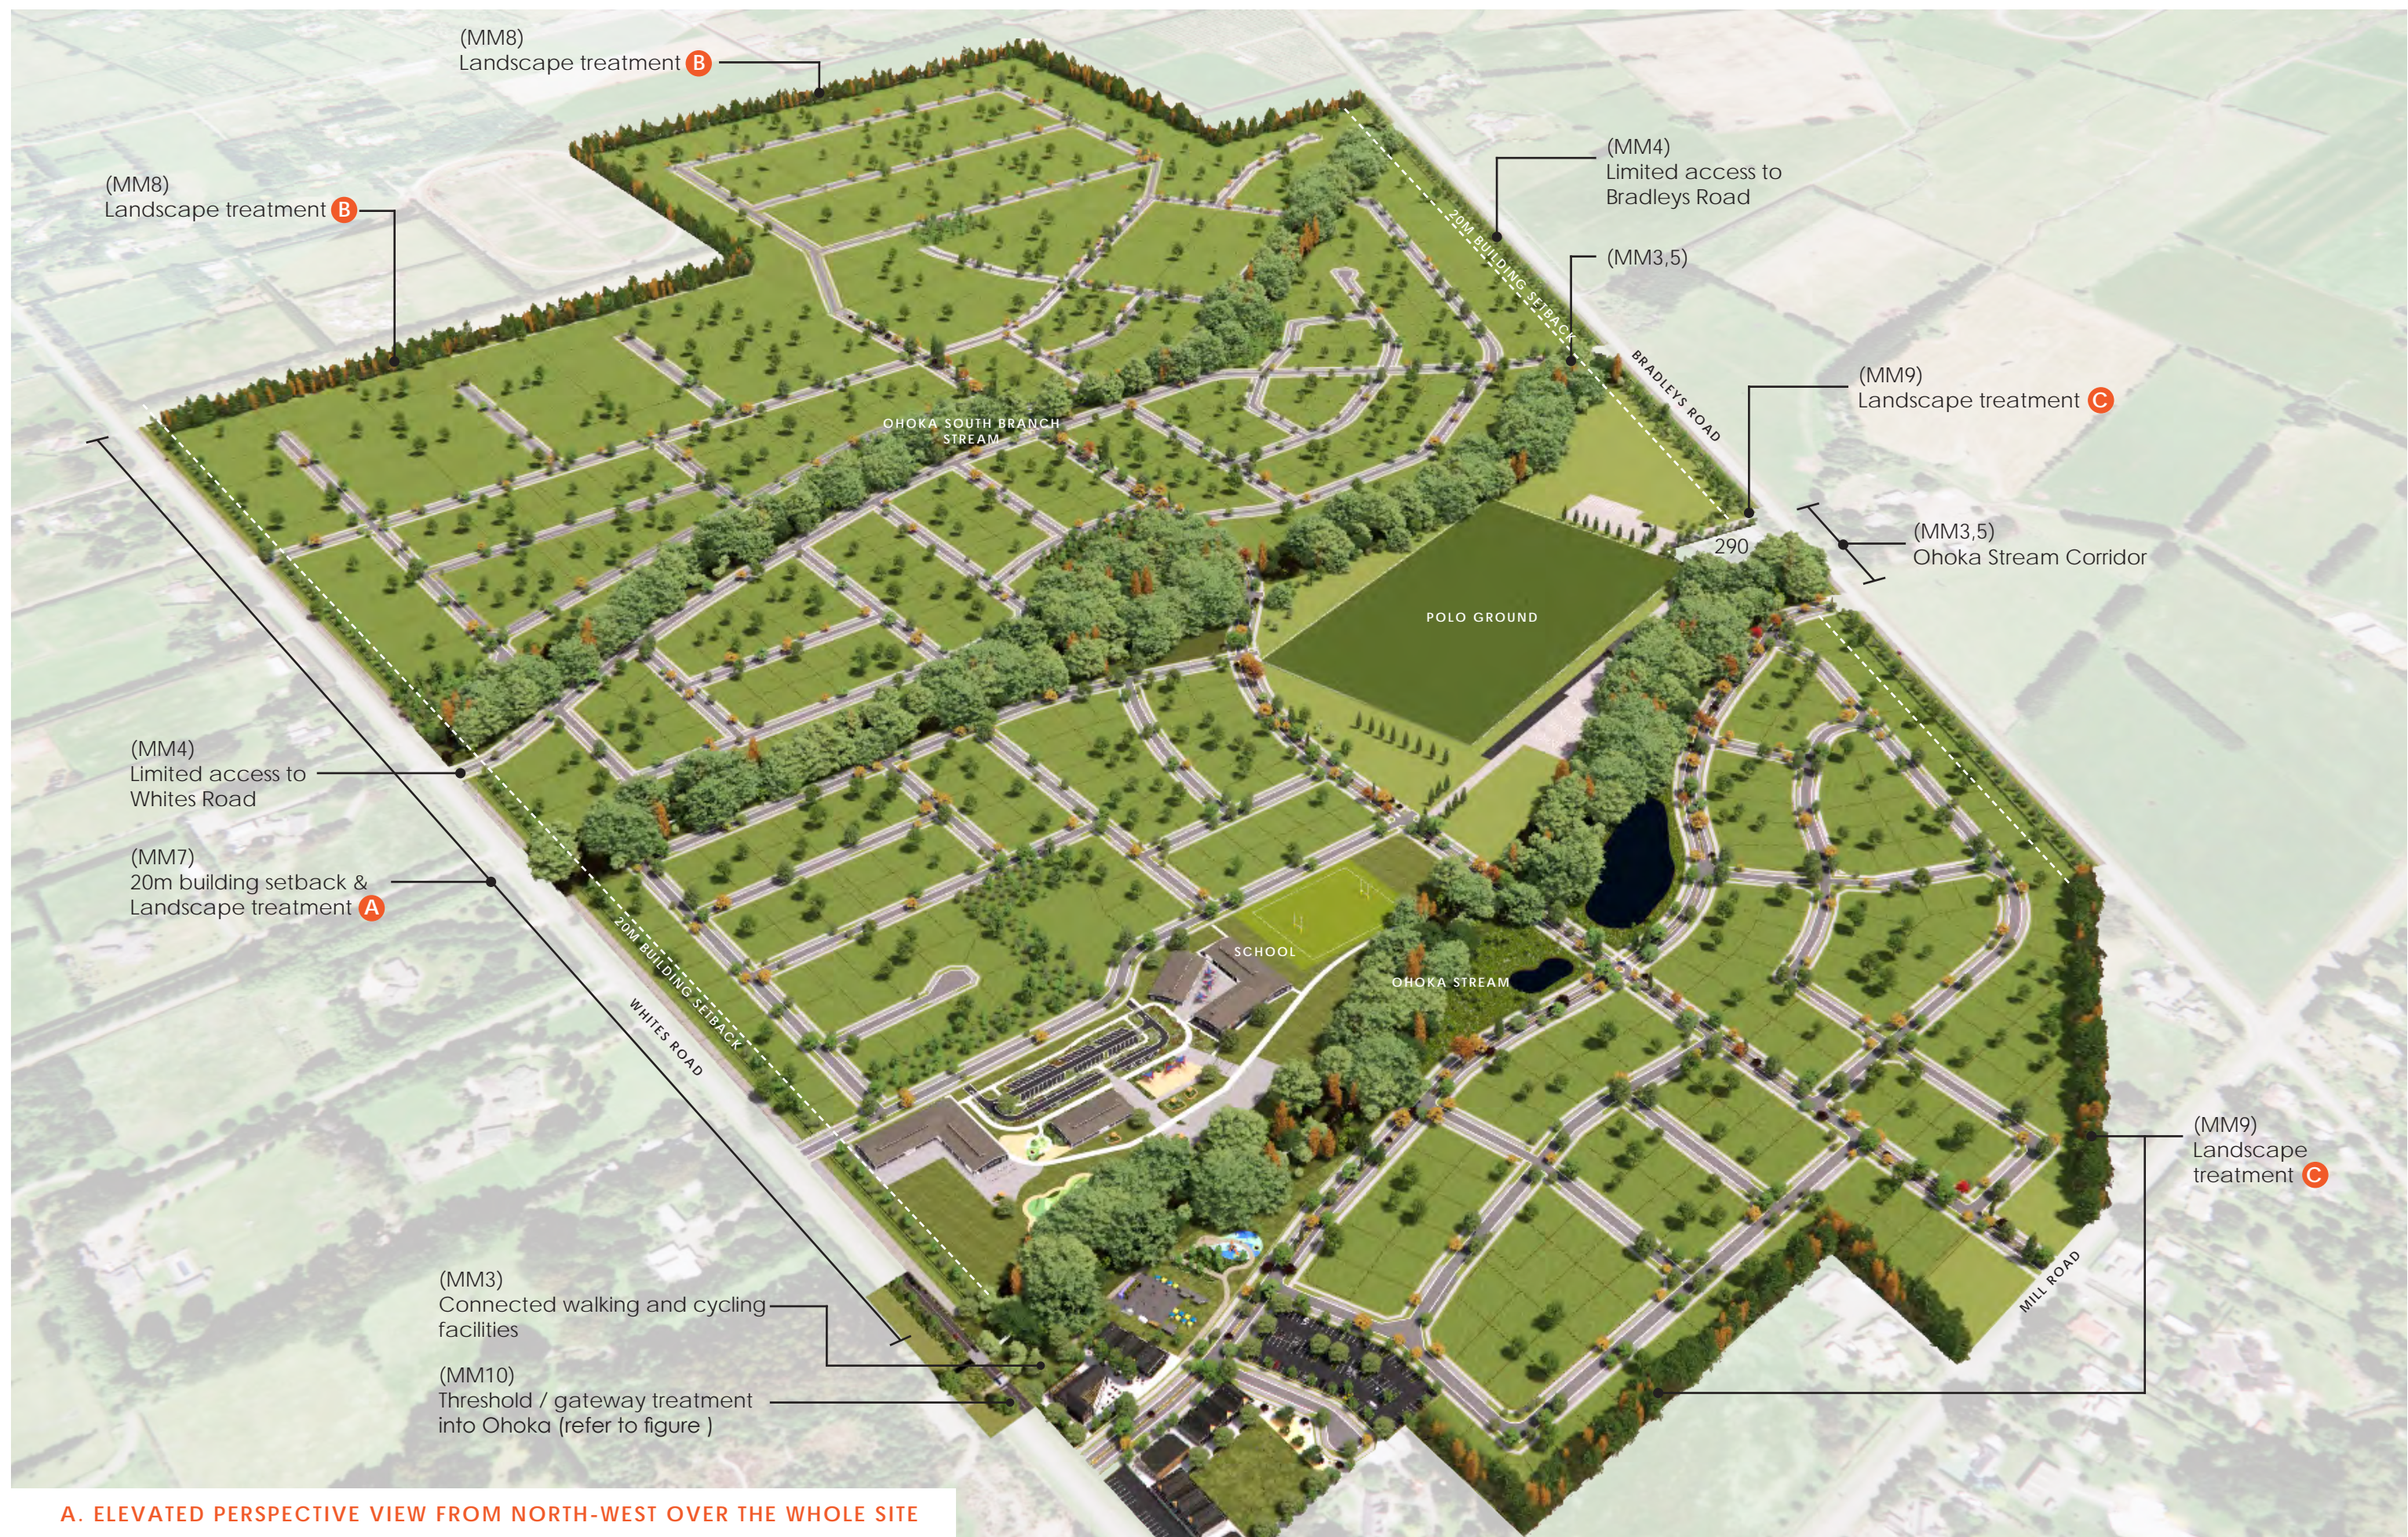
A. ELEVATED PERSPECTIVE VIEW FROM NORTH-WEST OVER THE WHOLE SITE

PROPOSAL - ILLUSTRATIVE MASTER PLAN

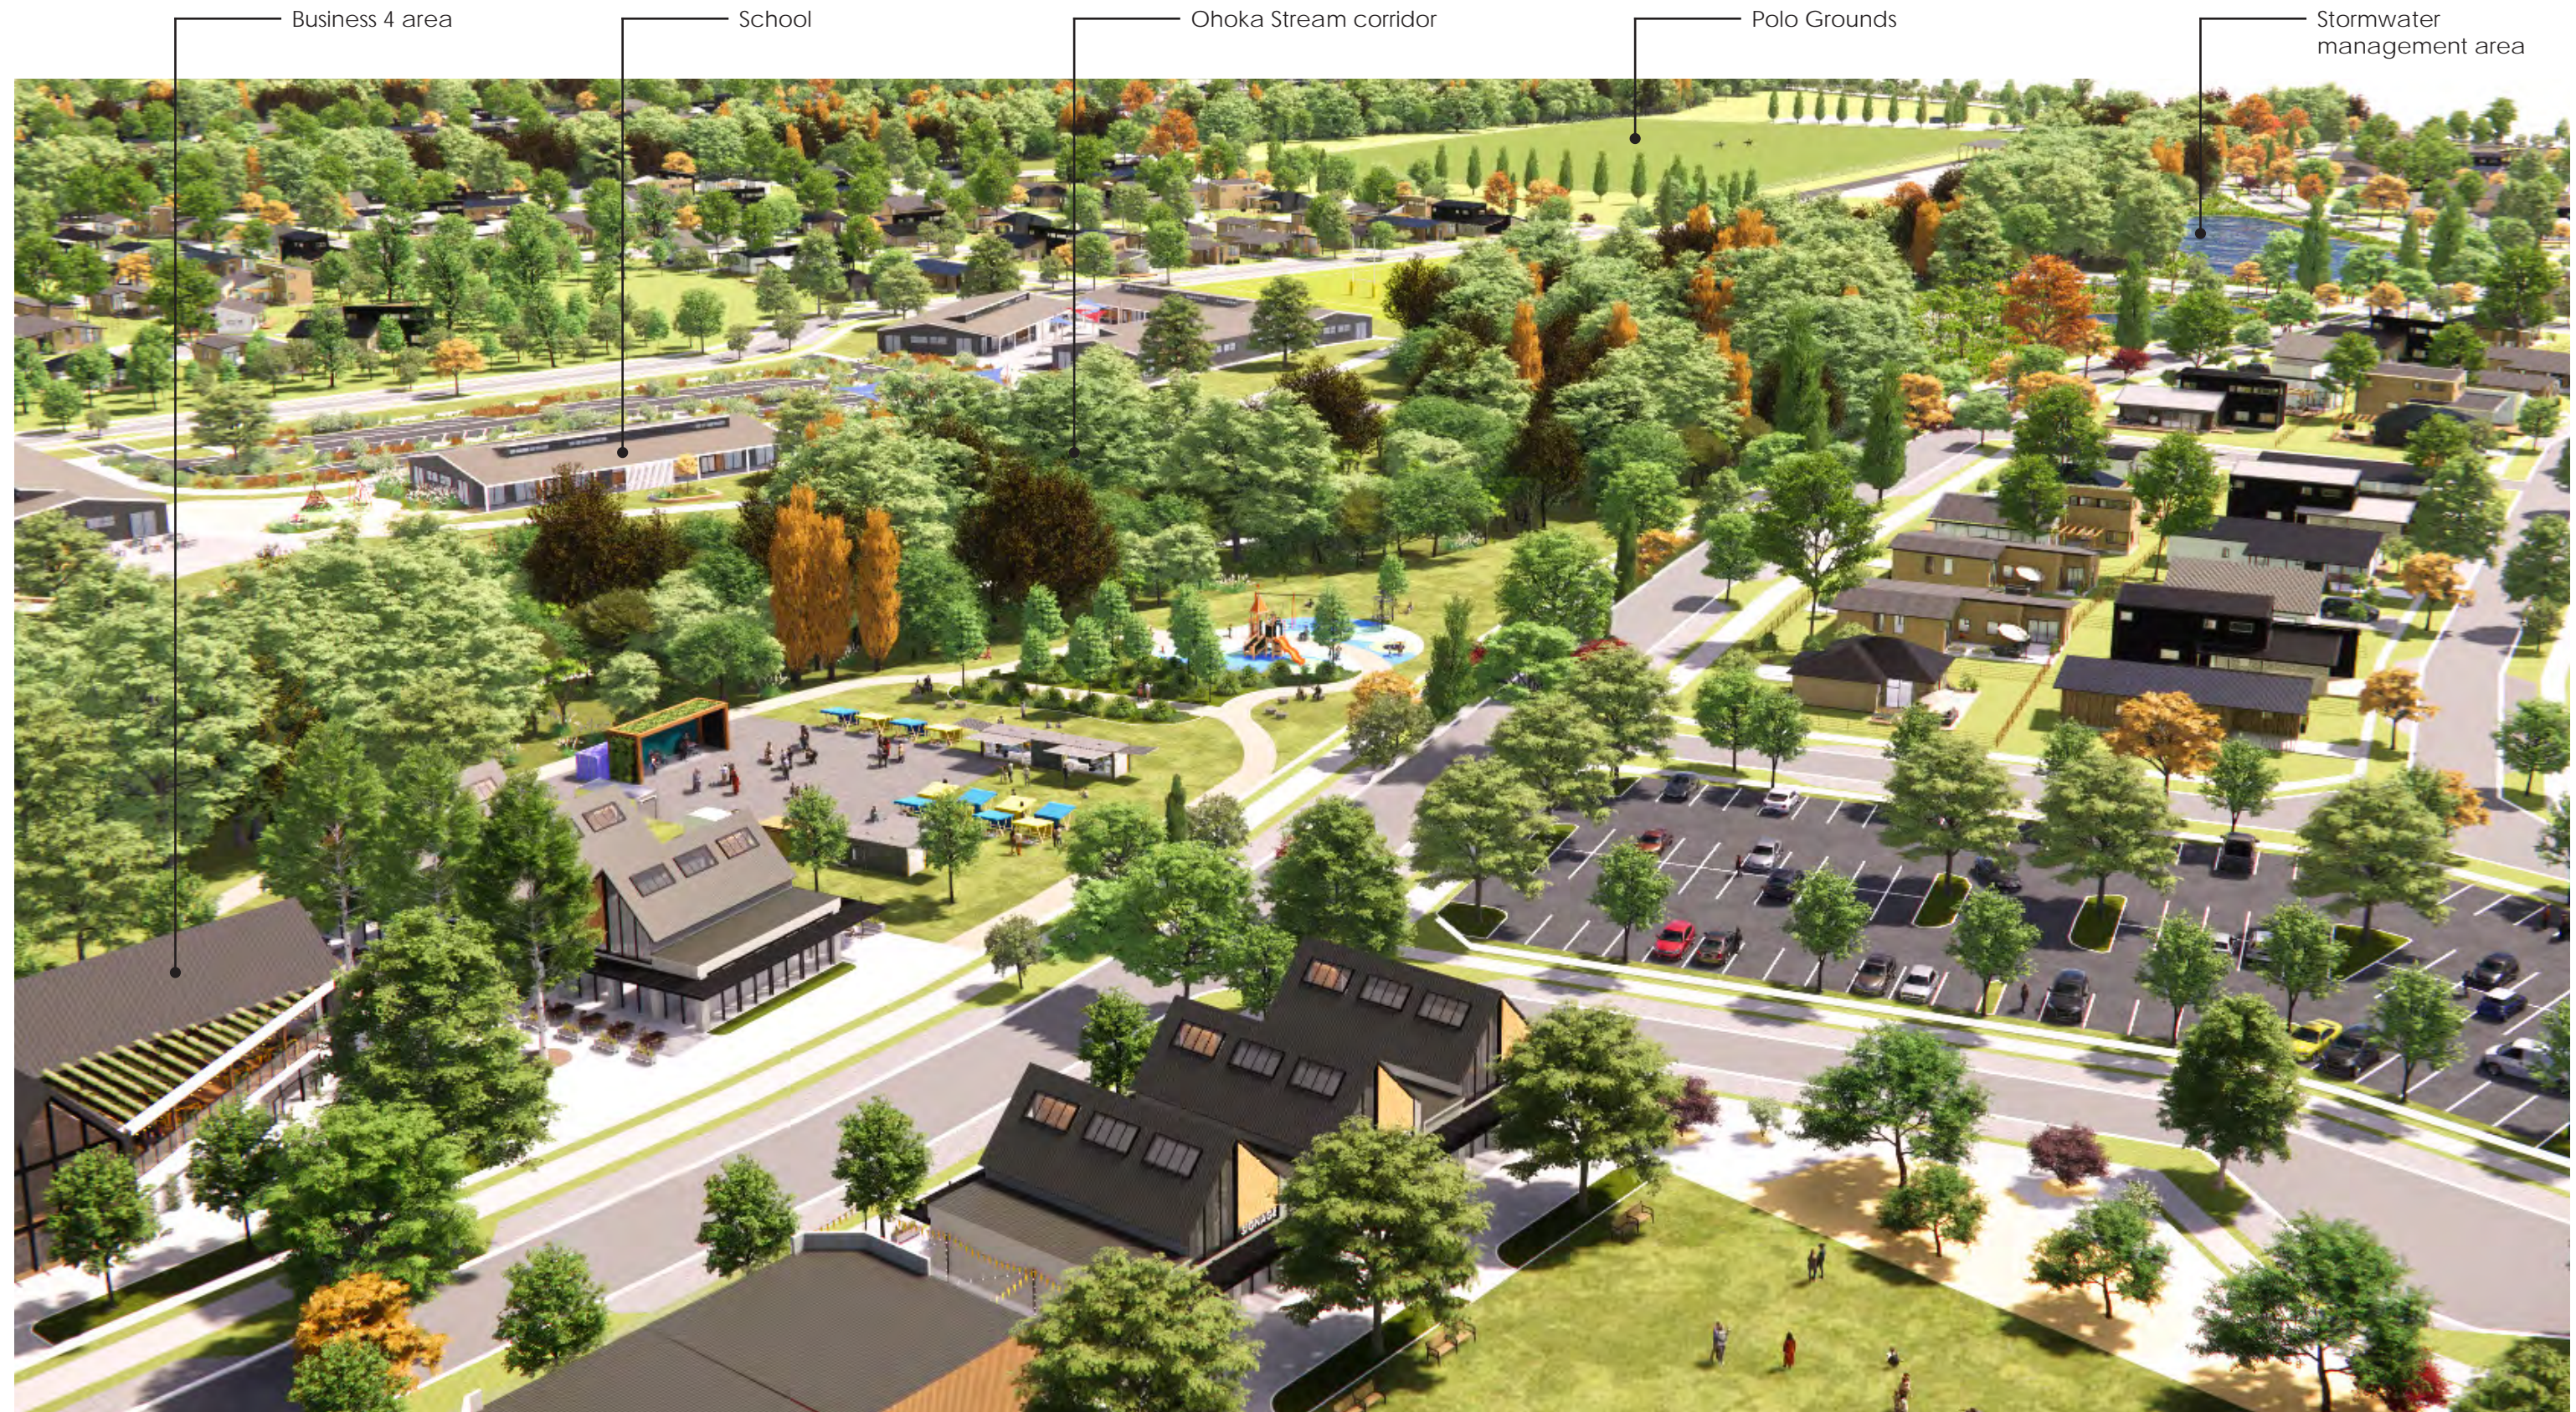
A. VIEW WEST FROM ABOVE WHITES ROAD

PROPOSAL - VILLAGE CHARACTER, DIVERSITY AND COMMUNITY FACILITIES

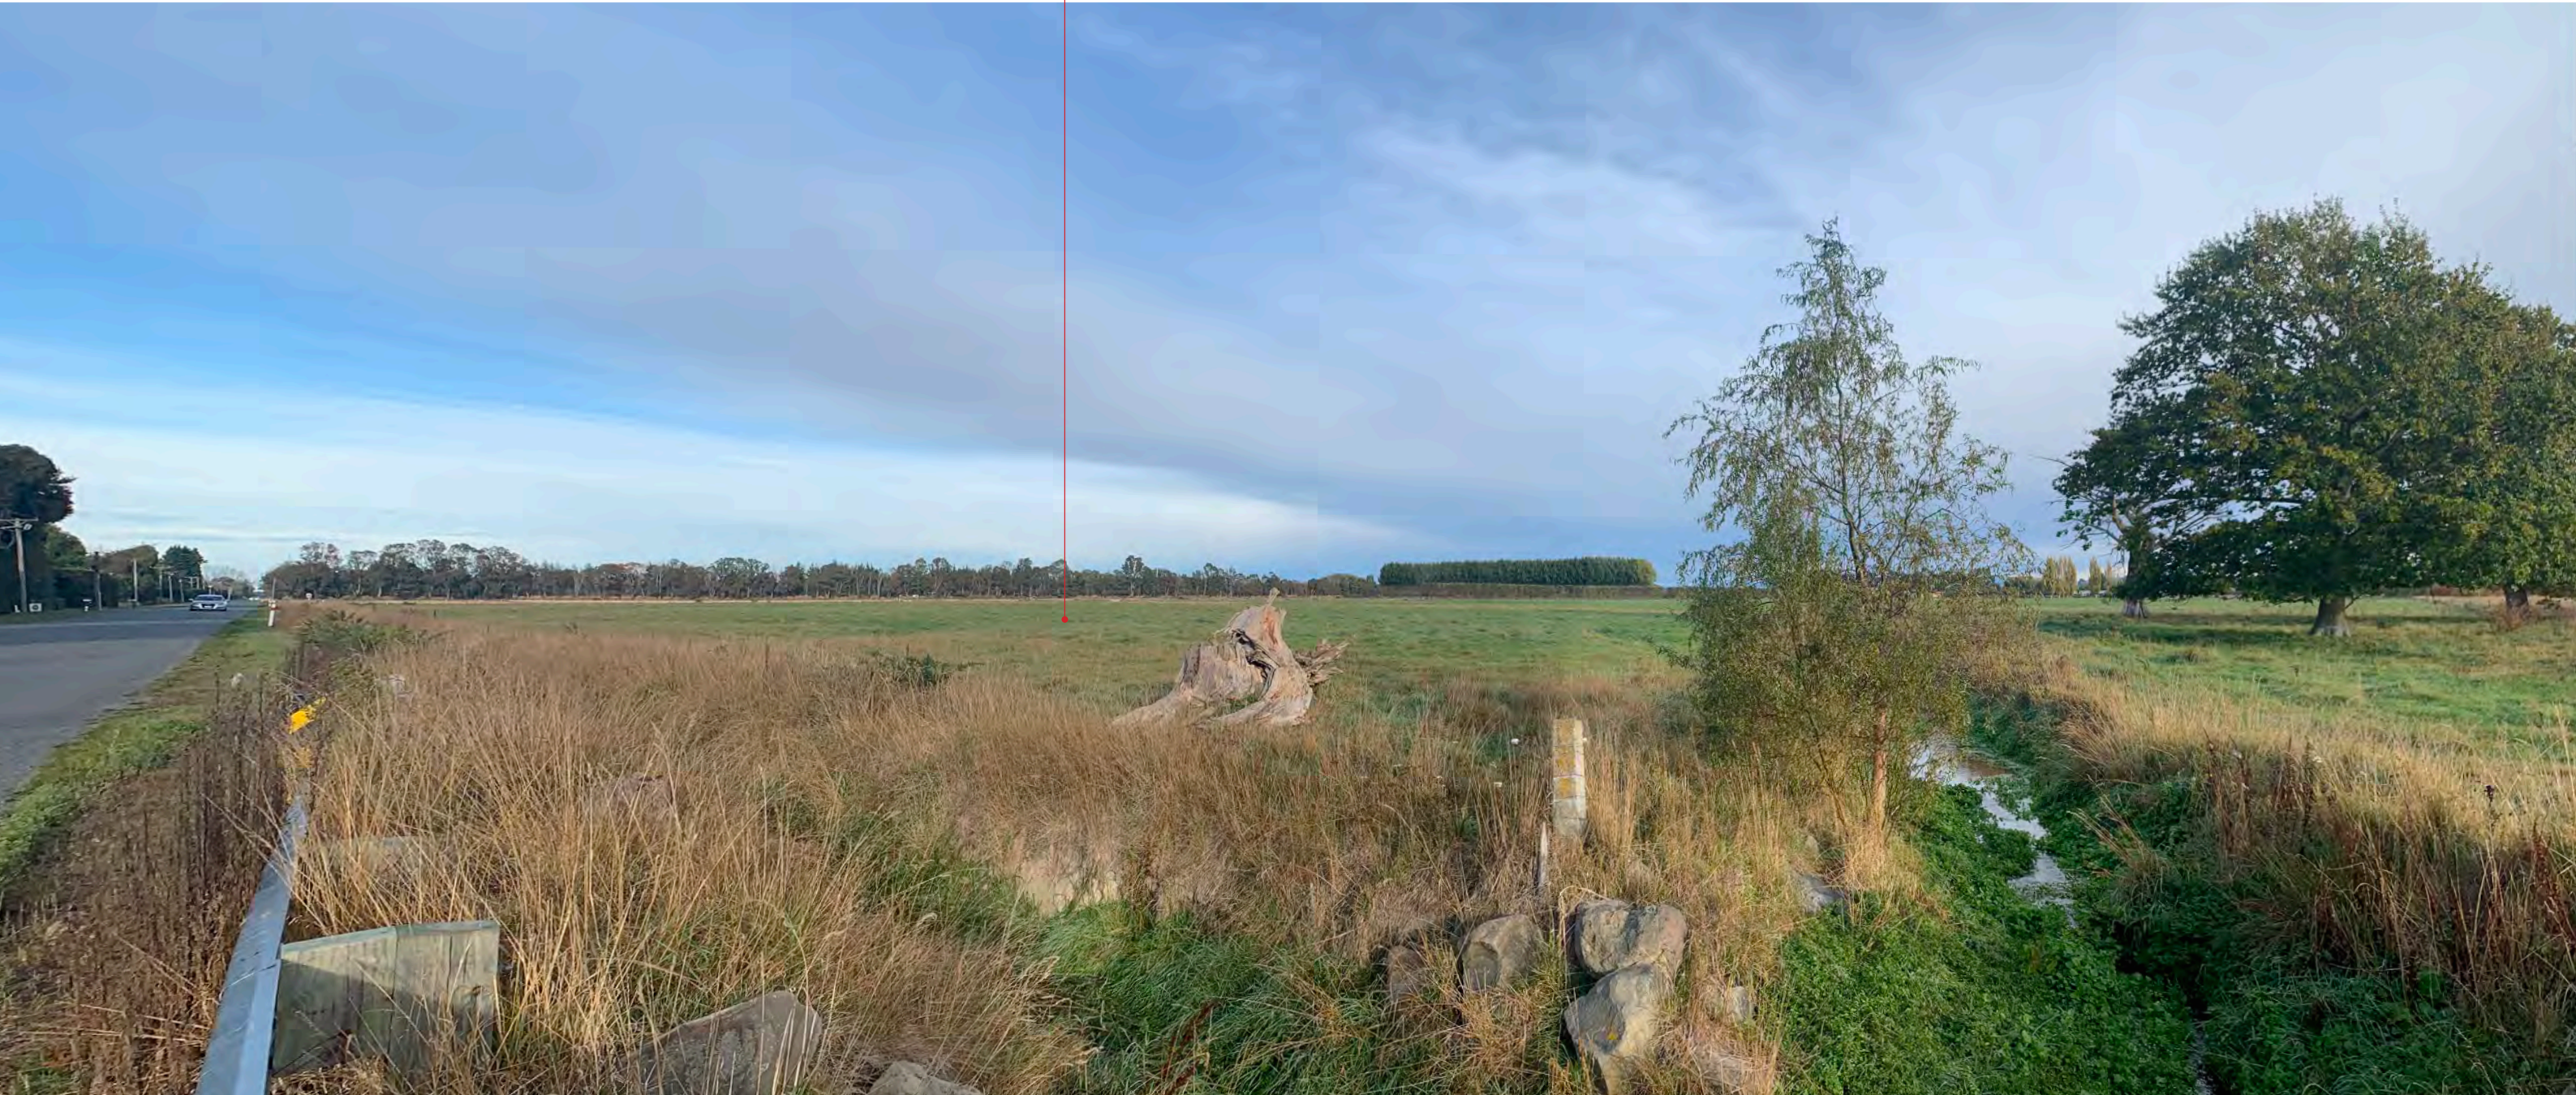
VP1 - VIEW SOUTH WEST FROM 318 WHITES ROAD

Image captured on Sony A6000
Focal length of 50mm
Date: 30th April 2021 at 8:57 am
Height of 1.7 metres
Photos merged in Photoshop CS to create panorama

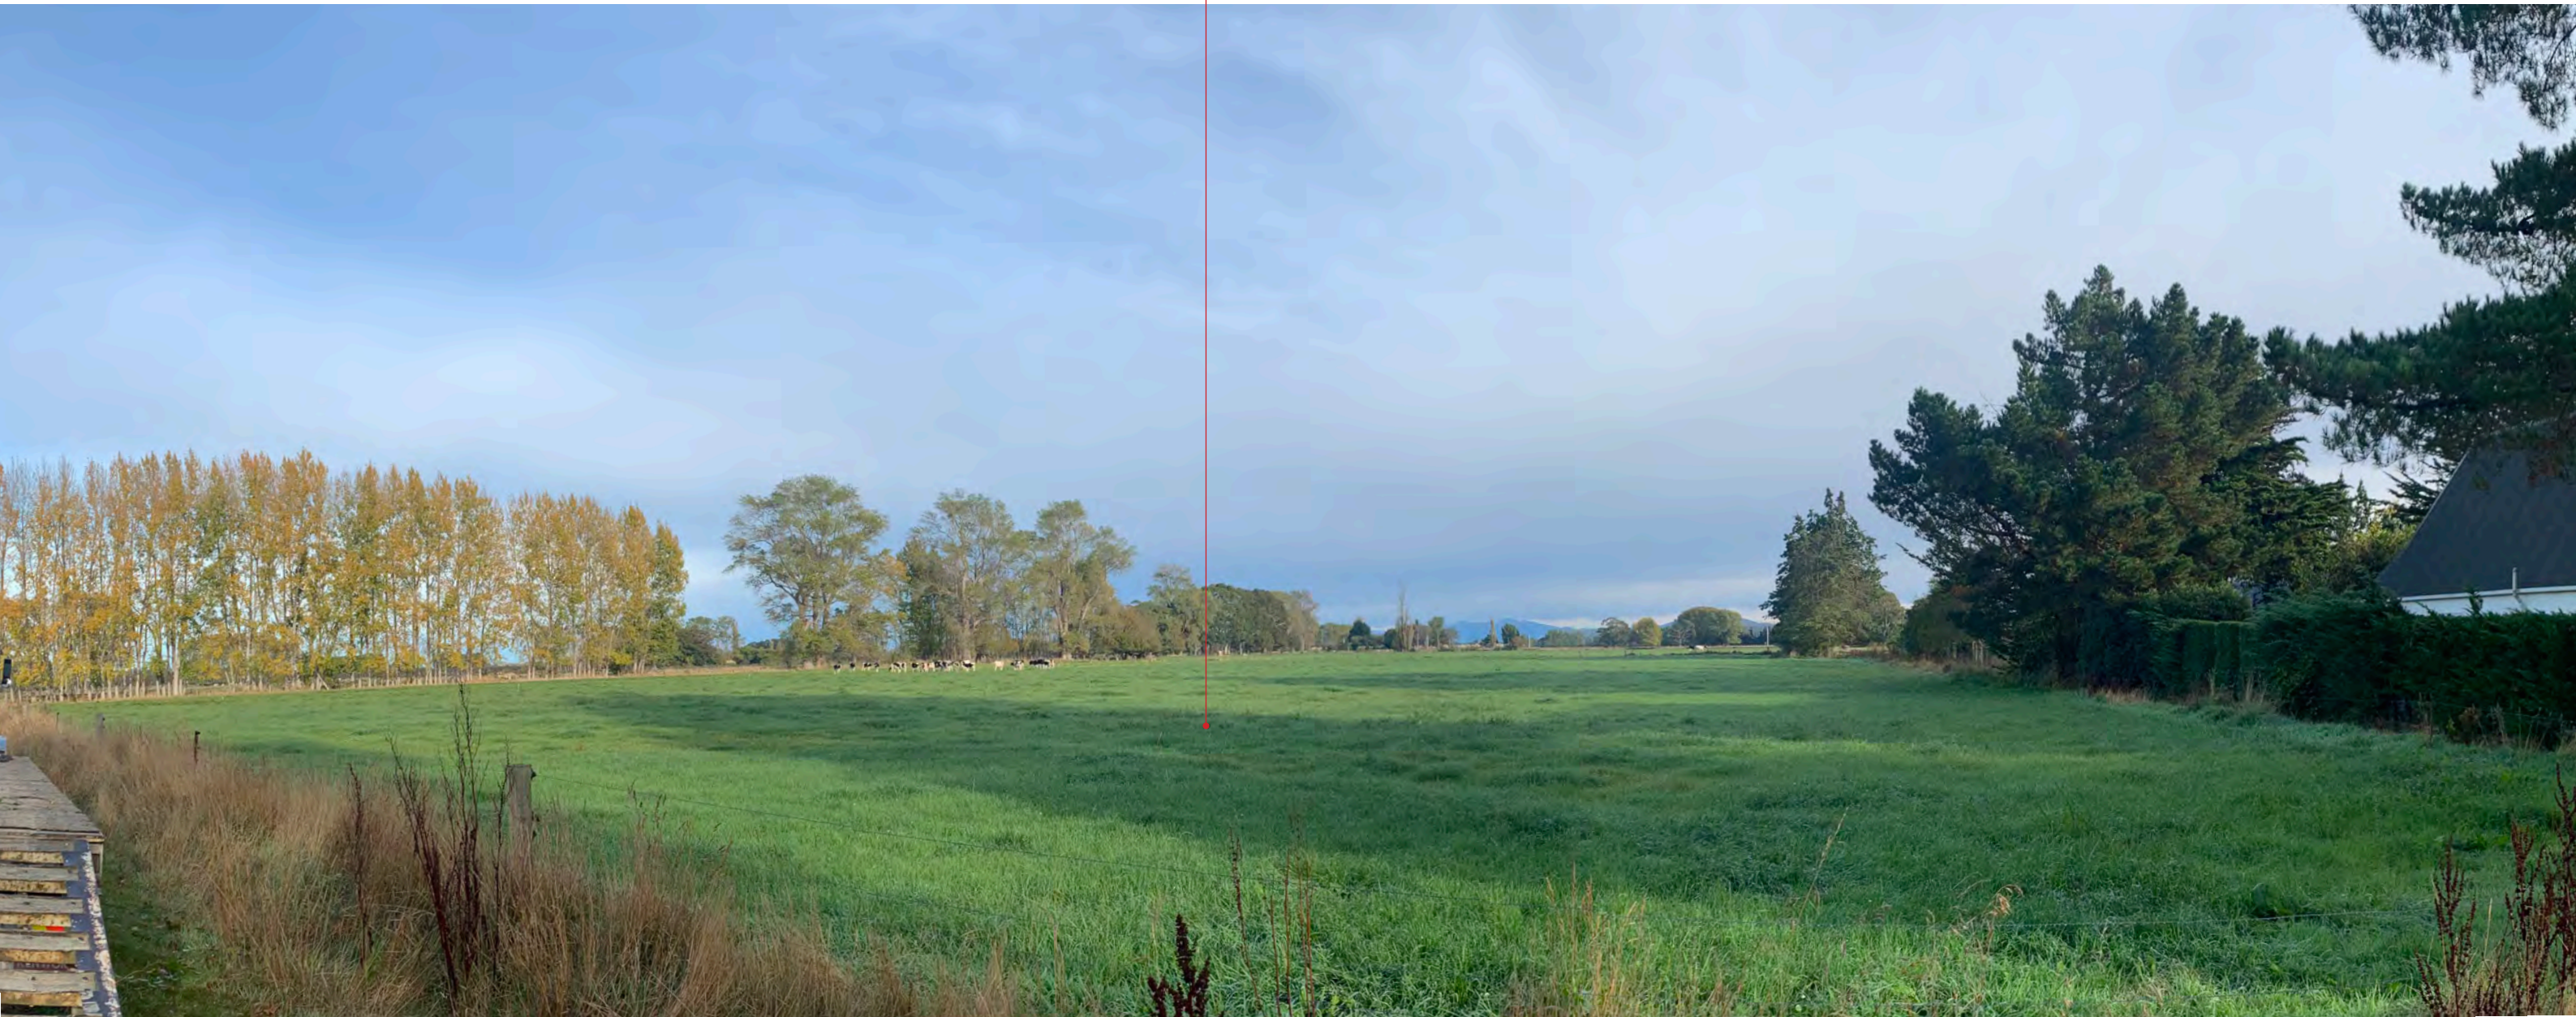
VP2 - VIEW SOUTH WEST FROM 410 WHITES ROAD

Image captured on Sony A6000
Focal length of 50mm
Date: 30th April 2021 at 9:02 am
Height of 1.7 metres
Photos merged in Photoshop CS to create panorama

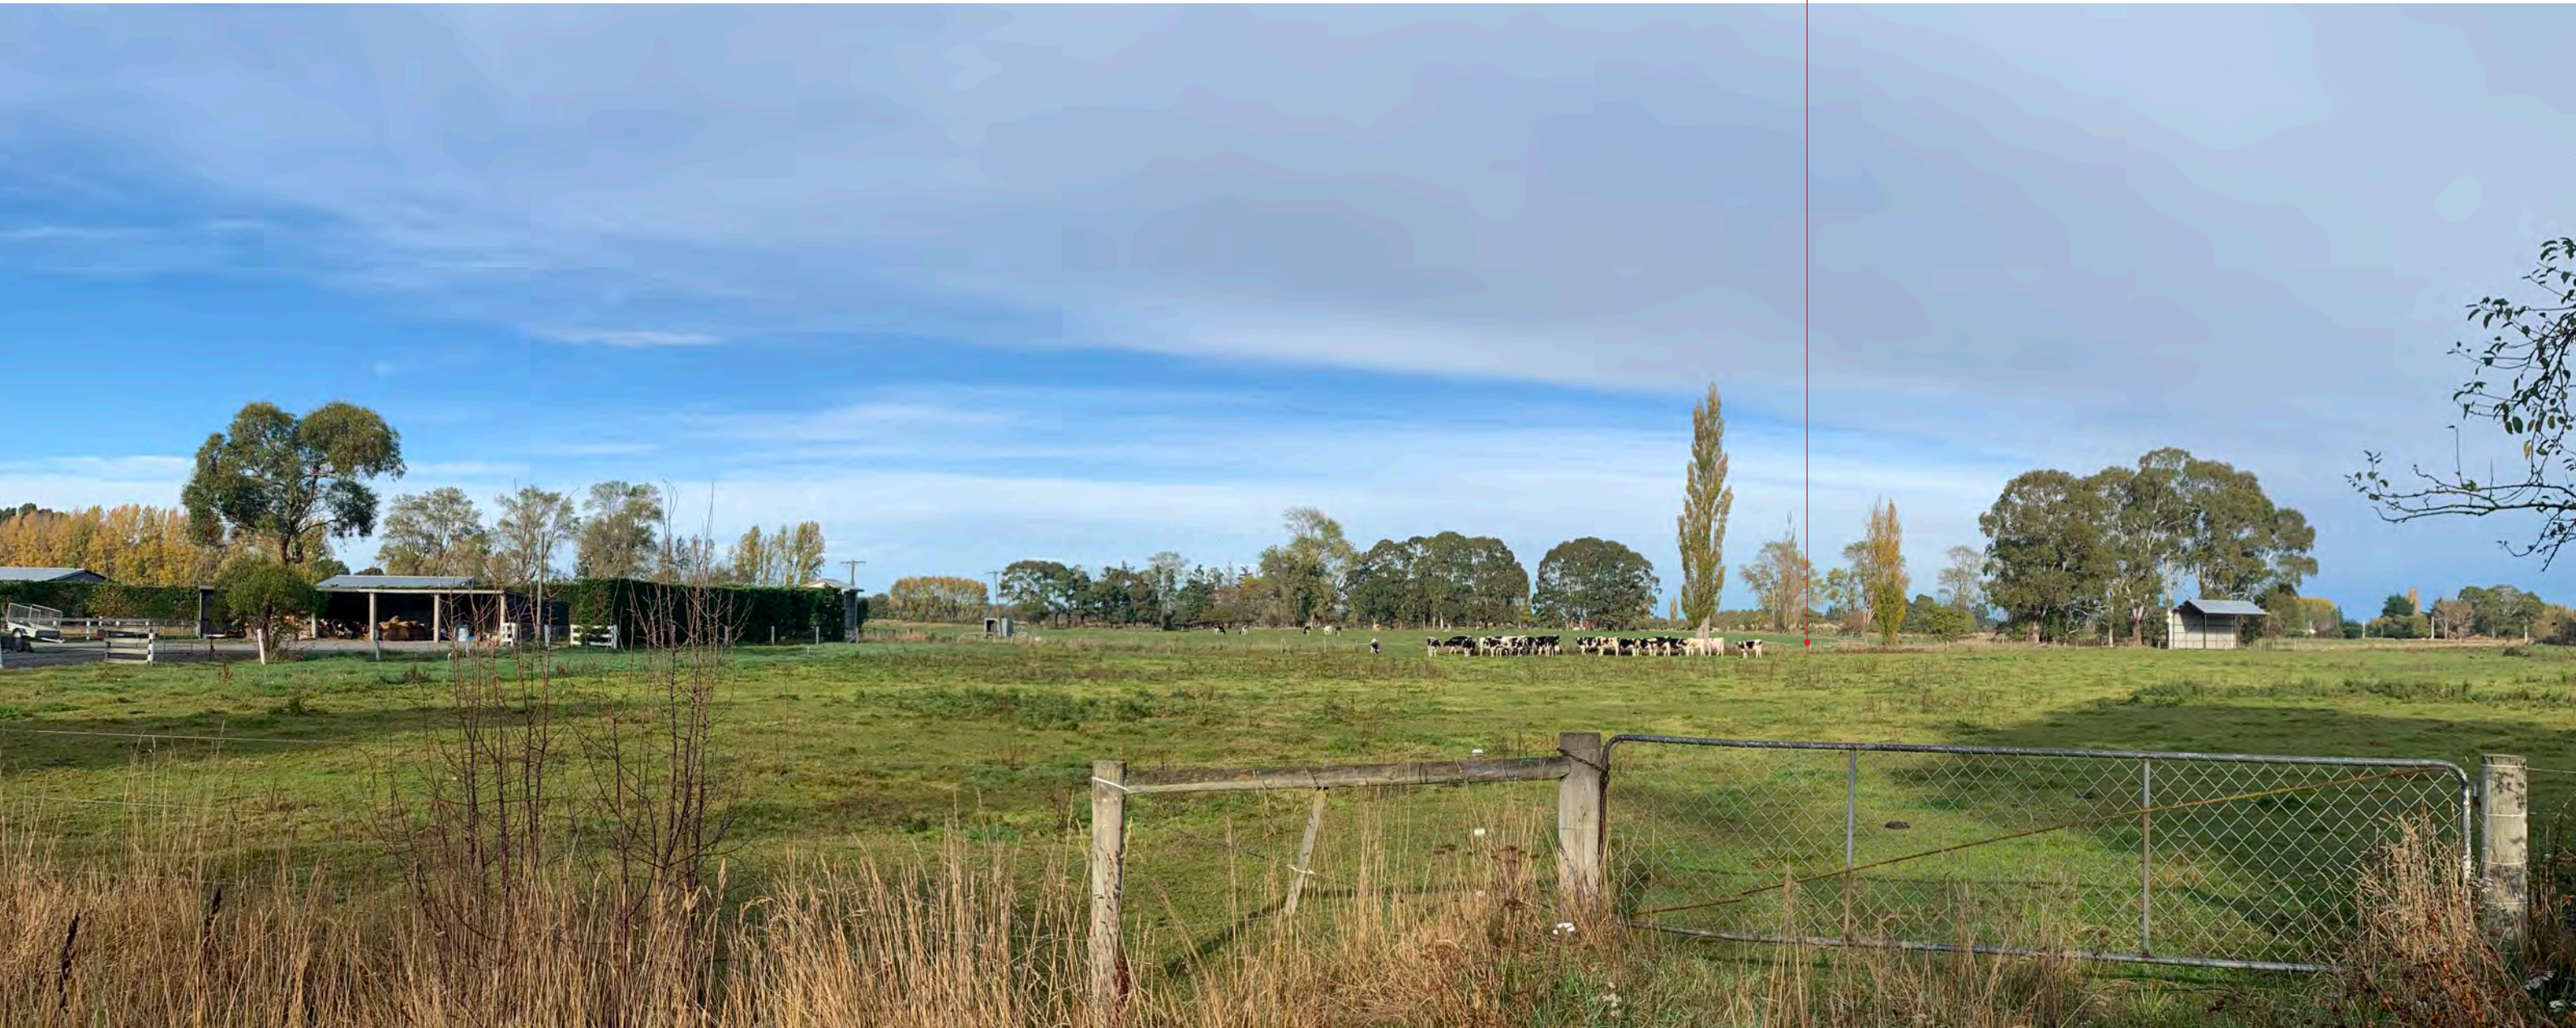
VP3 - VIEW SOUTH FROM 535 MILL ROAD

Image captured on Sony A6000
Focal length of 50mm
Date: 30th April 2021 at 9:20 am
Height of 1.7 metres
Photos merged in Photoshop CS to create panorama

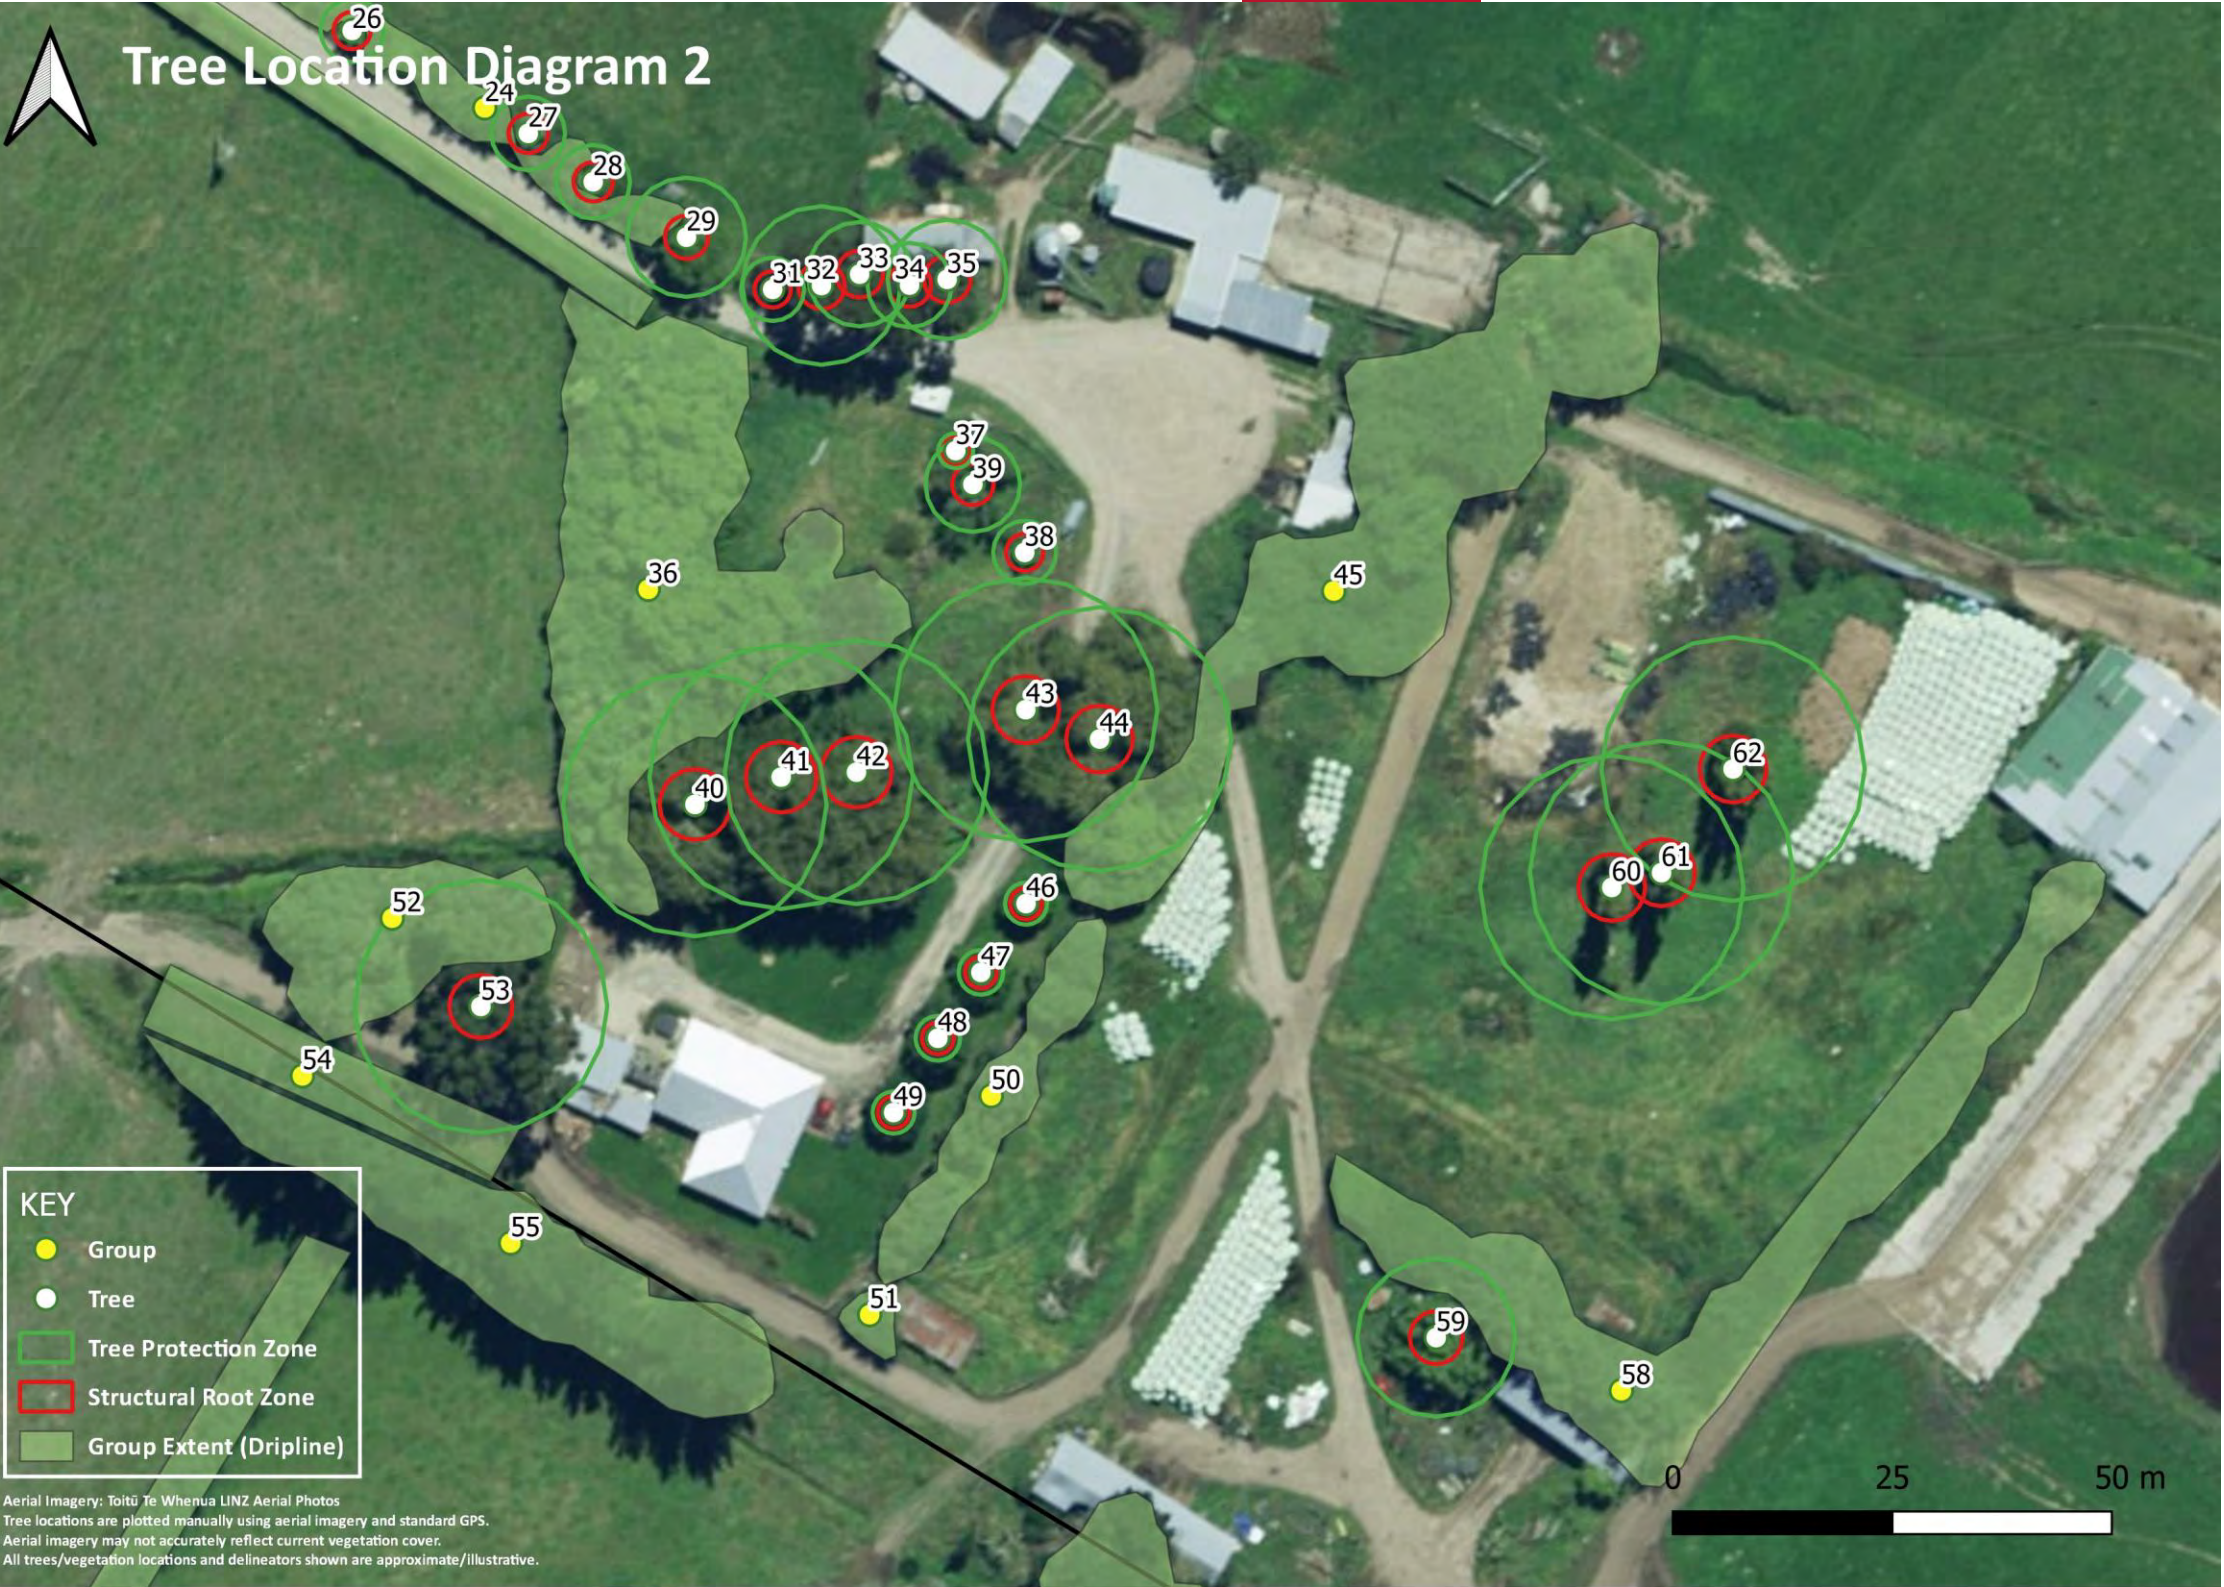
Tree Location Diagram 2

Aerial Imagery: Toitū Te Whenua LINZ Aerial Photos
Tree locations are plotted manually using aerial imagery and standard GPS.
Aerial imagery may not accurately reflect current vegetation cover.
All trees/vegetation locations and delineators shown are approximate/illustrative.
