Before an Independent Hearings Panel
at Waimakariri District Council

in the matter of: Proposed private plan change RCP031 to the Operative
Waimakariri District Plan

Evidence of Dave Compton-Moen

535 MILL ROAD, OHOKA - PLAN CHANGE
FOR ROLLESTON INDUSTRIAL DEVELOPMENTS LIMITED
7 JULY 2023

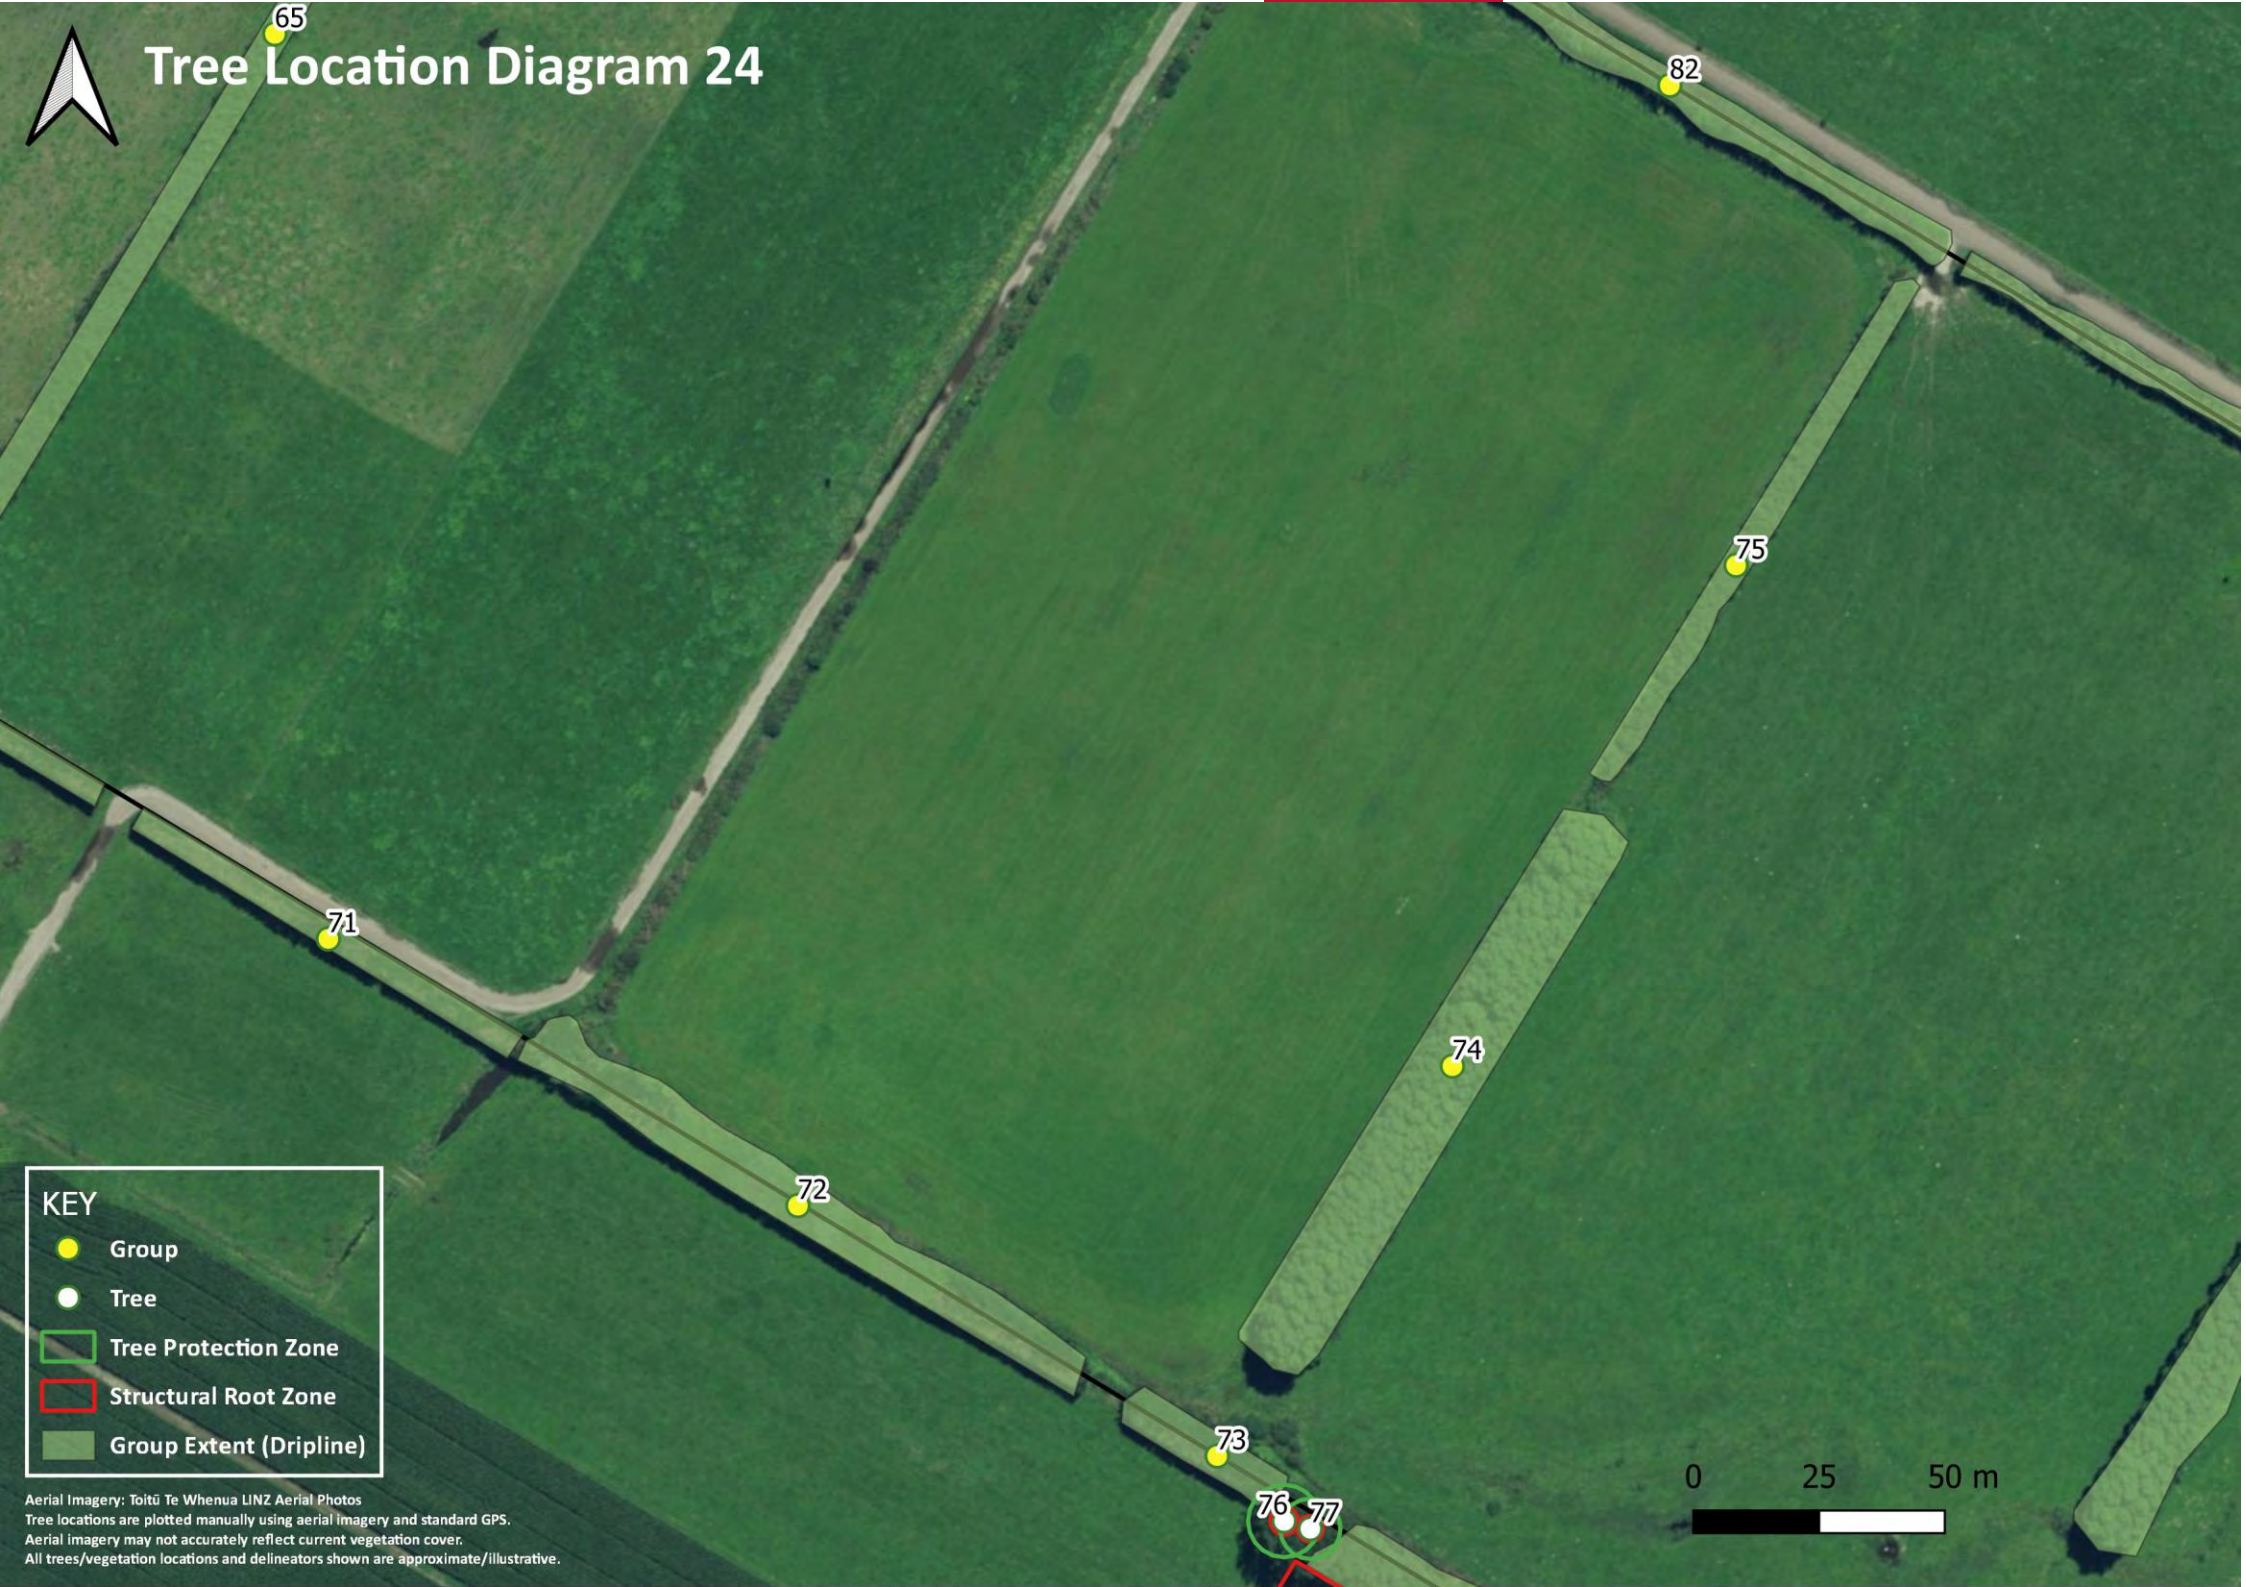
Tree Location Diagram 25

Aerial Imagery: Toitū Te Whenua LINZ Aerial Photos
Tree locations are plotted manually using aerial imagery and standard GPS.
Aerial imagery may not accurately reflect current vegetation cover.
All trees/vegetation locations and delineators shown are approximate/illustrative.

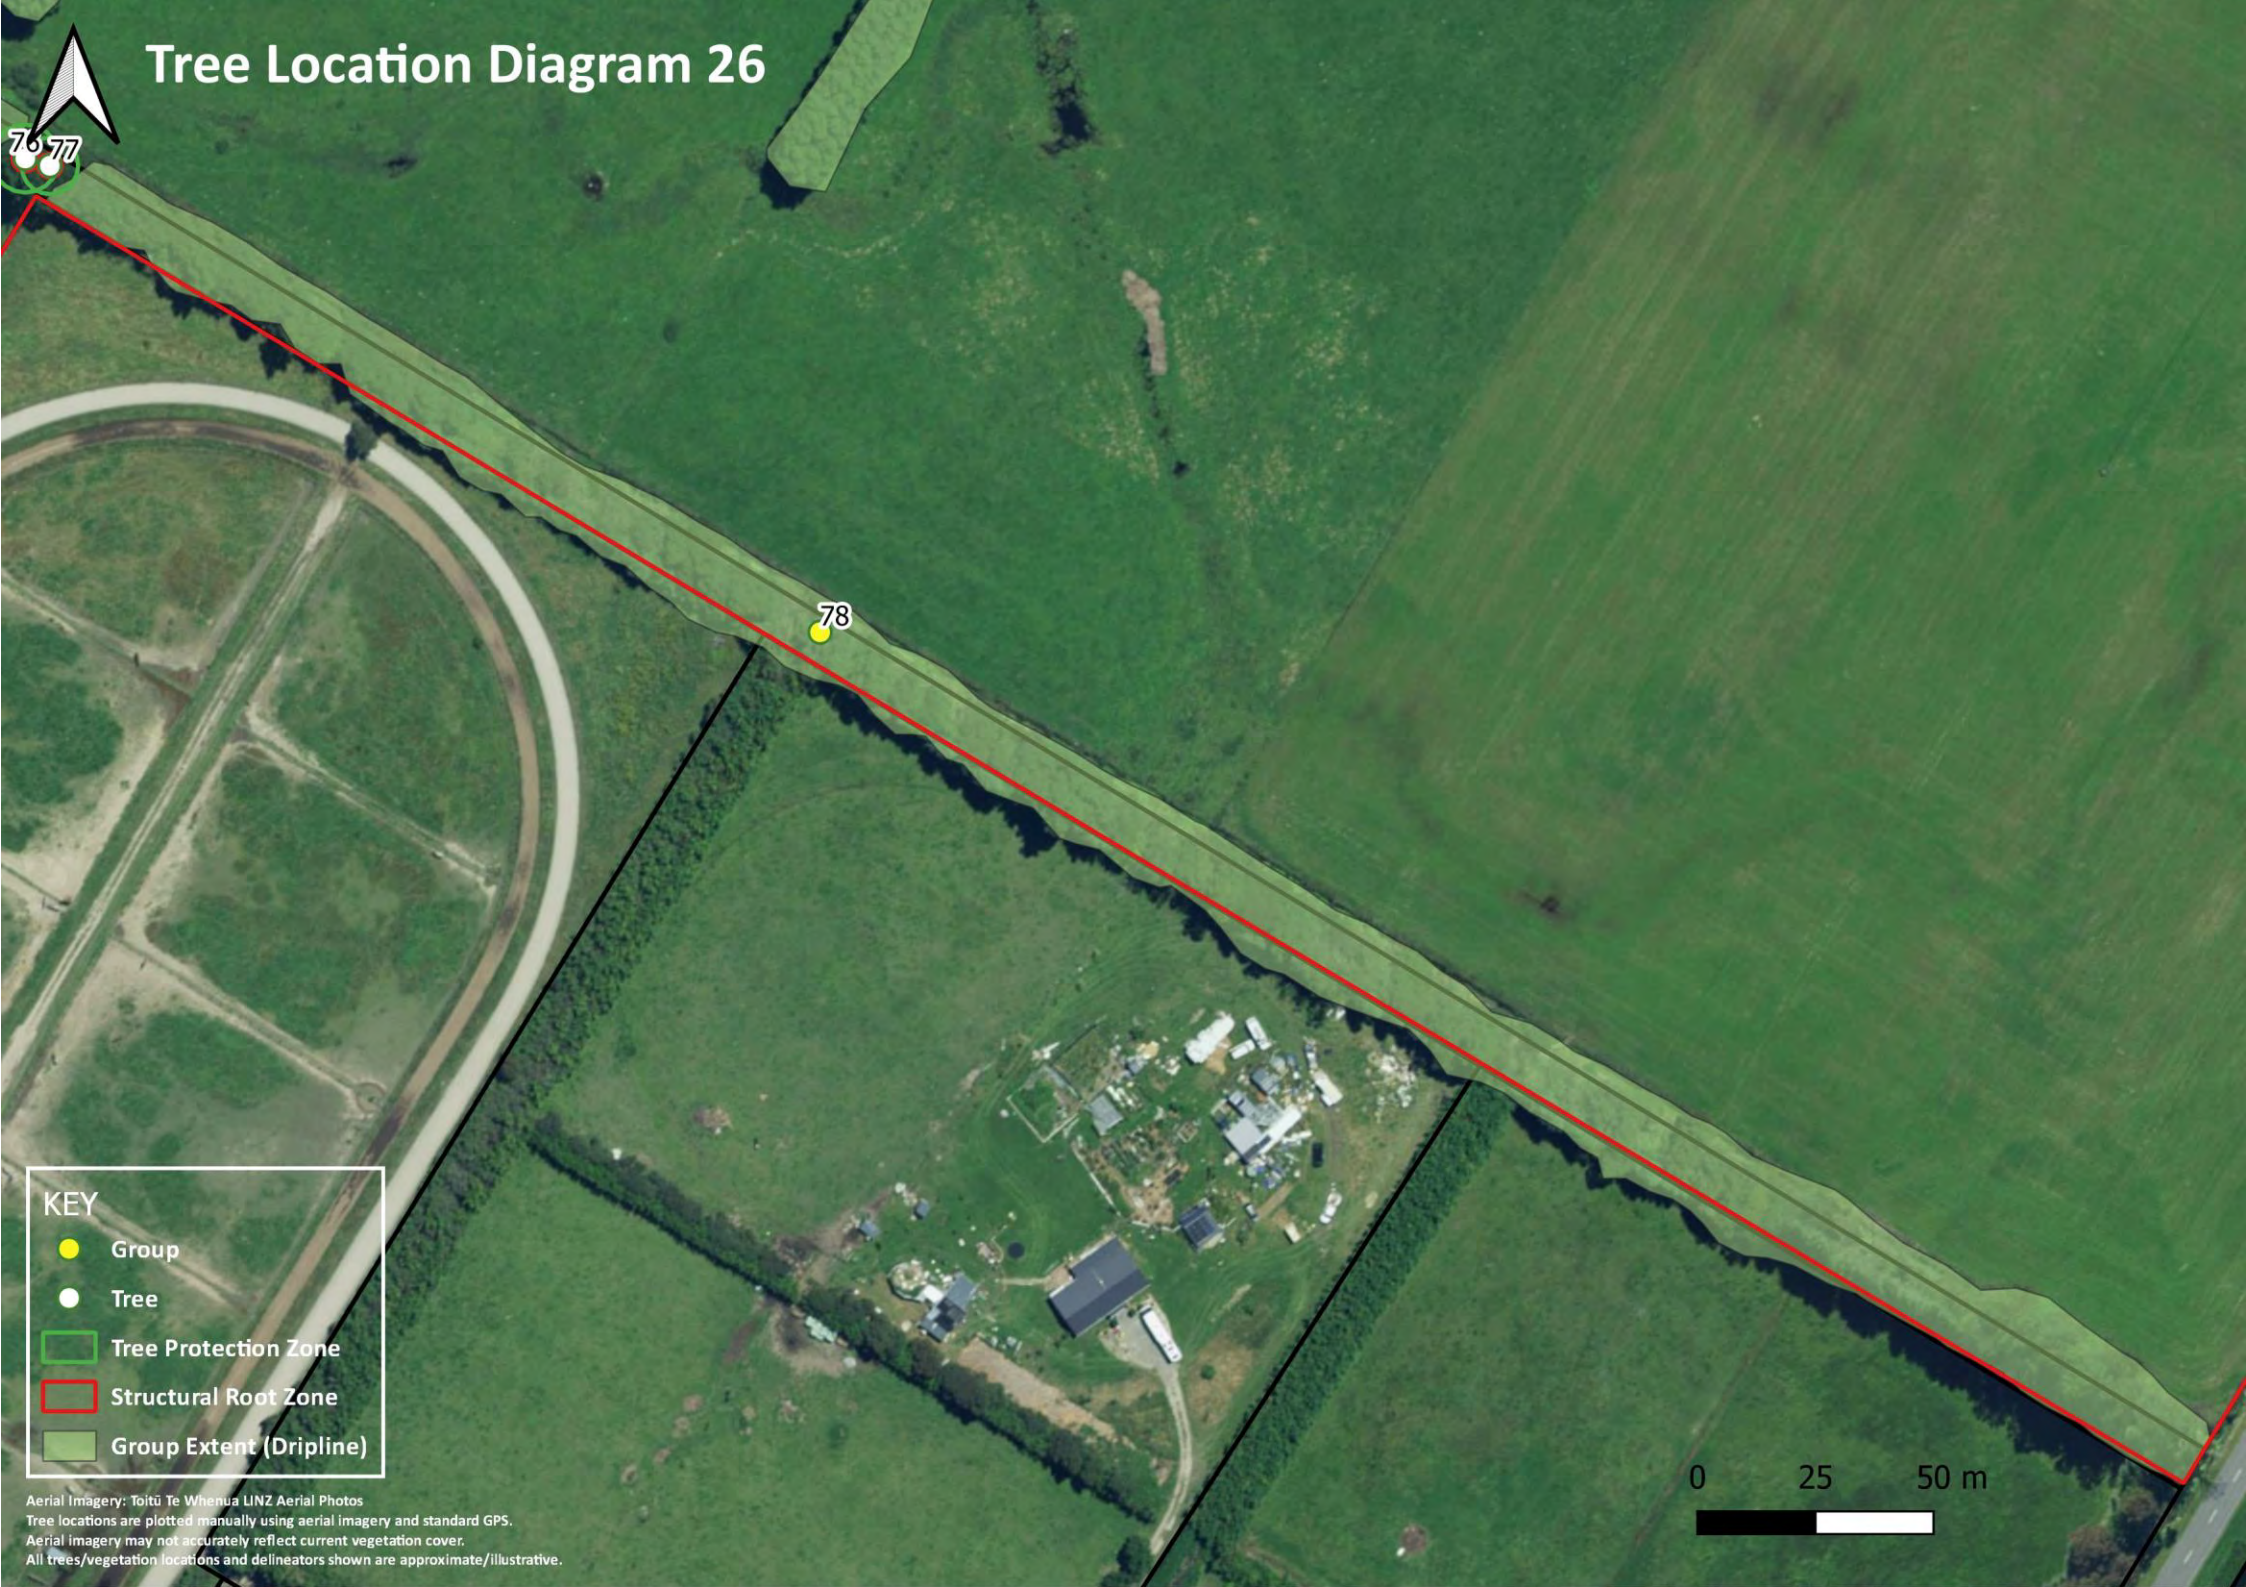
Tree Location Diagram 26

Aerial Imagery: Toitū Te Whenua LINZ Aerial Photos
Tree locations are plotted manually using aerial imagery and standard GPS.
Aerial imagery may not accurately reflect current vegetation cover.
All trees/vegetation locations and delineators shown are approximate/illustrative.
