**126 LEHMANS ROAD, RANGIORA.
Natural Hazard Assessment Report for
Rezoning Submission.**

04 March 2024

Project Reference	23235	
Project Name	126 LEHMANS ROAD, RANGIORA.	
Revision	B	
Prepared For	Miranda Hale	
Prepared By

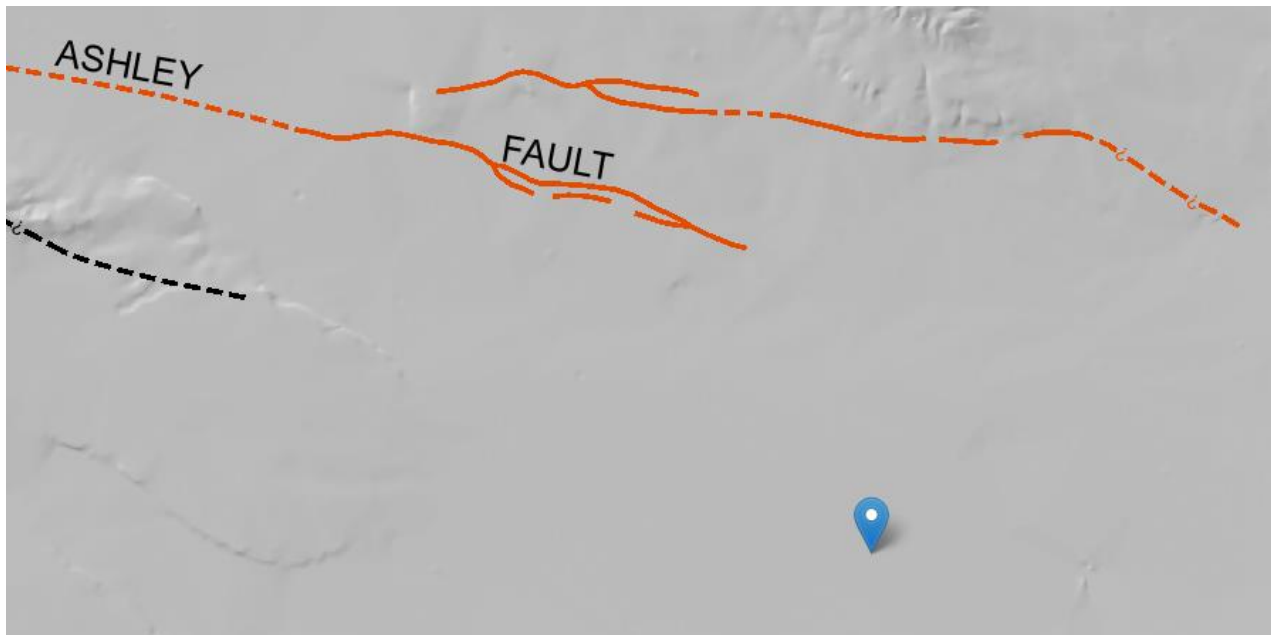
The GNS (2023) website image in Figure 3 shows the closest active fault- the Ashley Fault- located about 4 km due north of the site. The Ashley Fault Zone is the most active fault in the Waimakariri District. The fault has an expected recurrence interval (RI) of about 5,140 years corresponding to RI Class IV, based on average recurrence interval assessment techniques and work carried out by Dawson et al (2008), and Nicol et al (2012) on average recurrence intervals.

Figure 3: Site Location in relation to known active faults – from GNS (2023) geology web map. The dotted line represents part of the concealed Cust fault trace.

The Ashley fault has an inferred fault recurrence interval (RI) Class IV assessment, translating to an average fault recurrence interval of surface rupture between 5,000 – 10,000 years.

For the Ashley Fault Zone location discussed above, fault awareness zones have not been imposed on the subject property and therefore, location of future dwellings on the site is not restricted by such fault zones.

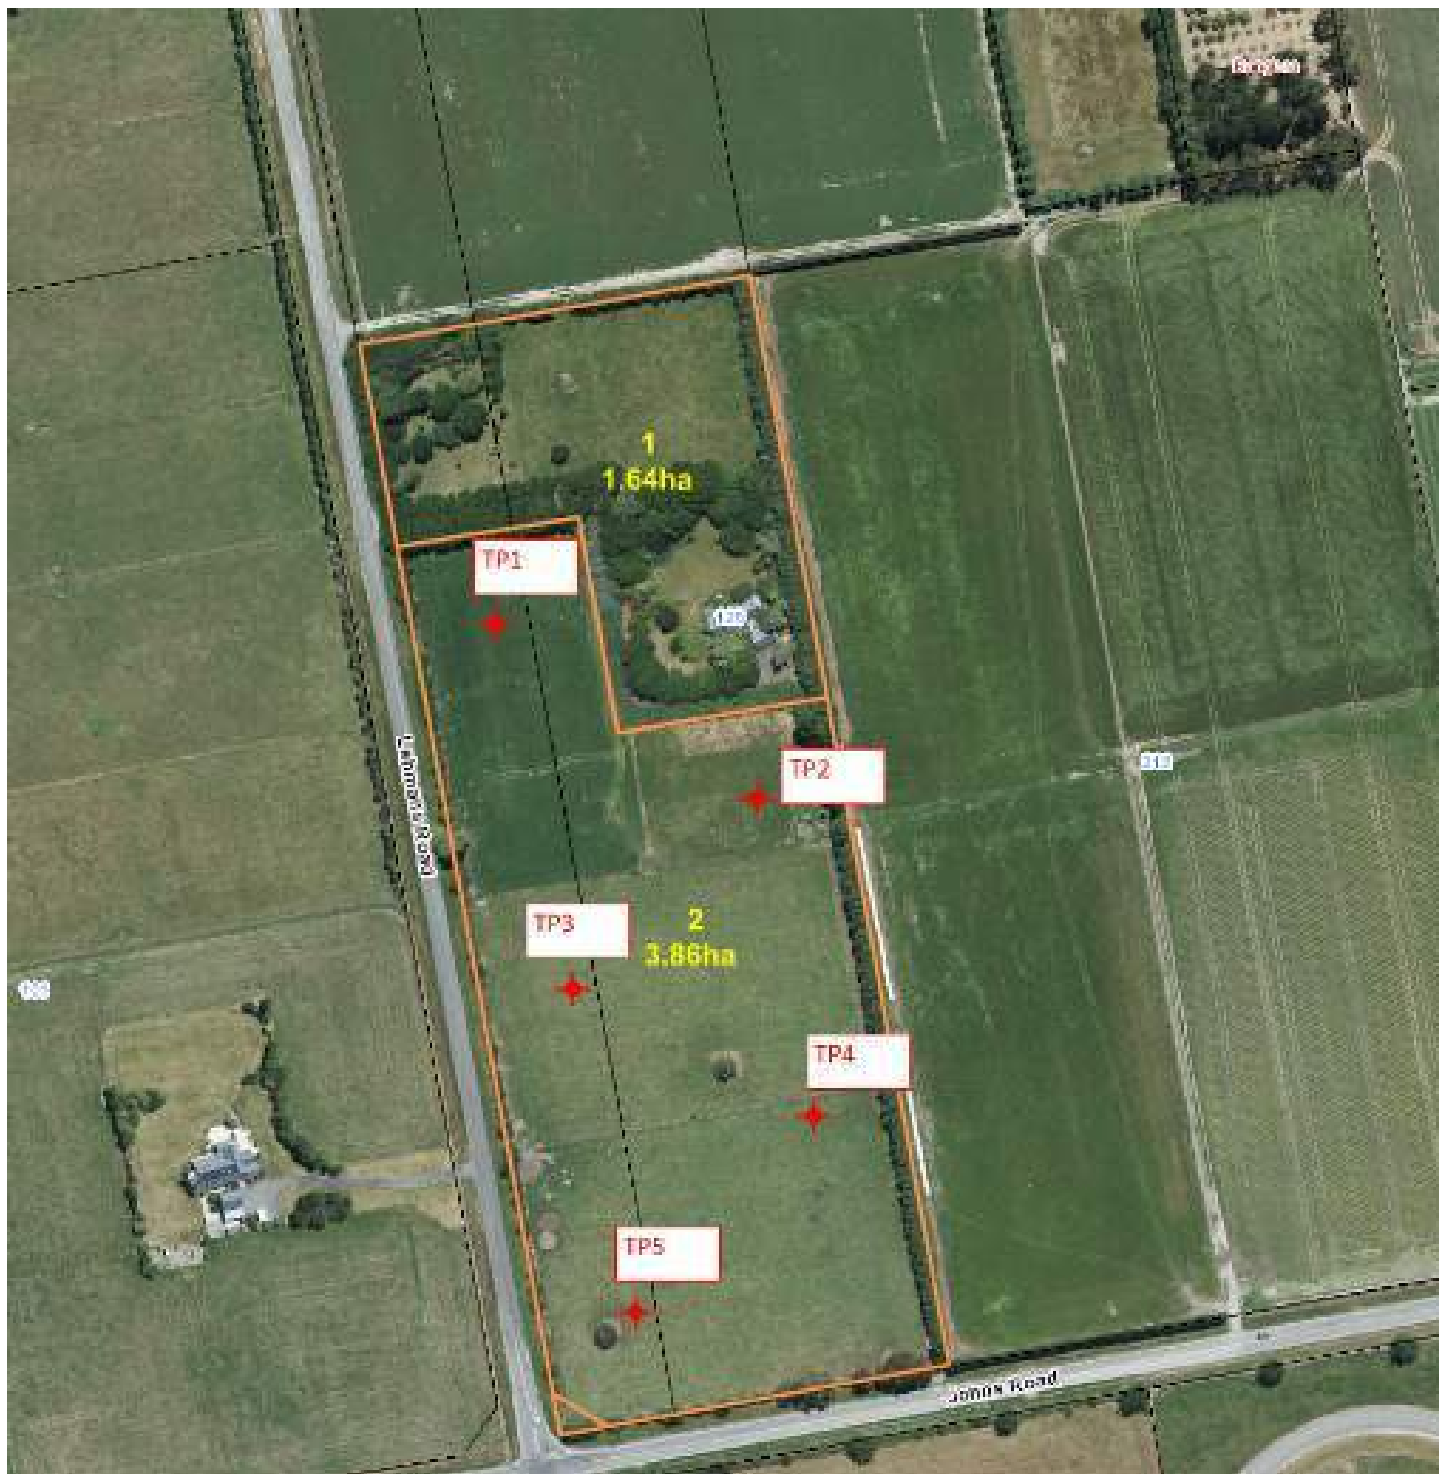
G1.0

**TP1** TEST PIT & SCALA PENETROMETER

TITLE
Test Location Plan

Shallow geotechnical testing was undertaken on 31st August 2023 and comprised five shallow test pile holes excavated with a 6-tonne digger. The test pit holes were excavated to a target depth of 2.9 m. Practical refusal of the Scala test was encountered at 1.4 – 2.2 m bgl in dense gravel with resistance values exceeding 12 blows/100 mm. The test pit and Scala penetrometer test locations and results are shown in Appendix A and summarized in Table 1 below.
