Statement of evidence of Chris Thompson (Geotech) on behalf of  
Crichton Developments Limited in relation to Gladstone Road  
rezoning request

## Geotechnical Assessment Report

Crichton Development Group Limited

Reference: 773-CHCGE332958

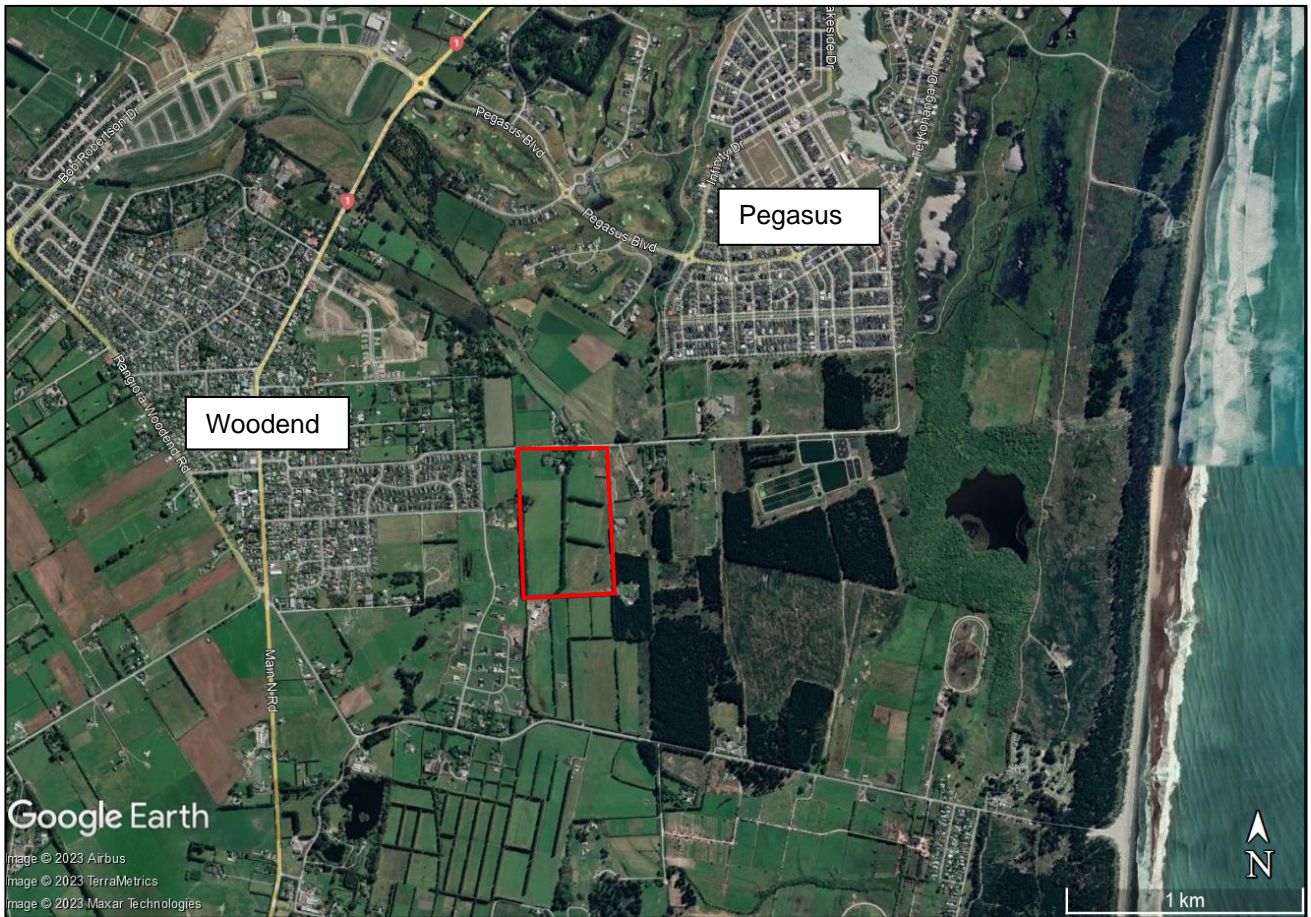
Figure 1: Proposed plan change area (red)

The property located at 145 & 167 Gladstone Road, known as Lot 1-2 DP 29099, spans approximately 20.7 hectares (Ha) and is situated at the southeastern boundary of the Woodend township (Figure 1). It is bordered by Gladstone Road to the north and rural greenfield land to the east and south. The topography of the site is predominantly flat, although there is a terrace in the western section that sits approximately 2.5 – 3.0 meters (m) higher than the eastern portion. Presently, there is a single dwelling with a detached garage and sheds on 145 Gladstone Road, along with a barn shed utilized for stockfeed storage on 167 Gladstone Road. The current purpose of the site is for grazing.

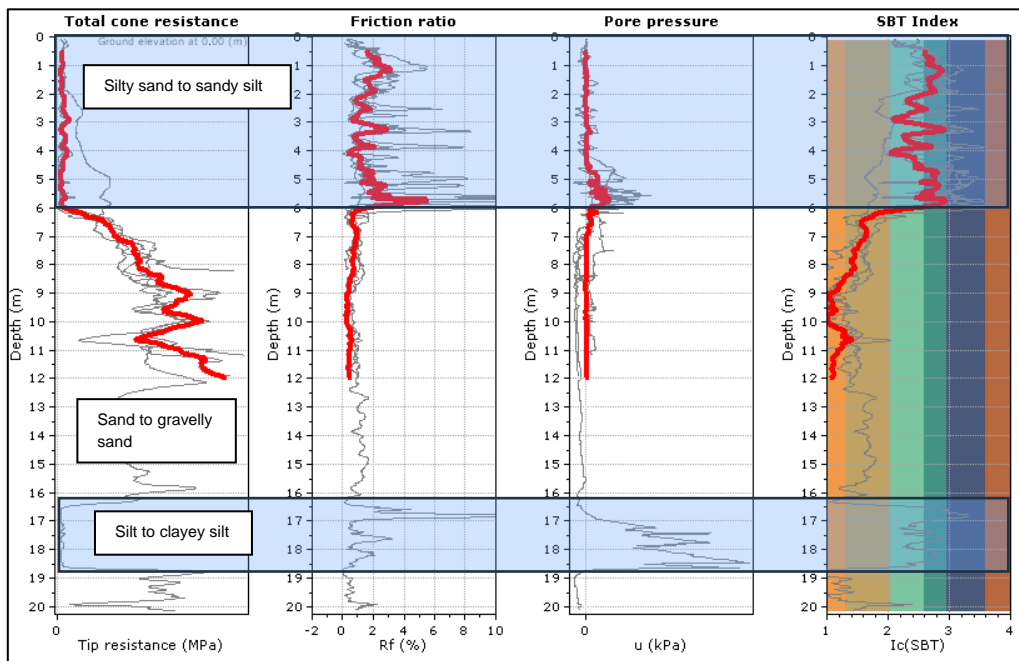
- Figure 2 utilises CPT\_01, 06, 07 and 08.
- There is generally a surficial topsoil layer ranging between 0.4 – 0.6m thick.
- From loose sandy material to ~ 2.0mbgl to medium dense silty sand to very stiff sandy silt to depths of up to ~6.0mbgl.
- Dense to very dense sand/gravelly sand between ~6.0 to at least 20.0mbgl
- The presence of a very stiff silt to clayey silt layer between ~16.0 -19.0mbgl.

Figure 2: Western portion of the site

The site has been divided into two distinct subsurface profiles, separated by an east-facing terrace that gradually increases in height to a maximum of approximately 3.0m. Figure 2 illustrates the subsurface conditions for the western portion of the site, while Figure 3 depicts the eastern portion. To present an indicative ground profile, we have calculated an average on-site and nearby CPT trace using the geometric

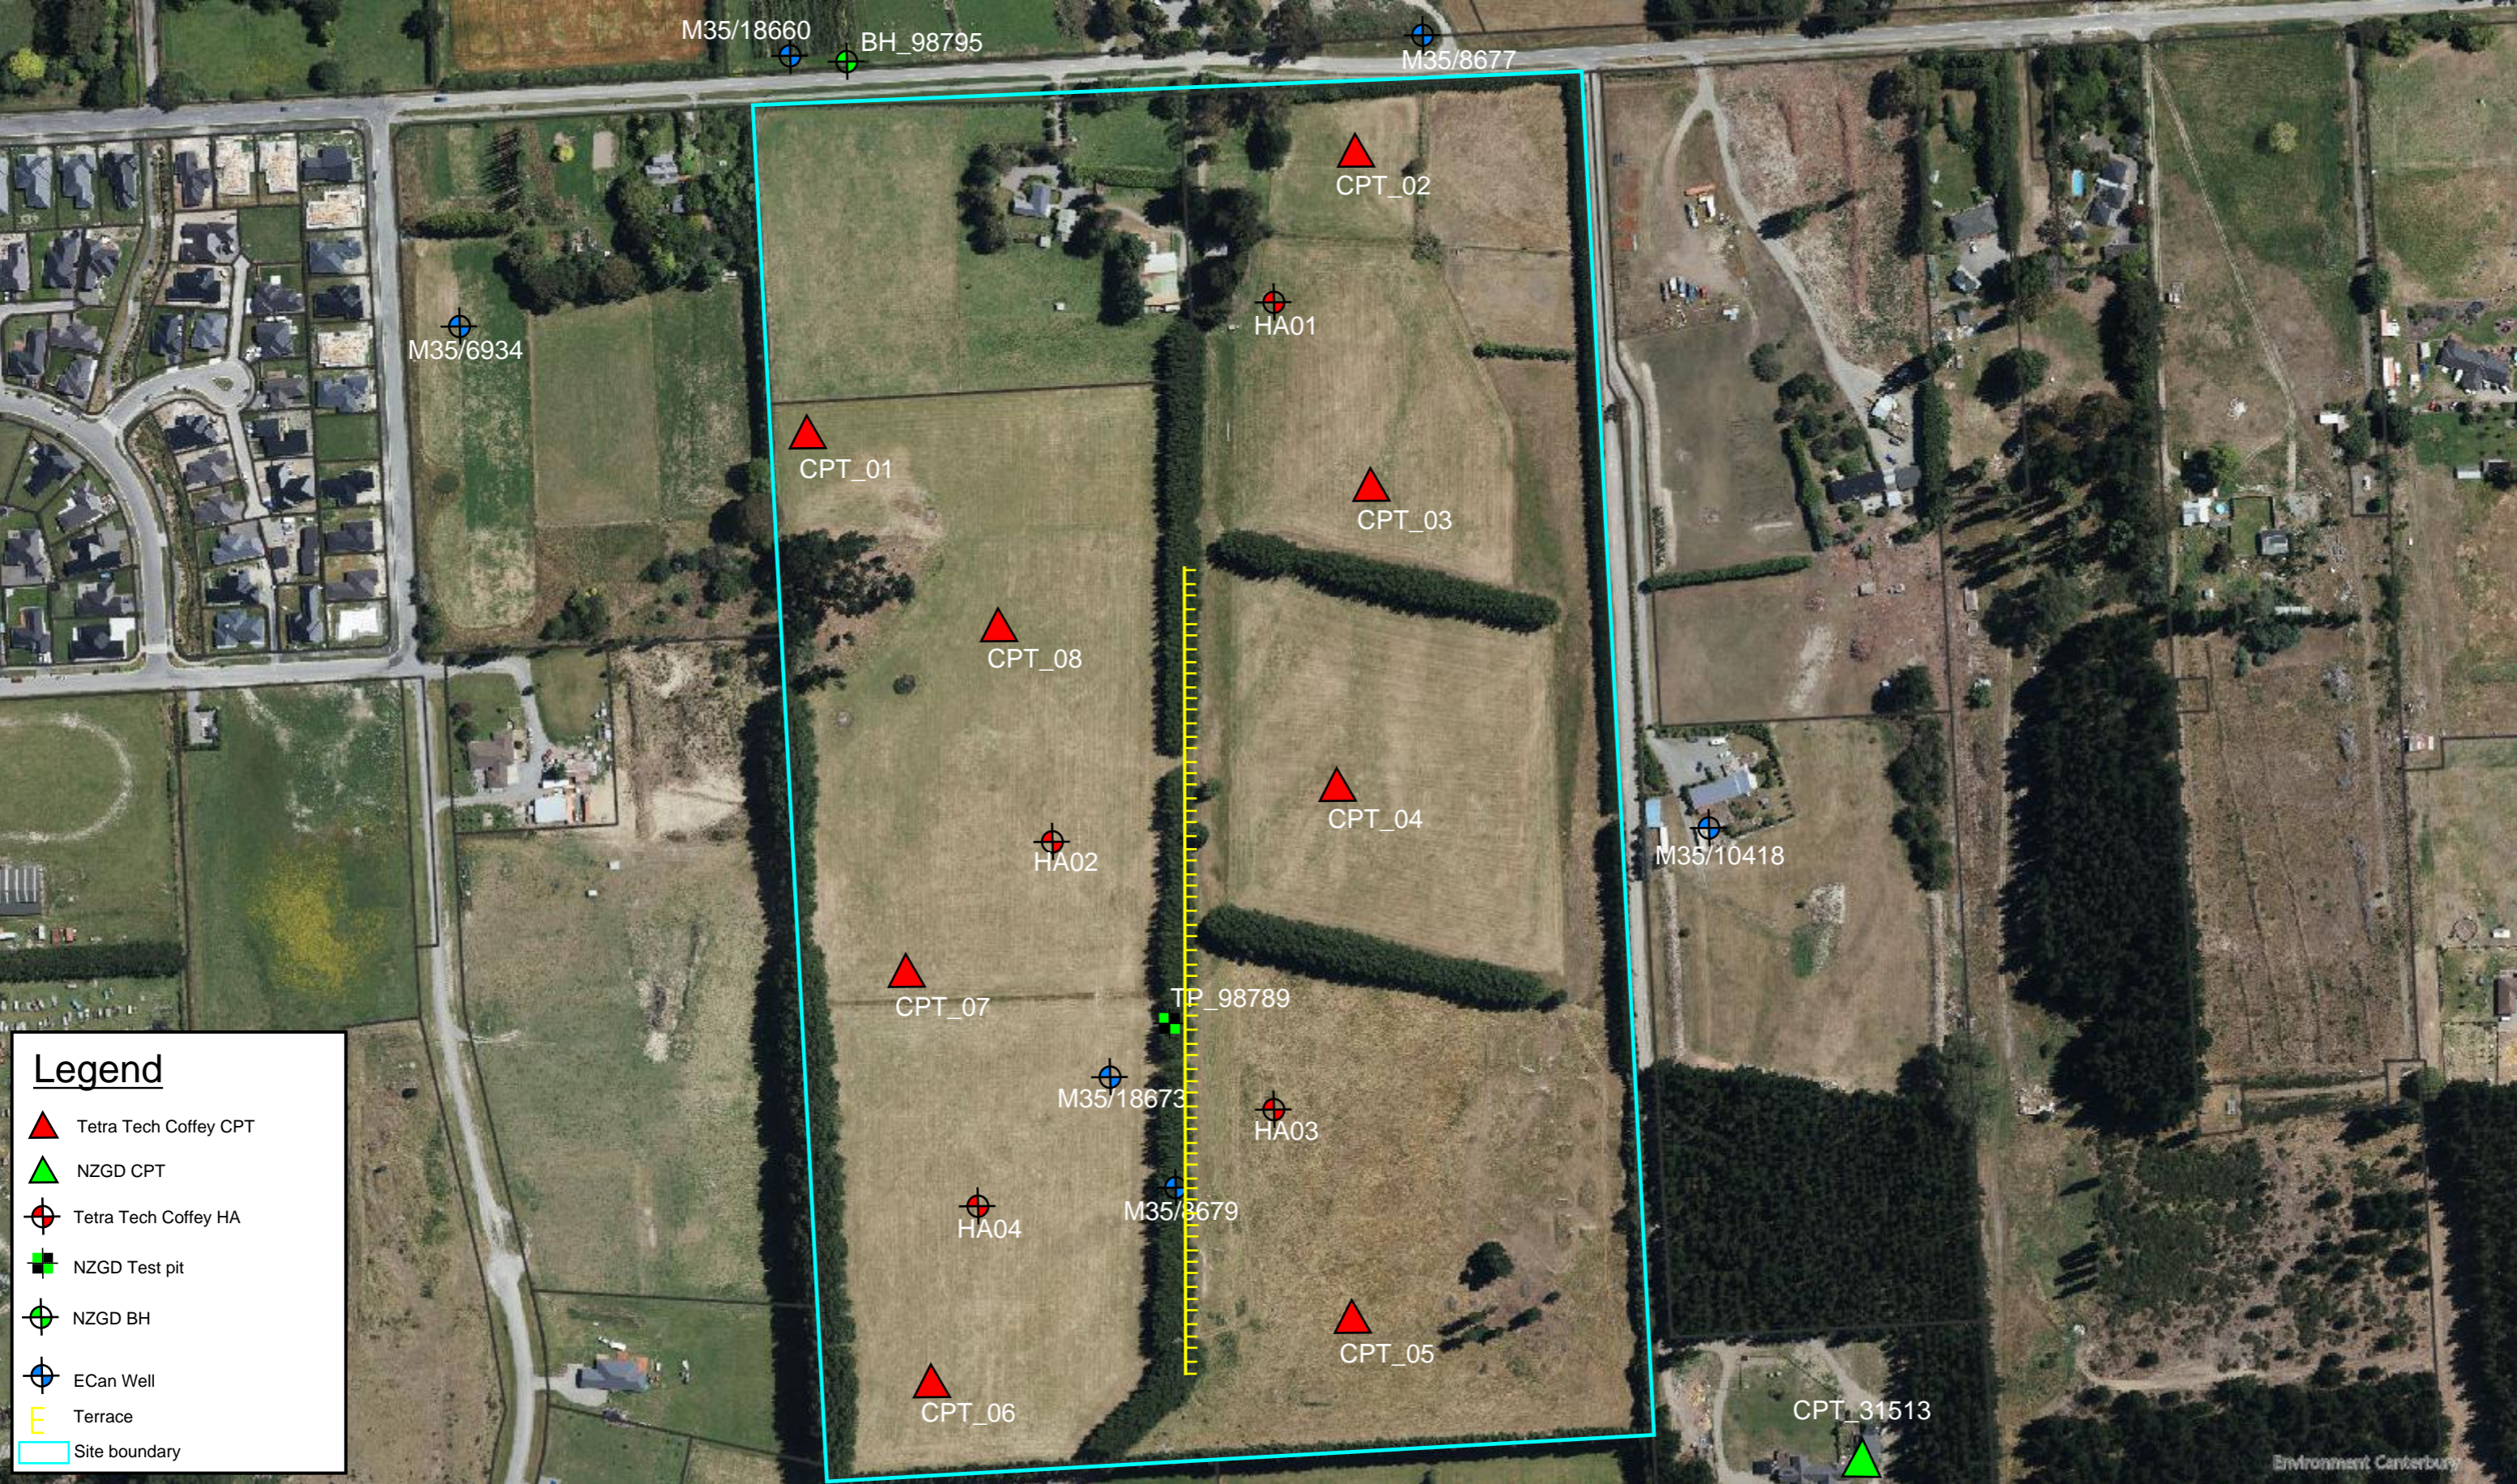
Crichton Development Group Limited		
project:	145 & 167 Gladstone Road, Woodend Plan Change	
title:	Geotechnical Investigation Locations Plan	
project no:	773-CHCGE332958	drawing no: 01
		rev: A

The existing investigation data is summarized in Table 1. Specific test locations can be found in Appendix A, and for a summary of the tests, Appendix B.

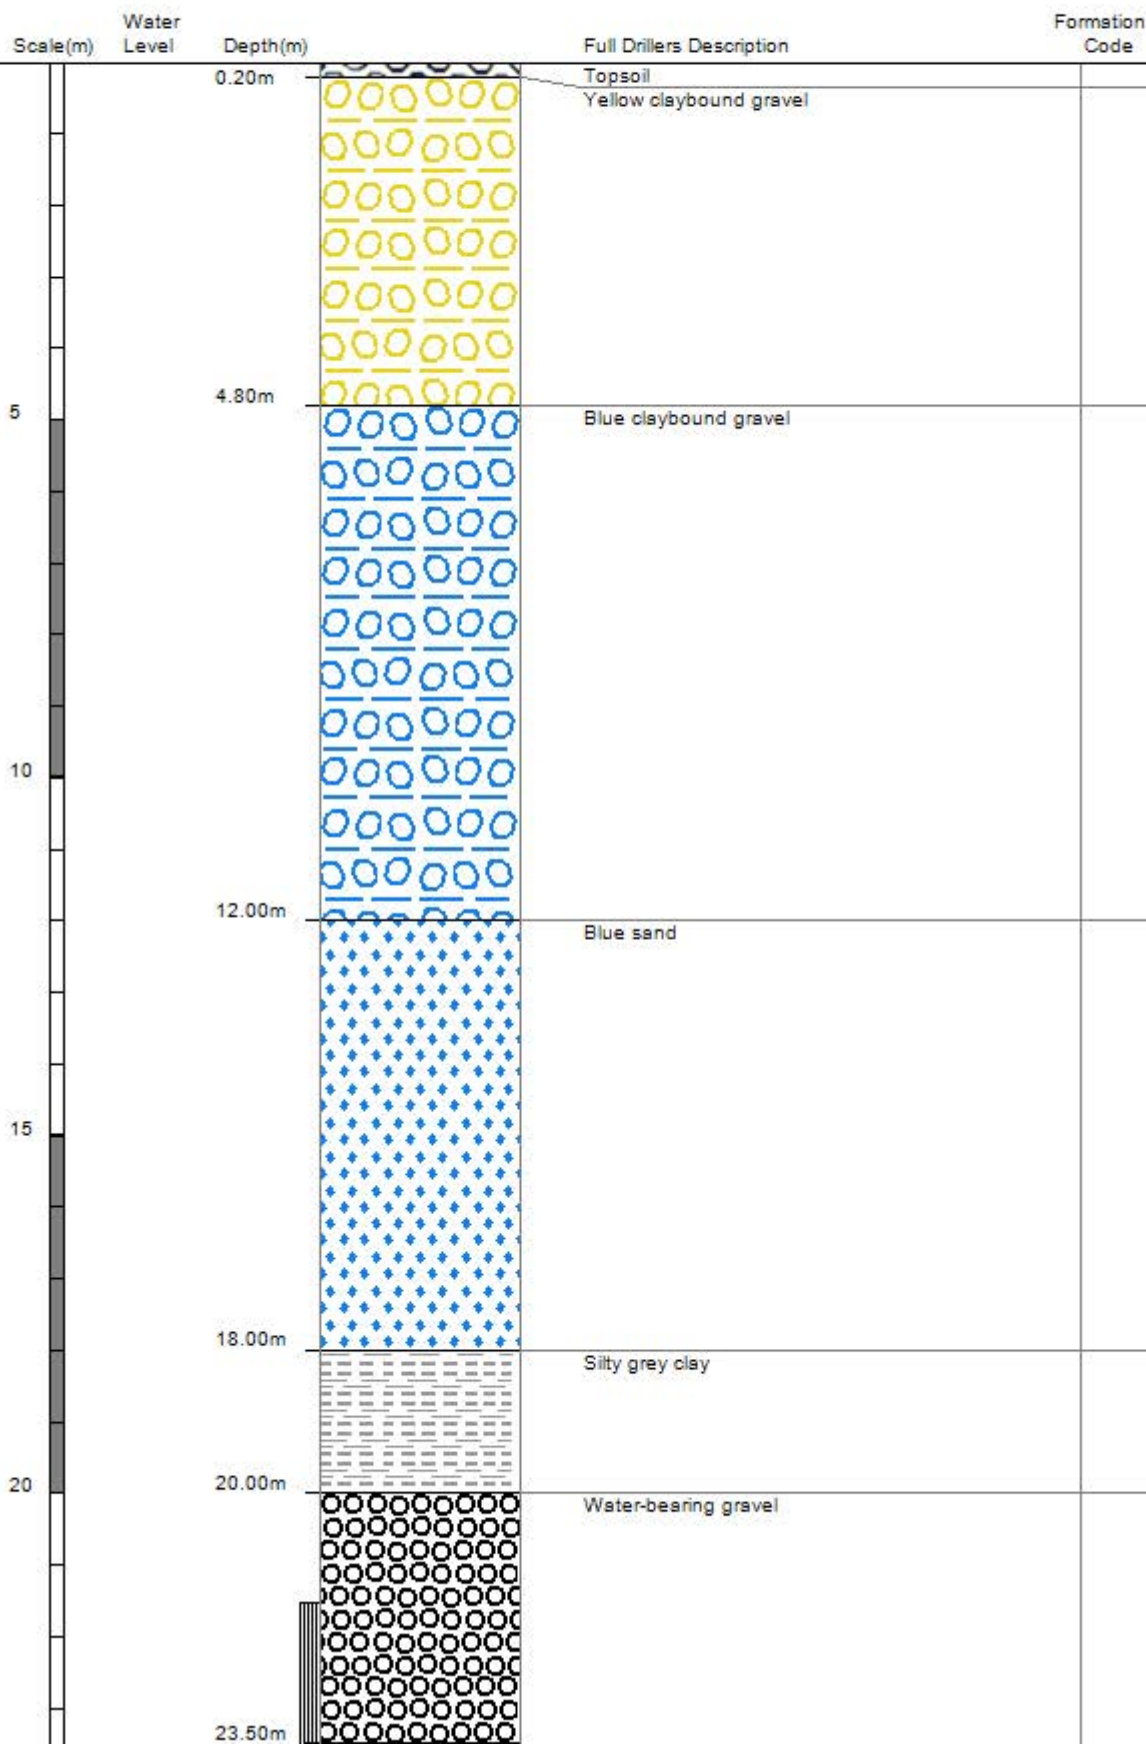
# Borelog for well M35/18660

Grid Reference (NZTM): 1574039 mE, 5203247 mN  
 Location Accuracy: 2 - 15m  
 Ground Level Altitude: 7.4 m +MSD Accuracy: < 0.5 m  
 Driller: McMillan Drilling Ltd  
 Drill Method: Sonic  
 Borelog Depth: 23.9 m Drill Date: 02-Feb-2012

- Standing groundwater was not encountered in our Tetra Tech Coffey HAs.
- Site-specific CPTs indicate a groundwater level between 2.0mbgl and 5.5mbgl. Deepest groundwater was observed in the southwest of the site and shallowing towards the northwest.
- Standing groundwater was measured within the piezometers at the end of the day in CPT\_02 and CPT\_06 to be 2.5mbgl and 3.6mbgl respectively.
- ECan Well M35/18660 measured groundwater to be at ~5.1mbgl in the month of February 2012.

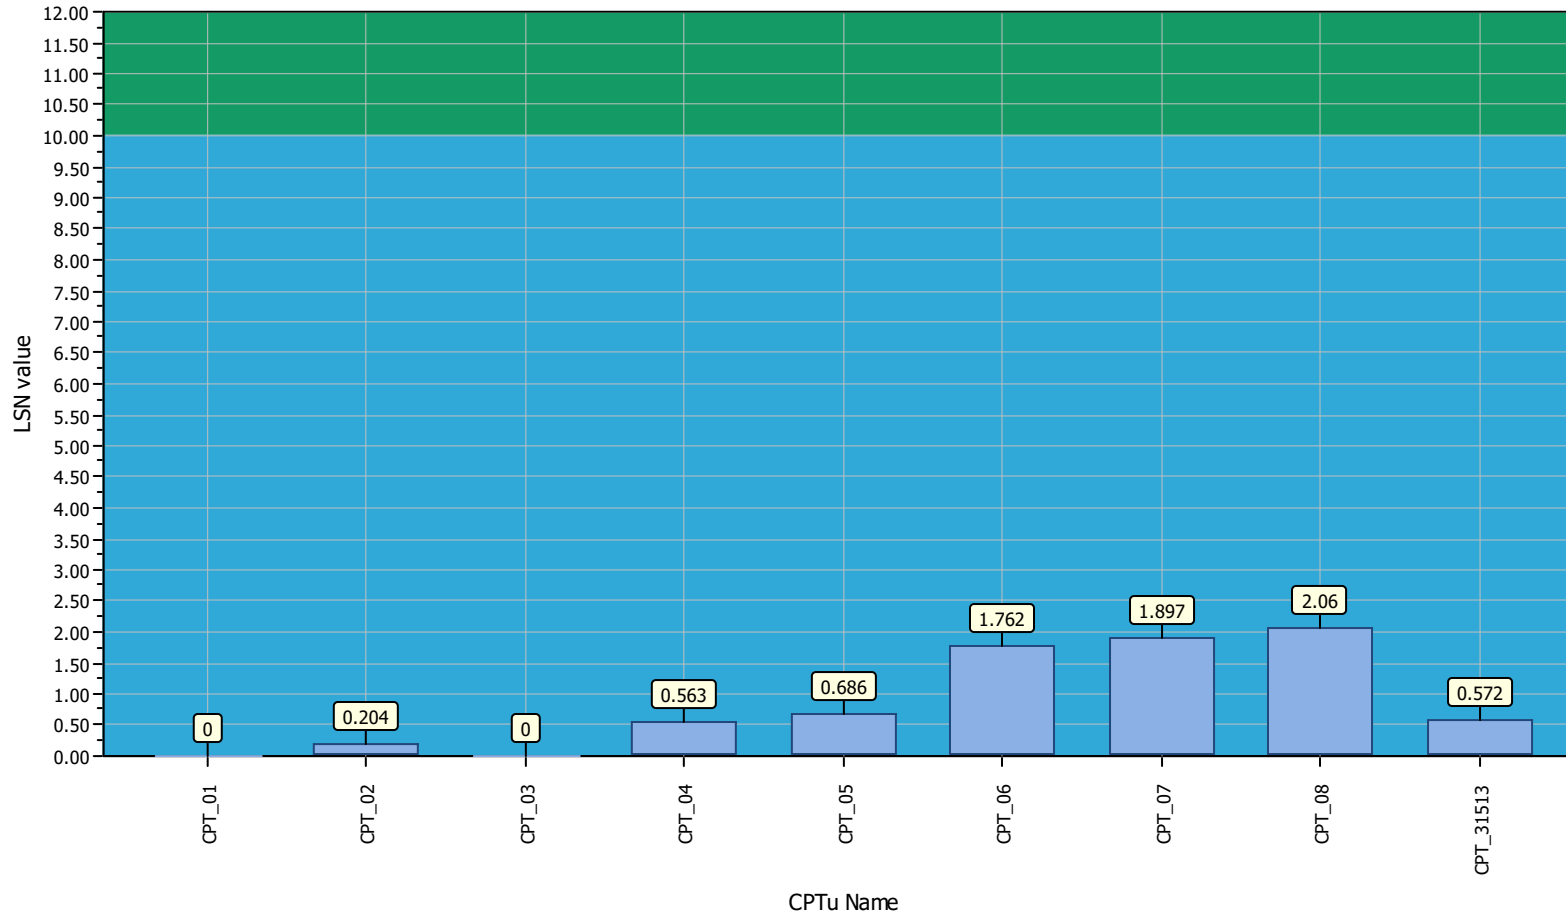
### Overall Liquefaction Severity Number report

Based on our analysis and given that medium dense gravelly sand and very stiff silt to clayey silt, liquefaction susceptibility is considered to be low in future earthquake events. Actual total settlements under SLS or ULS earthquake loading may be greater due to foundation loading. Liquefaction analysis results are presented in Appendix C and summarised in Table 3.
