**Soil Contamination Risk  
Preliminary Site Investigation Report**

**1275 Tram Road, Swannanoa,  
Canterbury**

September 2023

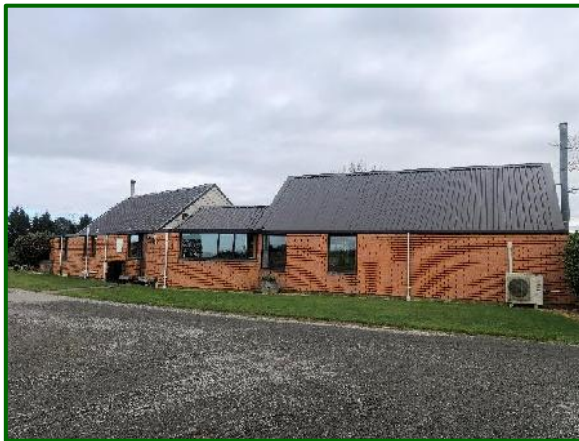
Photo 1 – Dwelling

The majority of the structures on the site are located near the north-east corner of the site. The structures in this area include a modern brick dwelling and two sheds. A metal shed with a dirt floor is currently used to store vehicles, this shed has been visible on aerial photographs since 1995. Minor storage of metal fencing, digger buckets and some containers of Roundup (glyphosate) is occurring around this shed and along the adjacent hedge. A vegetable garden is present at the rear of this shed. The second shed is a modern metal shed with a concrete floor. Minor storage of metal items and water tanks is occurring at the rear of this shed.

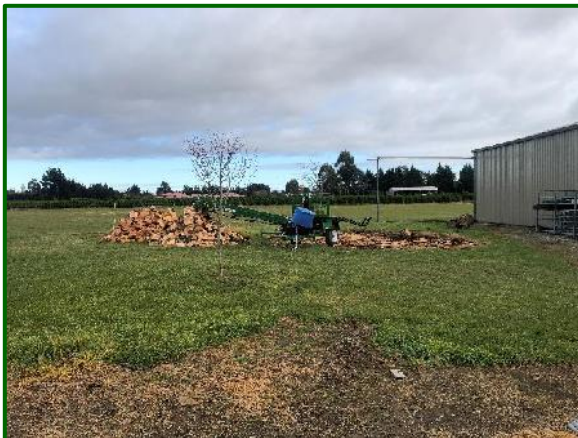
Photo 7 – Firewood processing south of shed

To the south of the modern shed is an area used for processing firewood. Firewood processing is occurring in several locations around the site. Beyond this firewood area, some excavation of soils has occurred to construct adjacent bike jumps. Beyond the bike jumps is a burn pile. Although the majority of the material in the pile was green waste, other non-green waste items were observed.

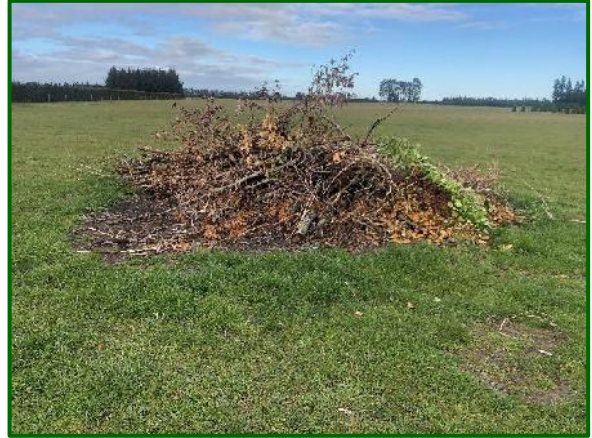
Photo 12 – Burn pile

A burn pile is currently present on the site and non-green waste items were observed within the pile. Contaminants of concern include heavy metals.

Therefore, it is recommended that Detailed Site Investigations, in terms of the Ministry for the Environment’s Contaminated Land Management Guidelines, be undertaken on the identified risk areas prior to development. These areas are shown on the Site Inspection Plans in **Appendix D**.

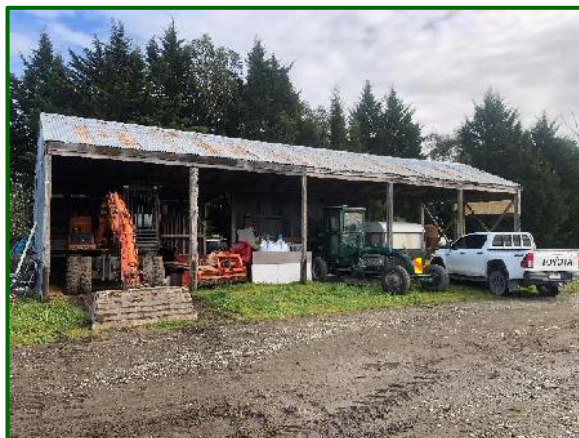
Photo 13 – Shed storing farm machinery & vehicles

The remaining structure on the site is a galvanised iron and timber shed with a dirt floor on the north-west corner of the site. This shed has been visible on aerial photographs since 1955. It is currently used to store farm machinery, a caravan and vehicles. Minor storage of fencing wire, irrigation pipes and other scrap metal is occurring around this shed. Storage of treated timber and some concrete pipes is occurring to the north-west of this shed, along the boundary of the site.

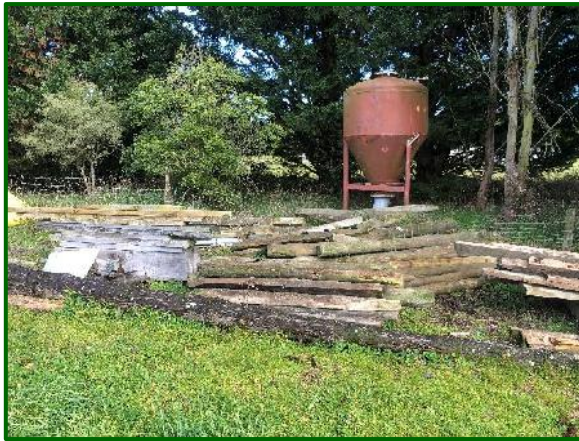
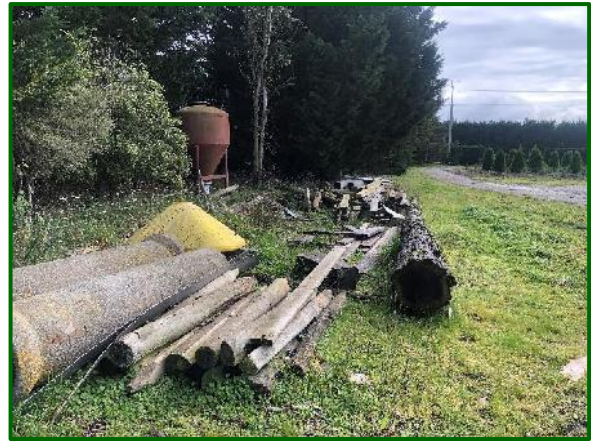
Photos 15 & 16 – Storage of treated timber

Storage of treated timber is occurring on the north-west corner of the site. Leaching of the treatment chemicals may have cause contamination of the underlying soils. Contaminants of concern include heavy metals.

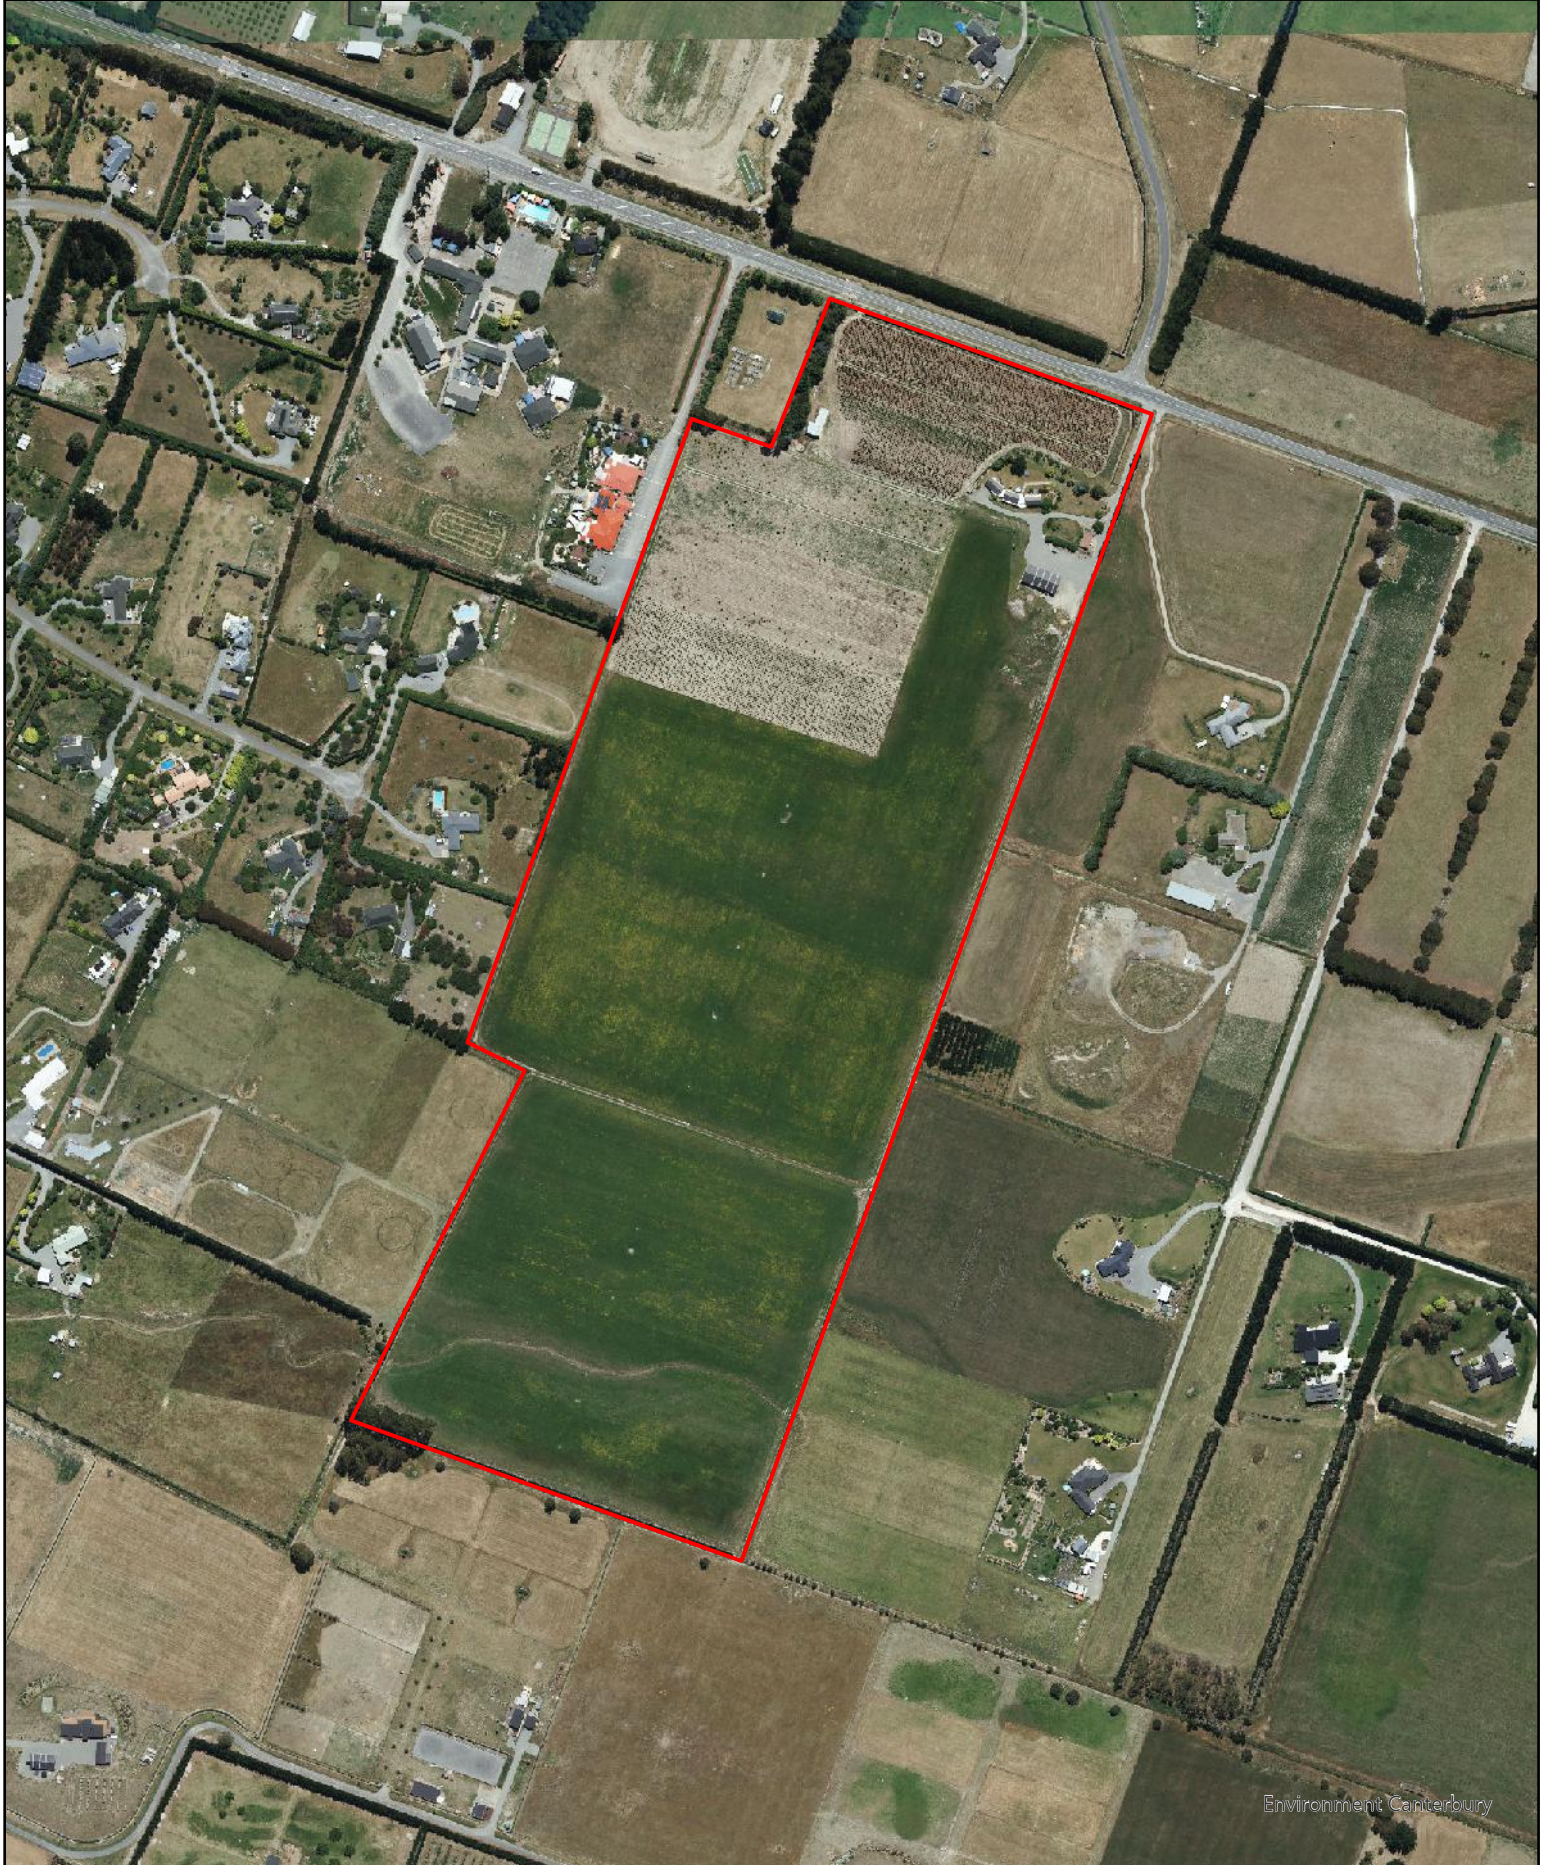
## Appendix D – Site Inspection Plan

An inspection was undertaken on 28 August 2023 to assess the likelihood of soil contamination on the site. A Site Inspection Plan and Risk Area Plan is included in **Appendix D**.
