BEFORE THE WAIMAKARIRI DISTRICT PLAN REVIEW HEARINGS PANEL

Hearing Stream 12E: Rezoning Requests

**FIRST STATEMENT OF EVIDENCE OF MARK TAYLOR
(ECOLOGY)
FOR RICHARD AND GEOFF SPARK
(PDP SUBMITTER 183 / VARIATION 1 SUBMITTER 61)**

Dated 4 March 2024

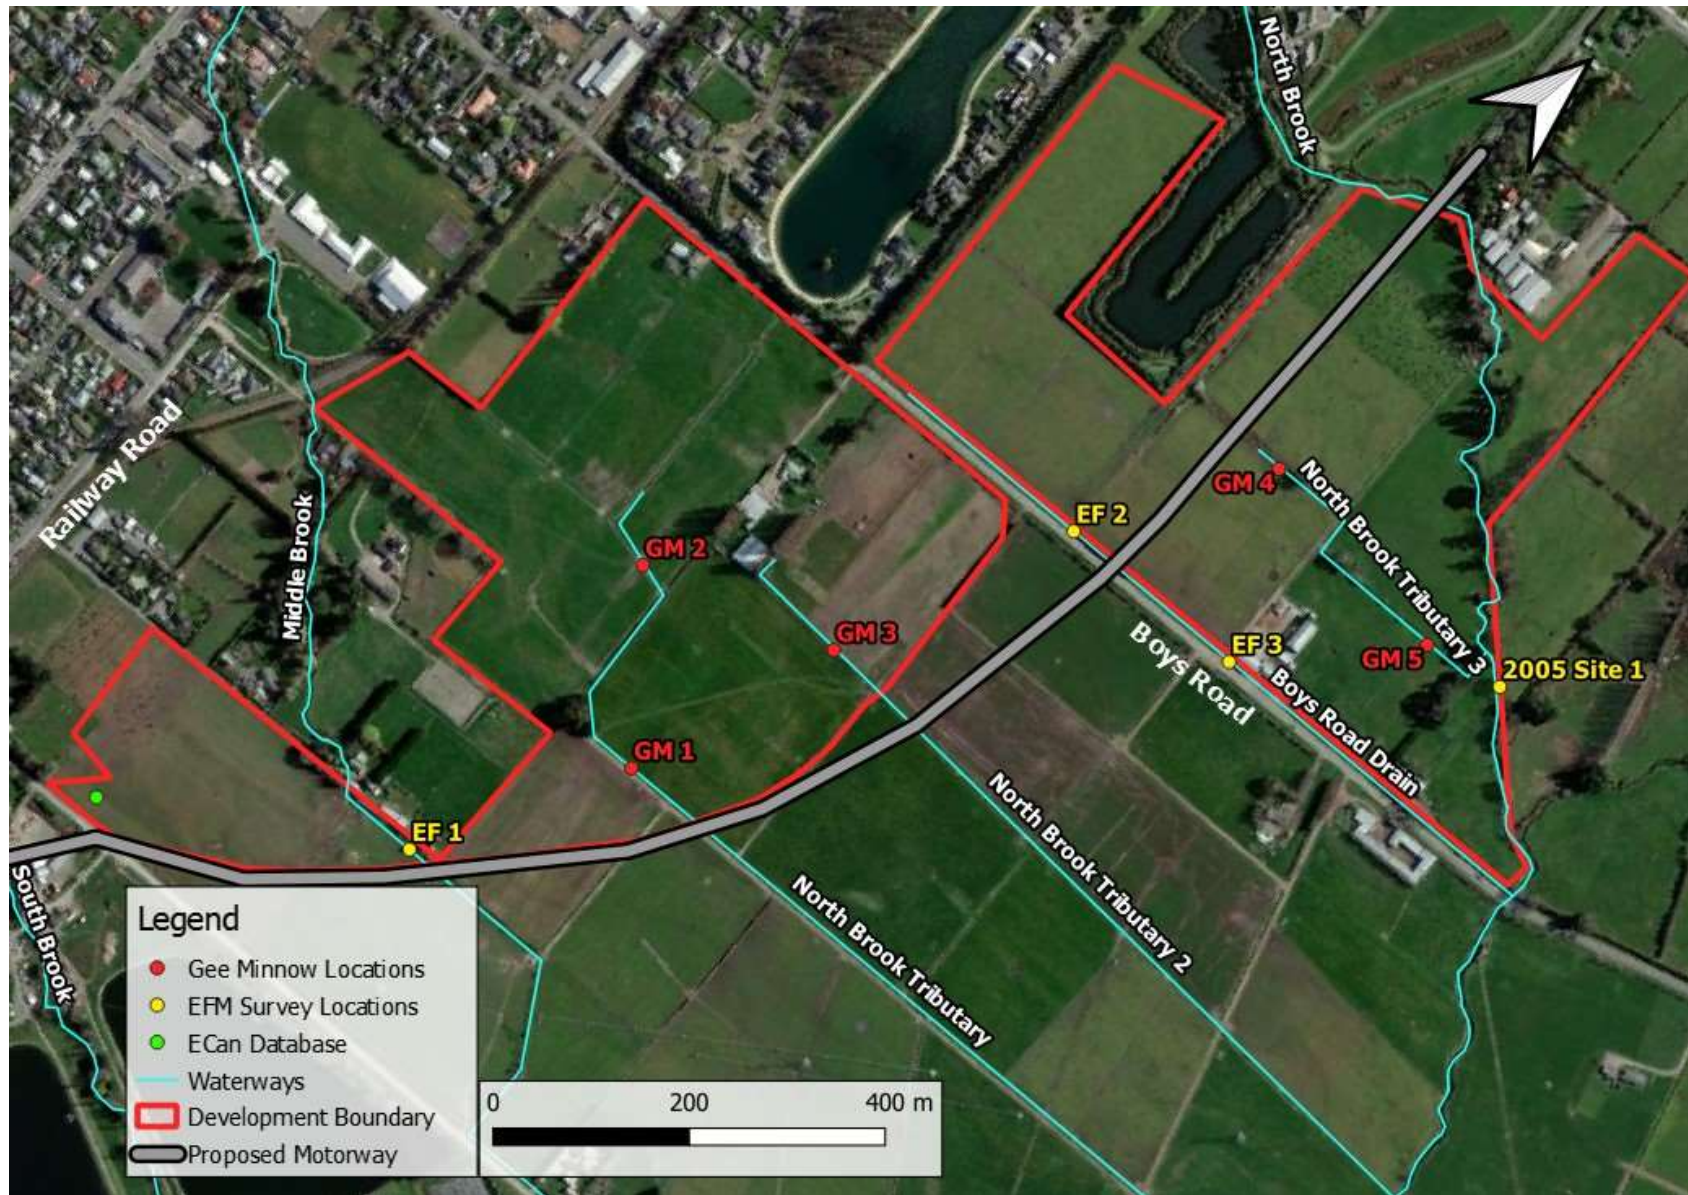
Figure i. A general map of the Proposed Plan Change Area, illustrating fishing locations, by method, and the ECan database location.

23 A map of the Proposed Plan Change Areas (PPCA) is provided in App. I Fig. i, along with some ecology sampling sites which I mention below in my evidence. In its entirety, the PPCA constitutes a significant proportion of the Spark Dairy Farm, with the Plan Change Area estimated at 26.6 Ha North of Boys Road, with a further 29.5 Ha, south of Boys Road. All of the land is pastoralised and flat.

site, labelled as “2005 Site 1” in App. I, Fig. I, was re-surveyed. Also of relevance, but not resurveyed, were two other 2005 survey sites further upstream of the PPCA on the North Brook, and a site on the Middle Brook downstream of the PPCA Marsh Road. In 2005, the survey sites were not chosen randomly, but were selected to provide ecological information on relatively superior habitats for each of the waterways and land use types.

- 38 The locations of 2023 fishing sampling sites are depicted in App. I, Fig. i These consist of three shallow electric fishing sites, one in the Middle Brook (EF1) and two on Boys Road Drain (EF 2, 3). In addition, five drain-like habitats, which traversed the PPCA area, were fished with baited traps Gee Minnow traps (labelled as GM 1-5 in App. Fig. i) on tributaries of the North Brook.

- 41 The lack of juvenile lamprey at the North Brook site was disappointing, given they were present in number in 2005. However, 3 juveniles (i.e. ammocoetes) of this primitive 'fish' were recorded in the Middle Brook at Site EF1 (App. I, Fig. i), so lamprey spawning

- 48 One site on the Middle Brook was fished (Site EF1 in App. I, Fig. i). Juvenile lamprey were recorded there. Lamprey were also recorded there in 2005, so it is highly likely lamprey spawning still occurs there. Like the North Brook, upland bully and shortfin eel were also present.

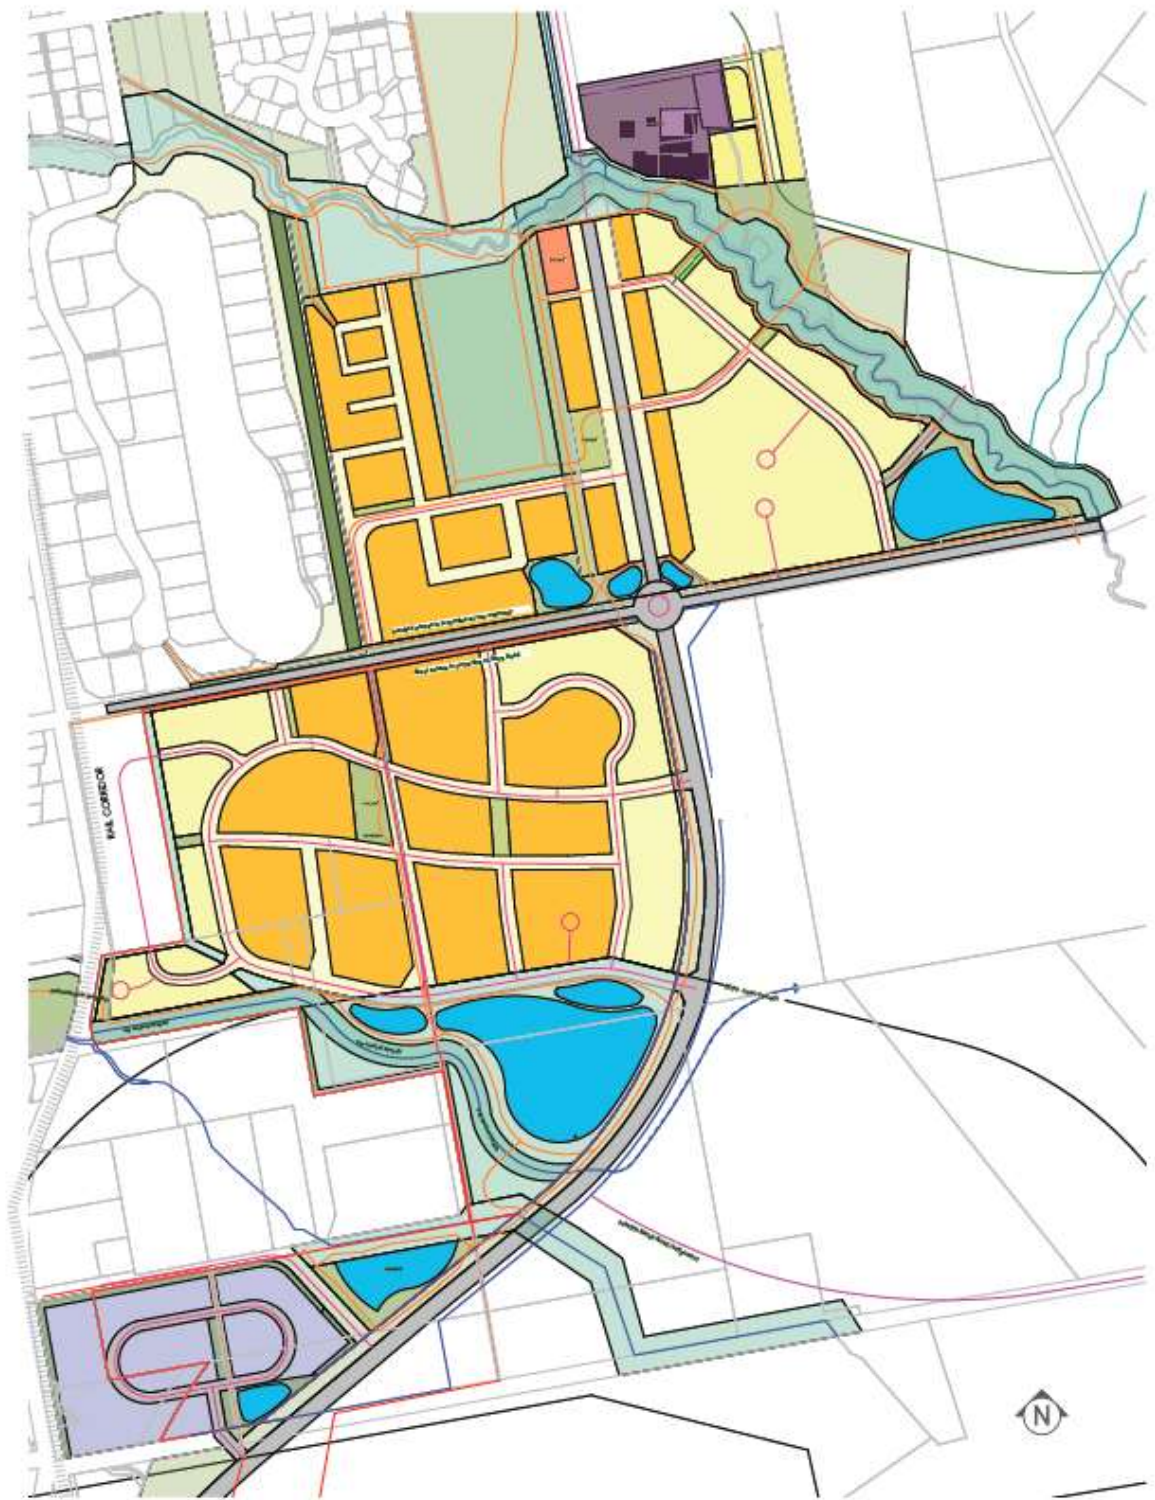
sheet 00

Figure ii. Overall Development Plan, Blocks A, B & C (Version 29).

26 The draft proposed Outline Development Plan (ODP, Ver. 29) is presented in App. I, Figs. ii-v. The Applicant's Urban Designer, Nicole Lauenstein, will talk to her Plan in detail, but the main ecological features include ecologically significant riparian strips composed of a largely continuous sward of native plants. For Block A, a notable ecological advantage is the potential extension of the ecological corridor along the North Brook to the North Brook wetlands to the north, as seen in App. I, Fig. iii. In addition, the Middle Brook ecology will benefit from an ecologically significant riparian strip which will link mature copses of trees south of Marsh Road, to their counterparts and riparian strips on the properties of 2 & 10 Dunlops Road.

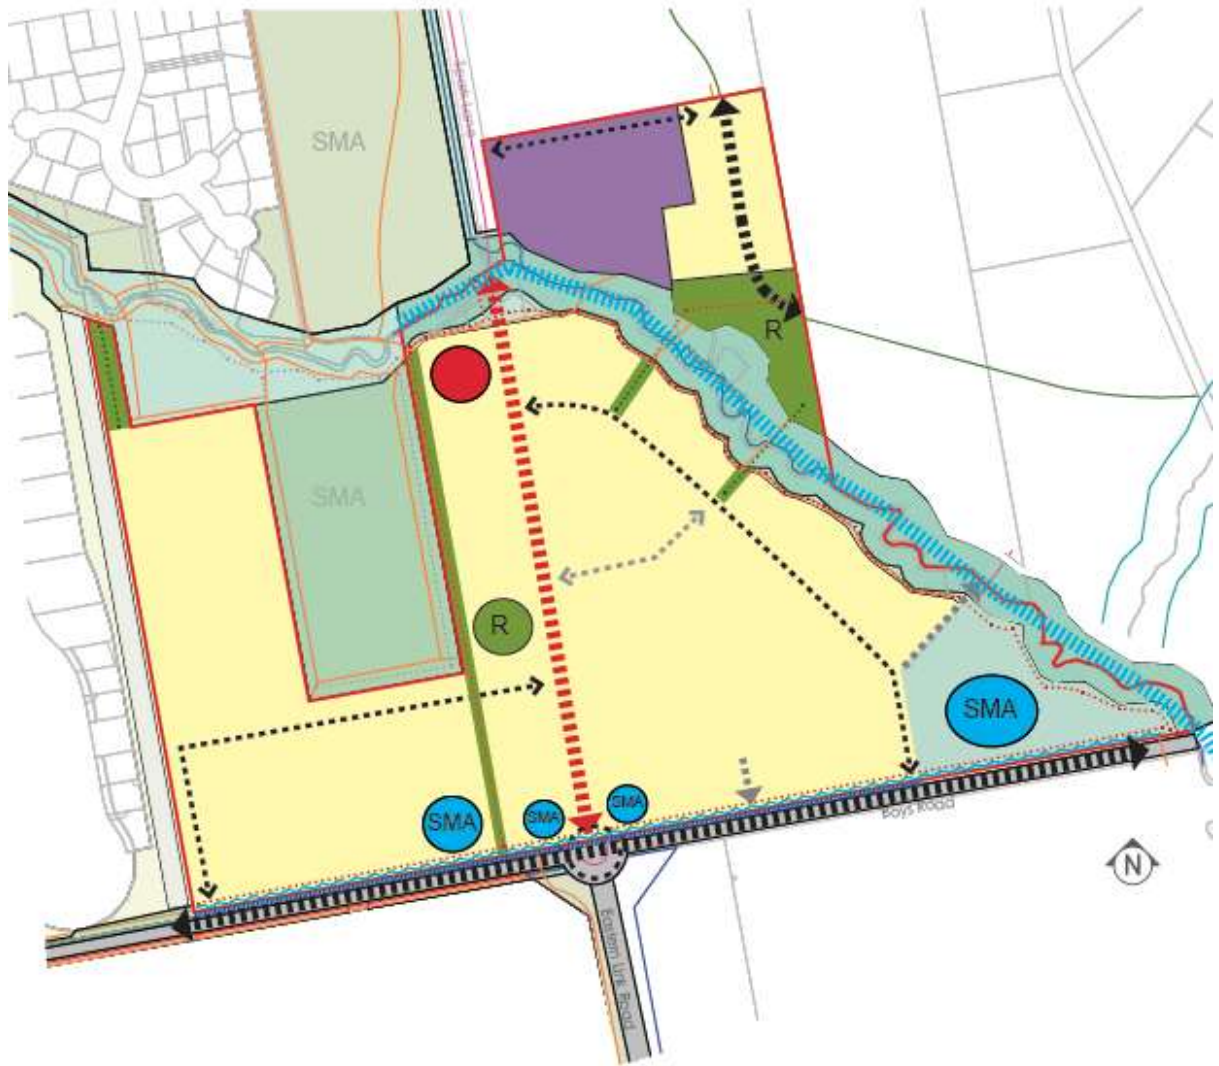
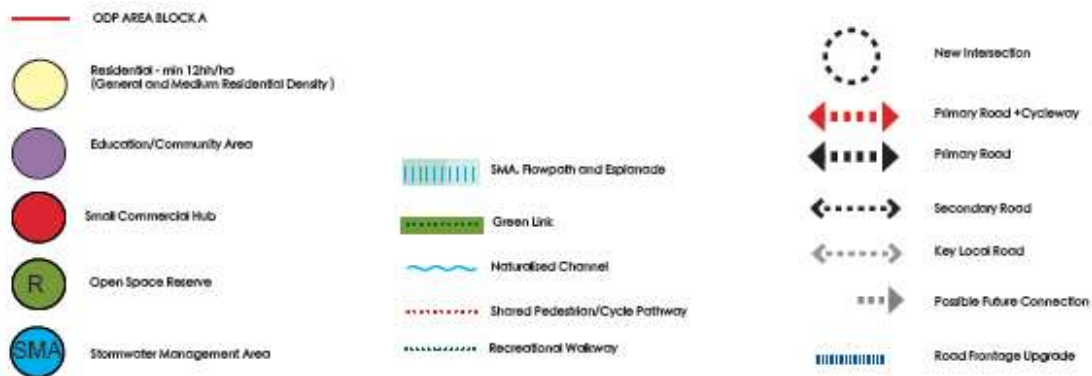
Figure iii. Sparks Development Plan, Block A only (version 29).

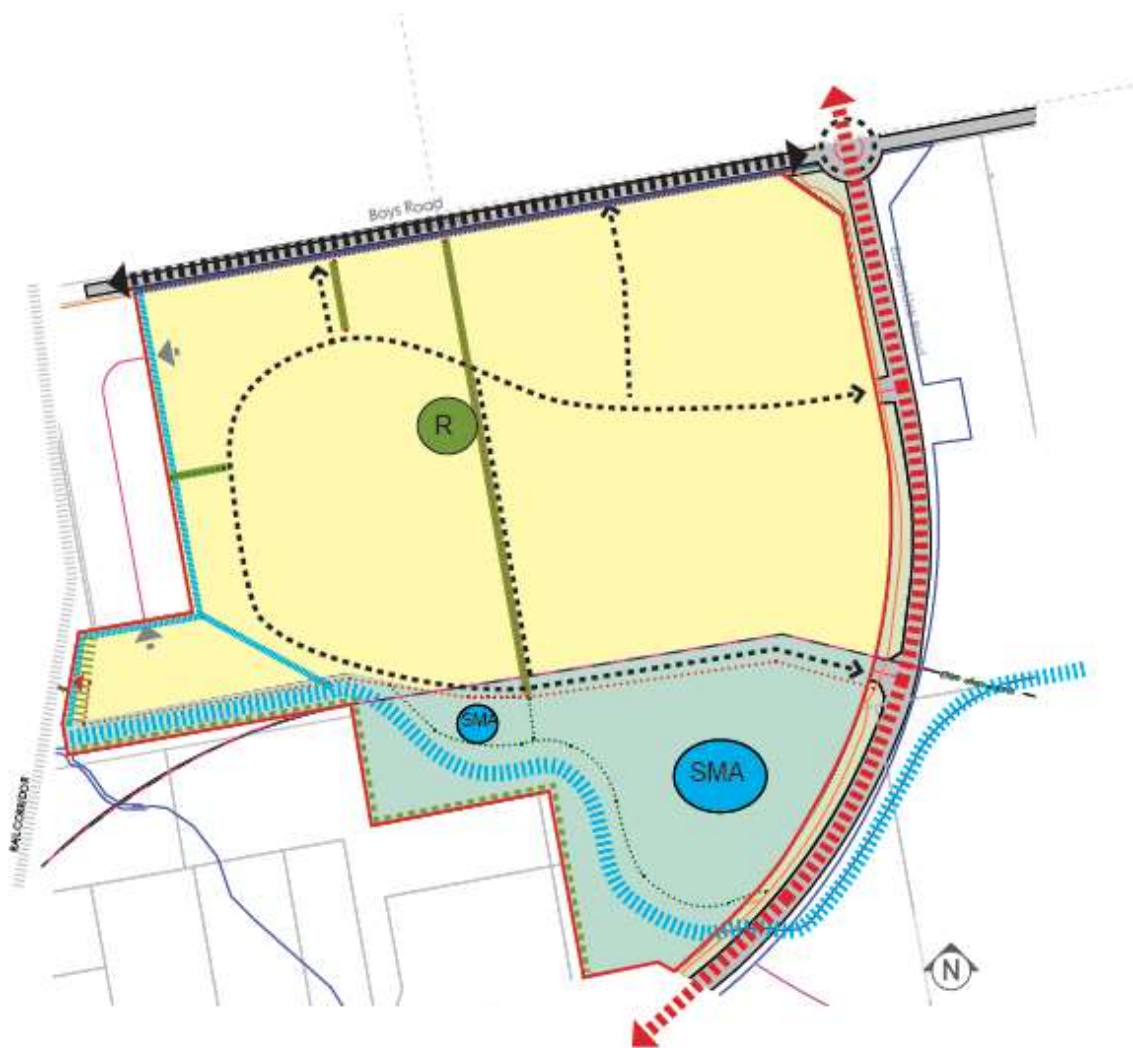
Figure iv. Sparks Development Plan, Block B only (version 29).

been integrated into the ODP and will align with the development setback around the reserve area in App. I, Fig. iv.

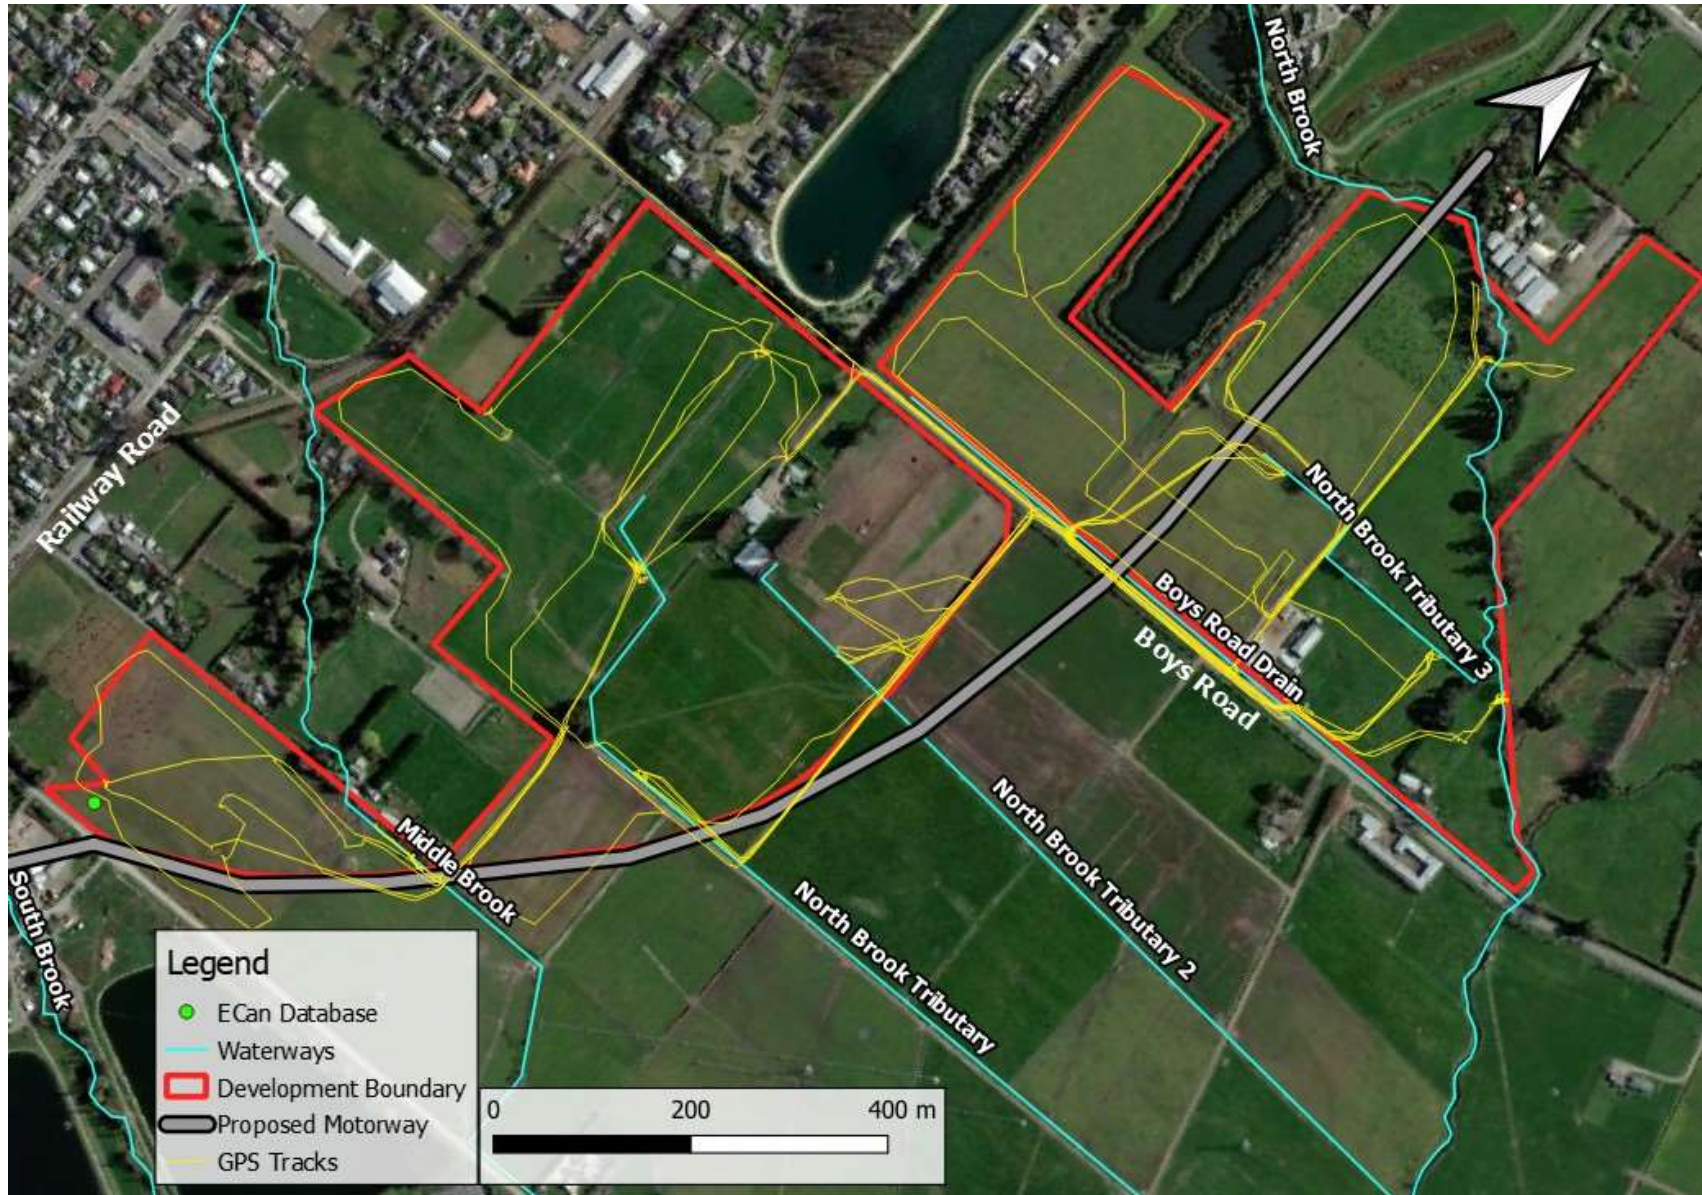
APPENDIX II. Figure i. The survey course (yellow track) to identify isolated wetlands in the PPCA.

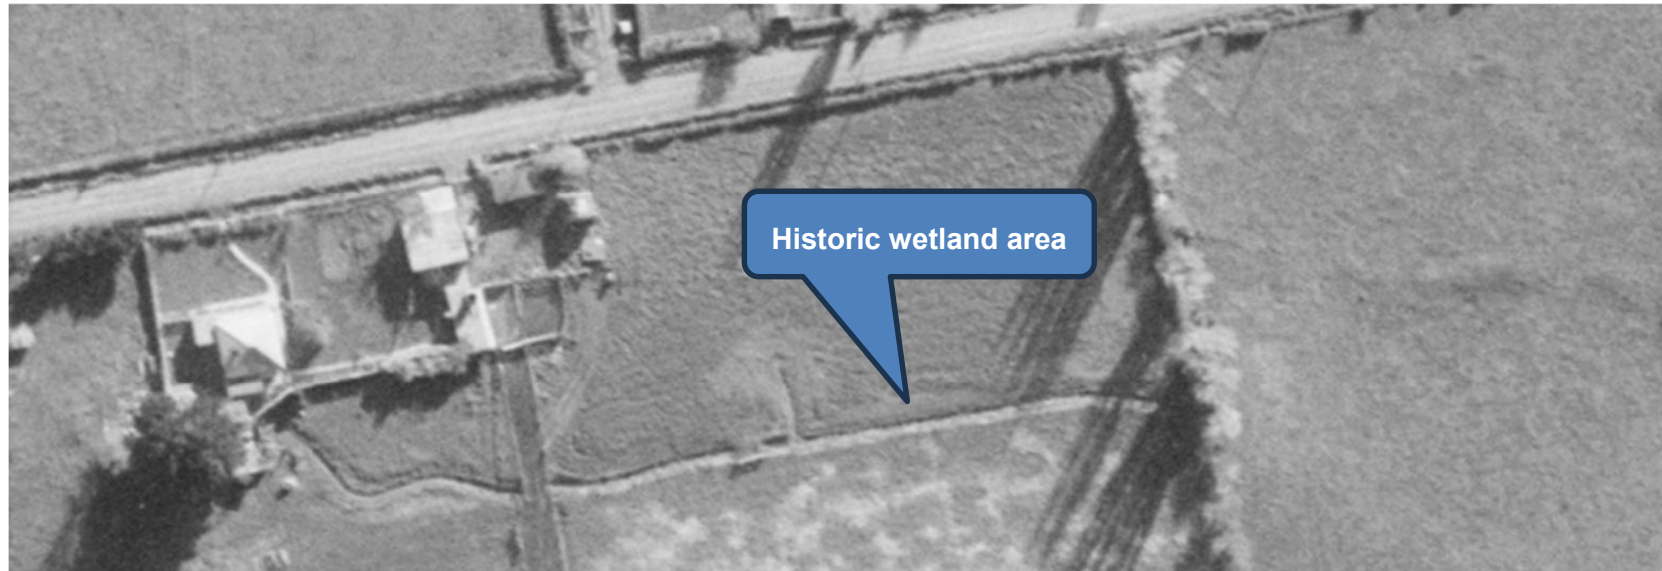
Figure ii. Wetland aerial (Canterbury Maps (1960-1964), on the property of 281 Boys Road.

- 72 As reported before, there is a natural inland wetland south of Boys Road, which is discernible in historic (1960-1964) imagery in Canterbury Maps (App. II, Figs. ii, iii). This is described in the background report to my evidence. While currently invaded by exotic weed species, especially willow weed, some native wetland rushes were present, including *J. pallidus*, and the sedge *Carex virgata*. With setback and protection, there is scope for this habitat to be naturalised and restored. This area has

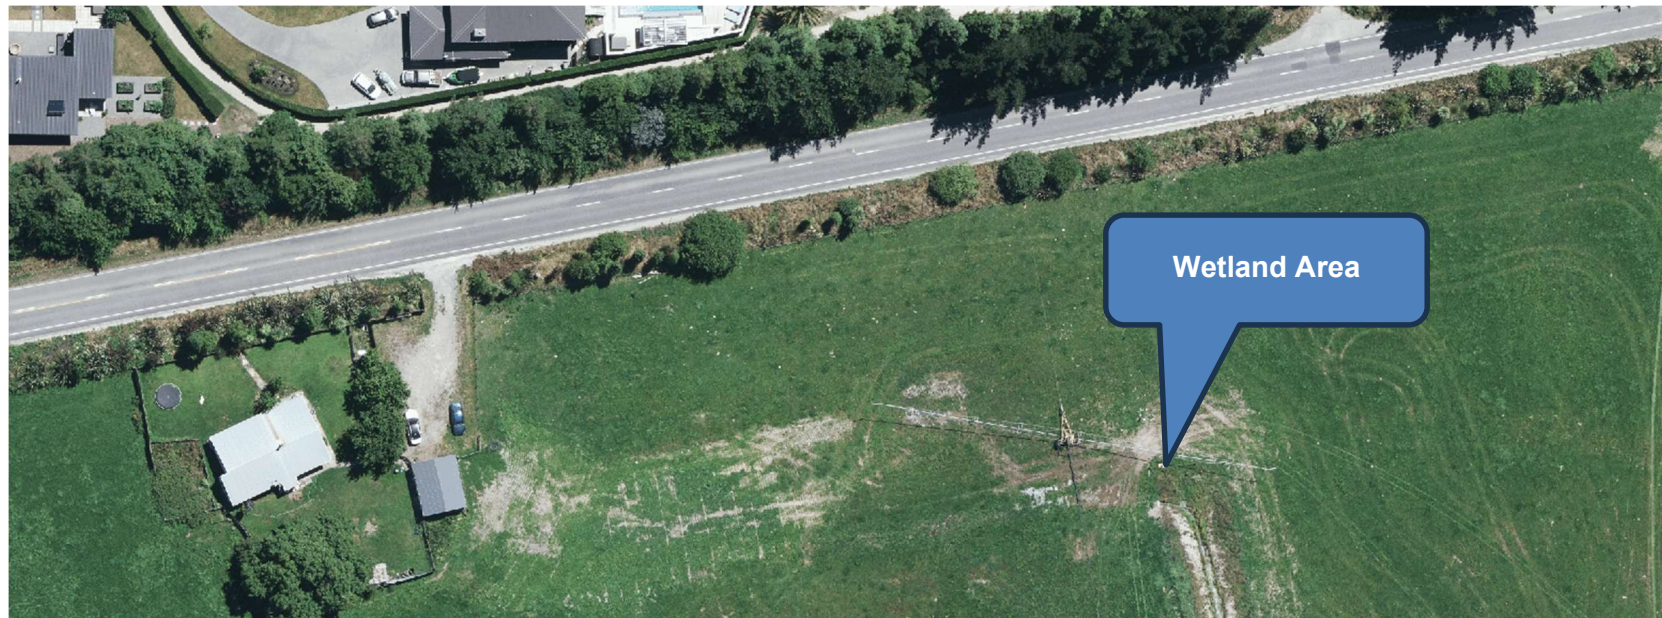
Figure iii. Wetland aerial (Canterbury Maps "recent imagery") on the property of 281 Boys Road.
