Wetland Delineation of Proposed Woodend Development, Woodwater Limited/ Urban Estates

Introduction/Proposal

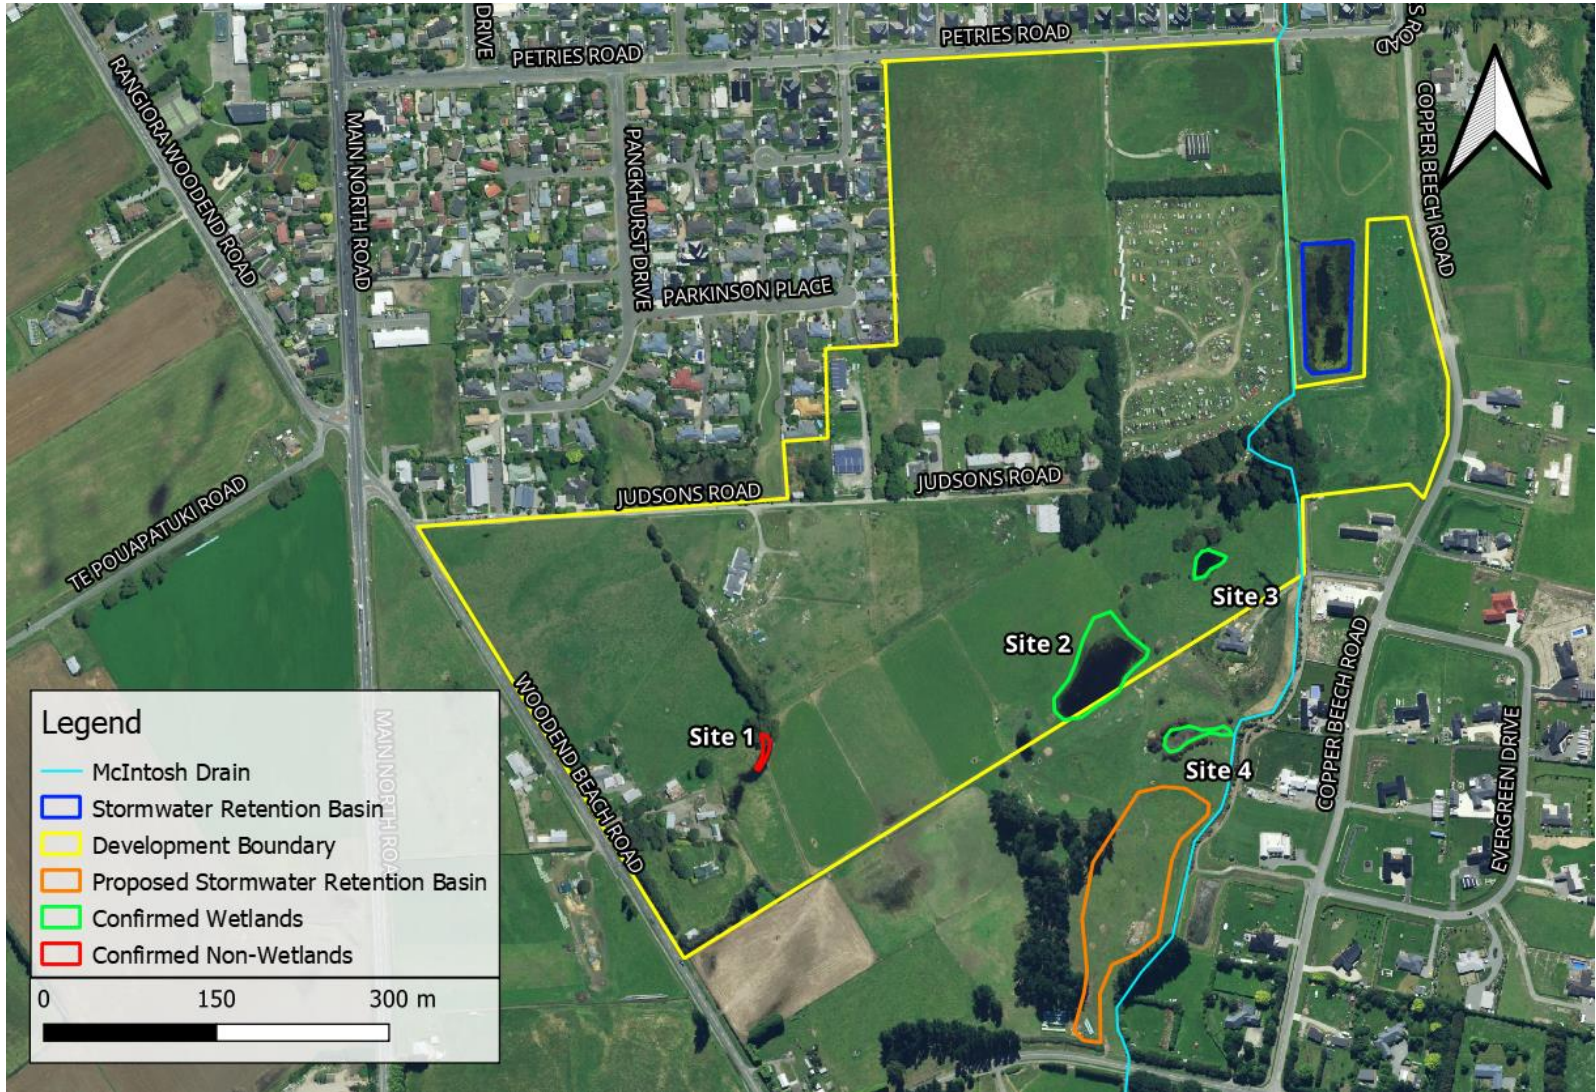
Figure i. The proposed development area, and field-delineated wetland habitats.

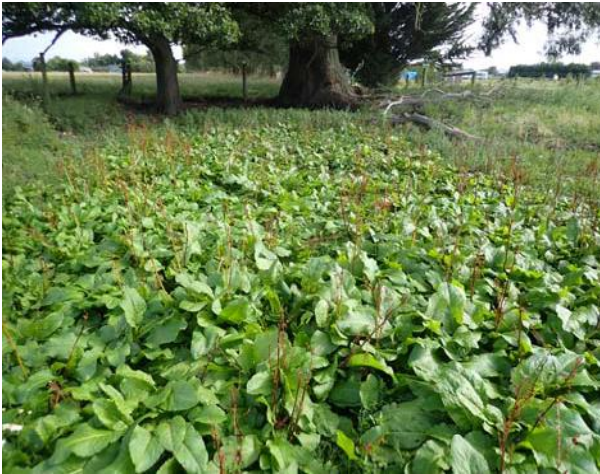
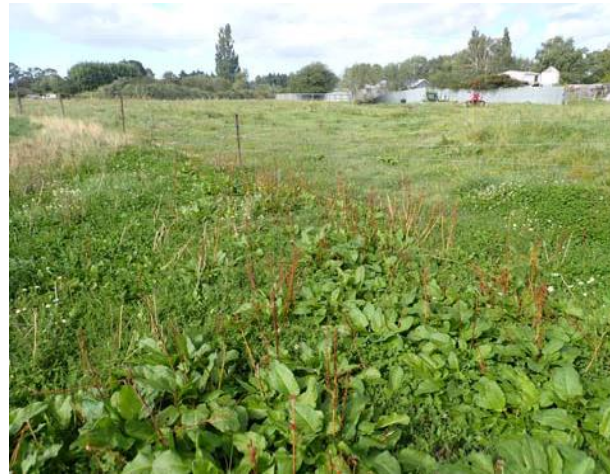
The assessed area was located in a ground depression, with vegetation that differed from the surrounding pasture grass. Site 1 did not contain surface water at the time of survey (App. II, Figs. i, ii). However, recent aerial imagery indicated Site 1 can retain surface water, presumably following rain or high groundwater levels (Google Earth, imagery dated 17/12/2021).

The dominant flora species in this wetland was the facultative broadleaf dock (*Rumex obtusifolius*) (App. III, Table i). The prevalence of this species meant the results of a wetland vegetation assessment were inconclusive. The hydric soil assessment was also inconclusive. Loam soil was observed to a depth of 40 cm, with no mottles observed and an overall low moisture content.

Based on the historical online imagery, Site 1 was not inundated frequently enough in recent aerial imagery to be considered a wetland. Only 4 of a total 34 aerial images taken between 2004 and 2021 depicted Site 1 as inundated, the remaining 30 images clearly depict the area as dry (Google Earth imagery). Only one secondary hydrology indicator, geomorphic position, was met by this survey area. The FAC-neutral test, in the wetland hydrology protocols, was also considered inconclusive, as only 1% of flora coverage was not facultative (willow weed, facultative wet). Wetland hydrology was therefore not present. Site 1 was excluded from the definition of a wetland under the RMA 1991 and NPS FM 2020 definitions.

It is noted that Site 1 appears to be the lower reach of a historic natural channel, with the upper reach decommissioned prior to 1963 (Retrolens). This likely contributes to the naturally dry nature of Site 1, and a wetland reinstatement at this location is not considered possible.

Figure i. Site 1, looking north.

Figure ii. Site 1, looking south.

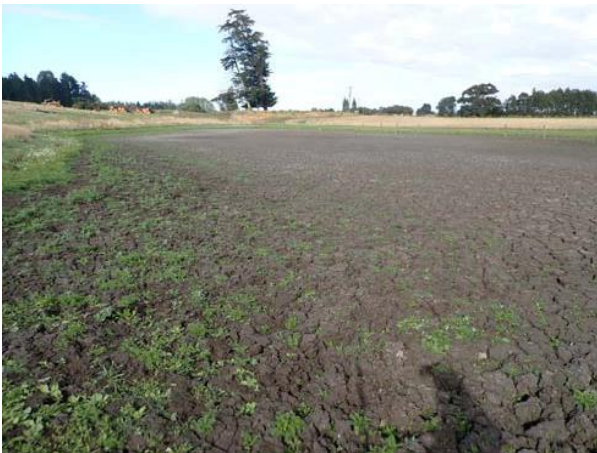
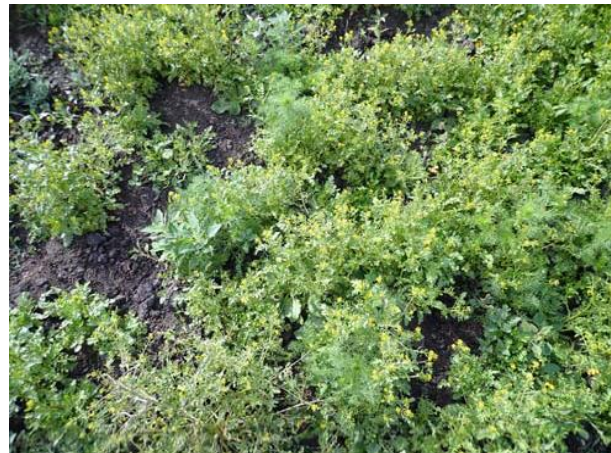
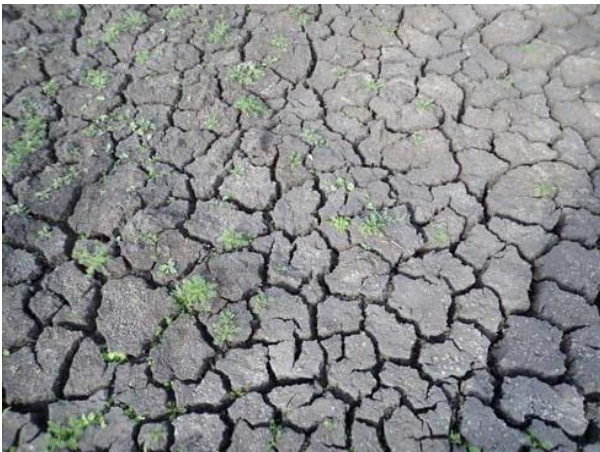
Site 2 did not contain surface water at the time of survey. This was a large, sparsely vegetated area, with deep cracking observed in the surface sediment throughout the site (App. II, Figs. iii - v). The site is known to retain surface water for approximately three months of each year, especially likely during winter (Andy Hall, DLS, pers. comm.).

The dominant flora species in the riparian zone of Site 2 was the obligate marsh yellowcress (*Rorippa palustris*) (App. III, Table i), and a vegetation assessment conducted in the riparian zone concluded that Site 2 was defined as a wetland under the RMA 1991 definition. However, it is noted that the deep cracking recorded in Site 2 is indicative of shrink-swell clays, and therefore does not imply the presence of a wetland (Indicator 2F in Ministry for the Environment 2021). Only one primary indicator of wetland hydrology was met, sparsely vegetated concave surface, along with two secondary hydrology indicators, geomorphic position and the FAC-neutral test.

Surface water is visible in Site 2 in the earliest aerial imagery accessible, taken in 1942. The site does not show signs of modification or artificial construction, and Site 2 is therefore defined as a natural inland wetland under the NPS FM 2020 definition. However, this highly ephemeral wetland does not provide habitat for fish fauna, and would likely only facilitate short-lived aquatic macroinvertebrates such as non-biting midges, mosquitos, and encysting micro-crustacea. The high sand content in the substrate means the wetland area has a high level of drainage, and native wetland plants such as *Juncus* sp. are unlikely to thrive in this location.

Figure iii. Site 2 overview.

Figure iv. Site 2 riparian vegetation, dominated by marsh yellowcress

Figure v. Deep cracking of sediment at Site 2.

The ecological values of the wetlands at Site 2 and Site 3 were low, and unlikely to be improved through protection, buffer strips or native planting. The well-drained nature of Site 2 means native wetland plants are unlikely to grow well, and the wetland status of Site 3 appears to be tied to the presence of an irrigator, which will be removed as a consequence of land development. These wetlands are therefore not good candidates for retention or improvement. Under Rule 45C of the NES-F 2020 (Ministry for the Environment 2020), earthworks within a natural inland wetland for the purpose of urban development is a discretionary activity. The wetlands at Site 2 and Site 3 could therefore potentially be decommissioned with consent from Environment Canterbury.

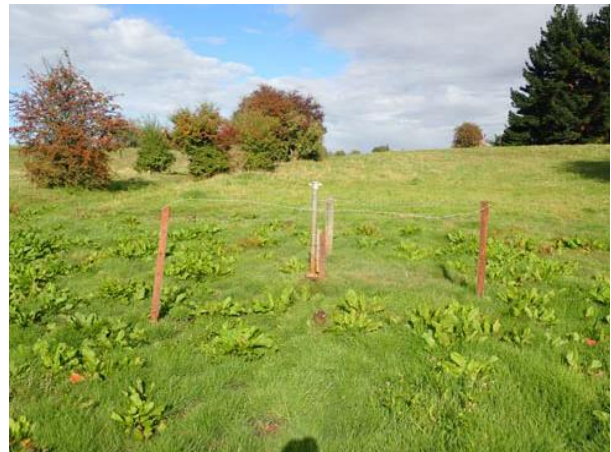
At the time of survey, Site 3 did not contain surface water. This site surrounded an irrigation device (App. II, Fig. vi), and the presence of wetland plant species may have been partially caused by leaking underground pipes. No flow or surface water connectivity was observed during the site visits.

Vegetation in the assessed area at Site 3 was dominated by, in order of abundance, marsh foxtail (*Alopecurus geniculatus*), broadleaf dock (*Rumex obtusifolius*) and willow weed (*Persicaria maculosa*) (App. III, Table i). Both marsh foxtail and willow weed have wetland indicator statuses of facultative wetland, and broadleaf dock is considered facultative. Therefore, this area passed the wetland vegetation assessment and was defined as a wetland under the RMA 1991 definition.

Most of the historic aerial imagery available for this location, excluding the most recent (2021) imagery, depicts Site 3 as dry. However, the presence of wetland-specific flora indicates the site may have remained damp for extended periods in recent years. This is likely due to the irrigator located within the assessed wetland area. This means Site 3 is defined as an induced wetland under the NPS FM 2020 definition, as it was likely created as a result of anthropogenic modification. An induced wetland has the same legal status as a natural inland wetland in the NPS FM 2020. For ease of understanding, this site has therefore been depicted as a natural inland wetland in this memorandum.

Figure vi. Site 3, showing the irrigator within the wetland area

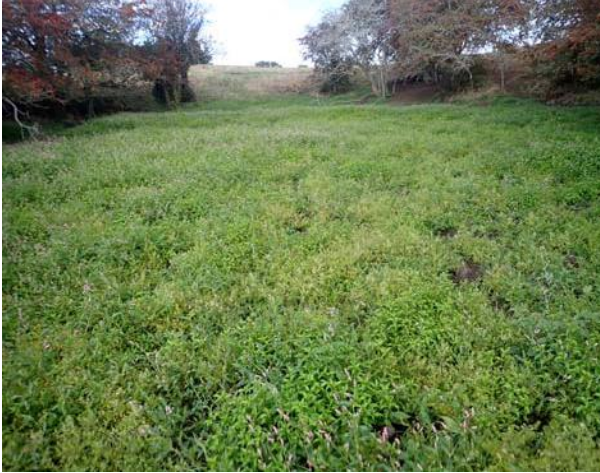
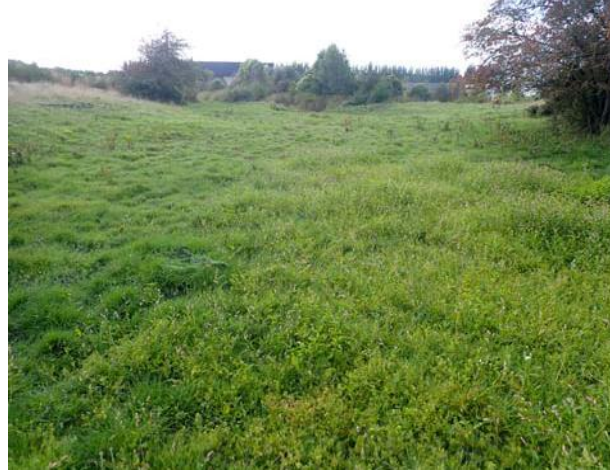
Site 4 did not contain surface water at the time of survey (App. II, Figs. vii, viii). However, when surface water was present during wet periods, this site was likely directly connected to the nearby McIntosh Drain. Vegetation at Site 4 was dominated by willow weed, marsh yellowcress, and marsh foxtail (App. III, Table i). Willow weed and marsh foxtail have facultative wetland indicator statuses, and marsh yellowcress is considered obligate. Site 4 therefore passed the vegetation tests, and was considered a wetland under the RMA 1991 definition. Historic aerial imagery indicates this wetland habitat is naturally occurring, and is therefore a natural inland wetland under the NPS FM 2020 definition.

Figure vii. Site 4, looking west.

Figure viii. Site 4, looking east toward McIntosh Drain

However, the ephemeral wetland at Site 4 could improve significantly in ecological value following protection and native planting. This wetland area is naturally occurring, and has connectivity to the nearby McIntosh rain during wet periods. Improvements to this wetland could include the removal of all exotic trees, to be replaced with native tree and shrub species such as harakeke (*Phormium tenax*), *Austroderia toetoe*, *Hebe salicifolia* and cabbage trees (*Cordyline australis*). The possibility of a covenant on this wetland area has also been suggested, to ensure the longevity of this ephemeral habitat (Andy Hall, DLS, pers. comms.).

- The decommissioning of wetlands at Sites 2 and 3 could be sufficiently offset by the improvement of wetland and aquatic habitat at Site 4 and the McIntosh Drain riparian zone.
- Site 4 – surrounding exotic trees should be removed and replaced with native riparian species.
- If permanent or near-permanent surface water is expected in the proposed new southern stormwater retention basin, this should be planted with native wetland plants, and should be accessible for fish via McIntosh Drain.
