URS Report: Taerutu Gully – Discharge of Water,
Contaminants, and Stormwater

Taerutu Gully - Discharge of Water, Contaminants, and Stormwater

23 AUGUST 2011

Prepared for
Pegasus Town Limited
PO Box 78001
Pegasus 7648
42180147

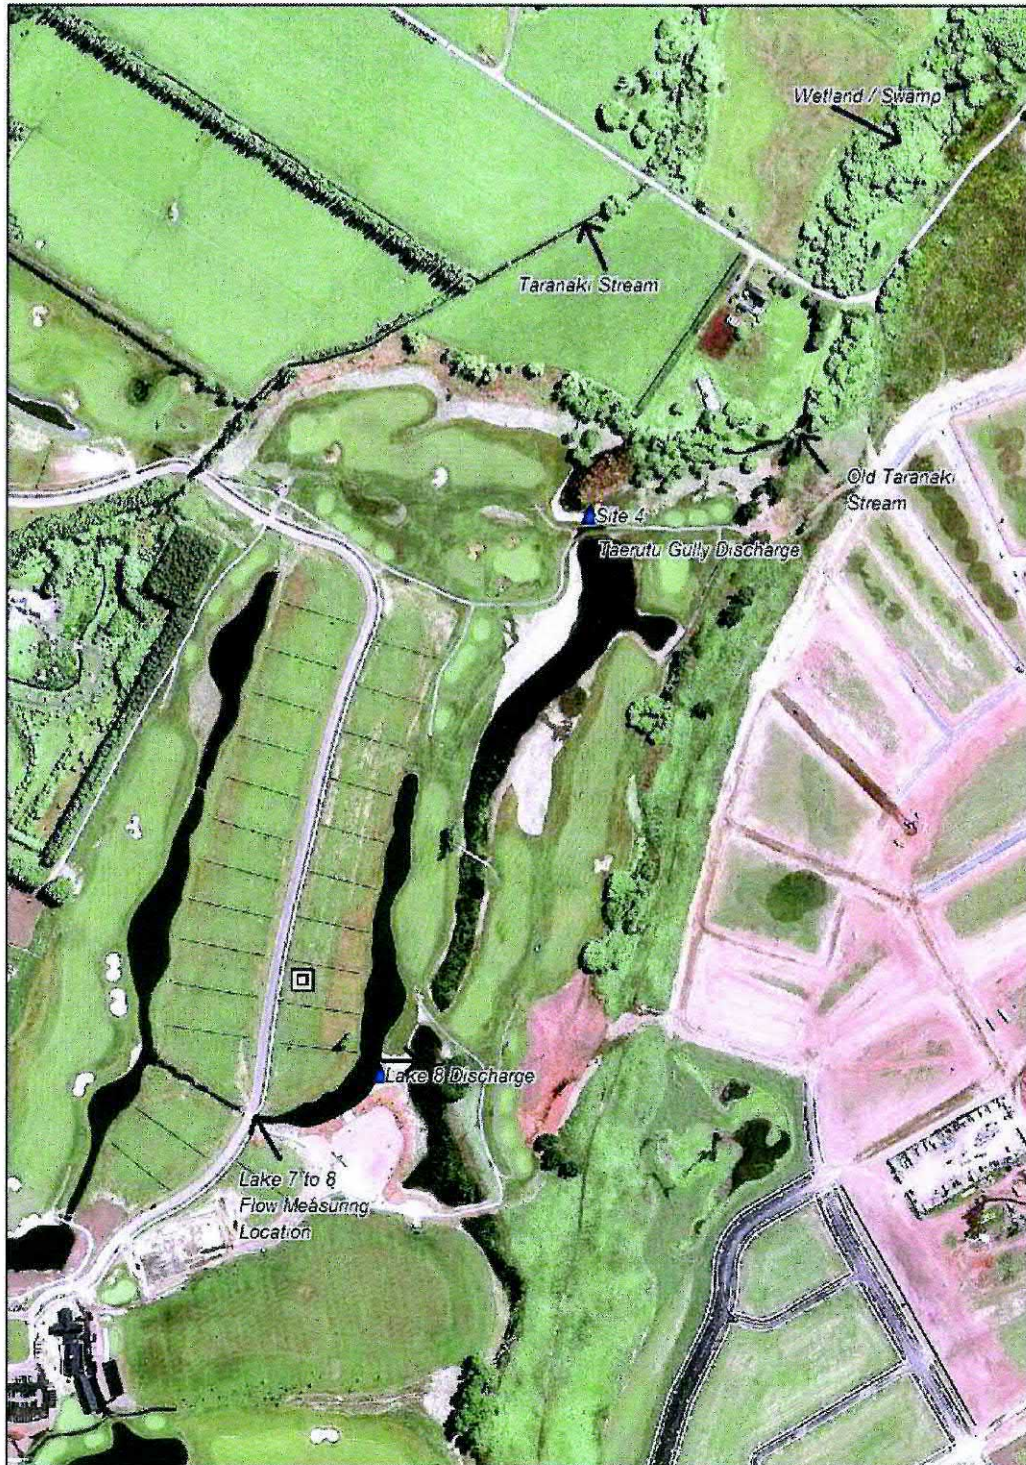
Figure 2-1 Location of lake and gully discharge points (Image Source: Google Maps)

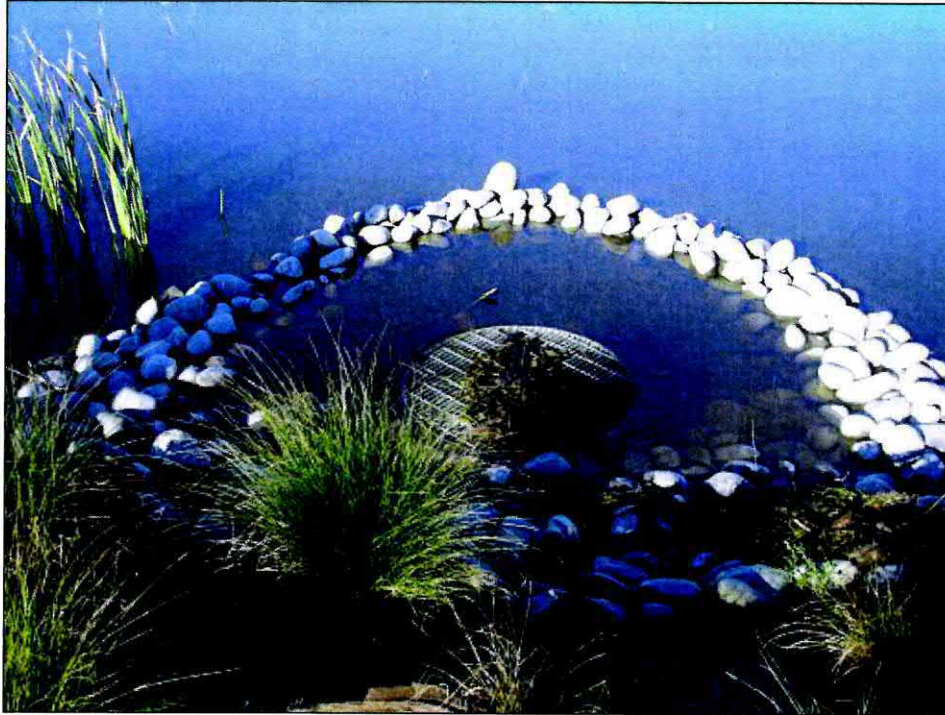
Plate 2-1 Orifice weir which discharges from Taerutu Gully to old Taranaki Stream

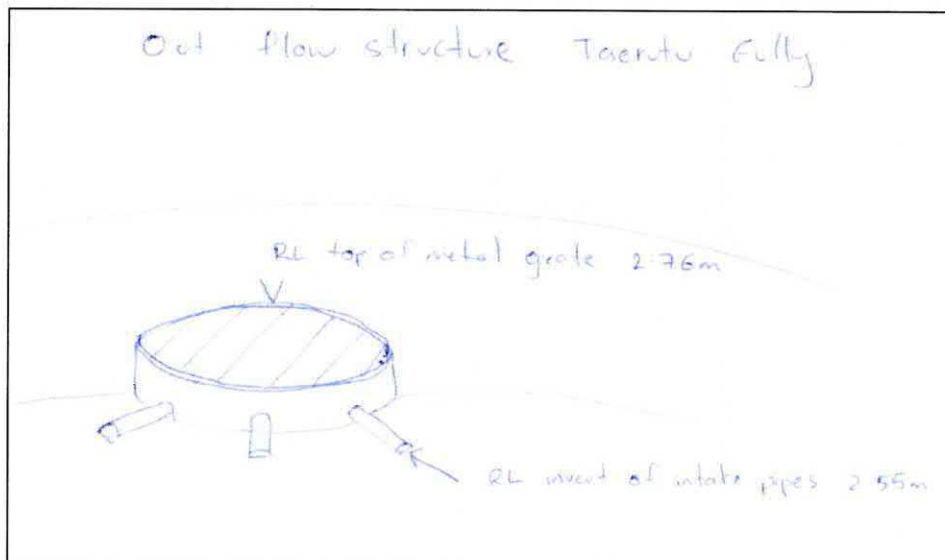
Figure 2-2 Schematic of Orifice Weir construction

The orifice weir is connected to a horizontal culvert of ~300 mm. The culvert runs under the constructed earth bund which has formed Taerutu Gully over a length of approximately 20 m. The culvert conveys water from Taerutu Gully to a receiving basin which has been formed in the old

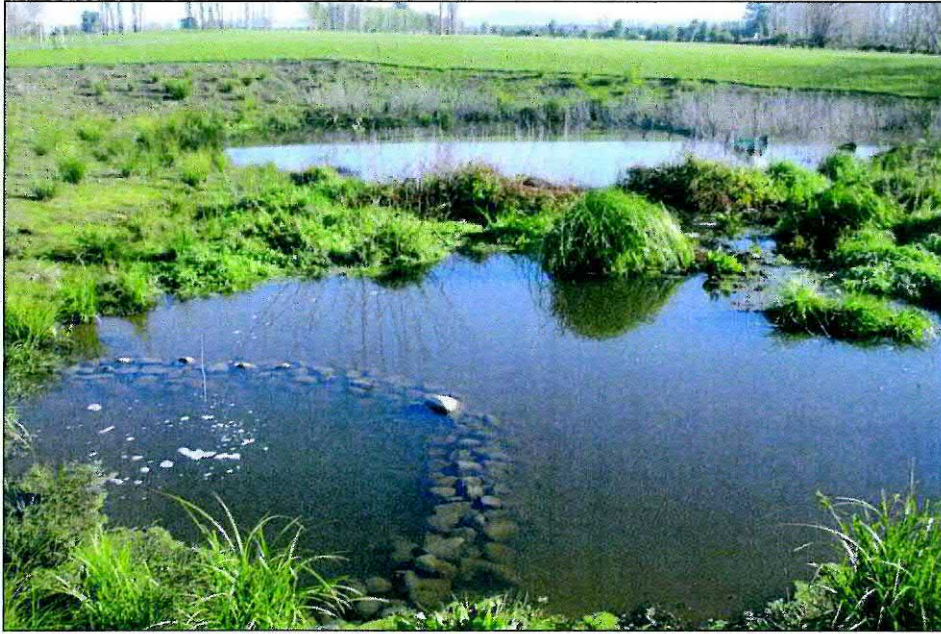
Taranaki Stream. A rock filter is used to further limit the movement of debris from the discharge to the receiving environment (Plate 2-2). A secondary filter screen is also used to capture any debris contained in the discharge (Plate 2-2).

Plate 2-2 Taerutu Gully to old Taranaki Stream discharge, rock filter, and fabric filter

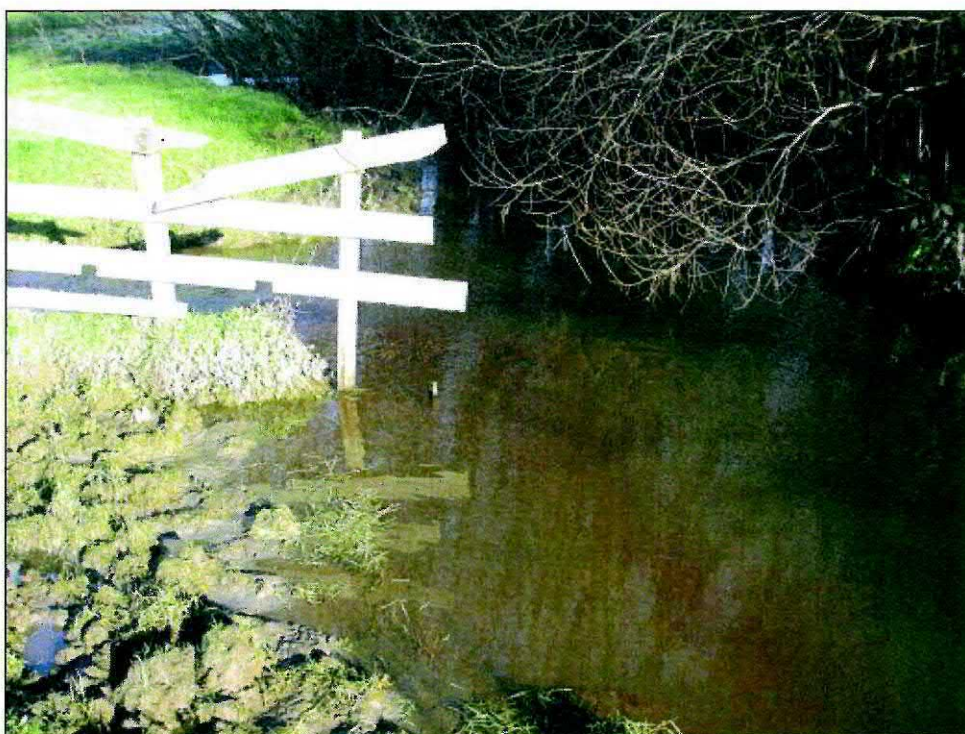
Plate 2-3 Taranaki Stream - downstream of confluence with old Taranaki Stream (June 2010)

Taranaki Stream river bank is lined with willows. The banks of the creek are affected by stock trampling, with a number of areas upstream and downstream of the confluence showing signs of stock induced bank erosion (Plates 2-3 and 2-4). The bed of Taranaki Stream is characterised by a layer of fine silt/clays which are not consolidated, both upstream and downstream of the confluence of the old channel. Taranaki stream discharges into the Ashley River, which in turn discharges into the ocean.

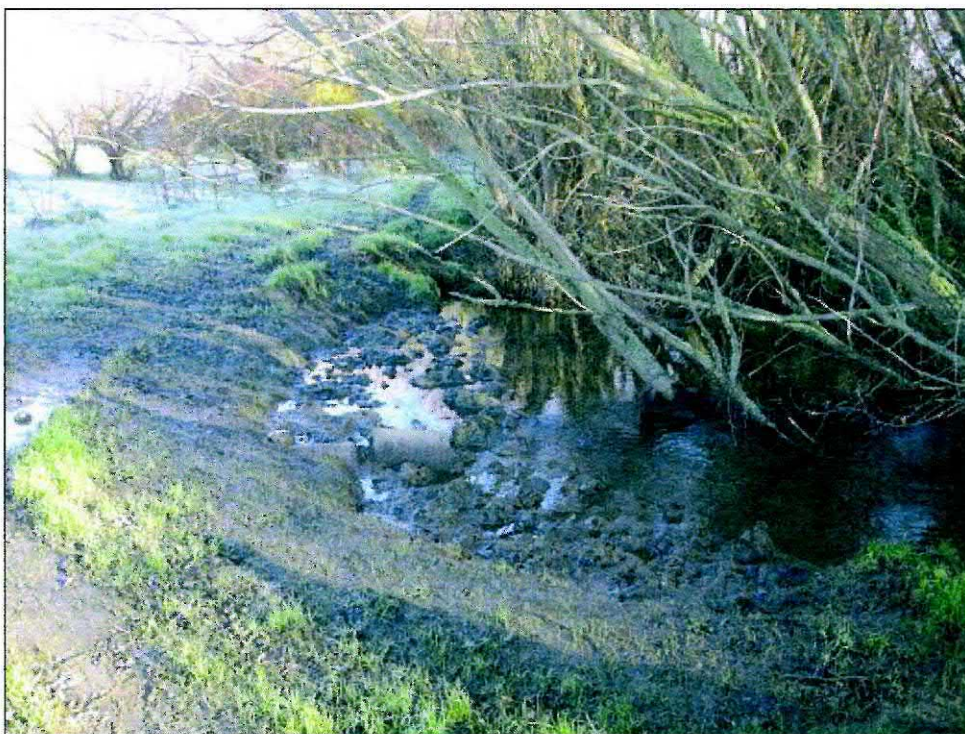
Plate 2-4 Taranaki Stream - upstream of the old channel confluence, (June 2010)

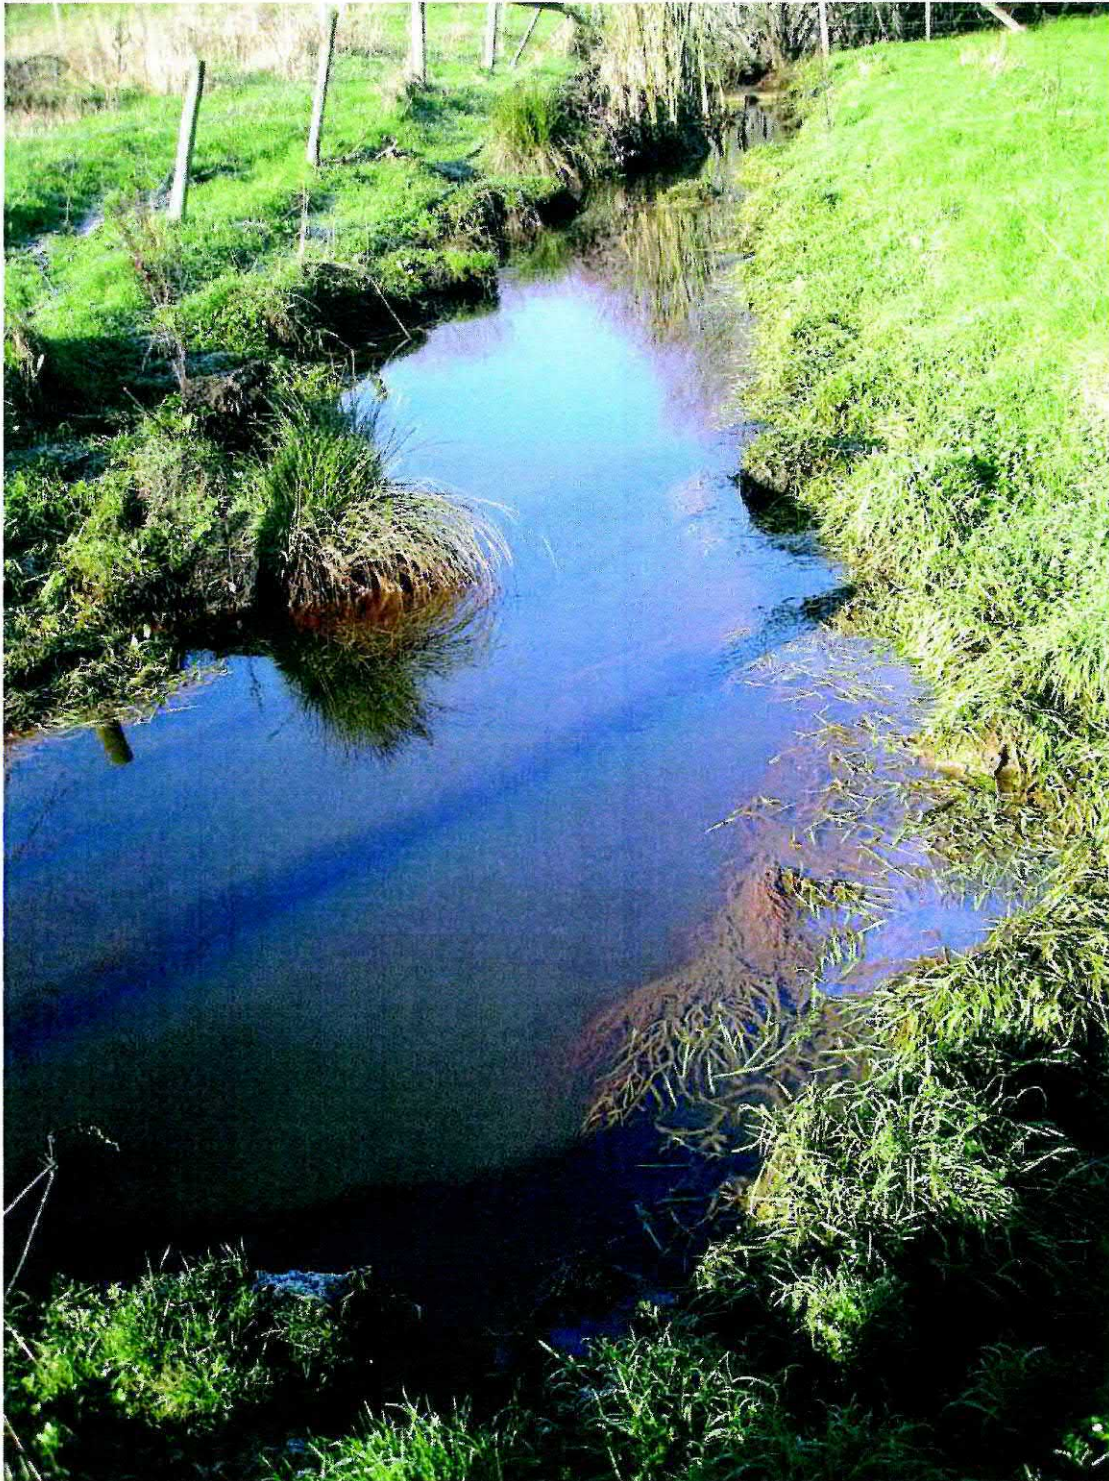
Plate 2-5 Old Taranaki Stream immediately upstream of confluence with Taranaki Stream (sheen on water)

The water quality measured at Site 2b (old Taranaki Stream) immediately upstream of the confluence with the Taranaki Stream is significantly different from the other samples. The pH is slightly acidic at 5.95, with very low Dissolved Oxygen indicating anoxic conditions. The water quality parameters measured at this location are also very different to the water quality measured at the Taerutu Gully discharge to old Taranaki Stream in June 2011 (Site 4) (see Table 2-4). The change to the water quality is considered to be associated with the influence of a wetland located on the northern side of Preeces Road. It is also noted that the shallow groundwater has a naturally elevated iron concentration, which is consumed by microorganisms in the Preeces Road wetland (where flows are very slow). Evidence of this biological process is shown by a sheen on the water at Site 2b (Plate 2-5). The consumption of the dissolved iron by microorganisms will reduce the dissolved oxygen concentration in the water, which is shown in the in-situ monitoring results.

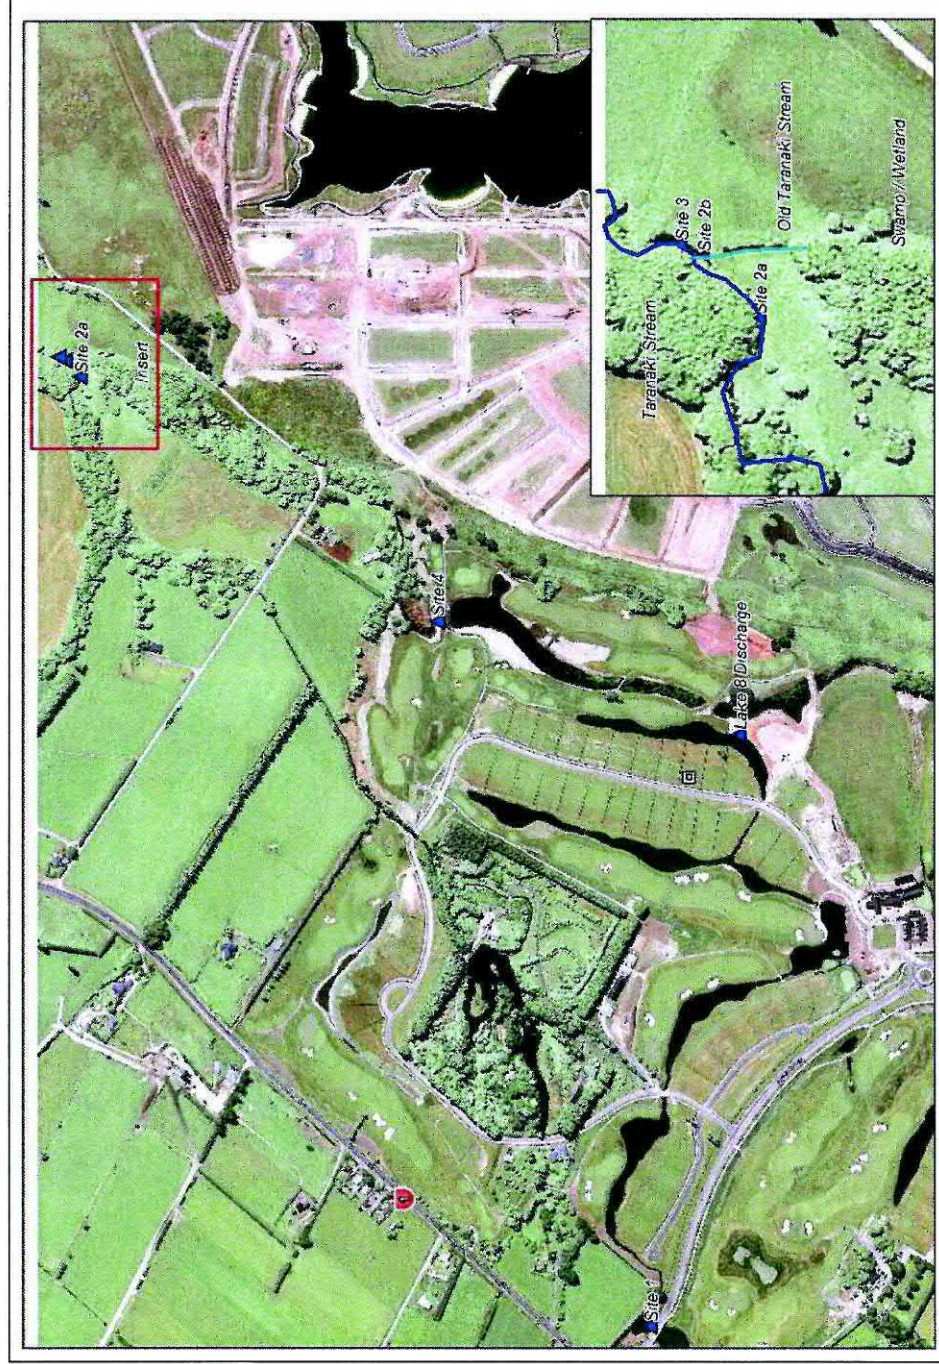
Figure 2-3 Water Quality Sampling Locations

On 23 May 2011 URS sampled the surface water of Taranaki Stream (upstream and downstream of its confluence with the old Taranaki Stream channel), old Taranaki Stream, and the Mapleham lakes at the main bridge into Pegasus Township. The location of the sampling points is shown on Figure 2-3. It is noted that the sampling location for old Taranaki Stream (Site 2b) is located immediately upstream of the confluence of the stream with Taranaki Stream. Site 2b is approximately 550m downstream of the point of discharge from the wetland.

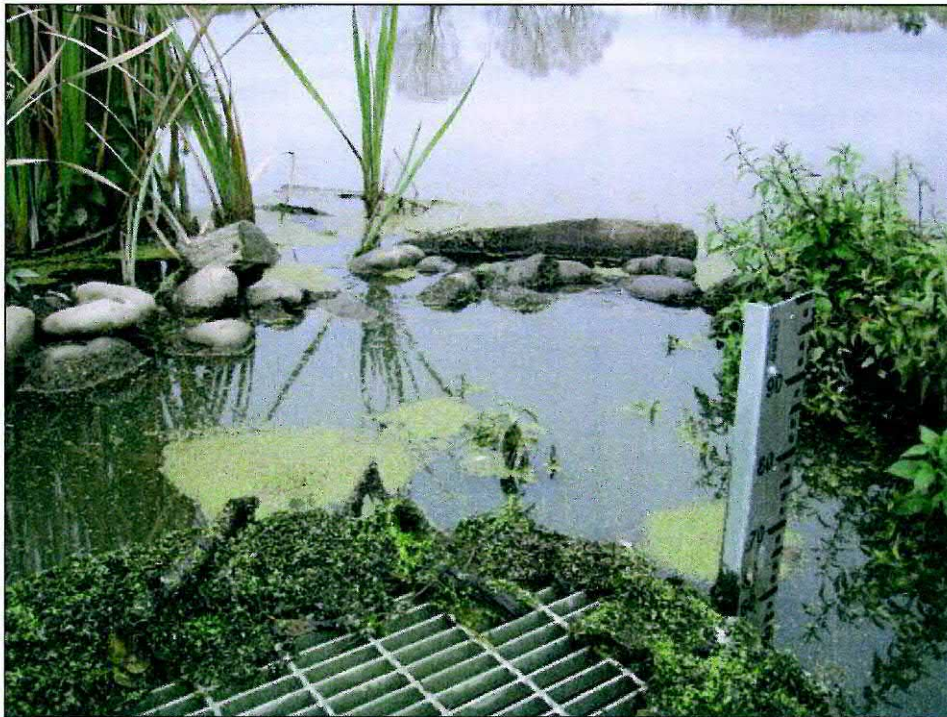
Plate 2-6 Taerutu Gully to old Taranaki Stream Discharge (1 June 2011)

URS visited the site of the discharge from Taerutu Gully to old Taranaki Stream (Site 4) on two occasions during June 2011. The first visit was on 1 June, which followed a moderate rainfall event (23 mm) on the 26 May 2011 that lasted for a period of 24 hours. Plate 2-6 and 2-7 show the water level in the wetland at the orifice weir and the discharge that was occurring via the PVC intake pipes. The flow of the discharge during this visit was measured at approximately 10 l/s. The water level in the wetland measured by the staff gauge was 0.54 m.

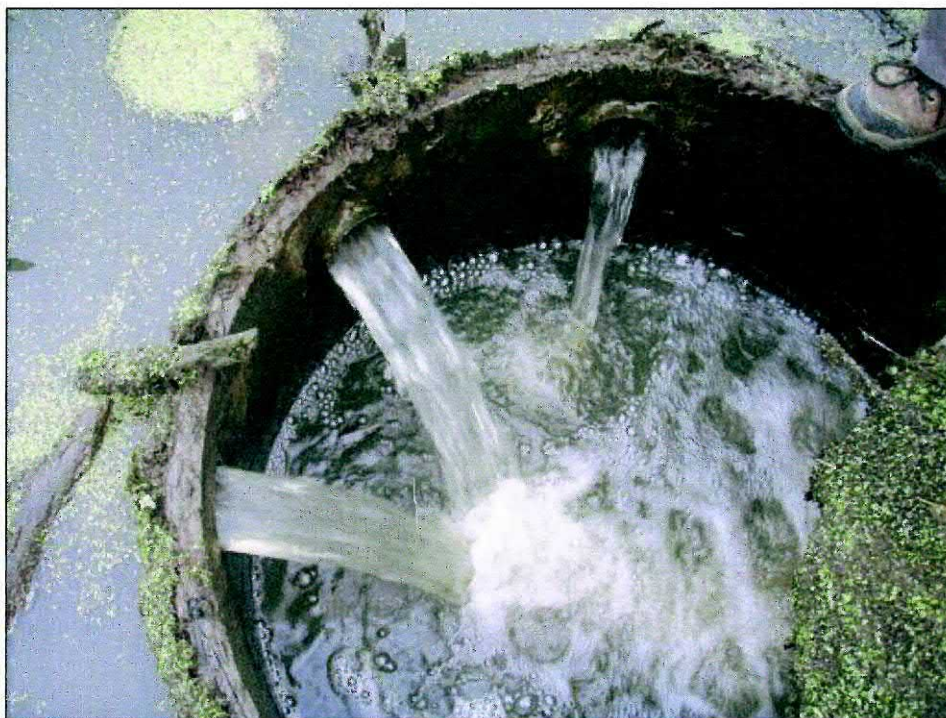
Plate 2-7 Taerutu Gully to old Taranaki Stream Discharge - flow through PVC Pipes (~10l/s)

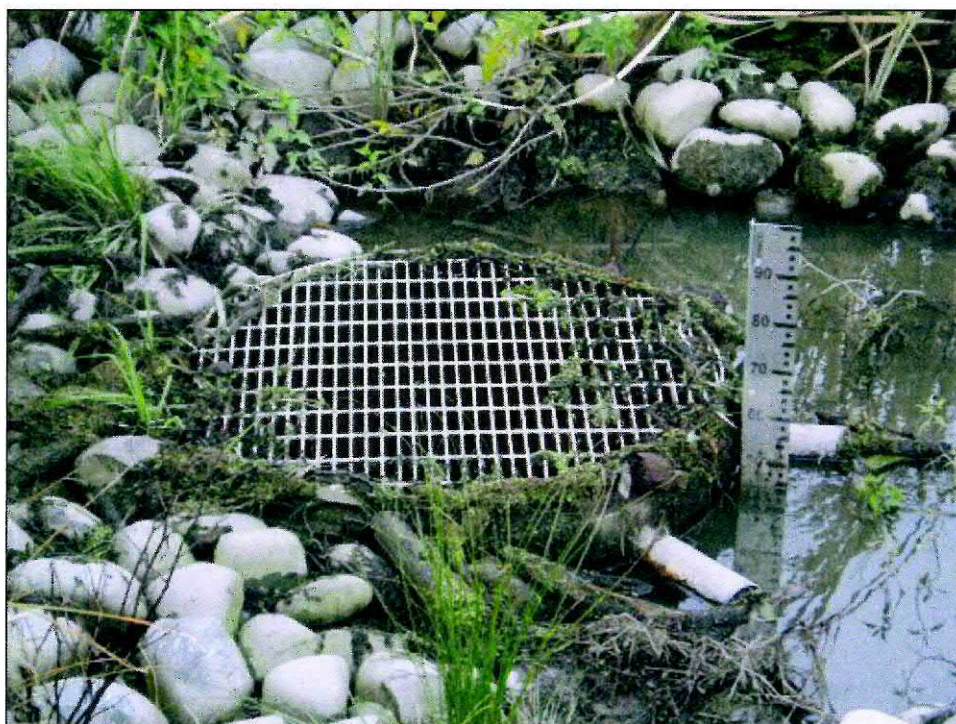
Plate 2-8 Taerutu Gully to old Taranaki Stream discharge Weir (29 June 2011)

A water quality sample was also collected at Site 4 on 29 June 2011. The wetland water level measured on the staff gauge at the orifice weir was 0.46 m (Plate 2-8). The discharge from the weir via the PVC pipes was measured at approximately 1.5 l/s. Table 2-4 shows the results of the in-situ water quality sampling. A water quality sample was also collected at that time and sent to Hills Laboratories for analysis. The results of the sample are shown in Table 2-5.

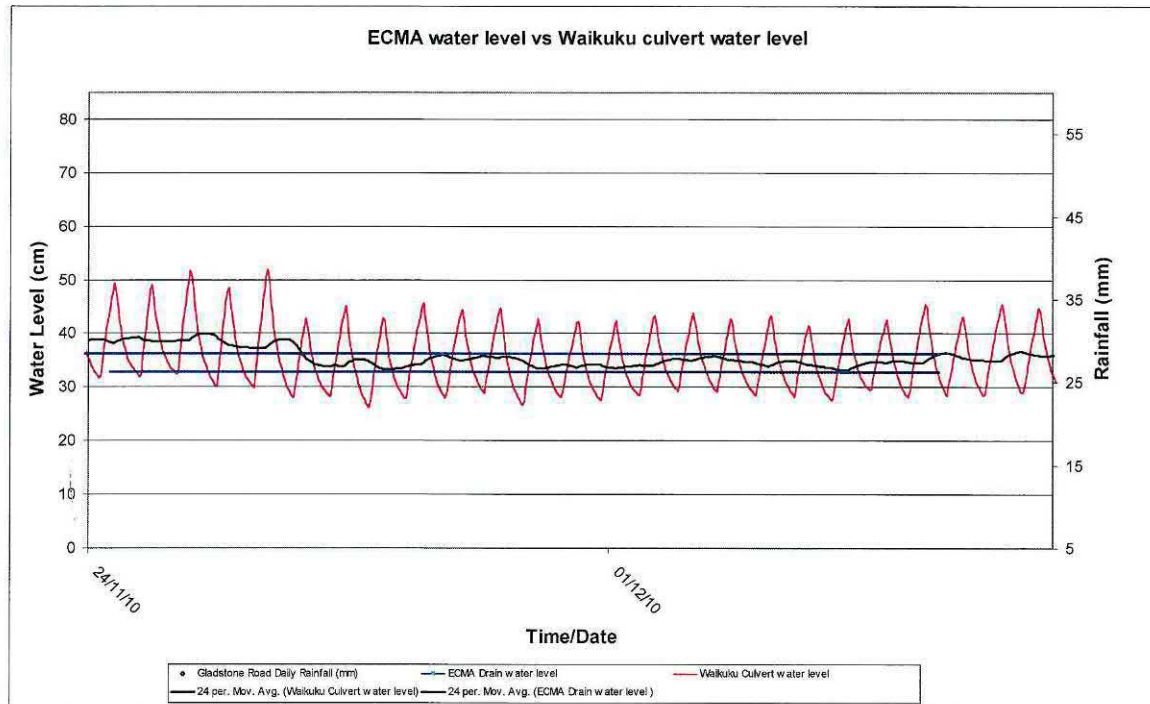
This discharge has very limited impact on the downstream receiving environment. In early December 2010 where the flow from the orifice weir was measured in the 3-5 l/s range, the water levels in Taranaki Stream measured at Waikuku Beach culvert were very stable, with a time averaged water level range in the order of +/- 0.05 m (Figure 3-1).

Figure 3-1 Water Levels at Waikuku Beach and Rainfall (Nov-Dec 2010)

During other periods where the discharge was measured in the range of 3-5 l/s from Taerutu Gully there was minimal change in the water levels recorded in Taranaki Stream at the Waikuku Beach culvert that could be interpreted as a direct result of the low flow discharge.

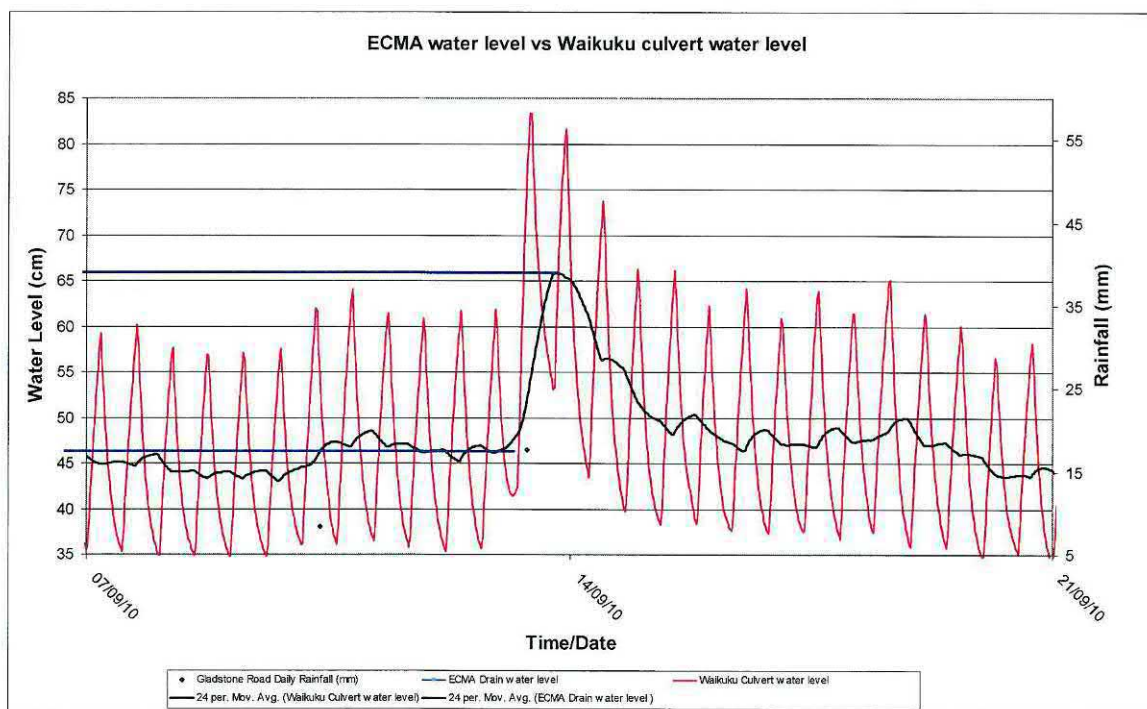
Figure 3-2 Water levels at Waikuku Beach and Rainfall (Sept 2010)

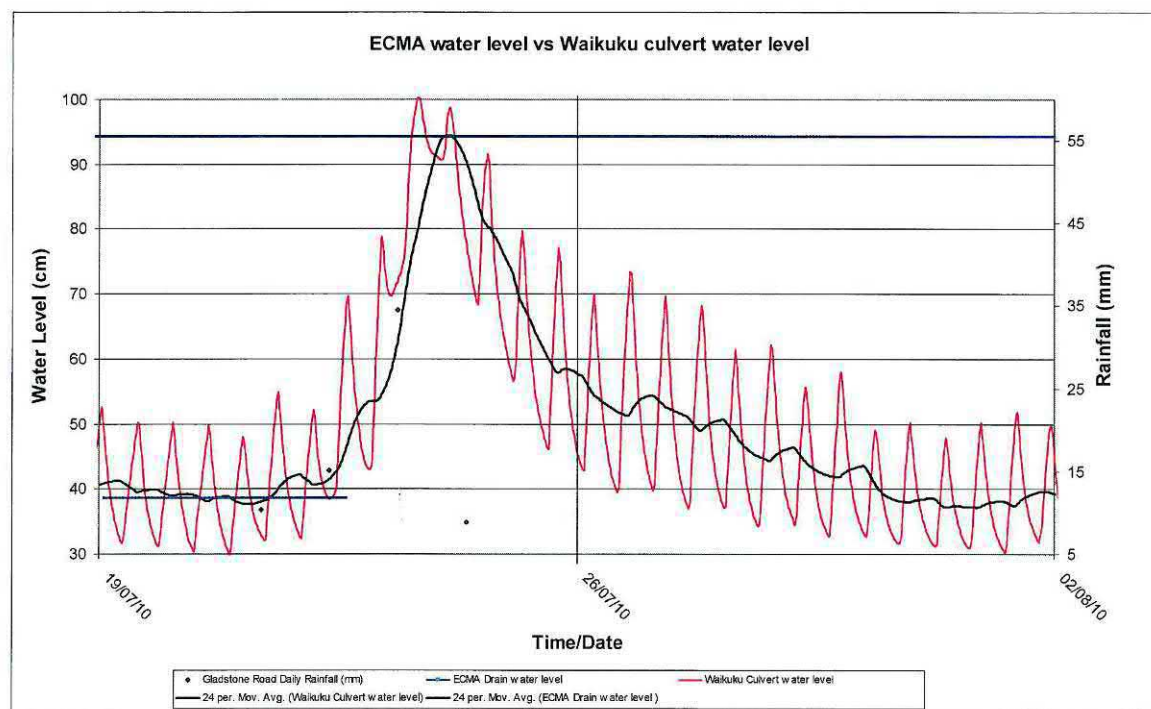
Figure 3-3 Water Levels at Waikuku Beach and Rainfall (July 2010)

The July 2010 event, which was recorded approximately 48 hours after the peak rainfall event on 26 July (which had a rainfall of 35 mm over a 24 hour period), showed a significant increase in water levels at the Waikuku Beach culvert. The water levels at the culvert increased by more than 0.5 m over a period of three days (over which time a total of approximately 60 mm of rainfall fell) (Figure 3-3). The measured discharge from the orifice weir was approximately 10 l/s on 26 July. This is likely to represent a small proportion of the overall flow at the Waikuku Beach culvert. However, there is no information available on the peak discharge that occurred at Waikuku Beach or from Taerutu Gully at that time.

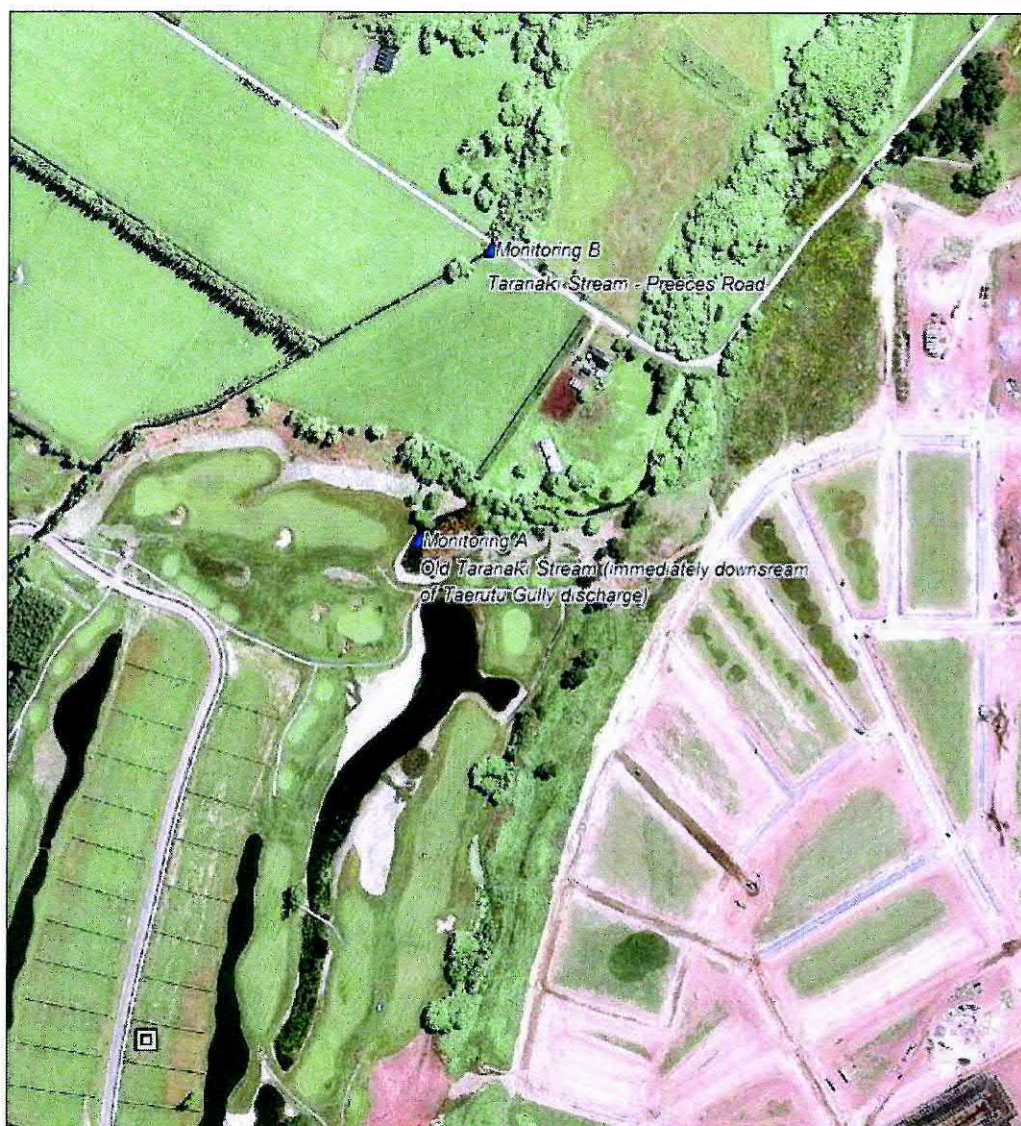
If condition 13 of CRC061218 is to be retained, then it is considered that the location of the sampling is changed to reflect the true nature of the discharge. The location of the proposed sampling sites is shown below (Site A and Site B). Site A would provide details on the quality of the water associated with the discharge from Taerutu Gully while Site B would provide information on the water quality associated with Taranaki Stream.

Figure 3-4 Proposed Sampling Locations
