**25 ASHLEY GORGE, OXFORD.  
Natural Hazard Assessment Report for  
Proposed Subdivision and Plan Change.**

**Revision: C**

18 October 2023

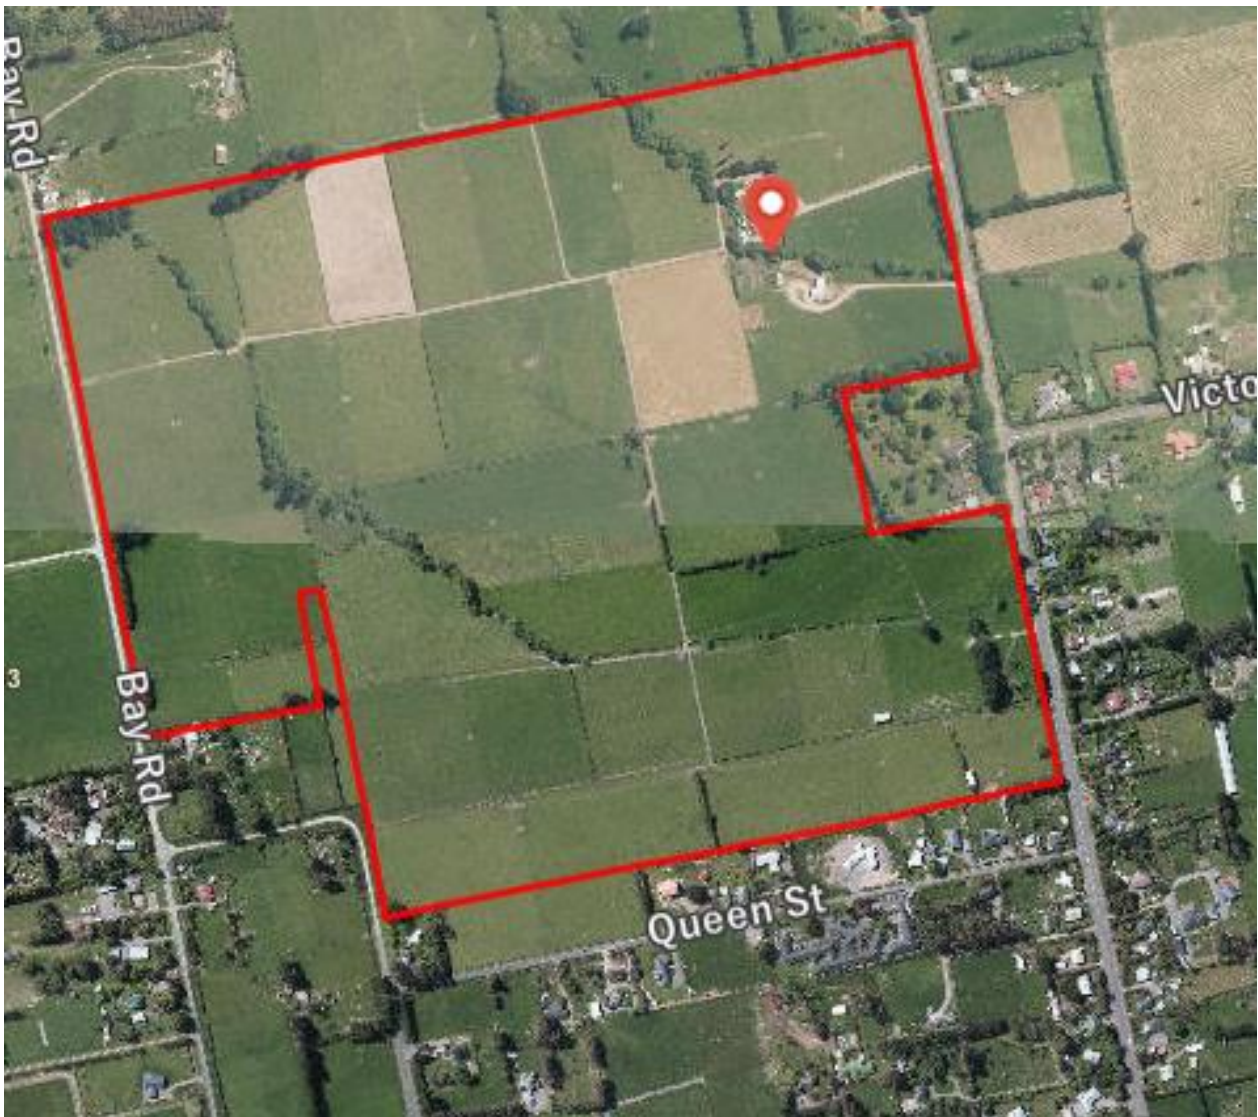
Figure 1: Approximate site boundaries.

Towards the northwest corner a stream enters the site and meanders roughly at a 45 degree angle to the west and north boundary before re-orientating in a general easterly direction towards the Ashley Gorge Rd side, at which point the stream connects to a concrete culvert and exits beneath the road. The west end of the stream is camouflaged by a line of small trees and shrubs as shown in Figure 1 below.

The east side of the site is generally flat with the observed ground level below Ashley Gorge Rd level and consequently this area appeared saturated with visible signs of surface water ponding.

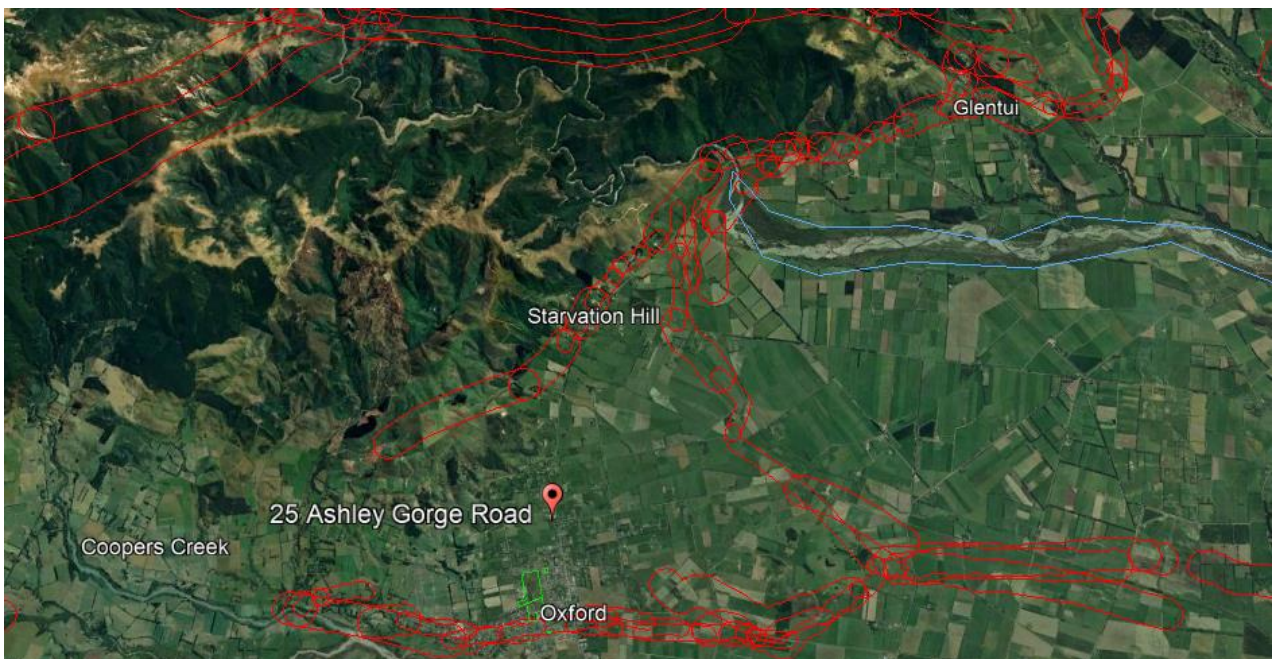
Not identified in Figure 1, but shown in Figure 2, is the ‘Knowles Top’ and ‘Ellis’ Faults. The Knowles fault is located to the north of the site and the Ellis fault to the east, with the latter fault trace orientated in an east-west direction before diverging in a north-west direction towards the Knowles Top fault Zone.

A recent fault, ‘Starvation Hill’, has been identified from Lidar survey imagery and topography mapping as shown in Figure 2 with this suspected fault passing through the Oxford Township. The fault is considered active, however further geological investigation is required to confirm whether in fact it is an active fault.

Figure 2: Updated active fault information from Canterbury Maps Fault Awareness Areas (2019).

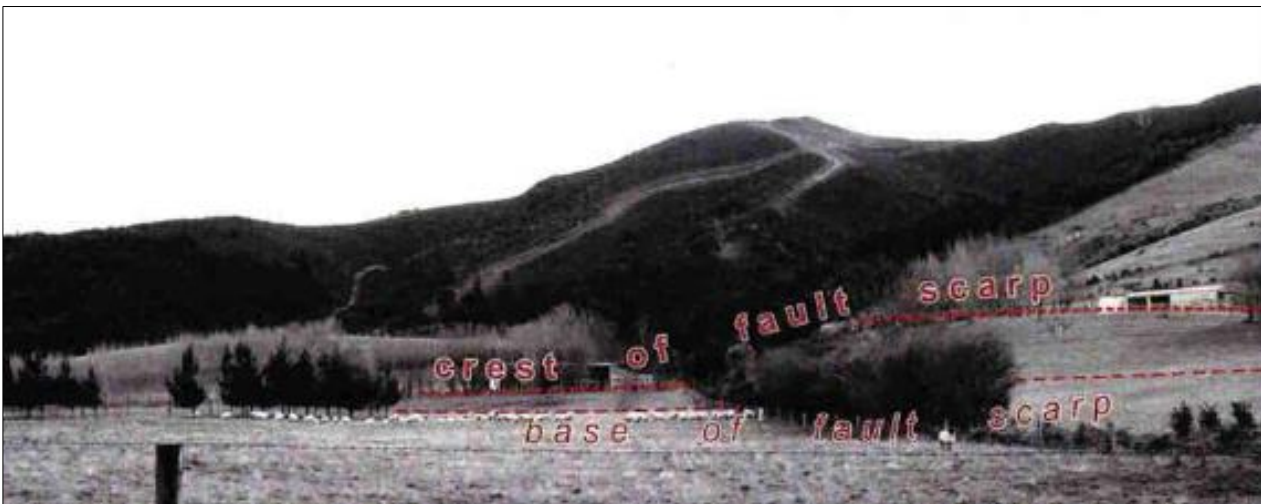
Of the active faults discussed, the 'Knowles Top' fault zone is the easiest fault to define, as observed by a fault scarp that runs across the slope of the alluvial fans formed by deposition of material from upslope of the fault as shown in Figure 3.

Figure 3: Fault scarp within the Knowles Fault Zone located about 0.5 km from German Road Intersection along Ashley Gorge Road (north of the subject property). Photo reproduced from GNS (2013) report.

The distinct 'step' in ground elevation just beyond the north boundary of the site cannot have been formed by stream action, and therefore can be classed as a definite fault. The Knowles Fault scarp varies in height from 2 – 3m to the west side of the northern boundary, and 8 – 10 m high towards the on the oldest alluvial fan terrace.

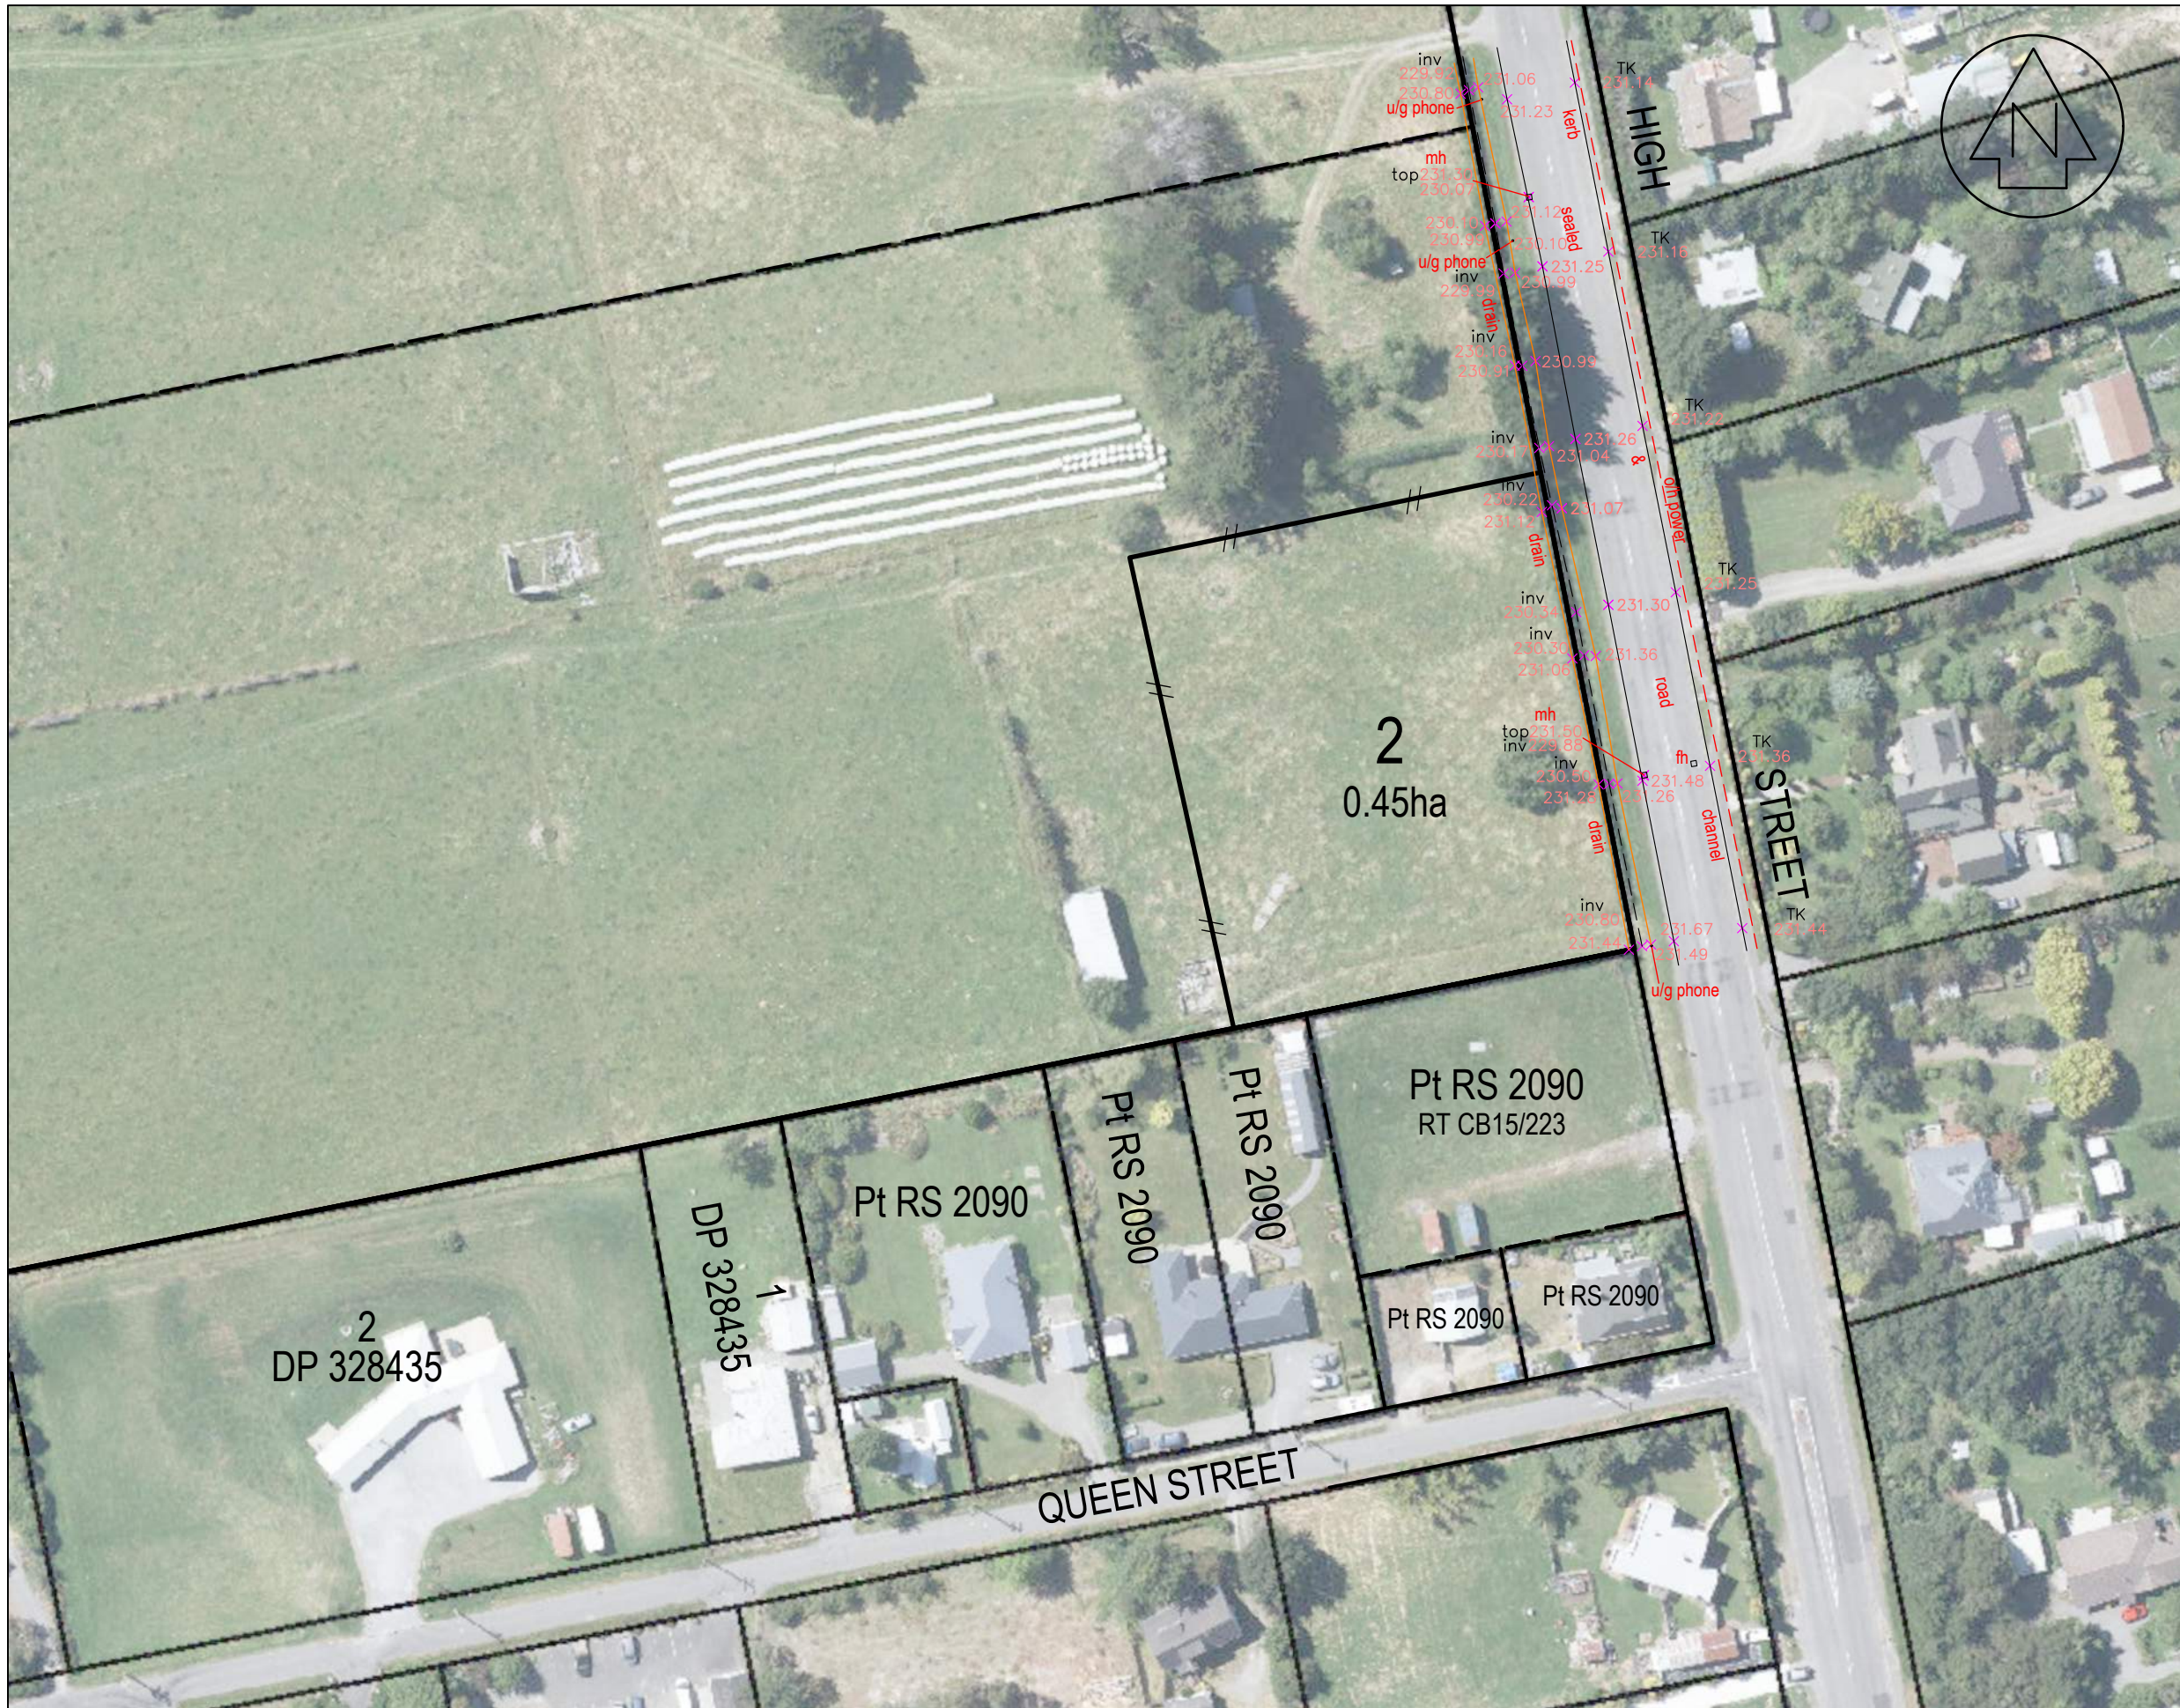
**AMALGAMATION CONDITION :**  
 THAT LOT 2 HEREON BE AMALGAMATED WITH PT RS 2090 (RT CB15/223) AND ONE CERTIFICATE OF TITLE BE ISSUED.

PROJECT	
MORGAN McINTOSH LTD - 25 ASHLEY GORGE ROAD	
TITLE	
PROPOSED SUBDIVISION OF Pt RS 1626 & RS's 1956 & 2405 RT CB376/258 Ltd	
SHEET 2 OF 2

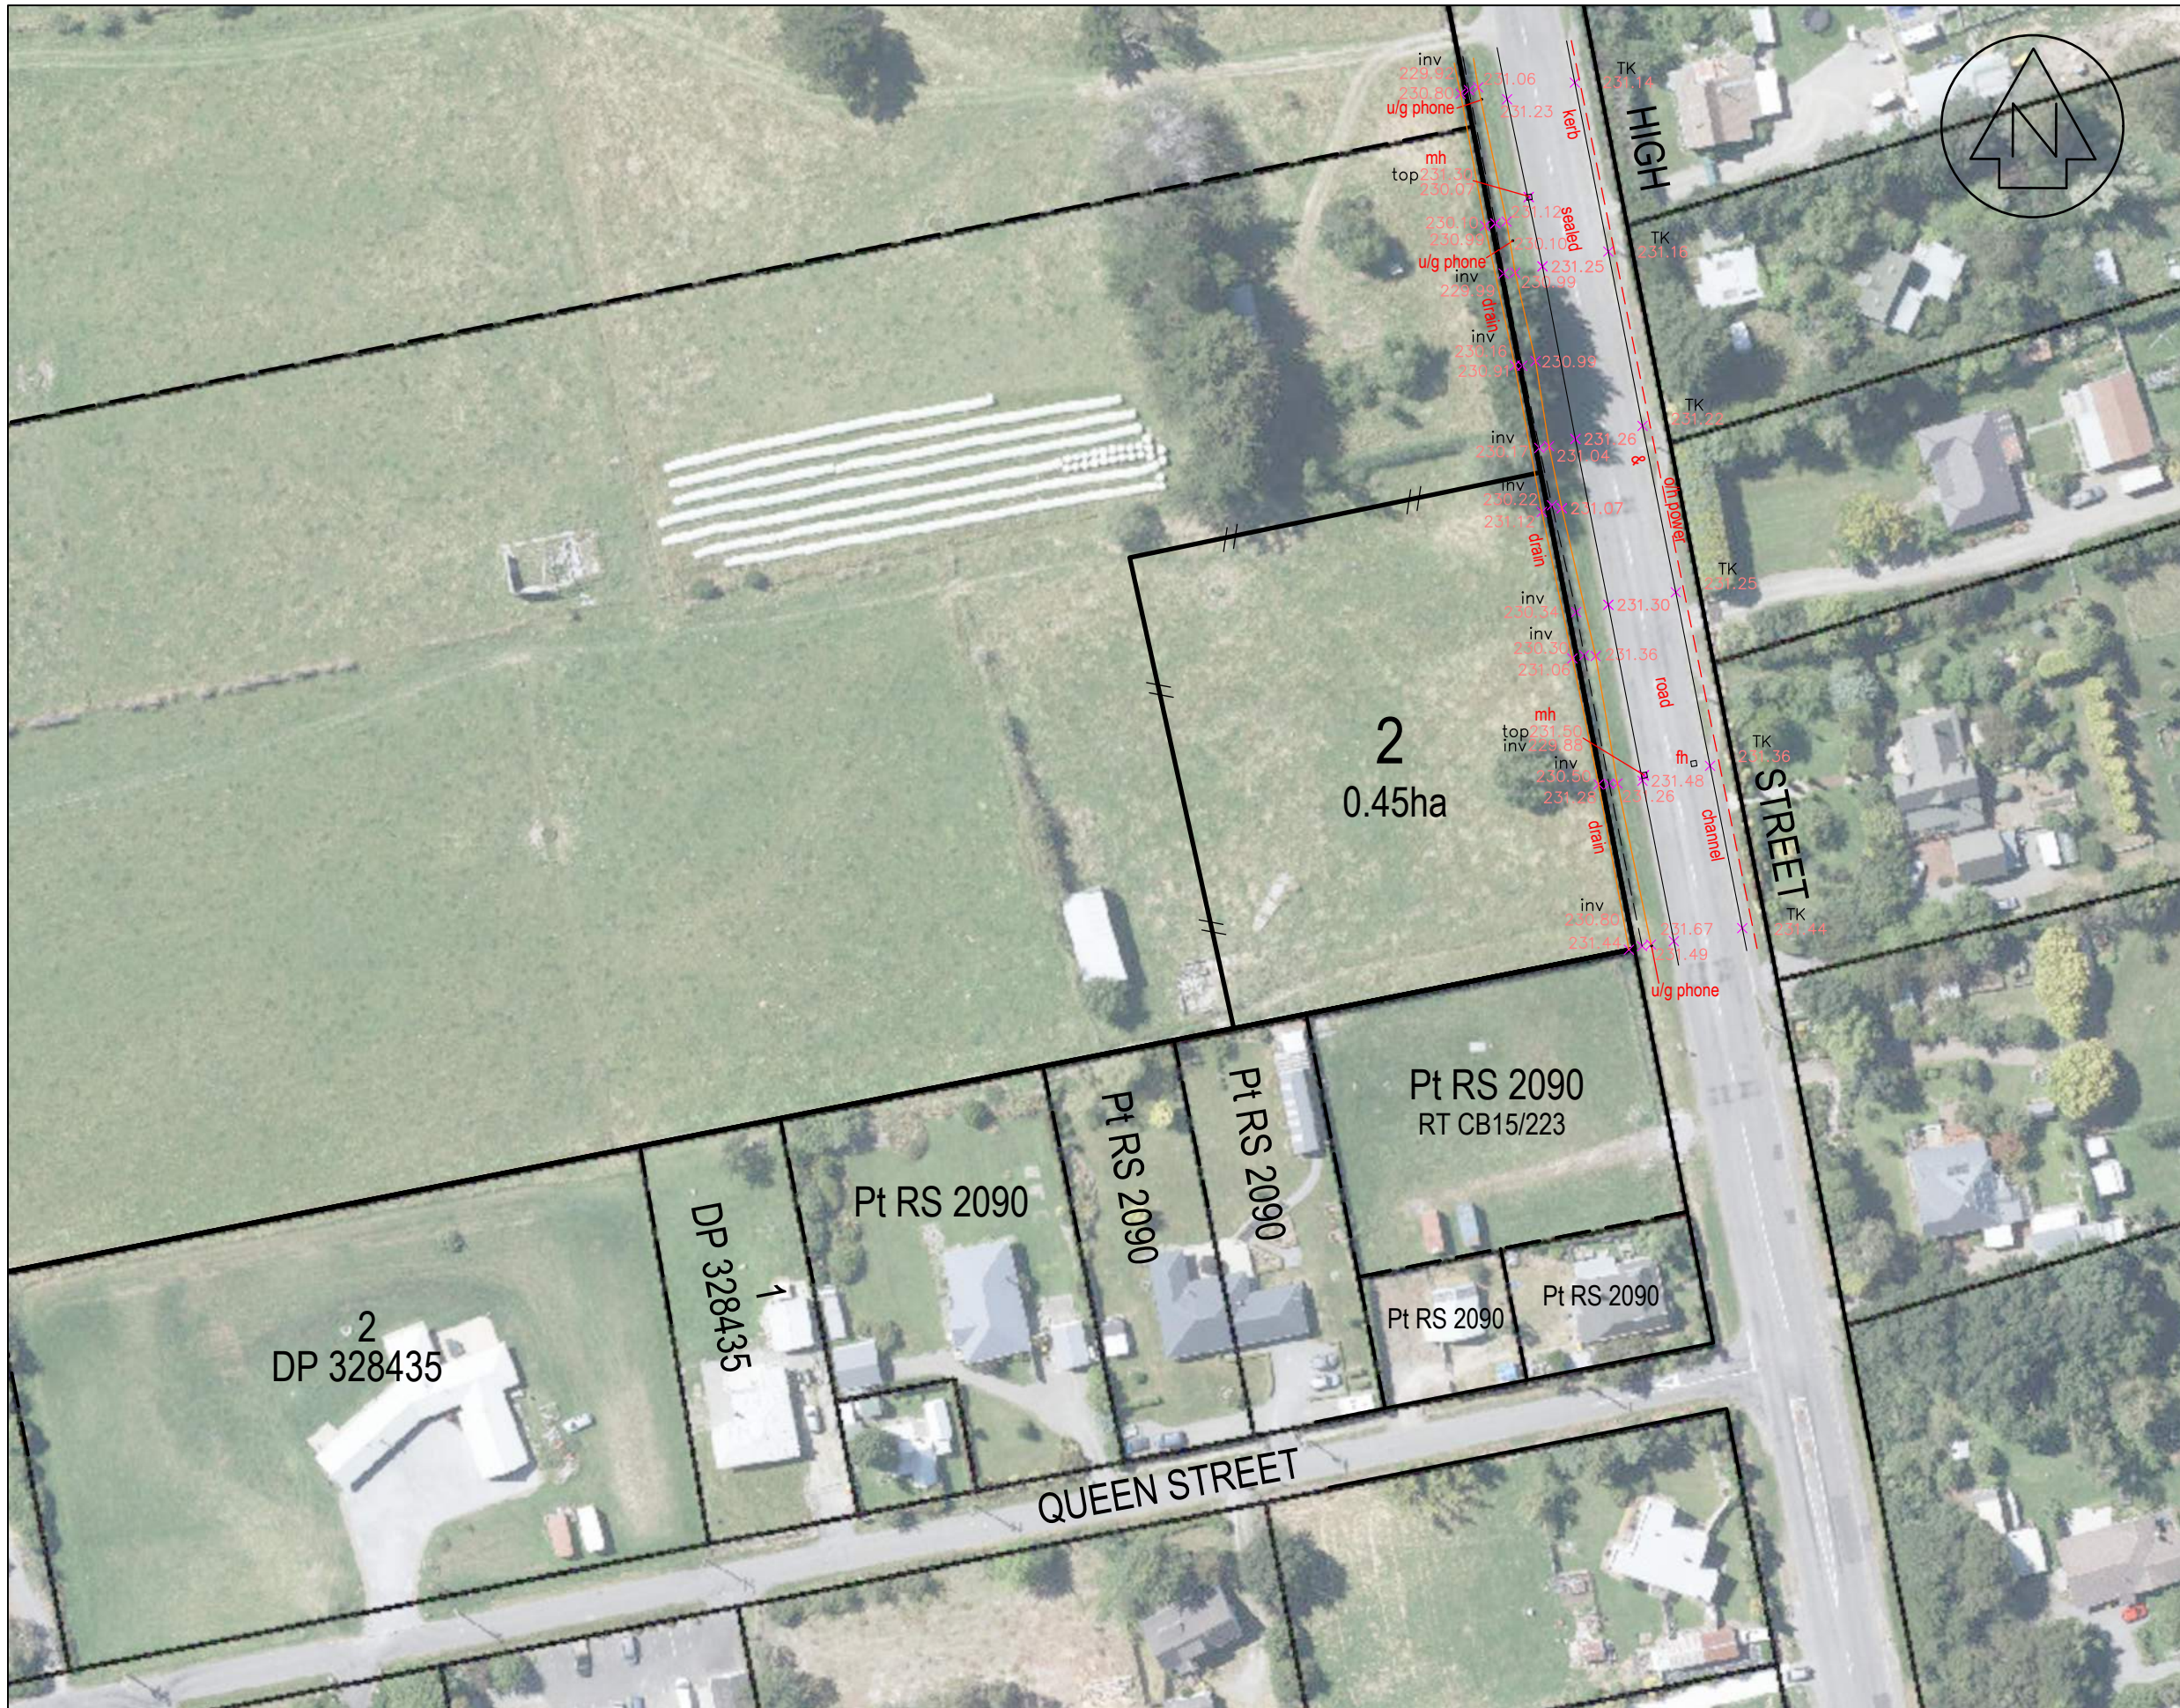
**AMALGAMATION CONDITION :**  
 THAT LOT 2 HEREON BE AMALGAMATED WITH PT RS 2090 (RT CB15/223) AND ONE CERTIFICATE OF TITLE BE ISSUED.
