DESKTOP REVIEW BLOCK A – 1401, 1419 AND 1379 TRAM ROAD, SWANNANOA (LOT 1, DP323637 AND LOTS 5 AND 7, DP321133)

1.0 Introduction

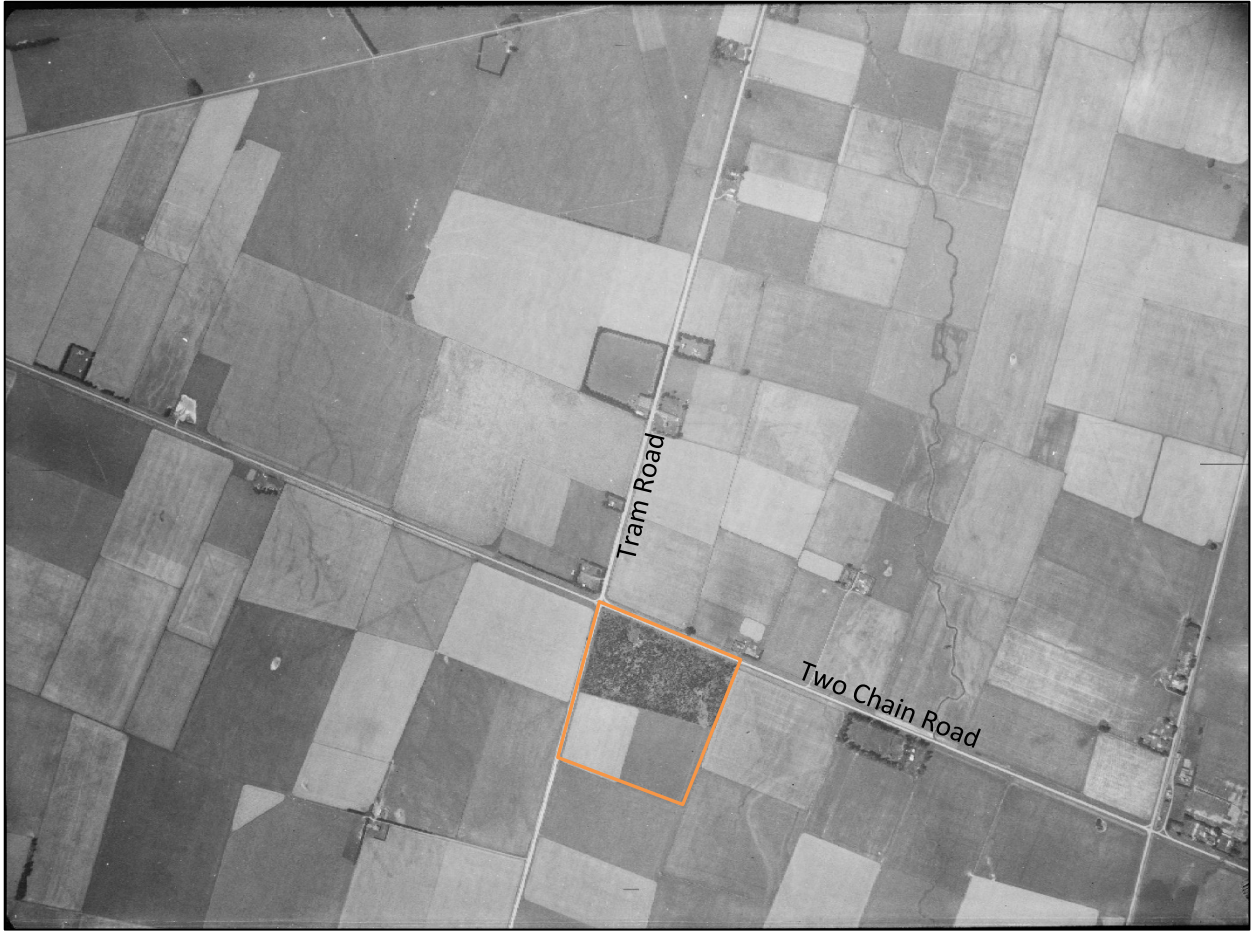
Photograph 1: 1941: Block A - 1401, 1419 and 1379 Tram Road, Swannanoa indicated by orange outline (Source Retrolens).

1941: Western part of Block A is vegetated with pasture grass (farmland). The Eastern part of Block A vegetated with trees – Possibility of potential pit / backfilled area indicated by an area visible in the north-eastern and southern parts of the site where there is a lack of vegetation.

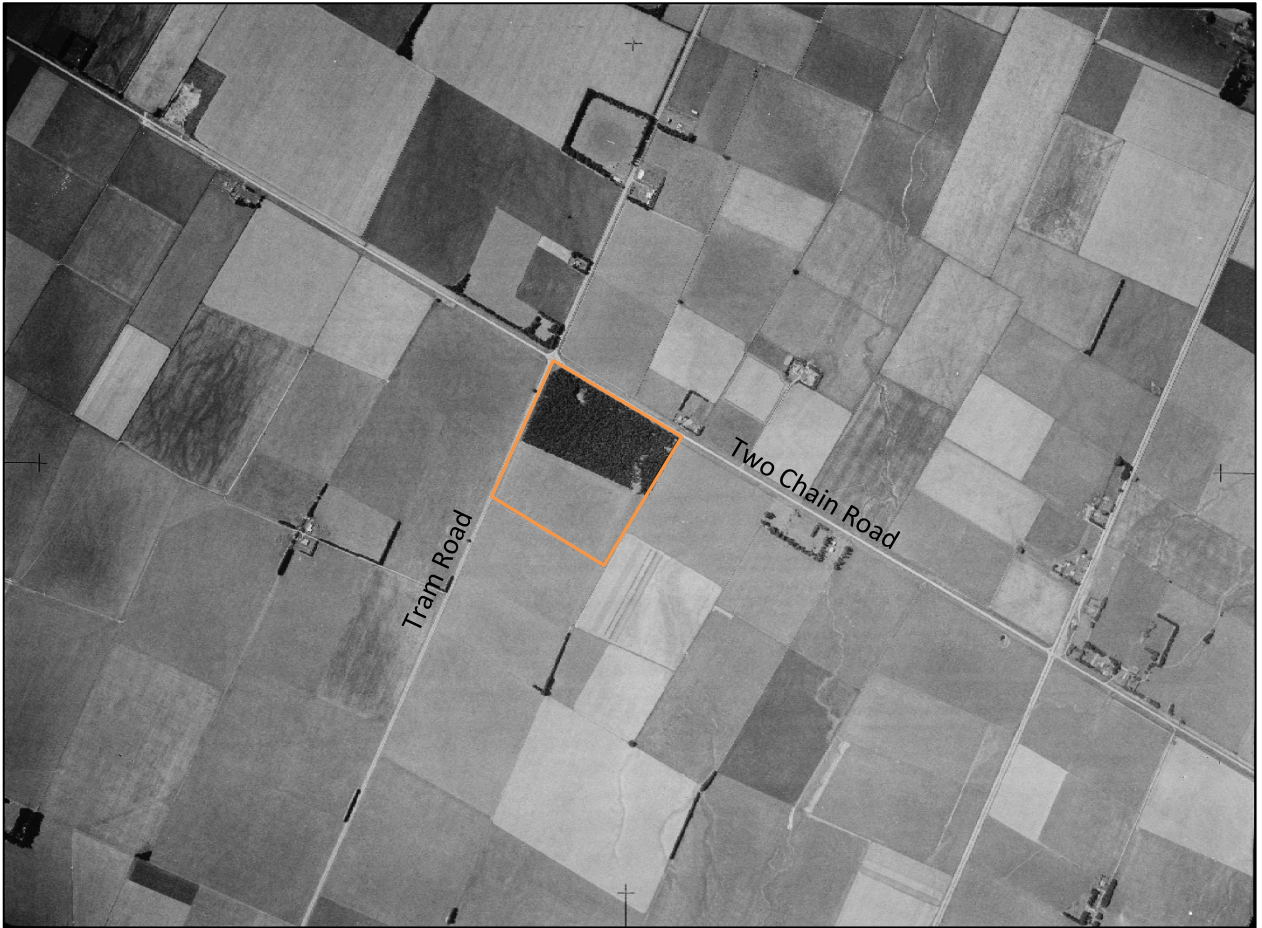
Photograph 2: 1955: Block A - 1401, 1419 and 1379 Tram Road, Swannanoa indicated by orange outline (Source Retrolens).

1955: Western half of Block A is vegetated with pasture grass (farmland). Eastern part of Block A vegetated with trees the same previously indicated areas with no vegetation are still visible.

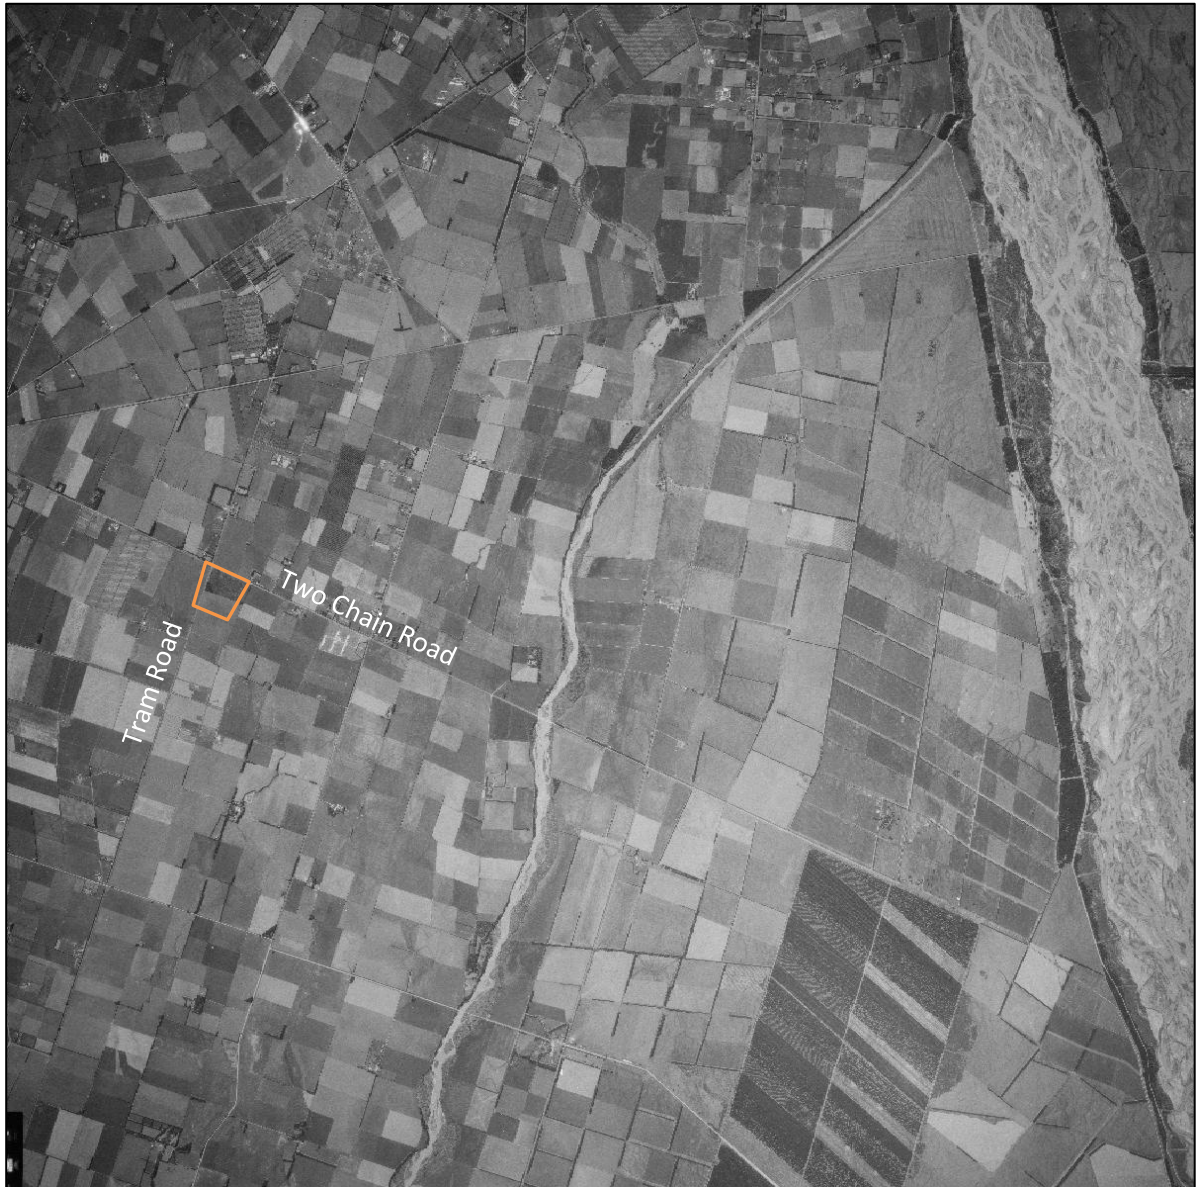
Photograph 6: 1994: Block A - 1401, 1419 and 1379 Tram Road, Swannanoa indicated by orange outline (Source Retrolens).

1994: Western part of Block A is vegetated with pastural grass (farmland). Eastern part of Block A, Northwestern corner of the site has been replanted. The balance of the site appears to have been harvested.

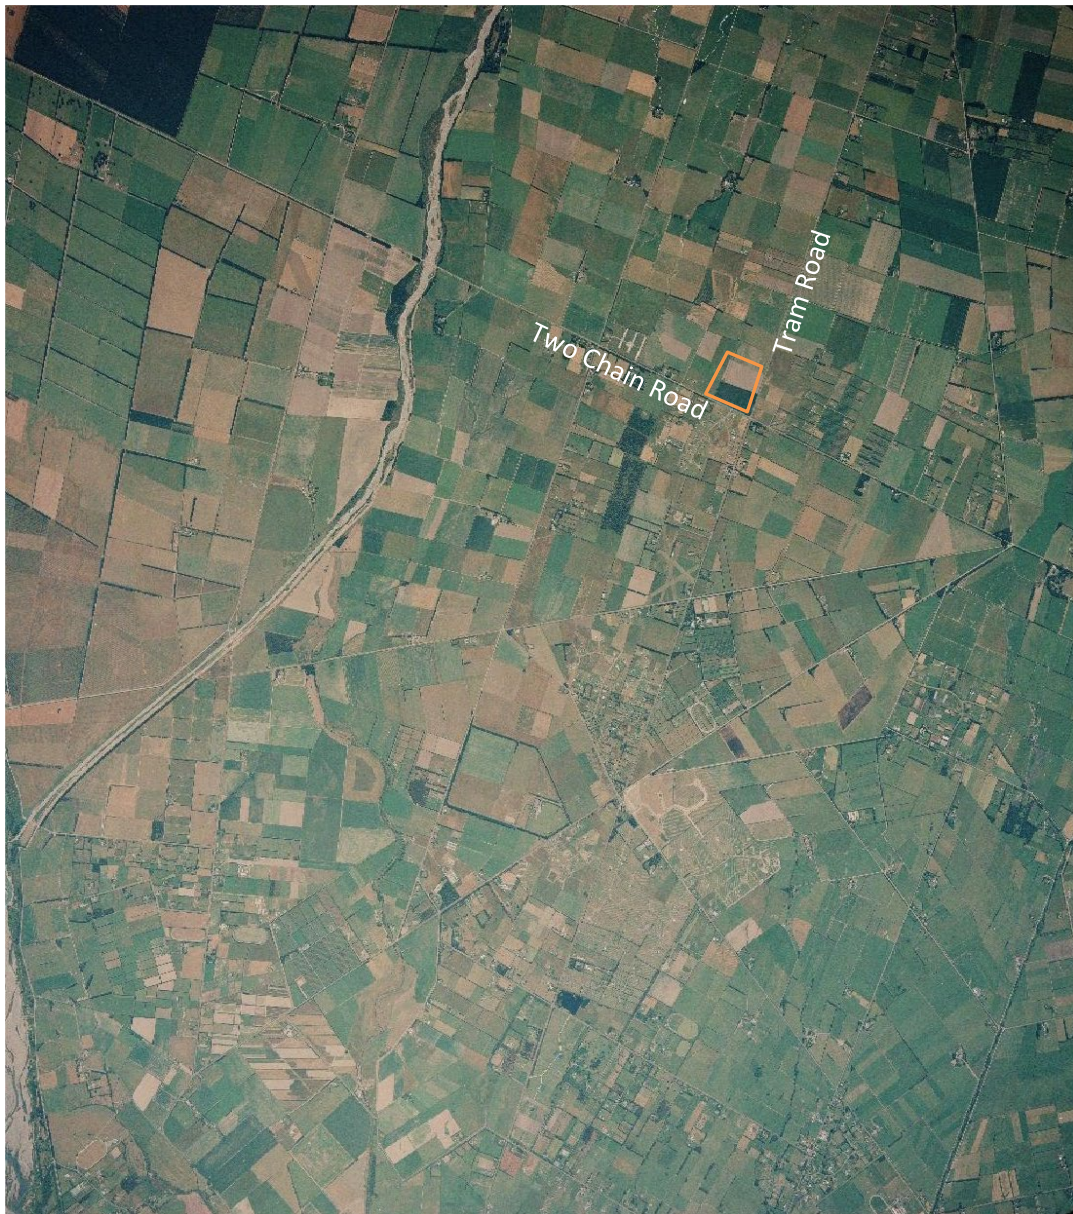
Photograph 7: 2000: Block A - 1401, 1419 and 1379 Tram Road, Swannanoa indicated by orange outline (Source Retrolens).

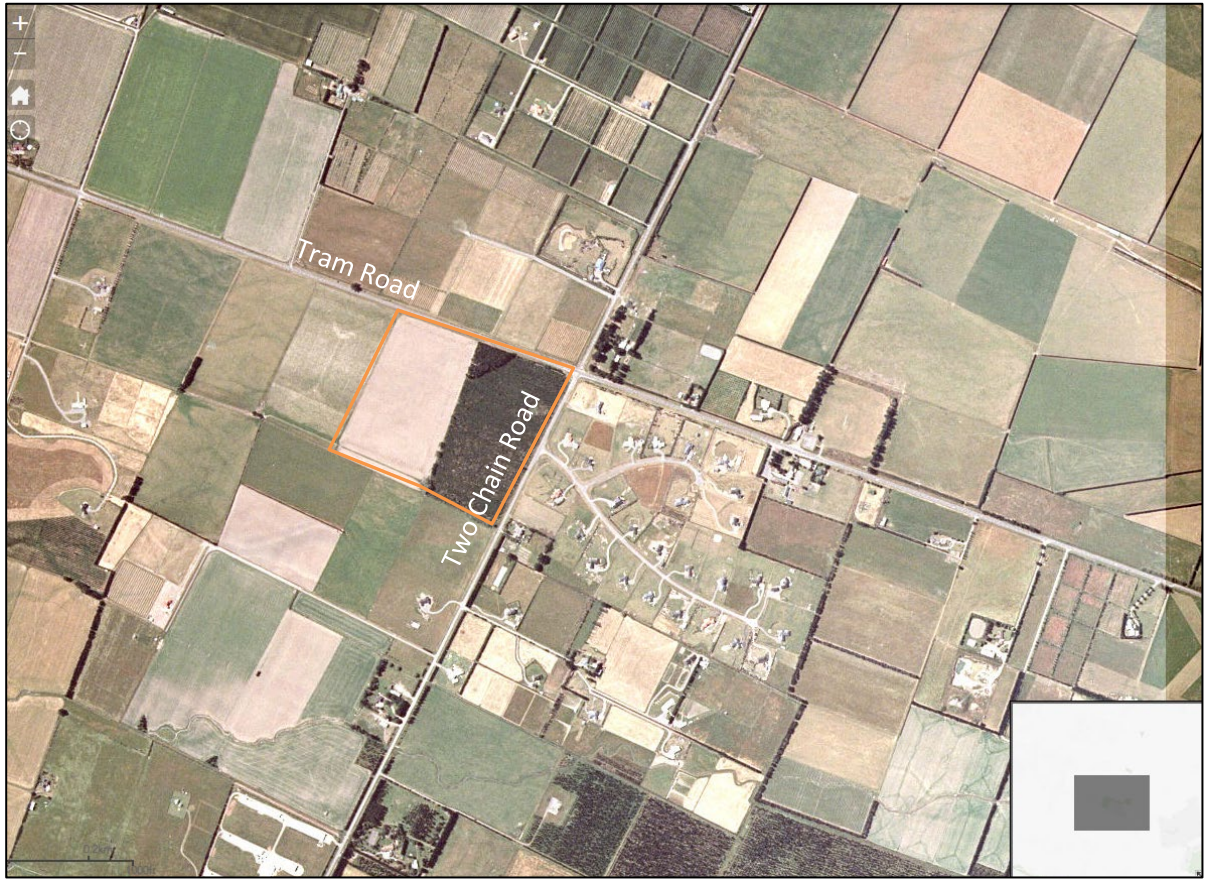
Photograph 9: 2000-2004: Block A - 1401, 1419 and 1379 Tram Road, Swannanoa indicated by orange outline (Source Canterbury Maps).

2000-2004: Western half of Block A is cultivated (farmland). Block A, revegetated with trees. Area of poor growth still visible in the northeastern part of the site.

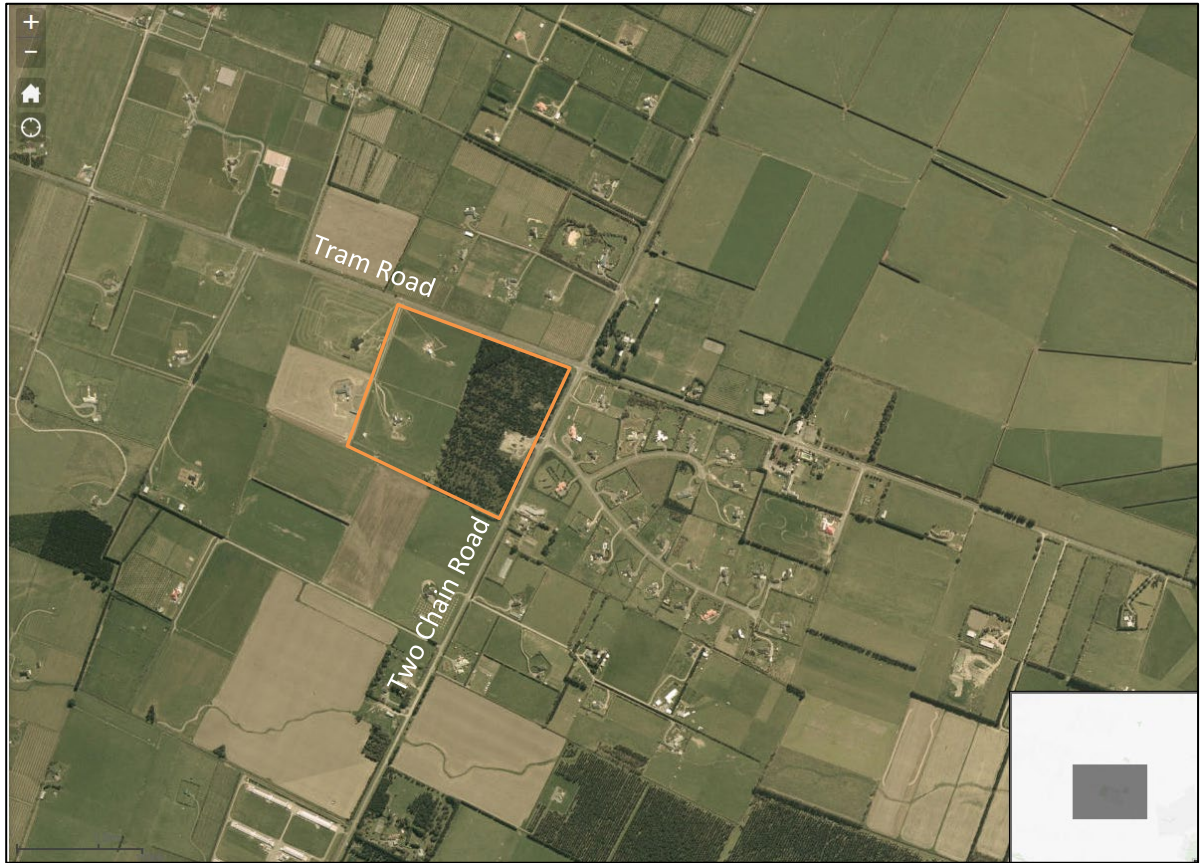
Photograph 10: 2004-2010: Block A - 1401, 1419 and 1379 Tram Road, Swannanoa indicated by orange outline (Source Canterbury Maps).

2004-2010: Western part of Block A has been subdivided into Lots 5 and 7, both Lots have had houses and sheds constructed at the site. Eastern part of Block A is generally vegetated with trees.

937 Two Chain Road (Mandeville water supply) has been cleared and construction of started on water supply.

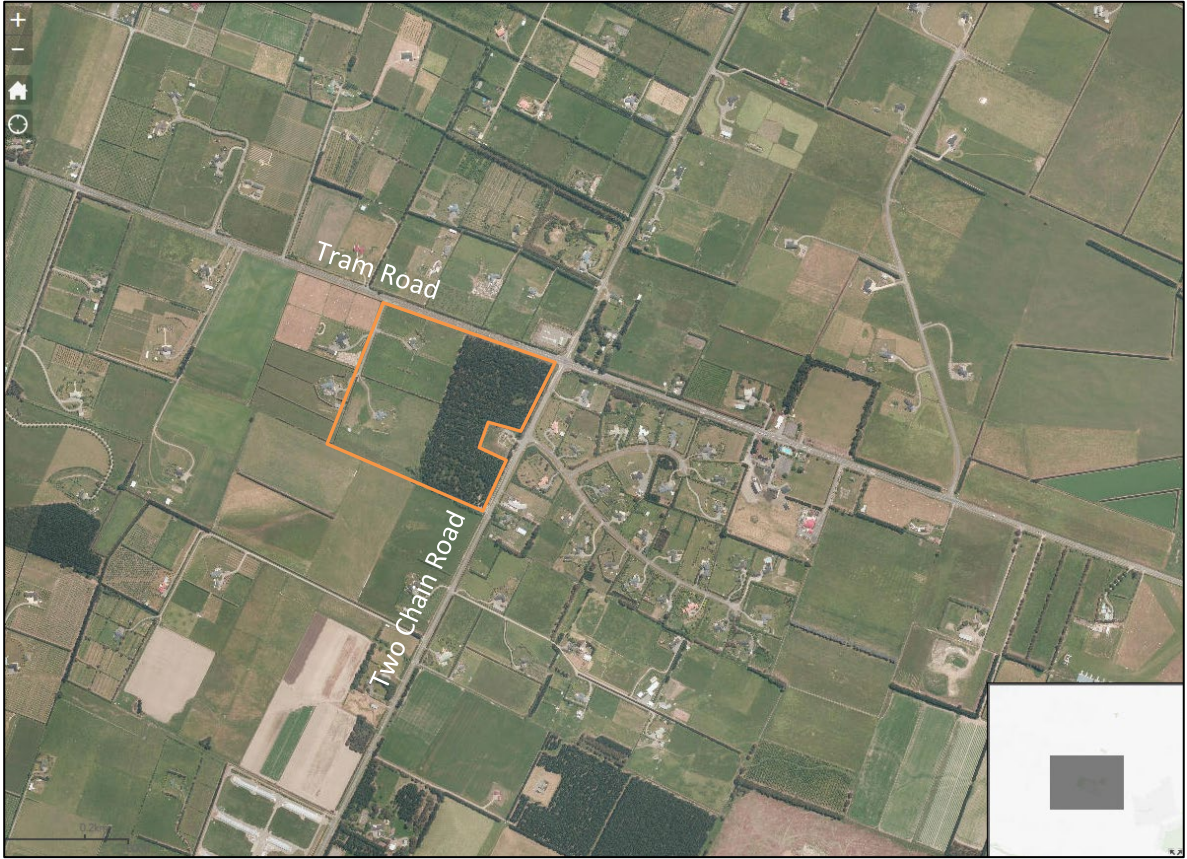
Photograph 11: 2010-2015: Block A - 1401, 1419 and 1379 Tram Road, Swannanoa indicated by orange outline (Source Canterbury Maps).

2010- Present day: Construction of water supply plant completed; eastern part of Block 1 still vegetated with trees.

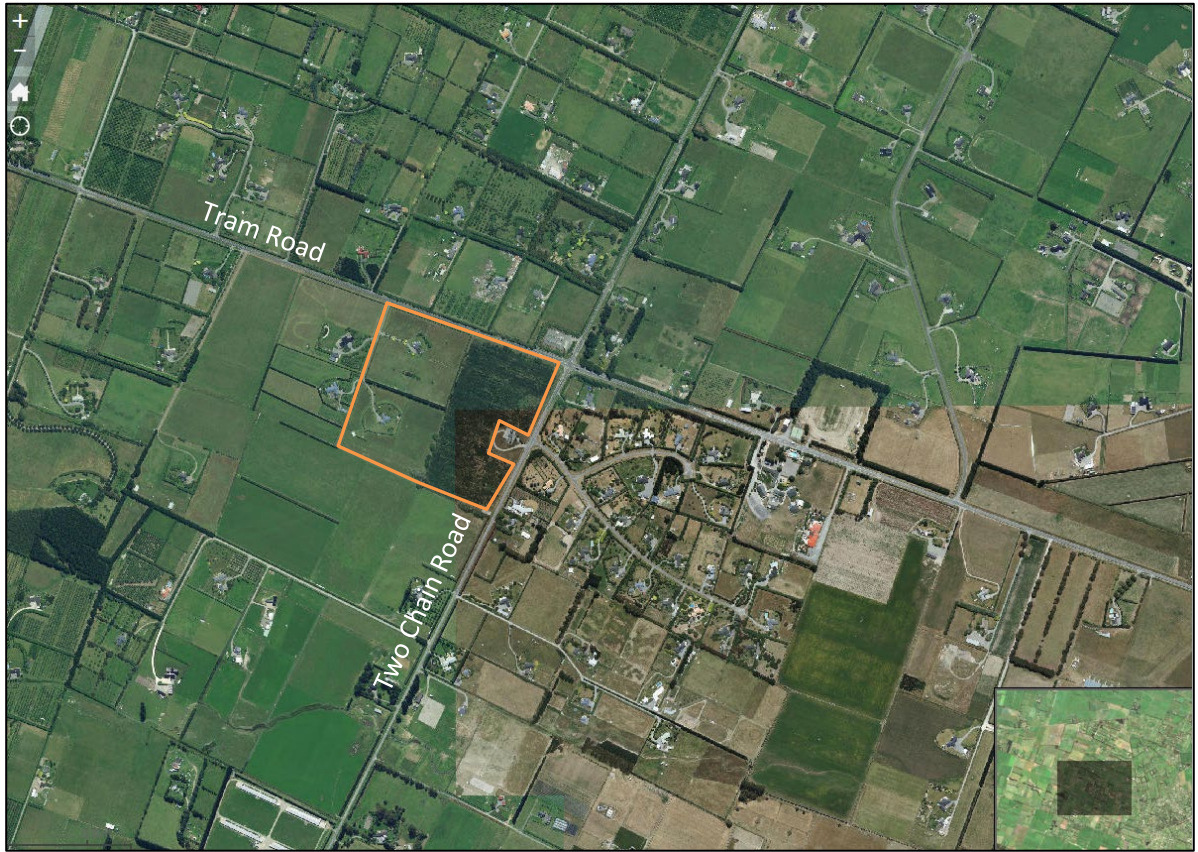
Photograph 12: 2004-2010: Block A - 1401, 1419 and 1379 Tram Road, Swannanoa indicated by orange outline (Source Canterbury Maps).
