**Soil Contamination Risk
Preliminary Site Investigation Report**

**126 Lehmans Road, Rangiora,
Canterbury**

July 2023

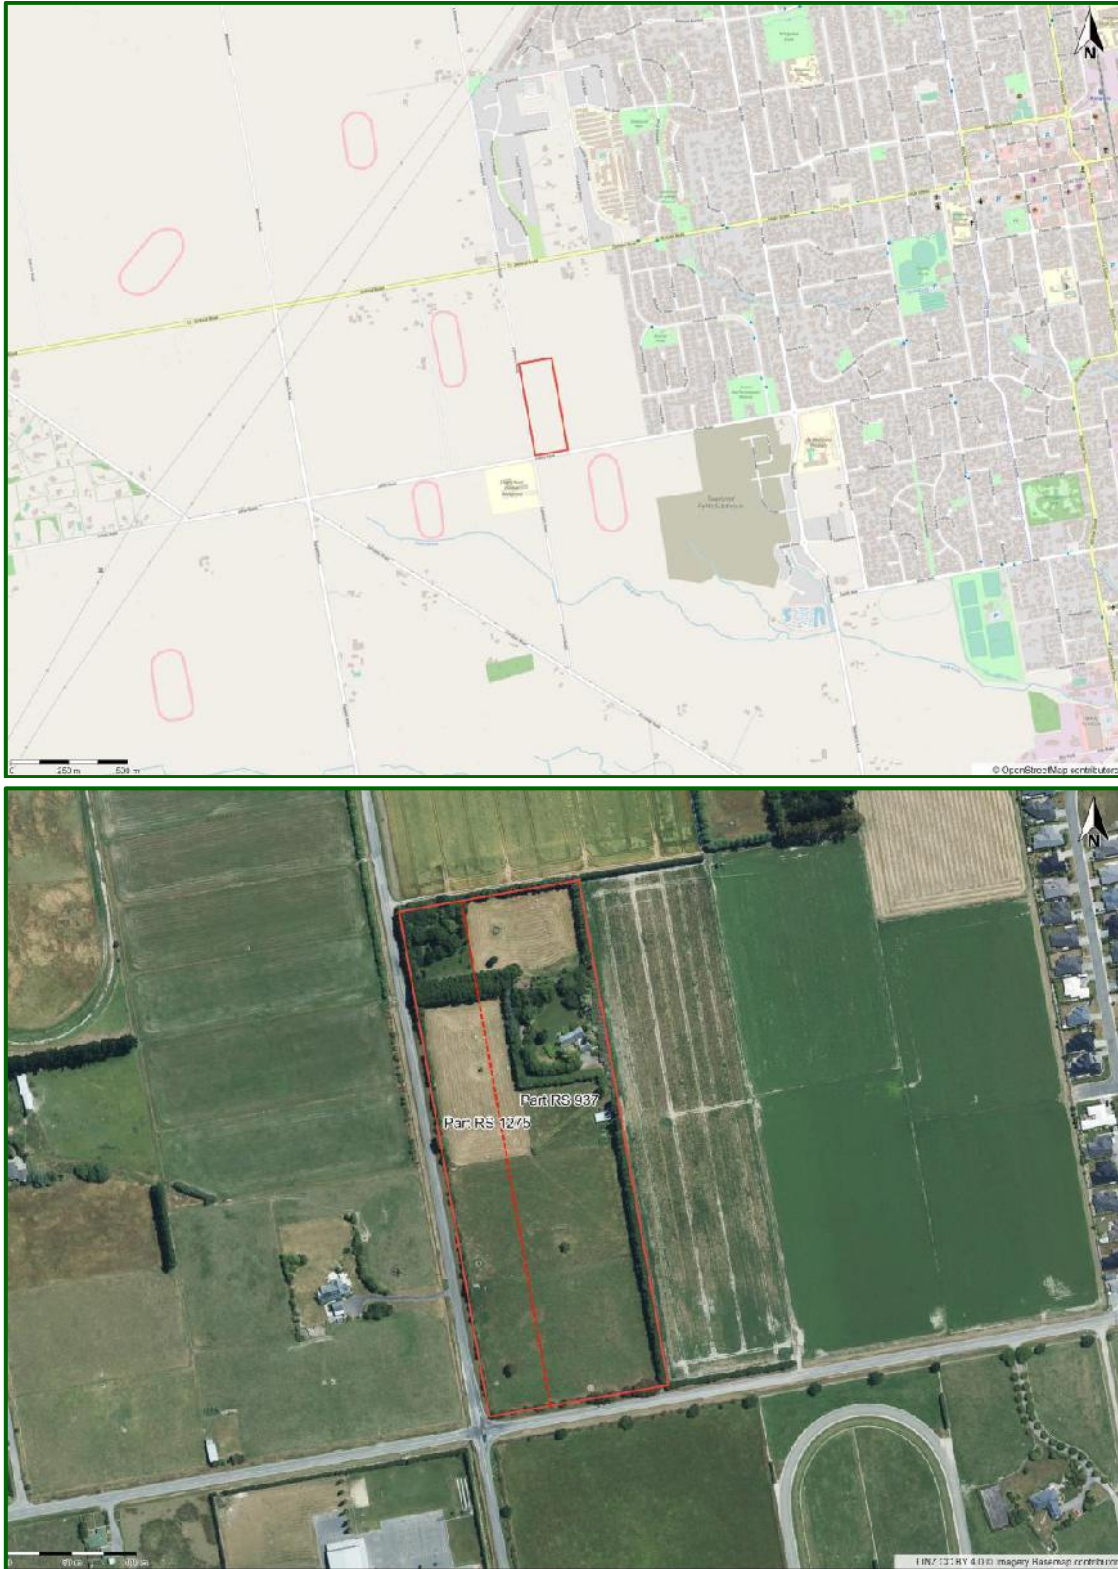
Figure 1 – Location Plan

The subject of this investigation is located at 126 Lehmans Road in Rangiora, Canterbury, from herein referred to as 'the site'. The site is legally described as Part RS 1275 and Part RS 937 and is 5.57ha, as shown in **Figure 1** below.

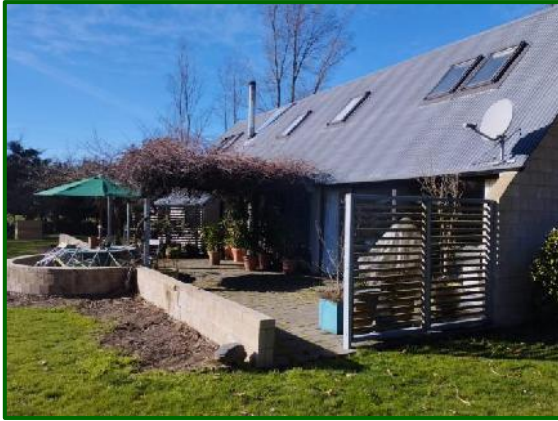
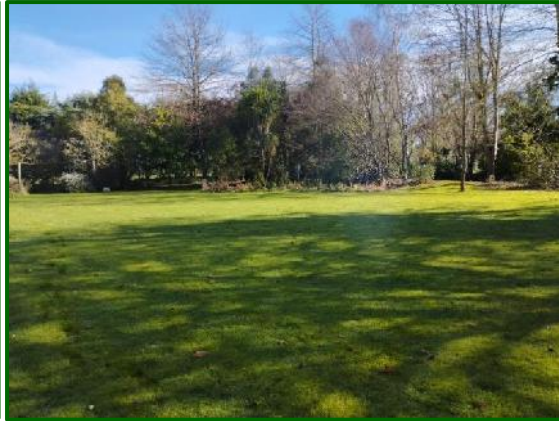
Photos 1 & 2 – Dwelling and curtilage area

The site contains a two-storey concrete block dwelling with attached garage. A patio entertainment area is present on the north side of the dwelling. The surrounding curtilage area is a grassed lawn and landscaped area. A timber and corrugated iron shed is present to the south-east of the dwelling. The shed has a concrete base and is used for firewood storage and storage of a lawn mower and quad bike.

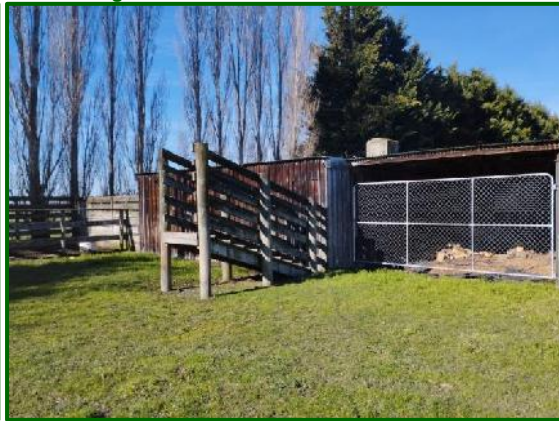
Photo 4 – Deer yards and haybarn

The paddocks are currently used for cow grazing. The client who was present at the time of the site inspection stated that since the 1990's the site was used for deer grazing. Deer yards and a haybarn are present in the paddock to the south of the dwelling. The deer yards and haybarn are a timber structure. A small domestic vegetable garden and water tank are present in a small, fenced pen to the south of the deer yards.

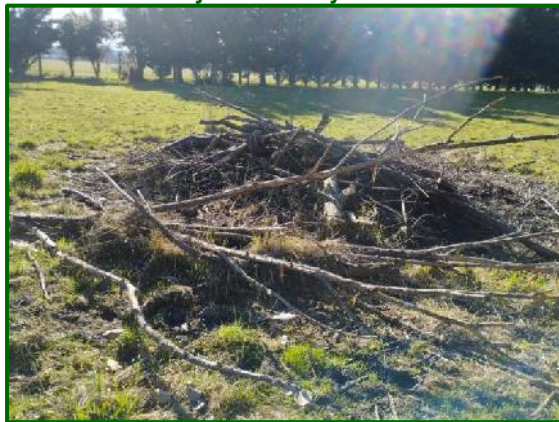
Photo 6 – Burn area

The burn area, identified in the 2021 aerial photograph, present in the paddock to the north of the dwelling was visible during the site inspection. The burn area contained green waste only. As the portable XRF was available at the time of the site inspection, it was used as a screening tool to test the soils at the base of the burn area. The XRF readings show arsenic and lead concentrations below the device limit of detection. The XRF readings are shown in **Table 2** below.

A burn area is visible in the latest aerial photograph. The site inspection and XRF screening confirmed the burn area has been used for green waste only and therefore does not constitute an intentional or accidental release of hazardous substances in sufficient quantity to pose a risk to human health.

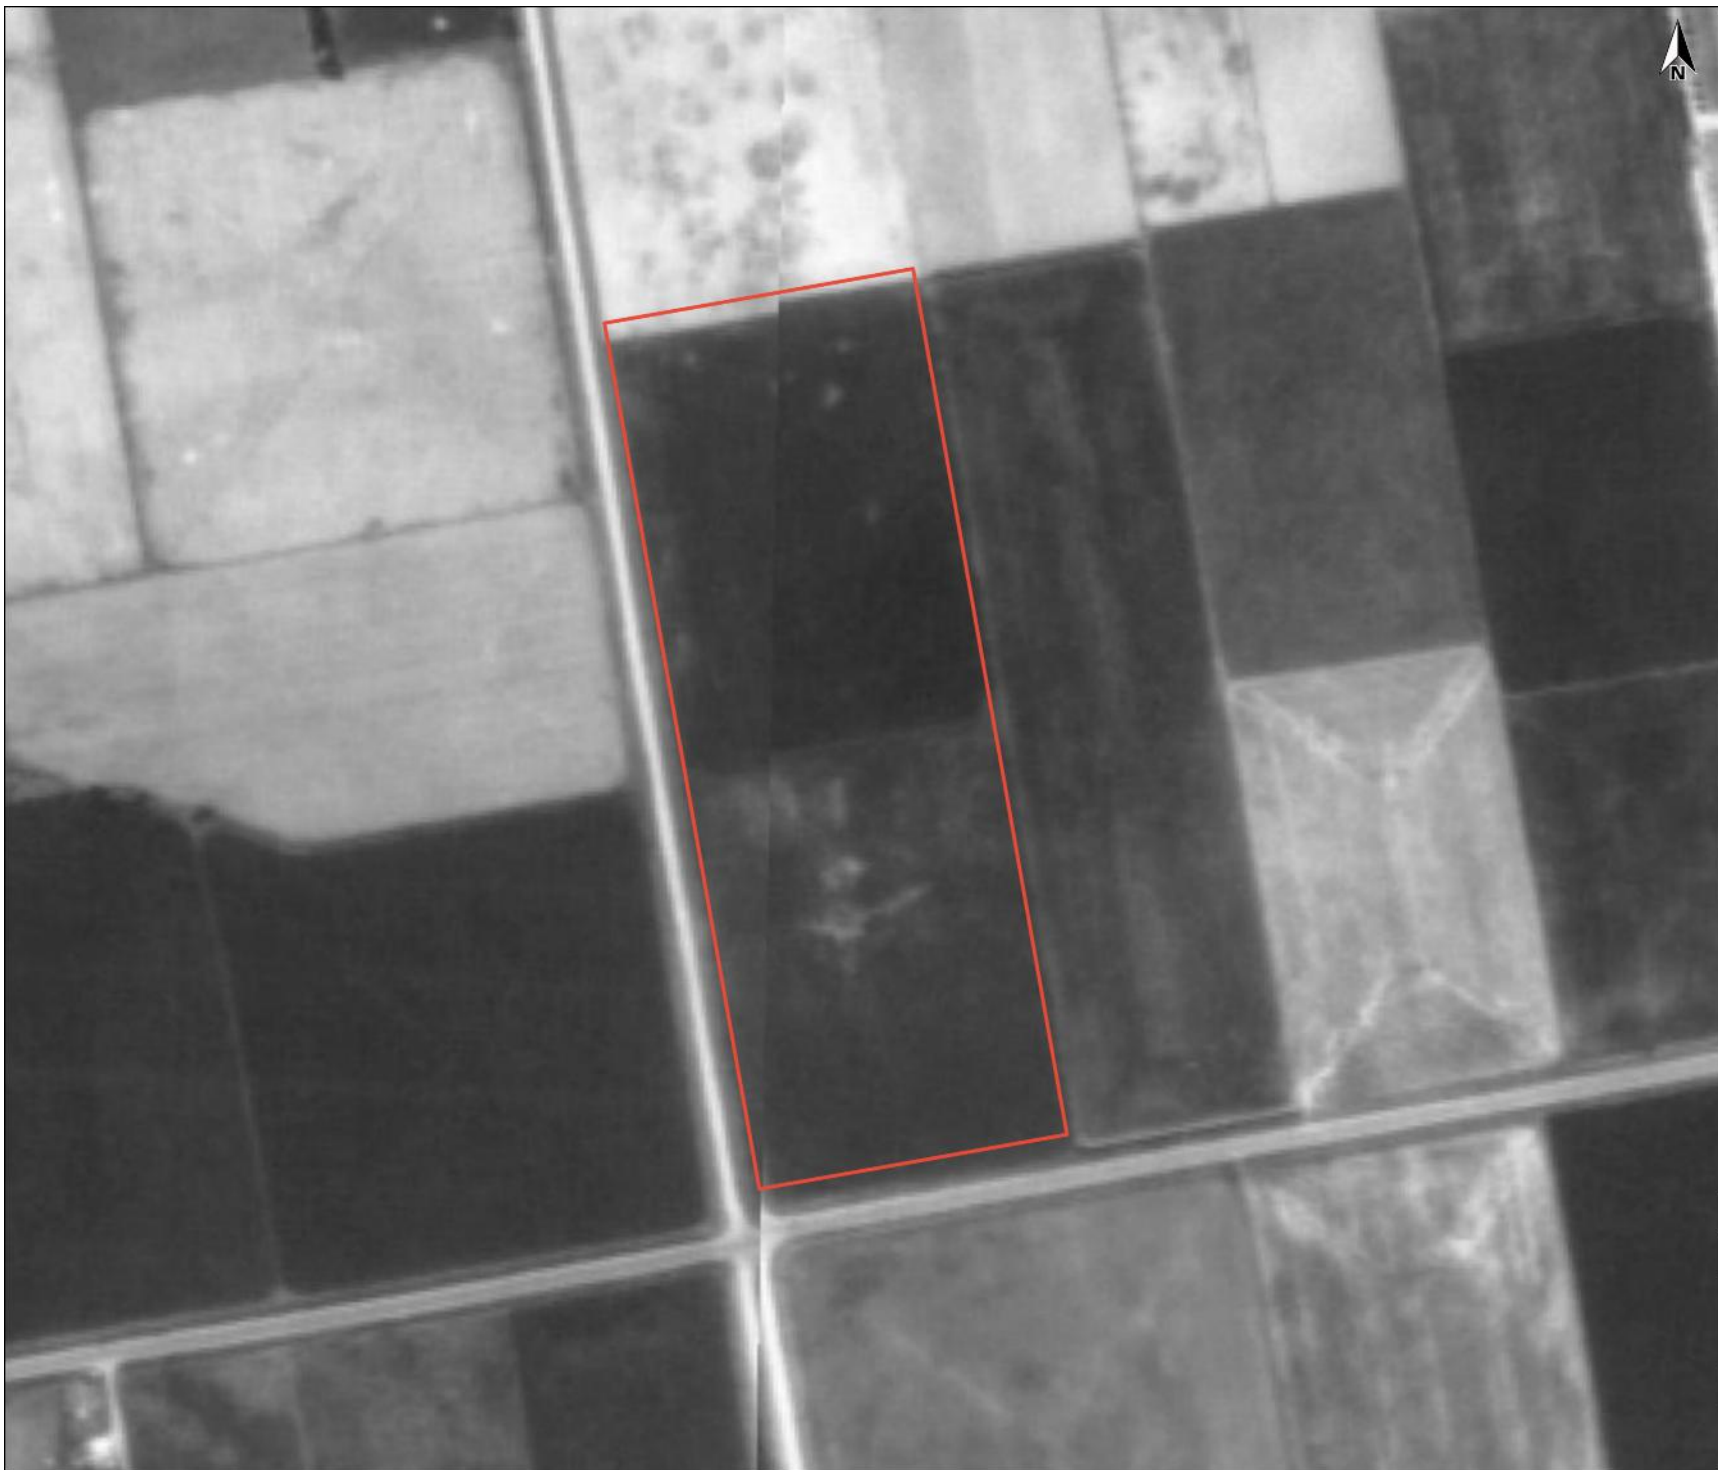
Title: 1980 Historical Aerial Photograph		
Client: Miranda Hales		
Project: 126 Lehmans Road	Drawn: HG	Appendix: C Size: A4
Date: 13-07-2023	Checked: NP	
Proj No.: 779	Scale: 1:3425	Version: Final

- The **1973** aerial photograph shows no significant changes to the site or surrounding area.
- The **1980** aerial photograph shows no significant changes to the site or surrounding area.

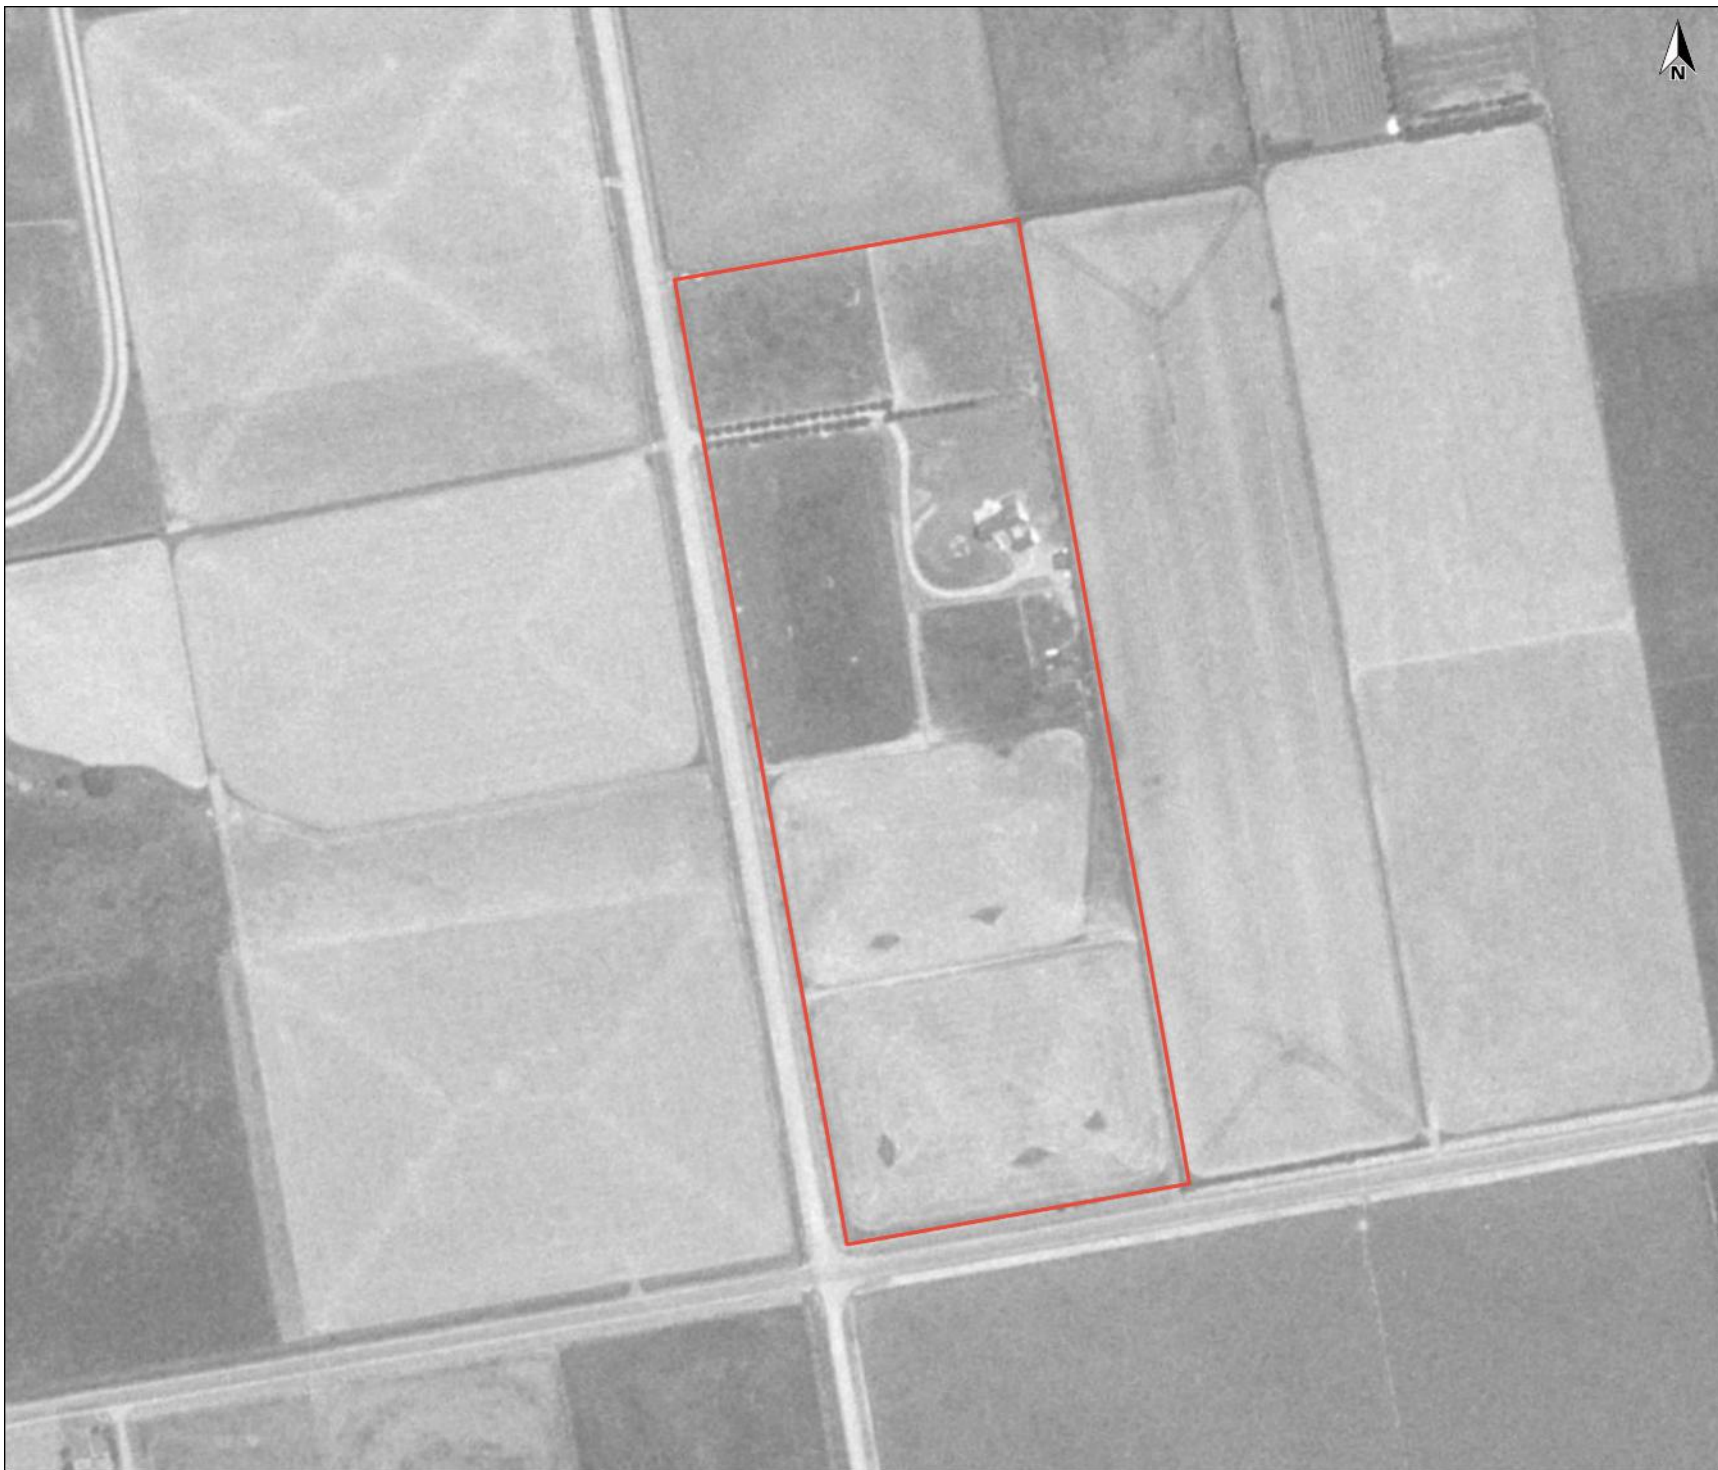
Title: 1994 Historical Aerial Photograph		
Client: Miranda Hales		
Project: 126 Lehmans Road	Drawn: HG	Appendix: C Size: A4
Date: 13-07-2023	Checked: NP	
Proj No.: 779	Scale: 1:3076	Version: Final

- The **1994** aerial photograph shows a dwelling, garage and shed now present at the site. The surrounding land remains vacant and in pasture.
- The **2000** aerial photograph shows no significant changes to the site. A dwelling is now present on land to the west of the site.

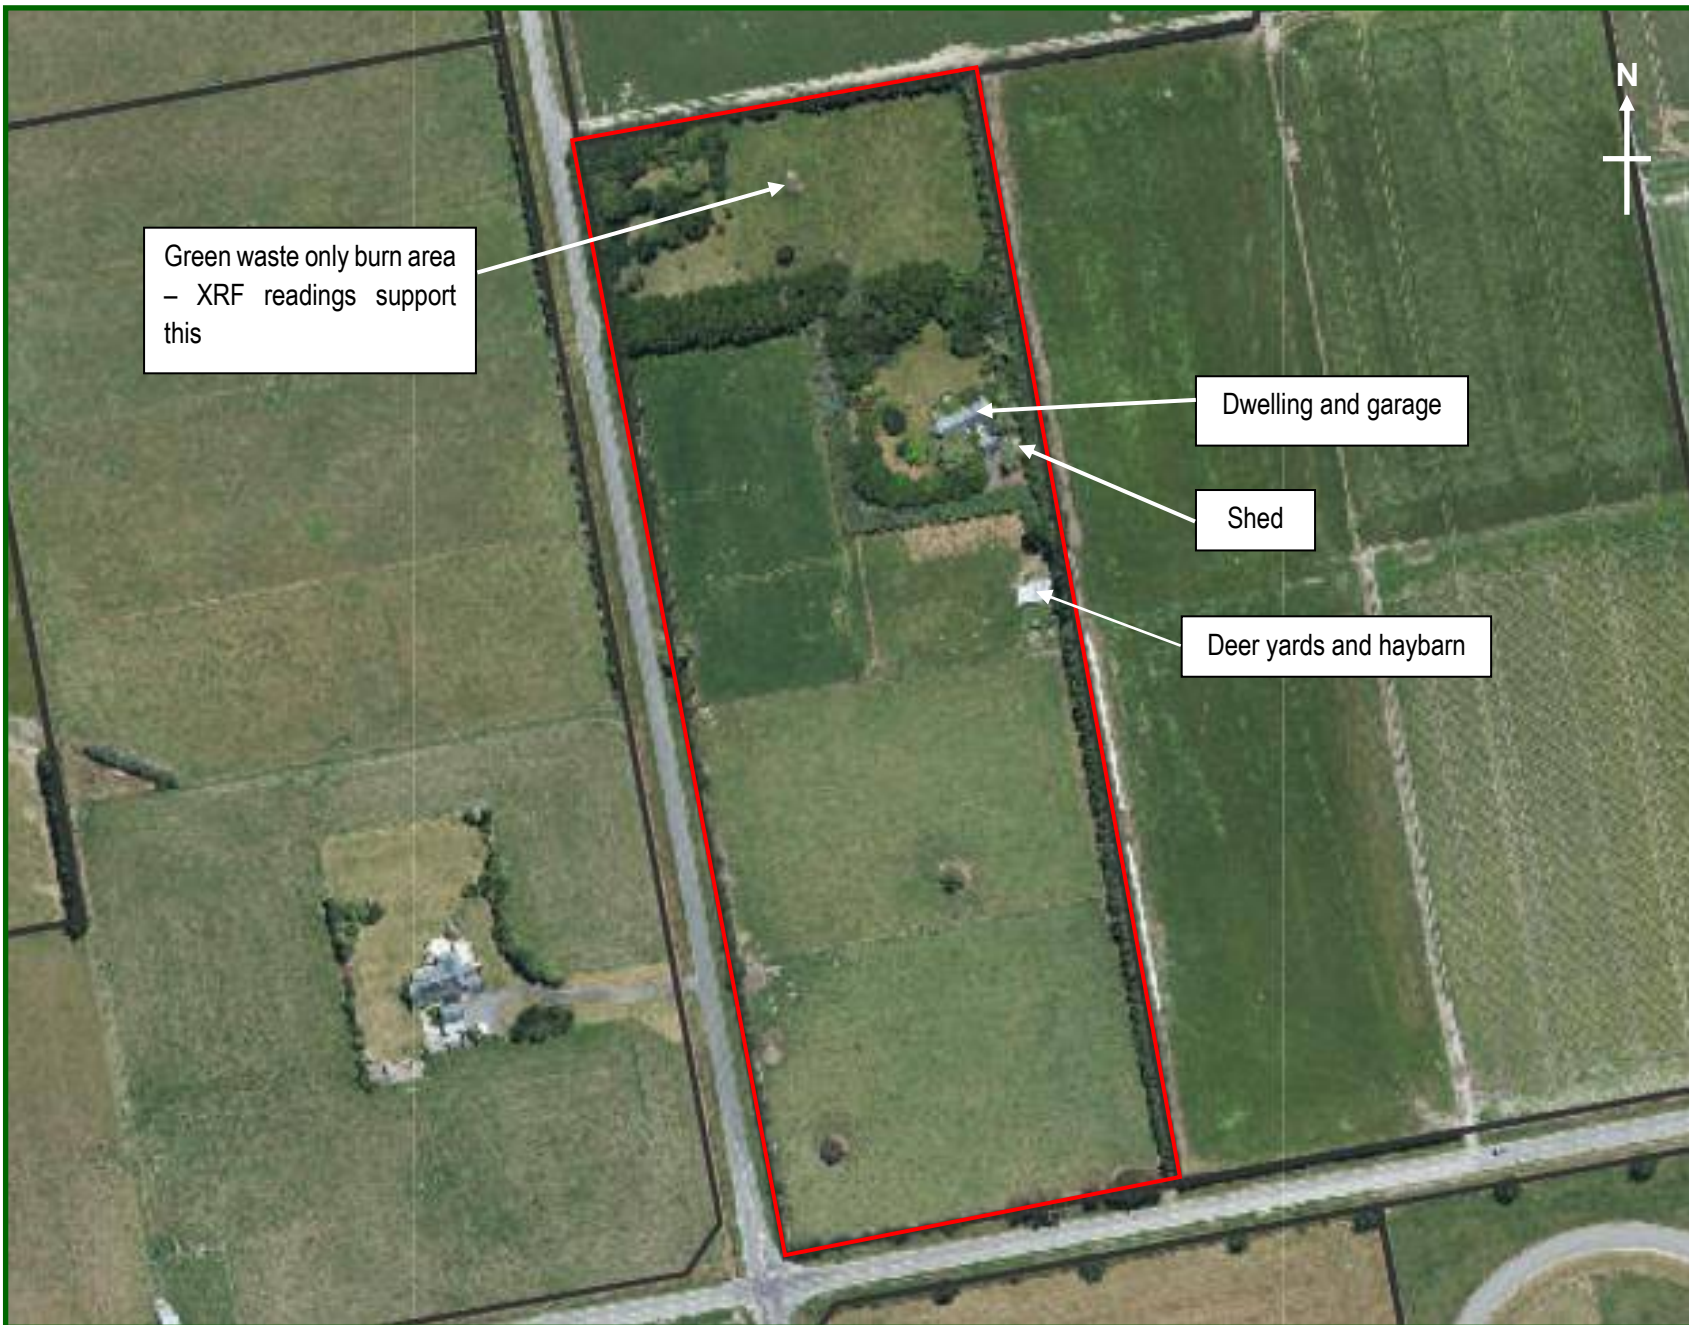
Appendix D – Site Inspection Plan

Green waste only burn area
 – XRF readings support this

Dwelling and garage
