the submissions of B & A Stokes on
the Waimakariri Proposed District
Plan (#214) and Variation 1 (#29)

**PRIMARY EVIDENCE OF DAVID
JOHN ROBOTHAM
ON BEHALF OF B AND A STOKES
(Contamination)**

4 March 2024

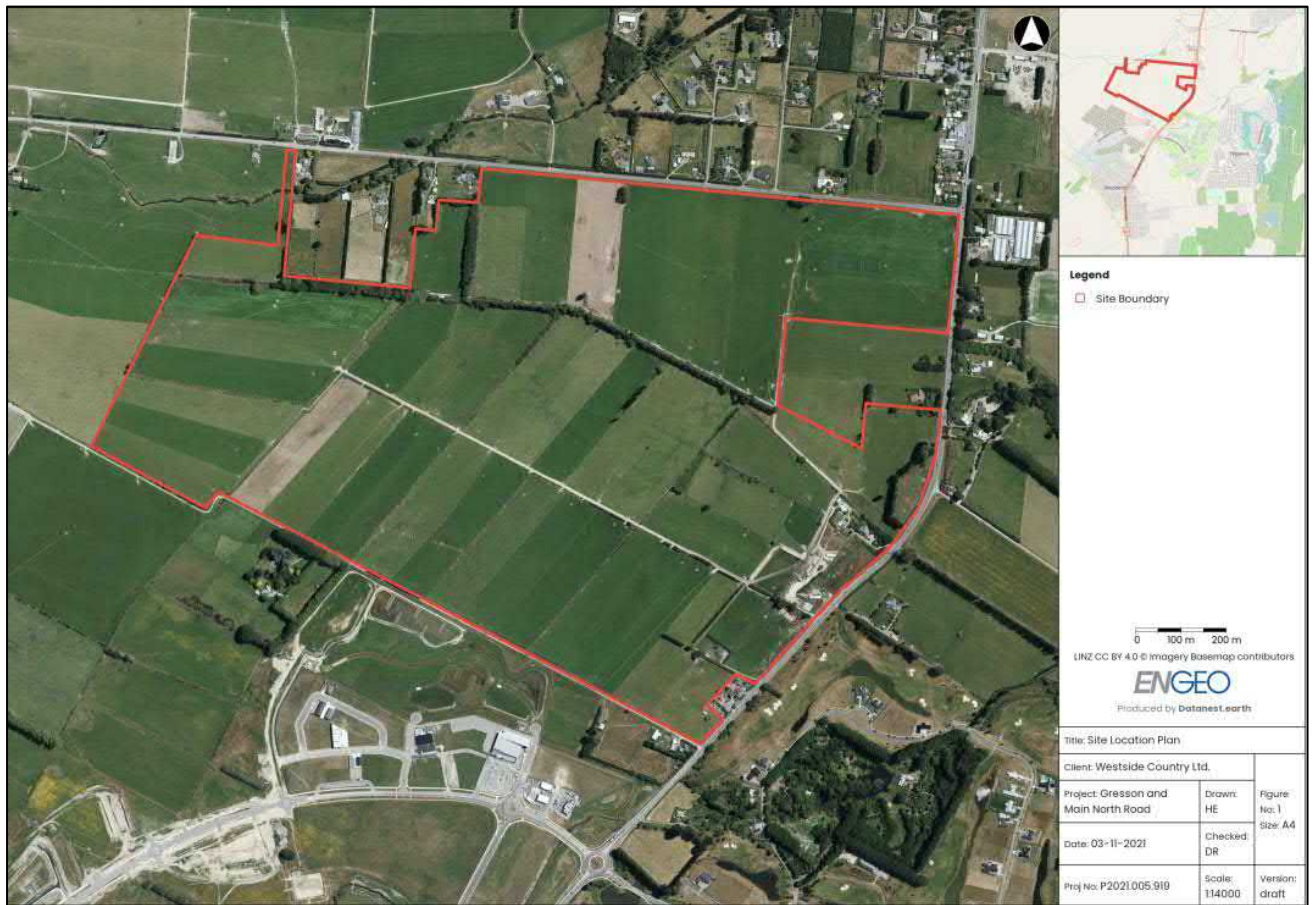
Figure 1: Site Location Plan

The site location is presented in Figure 1. The site identification, history, conditions and surrounding environment information are presented in Section 2.1 below:

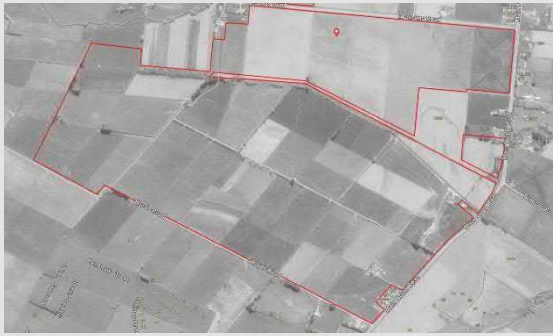
Date	Source	Description	Photo
1975-1979	Canterbury Maps Waimakariri District Council	The land appears to remain largely unchanged. Potential crop farming along the northwest boundary at the adjacent property has taken place.

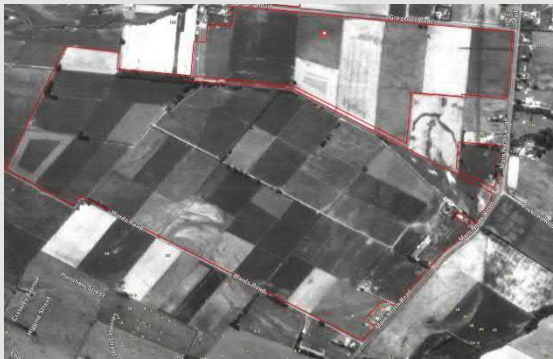
1980-1984	Canterbury Maps Waimakariri District Council	The land appears to remain largely unchanged within and outside the site boundary. Residences adjacent to the south are more predominant.

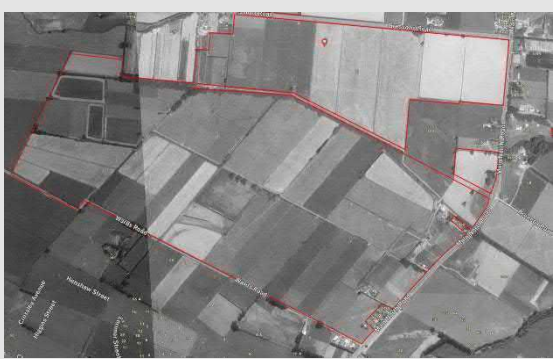
1985-1989	Canterbury Maps Waimakariri District Council	Resolution is poor, but it looks like crops has been rotated through different parcels.	 
1990-1994	Canterbury Maps Waimakariri District Council	Land appears to be largely unchanged from previous photos. The potential irrigation catchment has been slightly altered along the north-east boundary.

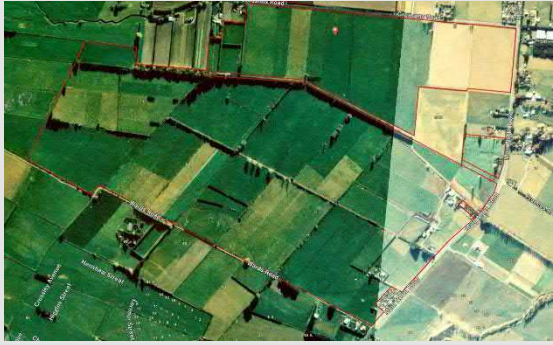
Date	Source	Description	Photo
1995-1999	Canterbury Maps Waimakariri District Council	Additional buildings appear along the eastern boundary adjacent to Main North Road.

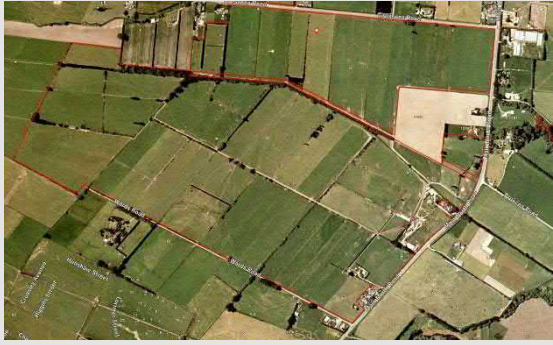
2000-2004	Canterbury Maps Waimakariri District Council	Land appears to remain largely unchanged from previous photo. Irrigation streams are more predominant. What appear to be watering troughs are visible throughout the fields. Residential properties adjacent to the east of the site are more developed.

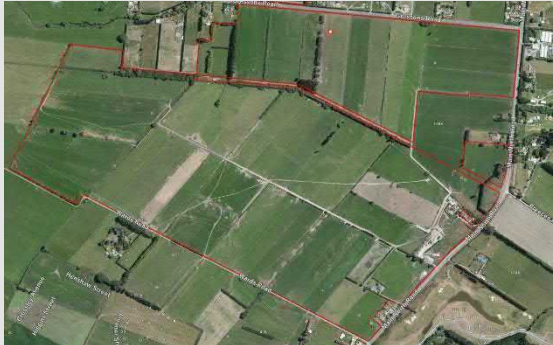
2010-2014	Canterbury Maps Waimakariri District Council	Additional structures have been added along the eastern Main North Road boundary. As well as a residential dwelling. Surrounding land has become more developed with residential properties.

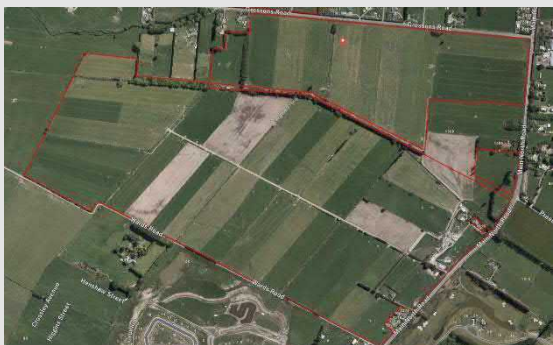
2015-2019	Canterbury Maps Waimakariri District Council	Similar land-use as previous photo, with slightly more activity along the eastern Main North Road boundary.

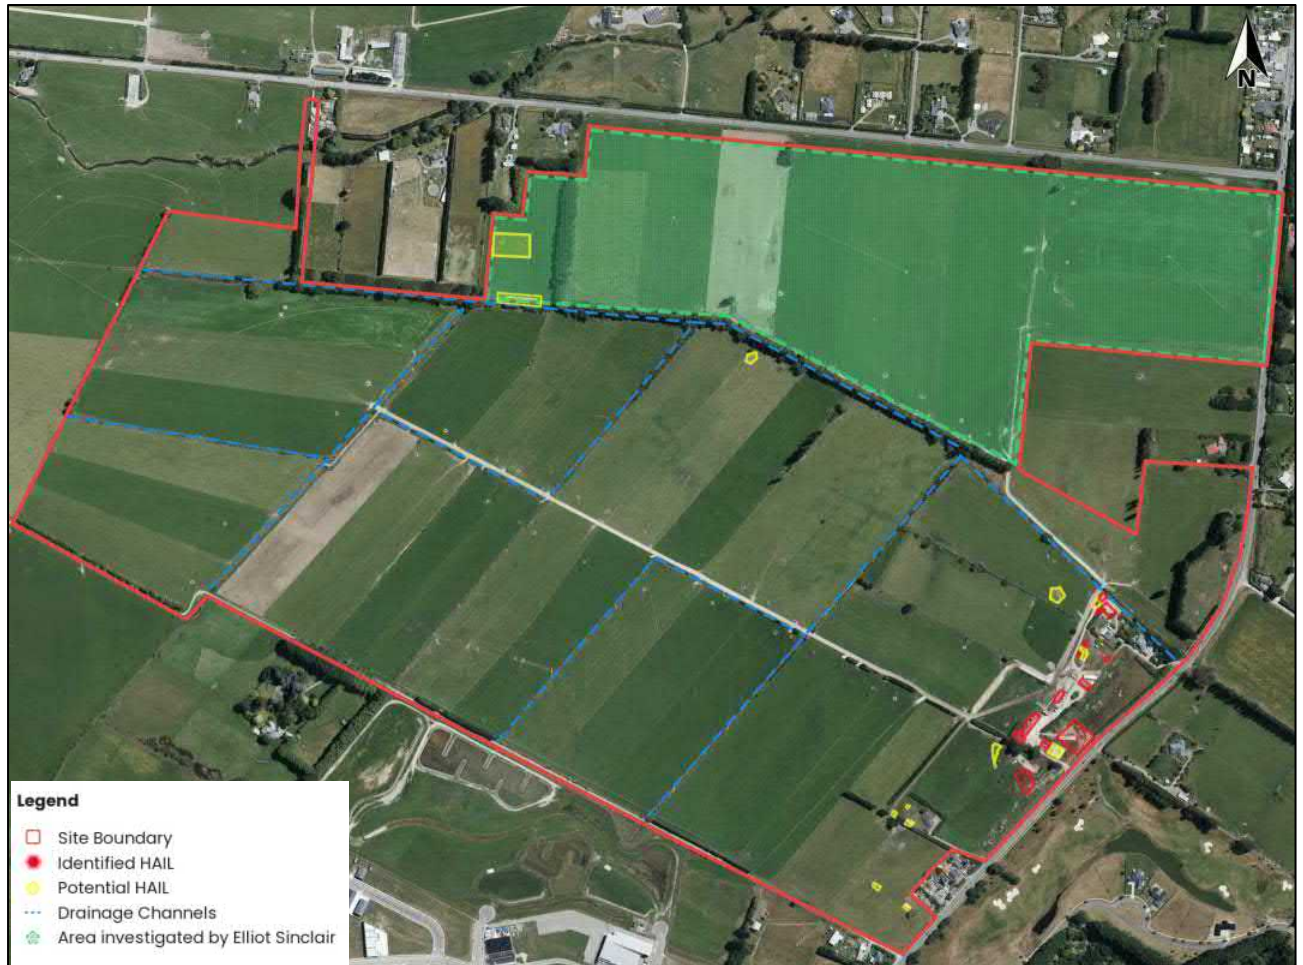
Figure 2: Site Walkover Overview

Site walkover observations are presented in Figures 2, 2.1, 2.2 and 2.3.

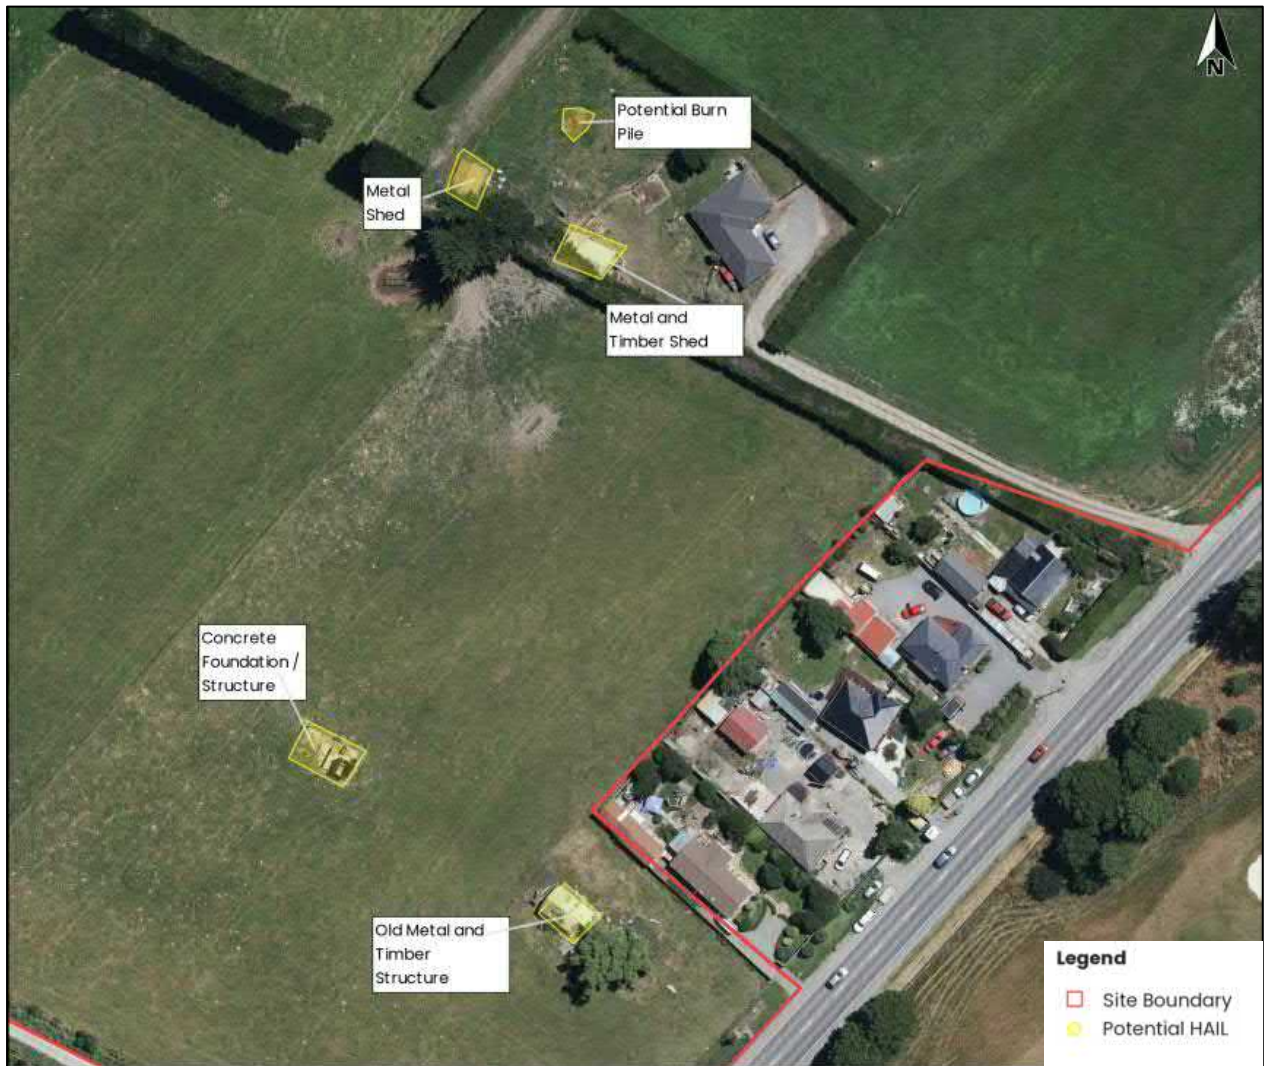
Figure 3: Areas of Concern South

Figure 2.3 identifies potential areas of concern in the southern portion of the site, shown below.

During the site walkover, it was noted that various storage containers of agrichemicals, fuel tanks, burn pits, empty drums, vehicle parts, old farm equipment, treated timber and scrap metal existed primarily along the eastern boundary of the site as denoted in Figure 2.1. Additionally, two burn pits and a demolished structure exist in the north-western area of the site as shown in Figure 2.2. There is also a potential burn pit at the residential dwelling towards the southern end of the site as shown in Figure 2.3.

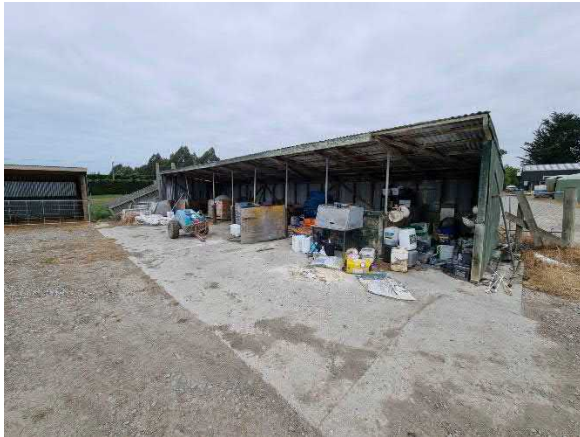
Photo 1: Bulk chemical storage at the eastern boundary of site.

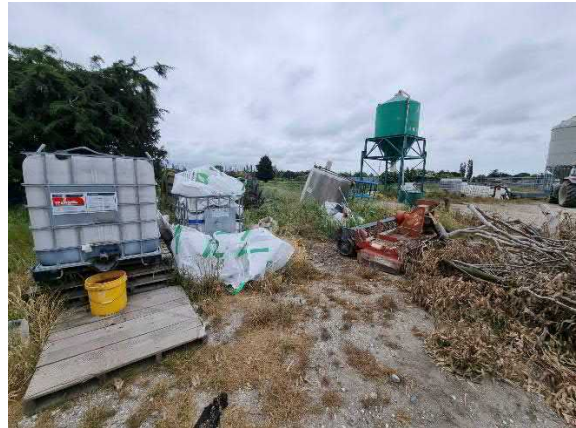
Photo 2: Bulk fertiliser, agrichemical and equipment storage at the eastern boundary of site. Chemicals noted included: Nitro humus 323, Teat X Humic acid, NPK 8.3.6 liquid fish fertilizer, and Castrol antifreeze.

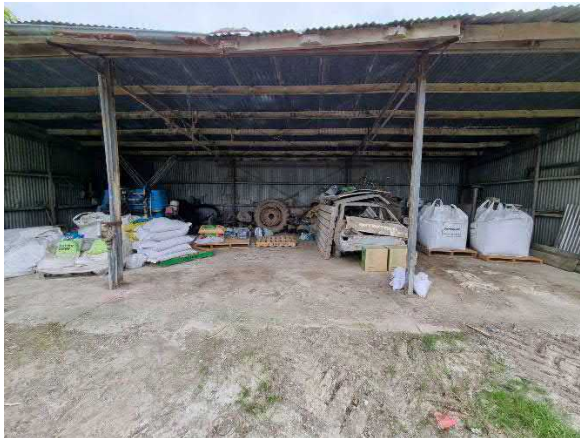
Photo 3: Bulk fertiliser storage, motor vehicle storage and agrichemical storage at eastern boundary of site. Chemicals noted were: Calcium supplements, Rock phosphate Magnesium oxide, and Vitophos for fertiliser.

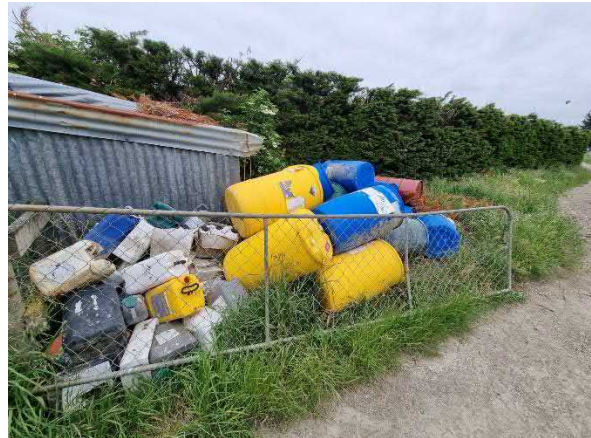
Photo 4: Used drum storage along shed at eastern boundary of site. Chemical labels included: Acid Teat spray, and Roundup Organophosphates.

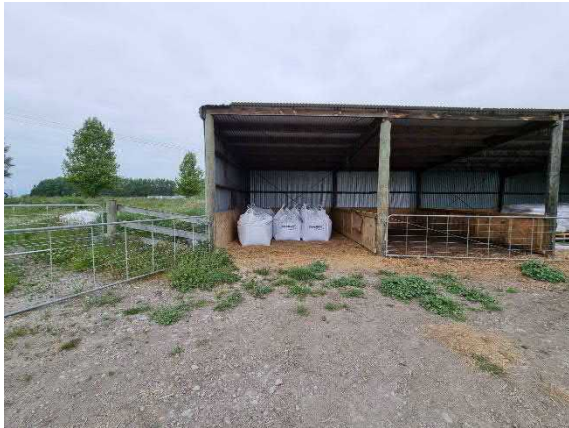
Photo 5: Bulk fertiliser storage along eastern side of site.

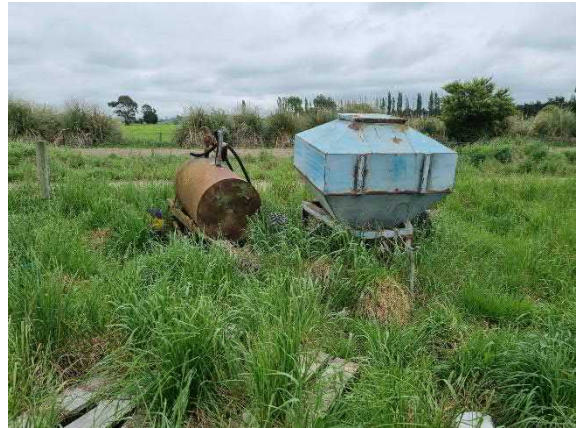
Photo 6: Above ground fuel tank towards along eastern side of site.

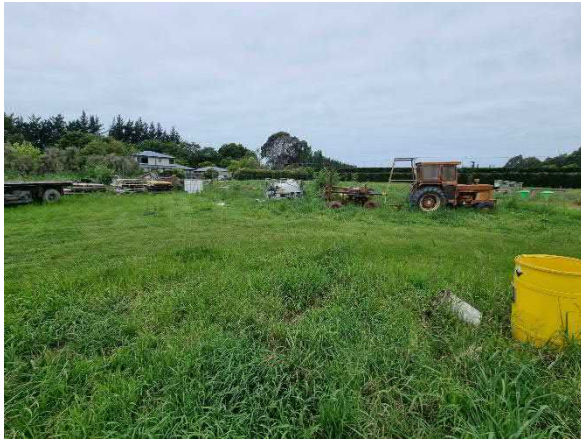
Photo 7: Farm equipment and machinery stored, drums also observed.

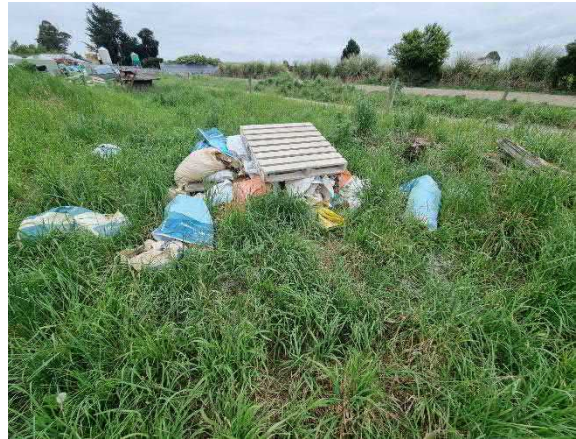
Photo 8: Old fertiliser bulk storage outside along eastern side of site.

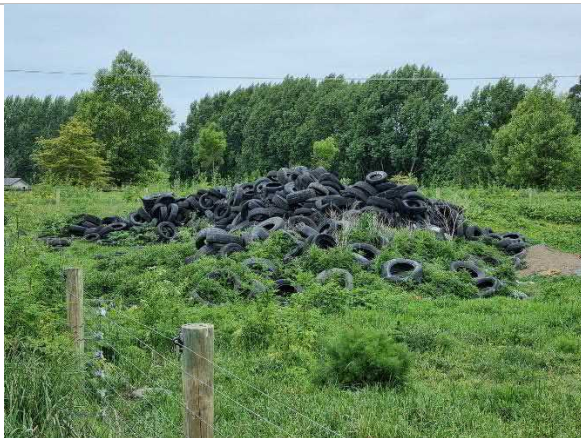
Photo 9: Outside tire storage along eastern side of site.

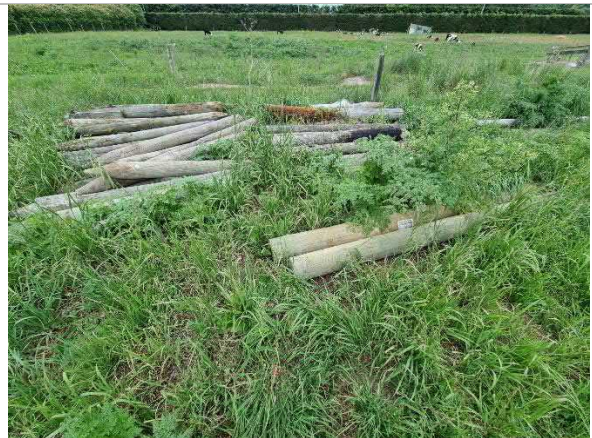
Photo 10: Potentially treated timber on open grass along eastern side of site.

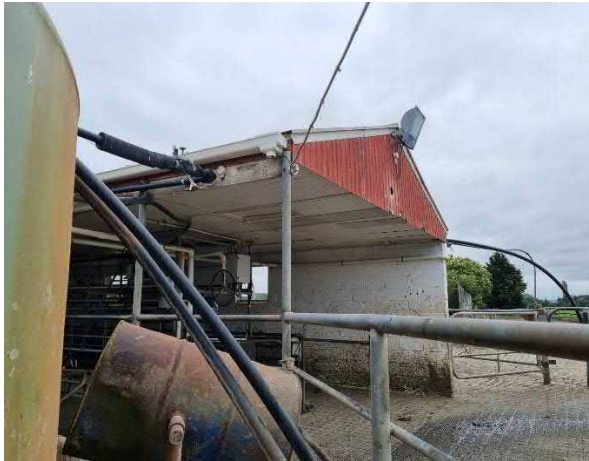
7.9 Additionally, there were building materials in a degraded condition at various locations on the Site. These materials have the potential to release asbestos fibres, which pose a risk to on-site redevelopment workers and long-term users of the Site through inhalation of fibres.

Photo 11: Asbestos in a degraded condition was observed on a milking shed along the eastern boundary of the site.

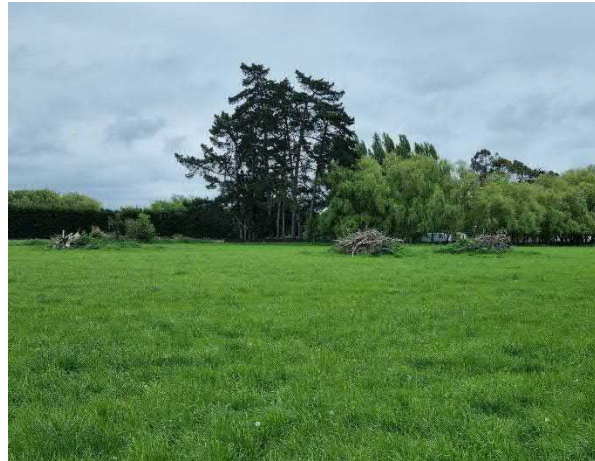
- 6.9 Mr. Stokes was also interviewed in 2020 and it was reported that irrigation lines had been installed in 2015. Stockpiled wood and vegetation was observed on the Site as well as a number of burn pads.

Photo 12: Two brush burn piles along the north-western side of the site.

- 6.10 Other than the small burn pads, the Site inspection and landowner interview did not raise other concerns about persistent ground contamination of the Site. The ES Assessment recommends that the burn pads should be removed or remediated before subdivision of the Site occurs. ES considered it highly unlikely that across the majority of the Site ground contamination from past or current activities will exceed the NES-CS soil contaminant standards for a proposed rural residential end use. ENGEO agree with the recommendation and consider that it is unlikely this should prevent the rezoning of the Site to General Residential/Medium Density Residential.

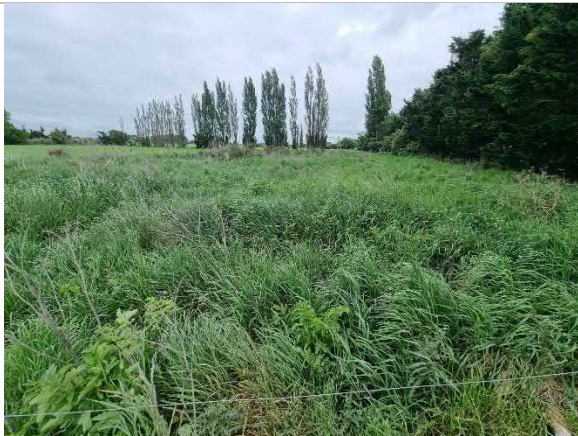
Photo 13: Marshland runs east-west along the centre of the site.

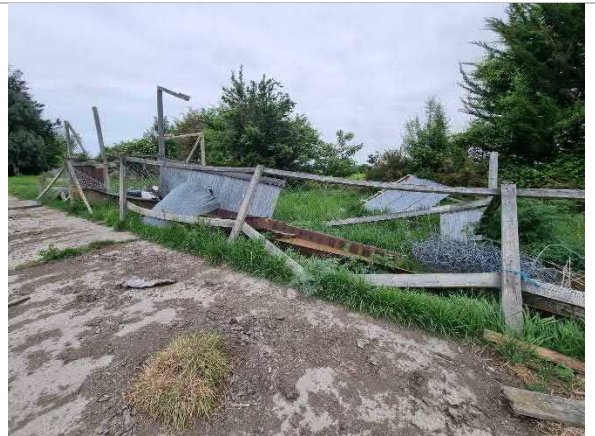
Photo 14: Remnants of an old barn / structure along the north-western side of the site.

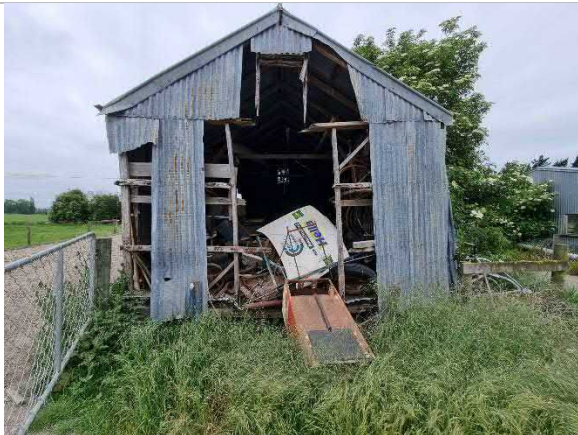
Photo 15: Scrap metal storage along the eastern side of the site.

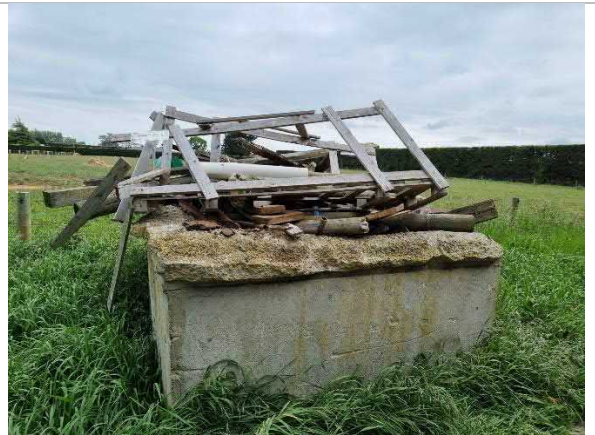
Photo 16: Storage on concrete block along eastern side of the site.

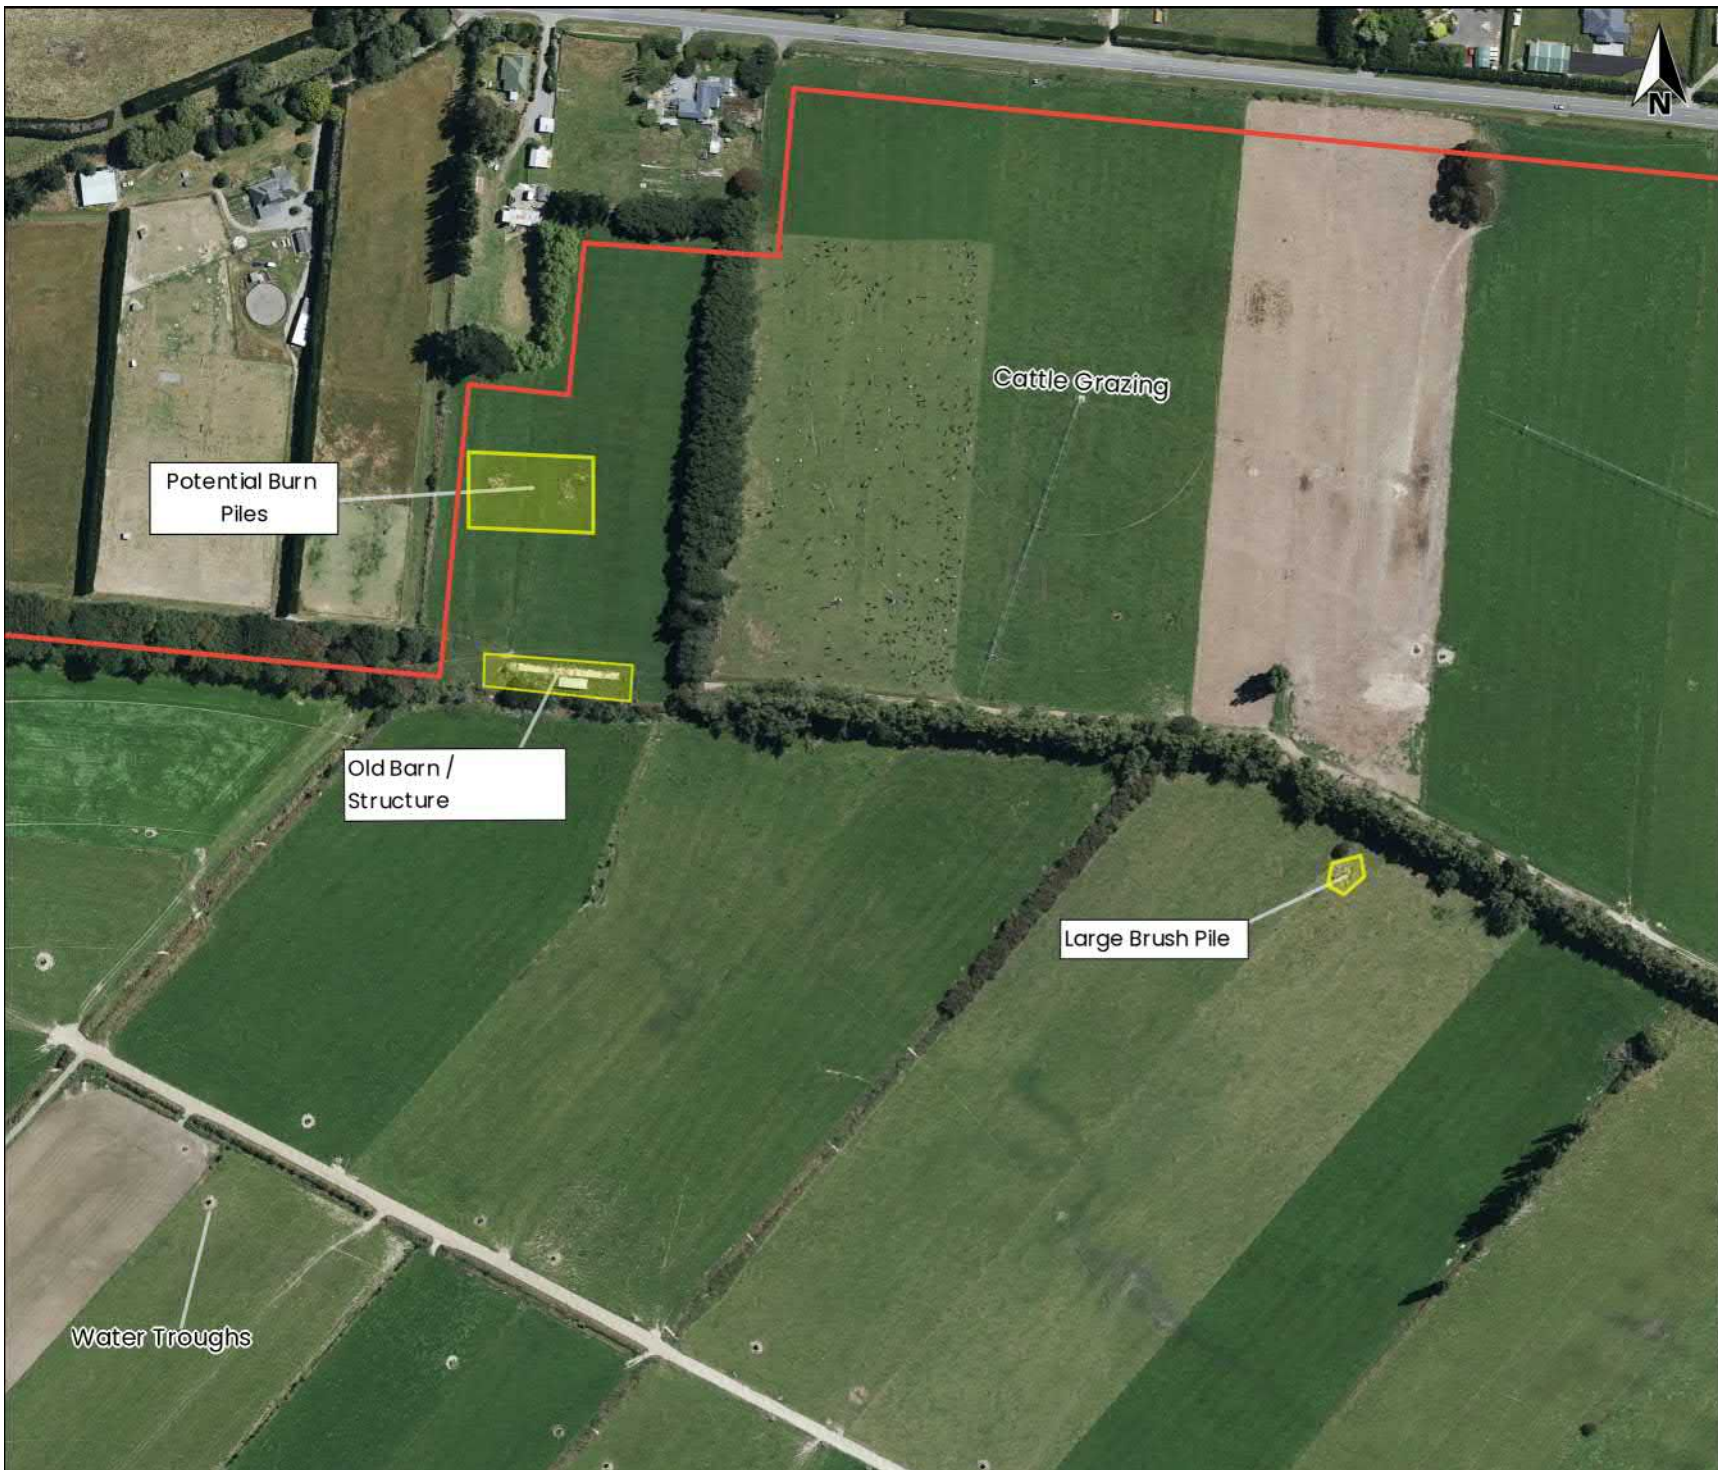
Title: Areas of Concern		
Client: Westside Country Ltd.		
Project: Gresson and Main North Road	Drawn: HE	Figure No: 2.2 Size: A4
Date: 03-11-2021	Checked: DR	
Proj No: P2021.005.919	Scale: 1:4637	Version: draft

- Legend**
- Site Boundary
 - Potential HAIL

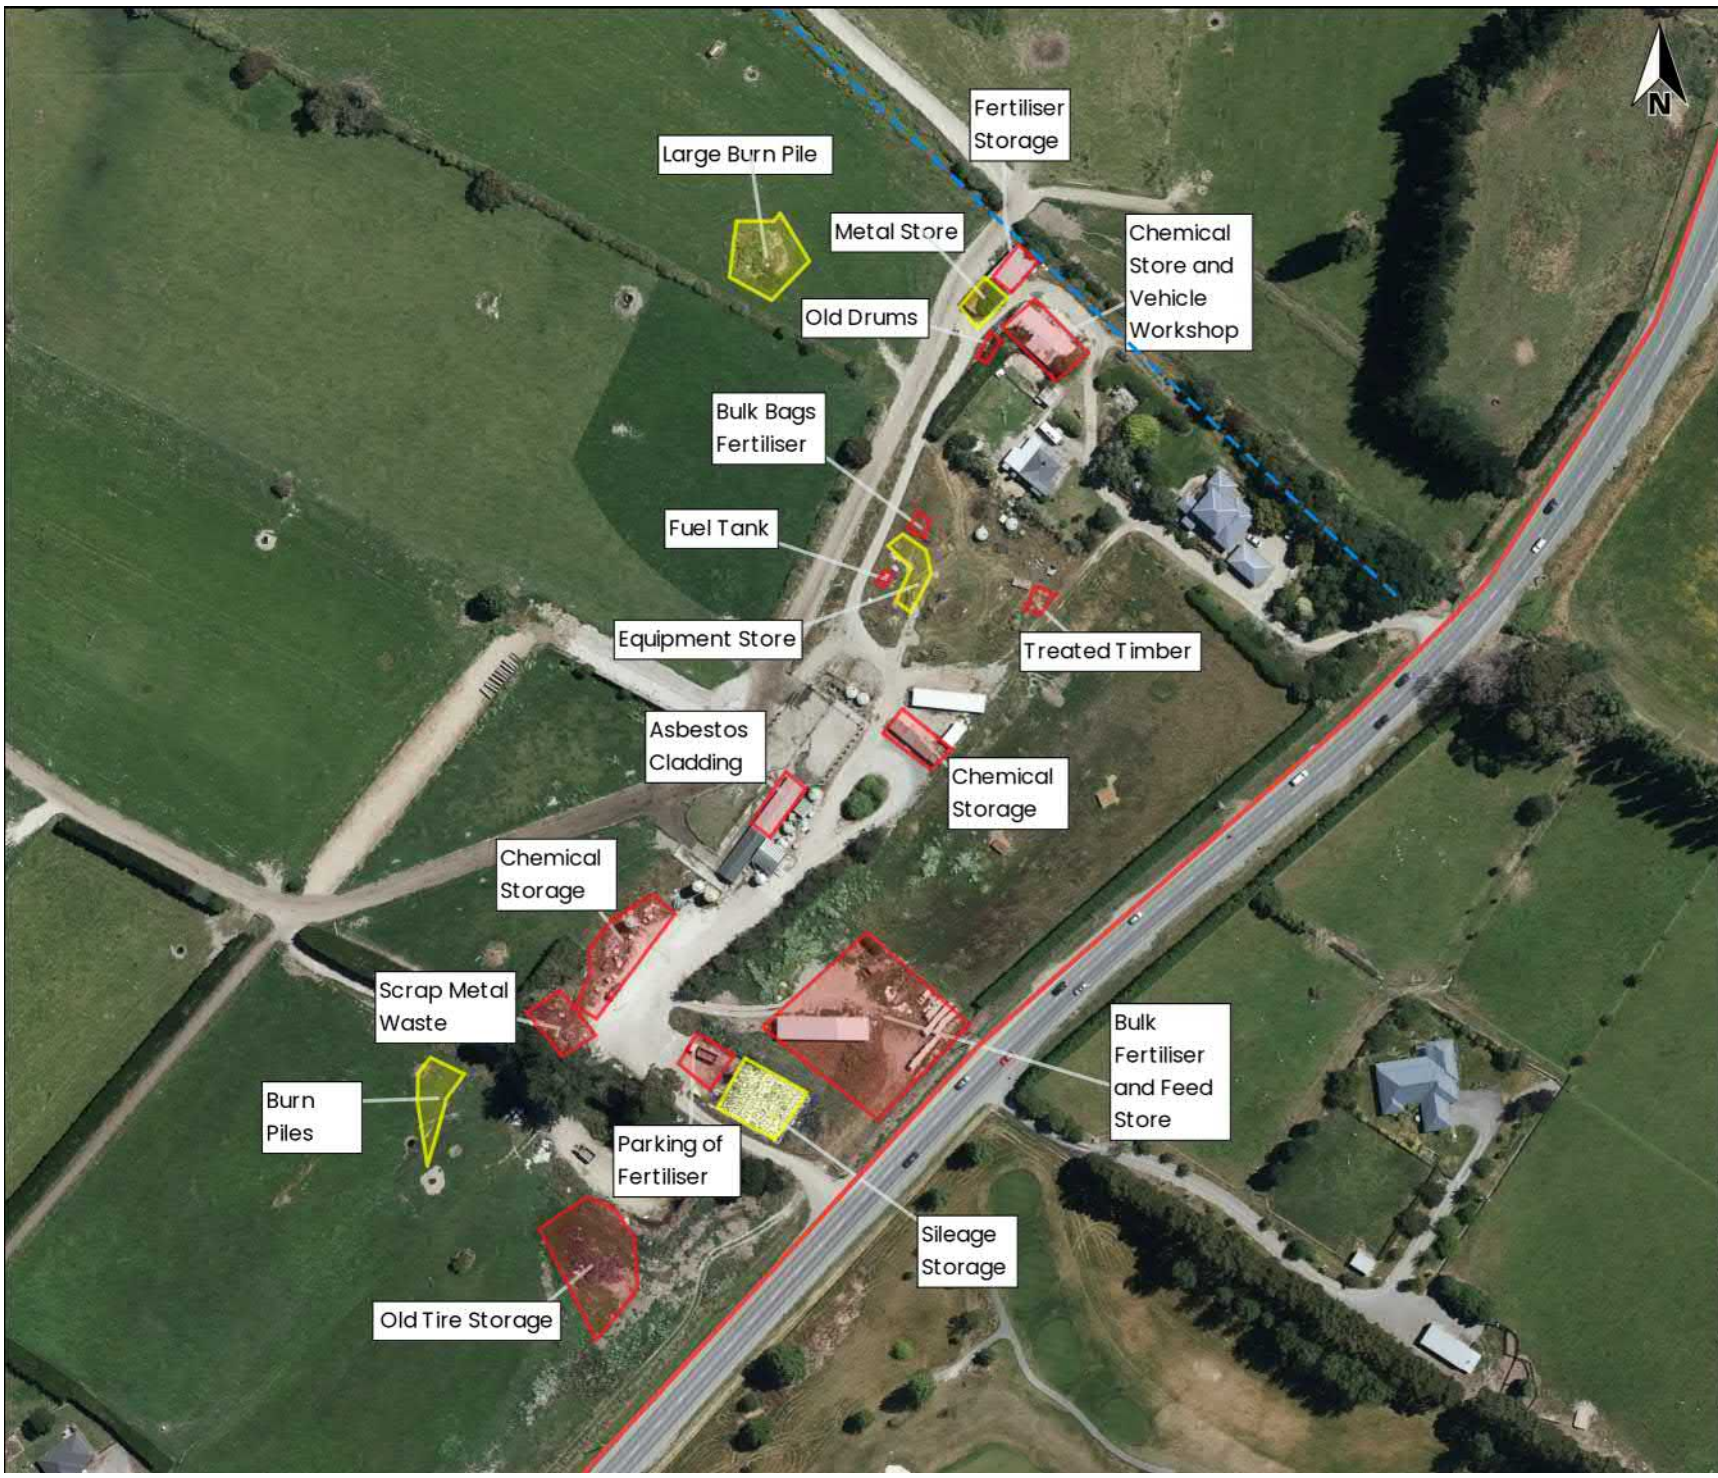
Title: Areas of Concern		
Client: Westside Country Ltd.		
Project: Gresson and Main North Road	Drawn: HE	Figure No: 2.2 Size: A4
Date: 03-11-2021	Checked: DR	
Proj No: P2021.005.919	Scale: 1:2913	Version: draft

- Legend**
- Site Boundary
 - Identified HAIL
 - Potential HAIL
 - Drainage Channels

However, a number of activities and potential activities included on the HAIL were identified during the site walk along the eastern, north-western and southern boundaries. These areas have the potential to have caused localised impact and further investigation is therefore required. This can be managed via the Resource Management (*National Environmental Standard for Assessing and Managing Contaminants in Soil to Protect Human Health*) Regulations 2011 and should also not have an impact on the proposed zone change.

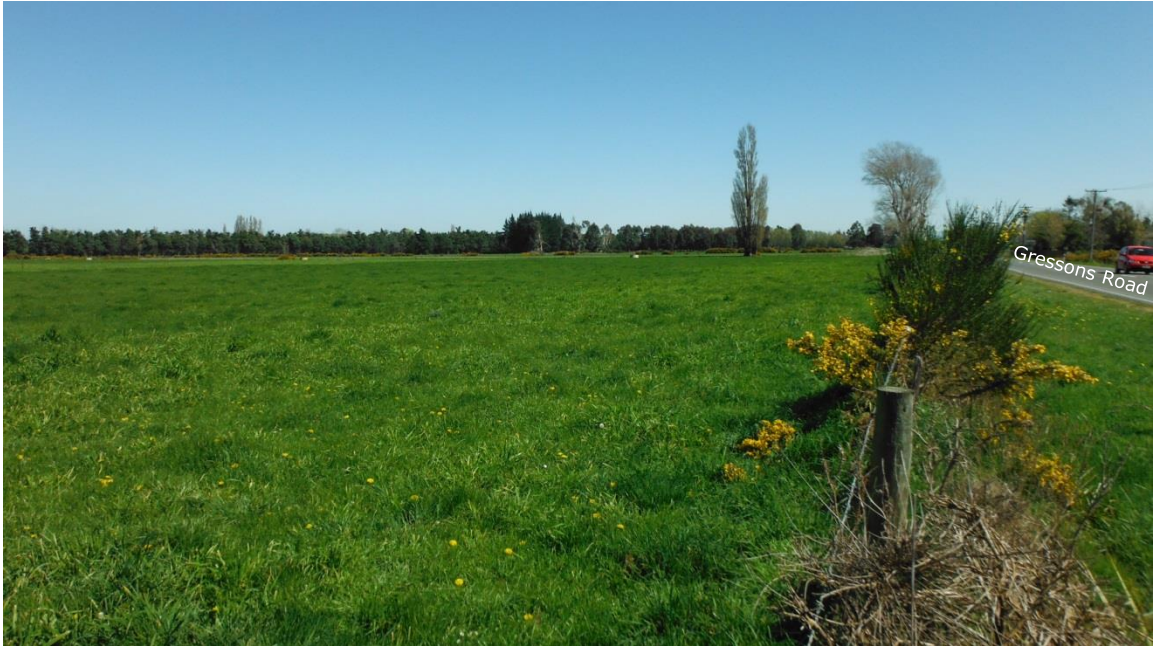
Photo 1. View across the site looking west.

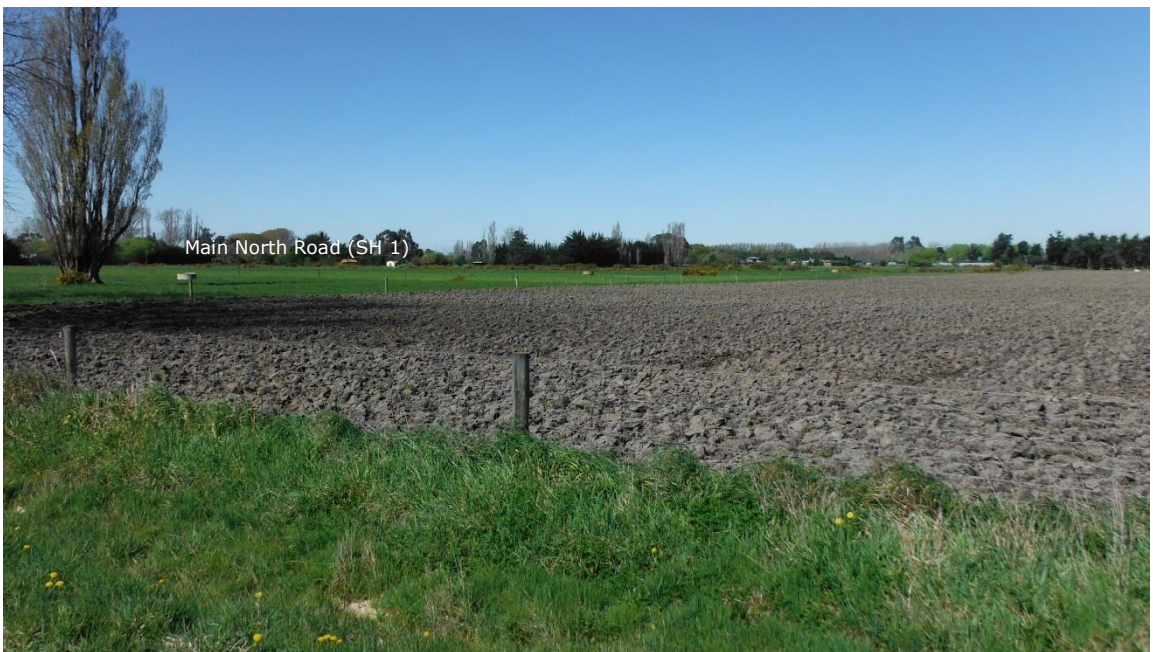
Photo 2. View across the site looking southeast towards Main North Road (SH1).

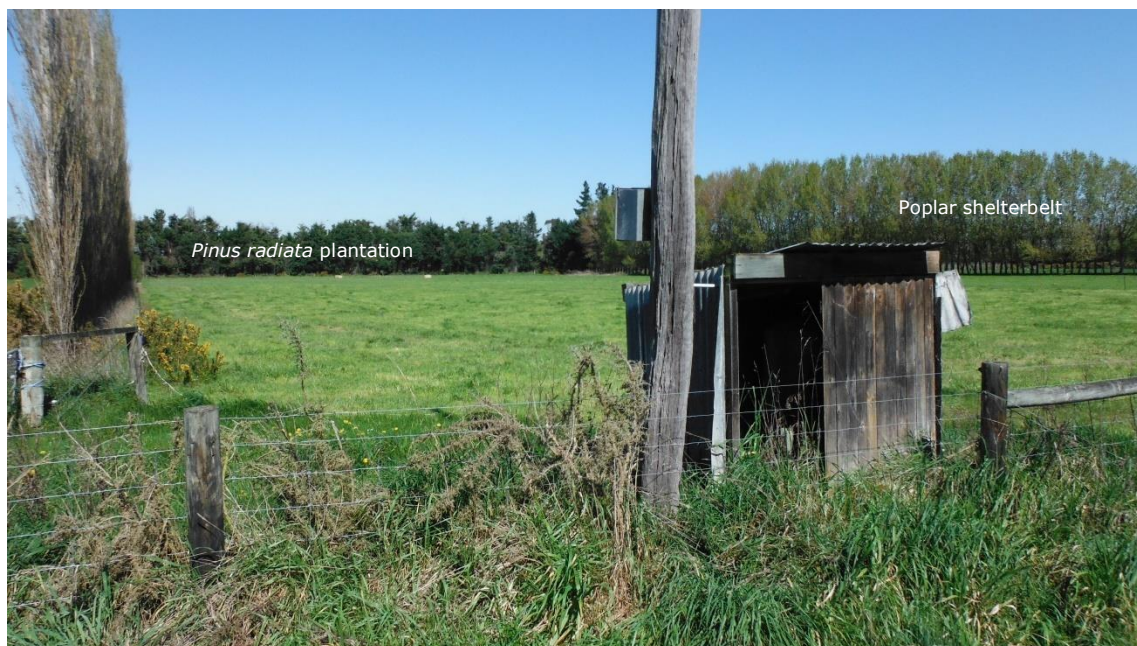
Photo 3. Power pole and disused well shed at 81 Gressons Road (looking south).

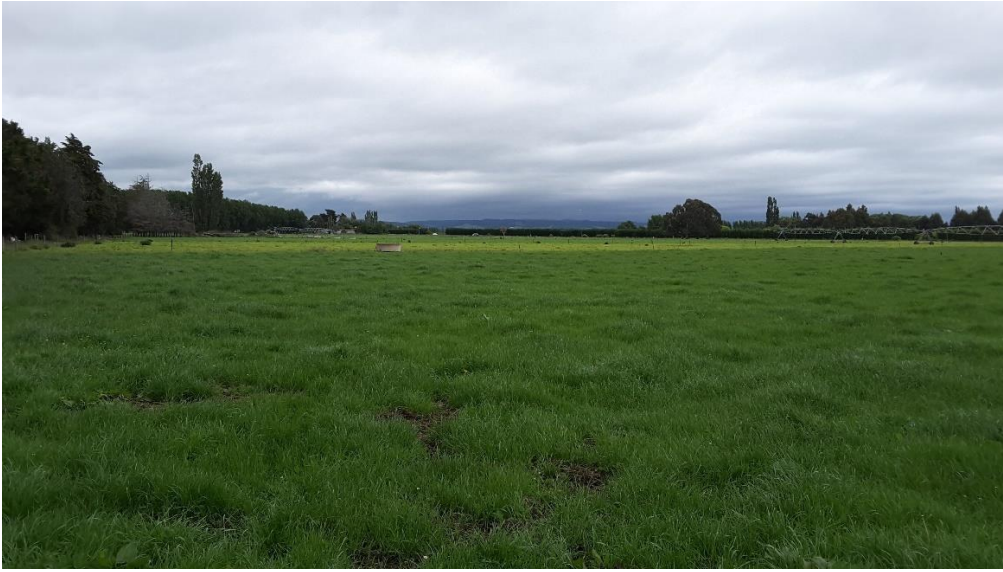
Photo 5. 81 Gressons Road (looking west).

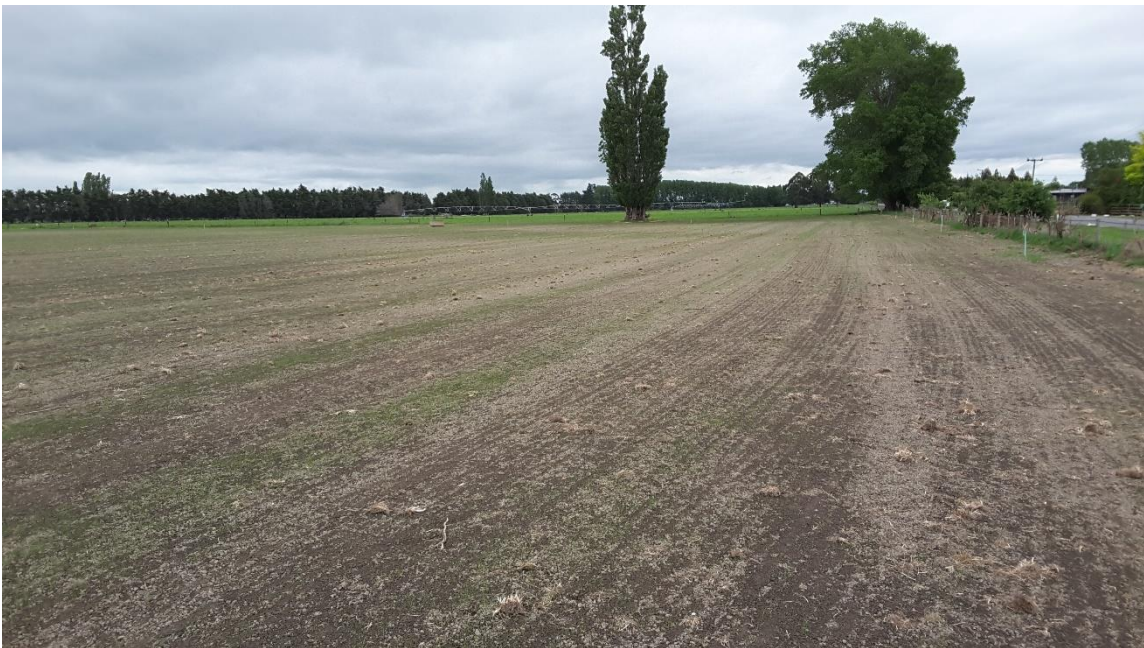
Photo 6. 1375 Main Road and 81 Gressons Road (looking west)
