GROUND CONTAMINATION ASSESSMENT

116/148 McHughs Road, Mandeville, Canterbury

On behalf of P.G. Harris

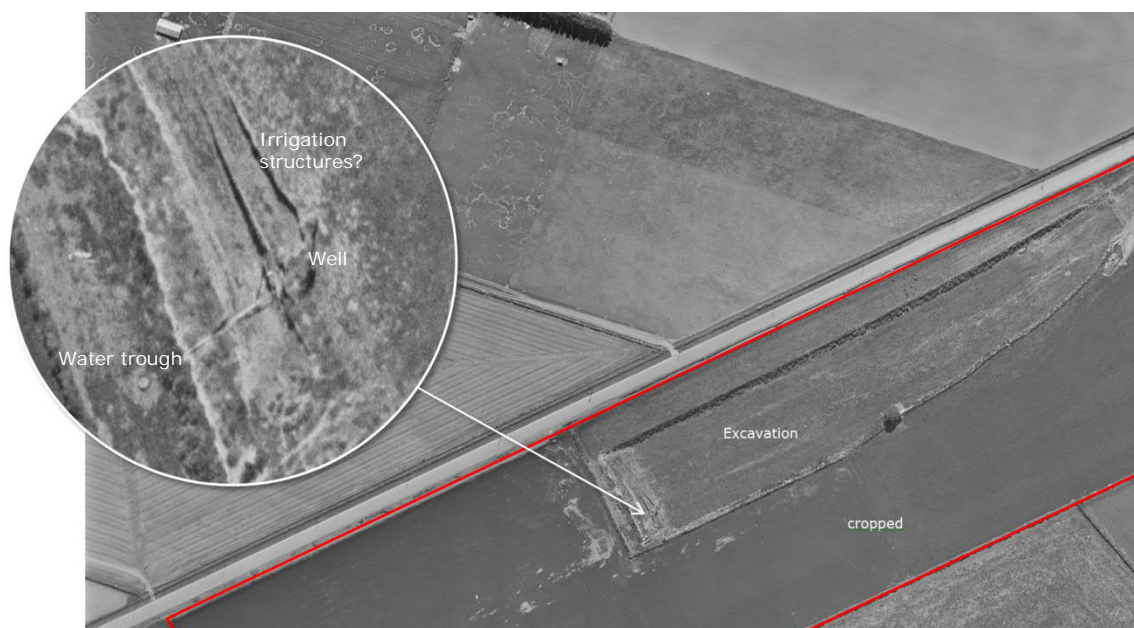
Figure 1. Aerial photo from 1973 showing excavated area and well structures.

14. **Topography and Surface Runoff:** The elevation of the site ranges from approximately 39m asl at the eastern boundary to approximately 42m asl at the western boundary of the site. This results in an average gradient of 1:275 from west to east.
