Ecological Survey and Bellgrove Residential Development at 52 Kippenberger Avenue

AEL Report No. 196

Final Report

February 2022

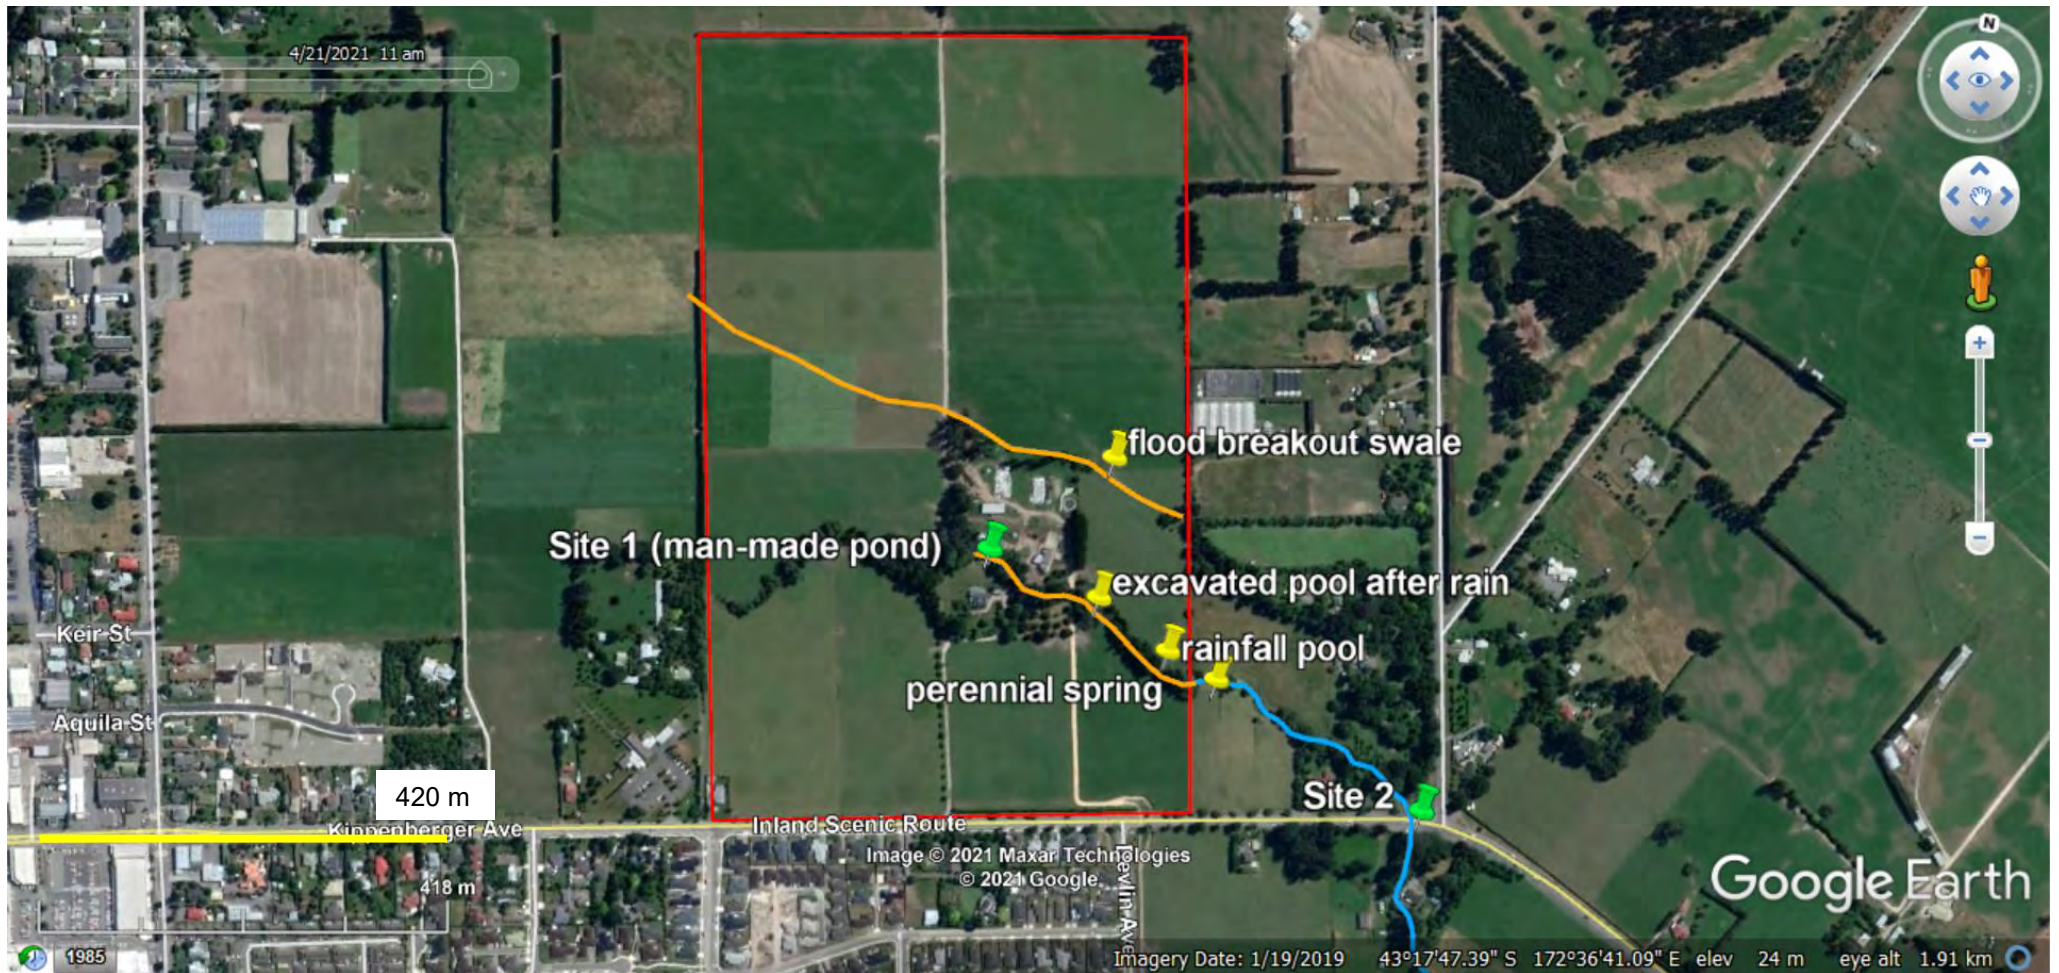
Figure 2. Map showing the boundary of the Stage 1 Site (red), Perennial Cam River (Coldstream) (blue), with brown lines indicate ephemeral reach. The flood breakout swale is also ephemeral.

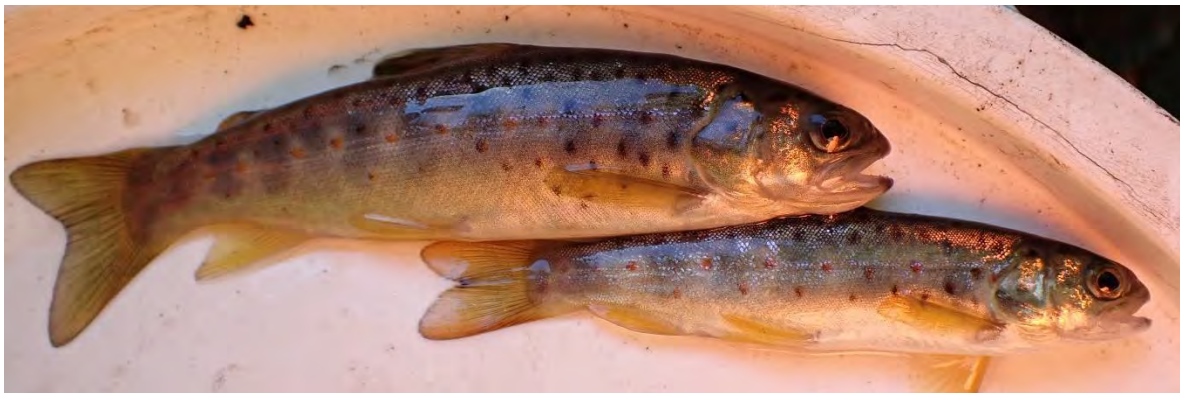
Figure 5. Juvenile brown trout from Cam River (Coldstream) downstream of Kippenberger Avenue.

After 13 minutes of active fishing effort at Site 2 two fish species were identified (Table 2). These were the brown trout (*Salmo trutta*, Fig. 5) and the common smelt (*Retropinna retropinna*, Fig. 6).

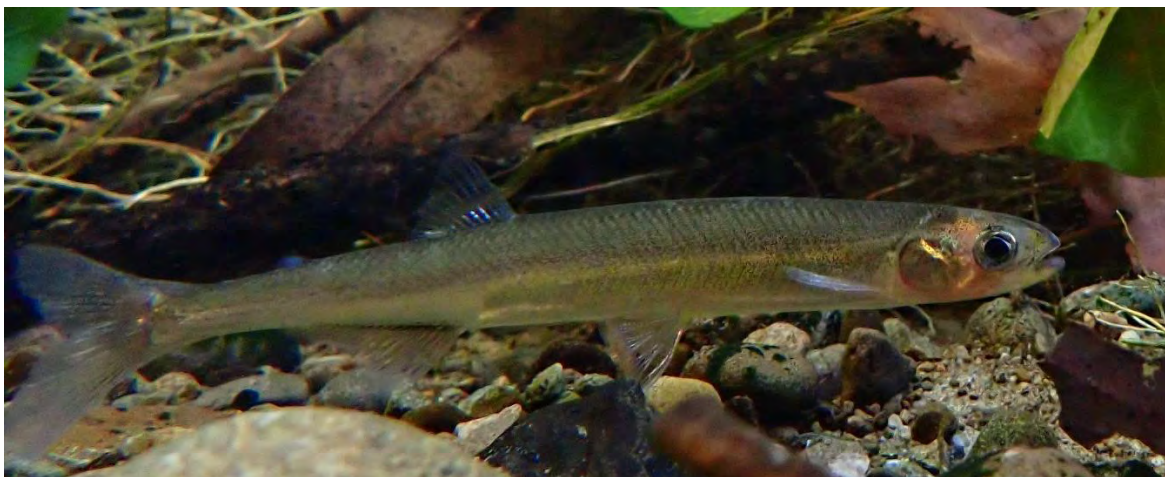
Figure 6. A common smelt from Cam River (Coldstream) downstream of Kippenberger Avenue. This fish was photographed while recovering from anaesthetic. The identification of this normally coastal fish was surprising.

The common smelt can be distinguished from the closely related Stokell's Smelt by the common smelt possessing larger, but fewer, scales along the lateral line (c. 60 *in* McDowall 1990). Stokell's smelt has smaller scales, approximately 100, along the lateral line.

The common smelt is native to New Zealand but is considered "Not Threatened" (Dunn *et al.* 2017). The brown trout is an introduced species. The presence of common smelt, but to a lesser extent the brown trout, indicate fair stream health. The lack of eels and bullies, but also the surprising presence of smelt, very much a coastal species, is a highly unusual fish community. There may be an anthropogenic reason or reasons for this, but this is not known with confidence.

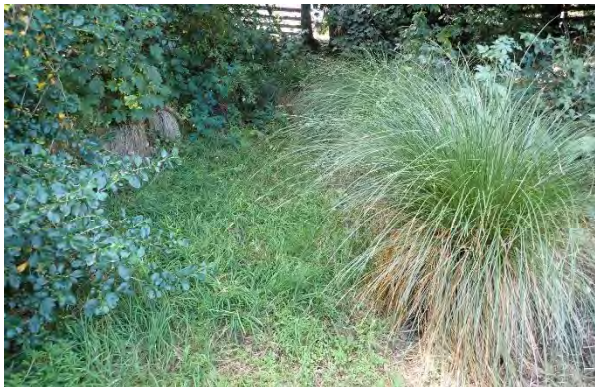
Figure 7a. Looking down gradient (east) of ornamental pond. Mature *C. secta*, like those in the pond.

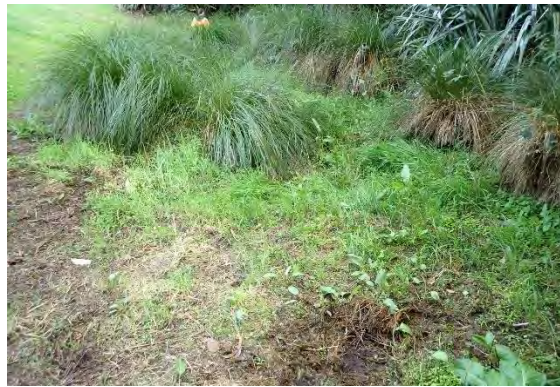
Figure 7b. Looking up gradient (west) towards ornamental pond. The invert contained broad-leaf plantain (*Plantago major*), but was dominated by willow weed, chickweed, and floating sweetgrass.

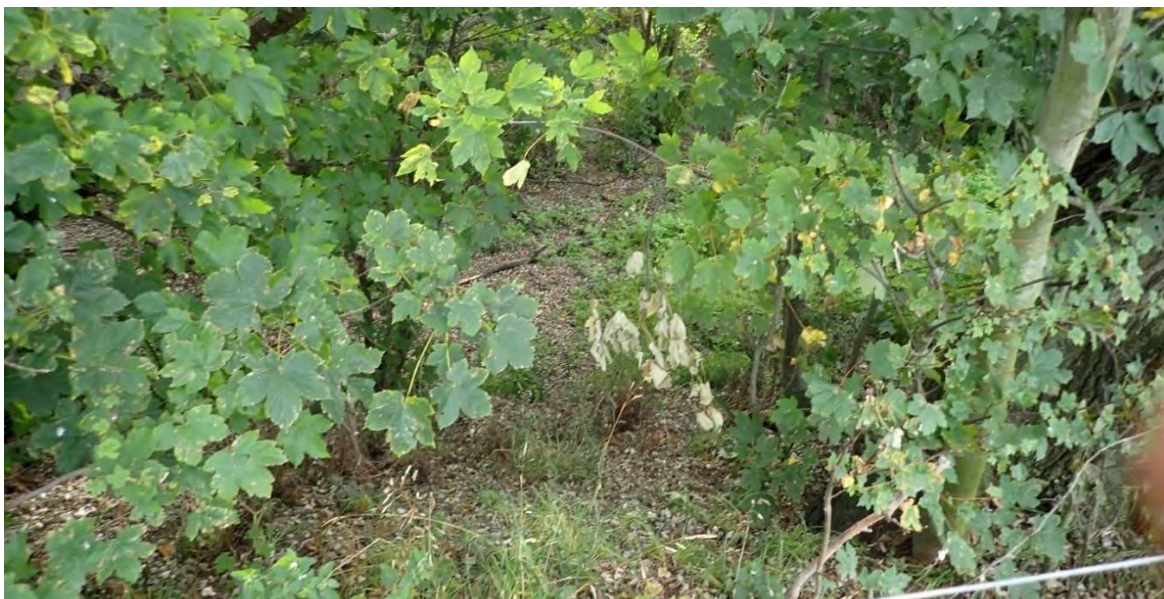
Figure 8. Ponding area which fills during heavy rain (AEL wpt 98, 15/3/2021). Area dug out, so potentially constructed. The invert had no vegetation.

With rain, the downstream swale can fill and flow east with rainwater, but it drains away to the neighbouring property. Water does puddle in one excavated location near the eastern boundary as a result of rainfall, even when there is no surface water inflow, suggesting its excavated invert connects to the shallow groundwater level. There are no wetland plants or soils at this location (Fig. 8), and consequently it also does not qualify as a ‘natural wetland’ as defined by the NPS-FM (Ministry for the Environment 2020a).

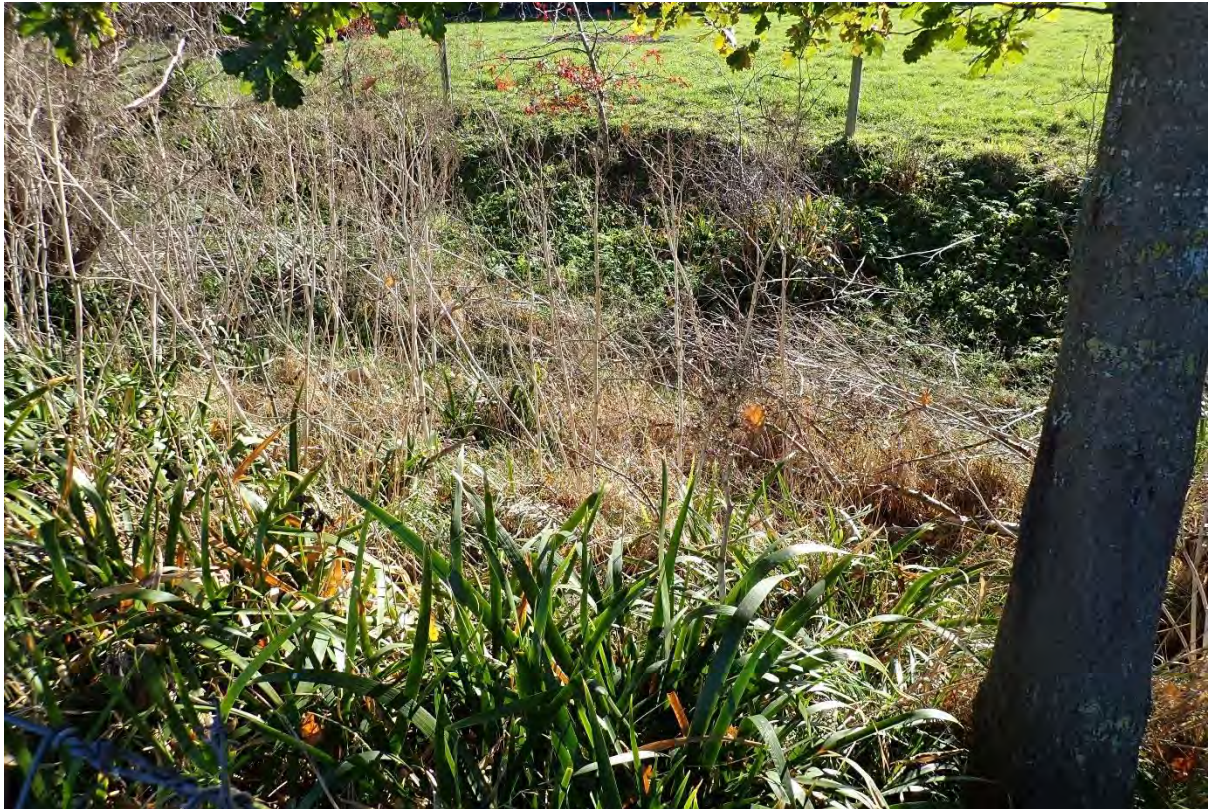
Fig. iii. Wpt 52. Fenced, but mixture of dryland shrubs and trees.

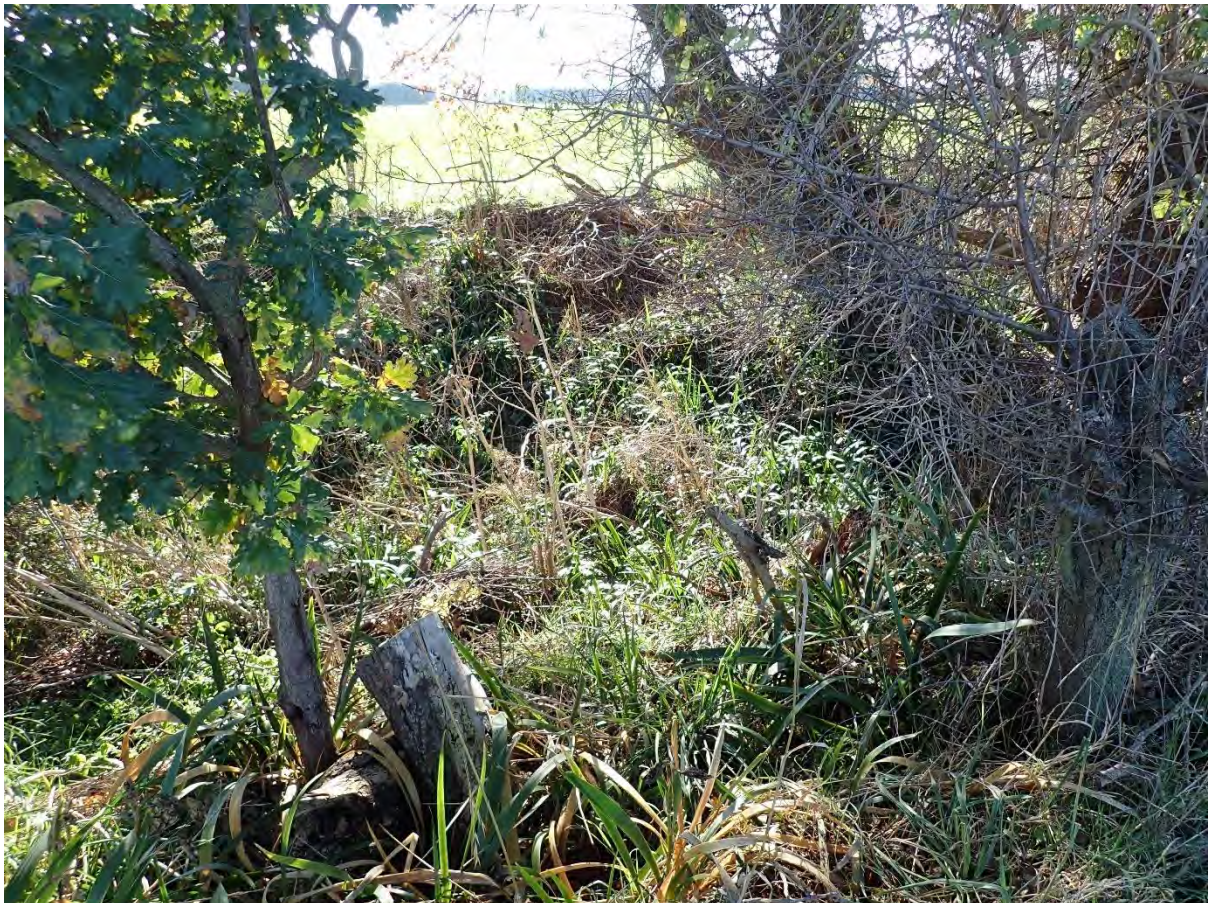
Figure iv. Wpt 51. Small trees and shrubs predominate, with no aquatic plants or surface water.

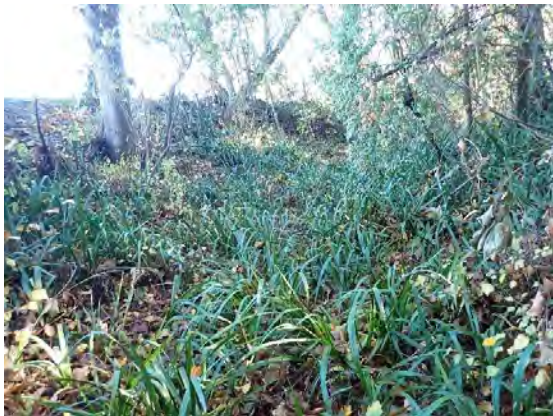
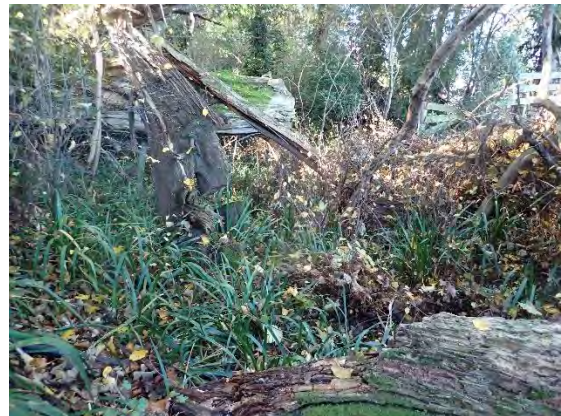
West of the ornamental pond (wpt 47) the channel was dry, with a sward of exotic shrubs and bulbs lining the channel (App. I, Figs. vi, vii). Immediately upstream of the pond (wpt 46) a fluvial channel form can be discerned (App. I, Figs. viii, ix), and was an area where water temporarily pools during rain events. Immediately west of the ornamental pond (wpt 46), vegetation in the swale was dryland (App. I, Fig vii), but an old fluvial channel form was perceptible looking towards the ornamental pond at this location (App. I. Fig ix).

Figure vi. Wpt 47 Looking west at dry swale west of the homestead's ornamental pond.

Figure vii. Wpt 47 Looking east at the dry swale bed upgradient of the ornamental pond

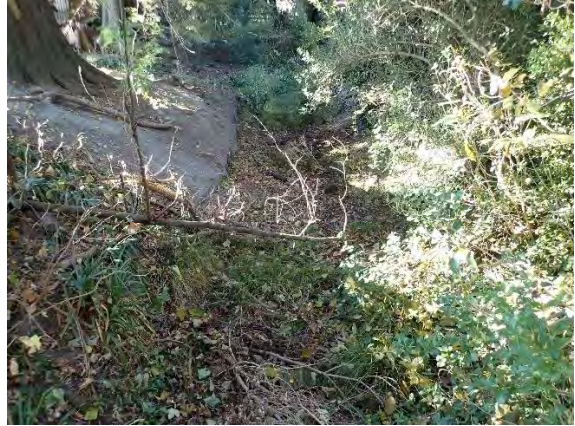
Figure ix. Wpt. 46, looking east towards the ornamental pond. An old fluvial channel is perceptible at this location.

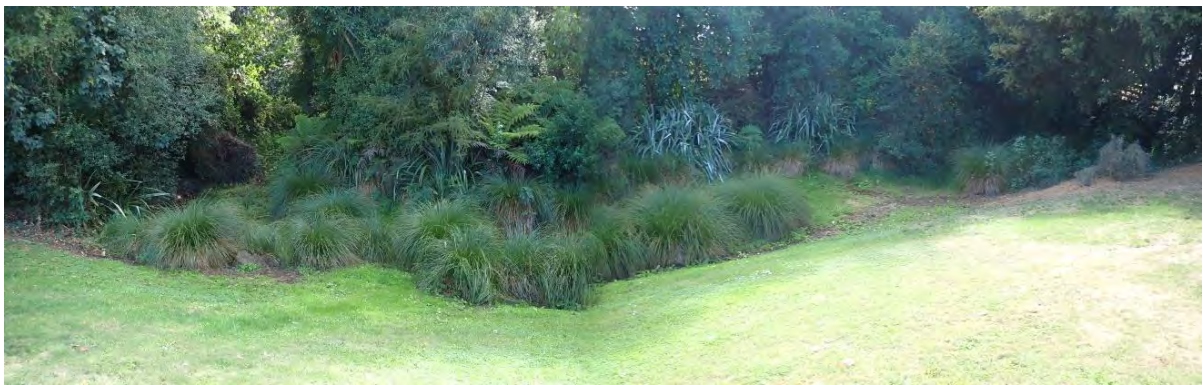
The man-made ornamental pond forms permanent aquatic habitat at the bottom of the homestead lawn (Site 1, Fig. 2, App. I, Fig. x). The base is plastic-lined to prevent the water draining to ground, and at the time of survey, the centre water depth was c. 0.4 m. The riparian area was planted with mature *Carex secta*, with some ferns and exotic umbrella sedge present. At the time, the water surface was largely obscured with a coating of the floating duckweed *Lemna minor* (App. I, Fig. xi). Within the water there was abundant woody debris present, derived from the overhead tree canopy. After 4 minutes of fishing (at 200 Volts) no fish were caught, although reportedly eels, and even a trout, has been observed.

Figure x. The ornamental pond at the base of the homestead lawn.

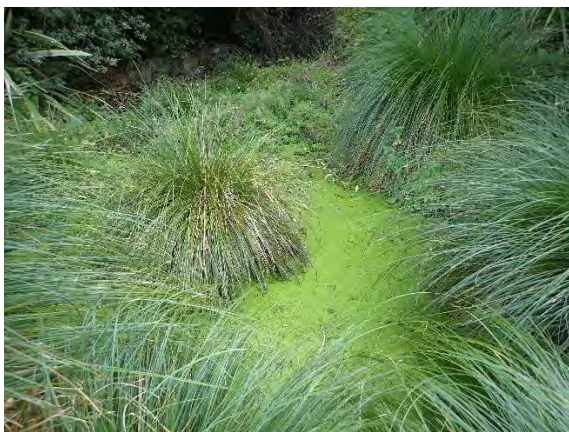
Figure xi. Carex secta growing in the ornamental pond.

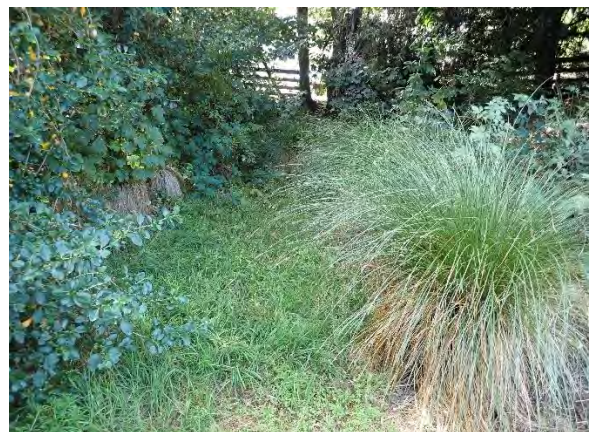
Down gradient (east) from the pond (App. I, Fig. xii), there was no surface water, or aquatic plants, but the soil was soft and damp with a sward of grass. Its possible eels could slither up here during rain if the channel is wet, but trout would require water depth of 10 cm or more.

Figure xii. The swale east and downgradient of the pond. Largely lined with *C. secta* and a riparian border of introduced and native shrubs and small trees.

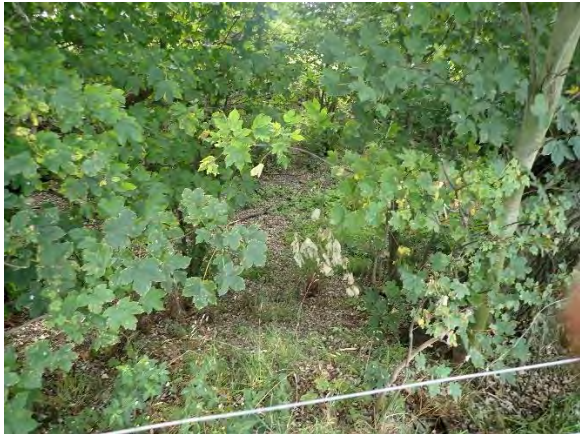
Figure xiii. An excavated depression where rainwater ponds.

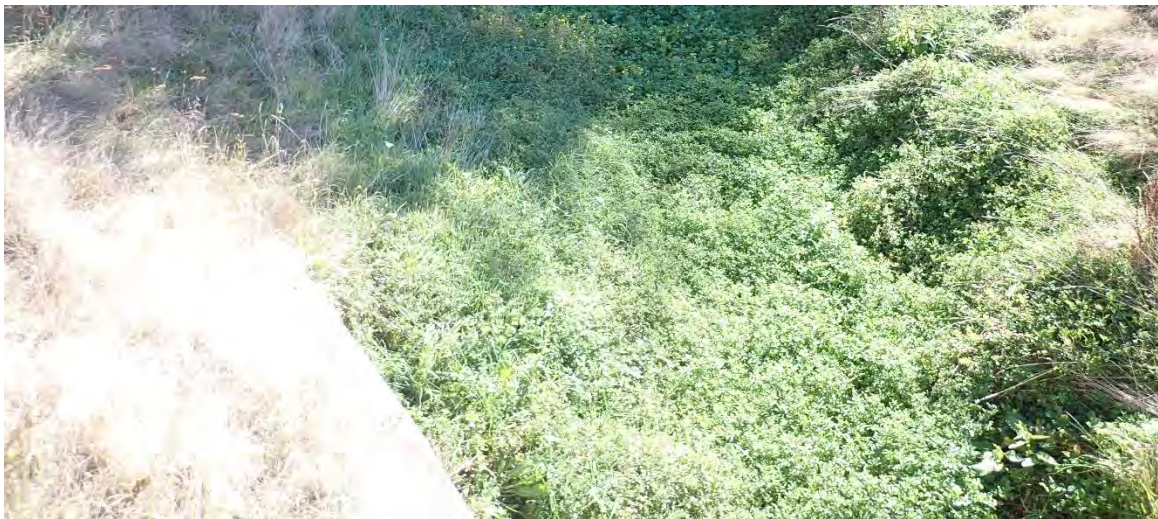
Figure xv. The Cam / Ruataniwha River headwaters immediately upstream of the Kippenberger Ave bridge. In the sunlit perennial reach of Coldwater Stream the channel was obscured by a raft of exotic introduced aquatic weeds.

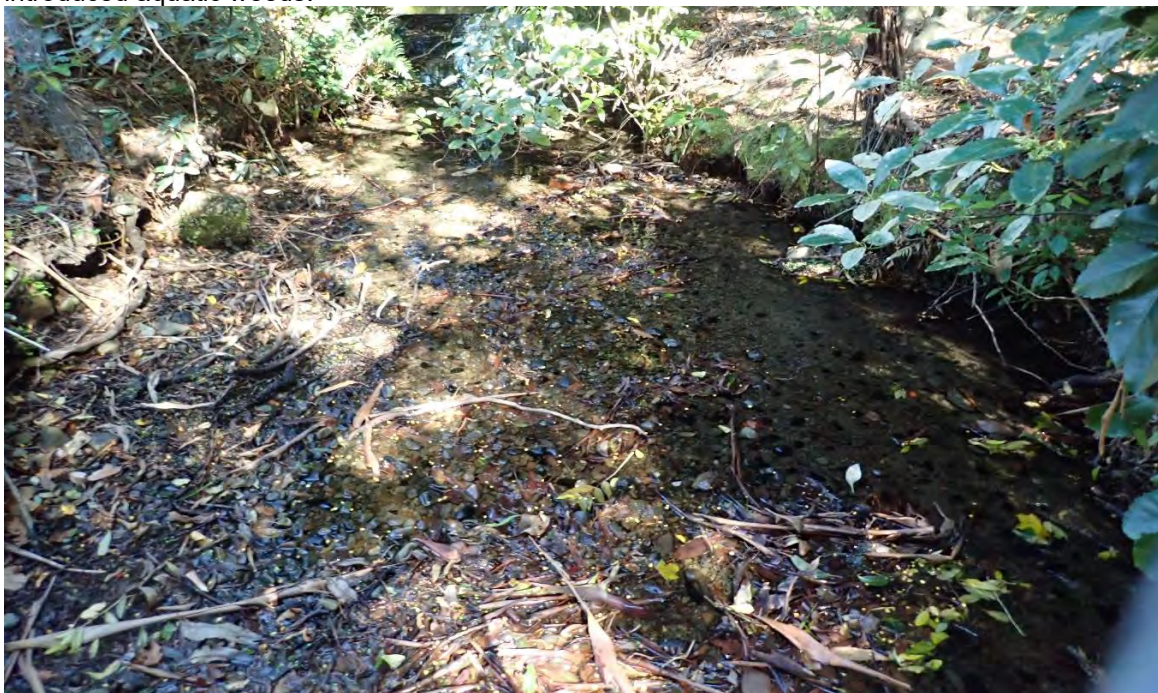
Further east, east of the access drive, the swale was dry with an excavated depression which reportedly fills with rainwater but is isolated from other aquatic habitats (App. I, Fig. xiii). Approximately further east, groundwater is visible when it rains, with the perennial spring 40 m eastwards, and over the site boundary in 7/8 Golf Links Road (Fig. 2, App. I, Fig. xiv). Immediately upstream (north) of Kippenberger Ave, the channel is sun-exposed, and obscured with a channel-choking sward of rafting exotic macrophytes, such as monkey musk (*Erythranthe guttata*) and watercress (*Nasturtium officinale*) (App. I, Fig xv). Downstream (south) of Kippenberger Ave culvert, flow is visible. Substrate in this reach is a mixture of cobbles, gravel and sediment, and riparian vegetation includes a variety of native and exotic species (App. I, Fig. xvi).

Figure xvi. The shaded shallow riffle habitat downstream of Kippenberger Avenue.

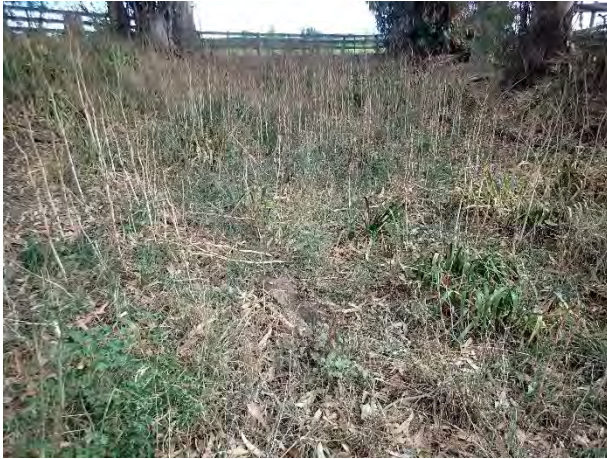
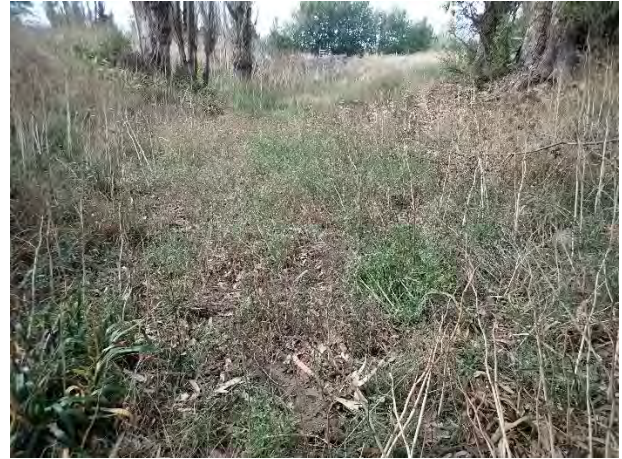
This forms a grassed depression across the grazed paddocks with no visible botanical zonation between the paddock and the swale cross-section (App. II, Figs. i, ii). The lack of any form of aquatic or even ephemeral vegetation extends eastwards, and the ground is dry and compacted (App. II, Fig. iii). The flora is composed of a sward of dryland weeds (fat hen, plantain), with a similar exotic species composition as the Cam headwater channel. We also noted an outbreak of Old Man's Beard invading the poplar tree line (App. II, Fig. iv). There was no facultative or obligate aquatic vegetation along the channel invert.

Figure i. Looking west along the Northern Flow Channel.

Figure ii. Looking east along the Northern Channel.

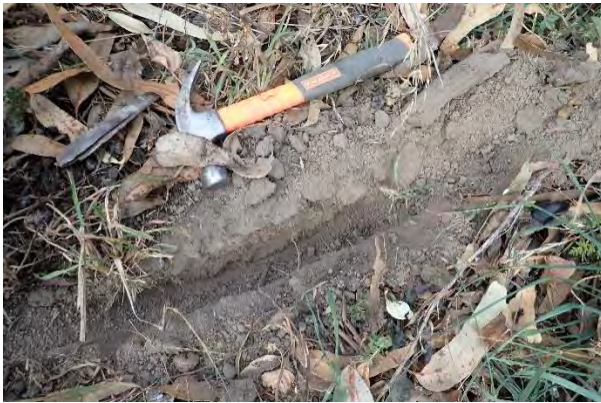
Figure iii. The soil in the thalweg is dry and compacted, and did not appear mottled or smell like a hydric soil.

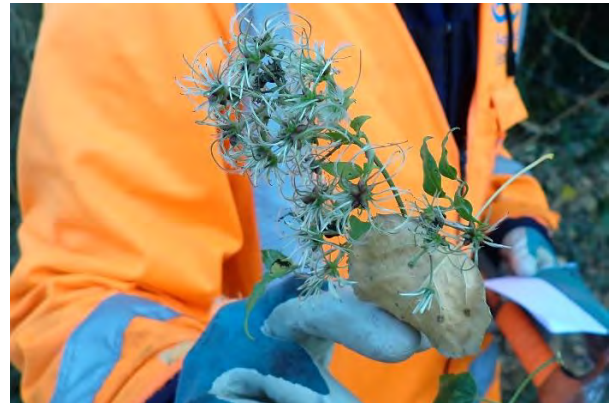
Figure iv. An outbreak of Old Man's Beard is invading the poplar tree line at one point.

In our opinion, in respect to the definition of a natural wetland, the Northern Flow Channel is not a wetland as it specifically excluded from that definition as it represents an “area of pasture that, at the commencement date, is dominated by (that is more than 50% of) exotic pasture species and is subject to temporary rain-derived water pooling” (Ministry for the Environment 2021). Moreover, the dry soils in the invert of the channel (App. II, Figs i-iii) were not indicative of wetland soils, indicated prolonged periods of wetland conditions, as described in Fraser *et al.* (2018). We therefore consider that is no need to set an esplanade reserve on either side of the Northern Channel, certainly in terms of preserving function for aquatic ecology. However, there will be some requirement for weed control at some stage, in particular the control of Old Man’s Beard. This will require a maintenance lane for weed control.

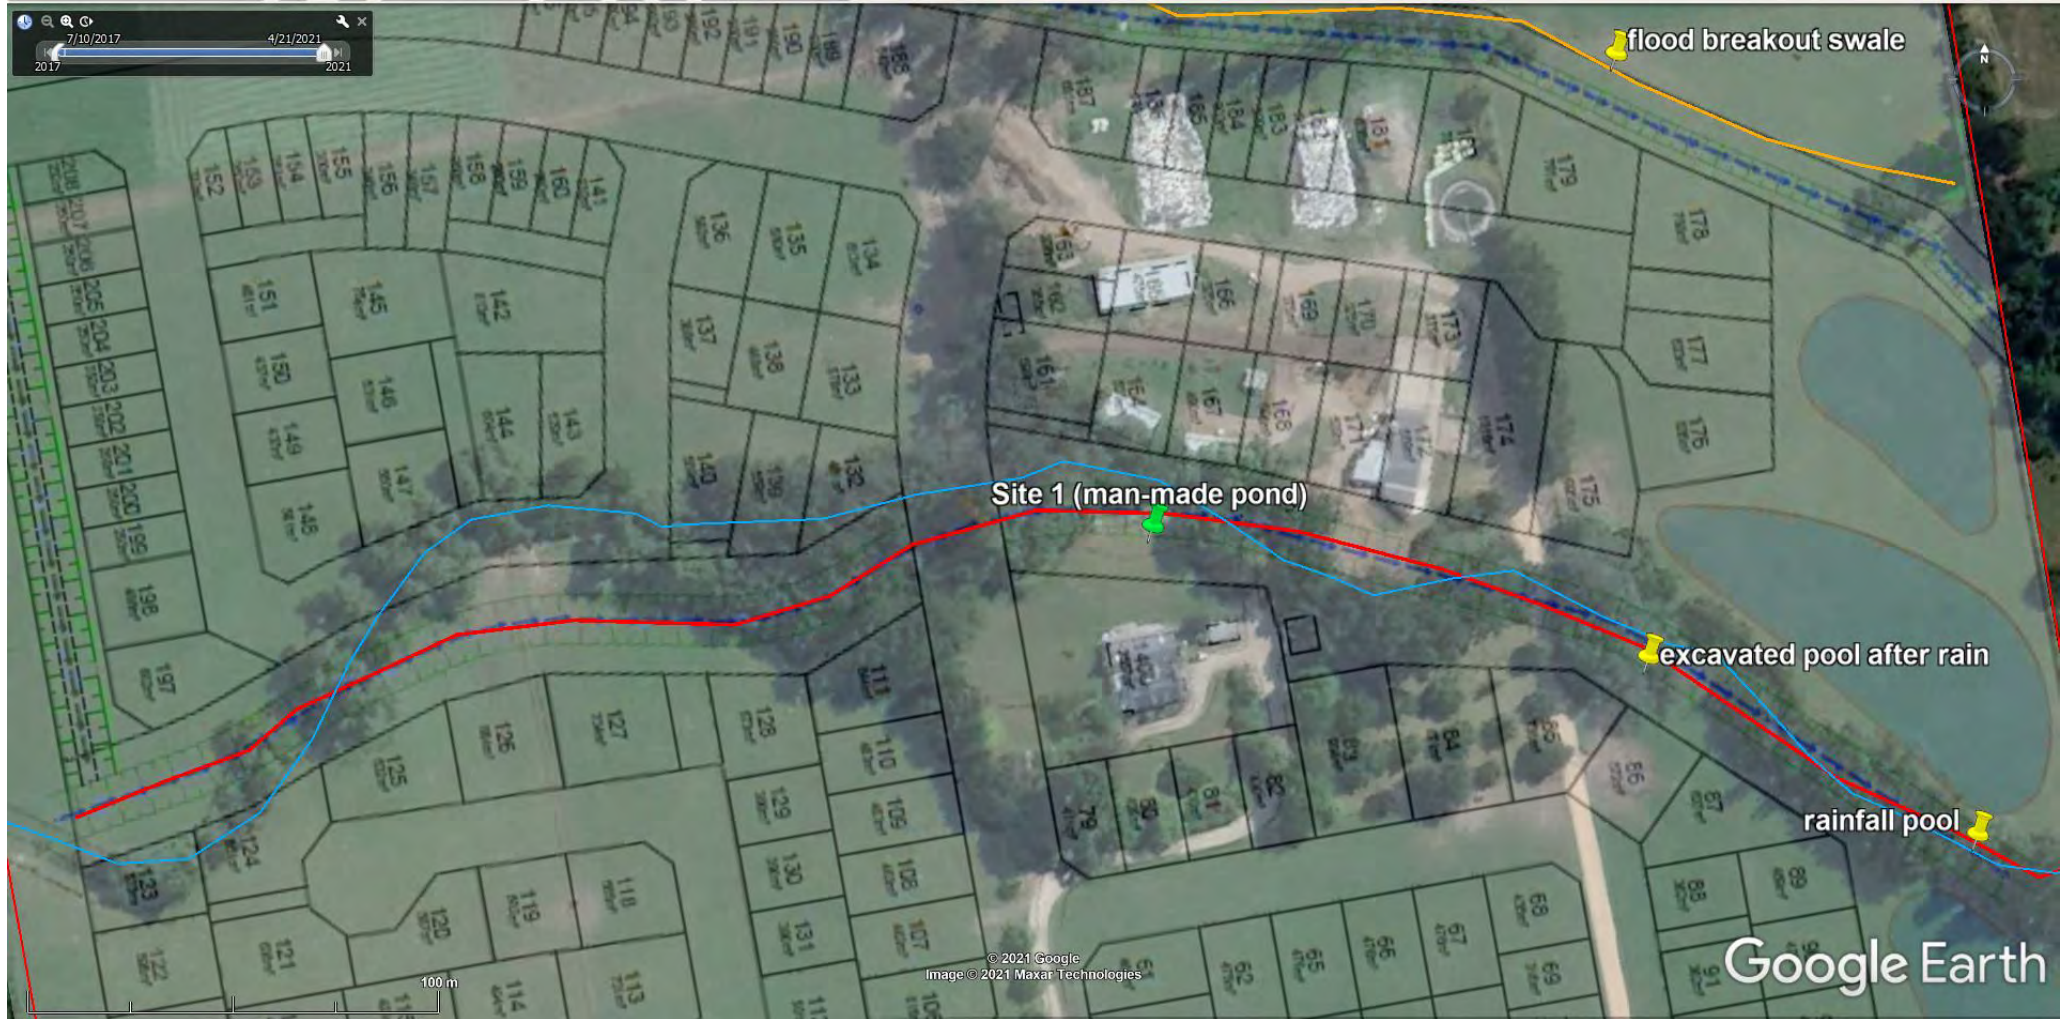
Figure i. Proposed re-alignment of the Cam / Ruataniwha River headwaters (red line), with existing course (blue line). The lot numbers are old and have been superseded.

In addition, the developer proposes to realign the uppermost reach west of the homestead, providing a gentler meander pattern.

I have seen the draft landscape designs for the Cam/Ruataniwha River and Northern Flow Channel prepared by Rough & Milne Ltd prepared by Fraser Miller. For the Cam River headwaters west of the homestead we recommend an ecologically functional buffer strip of 10 m width from the channel edge. The buffer strip will be composed of native trees and shrubs, including cabbage trees and lancewoods, but may include within its width a pervious grassed walking path on the true left (north) bank. Ecological linkages will benefit from a native riparian and wetland plant-out, beneficial for waterbirds and winged aquatic insect life-stages. This would represent a significant ecological improvement from the current community of introduced plants and weeds along its existing course (App. I, Figs. vi, vii). To affect the ecological enhancement, we would recommend a wetland specialist be engaged to prepare and help implement a wetland restoration plan, and that an indigenous plant-out is monitored/weeded for 5 years to ensure wetland plants establish and retain dominance.

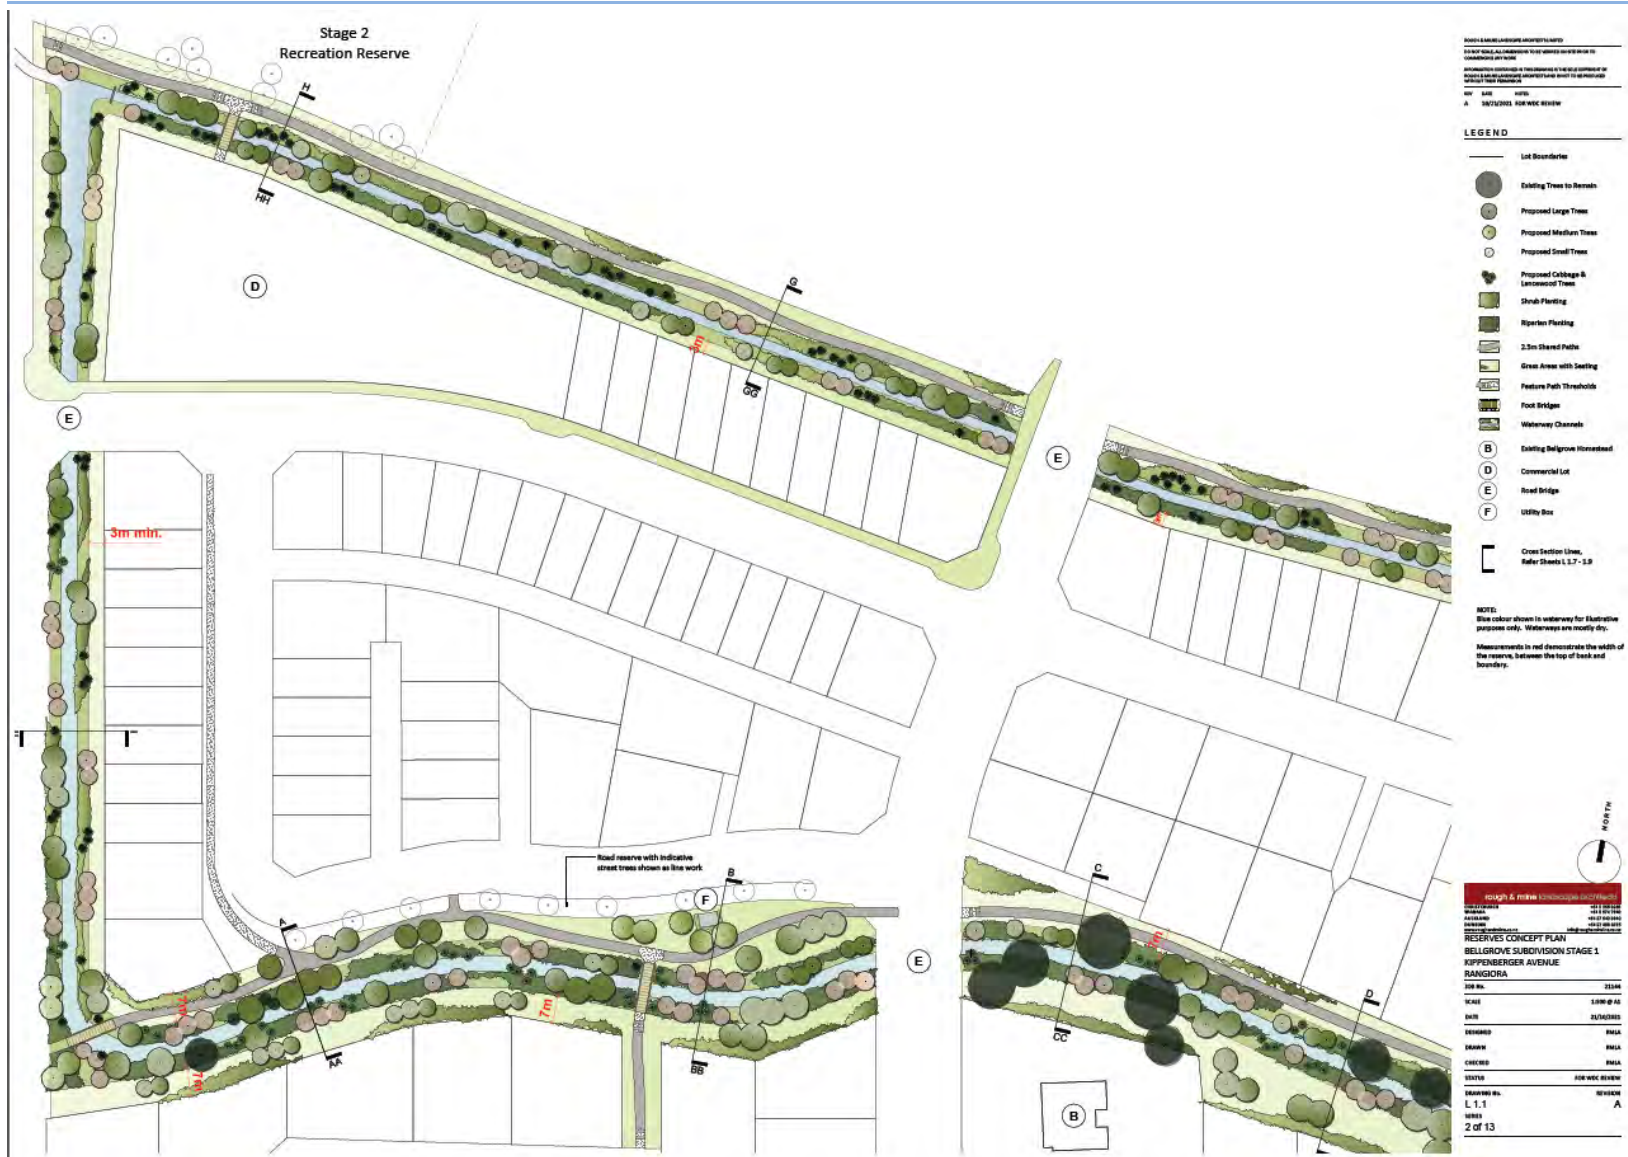
Figure ii. Proposed minimum setback widths (7 m plus vegetated buffer) in the October landscape plans for the Cam / Ruataniwha River.

There are locations where the offset width is significantly greater than 7m notably where the esplanade seamlessly integrates with the stormwater management areas and the curtilage of the historic homestead. For example, immediately north of Lot 50 the southern side of the esplanade reserve increases to a width of 18m.
