## DESKTOP REVIEW BLOCK B – 1275 TRAM ROAD, SWANNANOA (PT RURAL SEC 8183 BLK XIII RANGIORA SD)

### 1.0 Introduction

Pattle Delamore Partners (PDP) was commissioned by Andrew McAllister to undertake a desktop review of available data to assess any potential geotechnical risks associated with the proposed rezoning of approximately 21.2 ha of land comprising 1275 Tram Road, Swannanoa (PT RURAL SEC 8183 BLK XIII RANGIORA SD) rural zoned to residential zoned. For the purposes of this review the foregoing Lots will be collectively referred to as “Block B”.

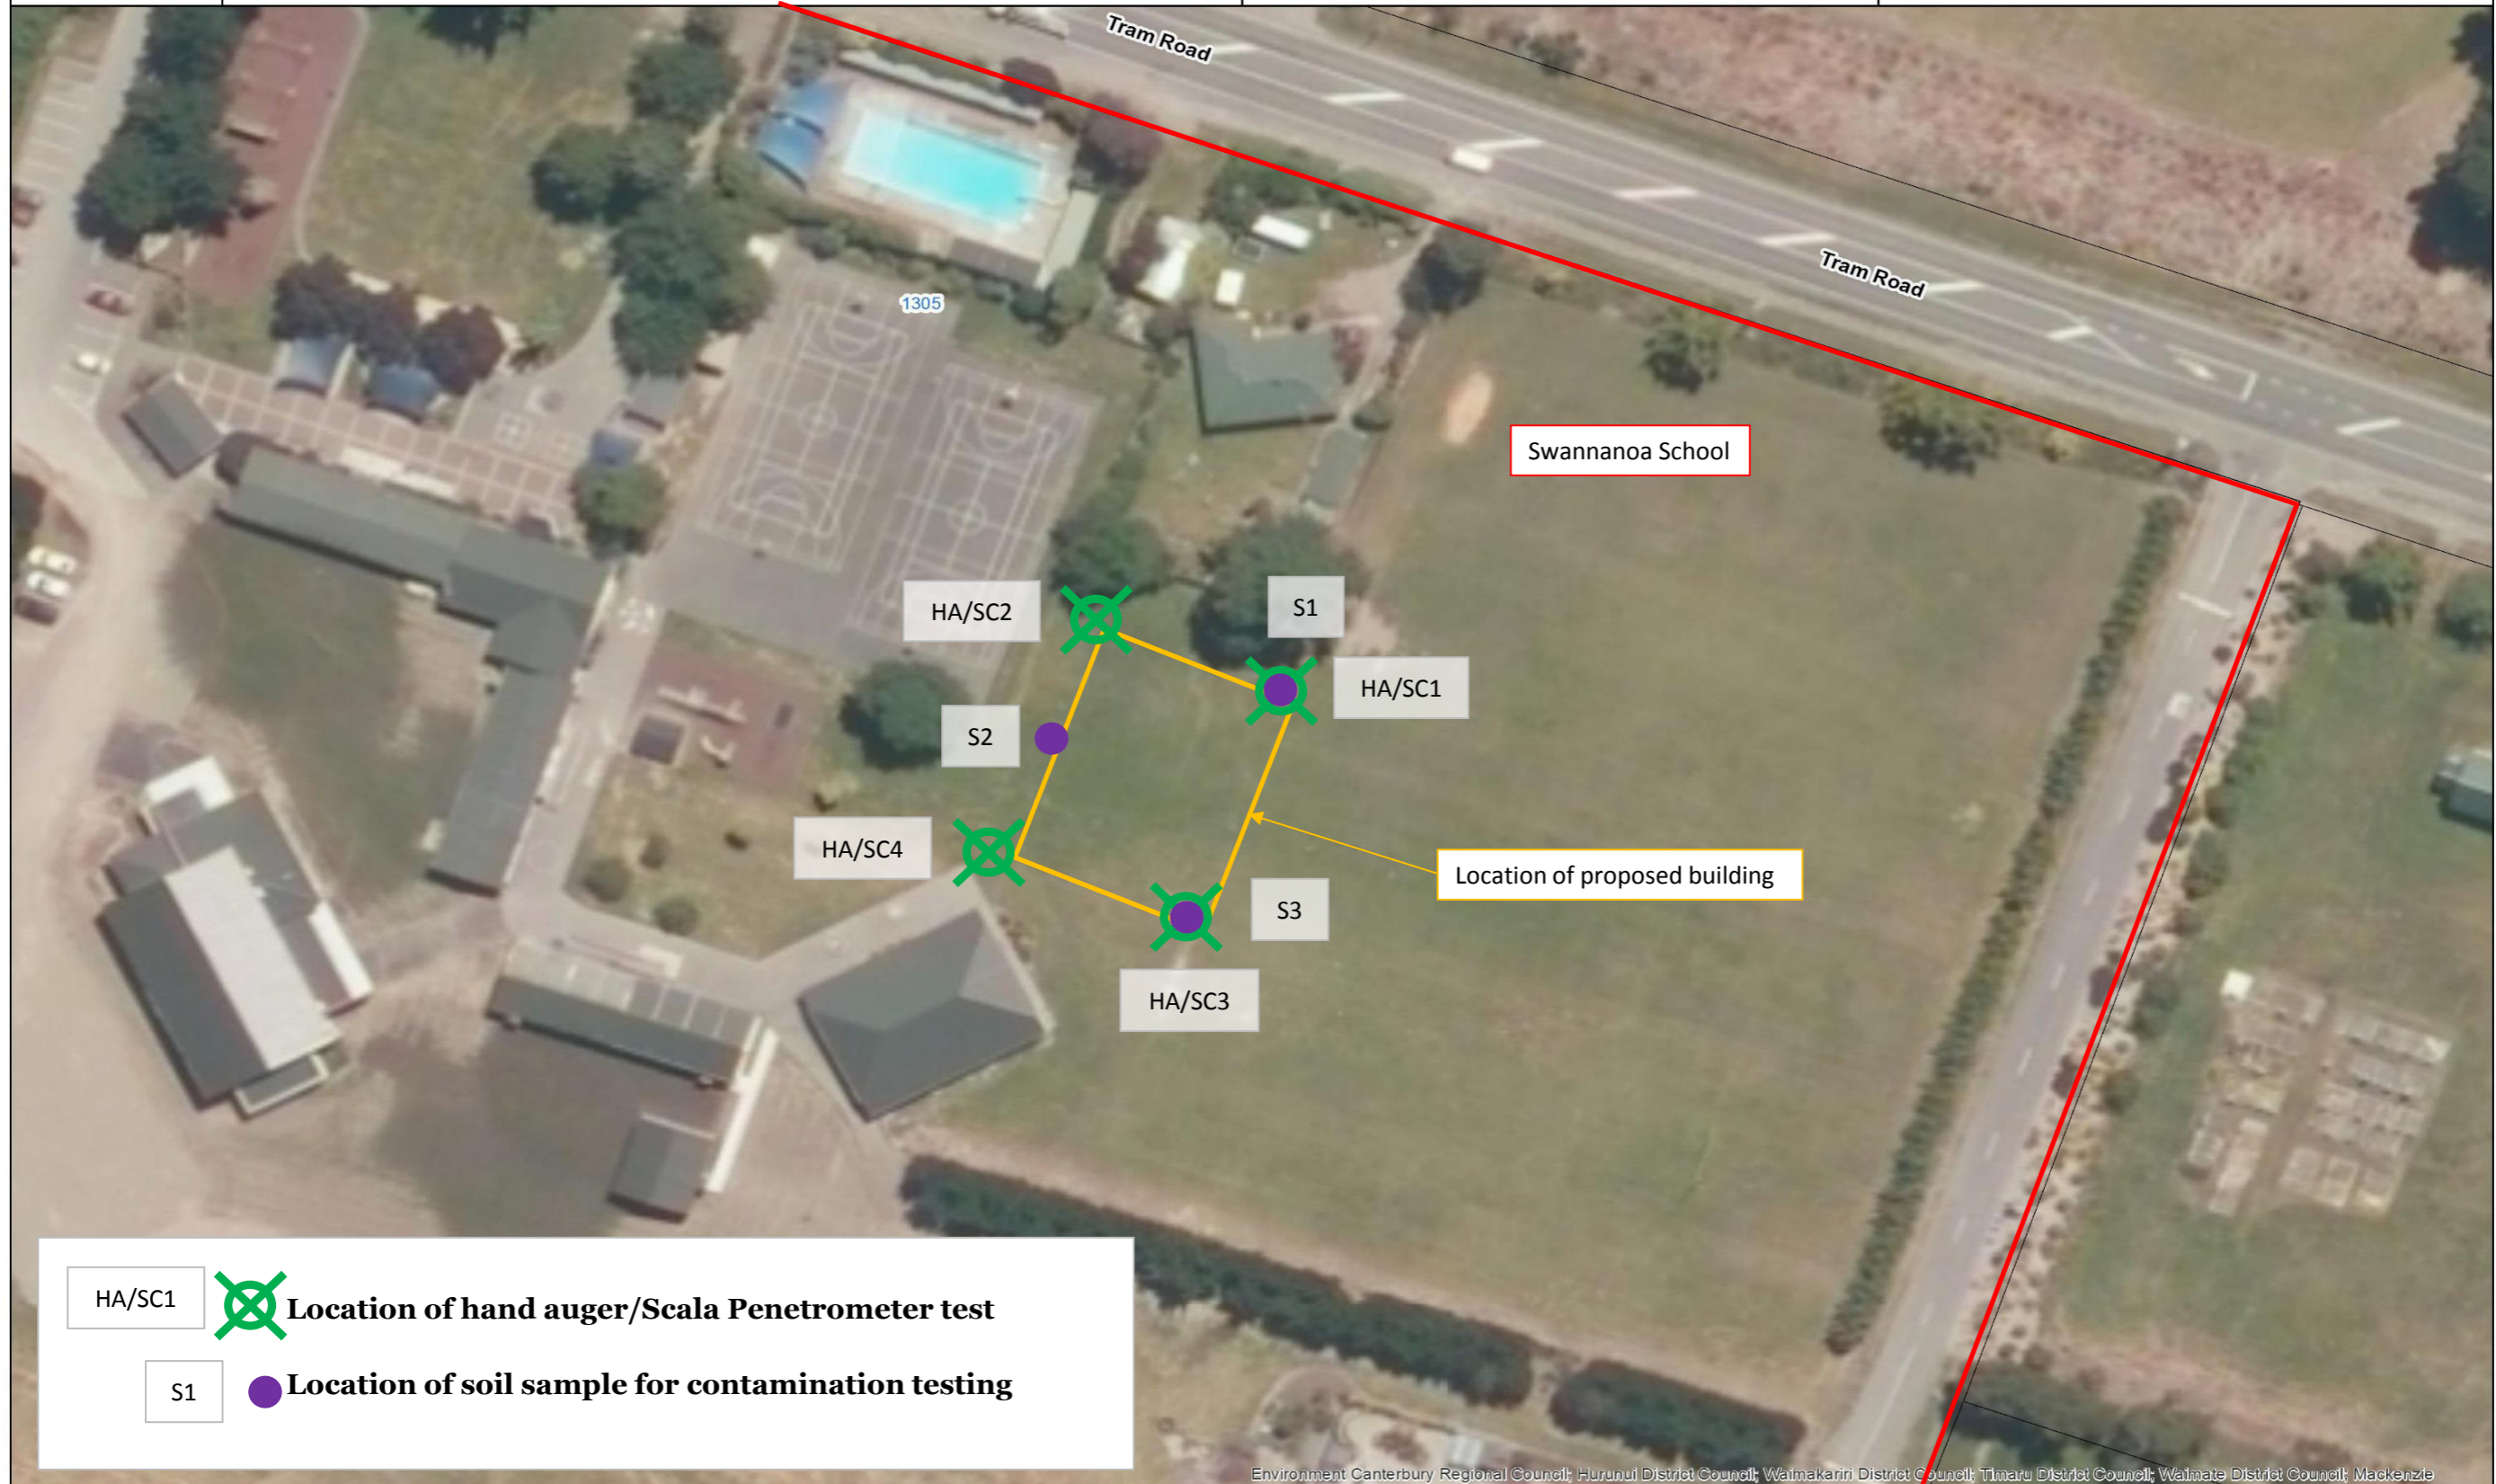
**Site Investigation Plan**

**Project:** Swannanoa School New Classrooms  
 Geotechnical Assessment  
**Project No.:** 4-11427.01 / 00GEO  
**Client:** Ministry of Education

A Shallow hand auger investigation undertaken with the Swannanoa School site numbered 62996 directly west of Block B encountered soils described as gravelly SILT inferred to be Springston Formation. The NZGD logs are presented in Appendix B.

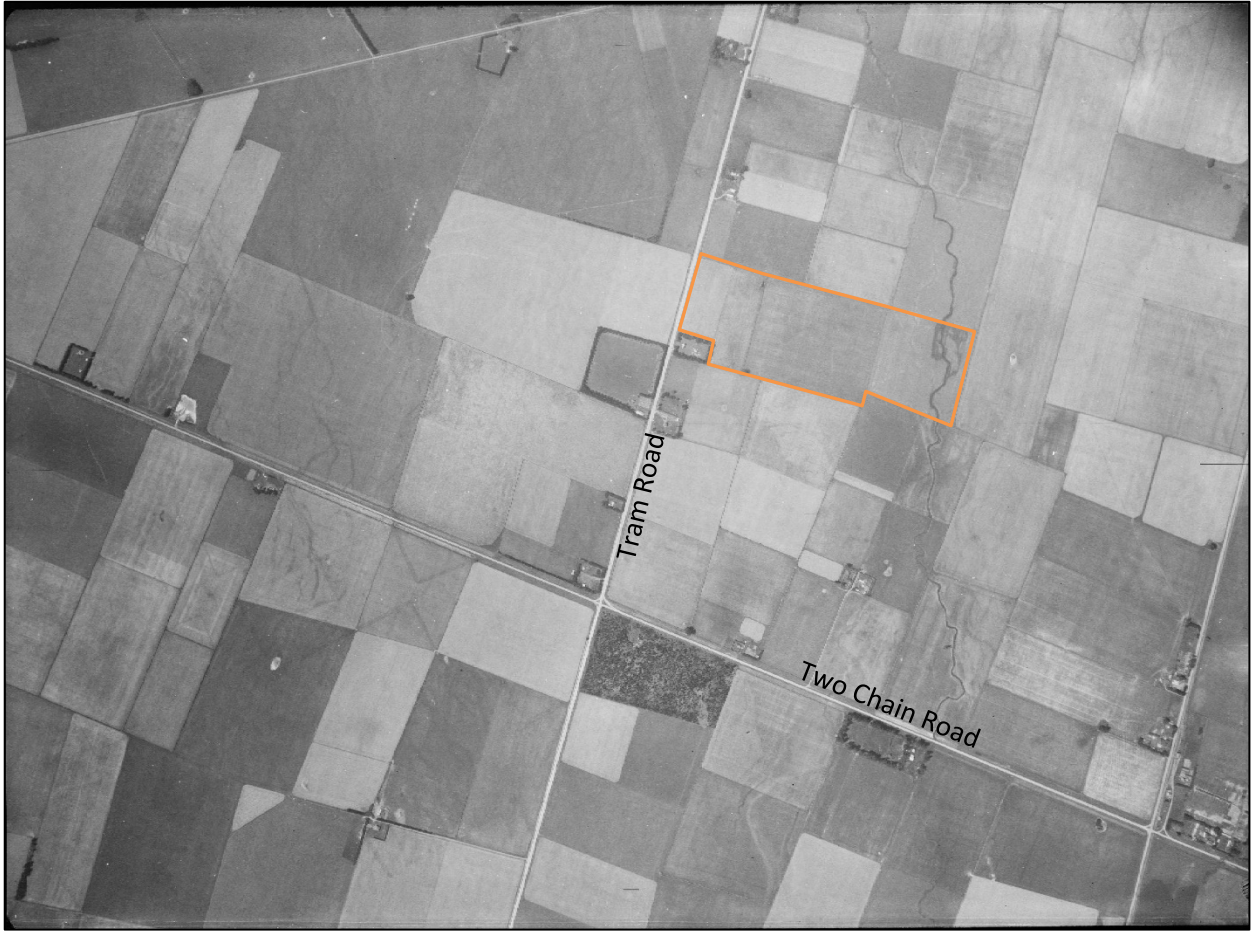
**Photograph 1: 1941: Block B - 1275 Tram Road, Swannanoa indicated by orange outline (Source Retrolens).**

**1945** – Block B comprises arable / pastoral farmland, small to medium size creek / stream crosses the southern part of the site.

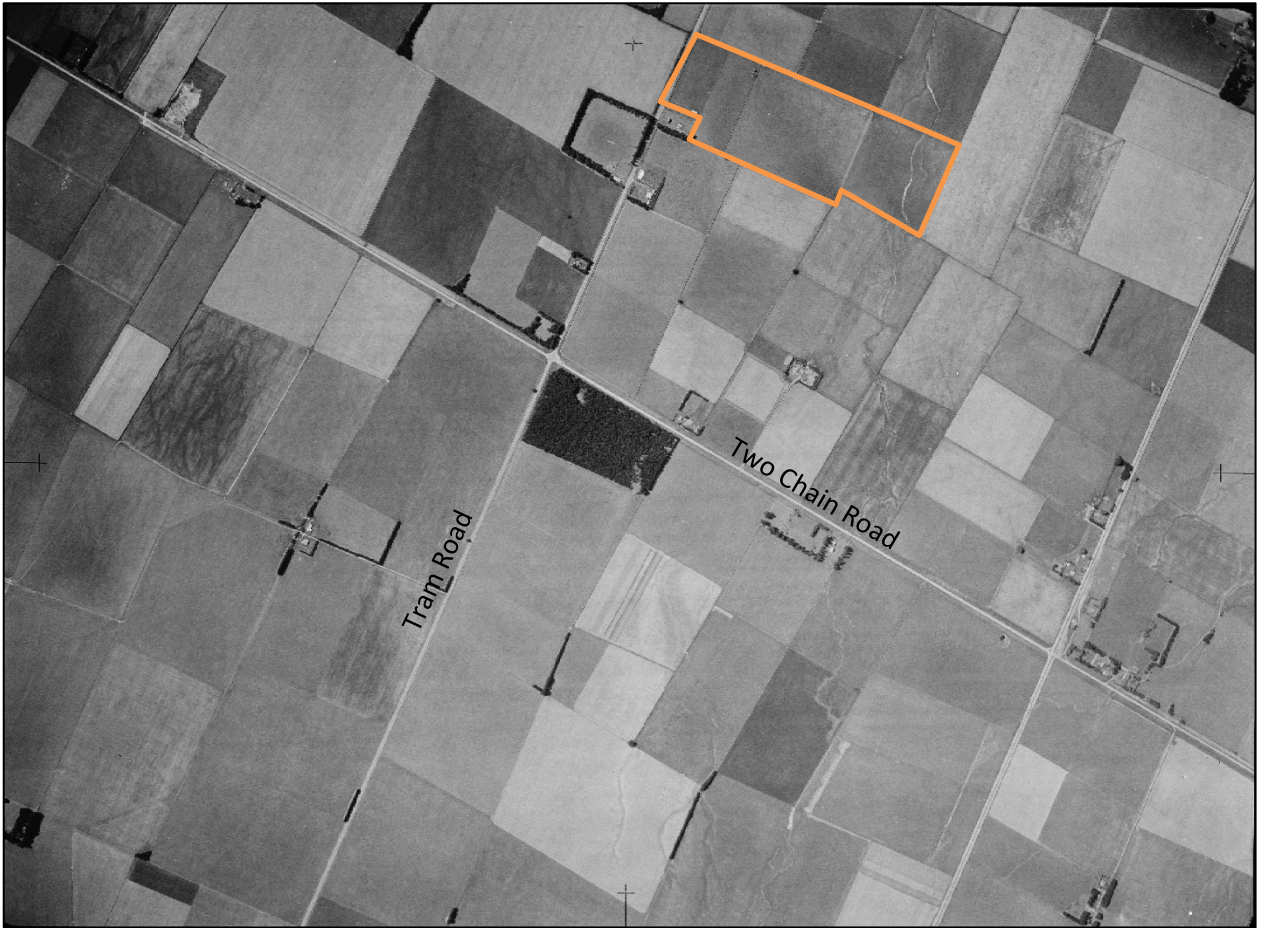
Photograph 2: 1955: Block B - 1275 Tram Road, Swannanoa indicated by orange outline (Source Retrolens).

**1955** – Shed built on northwestern side of the site adjacent to boundary with church and graveyard

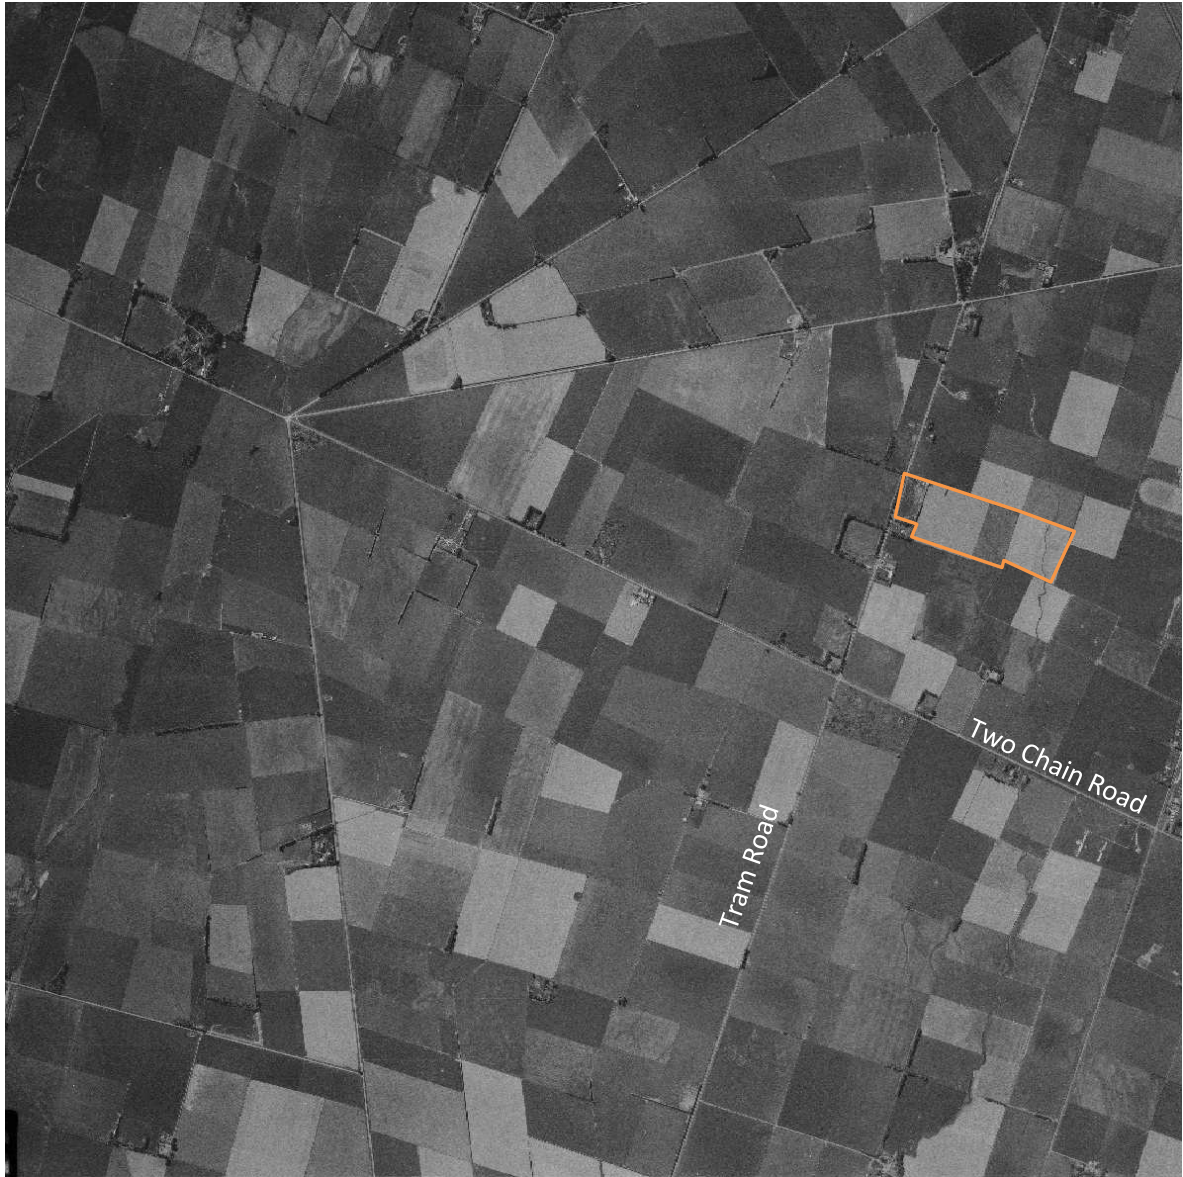
**Photograph 3: 1975: Block B - 1275 Tram Road, Swannanoa indicated by orange outline (Source Retrolens).**

**1975 – 1979** - Buildings inferred to be dwelling built in northeastern part of site opposite previously identified shed.

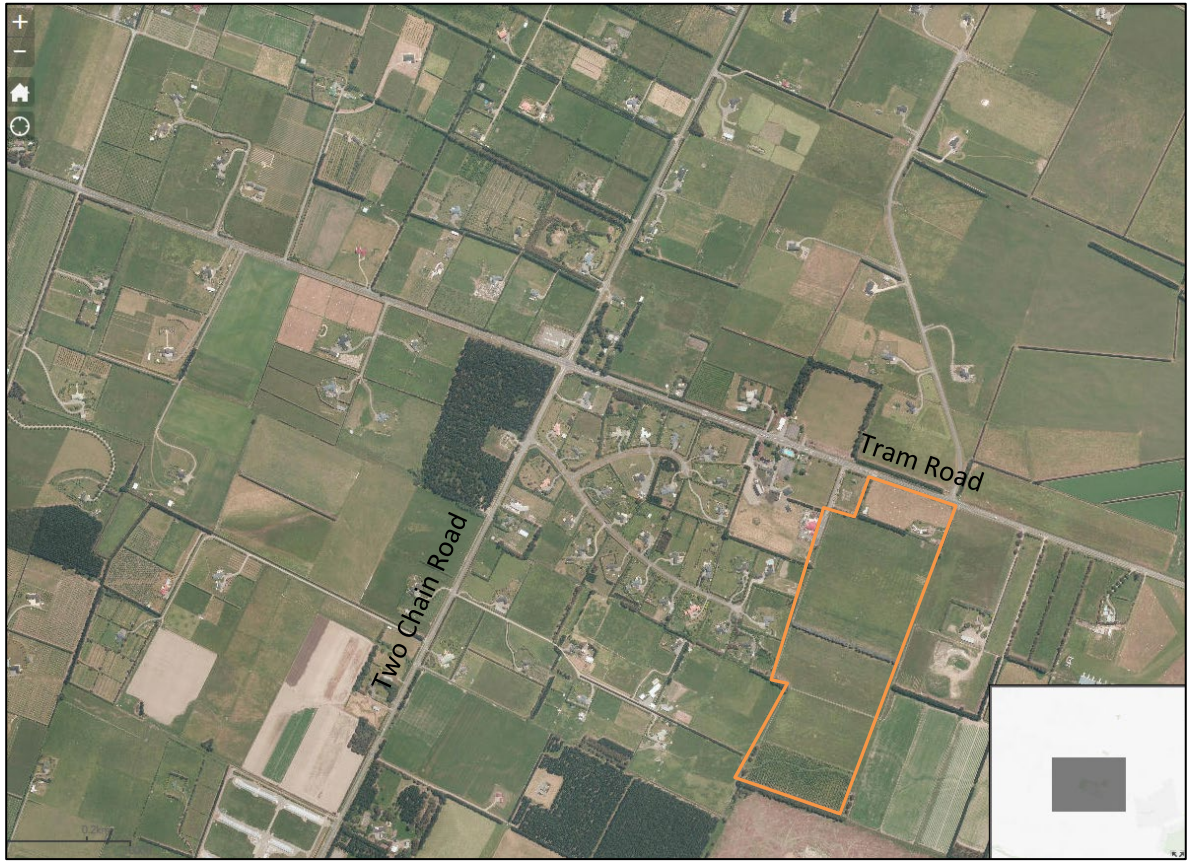
Photograph 11: 2010-2015: Block B - 1275 Tram Road, Swannanoa indicated by orange outline (Source Canterbury Maps).

**2010 -2015** - Area south of dwelling developed into handstand with new shed construction.

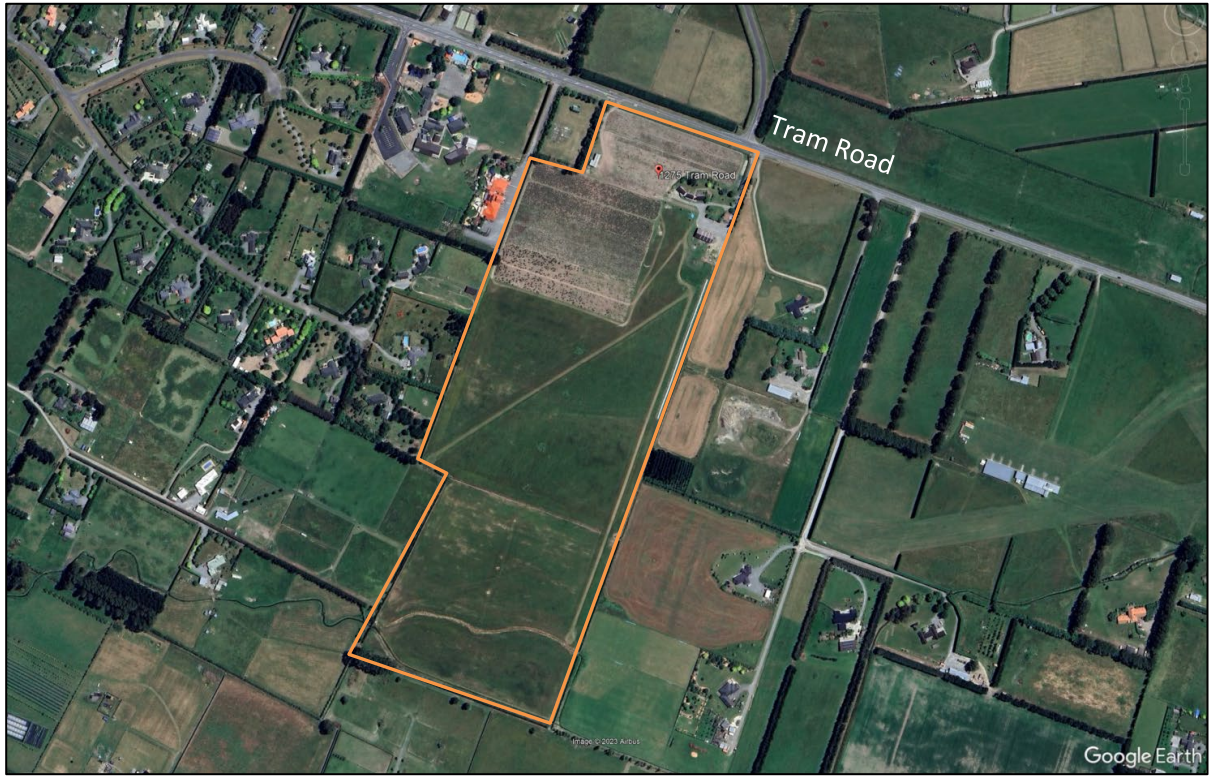
Photograph 13: 2022: Block B - 1275 Tram Road, Swannanoa indicated by orange outline (Source: Goggle Earth).

**2022 – Present day** - Creek that naturally ran through the southern part of the site has had its sides shallowed to form a swale through the paddock. A new open drain has been constructed along the southern site boundary.
