Statement of evidence of Mark Crooks (Contamination) on behalf  
of Carter Group Limited and Rolleston Industrial Developments  
Limited

# 535 Mill Road, Ohoka

## Preliminary Site Investigation

Rolleston Industrial Developments Limited

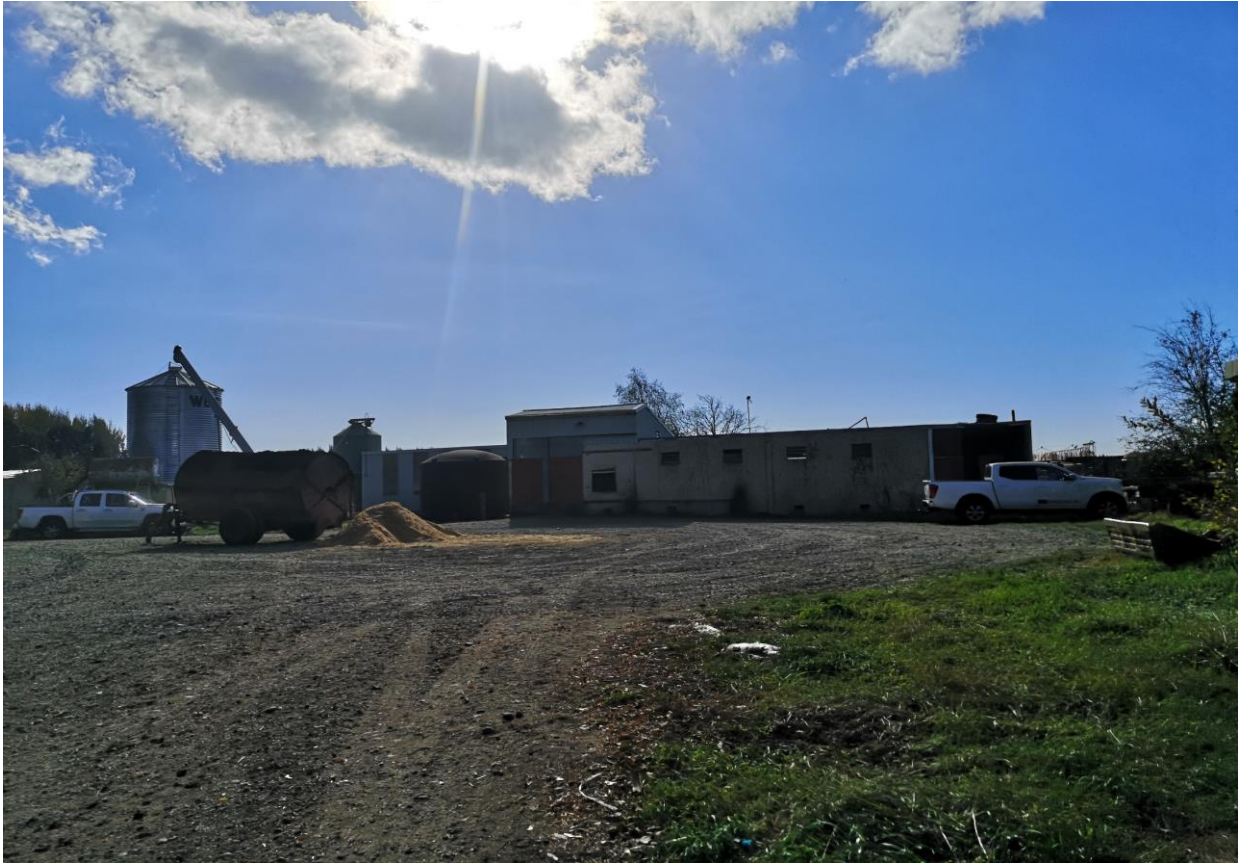
Photograph 1: Existing structures within the central section of the site.

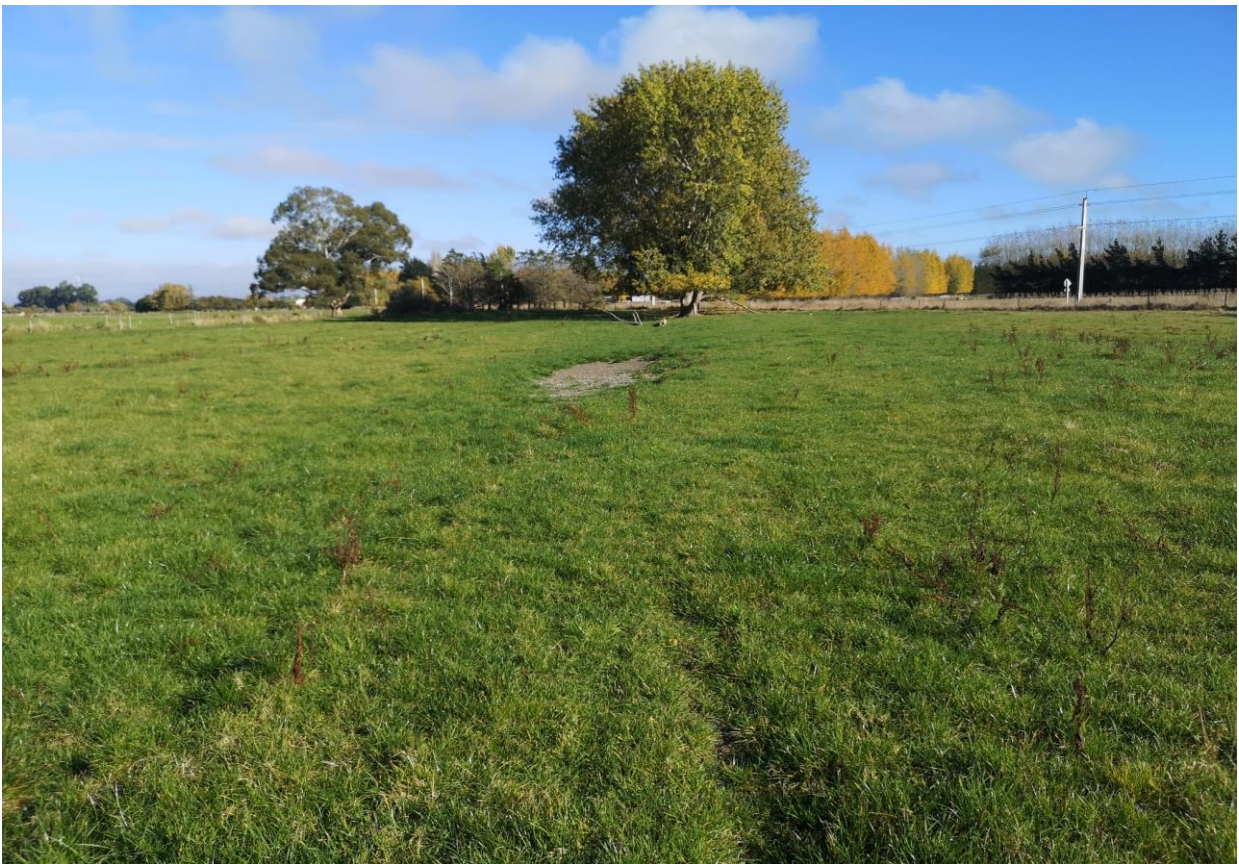
- Some areas of unnatural plant die-off were observed across the site.
- No major staining was observed during the walkover.
- Multiple potentially contaminating activities were noted within the area of main farm infrastructure, these included:
  - An above ground fuel tank,
  - Chemical storage within buildings and outside on natural surfaces,
  - A drenching and effluent settlement area.
- A farm dump was observed within the central section of the site which appeared to contain scrap concrete, plastic, bones, wire and other refuse.
- A burn area was noted in the central-northern section of the site.
- Agrichemicals have been used across the site over the years e.g. Glyphosate to kill off weeds in paddocks between plantings.
- Rubbish and metal scraps were observed across sections of the site. No major staining was observed during the walkover.

Photograph 2: General grass cover and example of die off.

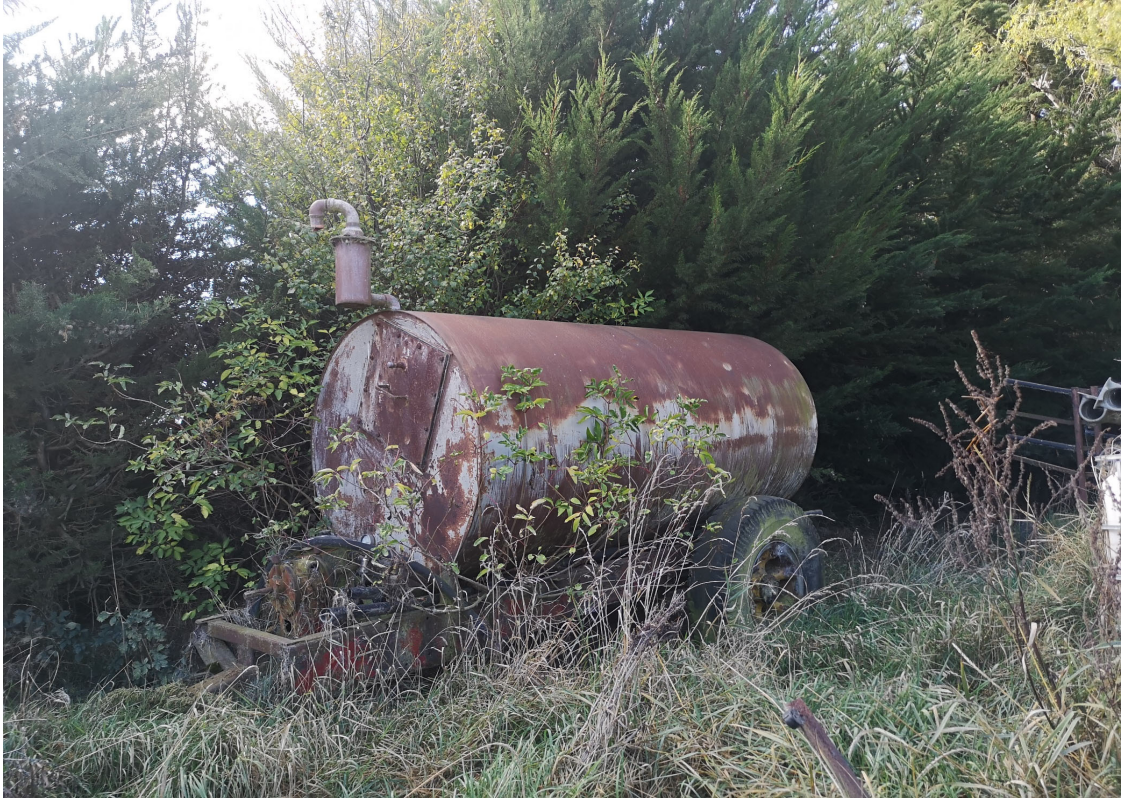
Photograph 3: Metal equipment left rusting within the site.

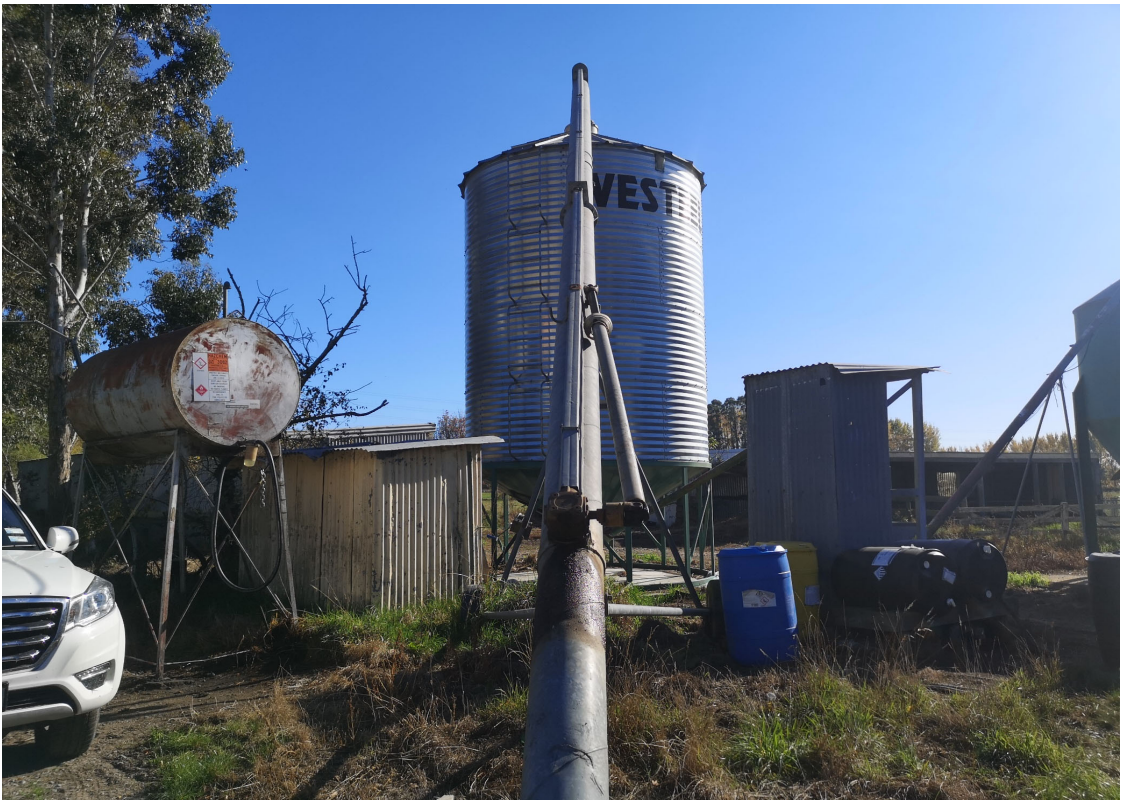
Photograph 4: Storage and above ground fuel tank within the central section of the site.

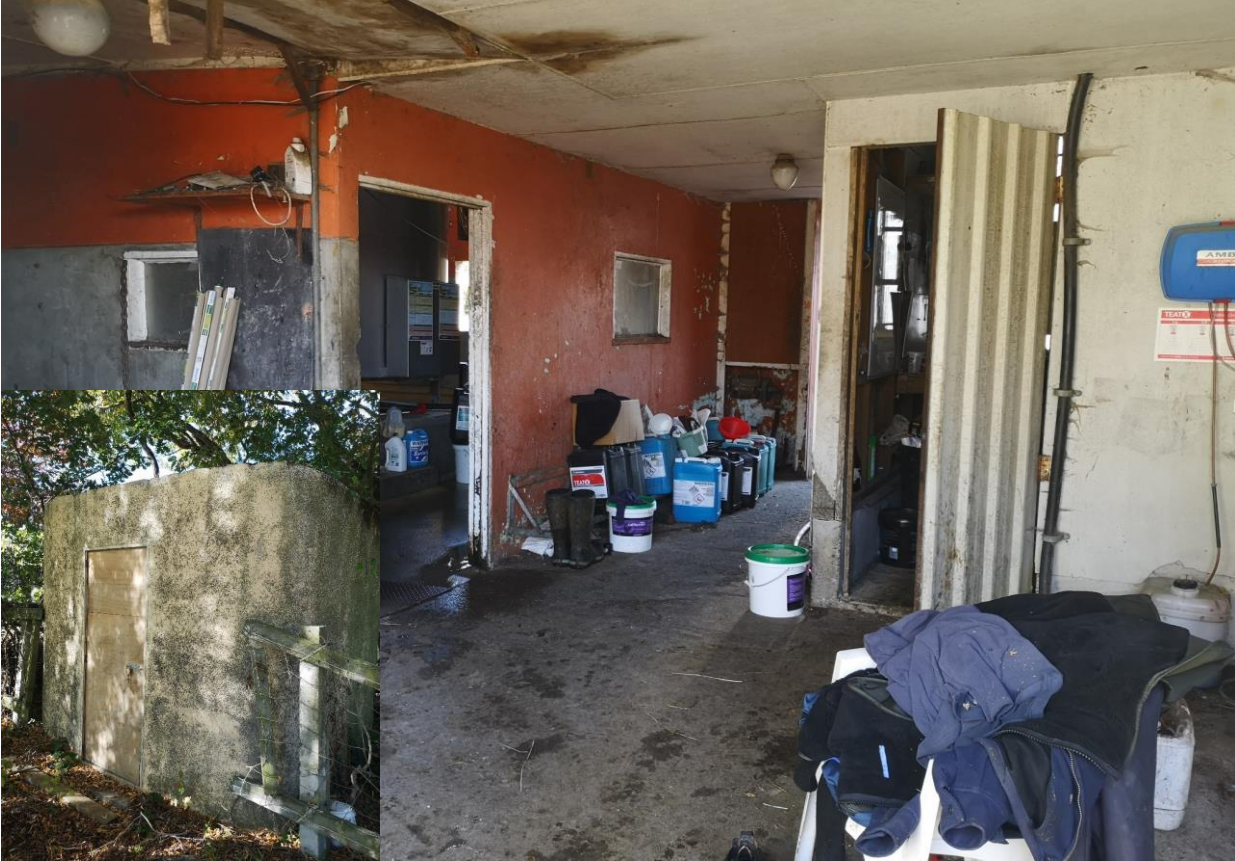
Photograph 5: Chemical storage area. Inset: Storage shed within the site.

The site is considered to be suitable for subdivision, however, Coffey recommends soil characterisation samples are taken from targeted locations of concern and from across the site to create a detailed site investigation (DSI) prior to earthworks consent being granted to ensure elevated contaminants and excessive use of pesticides are not present and to confirm the applicability of the NESCS to the site.
