Statement of evidence of Nicola Peacock (Contaminated land) on  
behalf of Crichton Developments Limited in relation to Gladstone  
Road rezoning request

**Soil Contamination Risk  
Preliminary Site Investigation Report**

**145 & 167 Gladstone Road, Woodend, Canterbury**

November 2023

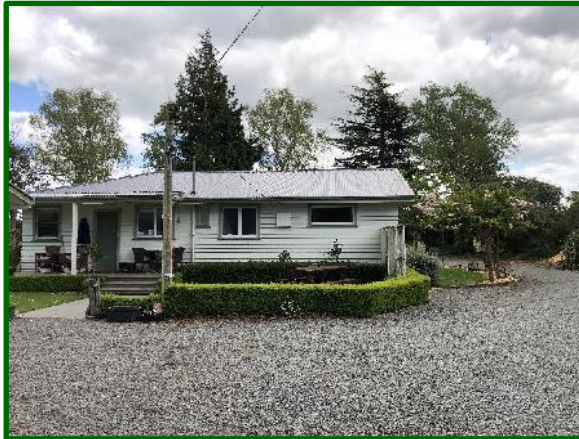
Photo 1 – Residential Dwelling

The site is accessed via a driveway off Gladstone Road. 145-Lot 1 DP 29099 contains a residential dwelling, a garage, a chicken house, raised beds for vegetable growing and a small sleep out. The dwelling is a timber and weatherboard structure with an iron roof. The garage is a concrete block construction with hardboard eaves and fascias. No potential sources of contamination were observed on the dwelling, garage or within the residential curtilage area.

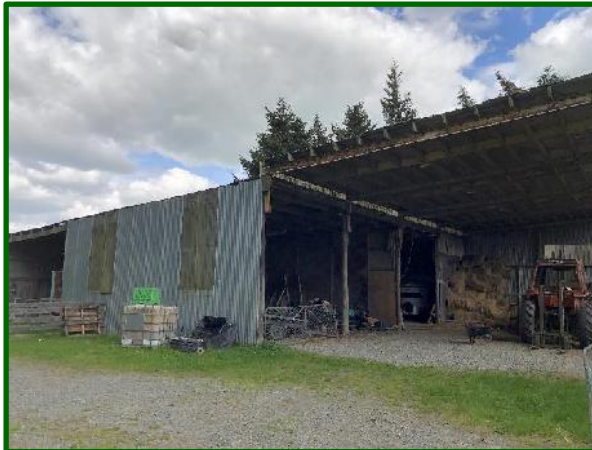
167-Lot 2 DP 29099 contains a large farm shed and an older timber shed, old stockyard/sheep dip/foot rot trough, a horse arena and large grassed paddock areas. This lot was generally untidy with rubbish items deposited in multiple locations near to the sheds, predominantly underneath the large trees. The tenant was present early in the inspection and stated that the horse arena was constructed using crusher dust, therefore, it is unlikely this would give rise to contamination.

Photo 3 – Large farm shed

There have also been a number of extensions to sheds during the 1970s when the use of asbestos containing materials was commonplace. There is a possibility that asbestos from the construction of the sheds, deterioration over time and demolition of old sheds may have contaminated the soils around them.

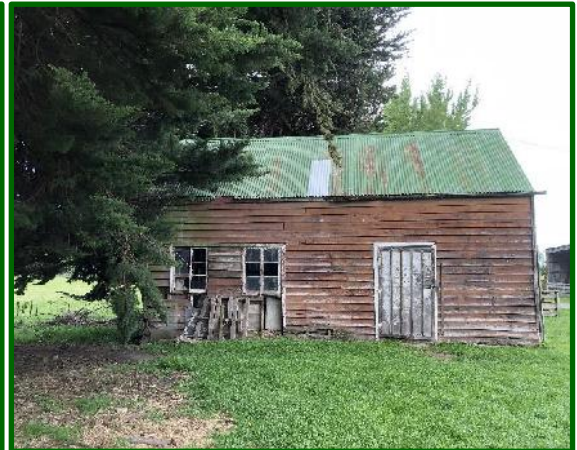
A smaller older painted wooden shed with an iron roof is located nearby to the east. This has the potential to have been painted using lead-based paint. At the rear of the older shed is a fenced area/stockyard which may have been a sheep dip and drip area or a foot rot trough and drip area. The area directly east of the stockyards are sloped downhill which may indicate that any livestock dip/chemical treatment residue may have contaminated land down slope of the application area. On the eastern side of the shed two drums of suspected waste oil were observed. A small burn area was noted to the north, near to the entrance to the site, and appeared to have been used recently. Also, in this area there is an old concrete trough in the ground with evidence of burnt material within.

Photo 4 Older farm shed

A dwelling and farm sheds were present on the site from at least the 1940's. Based on the era of the buildings present it is highly likely that lead based paint products and asbestos containing materials (ACM) were used and any natural deterioration or intentional removal may have caused contamination of the surrounding soils. Contaminants of concern include heavy metals and asbestos.

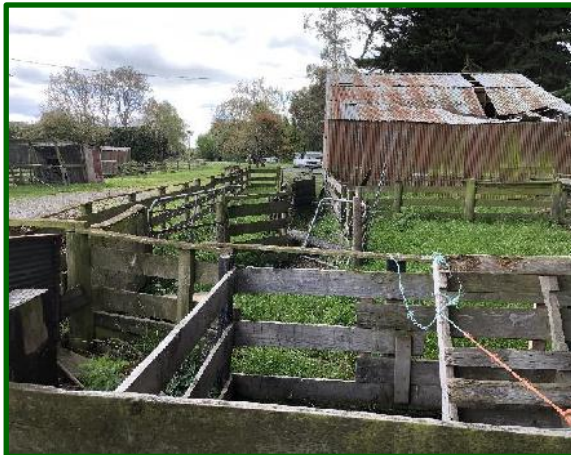
Photo 5 – Sheep dip/foot rot trough/drip area

There is evidence that sheep were grazed on the land in the 1970's and evidence from aerial photographs from this period that potential sheep dip/foot rot treatment areas were present. There is a possibility that chemical spillage and leakage could have contaminated the soils in this area. Contaminants of concern include heavy metals and organochlorine pesticides (OCPs).

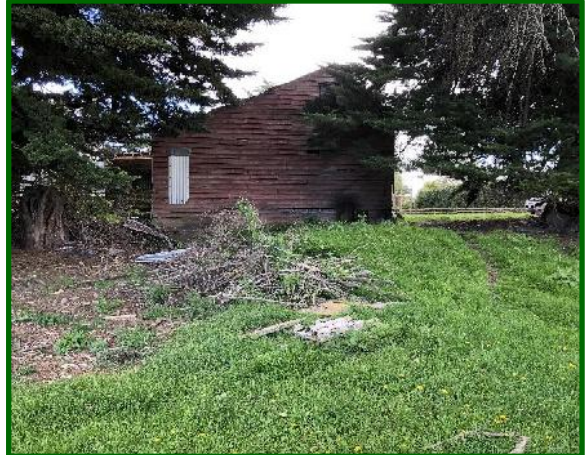
Photo 6 – ACM Super 6 storage area

Asbestos in a deteriorated condition was found in an area approximately 5m in diameter close to the older farm shed. A stack of asbestos containing corrugated 'Super 6" roofing sheets was present. Broken pieces were found lying on the surface and also some covered by long grass suggesting it has been there for some time.

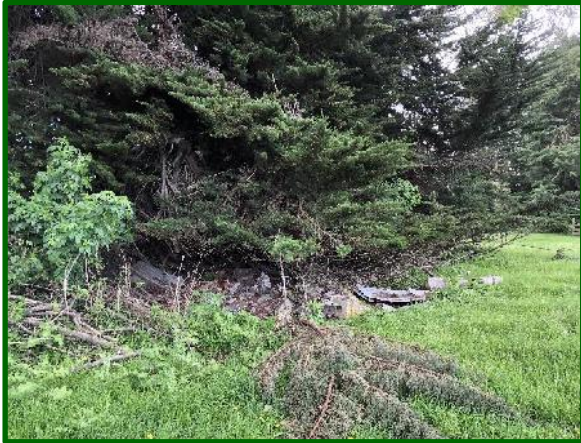
There are a number of large trees that surround the old farm shed and farm rubbish consisting of broken concrete, iron roofing, wooden crates, timber poles, bricks, tanks, empty drums, metal wire and broken asbestos containing material "super 6" has been deposited beneath them, with broken pieces currently affecting an area approximately 5m in diameter. Crates of firewood for domestic use were also evident underneath the trees.

Photo 7 – Rubbish beneath trees

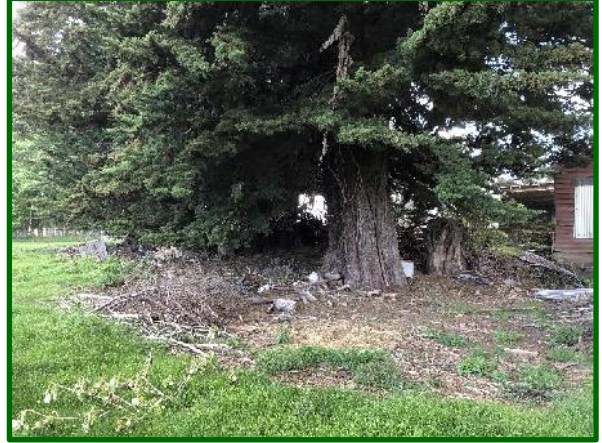
Photo 8 – Rubbish beneath trees

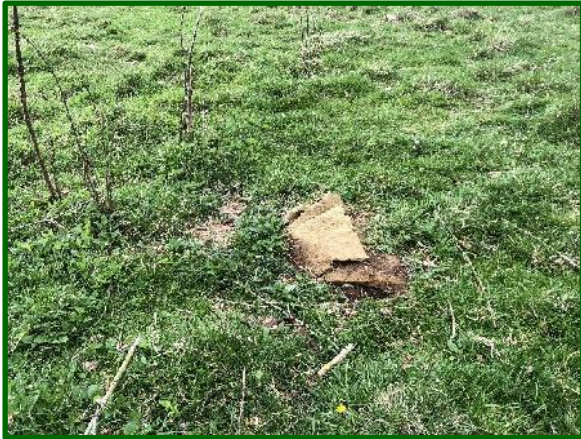
There were a number of green waste burn piles across the site predominantly on the western side of the site however, towards the southern boundary an historical burn area was found that appeared to have burnt upholstery foam contained within it. This area is close to the motocross track and was possibly a bonfire for enjoyment rather than burning green waste.

Photo 9 - Historical burn area (southern boundary)

A burn area which contained anthropogenic material was identified close to the entrance during the site inspection. Nearby was a concrete trough which had burnt material evident within. A further burn area containing upholstery foam was identified near to the southern boundary of the site. Contaminants of concern associated with these burn areas identified are heavy metals. The remaining burn areas identified during the site inspection were green waste material only.

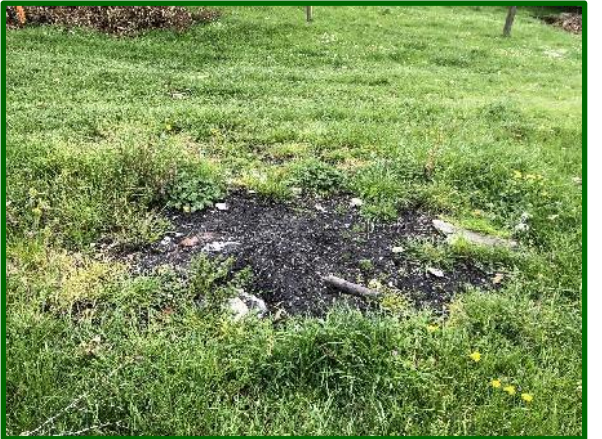
Photo 10 – Recent burn area

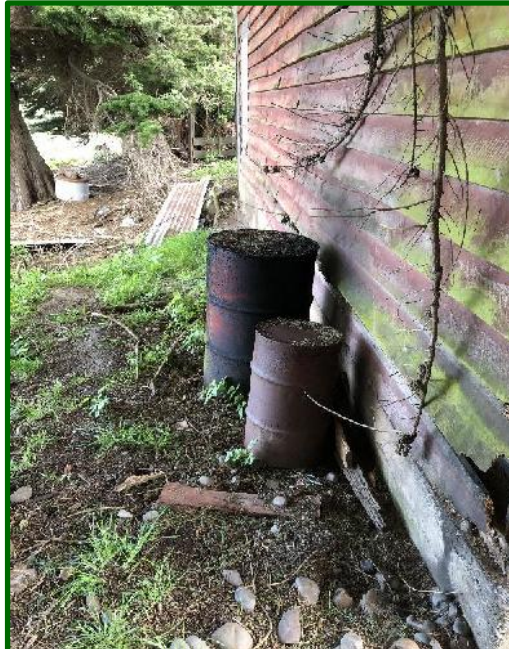
Photo 11 – Suspected waste oil drums

Two drums of suspected waste oil were discovered behind the older wooden shed during the site inspections. No olfactory evidence of spills or leaks were observed during the site inspection; however, the drums were rusted, and the larger drum had oil staining on the top and sides and they both appeared to have been in situ for a considerable time. The waste oil drums are considered highly unlikely to have caused soil contamination that would pose a significant risk to human health however there may be localised risk to the environment due to the integrity of the drums. Contaminants of concern are petroleum hydrocarbons (TPH).

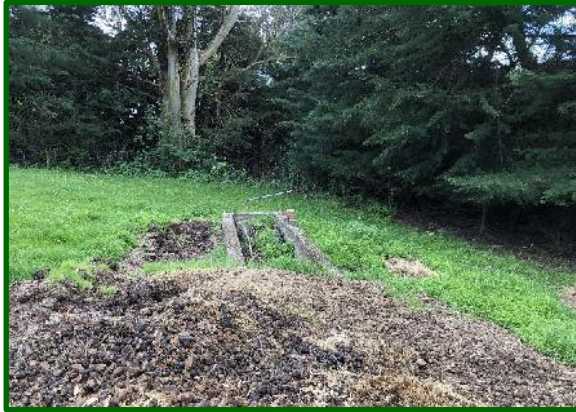
Photo 11 – Concrete trough with burnt material

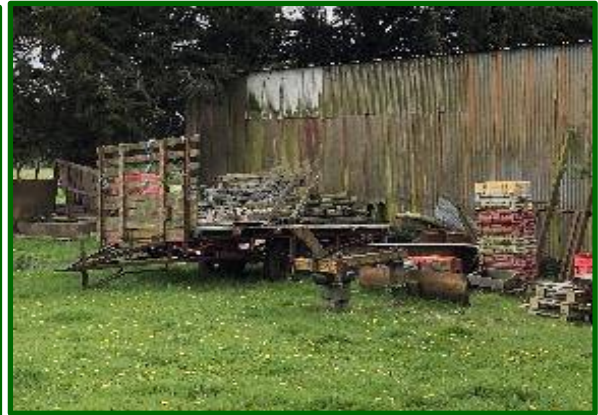
Photo 12 – Pile of treated timber posts (rear of shed)
