Before an Independent Hearings Panel  
Appointed by Waimakariri District Council

Statement of evidence of Dave Compton-Moen (Landscape) on  
behalf of Carter Group Limited and Rolleston Industrial  
Developments Limited

535 MILL ROAD, OHOKA - DISTRICT PLAN SUBMISSION  
FOR ROLLESTON INDUSTRIAL DEVELOPMENTS LIMITED  
5 MARCH 2024

## 535 MILL ROAD, OHOKA- PLAN CHANGE

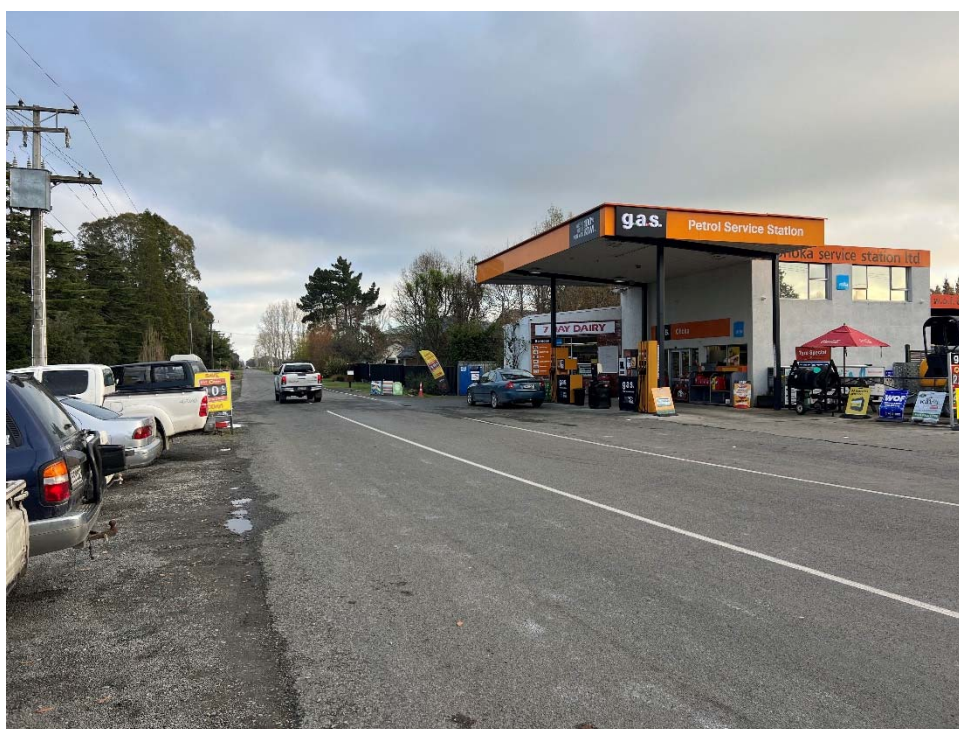
**Photo 1** - The existing GAS service station on the corner of Whites and Mill Roads

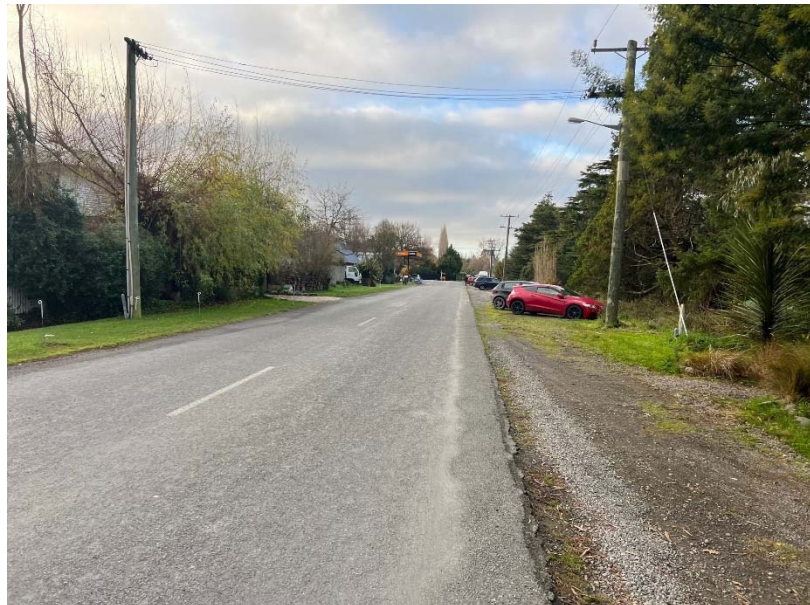
**Photo 22** - Photo looking north along Whites Road adjacent to the Domain. Note that the proposal does not seek to change any of the elements in this view which contributes to the character of Ōhoka, where people stand and talk close to the edge of the carriageway.

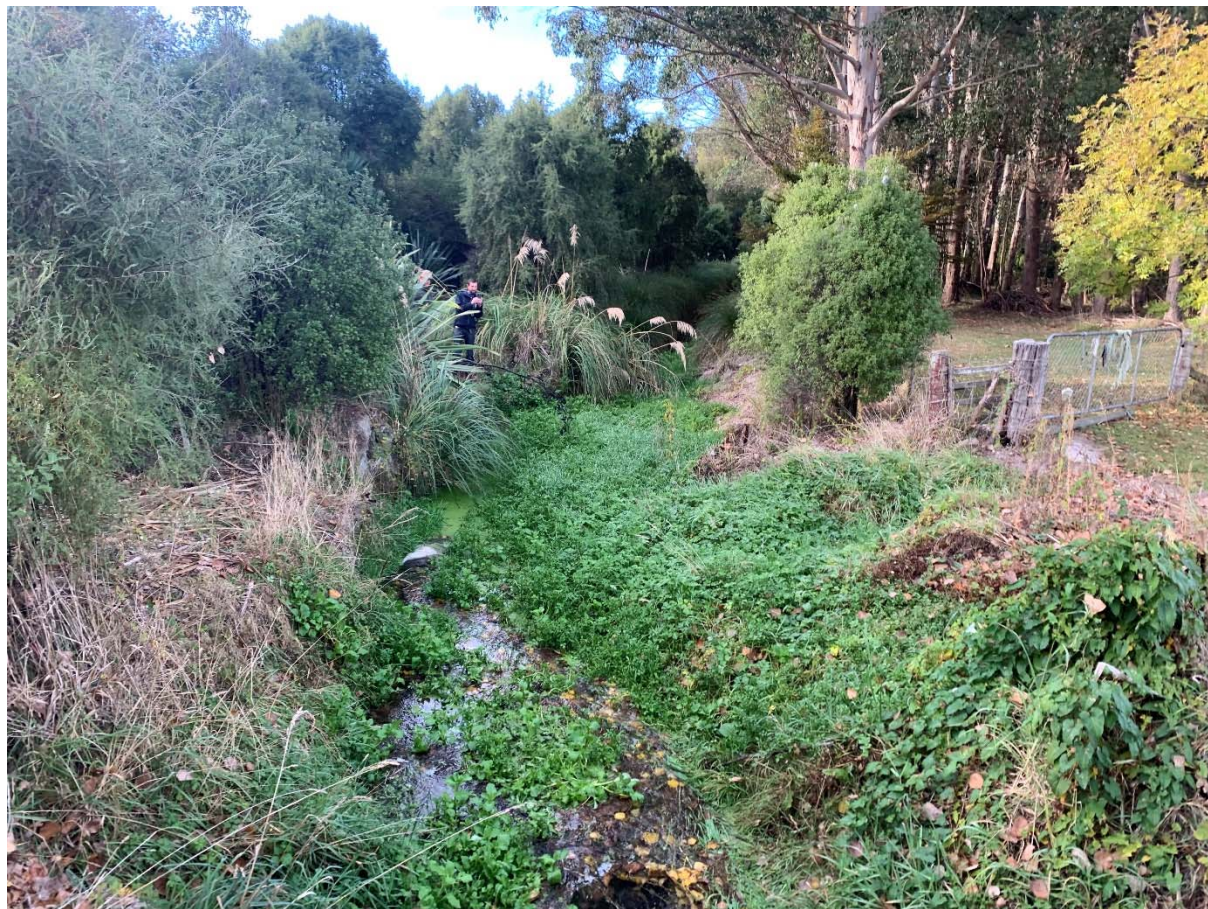
**Photo 3** - Native riparian planting in Ōhoka Bush as well as weed species

- 20 No indigenous species of note were found along the waterways on site during my inspection but to the southeast of the Site, downstream of Whites Road, the stream corridor has been planted extensively with native species although large numbers of weed species were also present (refer to Photo 2 above). This shows the potential for the waterways to become native corridors through the block but presently the waterways are considered to have a low sensitivity to change.

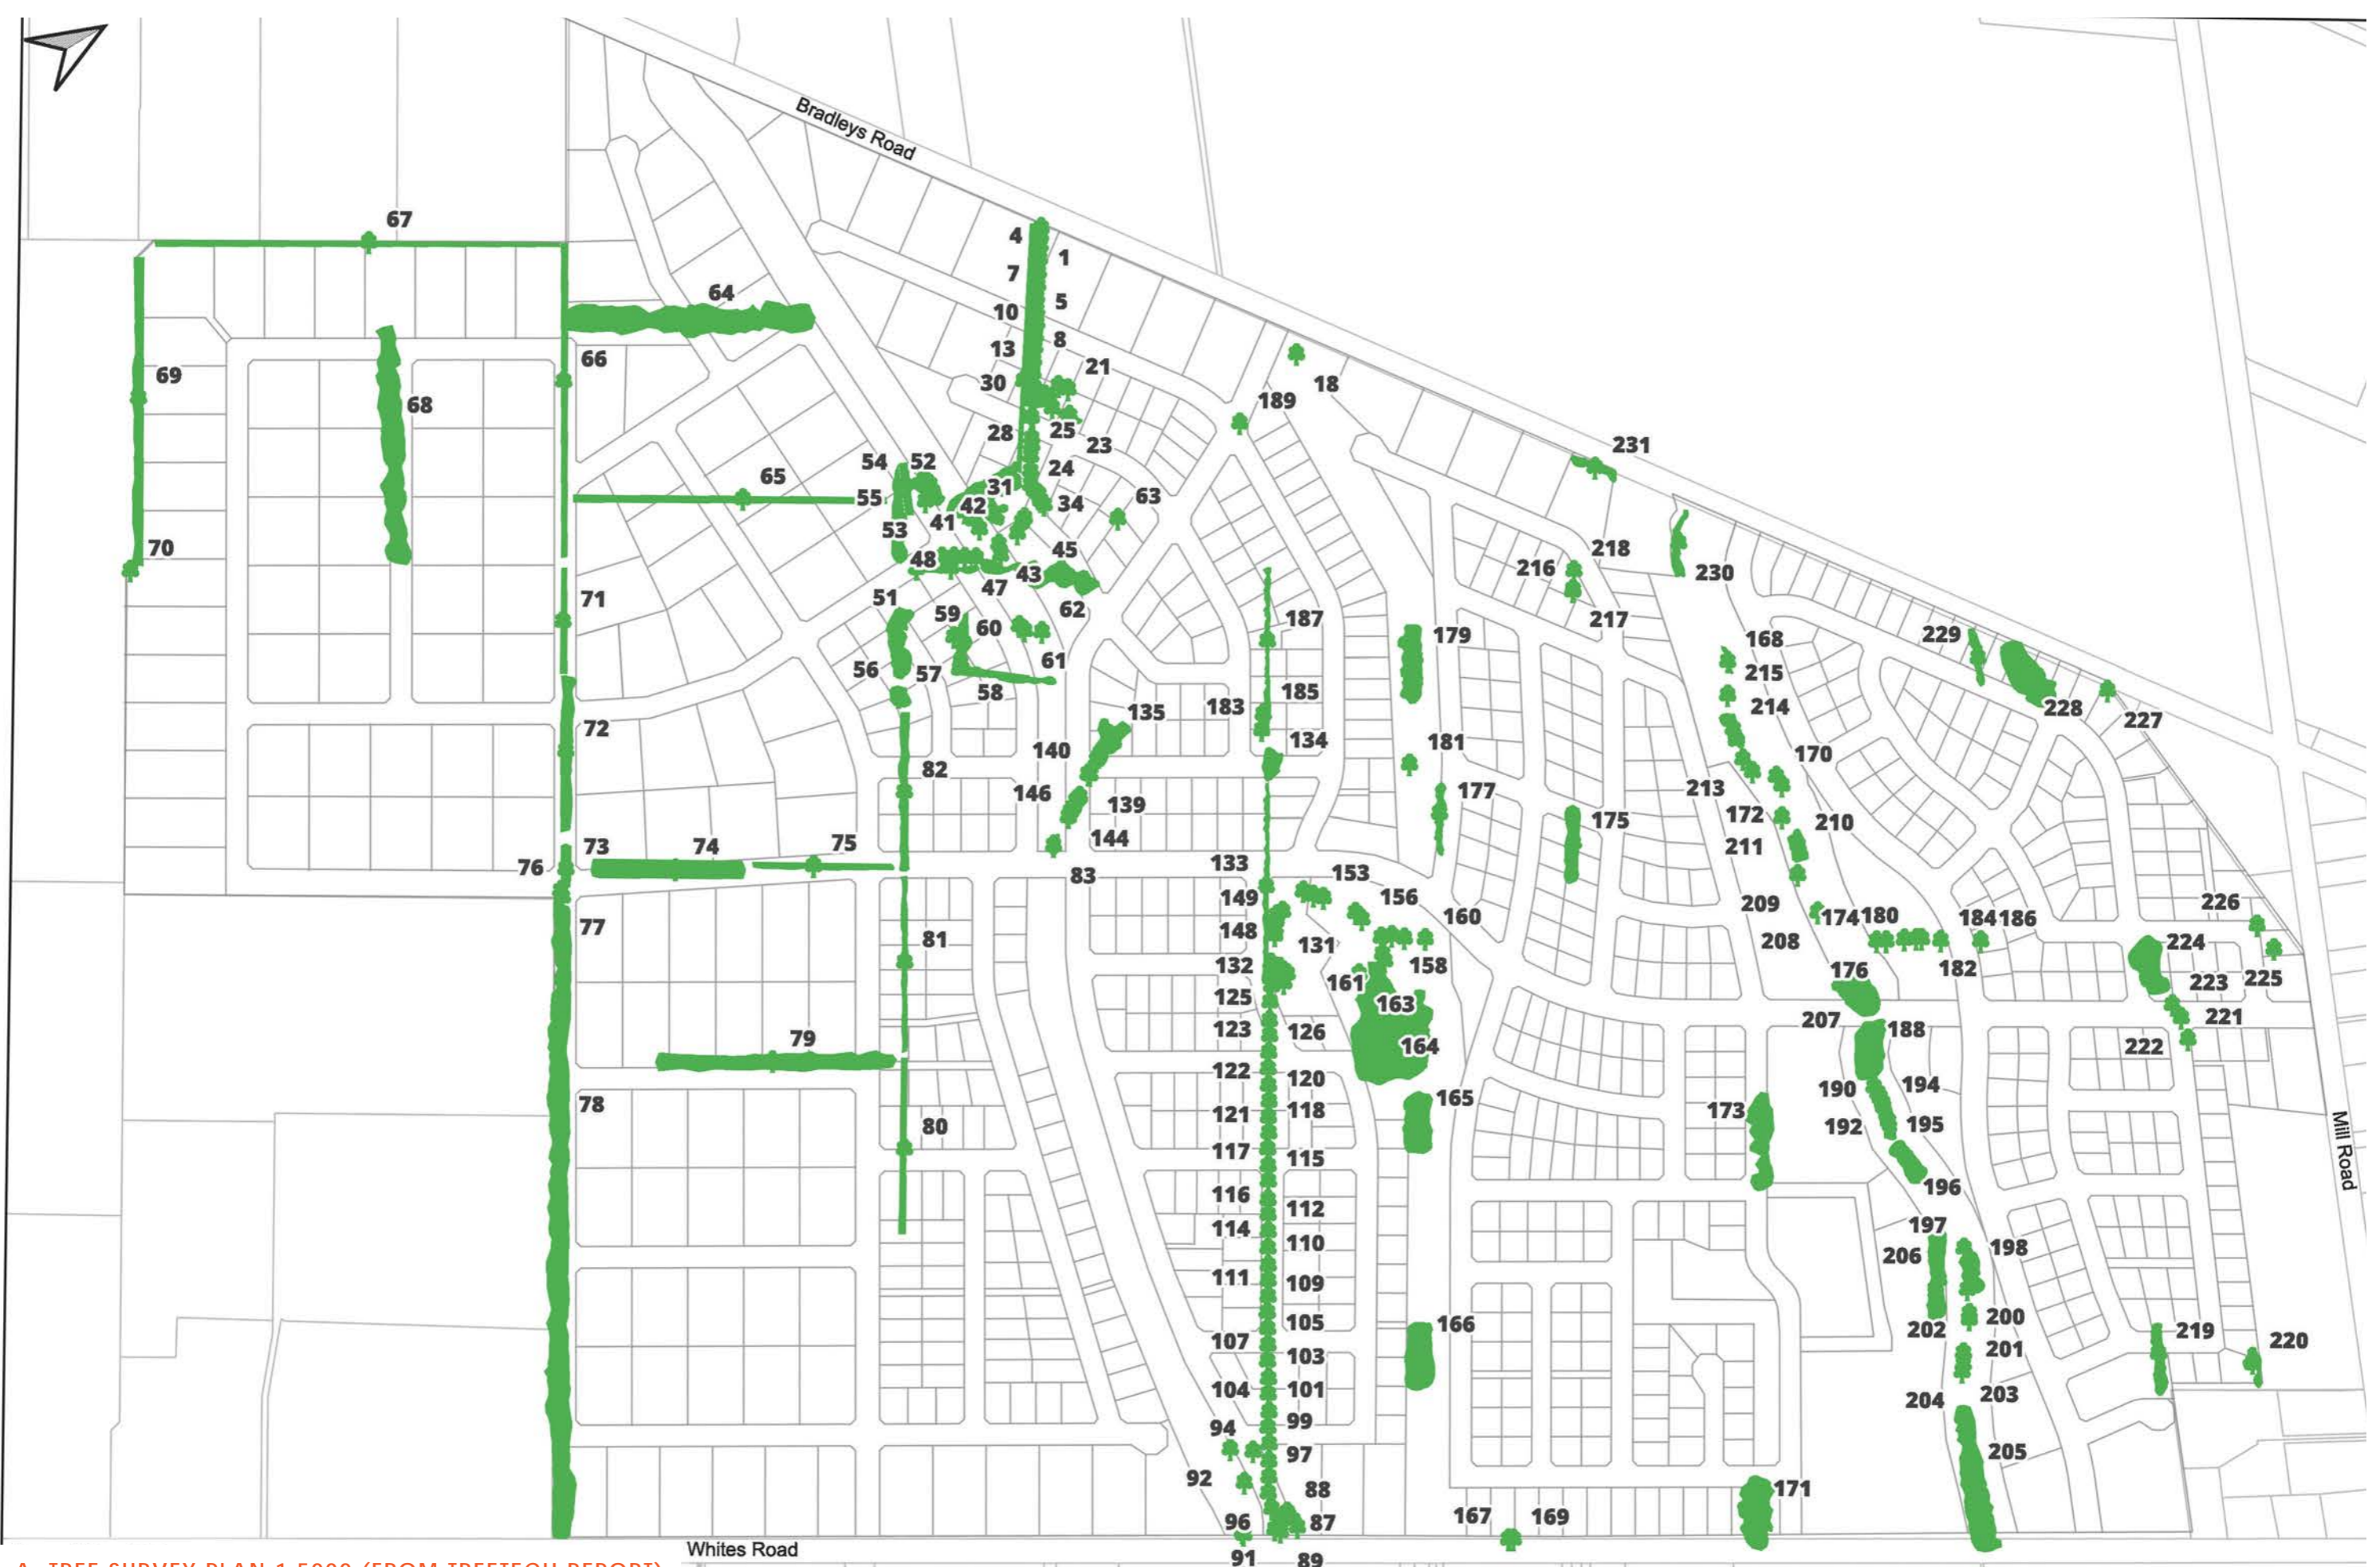
A. TREE SURVEY PLAN 1:5000 (FROM TREETECH REPORT)

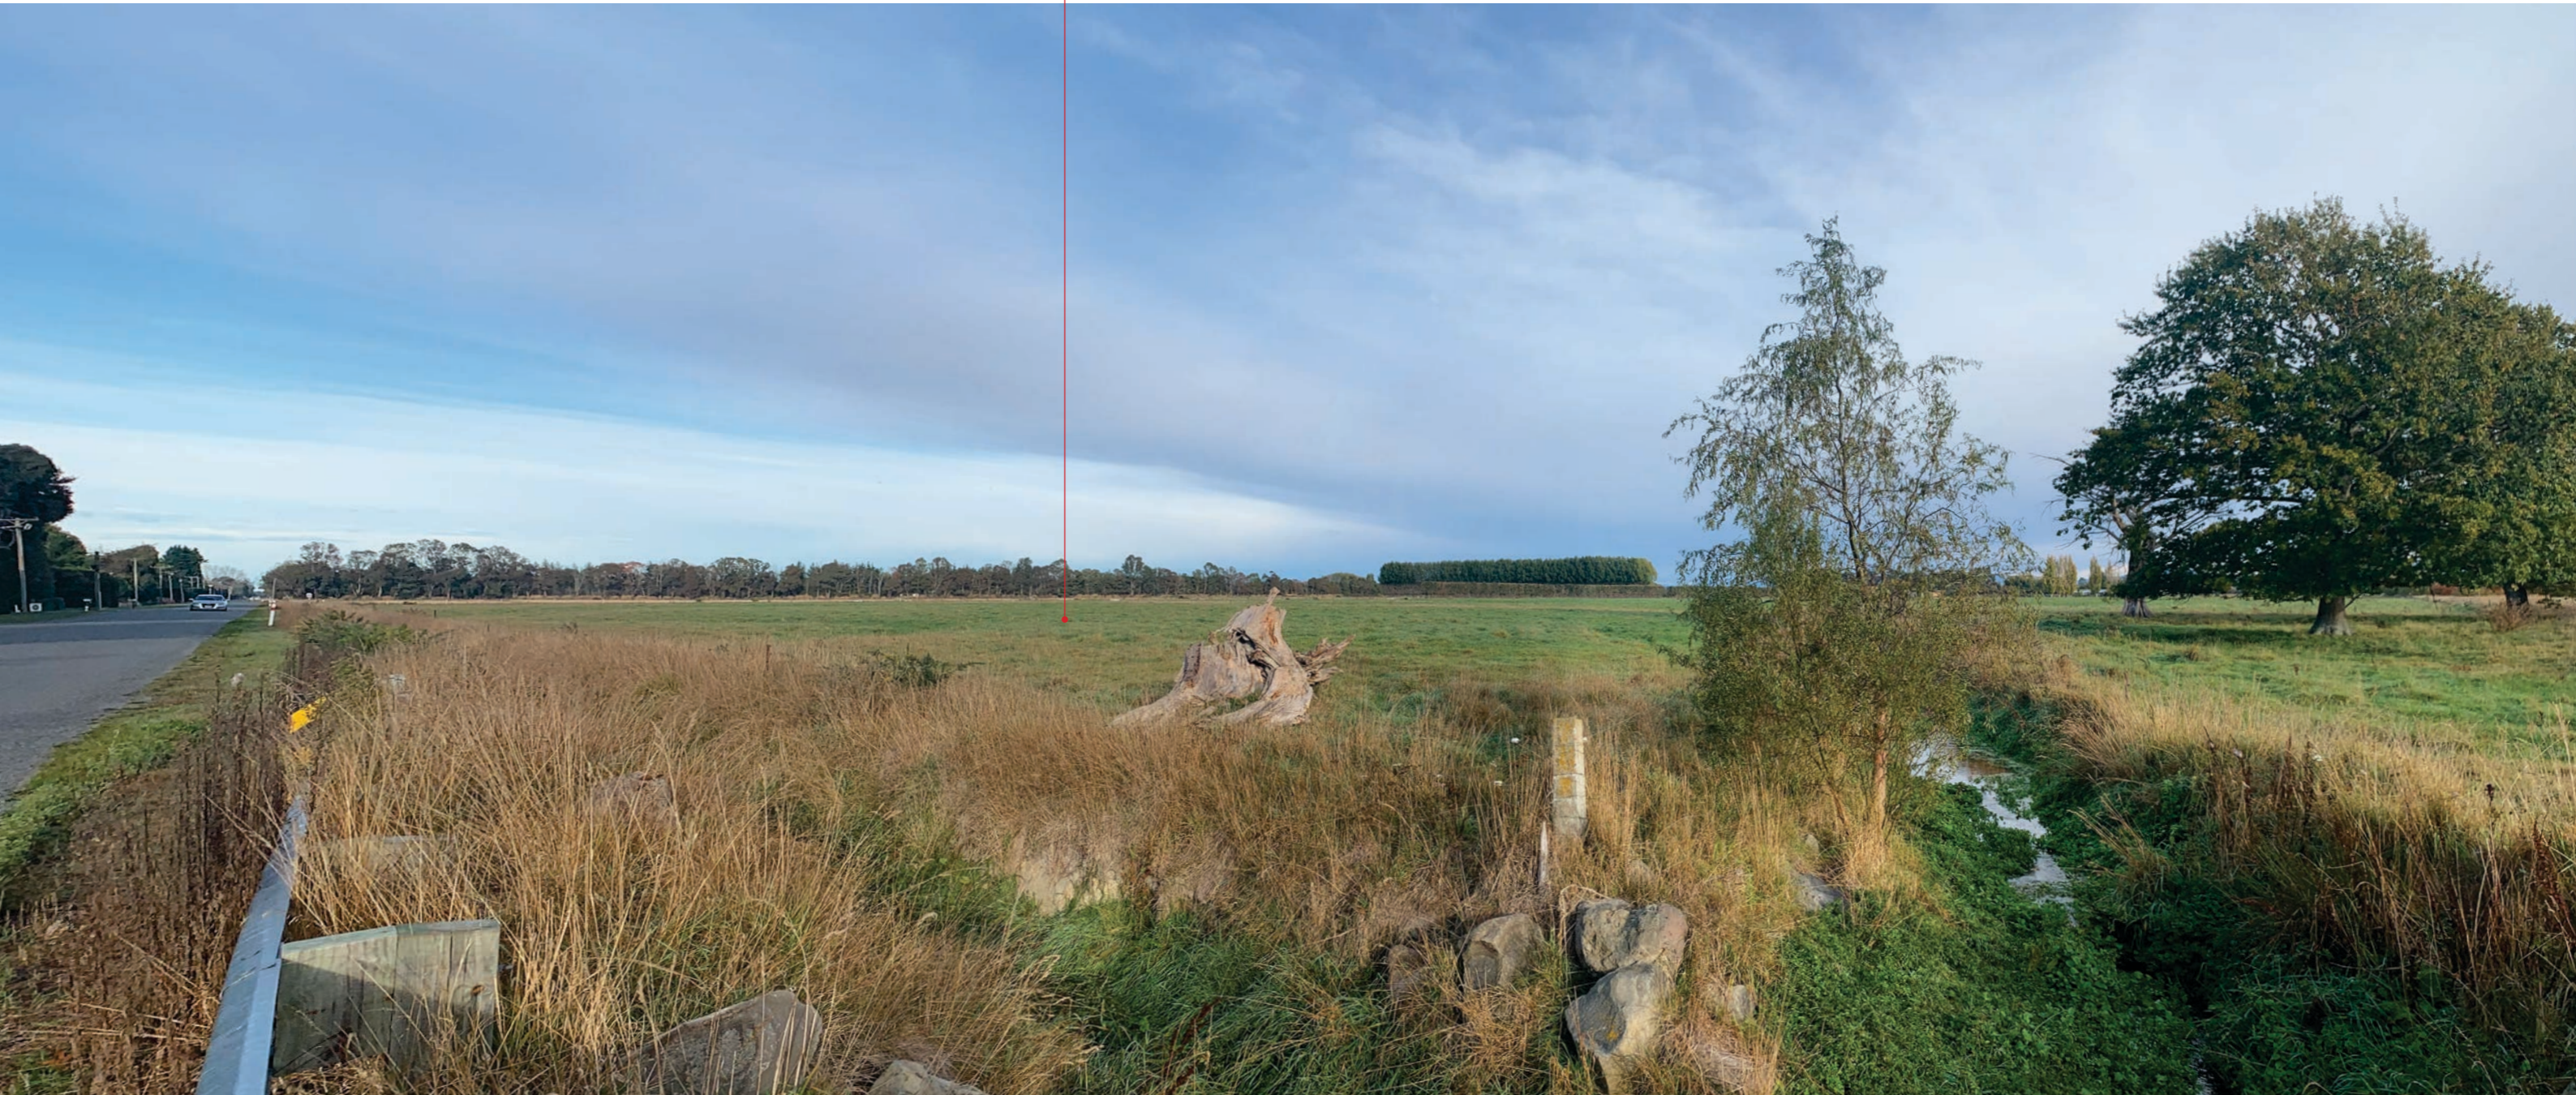
# VP1 - VIEW SOUTH WEST FROM 318 WHITES ROAD

Image captured on Sony A6000  
Focal length of 50mm  
Date: 30th April 2021 at 8:57 am  
Height of 1.7 metres  
Photos merged in Photoshop CS to create panorama

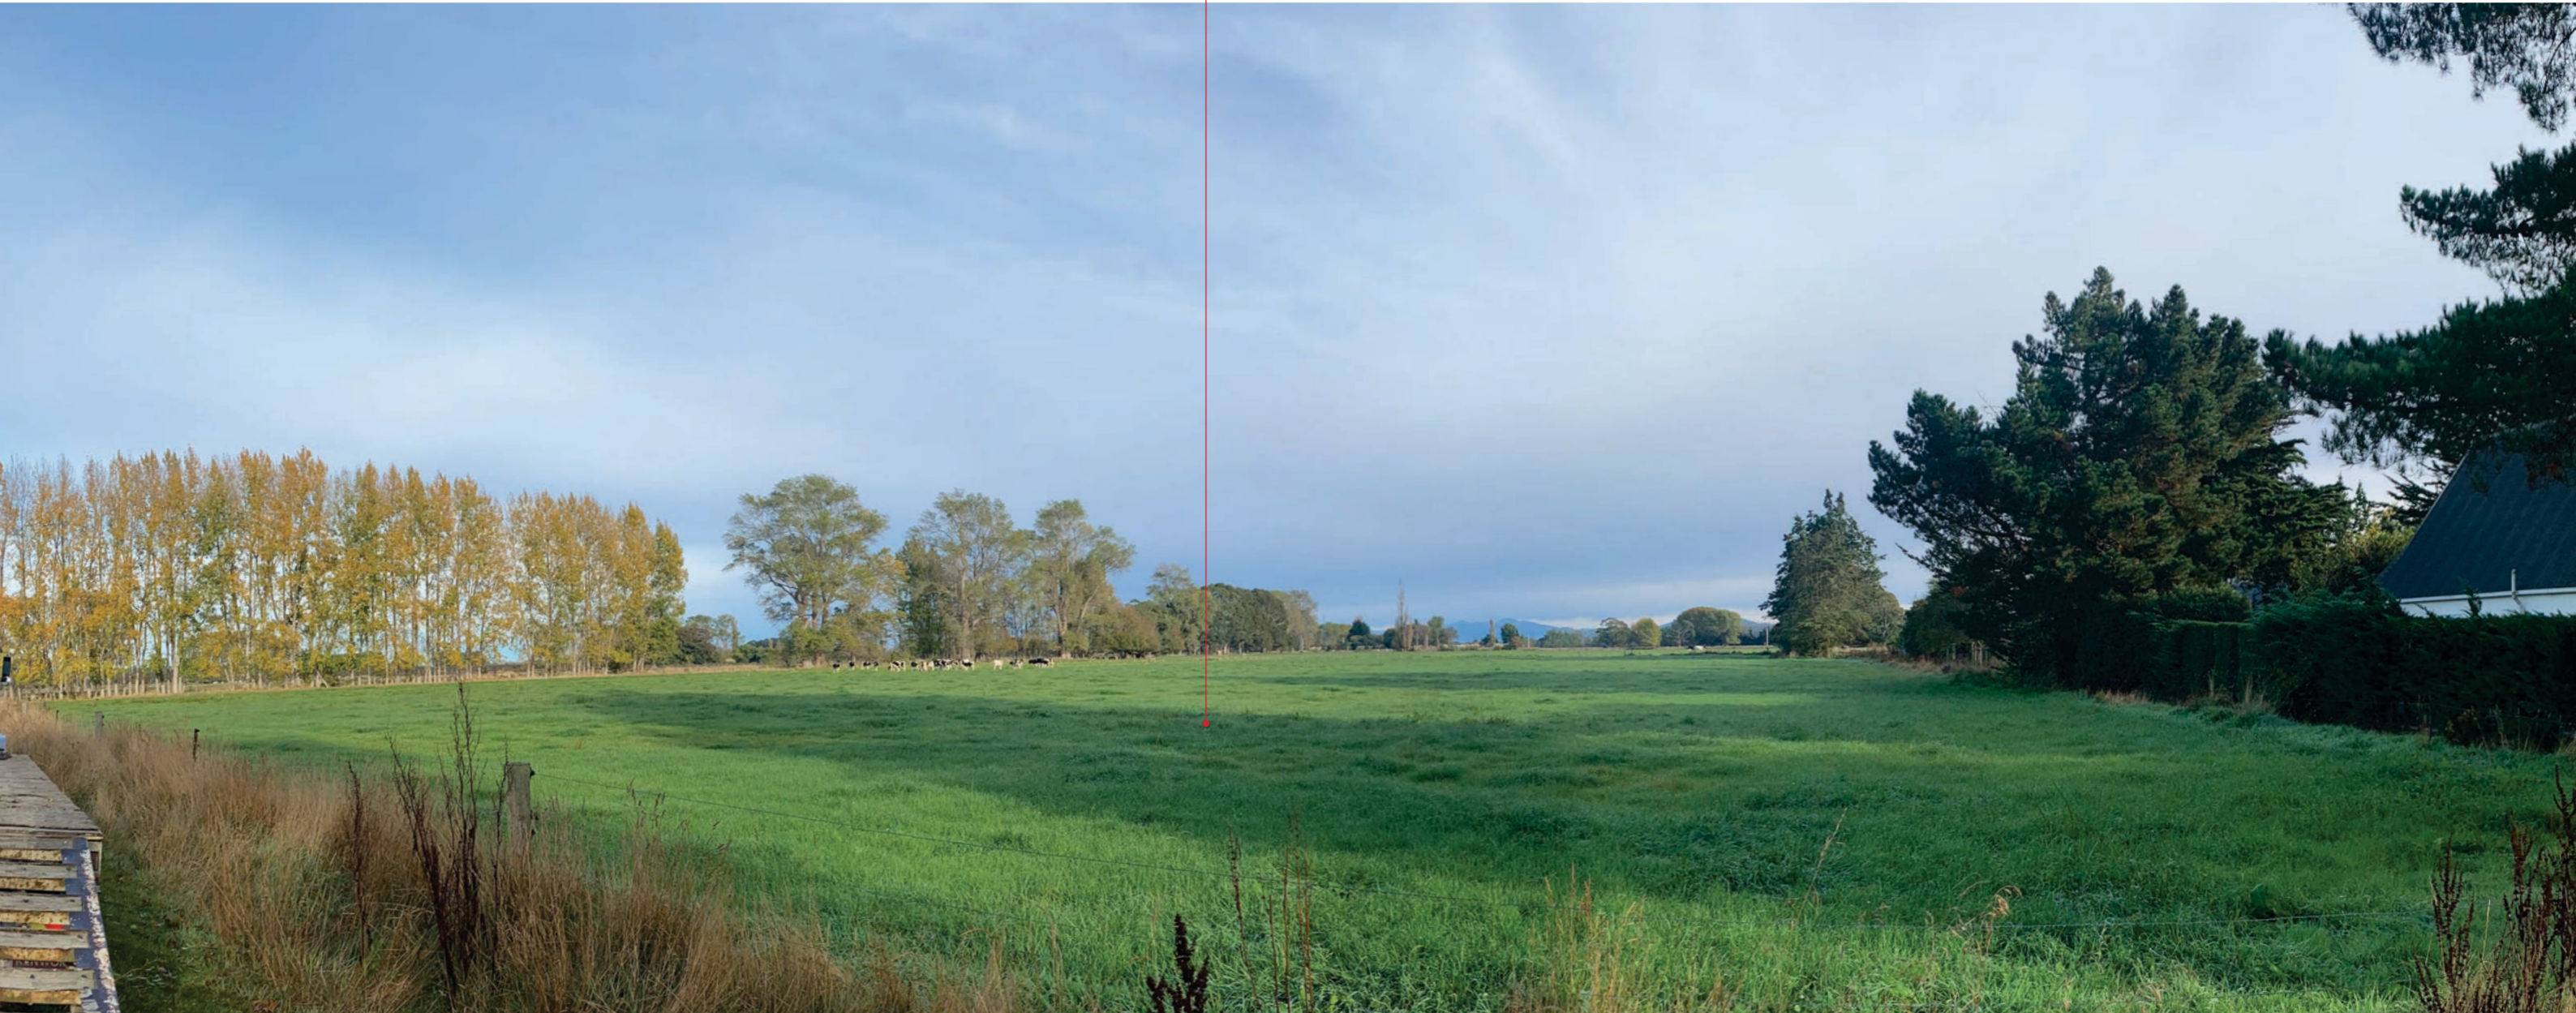
# VP2 - VIEW SOUTH WEST FROM 410 WHITES ROAD

Image captured on Sony A6000  
Focal length of 50mm  
Date: 30th April 2021 at 9:02 am  
Height of 1.7 metres  
Photos merged in Photoshop CS to create panorama

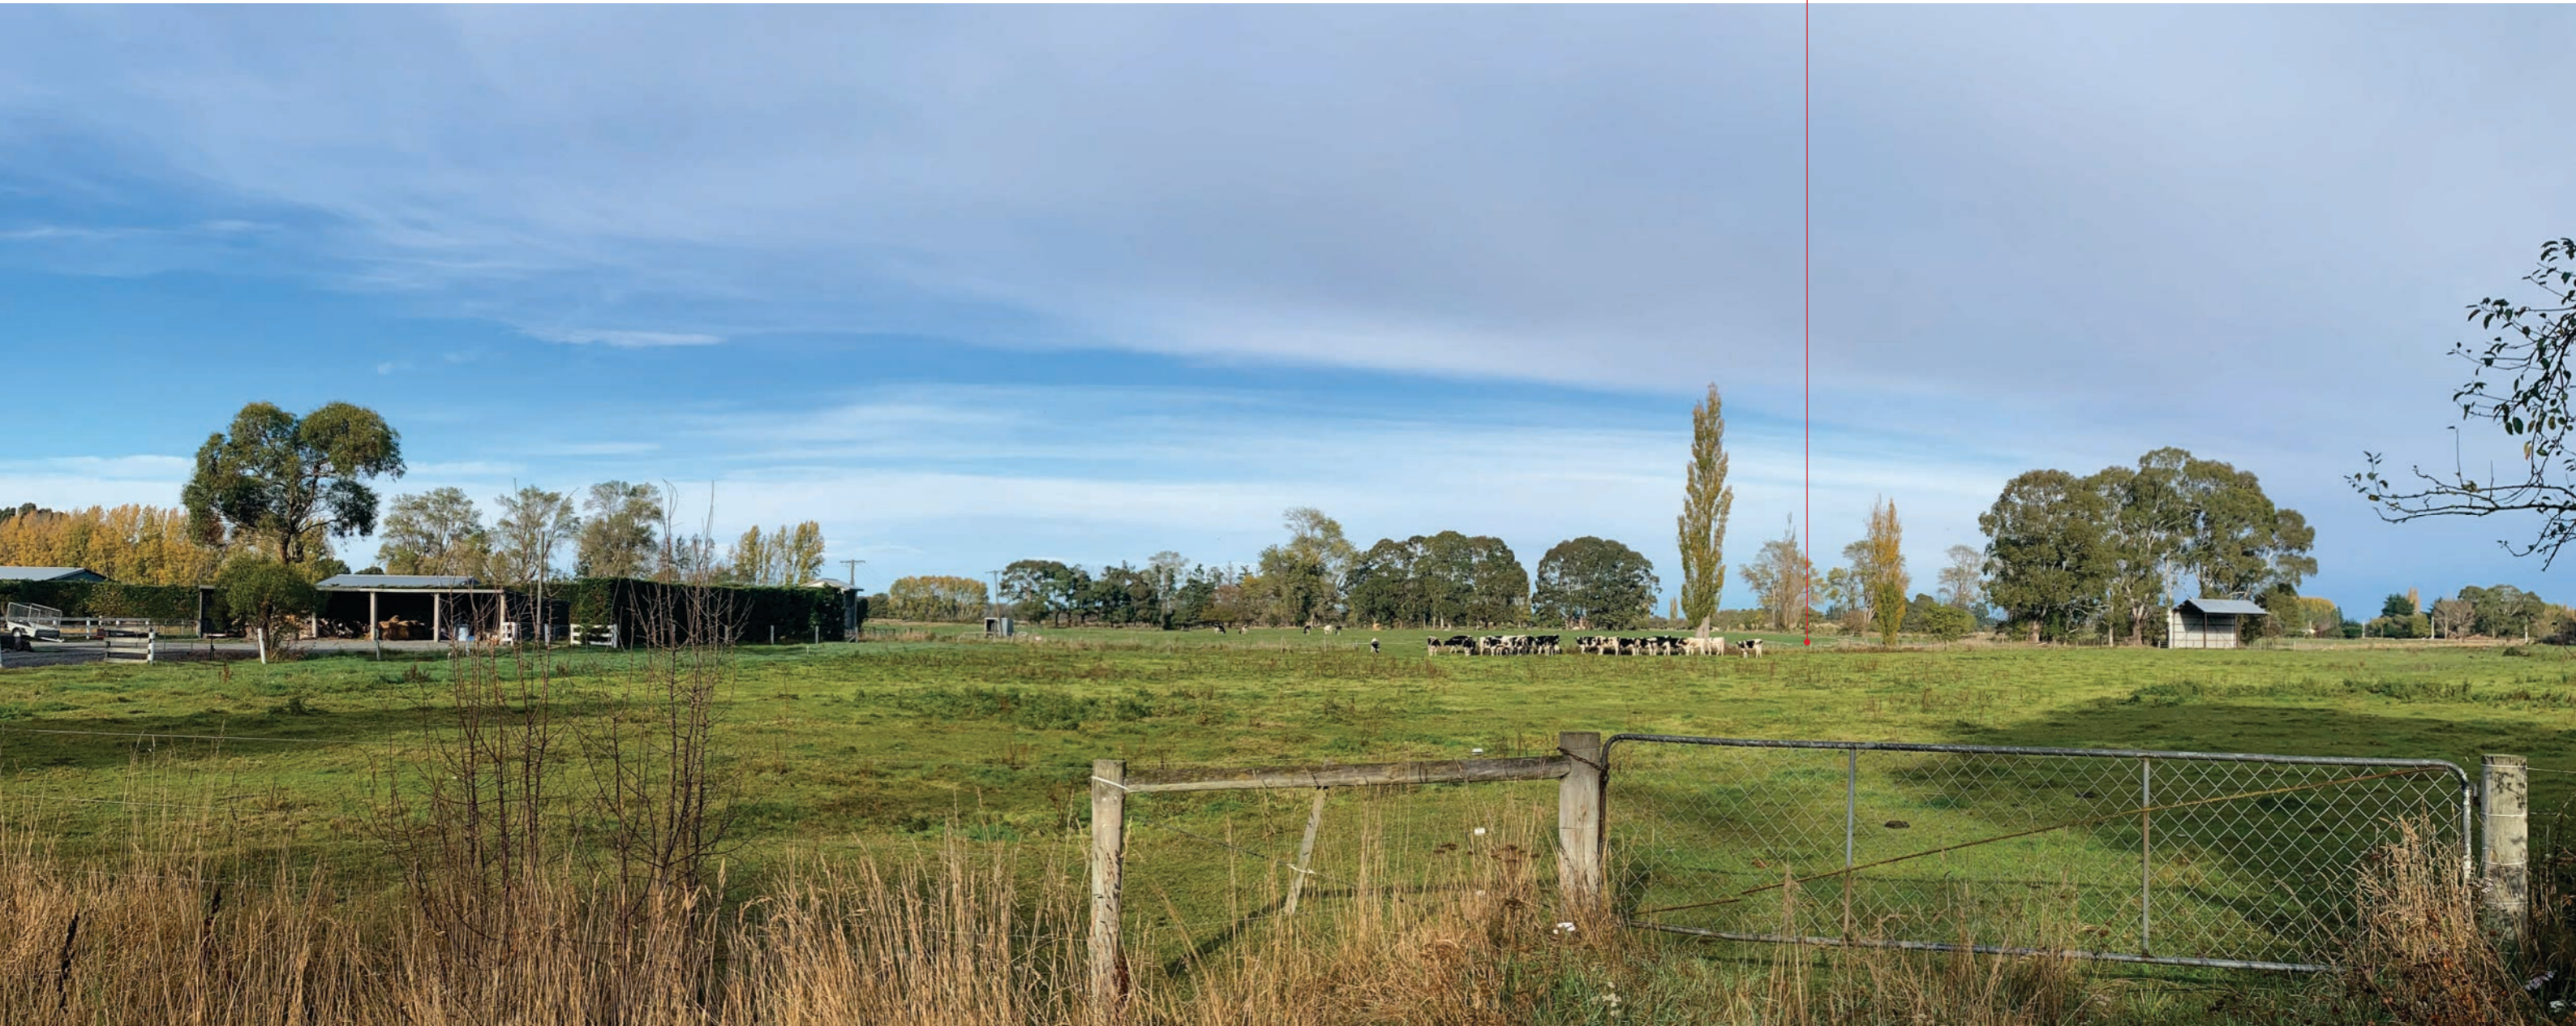
## VP3 - VIEW SOUTH FROM 535 MILL ROAD

Image captured on Sony A6000  
Focal length of 50mm  
Date: 30th April 2021 at 9:20 am  
Height of 1.7 metres  
Photos merged in Photoshop CS to create panorama

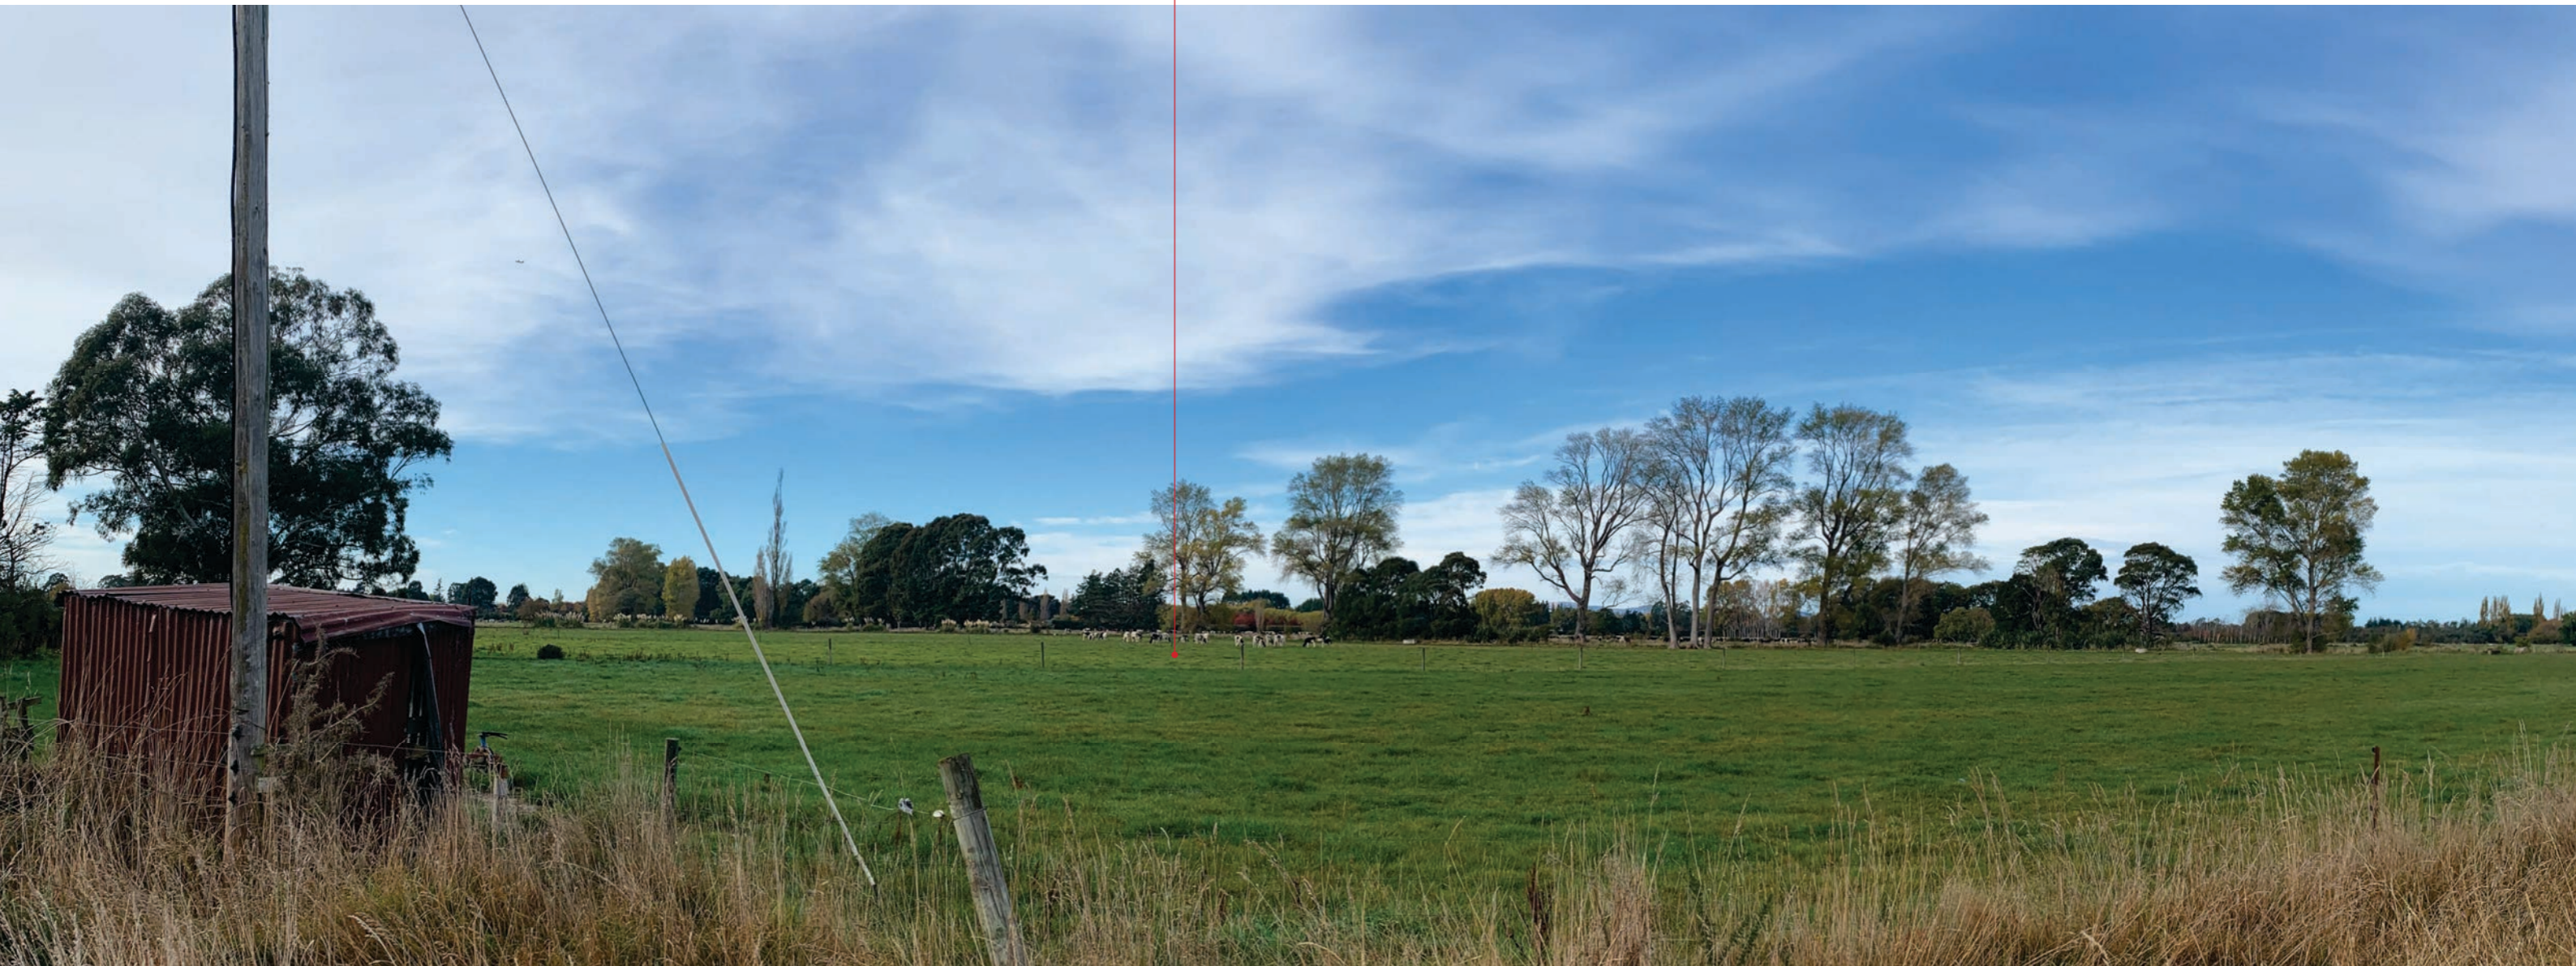
## VP4 - VIEW SOUTH FROM 301 BRADLEYS ROAD

Image captured on Sony A6000  
Focal length of 50mm  
Date: 30th April 2021 at 9:51 am  
Height of 1.7 metres  
Photos merged in Photoshop CS to create panorama

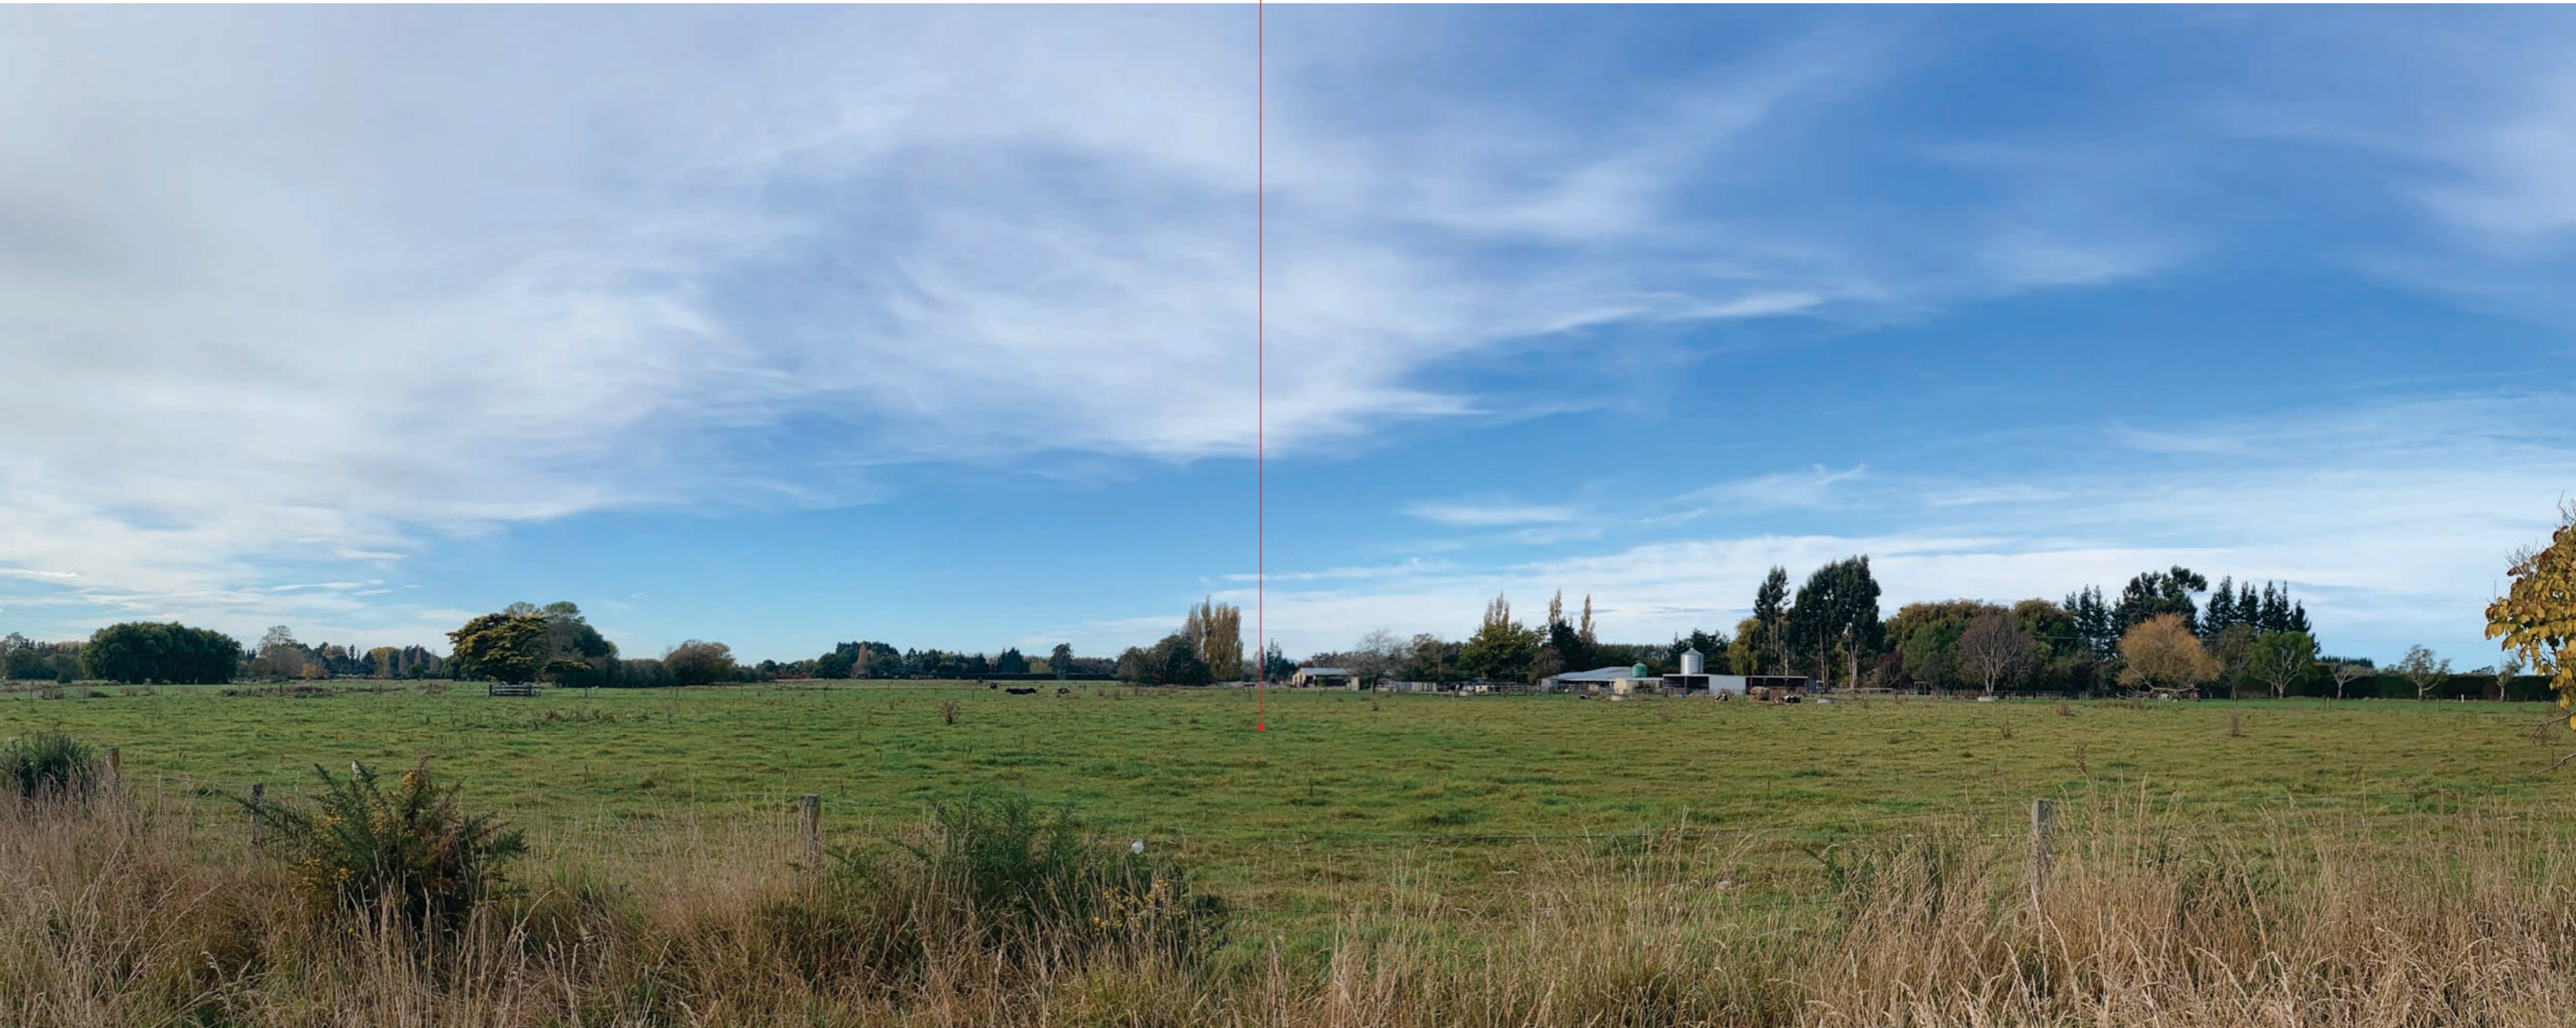
# VP5 - VIEW SOUTH EAST FROM 231 BRADLEYS ROAD

Image captured on Sony A6000  
Focal length of 50mm  
Date: 30th April 2021 at 9:54 am  
Height of 1.7 metres  
Photos merged in Photoshop CS to create panorama
