Prepared for Dexin Investments Ltd 503498

Desktop Natural Hazards Risk Assessment Report

Pegasus Mākete, 1250 Main North Road, Woodend

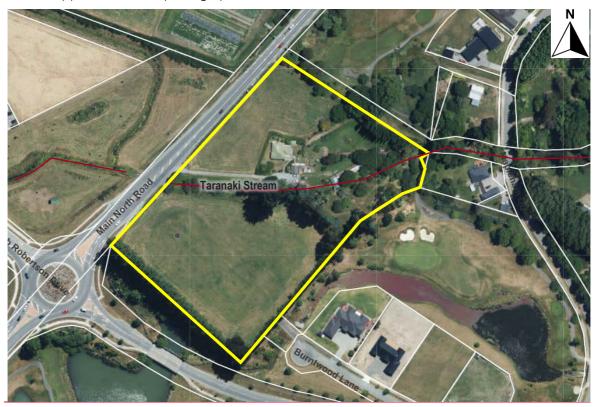
Figure 1. Aerial imagery sourced from Eliot Sinclair GIS. Approximate site boundary outlined in yellow.

Refer to Figure 1 for the site layout plan.

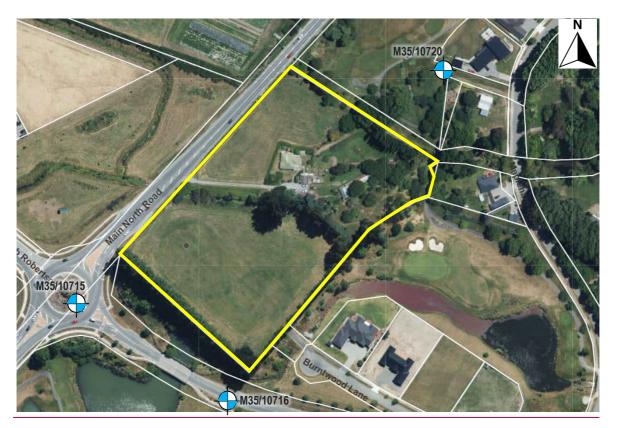
Figure 3. Aerial site plan with ECan well bores with borehole logs shown. Site is outlined in yellow.
