Geotechnical Report for Proposed Subdivision - North Block - for Plan Change Application

Prepared for
Momentum Land Ltd

Prepared by
Tonkin & Taylor Ltd

Date
May 2023

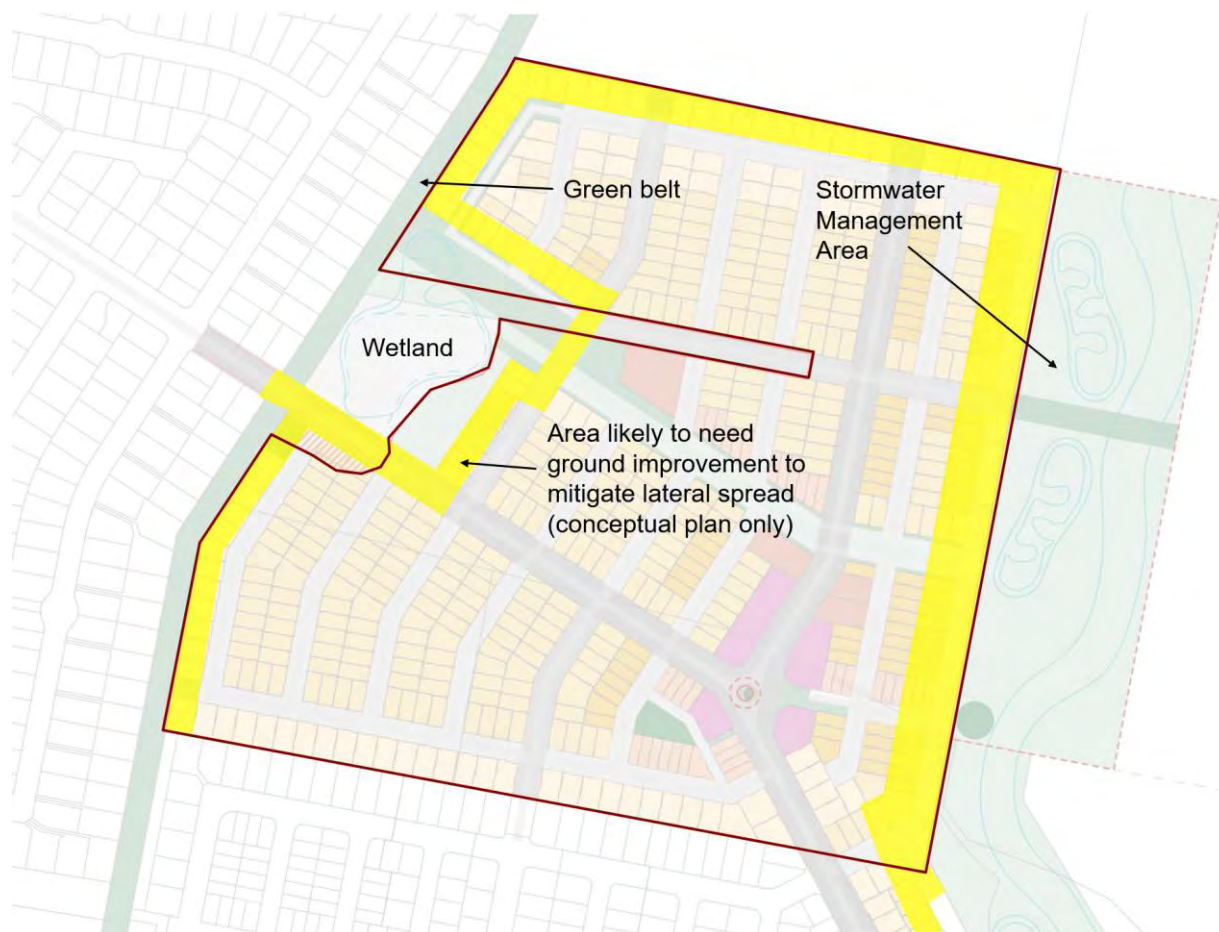
Figure 3: Lateral Spread ground improvement areas – concept only.

The conceptual site configuration has a green belt, wetland, farm, and stormwater management area around the eastern, northern, and western perimeter of the site which are expected to be at a lower elevation. This creates the potential for lateral spreading to occur along the edges of the site, with buildings moving towards the areas of lower elevation under liquefied conditions. Lateral spread mitigation methods such as stone column ground improvement should be anticipated beneath the perimeter roads and buildings, as shown in Figure 3. It is possible after further geotechnical investigations that mitigation measures may be reduced from deep to shallow ground improvement in favourable areas with less liquefaction hazard.

The potential distribution of lateral ground displacement may impact differently on different structures and underground services, and this will need to be considered during future design phases.

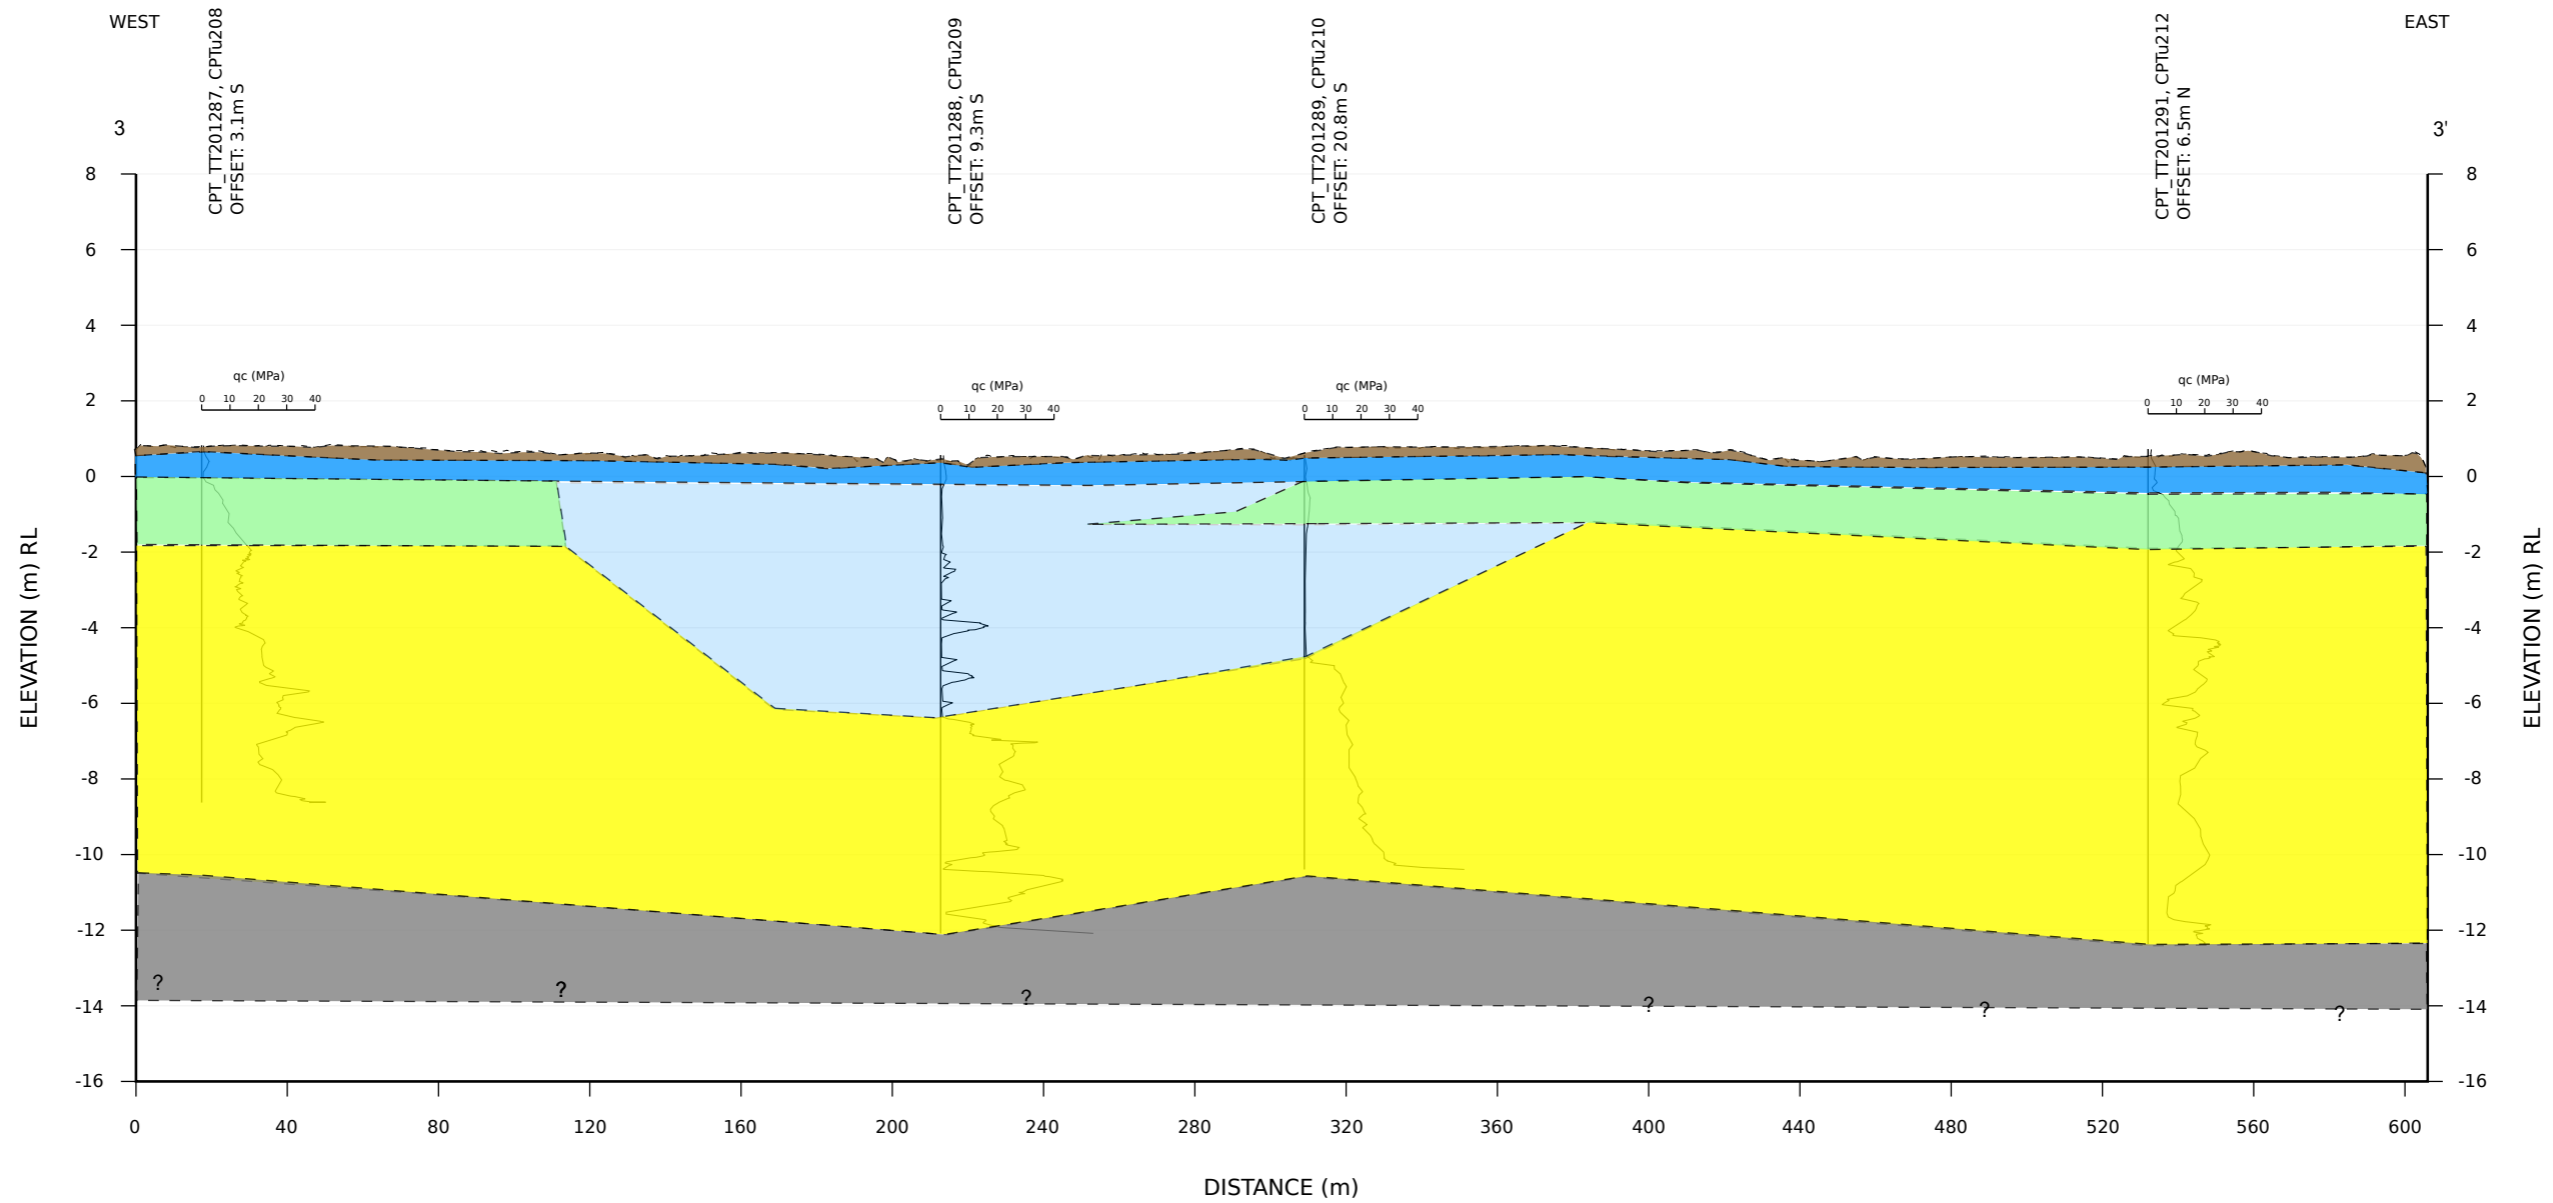
SECTION 3
SCALE: 1:2000H
(1:200V)

LEGEND	
	TOPSOIL
	SOFT SANDY SILT TO SILT
	VERY SOFT SILT WITH OCCASIONAL SAND LAMINATIONS
	LOOSE TO MEDIUM DENSE SAND WITH OCCASIONAL SILT BEDS
	MEDIUM DENSE TO DENSE SAND TO GRAVELLY SAND
	GRAVEL

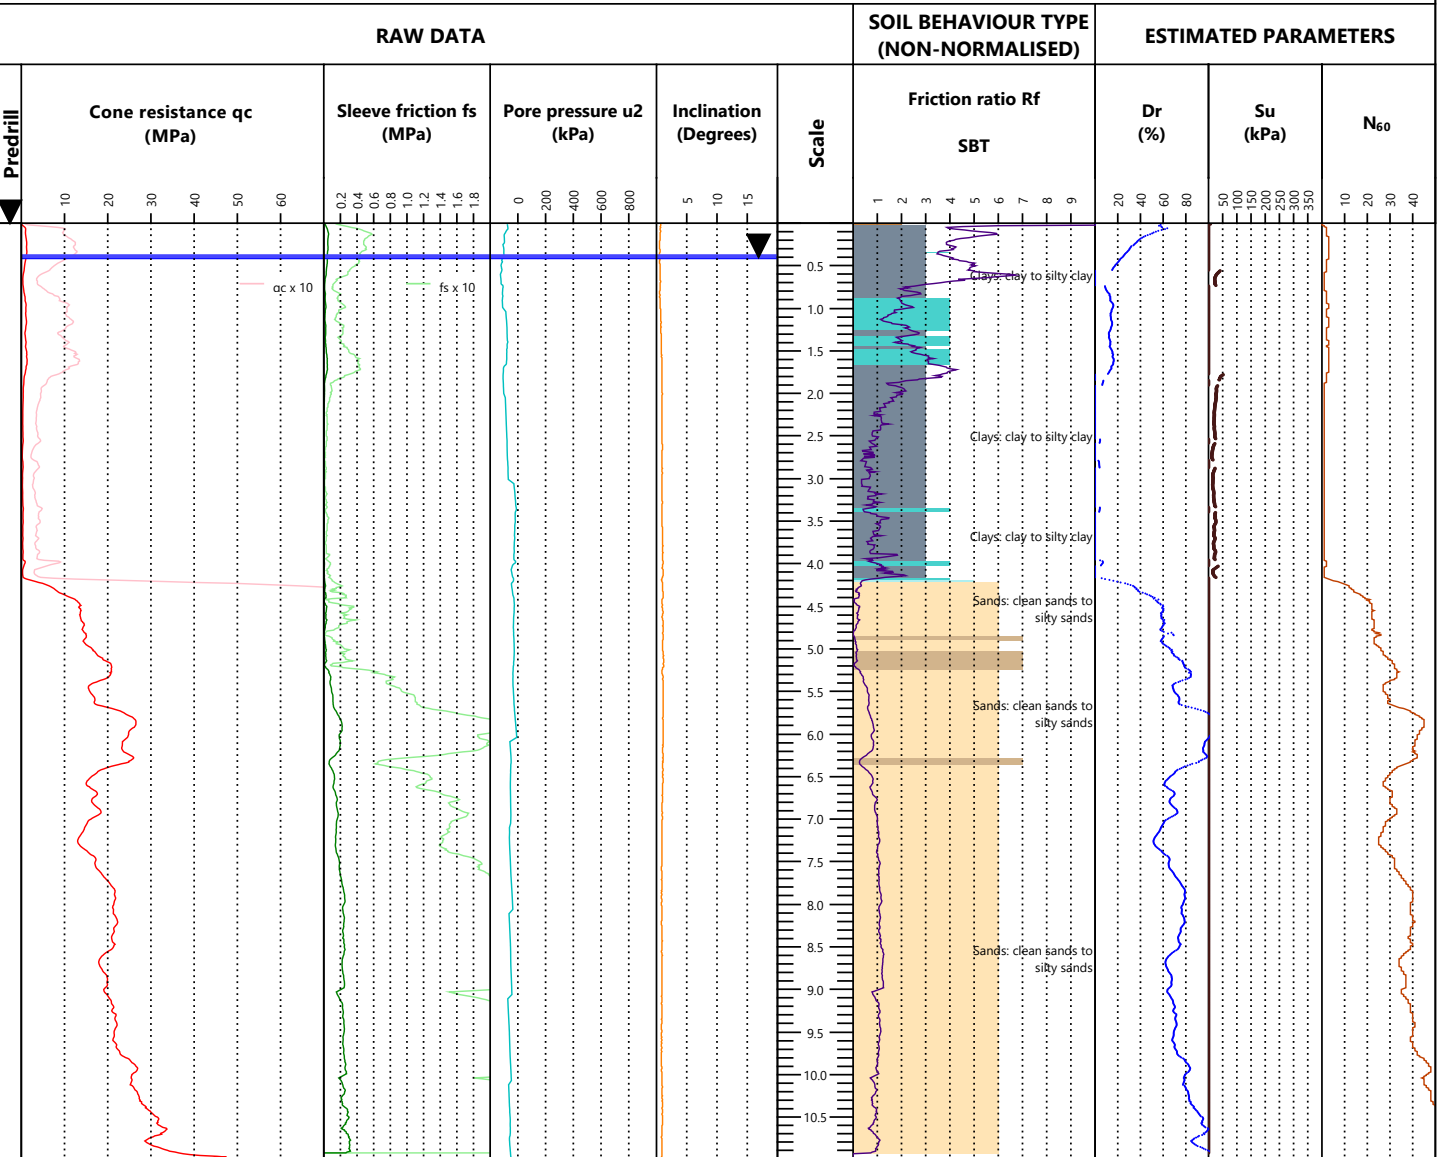
Site Location: 280 Beach Road, Kaiapoi	Date: 3/5/2022
Grid Reference: 1573447.32m E, 5197904.45m N (NZTM) - Map or aerial photograph	Rig Operator: B. Wilson
Elevation: 0.00m	Datum: Ground
	Equipment: Geomil Panther 100

Cone Type: I-CFY20-10 - Compression	Predrill: -	Termination	Soil Behaviour Type (SBT) - Robertson et al. 1986
Cone Reference: 100992	Water Level: 0.40m	Target Depth <input type="checkbox"/>	5 Sand mixtures: silty sand to sandy silt
Cone Area Ratio: 0.75	Collapse: 2.4m	Effective Refusal	6 Sands: clean sands to silty sands
Standards: ISO 22476-1:2012		Tip <input checked="" type="checkbox"/>	7 Dense sand to gravelly sand
Zero load outputs (MPa)	Before test	Gauge <input type="checkbox"/>	8 Stiff sand to clayey sand
Tip Resistance	0.8834	Inclinometer <input type="checkbox"/>	9 Stiff fine-grained
Local Friction	0.0258	Other <input type="checkbox"/>	
Pore Pressure	0.0453		
After test	0.8694		
	0.0263		
	0.0524

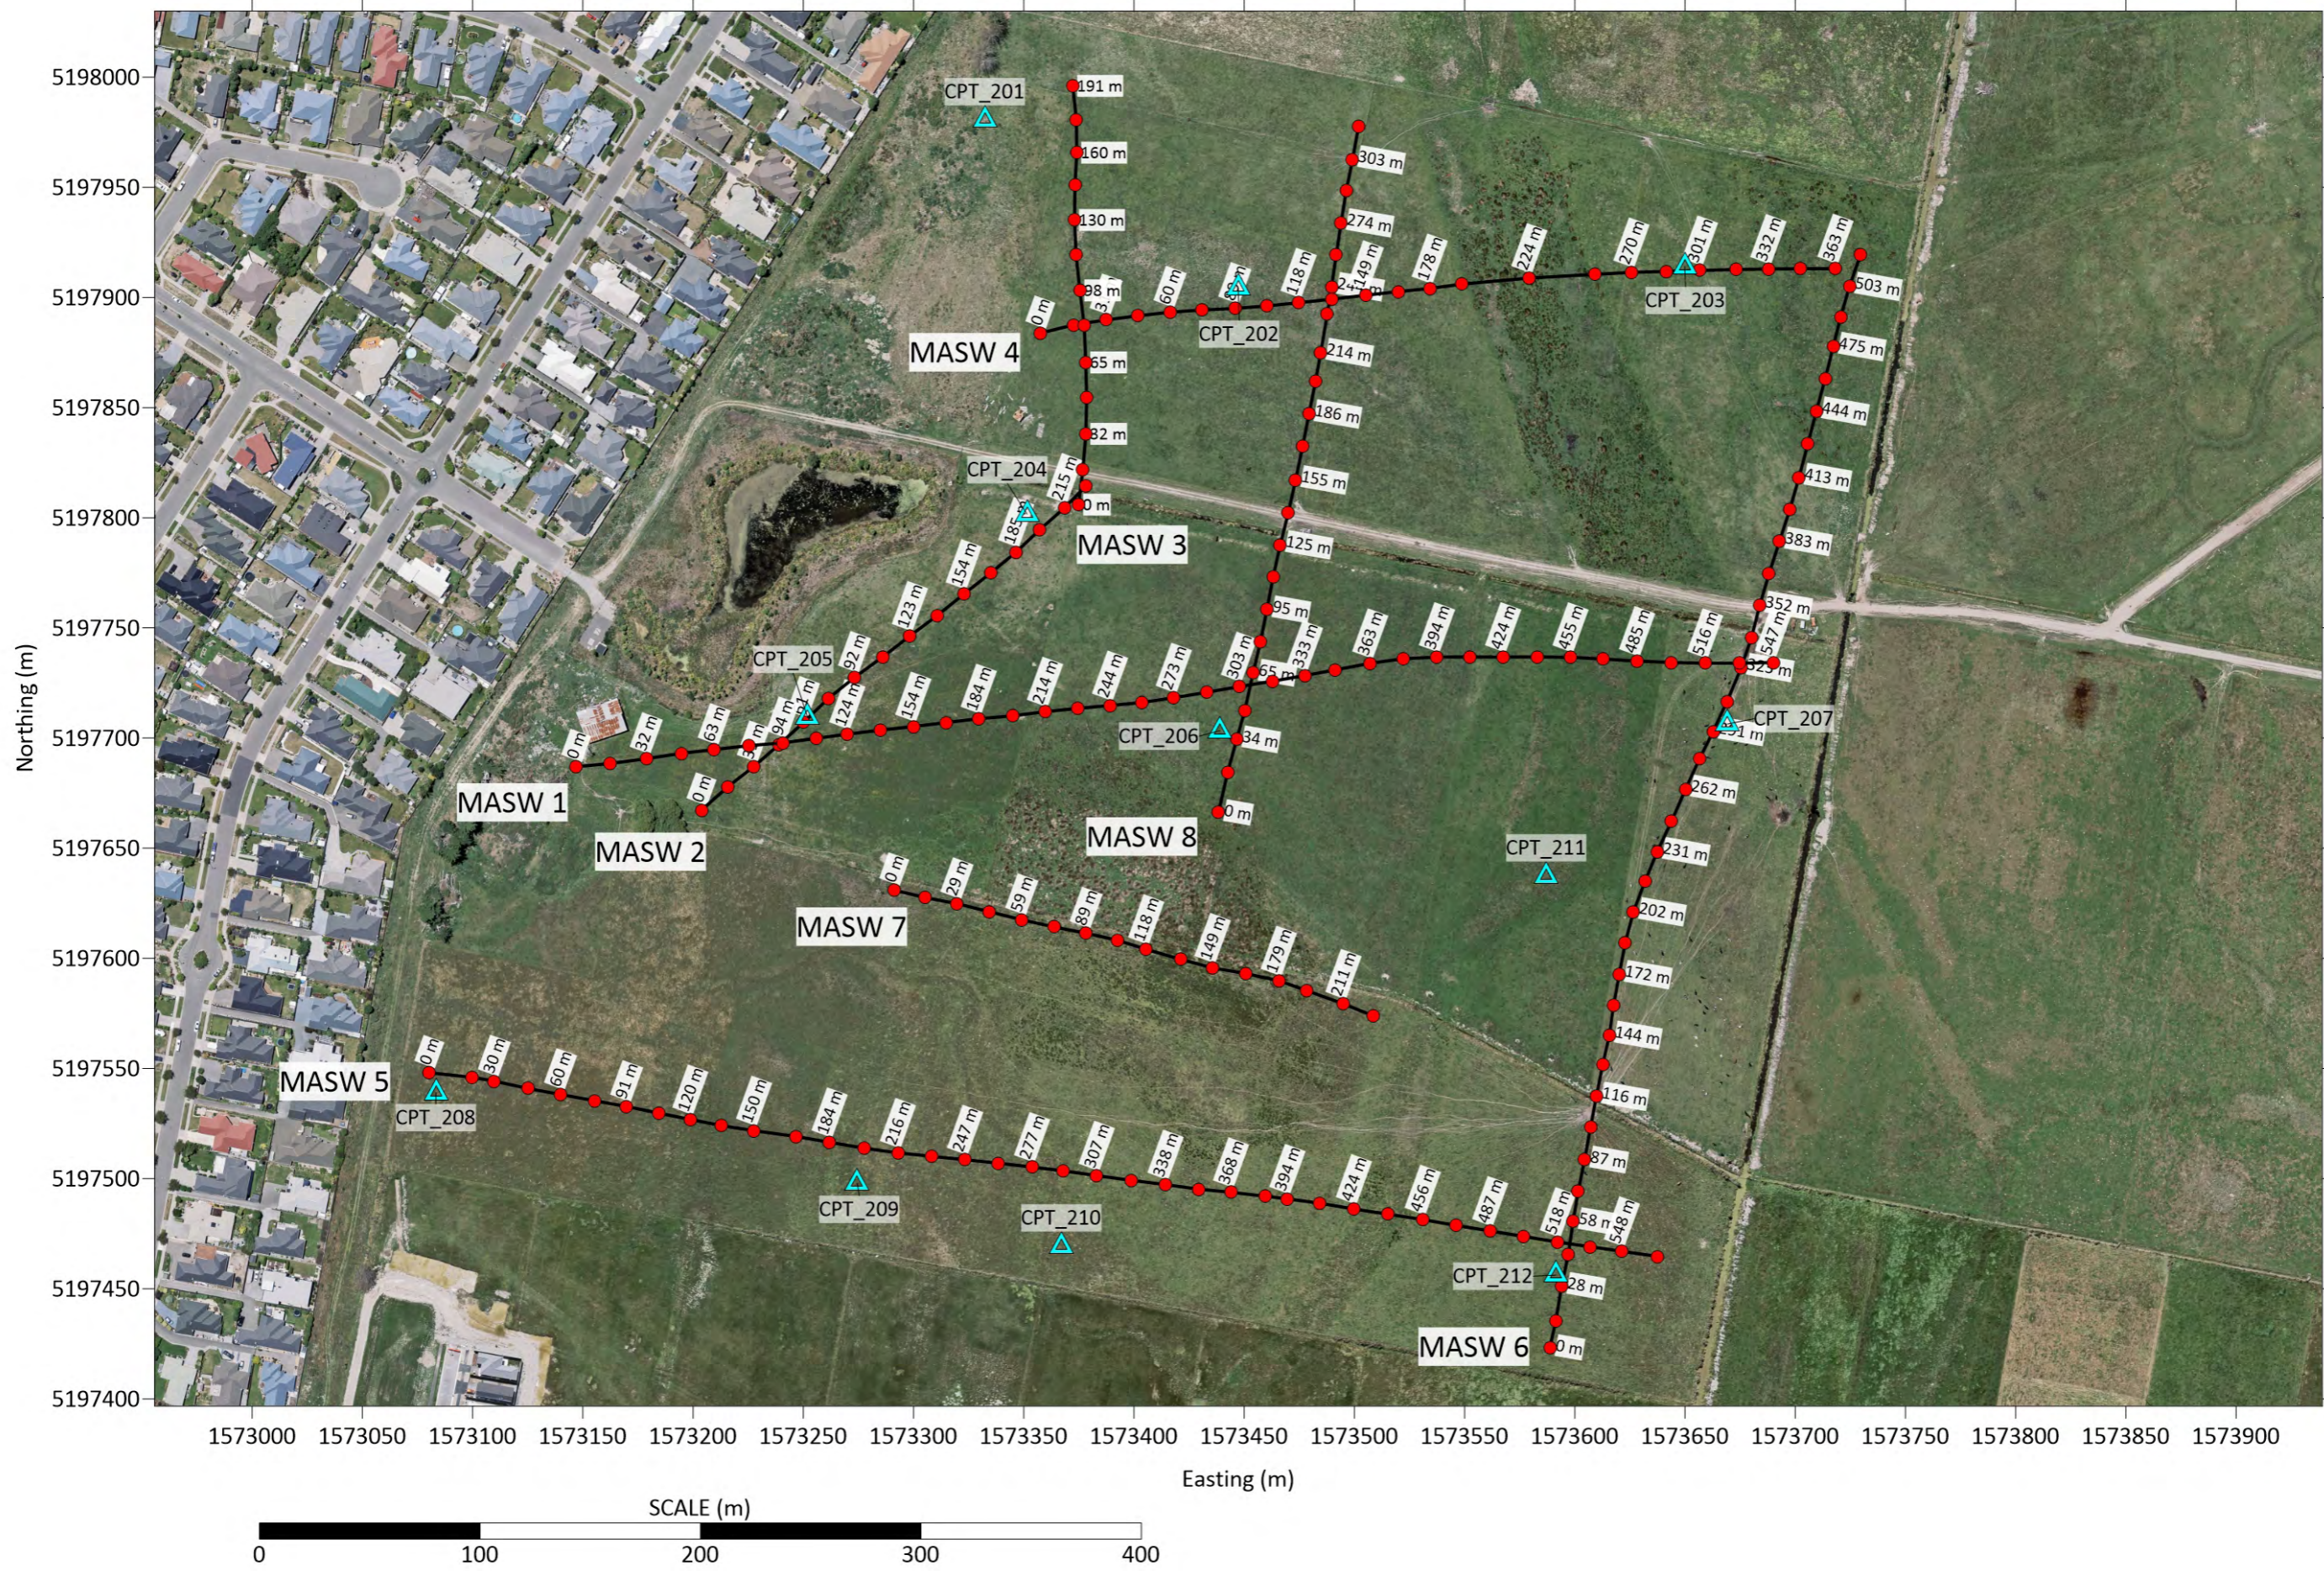
DRAWING - **Figure 1: Blocks 2 - 4, MASW Survey Site Map**
