## **Appendix I – Desktop HAIL Review**

Ref: 6-DHLHH.01-CLM-LTR-001-RevB2

## Waimakariri District Council: Rangiora Eastern Road Connection

### Technical Assessment – Desktop HAIL Review

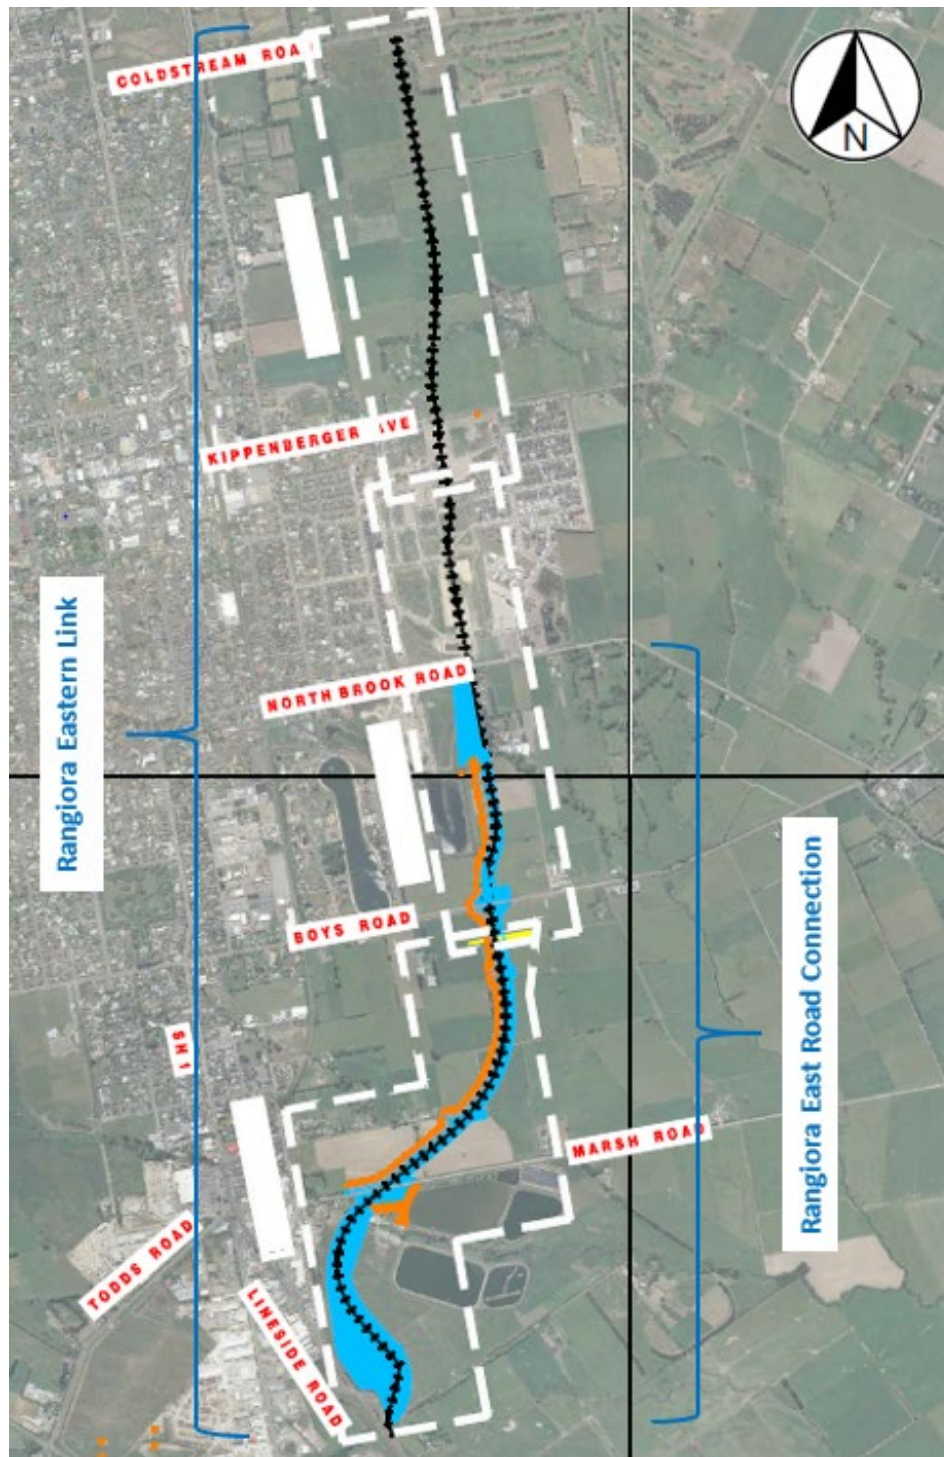
Figure 1: Layout Plan

The designation connects Lineside Road and Northbrook Road. The area to which the NOR applies is referred to as 'Rangiora East Road Connection' and is shown in **Figure 1** on the following page.

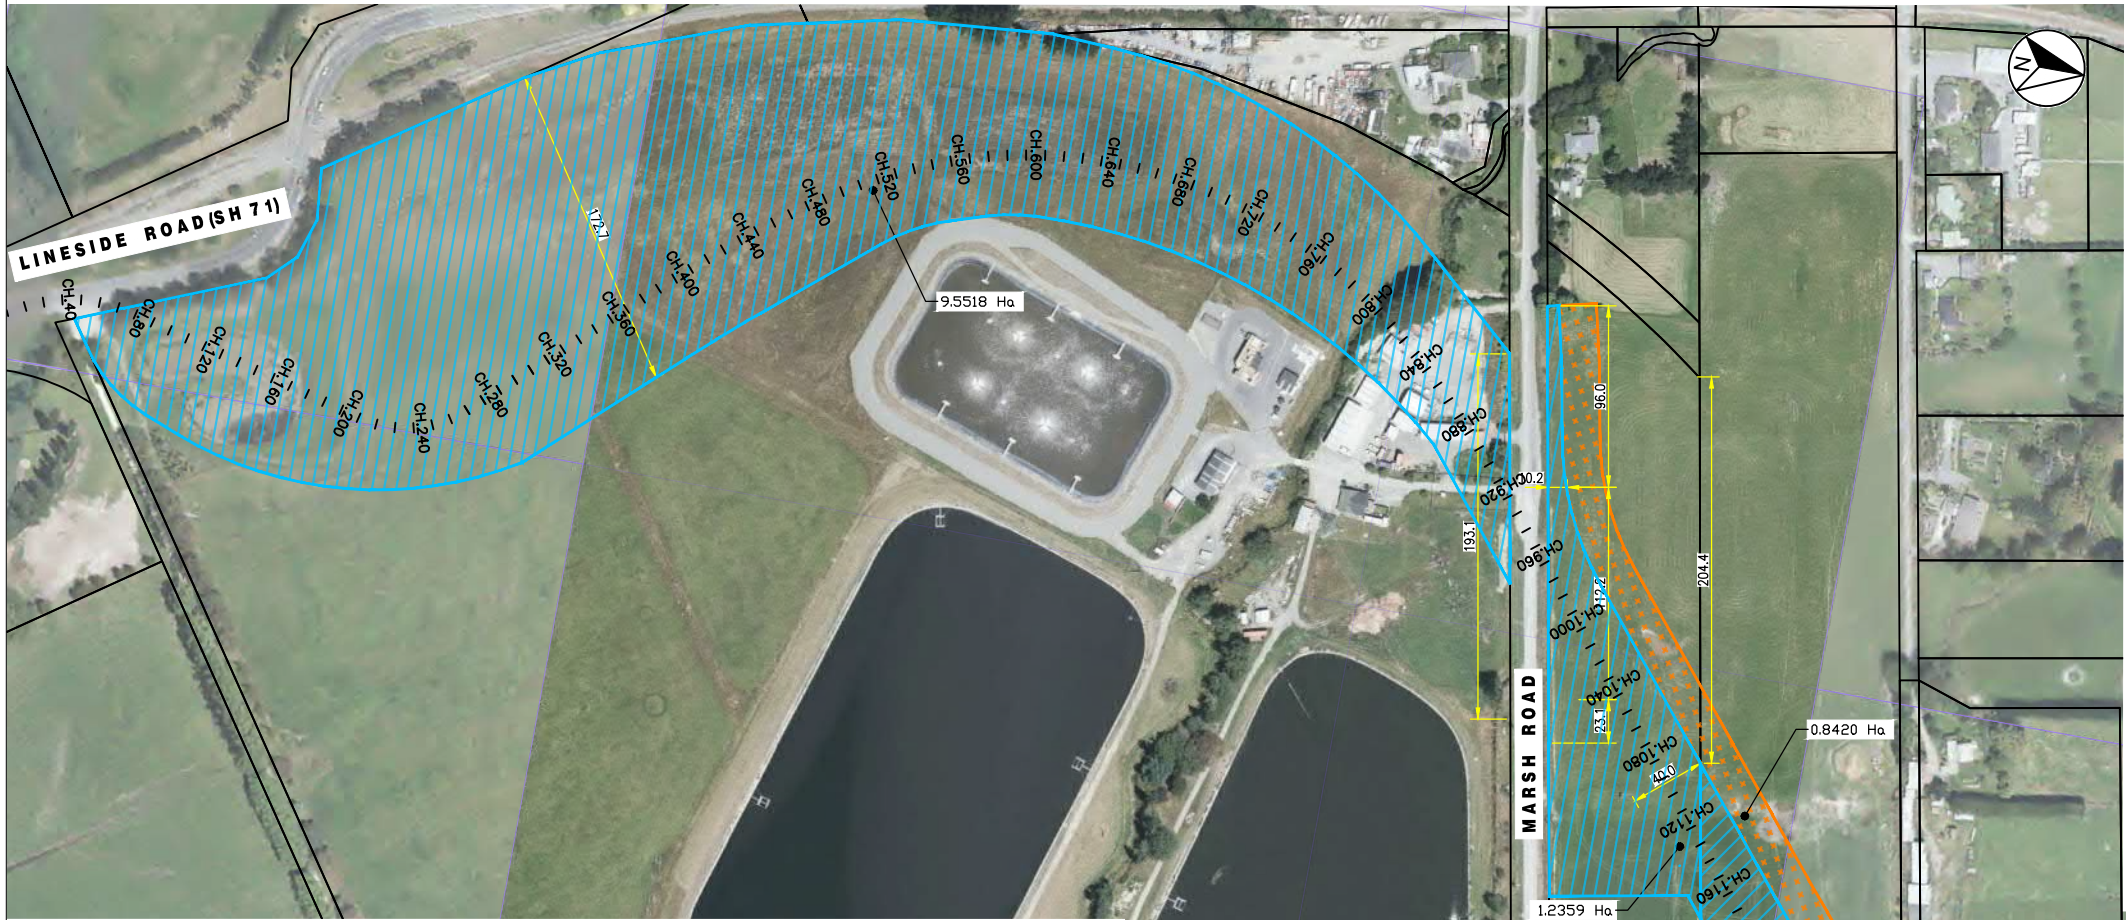
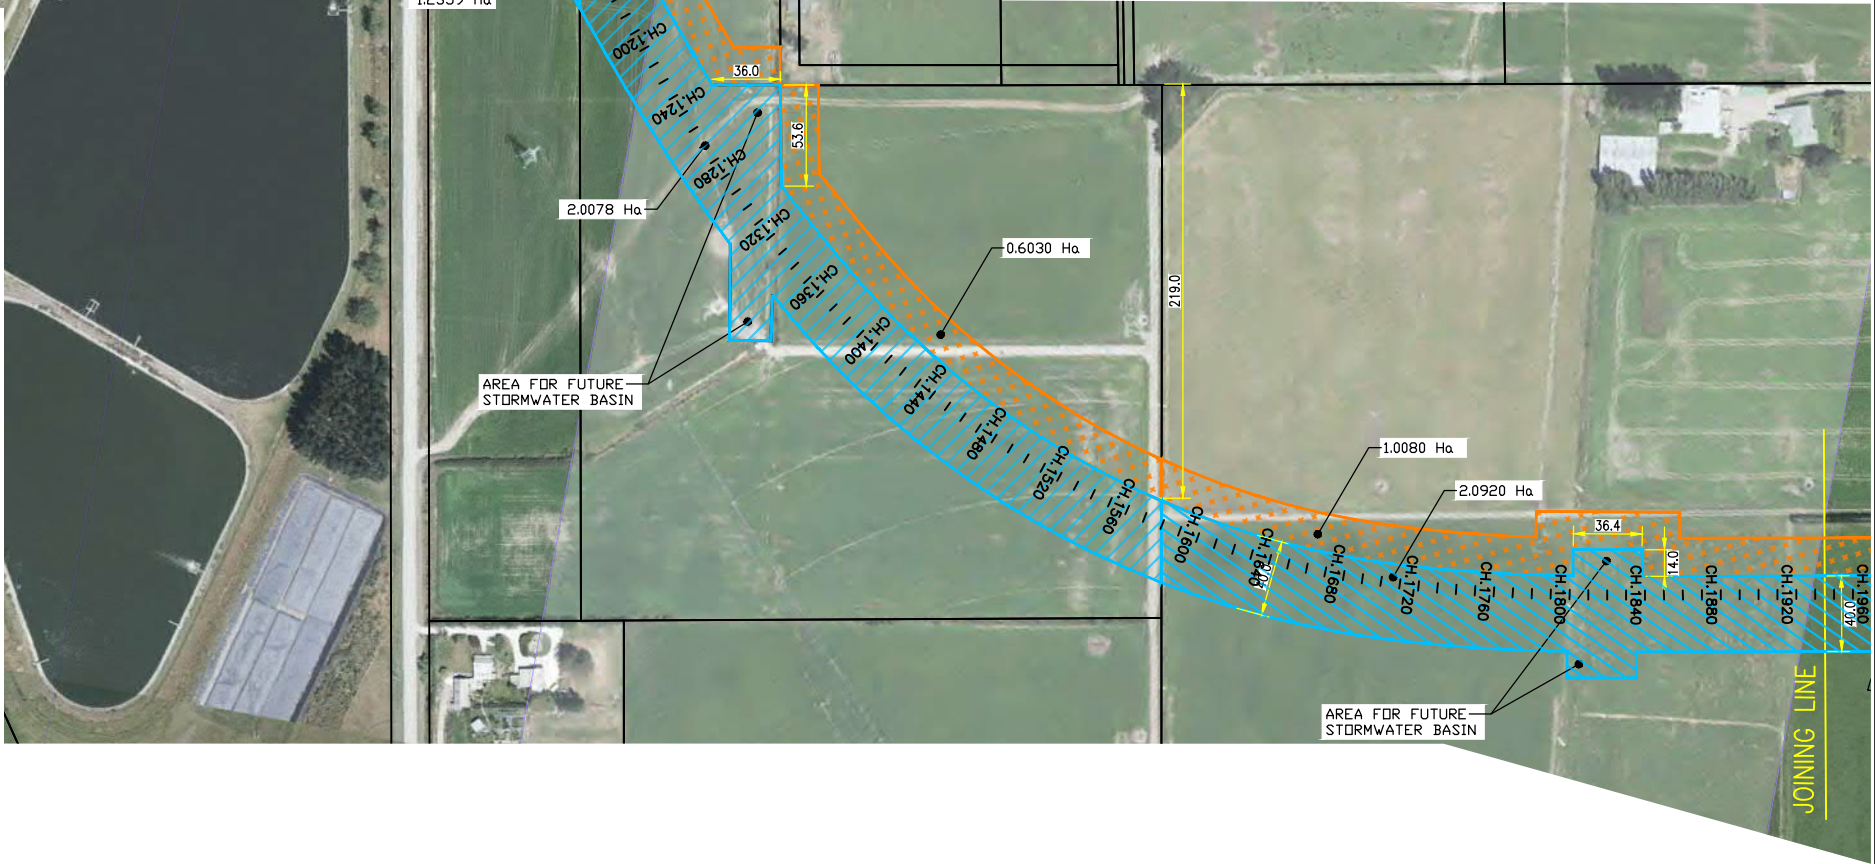
LAYOUT PLAN  
N.T.S

- LAND REQUIRED FOR ROAD
- LAND REQUIRED FOR CONSTRUCTION ACTIVITIES

PROJECT	WAIMAKARIRI DISTRICT COUNCIL RANGIORA LINK ROADS SOUTHERN, WESTERN & EASTERN LINKS
TITLE	OPTION P - EASTERN LINKS (LINESIDE TO COLDSTREAM) LAND PLAN - SHEET 1
WSP PROJECT NO. (SUB-PROJECT)	6-DHLHH.01
SHEET NO.	E1-1
REVISION	E

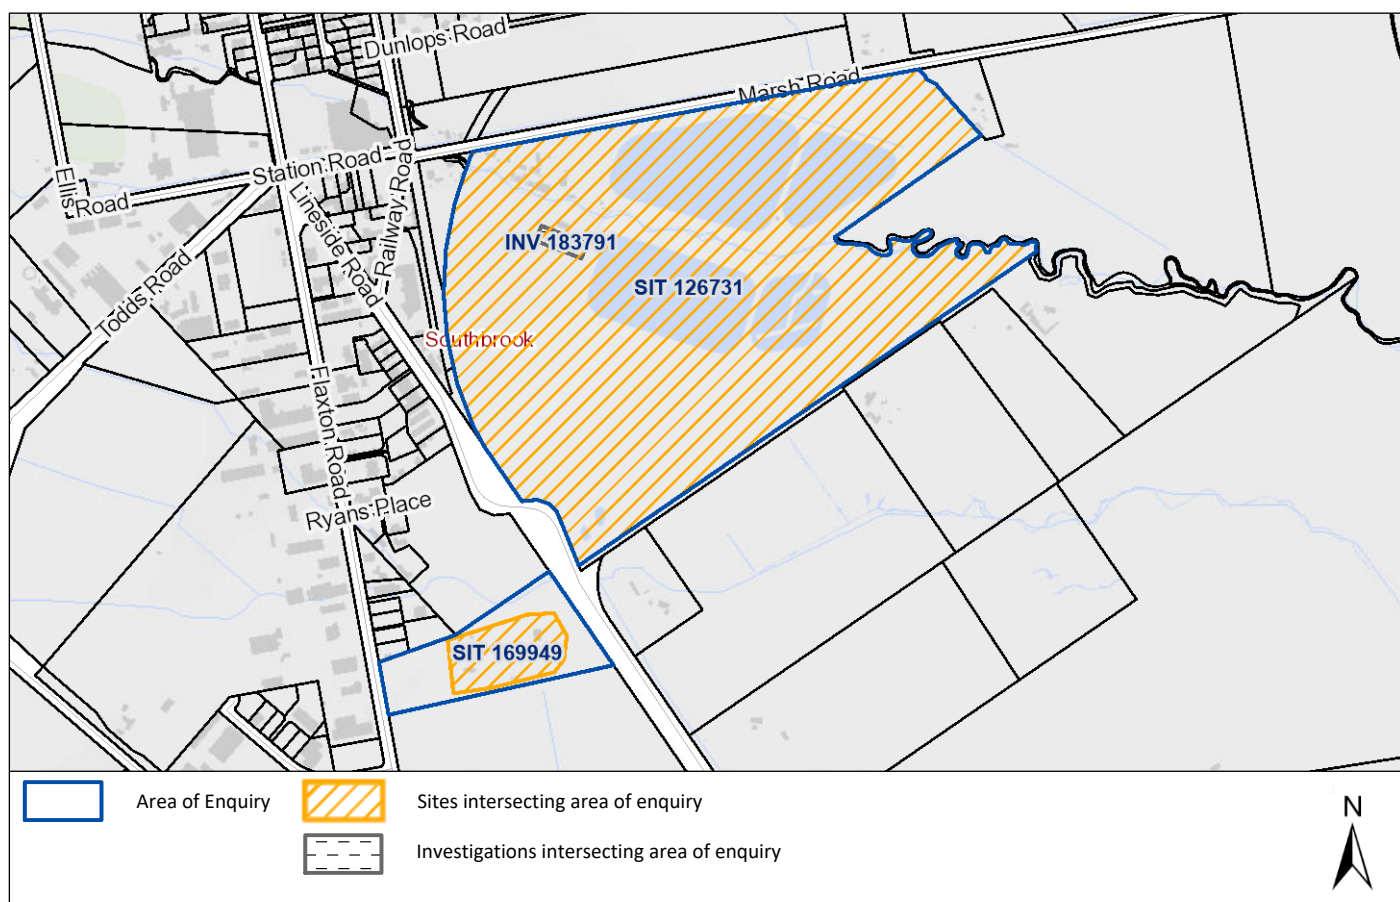
Land Uses (from HAIL):	Period From	Period To	HAIL land use
	Unknown	Current	Waste recycling or waste or wastewater treatment
	Unknown	2017	Asbestos products manufacture or disposal including sites with buildings containing asbestos products known to be in a deteriorated condition
	2017	Present	Asbestos products manufacture or disposal including sites with buildings containing asbestos products known to be in a deteriorated condition

**7 Jun 2017** The Rangiora Waste Water Treatment Plant was constructed in the early 1980's. Prior to that time the site appears to have been used for pasture as can be seen in historical aerial photographs. A basic investigation of the site history was made as part of a resource consent application to Environment Canterbury to expand the plant. No specific sources of contaminants were identified; however, soil sampling was recommended prior to disposal of excess material during construction. Several stockpiles of material were identified on the west end of pond 1B, the planned location for Aeration Pond B, in aerial photographs from the 1990's to the present. These were explained as being sourced from "on-site excavations for the installation of various manholes and other site infrastructure associated with enhancements made over time to the WWTP internal reticulation system.". It was thought unlikely that these would be contaminated from past site use.

<b>18 Dec 2016</b>	This record was created as part of the Waimakariri District Council 2016 HAIL identification project.
<b>7 Jul 2017</b>	Area defined from 2000 to Present aerial photographs. G6 - Waste recycling or waste or wastewater treatment was noted in aerial photographs reviewed.

WSP recommends that a detailed site investigation be undertaken on the 141 Marshs Road, Rangiora Wastewater Treatment Plant due to it being listed as a 'Verified HAIL site – not investigated' in the ECan LLUR that directly intersects the proposed route.

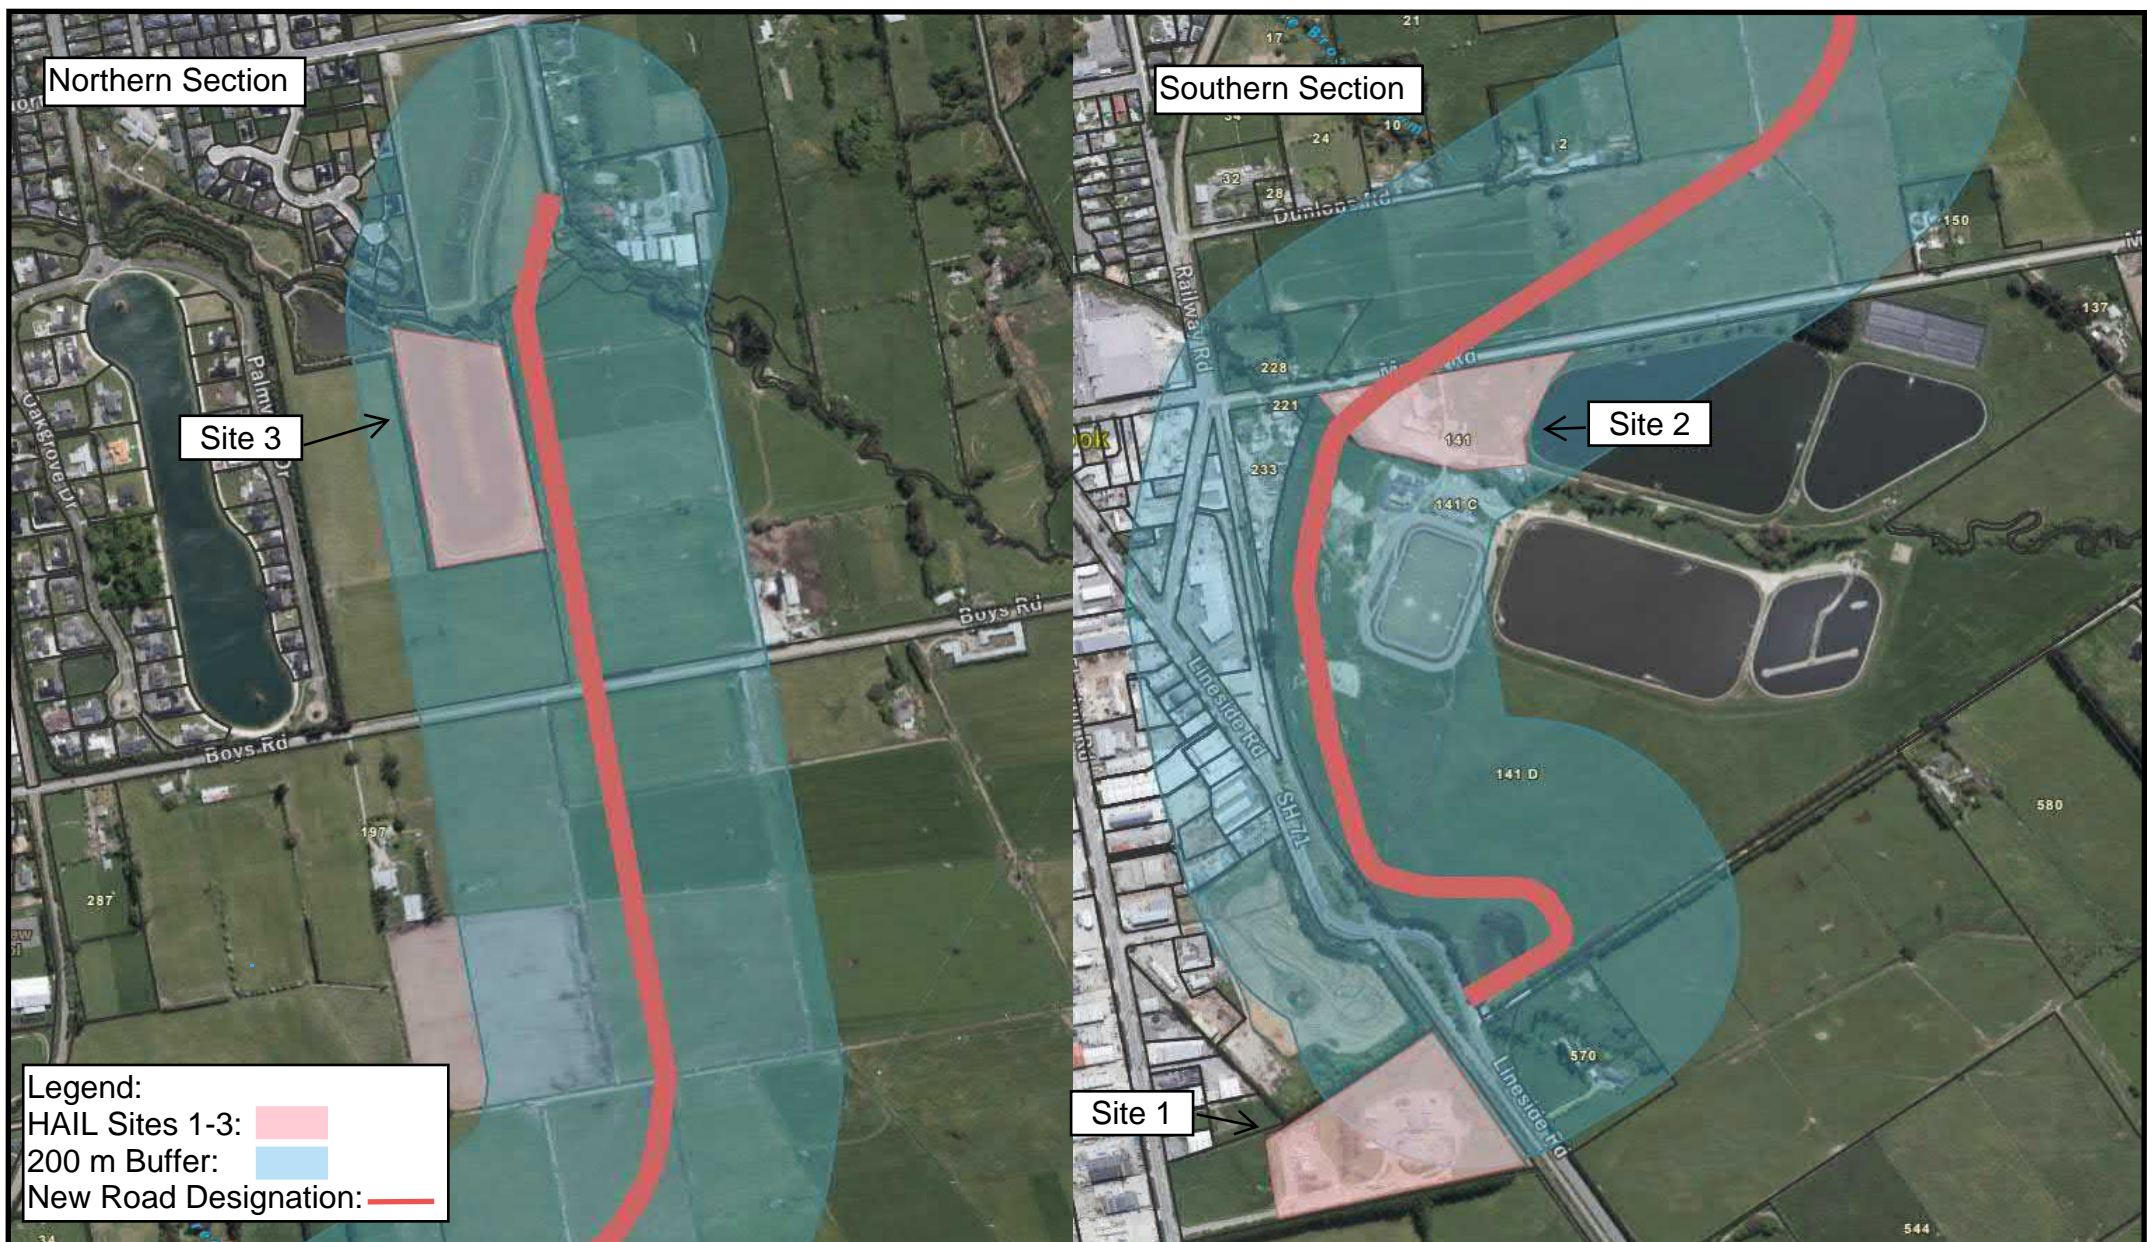
Figure 2 - HAIL Site Locations

Site ID	Address	HAIL Activity	Timeline	LLUR Definition <sup>1</sup>	Evidence obtained from information sources	Fig Reference <sup>4</sup>
169949	284 Flaxton Road, Southbrook	G6 – Waste recycling or waste or wastewater treatment.	2000 – Present	Verified HAIL – Not Investigated	Area identified as part of the WDC HAIL identification project <sup>2</sup> .	Site 1
126731	141 Marsh Road, Rangiora	G6 – Wastewater treatment  E1 – Buildings containing asbestos products known to be in a deteriorated condition.	1974 – Present  Pre-1940 – Present	Verified HAIL – Not Investigated	Rangiora Wastewater Treatment Plant <sup>2</sup> in early 1980s. DSI report (INV 183 791) by Pattle Delamore Partners Ltd, 26 Oct 2017 available on LLUR – not reviewed by WSP.  Associated building compounds within proposed designation area.	Site 2
169943	193 Northbrook Road	G6 – Waste recycling or waste or wastewater treatment.	1973 - 1984	Unverified HAIL	Northbrook wetlands <sup>5</sup>	Site 3

Site ID	Address	HAIL Activity	Site Activity	Proximity to Site	Associated Hazardous Substances	Project Risk
<b>126731</b>	141 Marsh Road, Rangiora	G6	Waste Water Treatment Plant	0 m	- Asbestos - Heavy metal/metalloids - Polycyclic aromatic hydrocarbons	<b>Likely</b> – The oxidation ponds are not within the proposed extent of designation; however, the plant work compound accessed off Marsh Road will require removal.
<b>N/A</b>	193 Northbrook Road	G6	Stormwater retention ponds	10 m	- Heavy metal/metalloids - Polycyclic aromatic hydrocarbons	<b>Unlikely</b> – The previous investigations on the site found no contaminants of concern above the relevant soil guideline values within the area for the proposed road corridor.
<b>169949</b>	284 Flaxton Road, Southbrook	G6	Resource Recycling Centre	100 - 200 m	Depends on type of materials being recycled	<b>Highly Unlikely</b> – Due to distance to property and low likelihood of mobile contaminants of significant quantities.
