Hearing Stream 12: Rezoning

Evidence of Philippe Dumont

Preliminary Site Investigation

518 Rangiora Woodend Road & 4 Golf Links Road, Rangiora, Canterbury

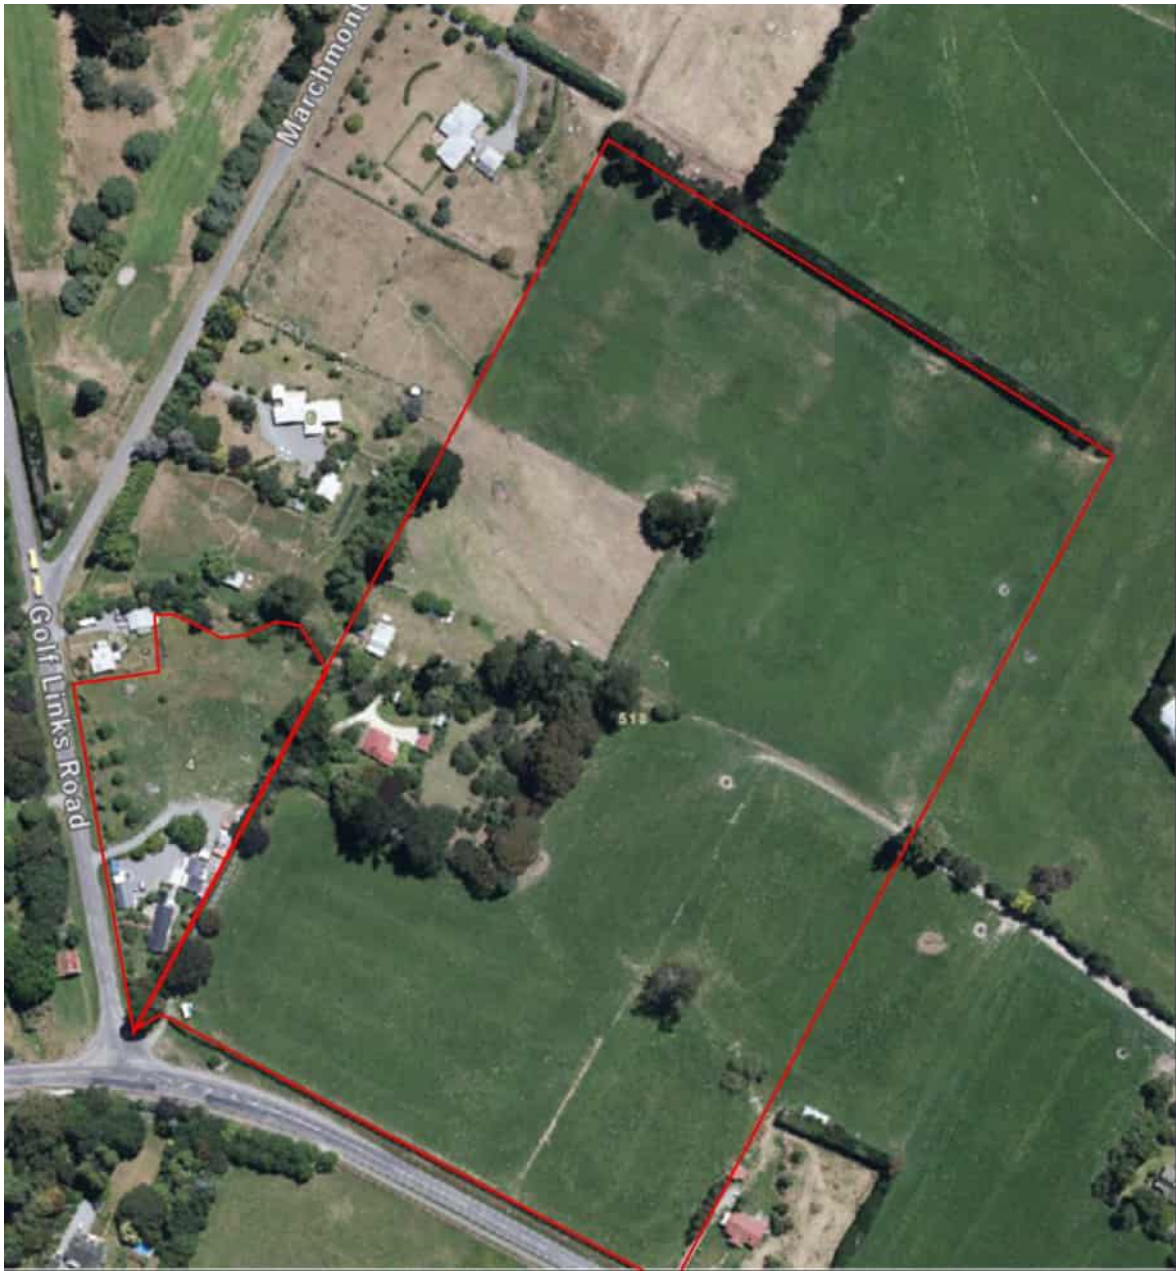
Figure 1. Current site layout with the property boundaries indicated in red (Sourced: Canterbury Maps, 2023).

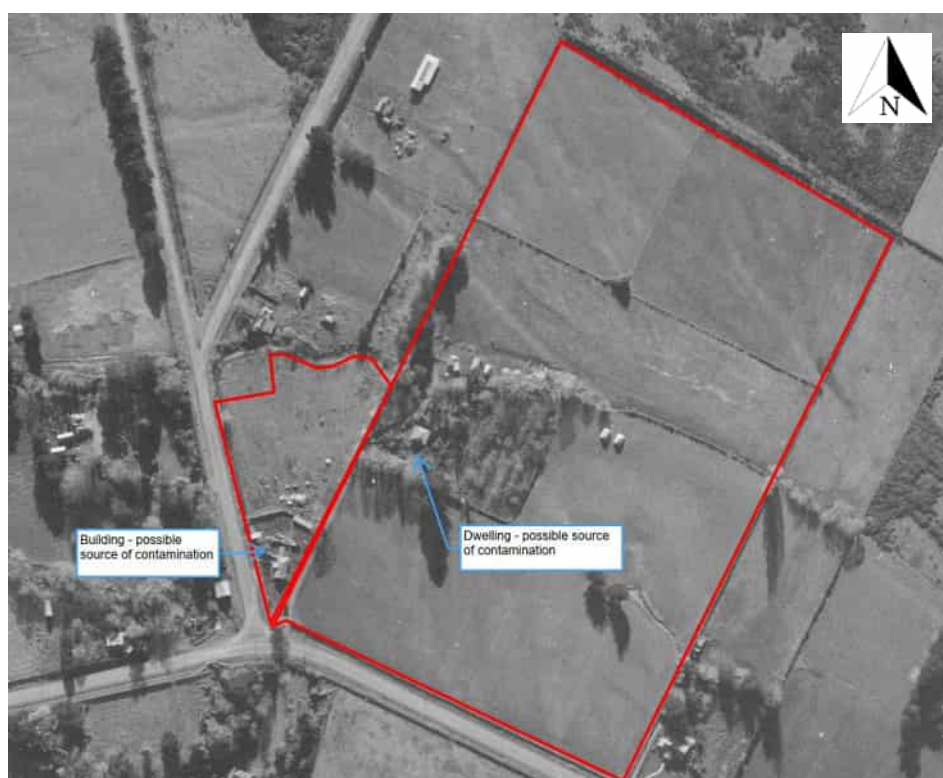
Figure 3 shows the first appearance of a dwelling on 518 Rangiora Woodend Road and a building on 4 Golf Links Road. Due to the date of its construction – prior to 1944, the risks of soil contamination by asbestos and lead-based paint (**HAIL I**) exist. Although this cannot be confirmed, the likelihood of that building to have been a “shearing” shed or a building used for an activity related to sheep/cattle treatment cannot be ruled out, particularly the structures on the north side of the building which could have been part of a sheep treatment/management. This activity would be related to **HAIL A8**: Livestock dip or spray race operations. The entire site seems to be used for agricultural/pastoral activities which potentially involved the use of persistent pesticides (**HAIL A10**).

Figure 3. Site between 1940-1944 (Retrolens).

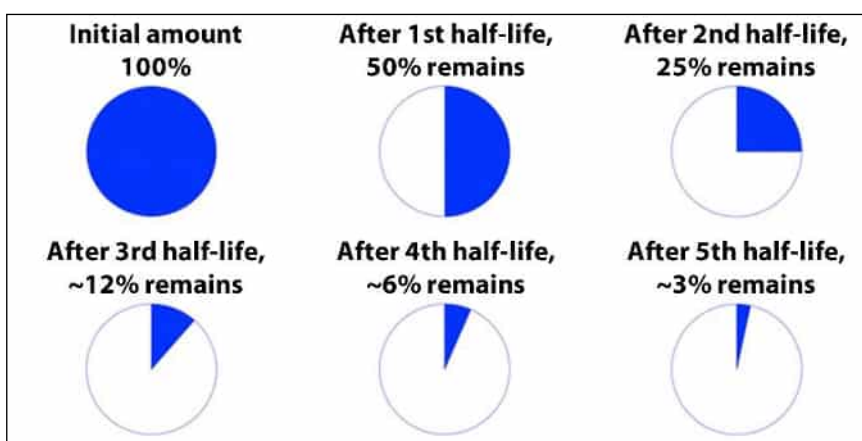
DDT is known for having a *half-life* ranging from 10 to 30 years in the soil (depending on the soil environment). The half-life of a pesticide in the soil gives the time it takes for the pesticide concentration to decrease to half of the initial concentration. This means that pesticide can still be largely present in the soils after that period of time as explained below.

"A given pesticide's half-life is the time it takes for a certain amount of a pesticide to be reduced by half. This occurs as it dissipates or breaks down in the environment. In general, a pesticide will break down to 50% of the original amount after a single half-life. This means that after two half-lives, 25% will remain. About 12% will remain after three half-lives. This continues until the amount remaining is nearly zero. The half-life can help estimate whether or not a pesticide tends to build up in the environment. Pesticide half-lives can be lumped into three groups in order to estimate persistence. These are low (less than 16 day half-life), moderate (16 to 59 days), and high (over 60 days). Pesticides with shorter half-lives tend to build up less because they are much less likely to persist in the environment. In contrast, pesticides with longer half-lives are more likely to build up after repeated applications. This may increase the risk of contaminating nearby surface water, ground water, plants, and animals." (Oregon National Pesticides Information Centre (NPIC)). This can be illustrated with Figure 5.3.4 below.

Figure 4. Approximate amount of pesticide (shaded area) remaining at the application site over time (source: NPIC)

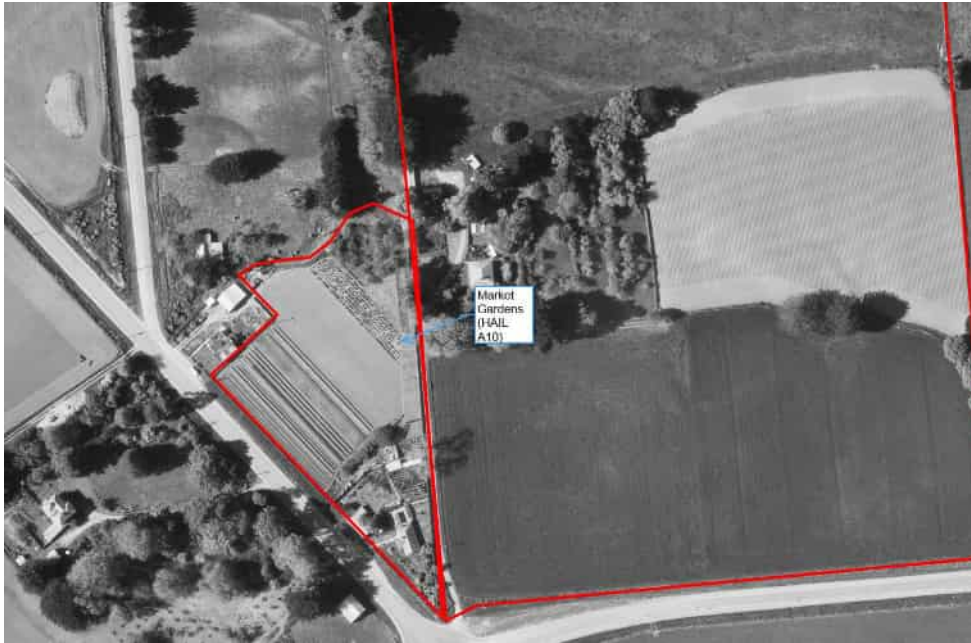
Figure 5 clearly shows market gardens on 4 Golf Links Road, indicating the likely Hail A10 of persistent pesticide bulk storage and use. This activity carried on for many years, with its first appearance in 1963 and carrying on through till the 1990's.

Figure 5. Site between 1960-1970 (Retrolens).

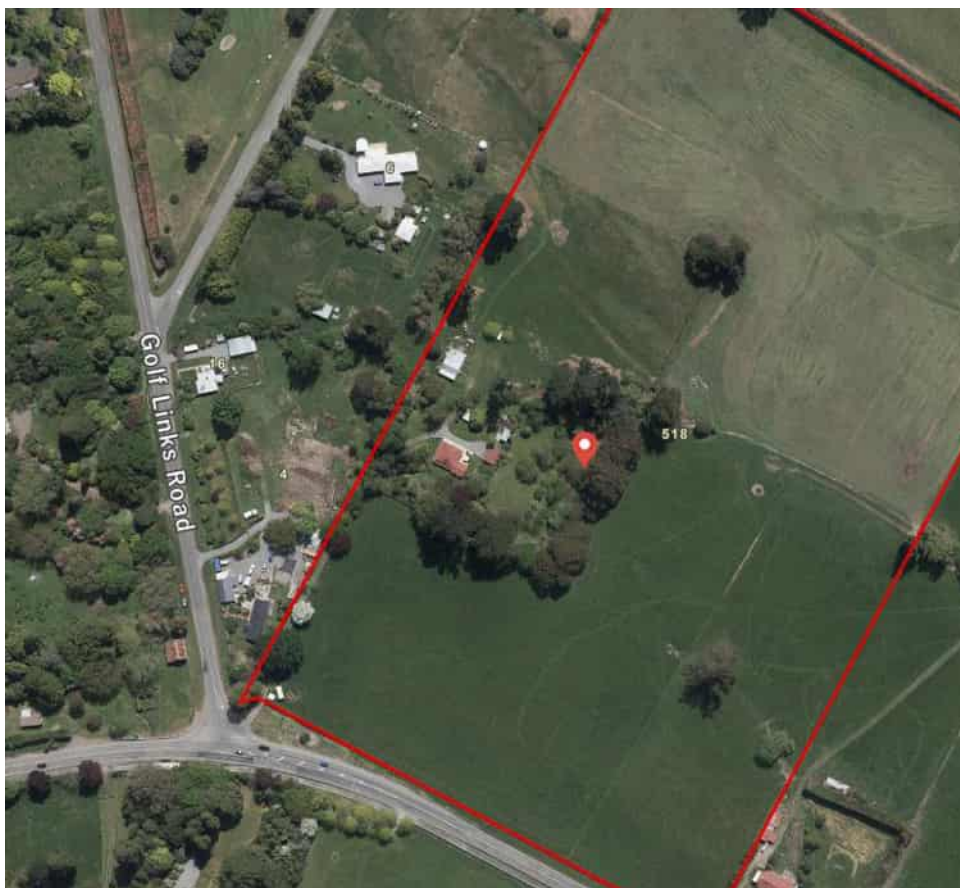
Figure 6. Site between 2015 – 2019 (Canterbury Maps)

Figure 6 shows stockpiles near the shed on 518 Rangiora Woodend Road. Exposed soil in around the trees and to the northeast of the dwelling.

New driveway being developed and buildings on 4 Golf Links Road. Exposed soil where garden was.

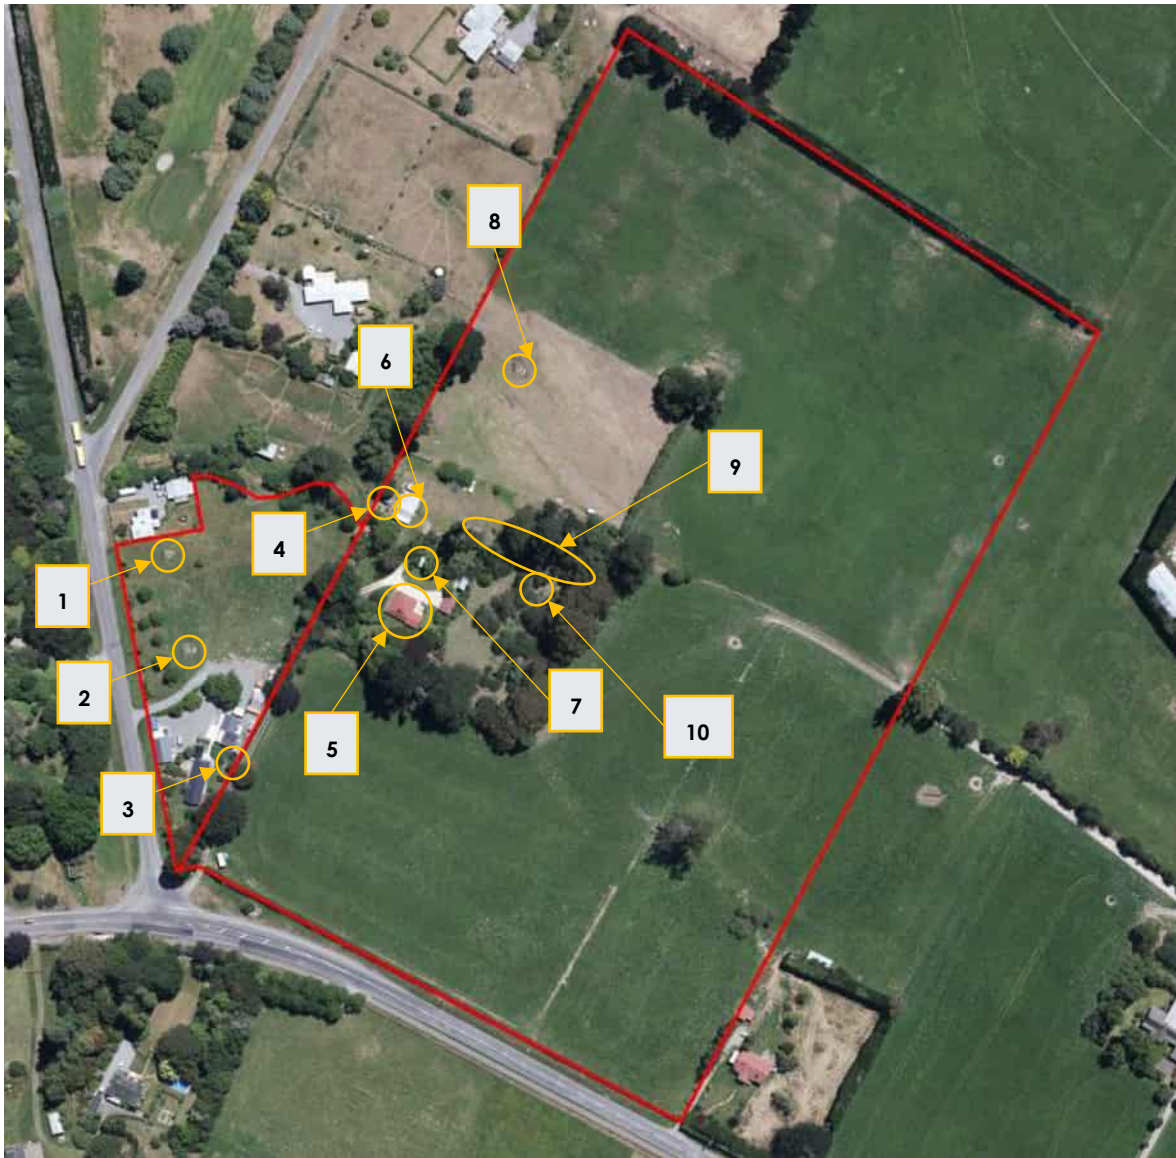
Figure 7. Locations of Interest at 518 Rangiora Woodend Road and 4 Golf Links Road (Eliot Sinclair Maps, 2023).

The LOIs are outlined on Figure 6 and details are provided below with site images attached as Appendix B.

1. Mound of deposited fill (**HAIL G3**).
2. Burn pad with evidence of household rubbish being burned (**HAIL I**).
3. Septic waste system. Unsure of the nature of the wastewater disposal system.
- 4 Storage of empty and rusted drums. It is not known what these may have used to hold but the risk of chemicals being lost to ground cannot be ruled out (**HAIL I**).
5. Residential dwelling from 1940's. The presence of asbestos and lead based paint in a degraded condition cannot be ruled out (**HAIL I**).
6. Farm sheds/workshops that contain a variety of commercial/industry grade products (herbicide/pesticides, oils, paints, etc) on bare ground. **HAIL I** and **HAIL A10** cannot be ruled out.

7. Farm sheds/workshops that contain a variety of commercial/industry grade products (herbicide/pesticides, oils, paints, etc). **HAIL I** and **HAIL A10** cannot be ruled out.
8. Burn pad with evidence of household rubbish being burned (**HAIL I**).
9. Treated timber posts stored on ground along with a variety of farm incidentals (**HAIL A18**)
10. Long drop toilet.

- c) **However**, we recommend that the areas outlined as potential HAIL areas undergo additional detailed site investigation (DSI) in terms of the Ministry for the Environment's Contaminated Land Management Guidelines to establish the nature, degree, and extent of contaminants distribution.

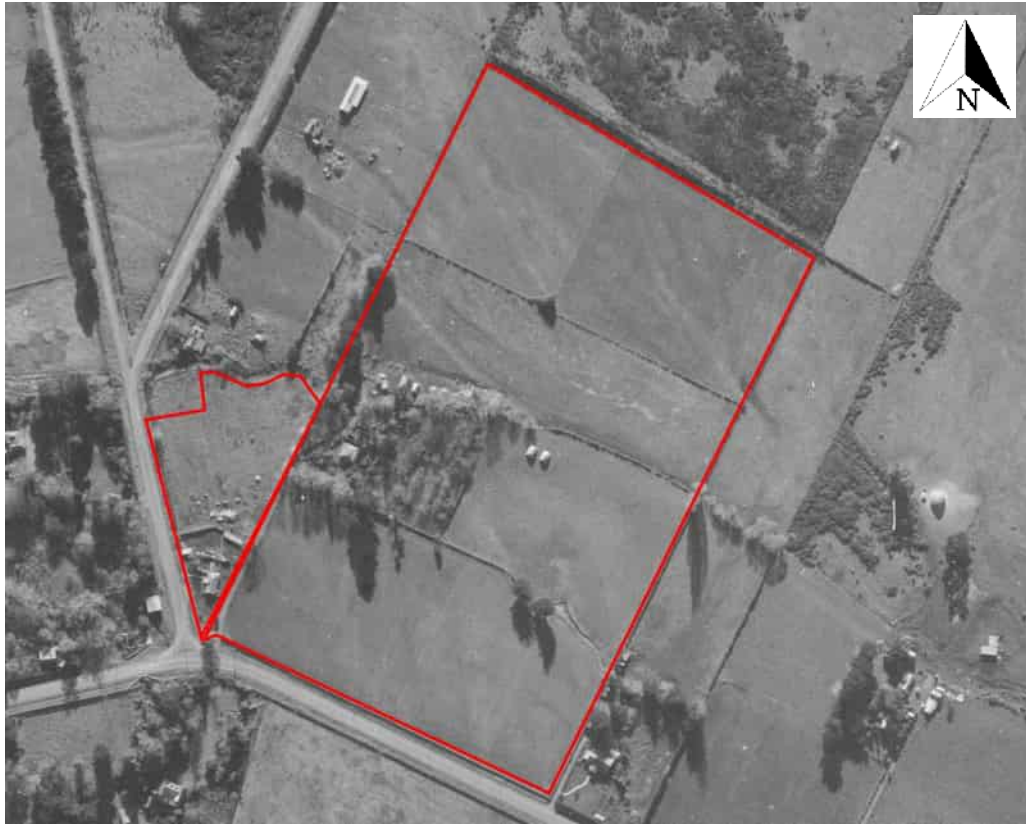
Aerial imagery of 4 Golf Links Road (left) and 518 Rangiora Woodend Road (right) in 1942 (site boundary outlined in red). Retrieved from Retrolens.

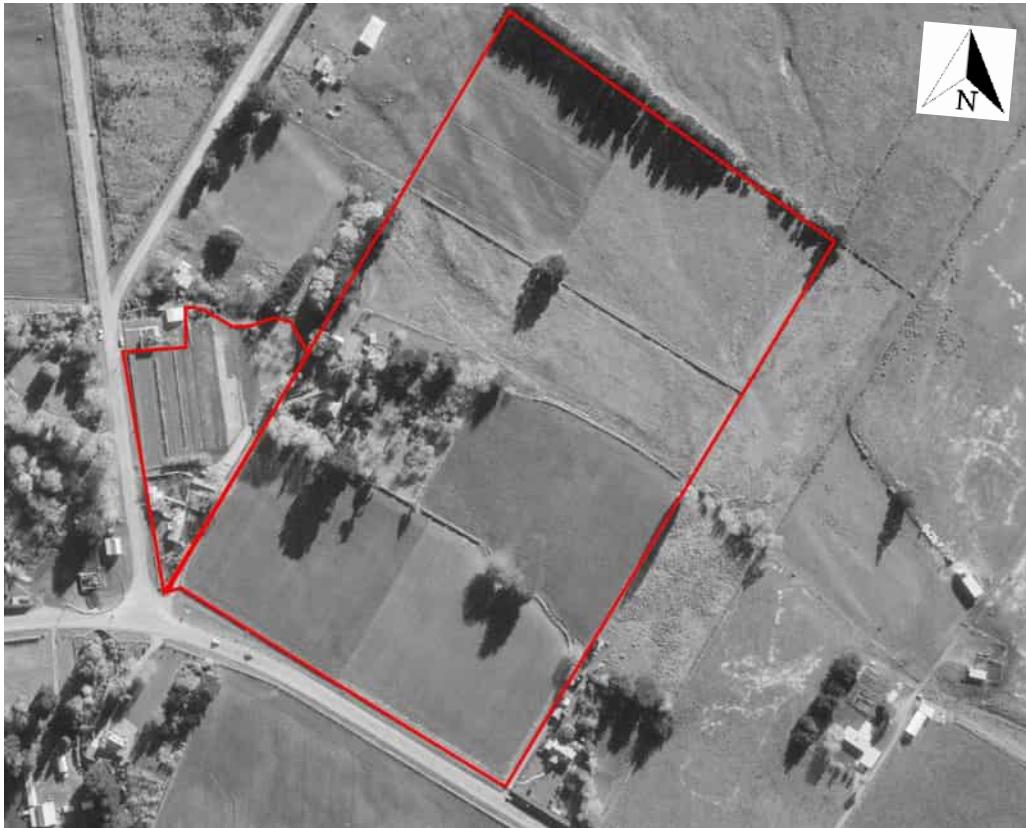
Aerial imagery of 4 Golf Links Road (left) and 518 Rangiora Woodend Road (right) in 1963 (site boundary outlined in red). Retrieved from Retrolens.

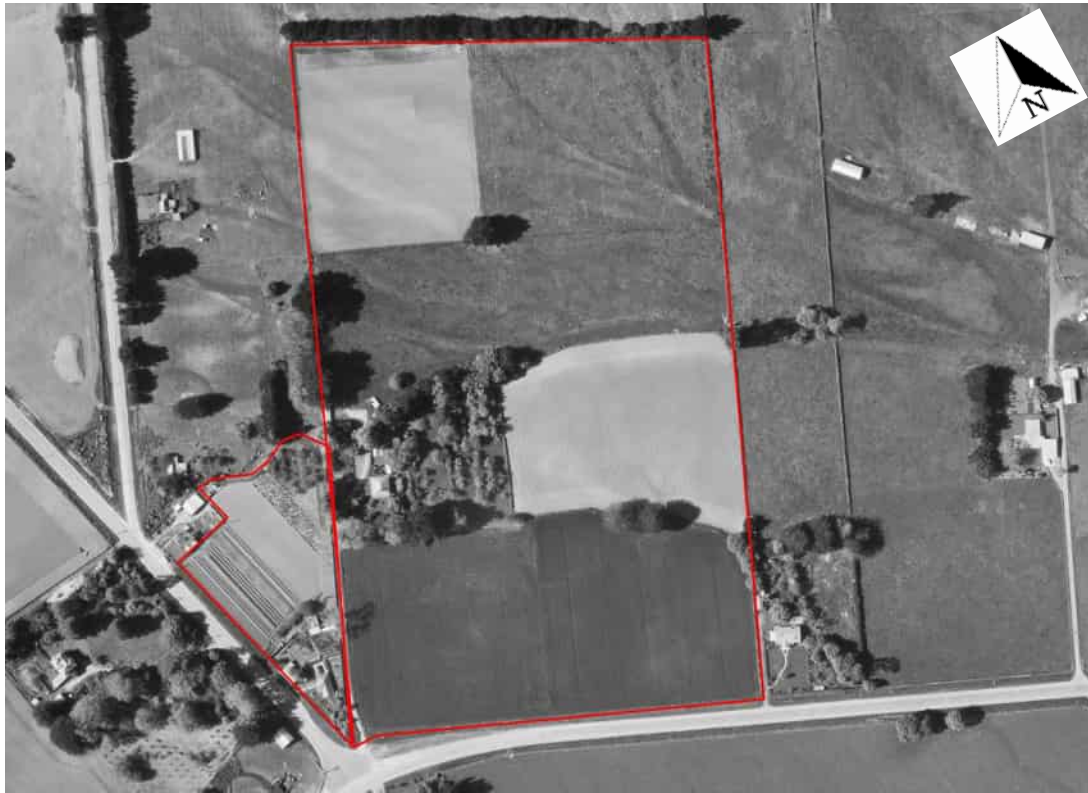
Aerial imagery of 4 Golf Links Road (left) and 518 Rangiora Woodend Road (right) in 1969 (site boundary outlined in red). Retrieved from Retrolens.

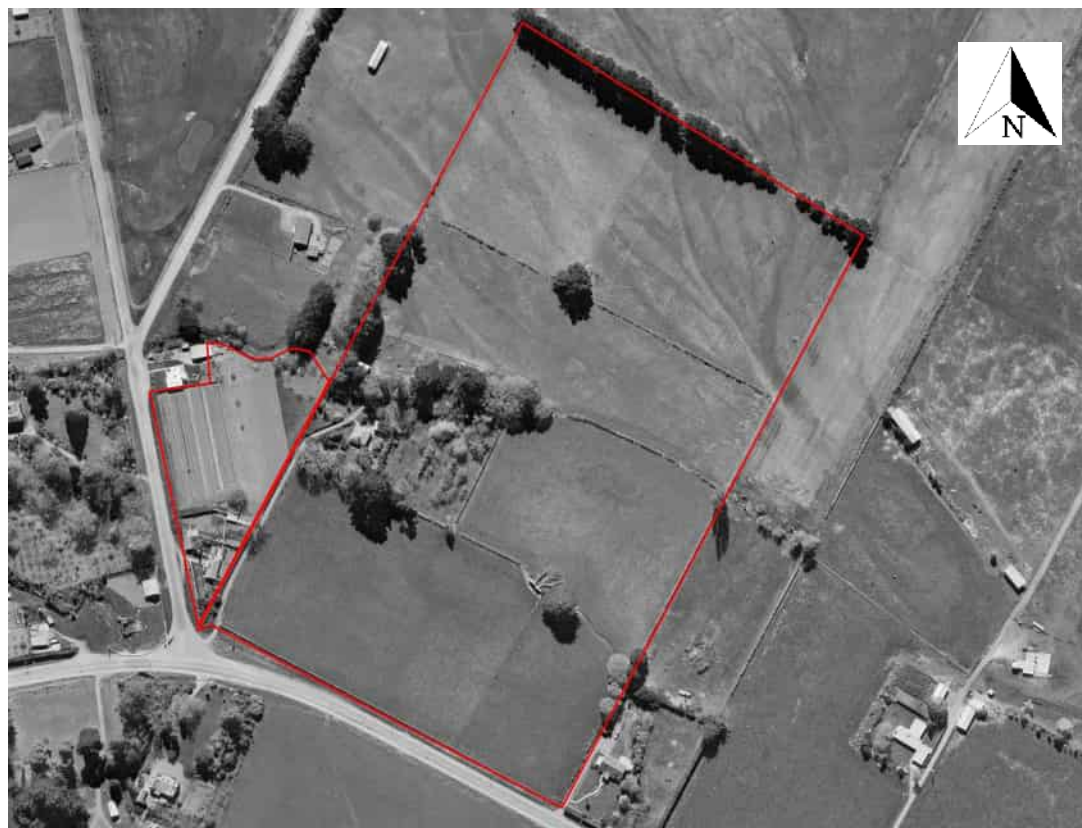
Aerial imagery of 4 Golf Links Road (left) and 518 Rangiora Woodend Road (right) in 1973 (site boundary outlined in red). Retrieved from Retrolens.

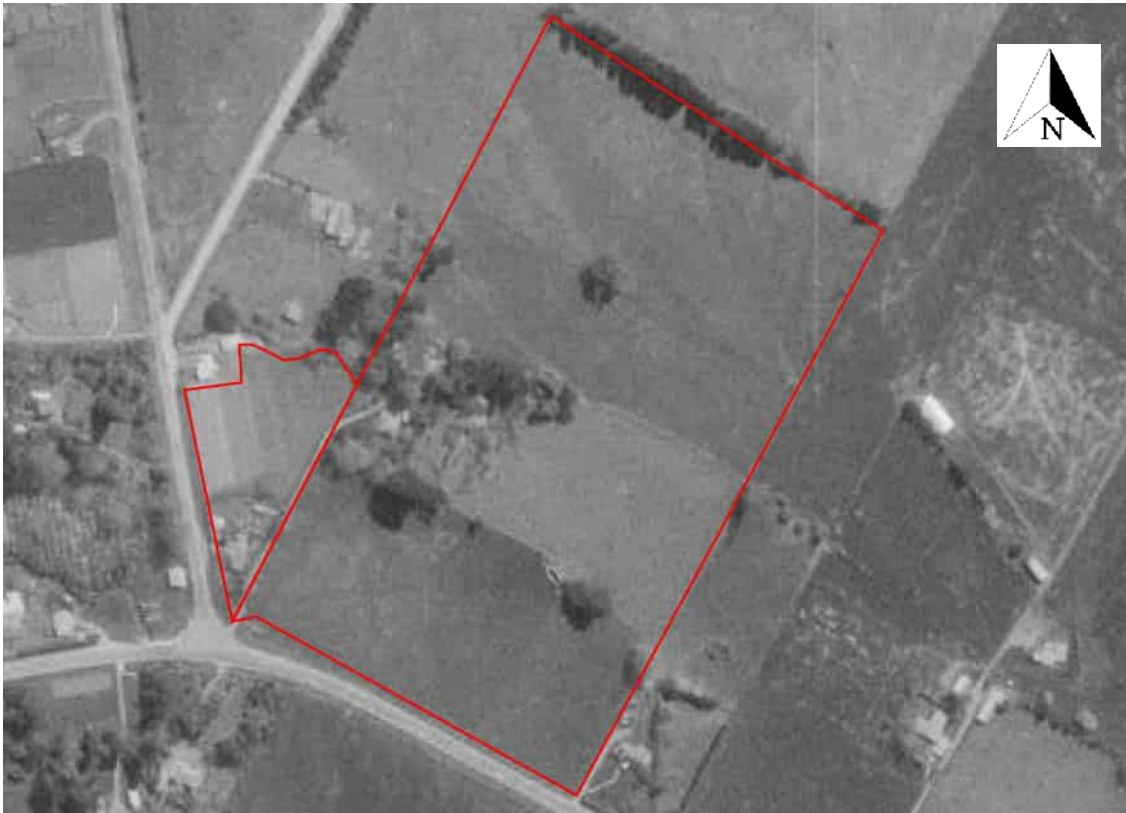
Aerial imagery of 4 Golf Links Road (left) and 518 Rangiora Woodend Road (right) in 1976 (site boundary outlined in red). Retrieved from Retrolens.

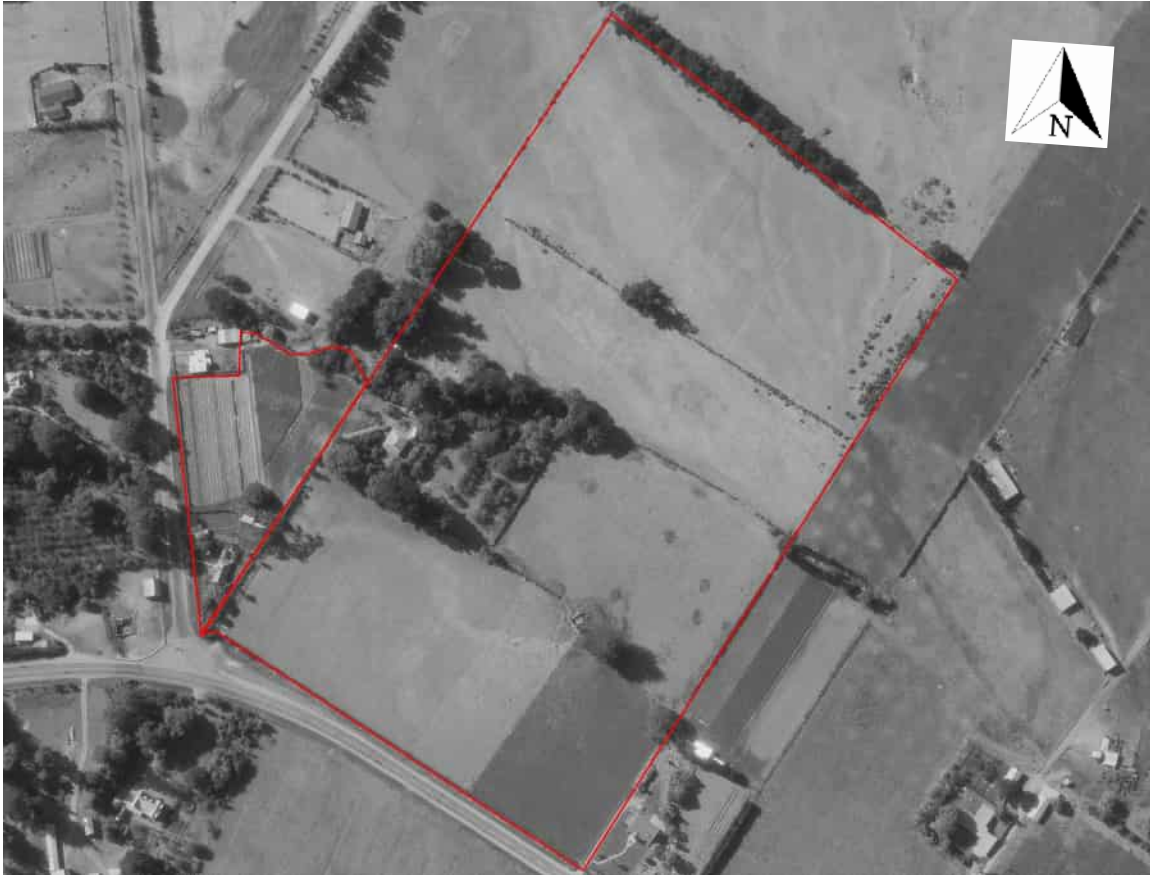
Aerial imagery of 4 Golf Links Road (left) and 518 Rangiora Woodend Road (right) in 1978 (site boundary outlined in red). Retrieved from Retrolens.

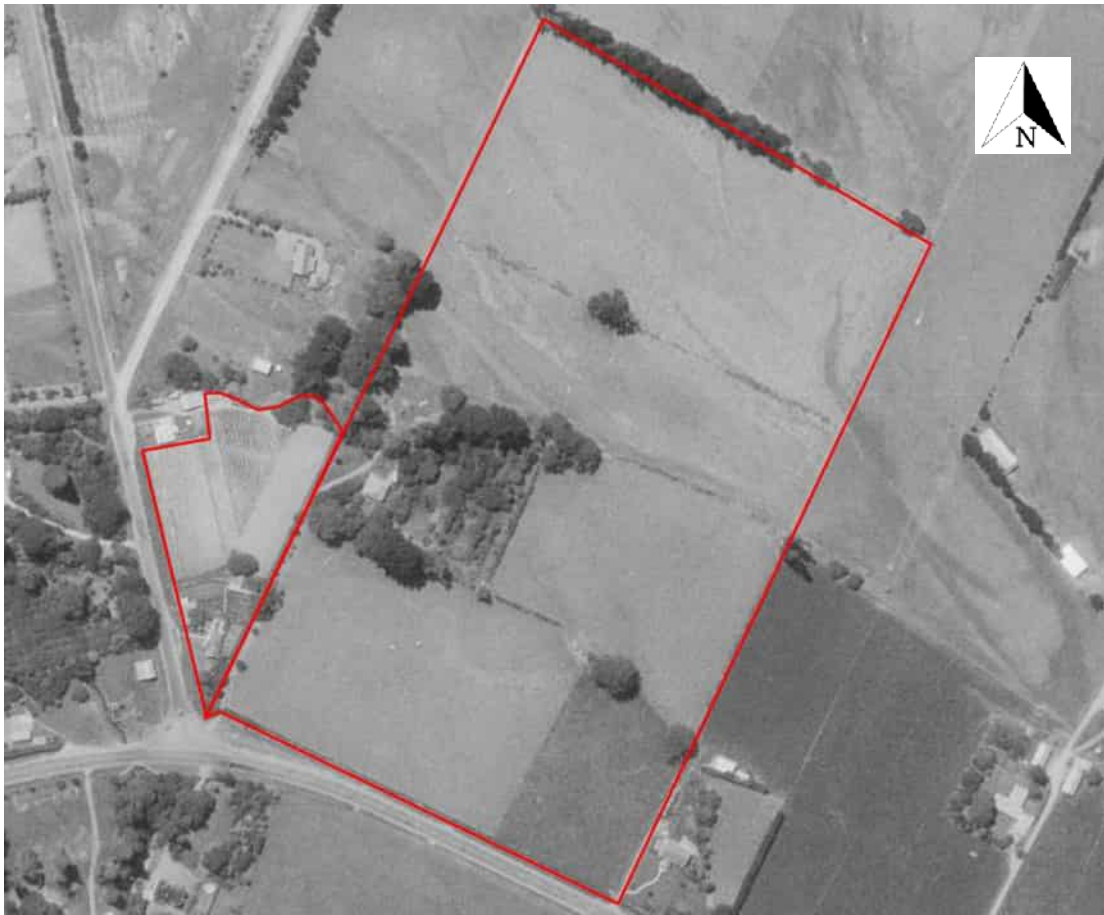
Aerial imagery of 4 Golf Links Road (left) and 518 Rangiora Woodend Road (right) in 1980 (site boundary outlined in red). Retrieved from Retrolens.

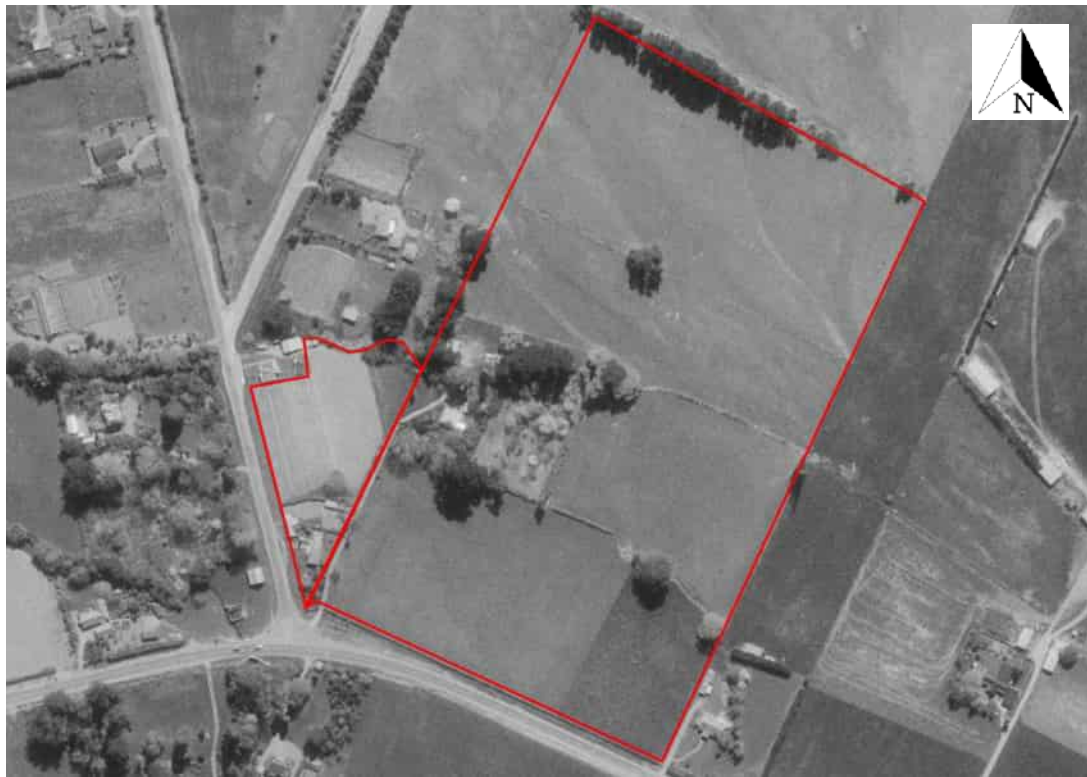
Aerial imagery of 4 Golf Links Road (left) and 518 Rangiora Woodend Road (right) in 1984 (site boundary outlined in red). Retrieved from Retrolens.

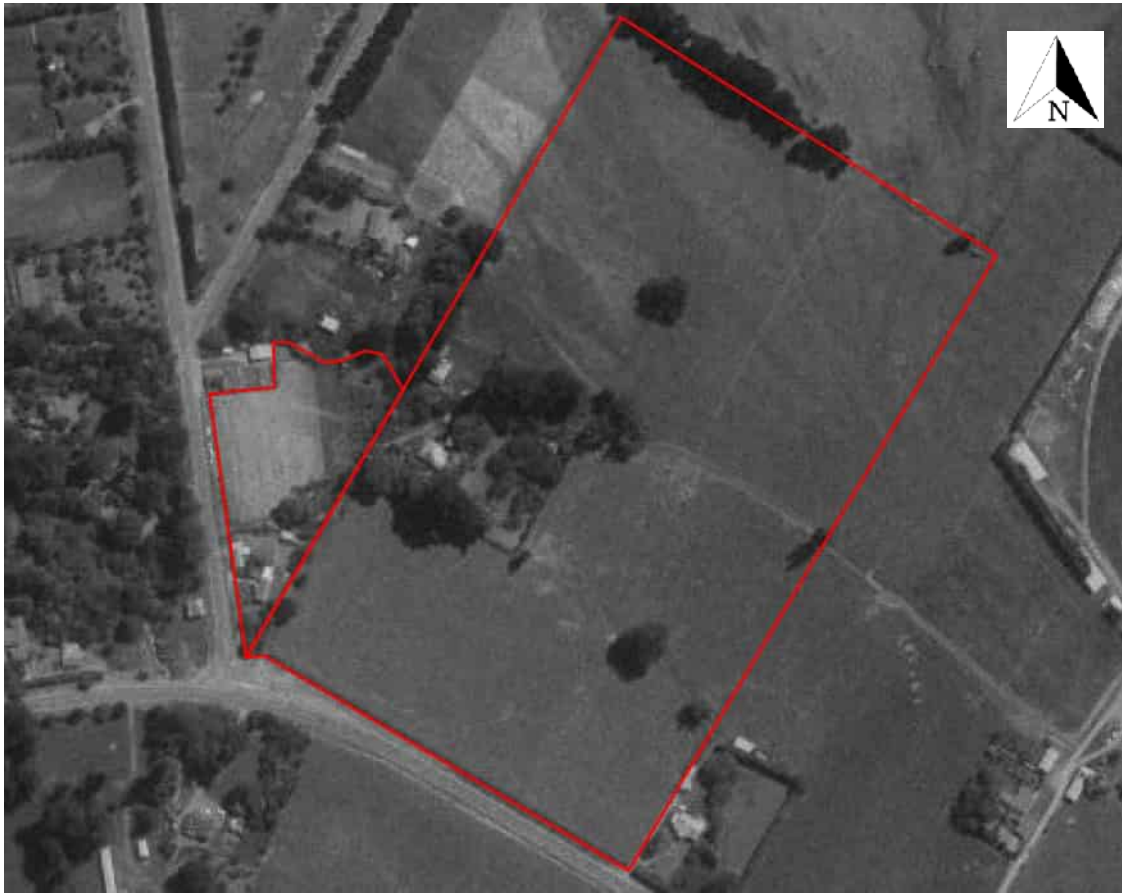
Aerial imagery of 4 Golf Links Road (left) and 518 Rangiora Woodend Road (right) in 1994 (site boundary outlined in red). Retrieved from Retrolens.

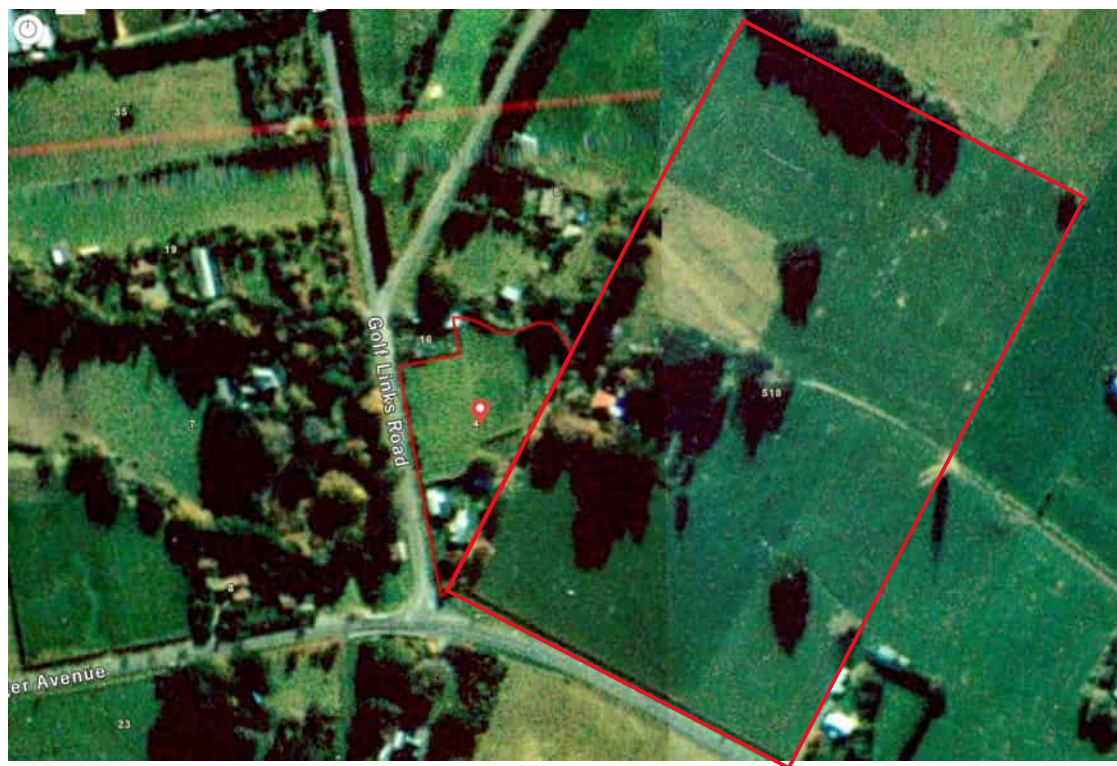
Aerial imagery of 4 Golf Links Road (left) and 518 Rangiora Woodend Road (right) between 1995-1999 (site boundary outlined in red). Retrieved from Canterbury Maps.

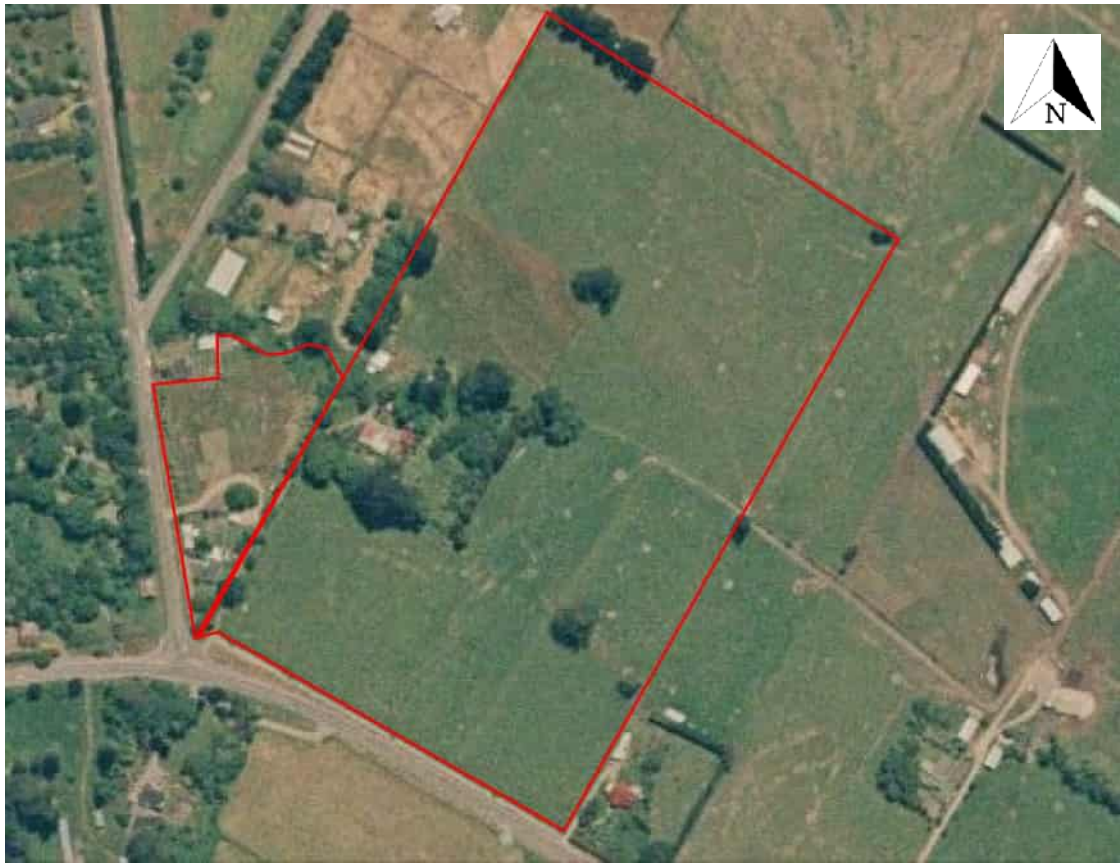
Aerial imagery of 4 Golf Links Road (left) and 518 Rangiora Woodend Road (right) in 2000 (site boundary outlined in red). Retrieved from Retrolens.

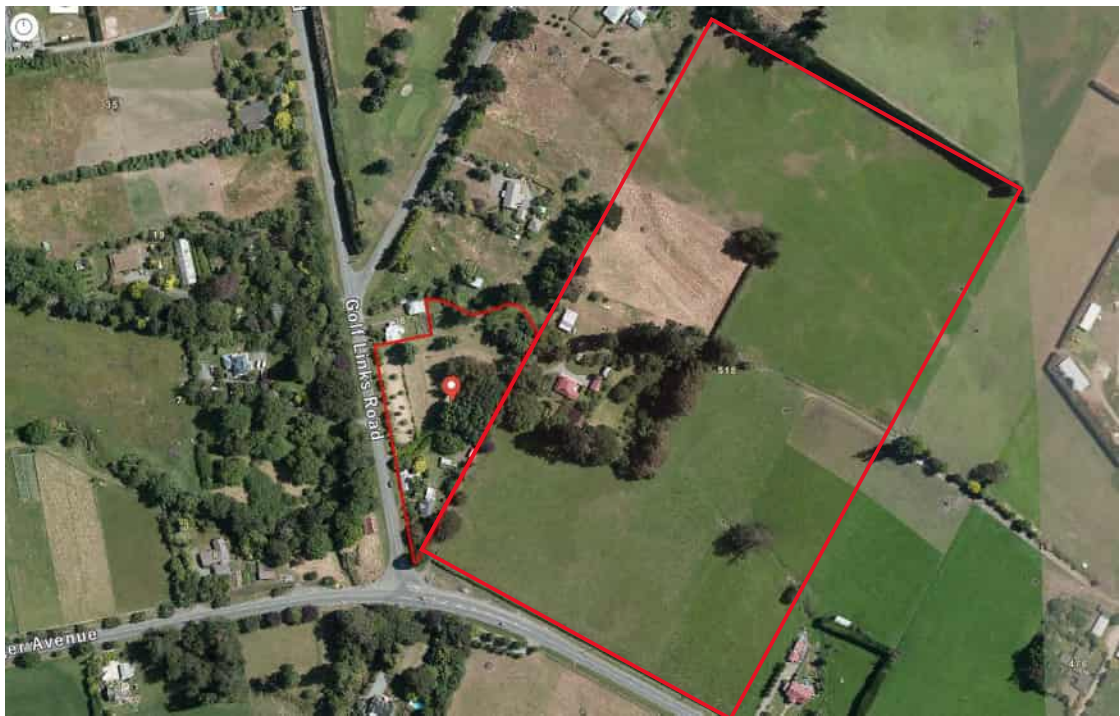
Aerial imagery of 4 Golf Links Road (left) and 518 Rangiora Woodend Road (right) between 2010- 2014 (site boundary outlined in red). Retrieved from Canterbury Maps.

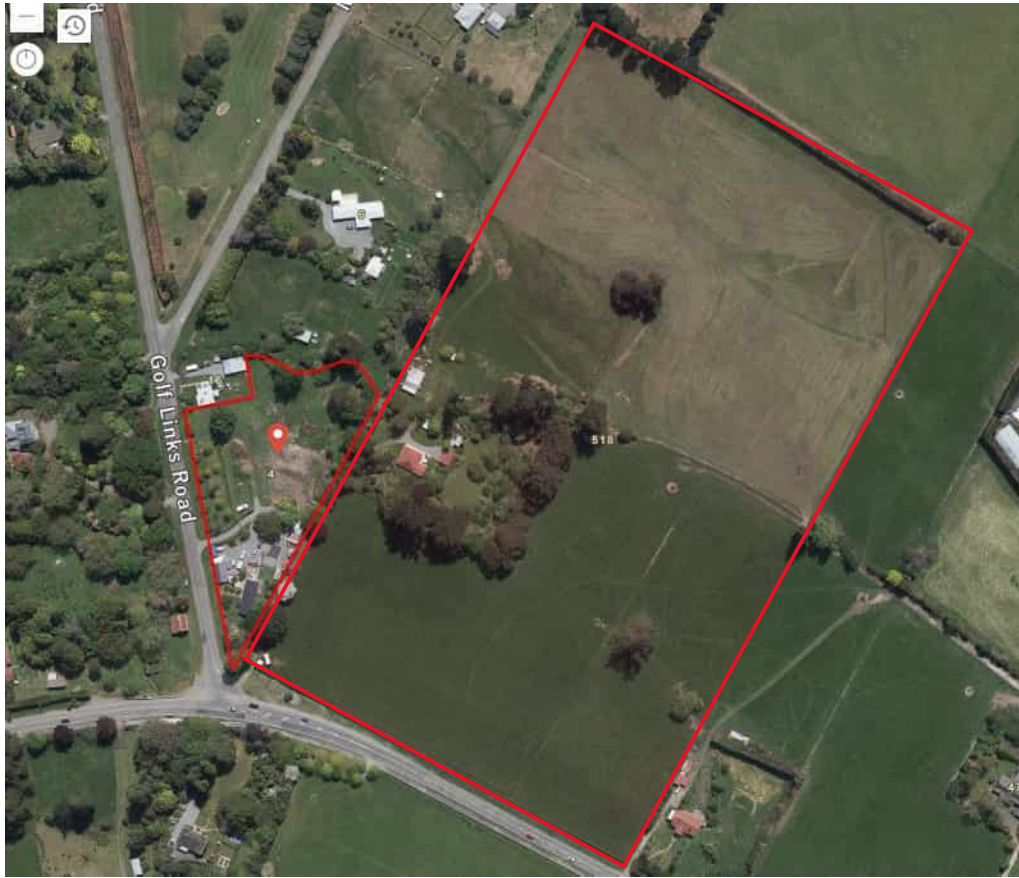
Aerial imagery of 4 Golf Links Road (left) and 518 Rangiora Woodend Road (right) between 2015- 2019 (site boundary outlined in red). Retrieved from Canterbury Maps.

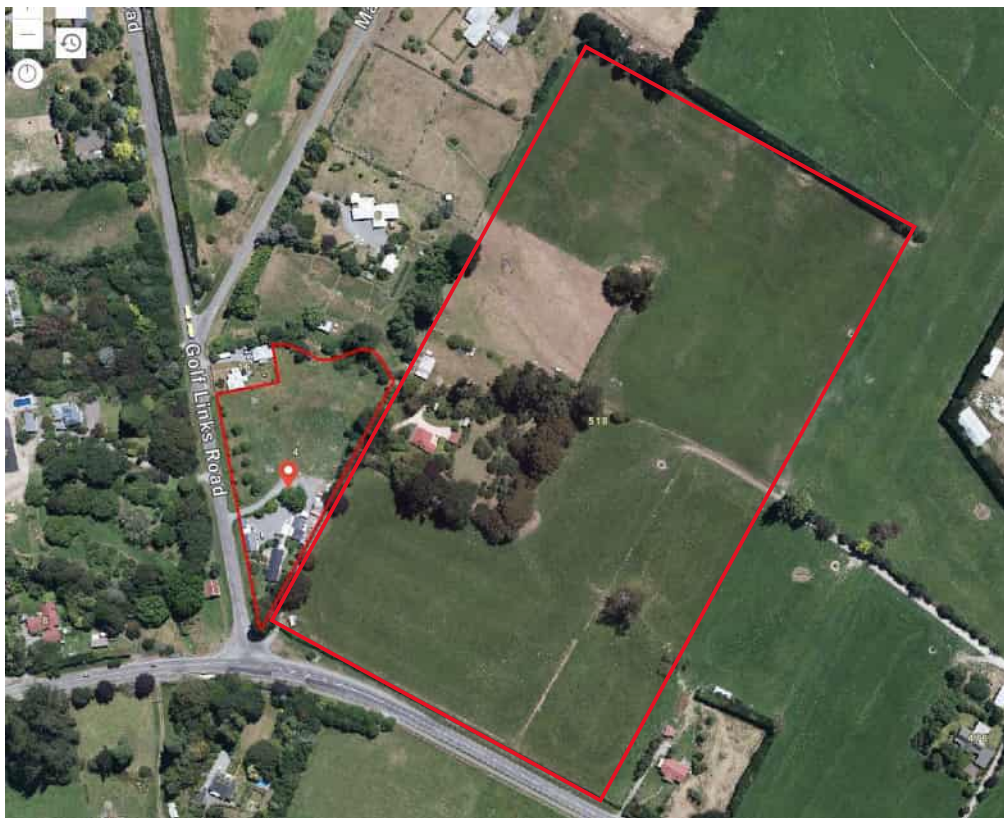
Latest aerial imagery of 4 Golf Links Road (left) and 518 Rangiora Woodend Road (right) (site boundary outlined in red). Retrieved from Canterbury Maps.
