Title: Momentum Land Living					
Date	Version	Description	Prepared by:	Reviewed by:	Authorised by:
13/09/2022	1	Report for resource consent application	S Burgess	A Sleight	G Lovell
22/02/2023	2	Report for District Plan Variation submission	S Burgess	A Sleight	G Lovell
18/05/2023	3	Rename to South Block	S Burgess	R Brunton	A Sleight

This assessment summarises the investigations and analyses that have been completed to provide Master Planning conceptual design-level recommendations for the site and is intended to support the submission process to Variation 1 of the Proposed Waimakariri District Plan.

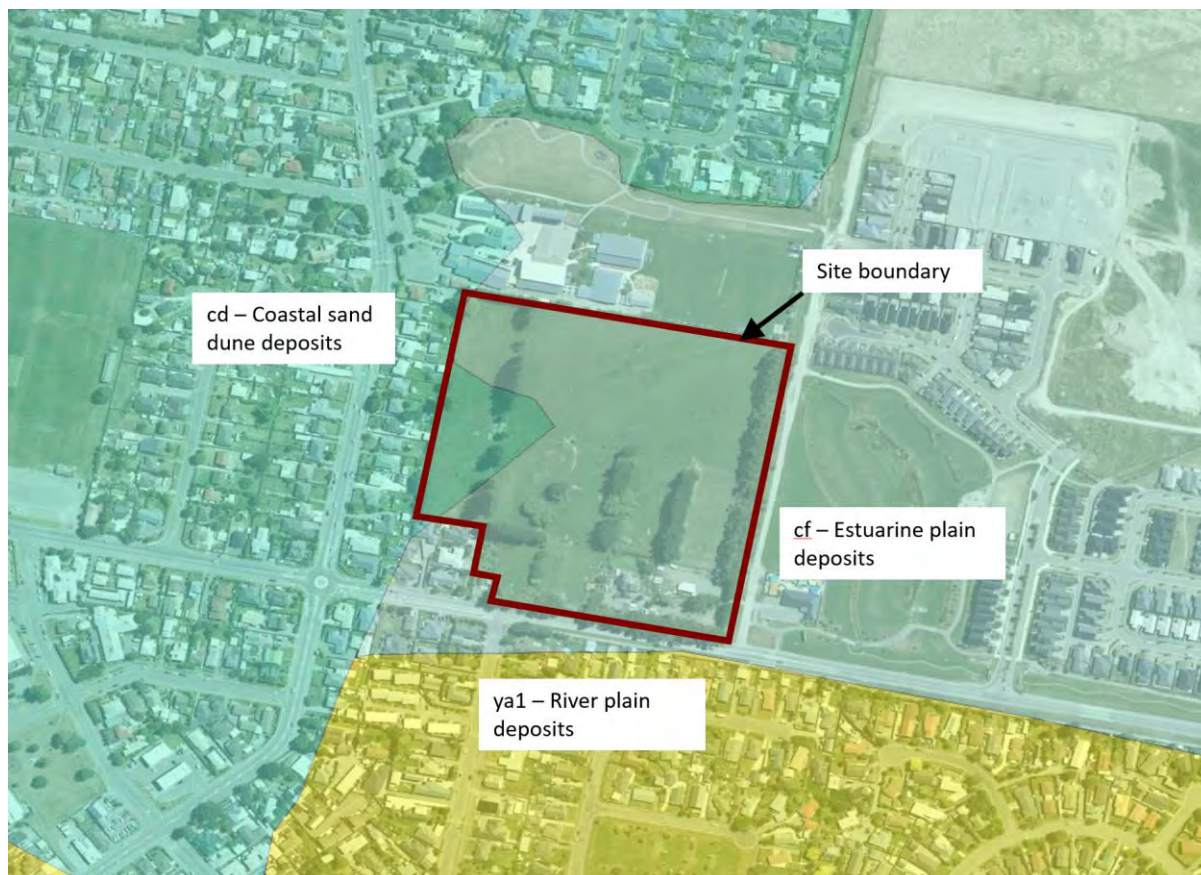
These formations comprise layers of interbedded river deposited alluvial gravel, over bank alluvial silt and freshwater swamp peat, coastal sand deposits, and estuarine sand and silt deposits.

Figure 2.1: Extract from geomorphological map.

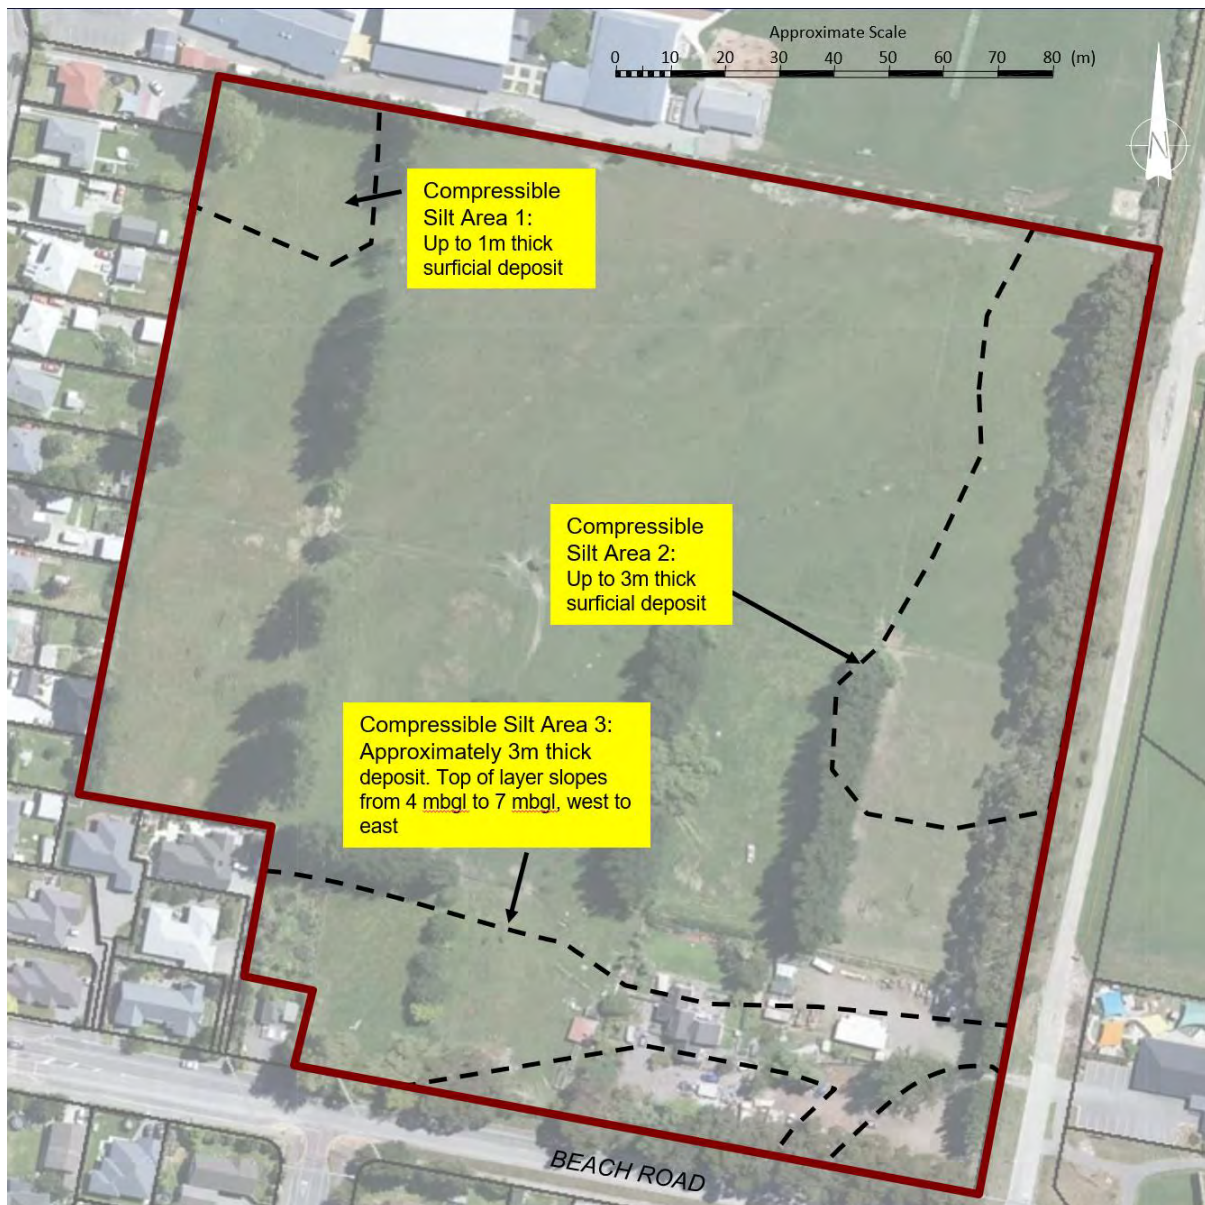
Whilst more investigations are required, initial investigations findings are shown in Figure 2.3 and these areas have informed initial indications for geotechnical zones discussed in Section 3.3.

Figure 2.3: Preliminary areas soft compressible silt deposits.

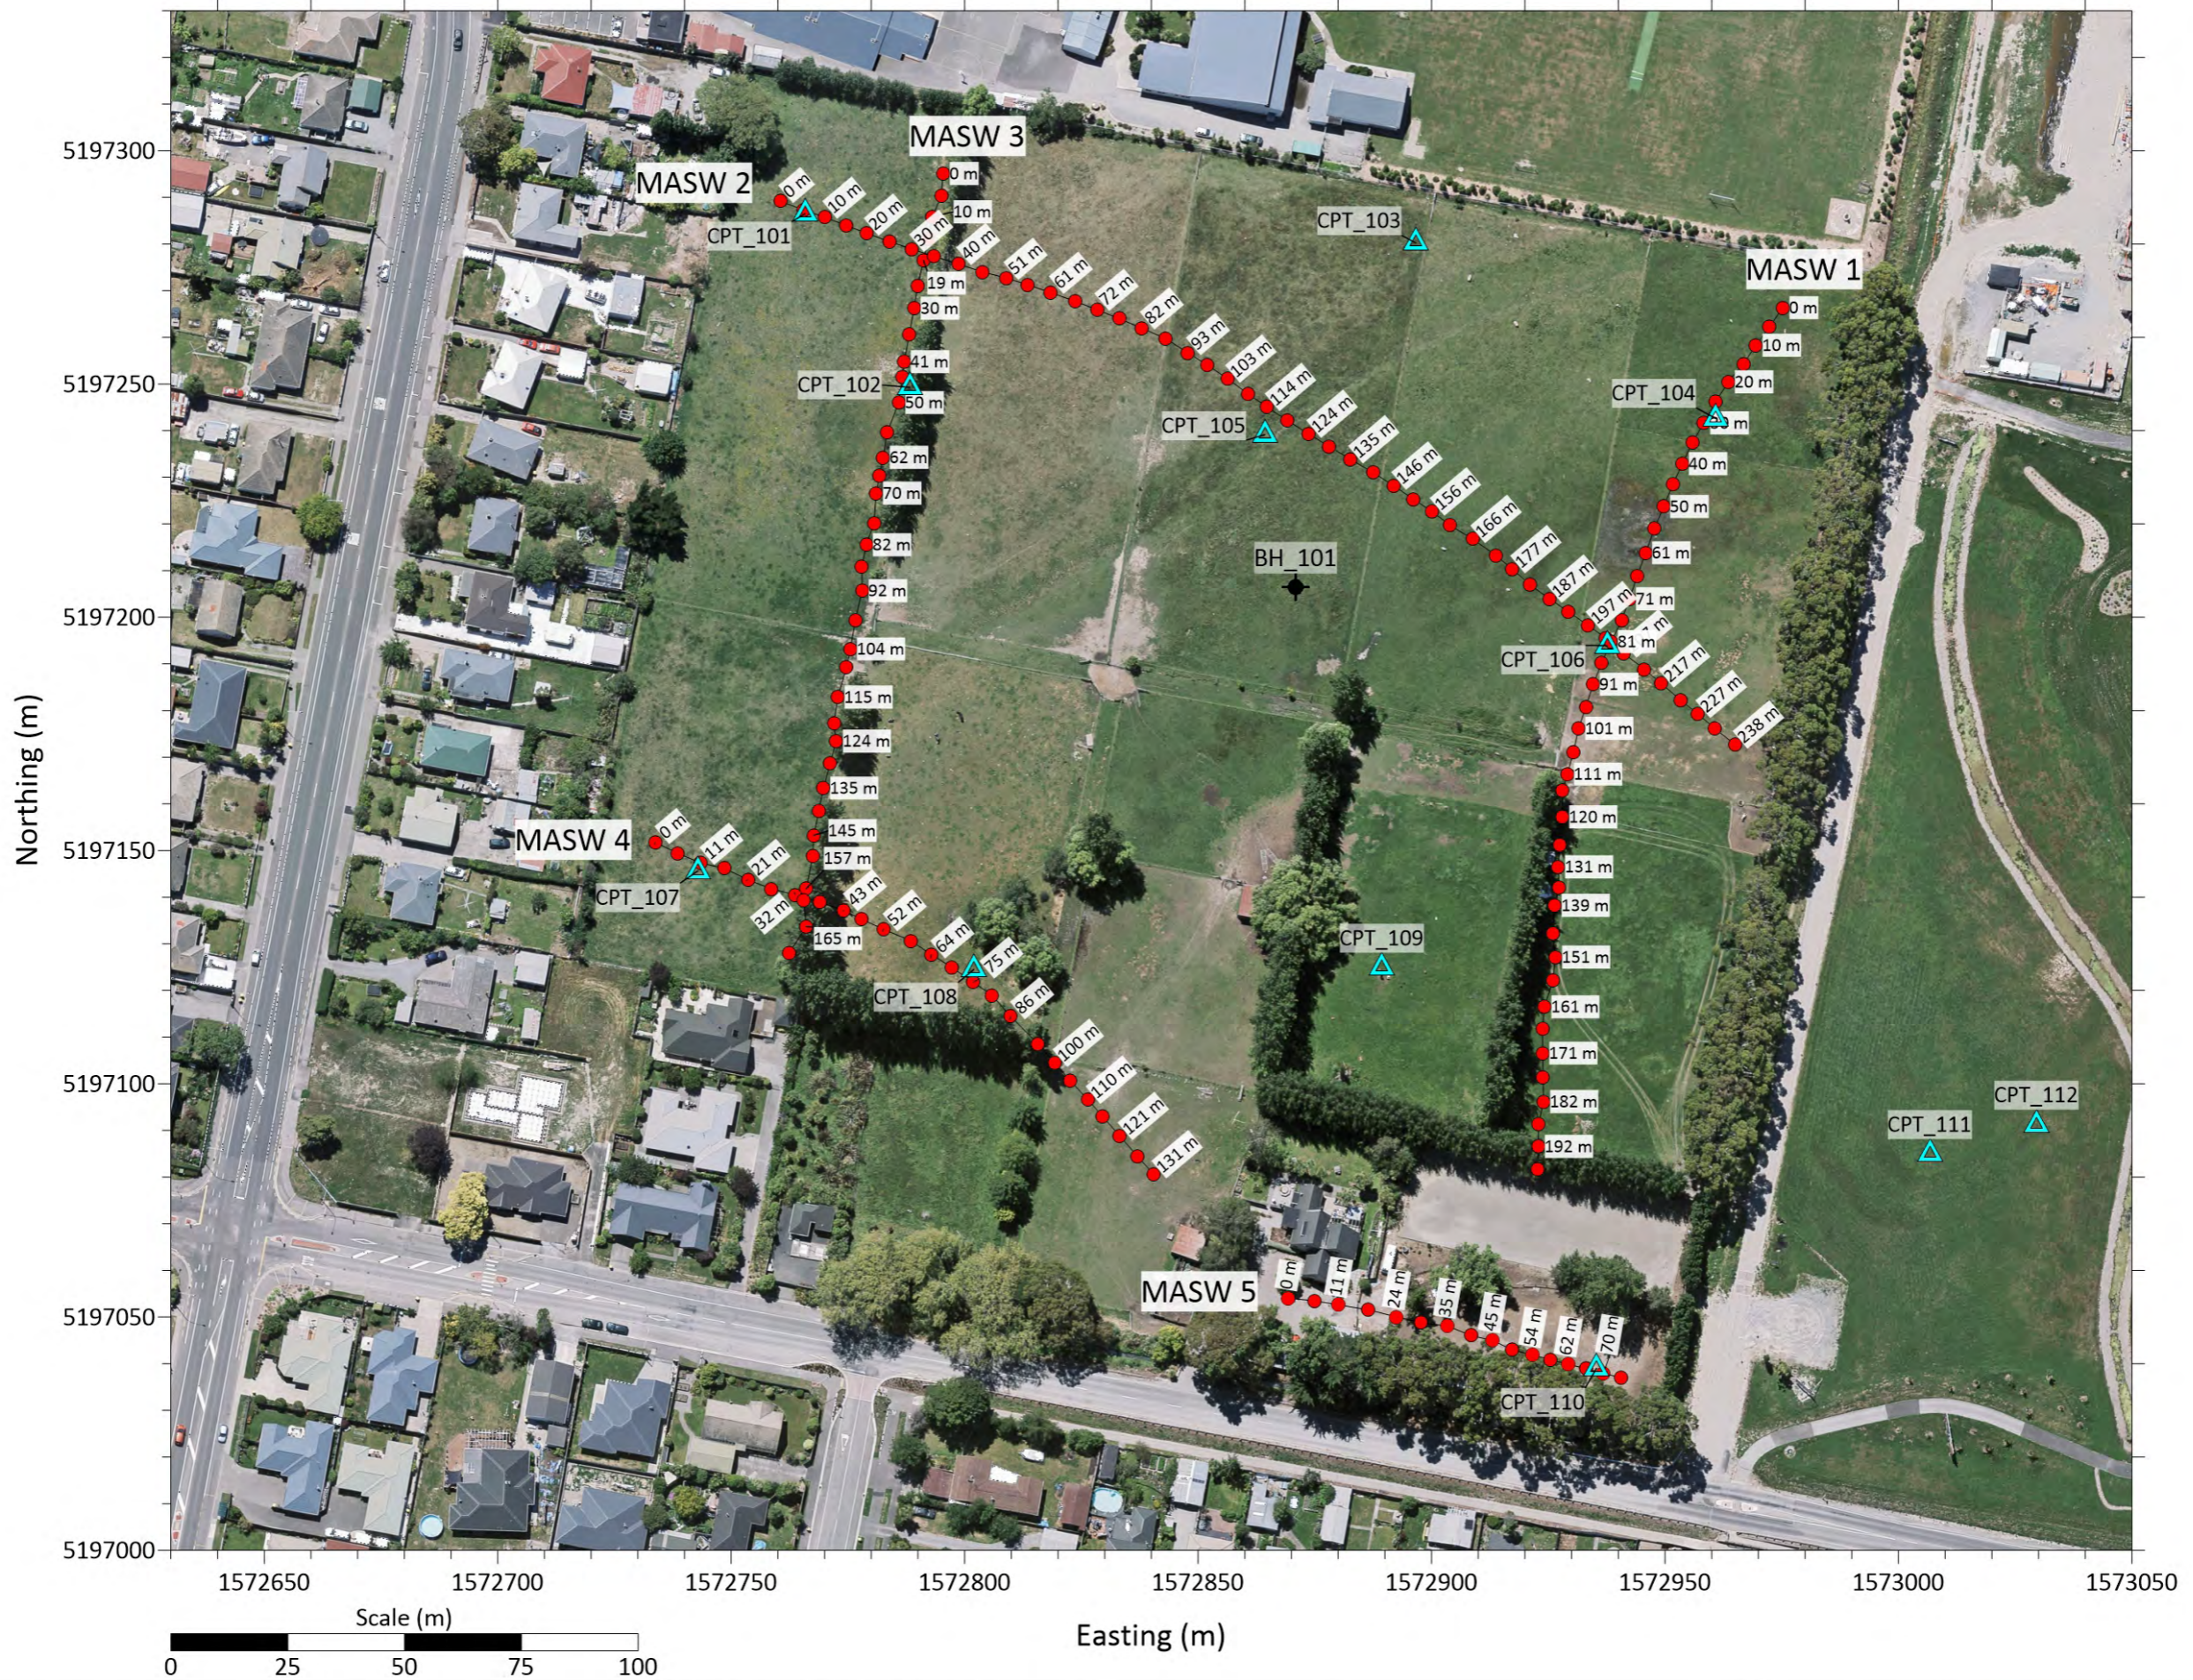
DRAWING - **Figure 1: Block 1 MASW Survey Site Map**

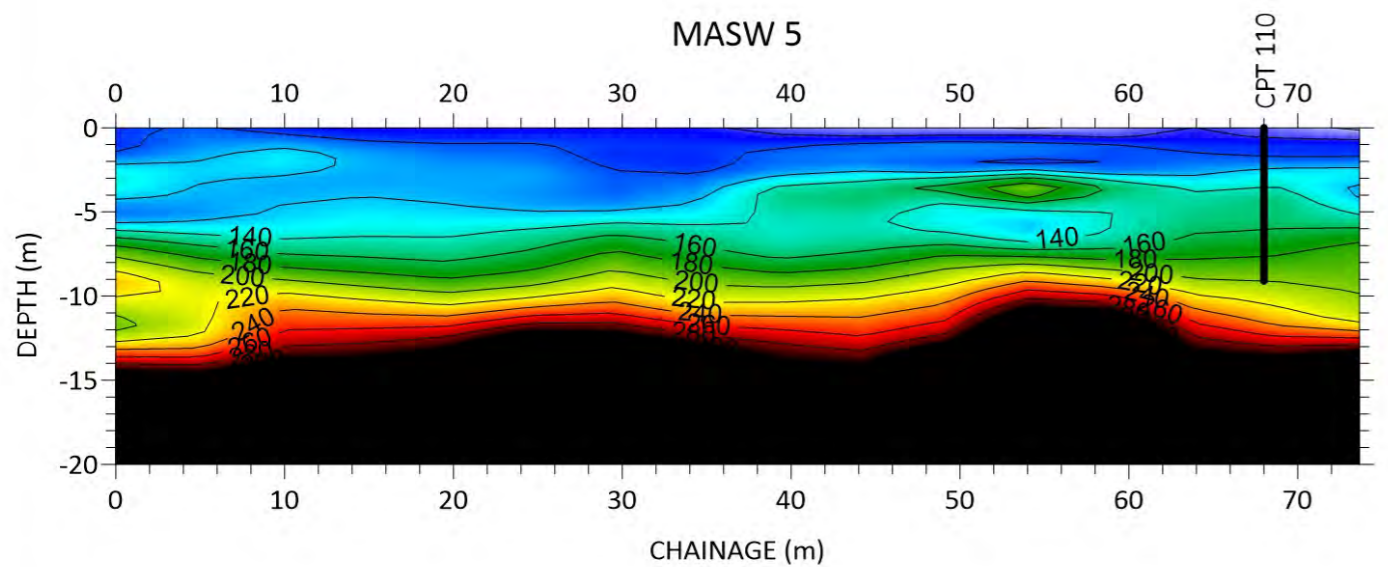
DRAWING - Figure 3: Block 1, MASW 2D V_s Profiles 3, 4, & 5

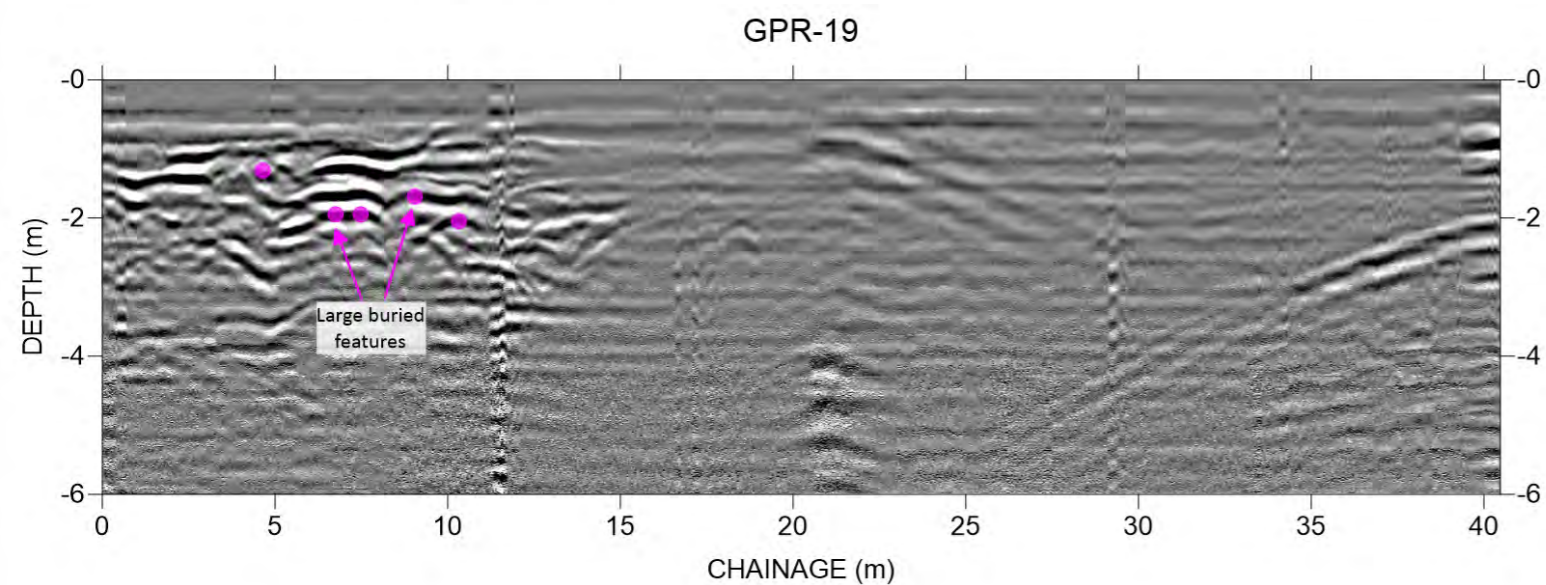
DRAWING - **Figure 6: Block 1 Example GPR Radargrams
Lines 7, 8, 19, and 23**
