**GEOTECHNICAL ASSESSMENT  
TO SUPPORT PROPOSED  
PLAN CHANGE  
104 TOWNSEND ROAD  
AND 141 SOUTH BELT  
WAIMAKARIRI, RANGIORA**

**Report prepared for:** Summerset Villages (Rangiora) Limited

**Report reference:** 170743-C

**Date:** 15 October 2019

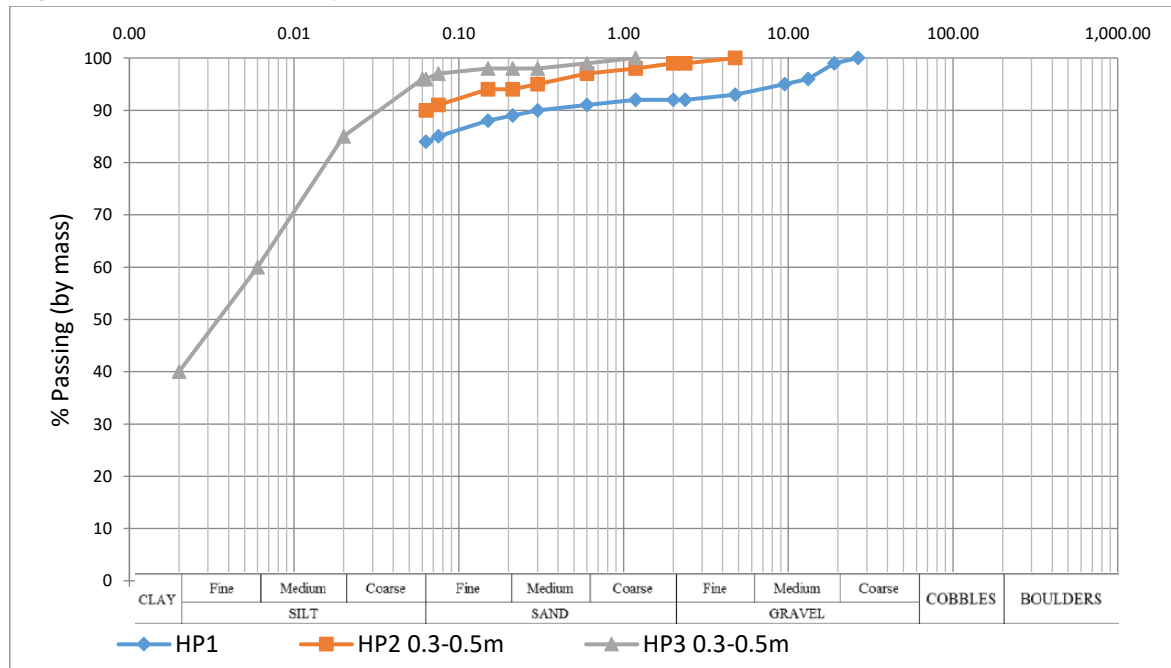
**Figure 2: Plot of PSD and Hydrometer Test Results**

As shown by the results, the fines content (FC) of the soil is between 84% to 96% between 0.3m to 0.5m bgl.

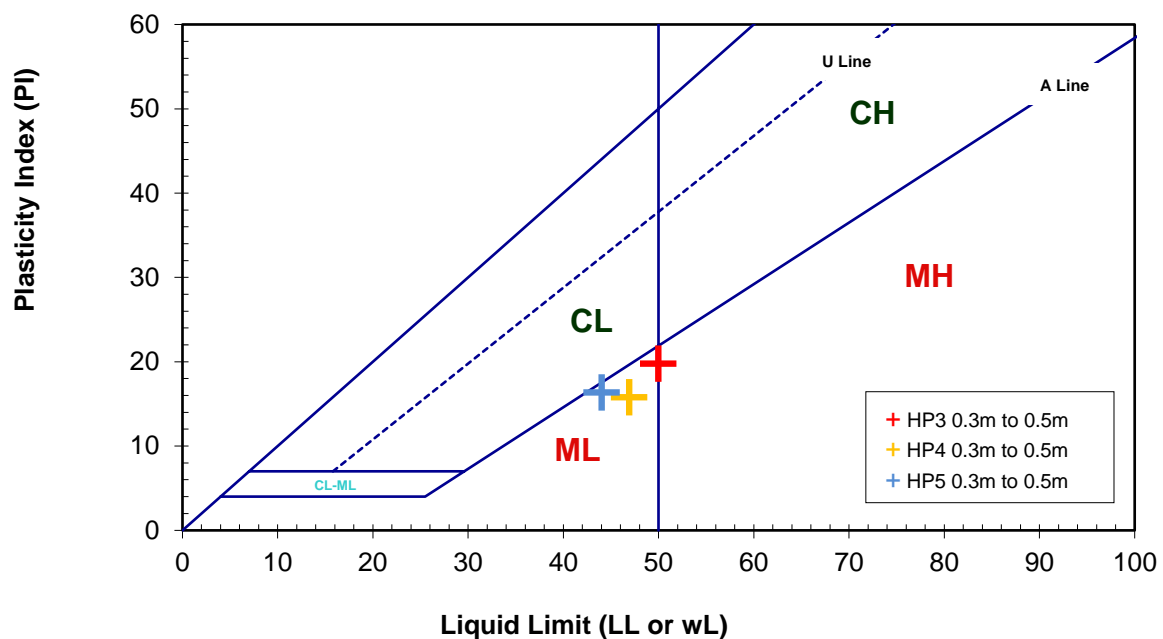
Figure 3: Plot of Material at 0.3m to 0.5m Deep on Plasticity Chart

- Alluvium
  - Silt/clay mixtures were encountered below topsoil within all test locations across the site, comprising silt and clay mixtures with trace sand to a maximum depth ranging between 0.45m and 1.7m depth. Strength of the soil ranged from loose to medium dense across the site with Scala penetrometer tests indicating blows of one to seven per 100mm penetration, but most typically in the range two to three blows per 100mm. Soil is logged as having low plasticity, though plasticity testing indicates that the material is sufficiently plastic to be considered non-liquefiable.

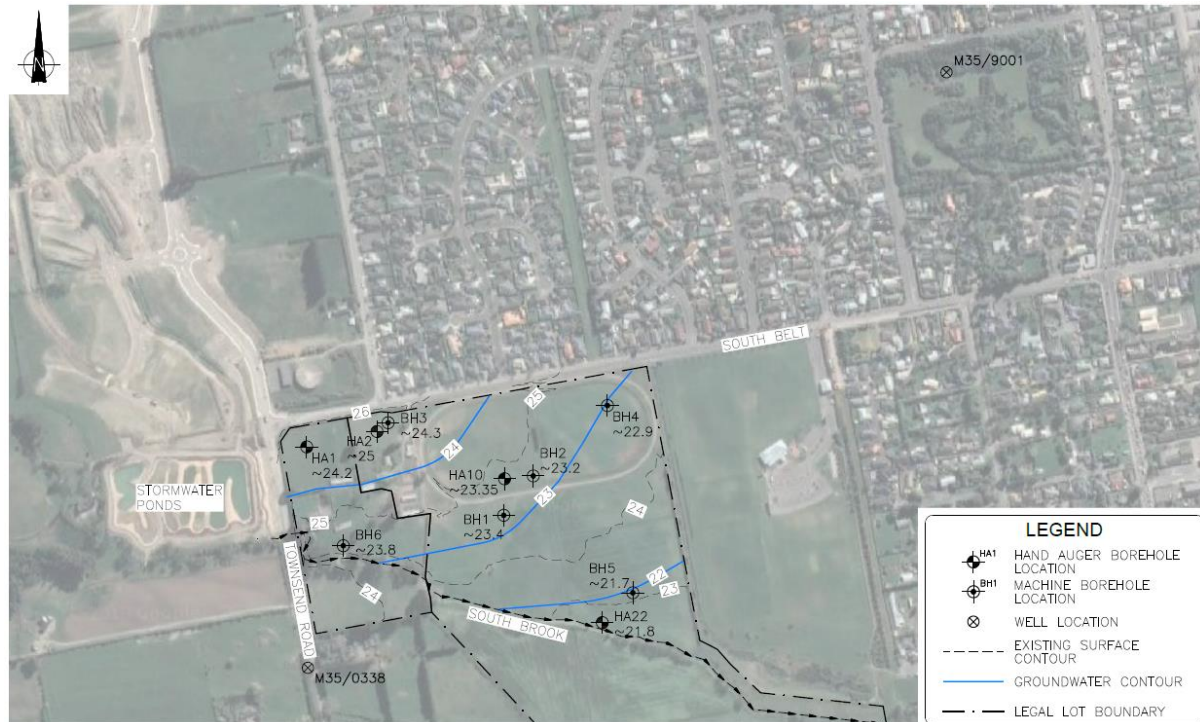
**Figure 4: Preliminary Median Groundwater Contours from Site Observations**

It should be noted that when the groundwater measurements were taken in December 2018, there had been high rainfall recorded in area between the 19 December and 21 December. It should also be noted that the groundwater readings taken in December 2018 were taken immediately preceding the drilling works and that water was added to the hole to assist the drilling process. However, it is unlikely that the drilling water added to the hole will have had a significant impact upon the groundwater level due to the coarse-grained geology underlying the site.

- Groundwater is generally found below 1.3m bgl across the site, however, adjacent to Southbrook Stream groundwater is encountered as shallow as 0.65m bgl where the ground drops away towards the stream. Based on nearby well data our measured groundwater depths are assumed to be representative of a median groundwater level and very little seasonal variation may be expected.

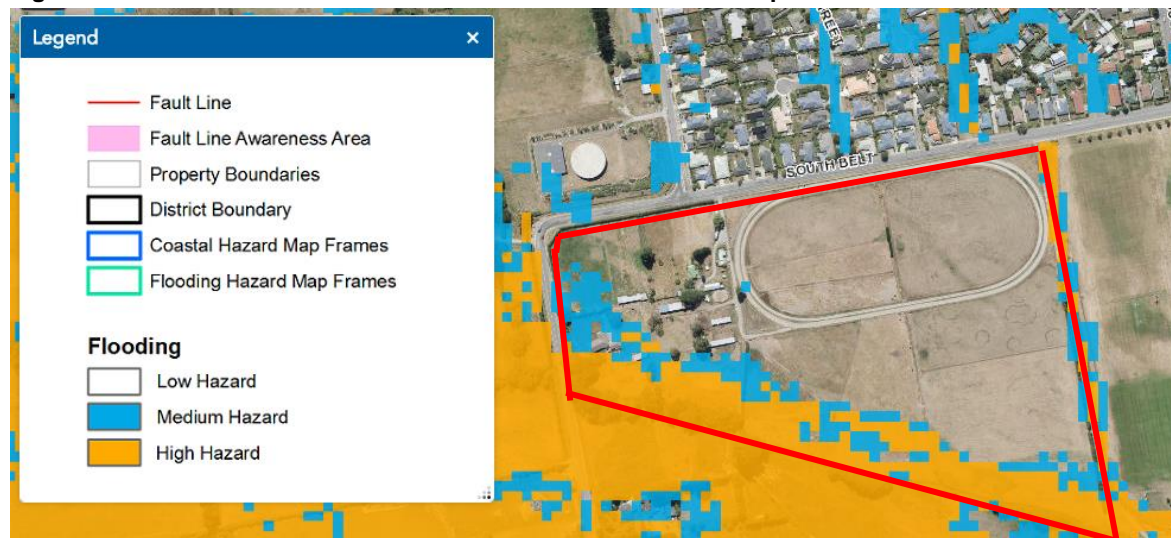
**Figure 5: Exert from Waimakariri District Council Flood Hazard Map**

The WDC District Plan Hazards Map indicates that areas of the site are at risk of inundation during flood events. The southern edge of the site along Southbrook Stream and adjacent to the eastern property boundary are considered a medium to high hazard indicating the site is susceptible to flooding during a 1 in 200-year (0.5% annual exceedance probability) flood event with flooding of up to 2.0m above the stream possible. The majority of the flooding hazard is located within approximately 50m of the stream and a large part of the site is considered at low risk.

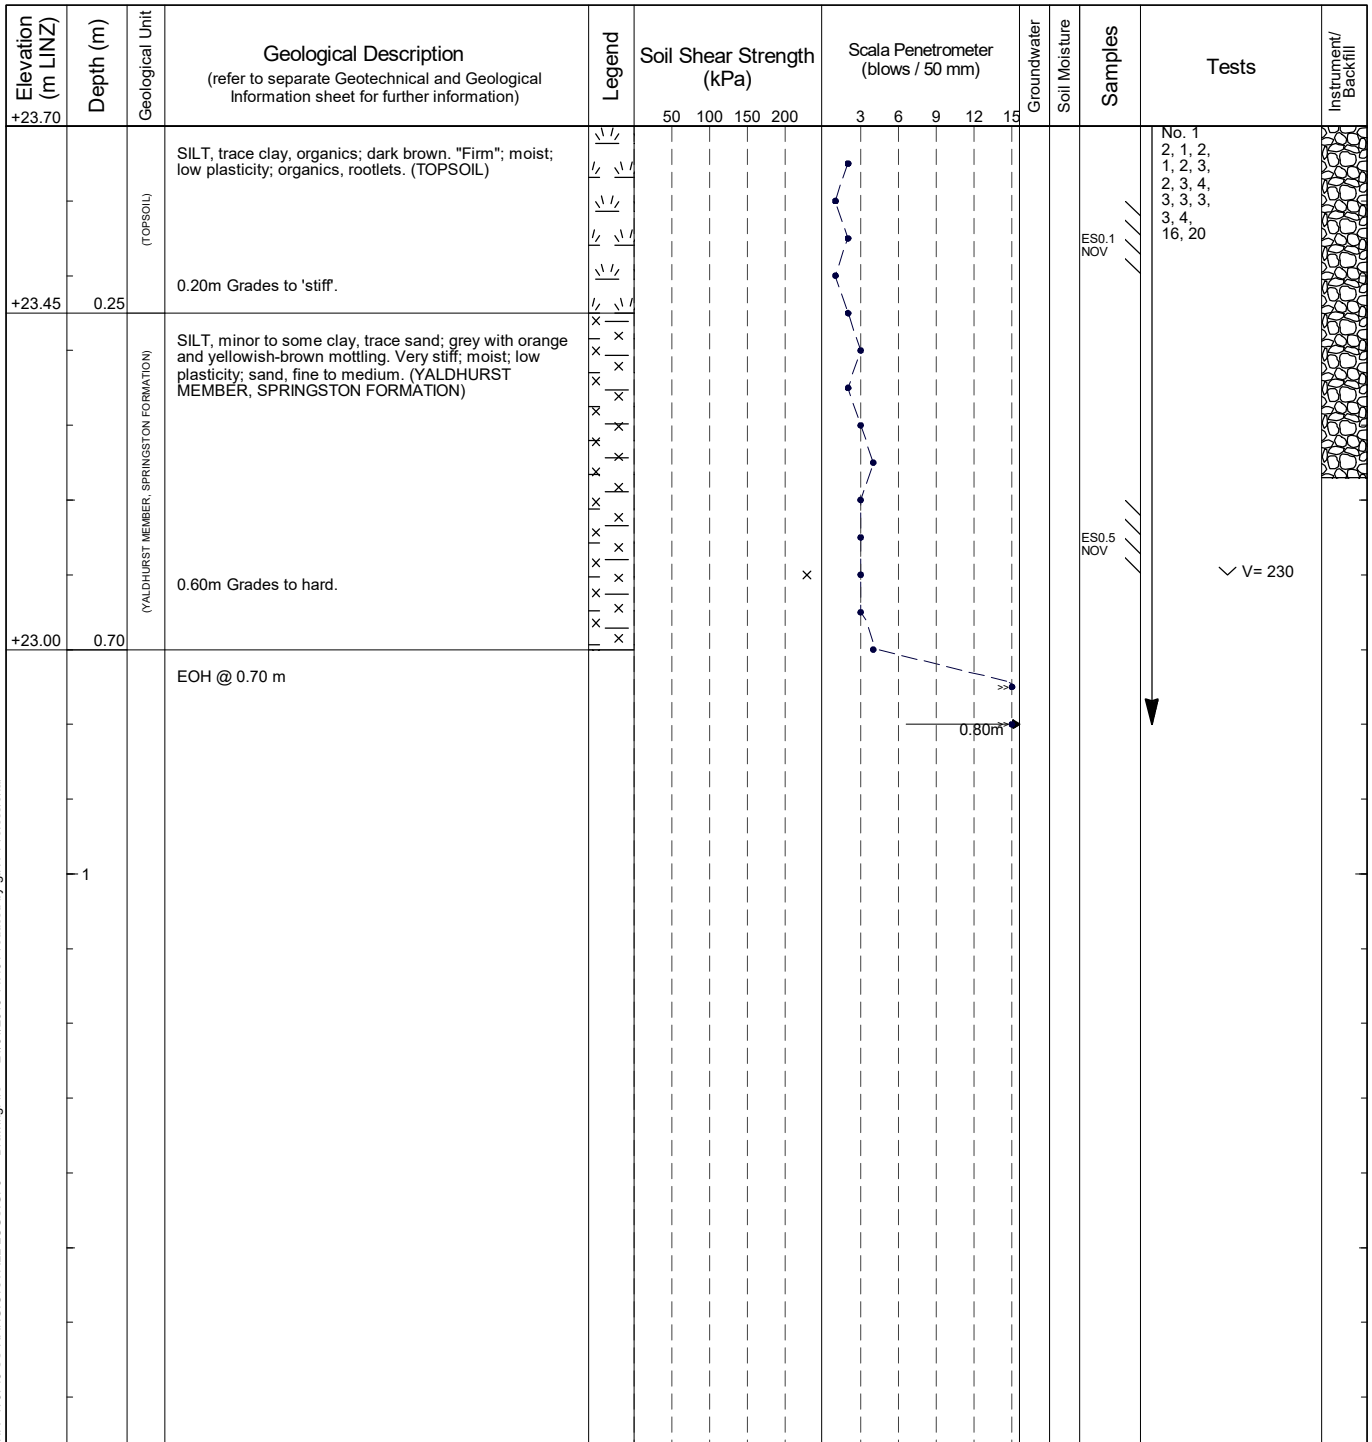
- ▼ Scala Penetrometer - blows/50mm
- ▼ Permeability Test
- ✓ Schmidt Hammer
- Insitu Vane Shear Strength (kPa)
- V=Peak, R=Residual,
- WTP=Unable to penetrate
- Soil Moisture
- D = dry; M = moist; W = wet; S =
- Small Disturbed Sample
- Large Disturbed Sample
- U100 Undisturbed Sample
- ↓ Water Strike (1st, 2nd ...)
- ↑ Water Rise (1st, 2nd ...) and
- ⏱ Rise Time (minutes)

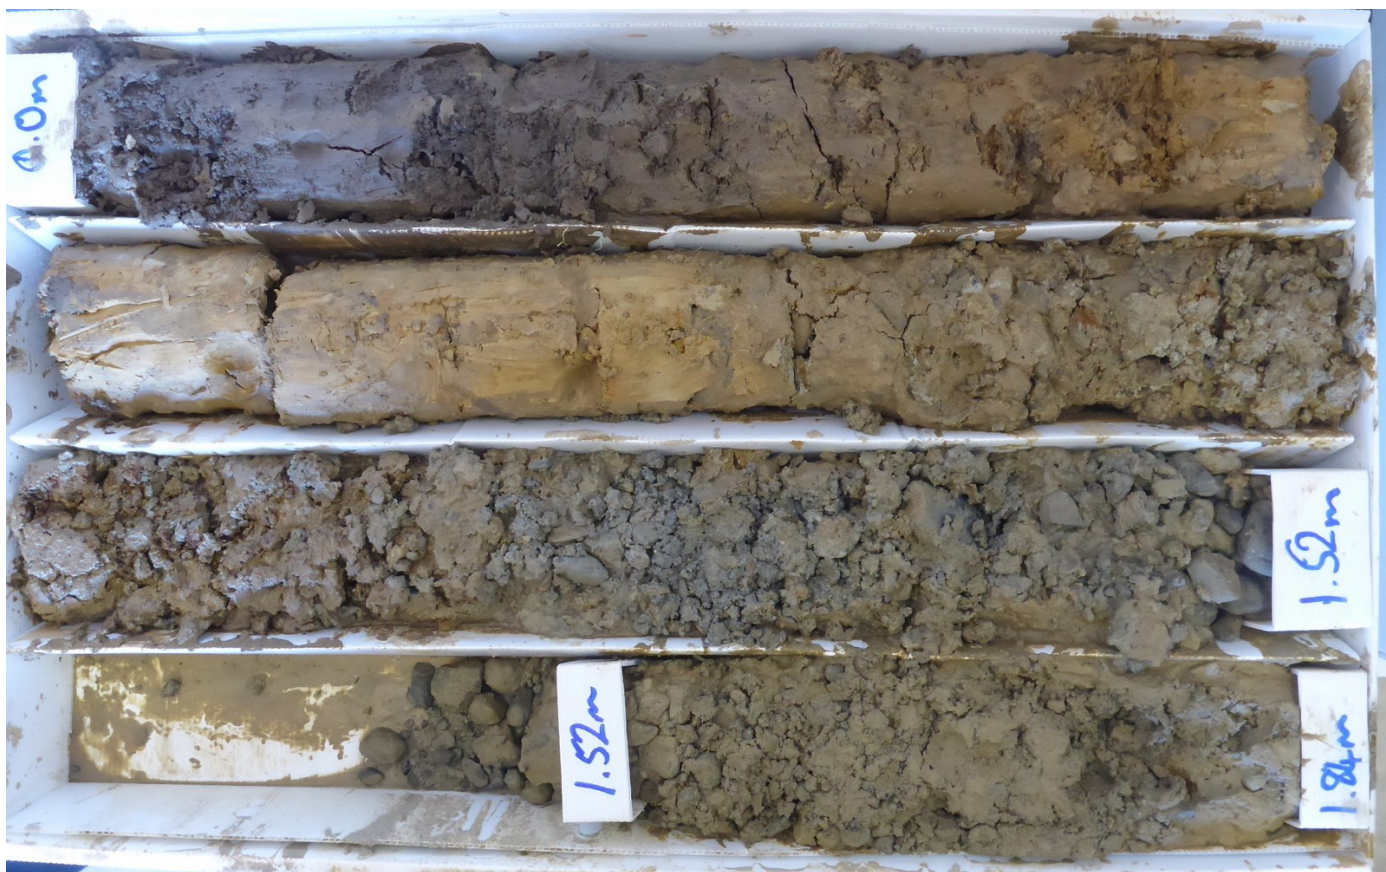
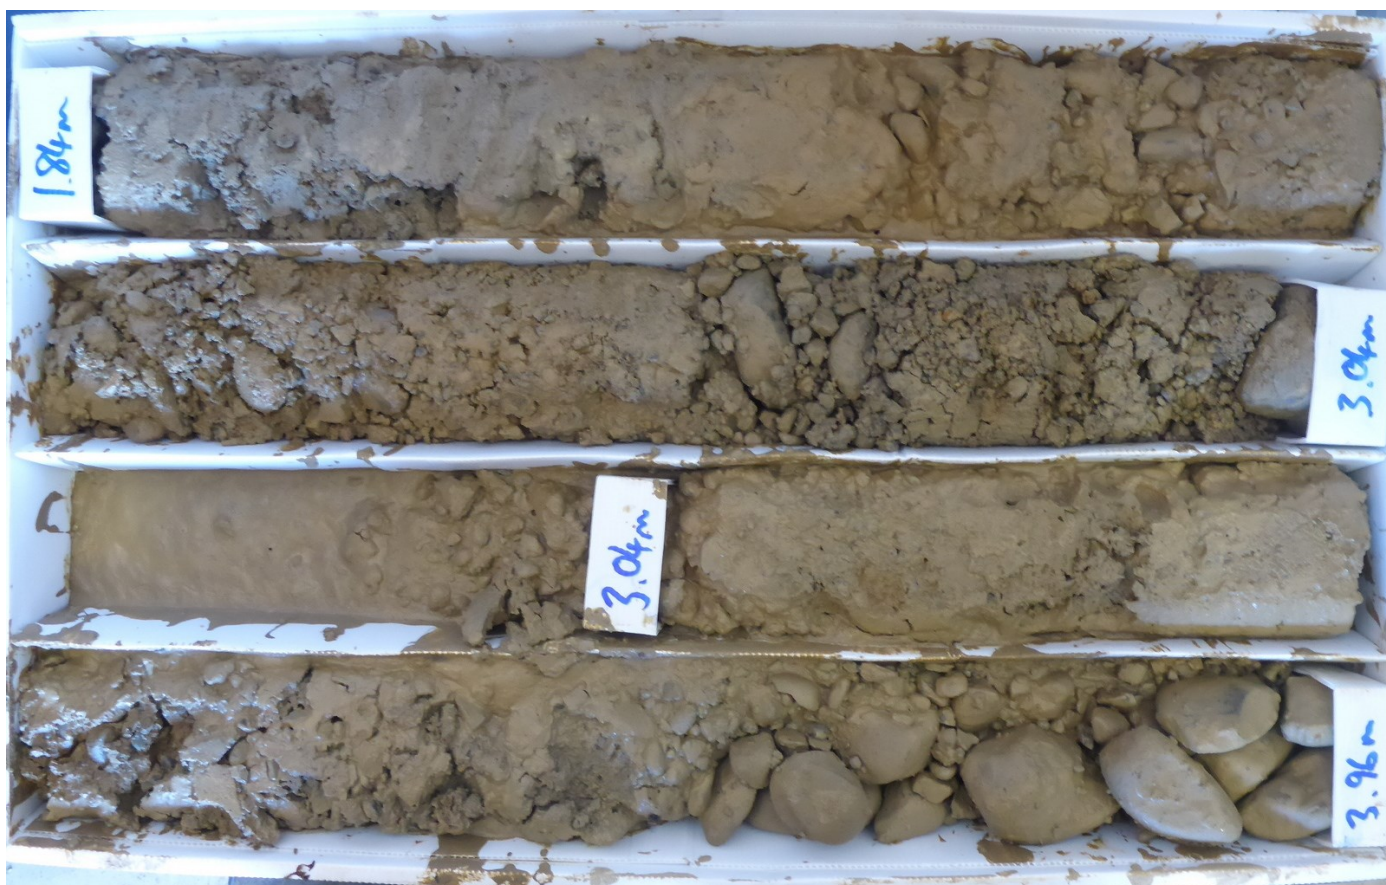
<b>Client / Project:</b>	SUMMERSET GROUP HOLDINGS LTD SUMMERSET RANGIORA DUE DILIGENCE MACHINE BOREHOLE CORE PHOTOS	<b>Hole ID:</b>	BH1

<b>Date:</b>	18-19 DEC 2018	
<b>Notes:</b>	1. Drill sampling method: McMillan SONIC Geoprobe 8140LC (150Hz) 2. Markers: start/end of run and SPT split-spoon sample in metres; "CL" indicates core loss in metres; brackets indicate run split between boxes; SPT blows/75mm.	<b>Box No(s).</b>	1 and 2 of 8	
		<b>Depth from (m):</b>	0.00m	
		<b>Depth To (m):</b>	3.96m	
		<b>Interval (m):</b>	3.96m	
<b>Project No.</b>	170743

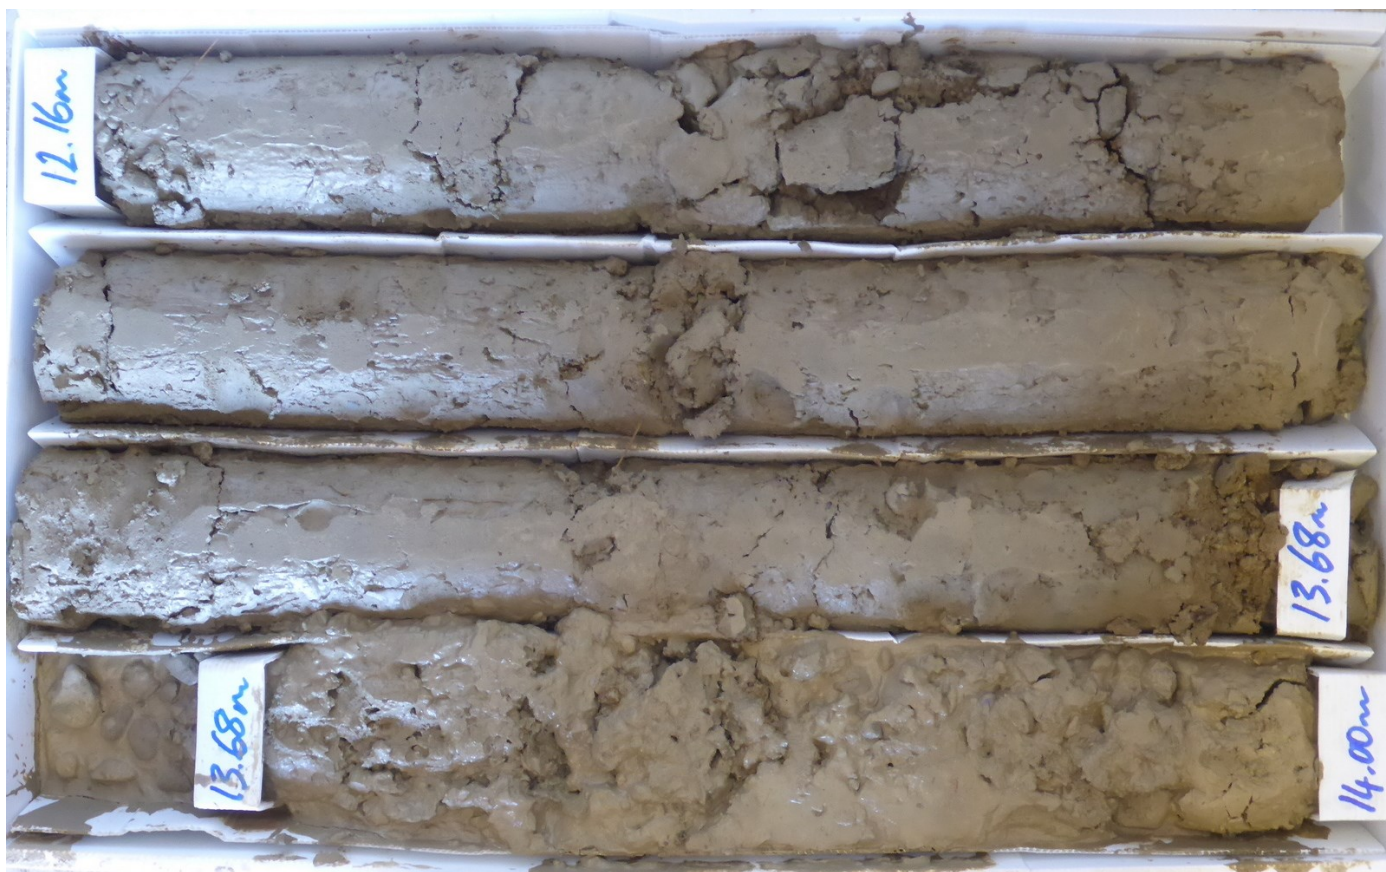
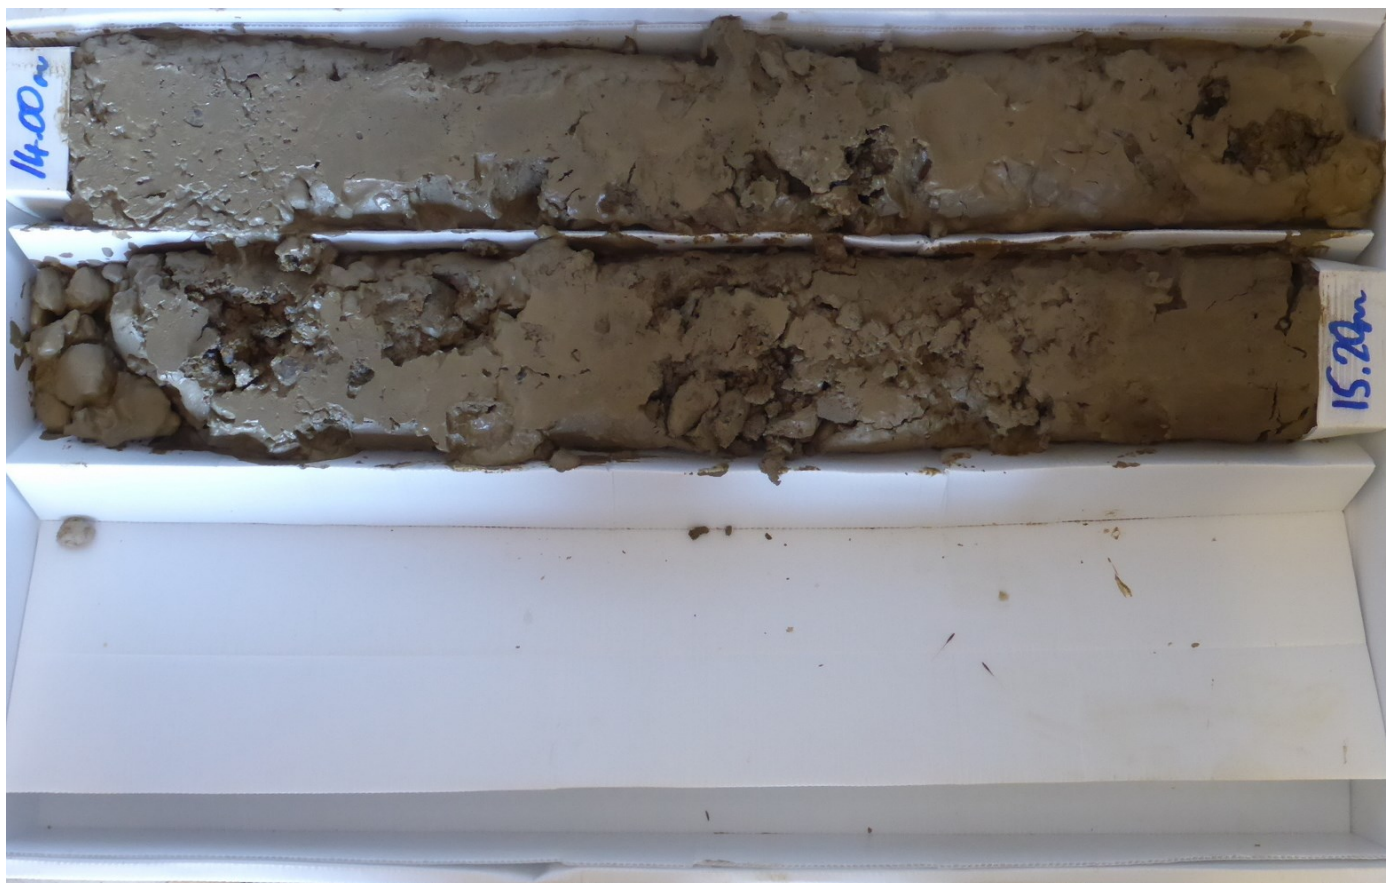
<b>Date:</b>	18-19 DEC 2018	
<b>Notes:</b>	1. Drill sampling method: McMillan SONIC Geoprobe 8140LC (150Hz) 2. Markers: start/end of run and SPT split-spoon sample in metres; "CL" indicates core loss in metres; brackets indicate run split between boxes; SPT blows/75mm.	<b>Box No(s).</b>	5 and 6 of 8	
		<b>Depth from (m):</b>	7.92m	
		<b>Depth To (m):</b>	12.16m	
		<b>Interval (m):</b>	4.24m	
<b>Project No.</b>	170743

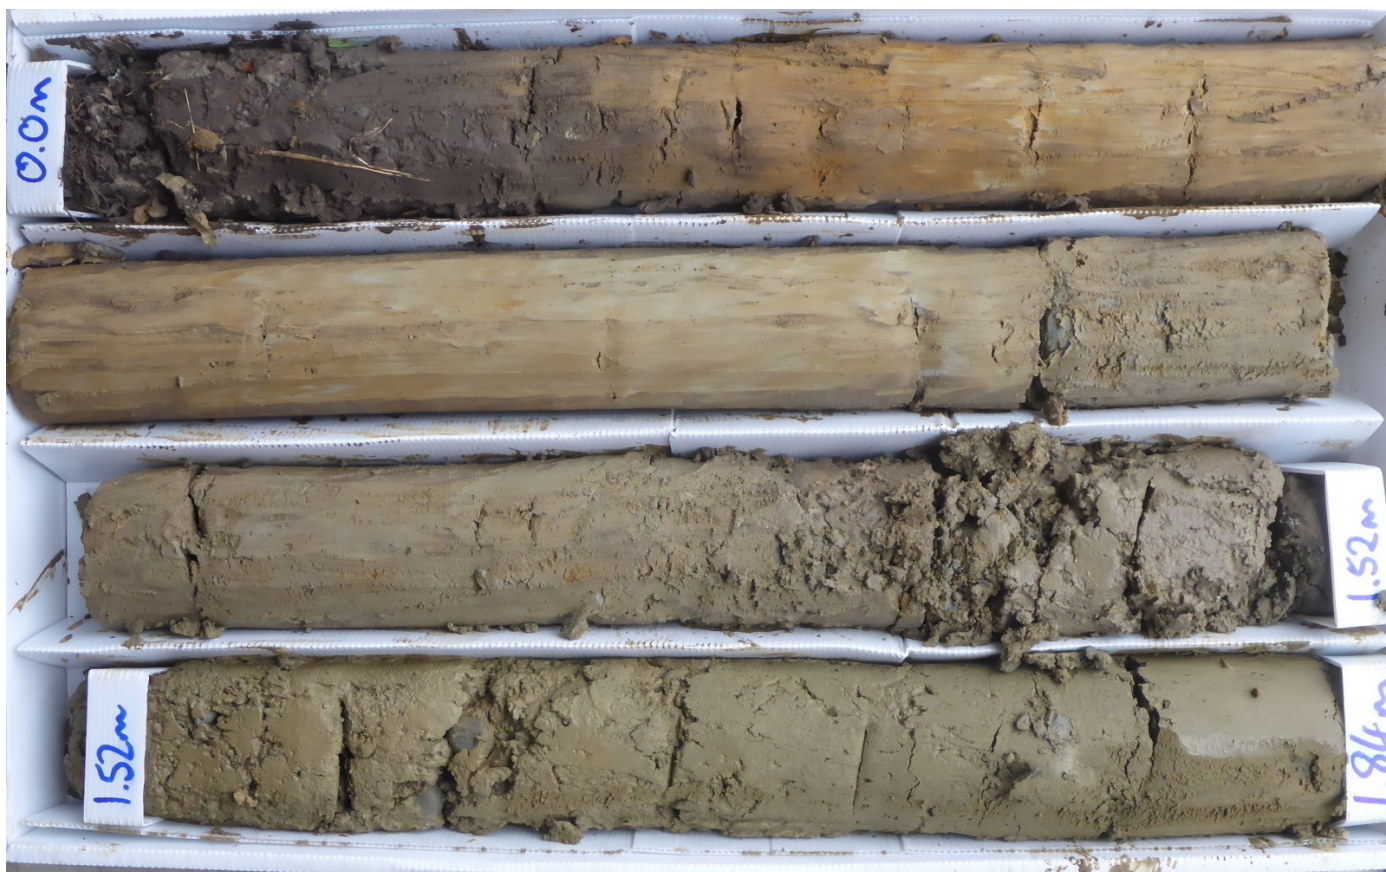
<b>Date:</b>	17-18 DEC 2018	
<b>Notes:</b>	1. Drill sampling method: McMillan SONIC Geoprobe 8140LC (150Hz) 2. Markers: start/end of run and SPT split-spoon sample in metres; "CL" indicates core loss in metres; brackets indicate run split between boxes; SPT blows/75mm.	<b>Box No(s).</b>	7 and 8 of 8	
		<b>Depth from (m):</b>	12.16m	
		<b>Depth To (m):</b>	15.20m	
<b>Project No.</b>	170743	<b>Interval (m):</b>	3.04m

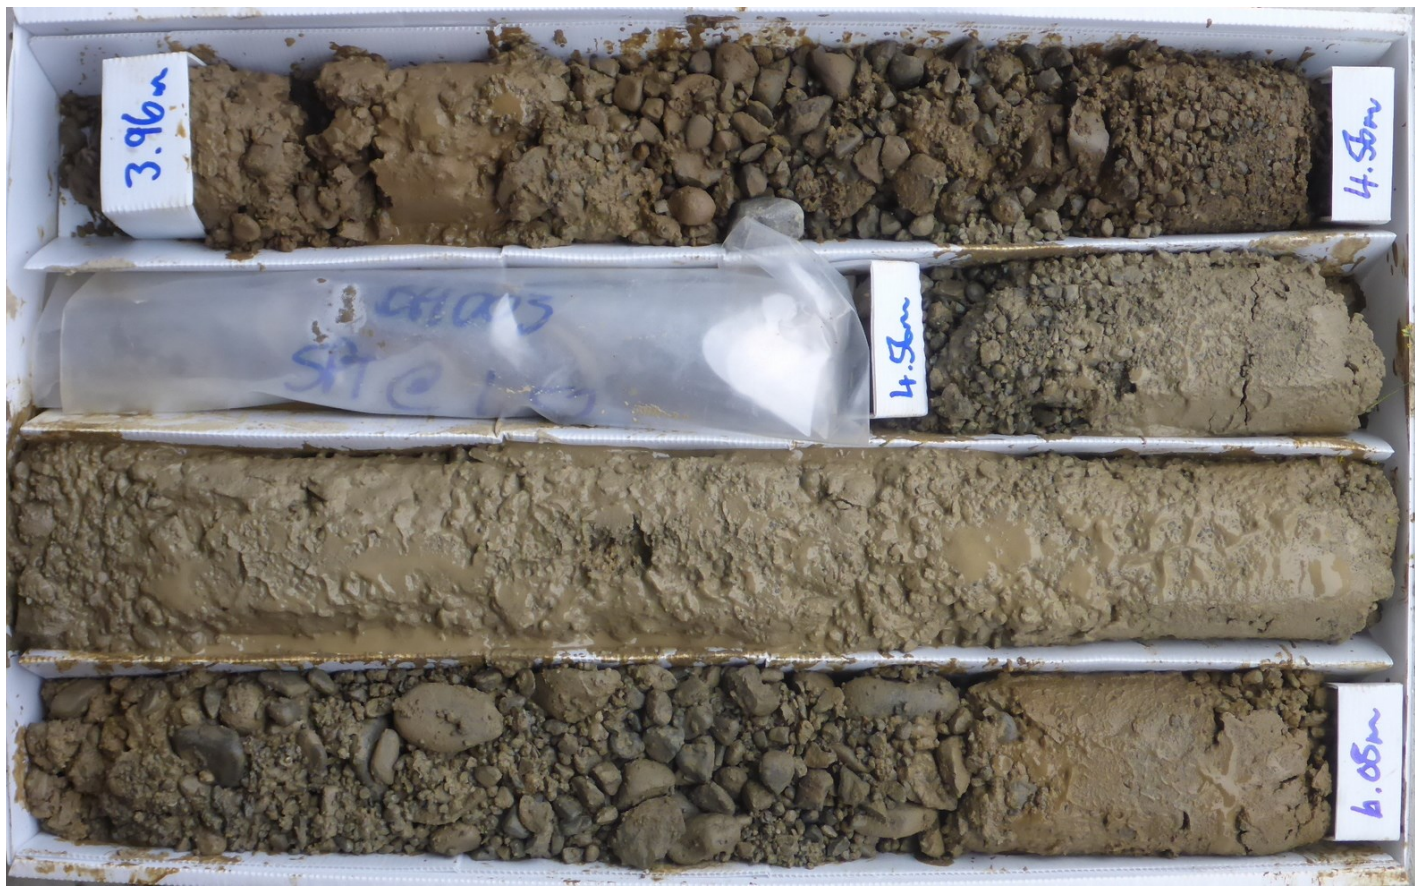
<b>Date:</b>	18 DEC 2018	
<b>Notes:</b>	1. Drill sampling method: McMillan SONIC Geoprobe 8140LC (150Hz) 2. Markers: start/end of run and SPT split-spoon sample in metres; "CL" indicates core loss in metres; brackets indicate run split between boxes; SPT blows/75mm.	<b>Box No(s).</b>	1 and 2 of 3	
		<b>Depth from (m):</b>	0.00m	
		<b>Depth To (m):</b>	3.96m	
<b>Project No.</b>	170743	<b>Interval (m):</b>	3.96m

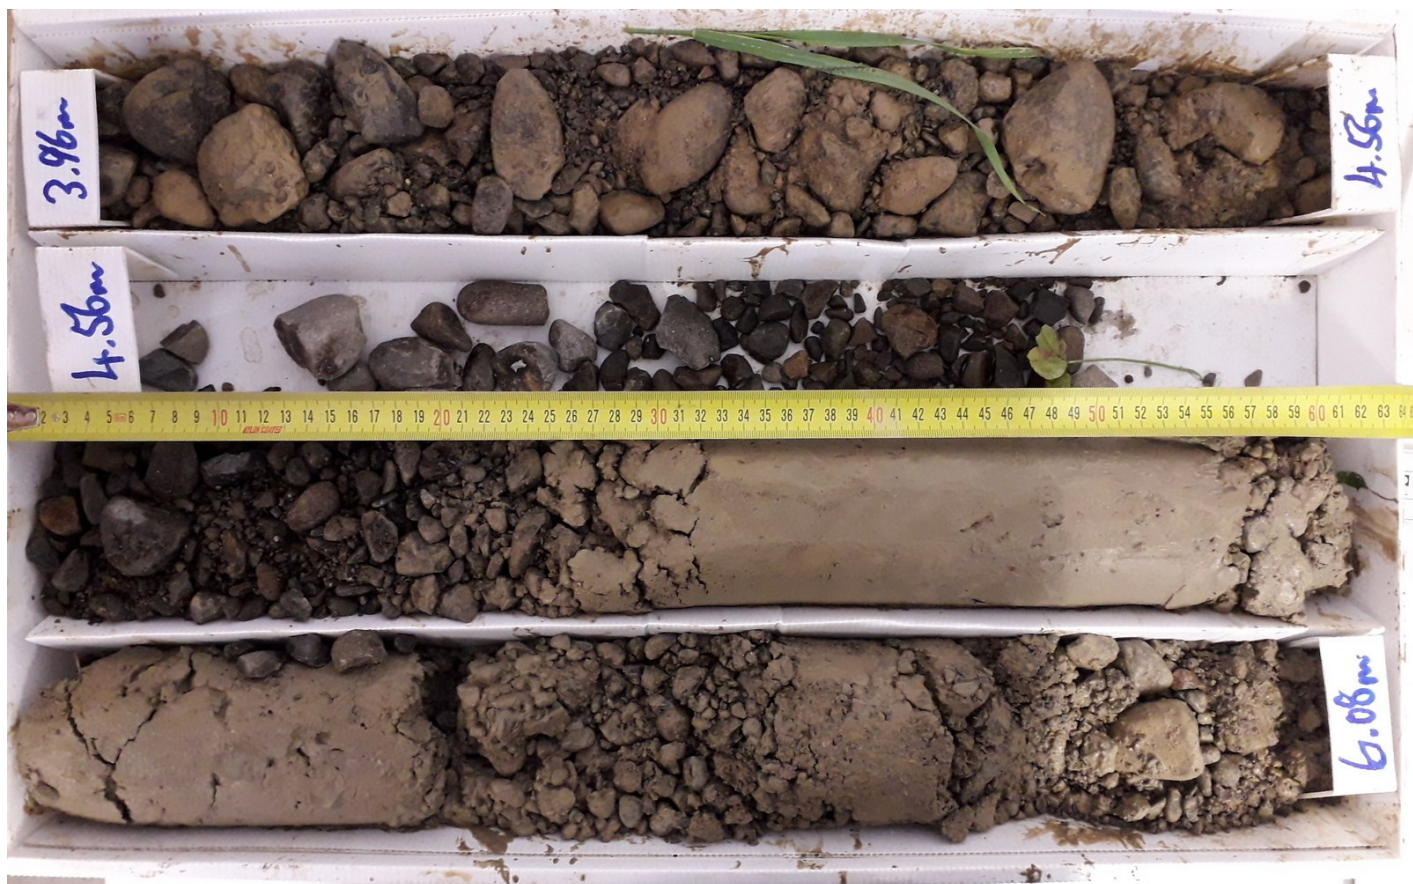
<b>Date:</b>	20 DEC 2018	
<b>Notes:</b>	1. Drill sampling method: McMillan SONIC Geoprobe 8140LC (150Hz) 2. Markers: start/end of run and SPT split-spoon sample in metres; "CL" indicates core loss in metres; brackets indicate run split between boxes; SPT blows/75mm.	<b>Box No(s).</b>	1 and 2 of 3	
		<b>Depth from (m):</b>	0.00m	
		<b>Depth To (m):</b>	3.96m	
<b>Project No.</b>	170743	<b>Interval (m):</b>	3.96m

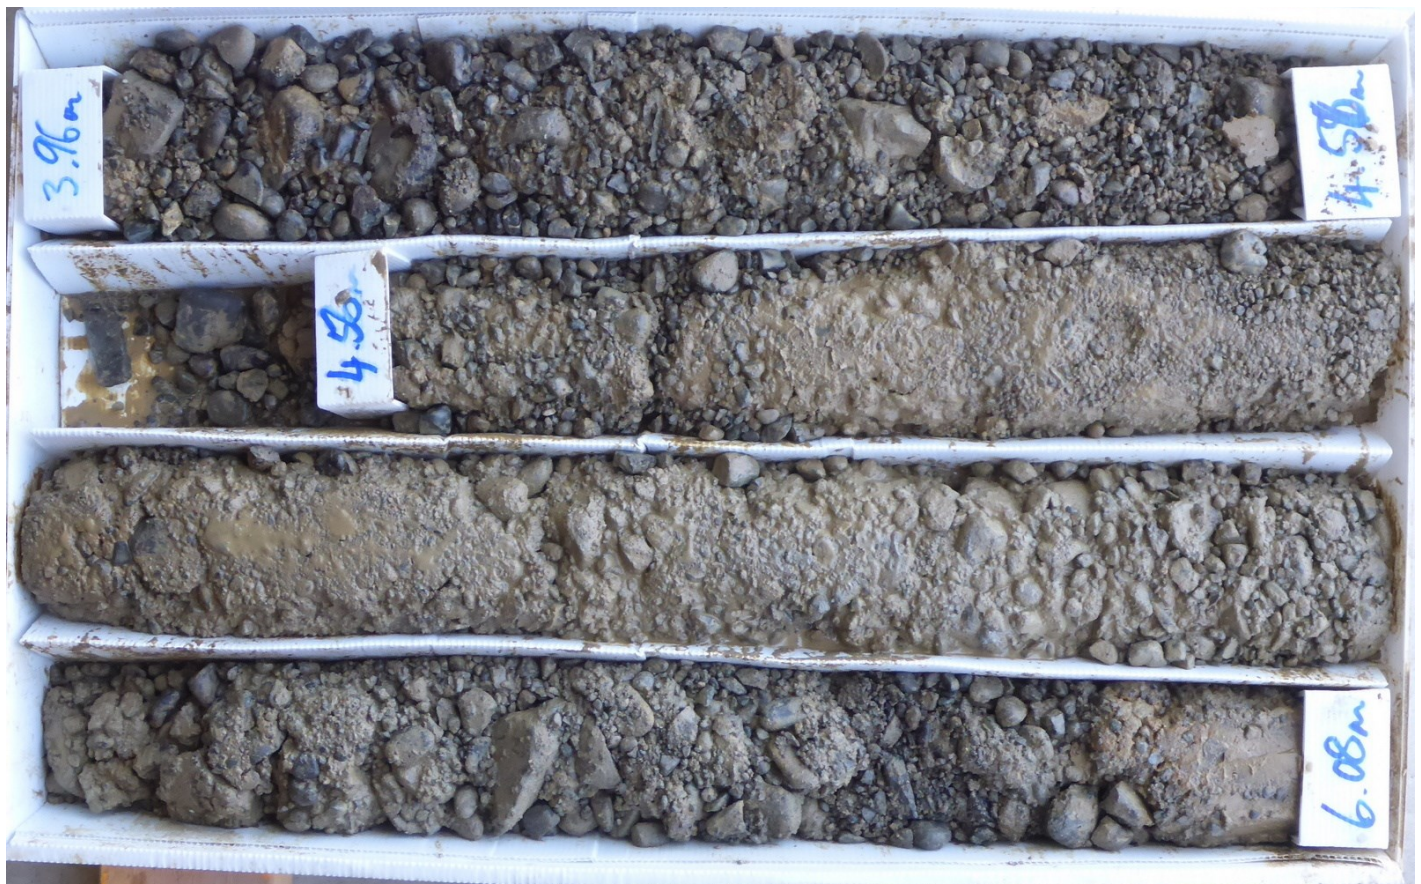
<b>Date:</b>	19 DEC 2018	
<b>Notes:</b>	1. Drill sampling method: McMillan SONIC Geoprobe 8140LC (150Hz) 2. Markers: start/end of run and SPT split-spoon sample in metres; "CL" indicates core loss in metres; brackets indicate run split between boxes; SPT blows/75mm.	<b>Box No(s).</b>	1 and 2 of 3	
		<b>Depth from (m):</b>	0.00m	
		<b>Depth To (m):</b>	3.96m	
<b>Project No.</b>	170743	<b>Interval (m):</b>	3.96m

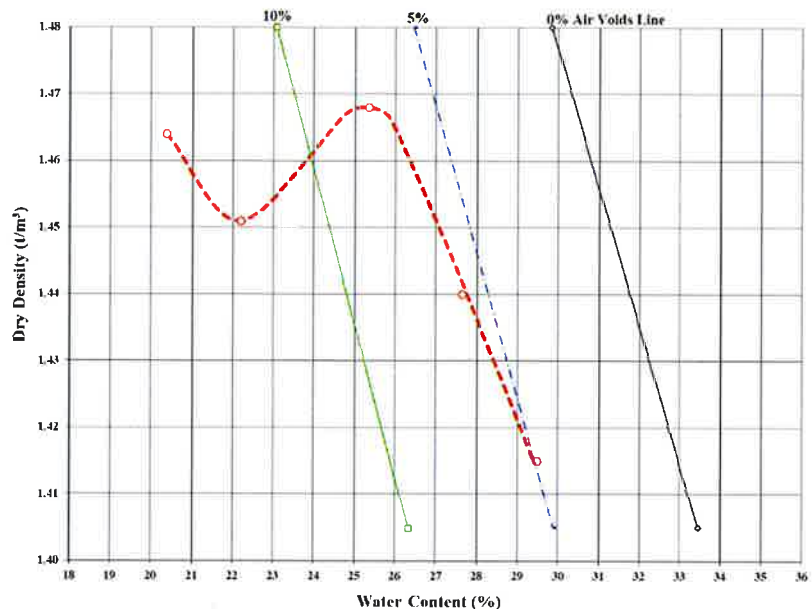
- The sample was received in a natural state.
- The material tested in the NZ Standard Compaction test was the fraction passing a 19.0mm test sieve.
- The air voids lines were calculated from an assumed solid density of 2.65 t/m<sup>3</sup>.

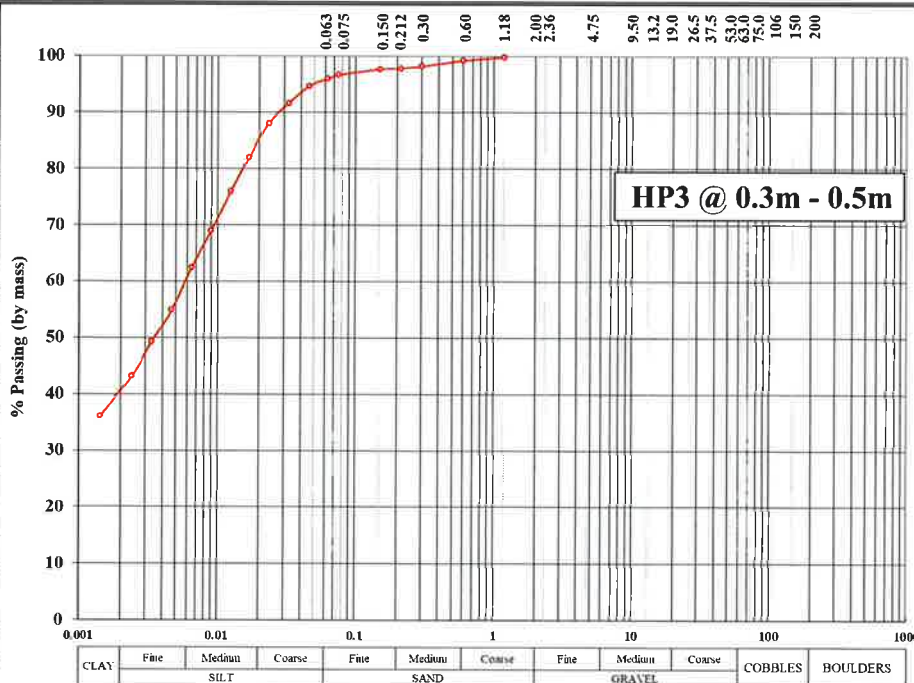
Fraction Size	Interpolated % Passing
60 µm	96
20 µm	85
6 µm	60
2 µm	40

The sample was received in a natural state. The percentage passing the 63µm test sieve was obtained by difference. The pH of the hydrometer suspension was 9.5. Sodium hexametaphosphate was used as a dispersant.

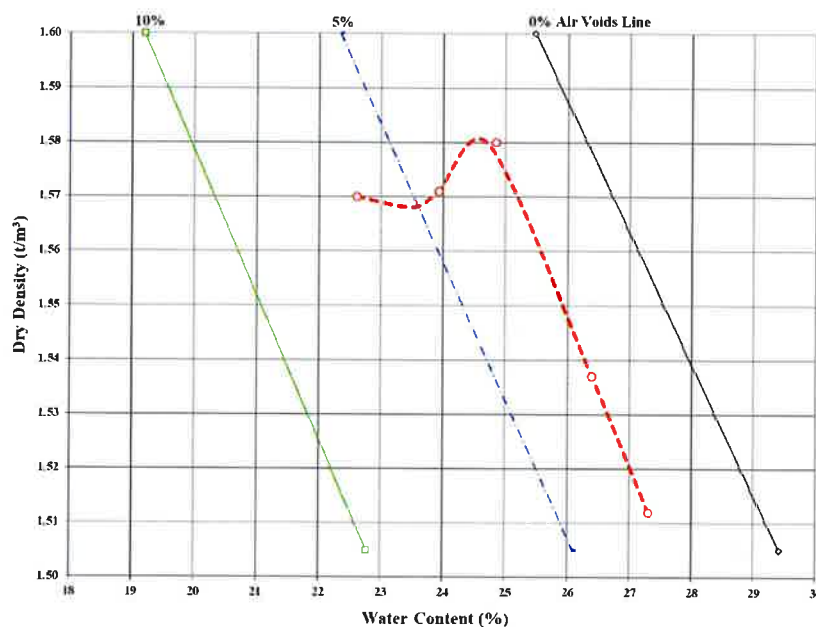
- The sample was received in a natural state.
- The material tested in the NZ Standard Compaction test was whole soil.
- The air voids lines were calculated from an assumed solid density of 2.70 t/m<sup>3</sup>.

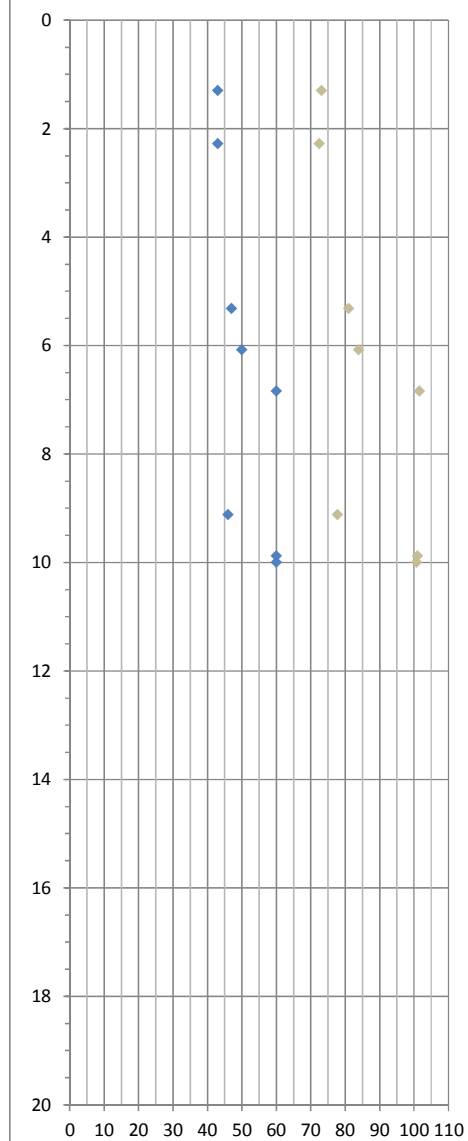
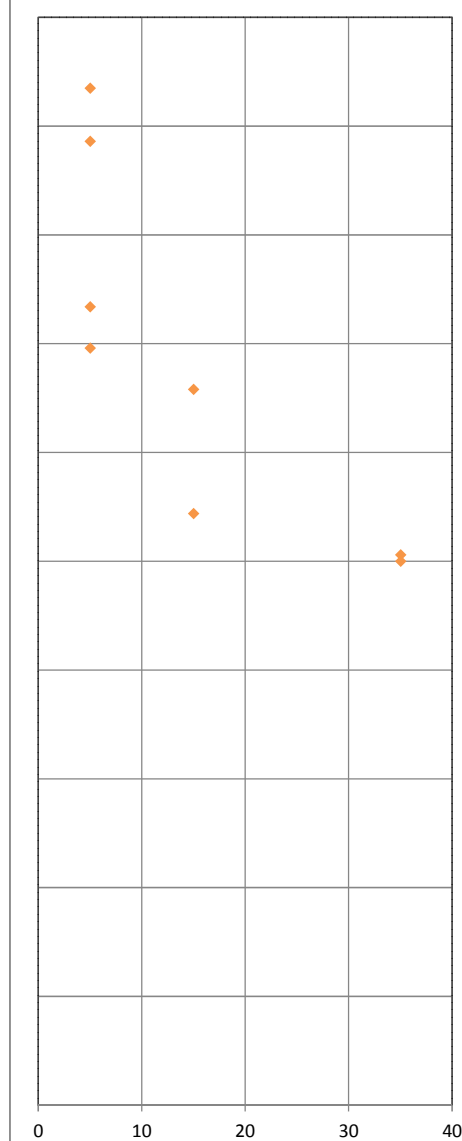
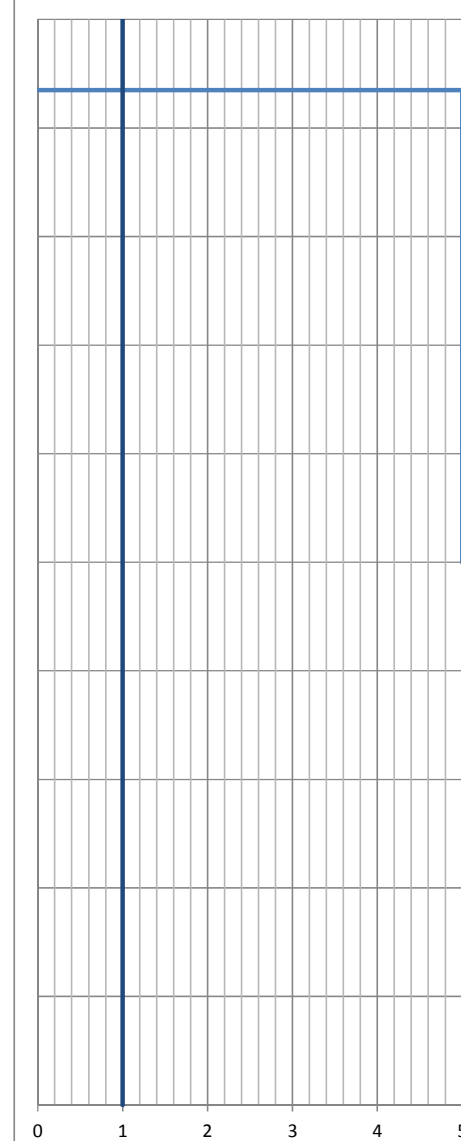
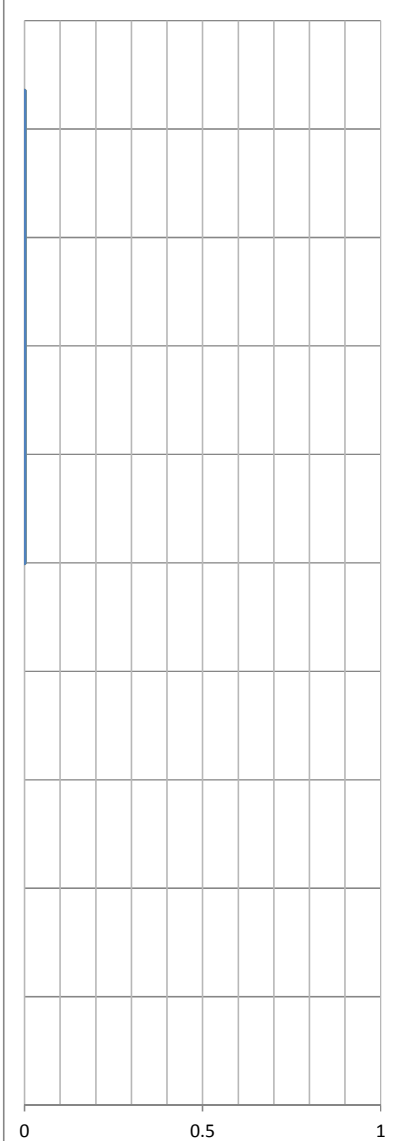
Test: **170743** File: BH2  
Project: Summerset Rangiora  
Water table depth: 1.3 m

**SPT N, (N<sub>1</sub>)<sub>60-CS</sub>**

**Fines Content (%)**

**Factor of Safety (Liquefaction triggering)**

**Settlement, S (mm)**

In accordance with the MBIE Guidelines, for a foundation technical category (TC) of TC1 to be applied, the SLS index settlement must be <15mm, and ULS index settlement <25mm. A review of the liquefaction analysis results indicates a TC1 classification is appropriate for the site.

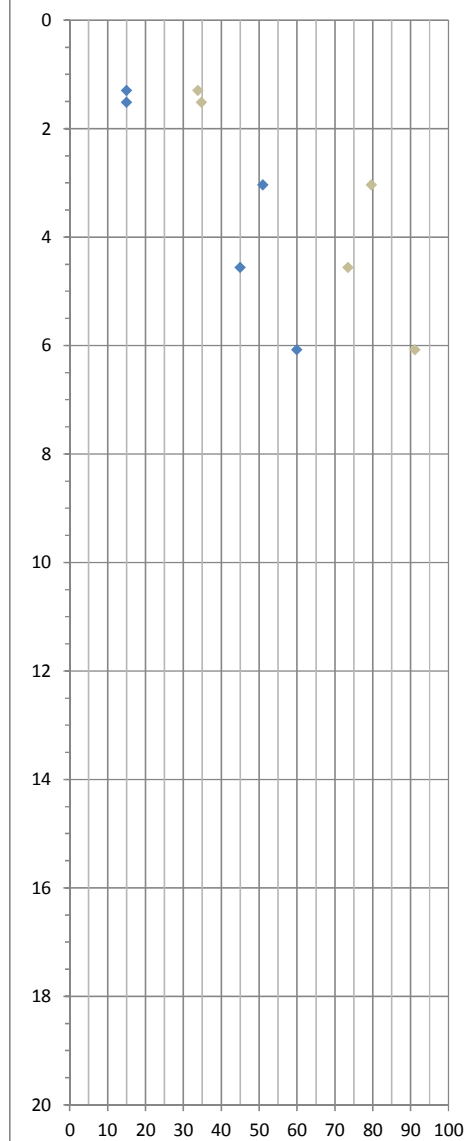
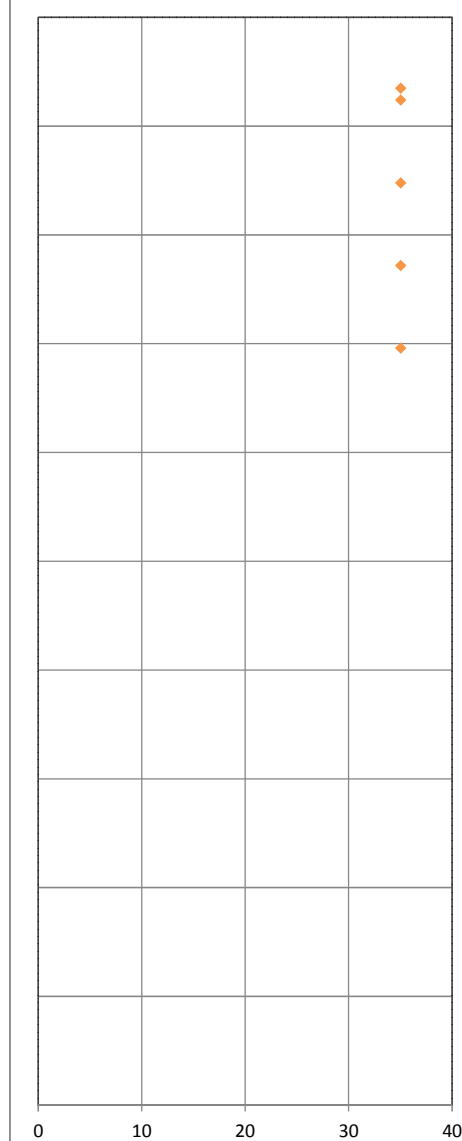
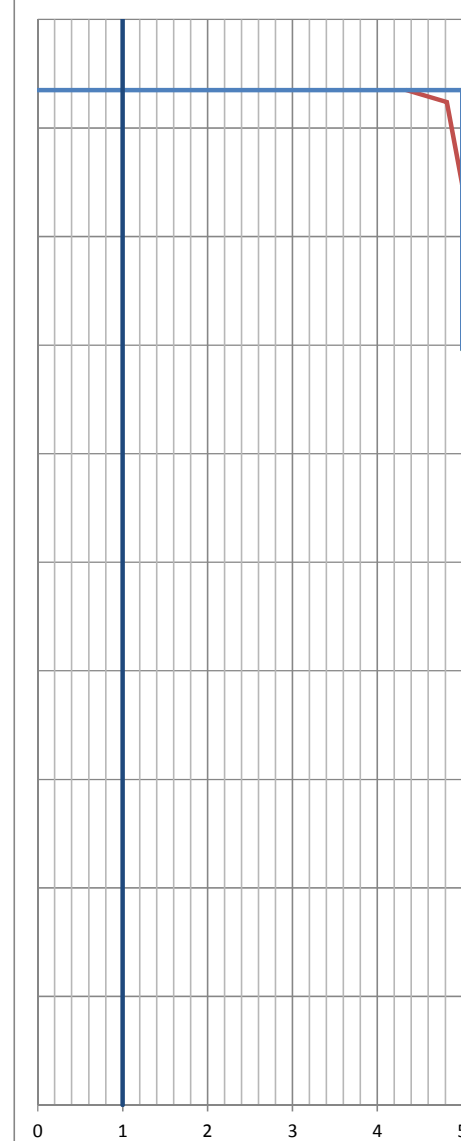
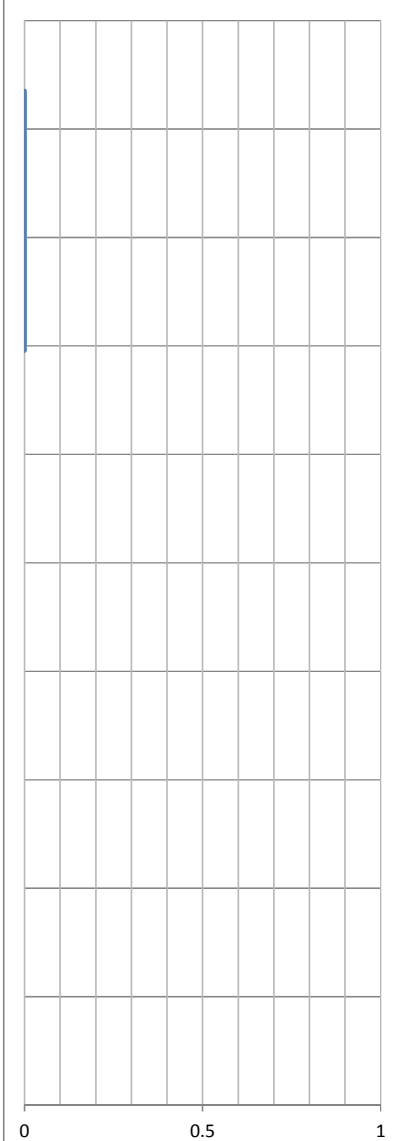
Test: **BH4** File: 170743  
Project: Summerset Rangiora  
Water table depth: 1.3 m

**SPT N, (N<sub>1</sub>)<sub>60-CS</sub>**

**Fines Content (%)**

**Factor of Safety (Liquefaction triggering)**

**Settlement, S (mm)**
