**GEOTECHNICAL ASSESSMENT  
TO SUPPORT PROPOSED  
PLAN CHANGE  
104 TOWNSEND ROAD  
AND 141 SOUTH BELT  
WAIMAKARIRI, RANGIORA**

**Report prepared for:** Summerset Villages (Rangiora) Limited

**Report reference:** 170743-C

**Date:** 15 October 2019

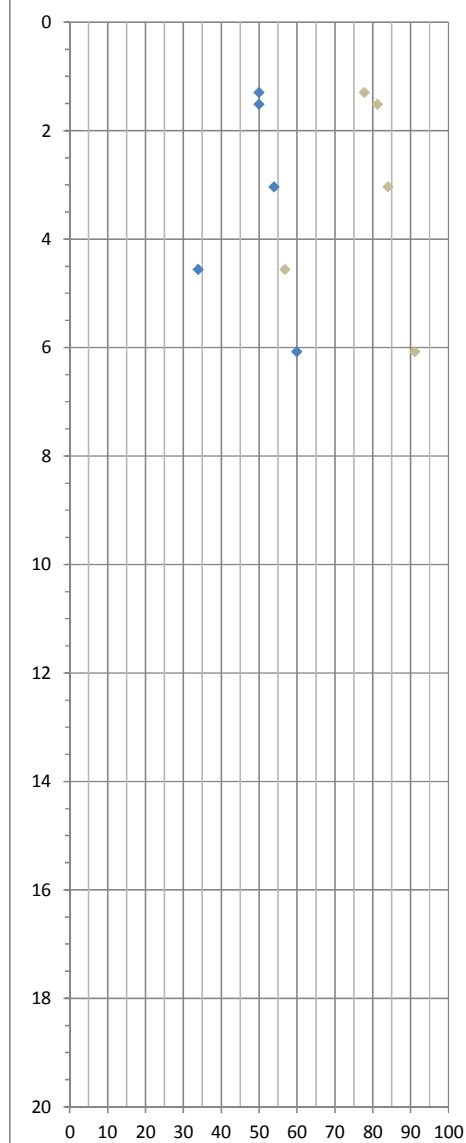
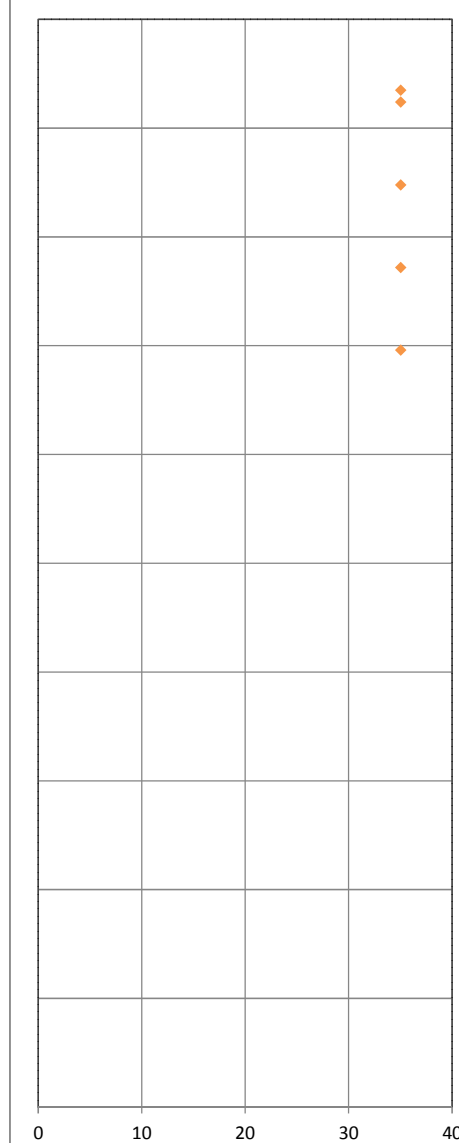
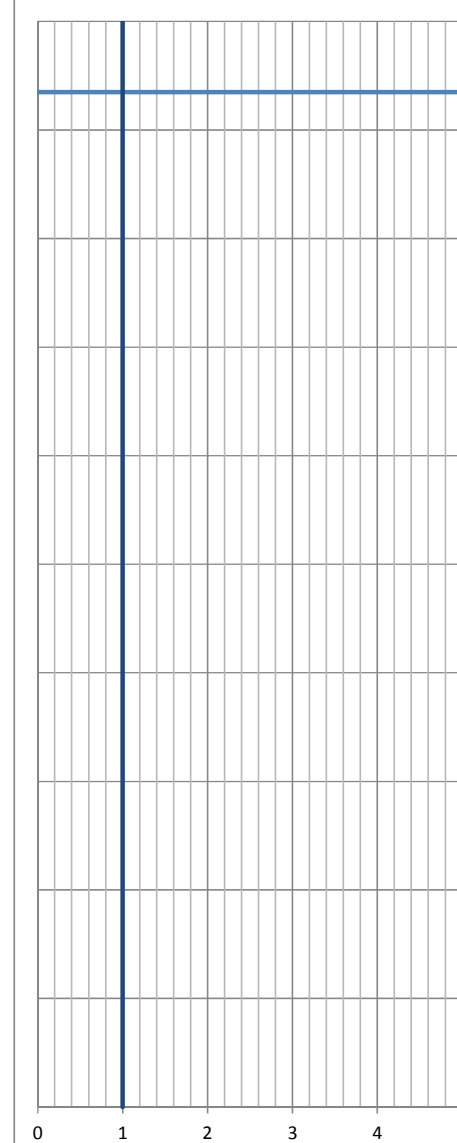
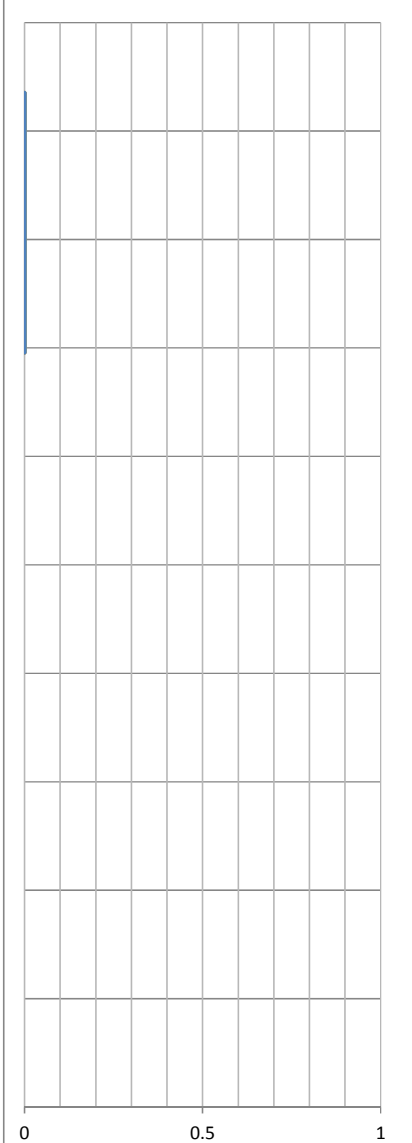
Test: **BH6** File: 170743  
Project: Summerset Rangiora  
Water table depth: 1.3 m

**SPT N, (N<sub>1</sub>)<sub>60-CS</sub>**

**Fines Content (%)**

**Factor of Safety (Liquefaction triggering)**

**Settlement, S (mm)**

In accordance with the MBIE Guidelines, for a foundation technical category (TC) of TC1 to be applied, the SLS index settlement must be <15mm, and ULS index settlement <25mm. A review of the liquefaction analysis results indicates a TC1 classification is appropriate for the site.

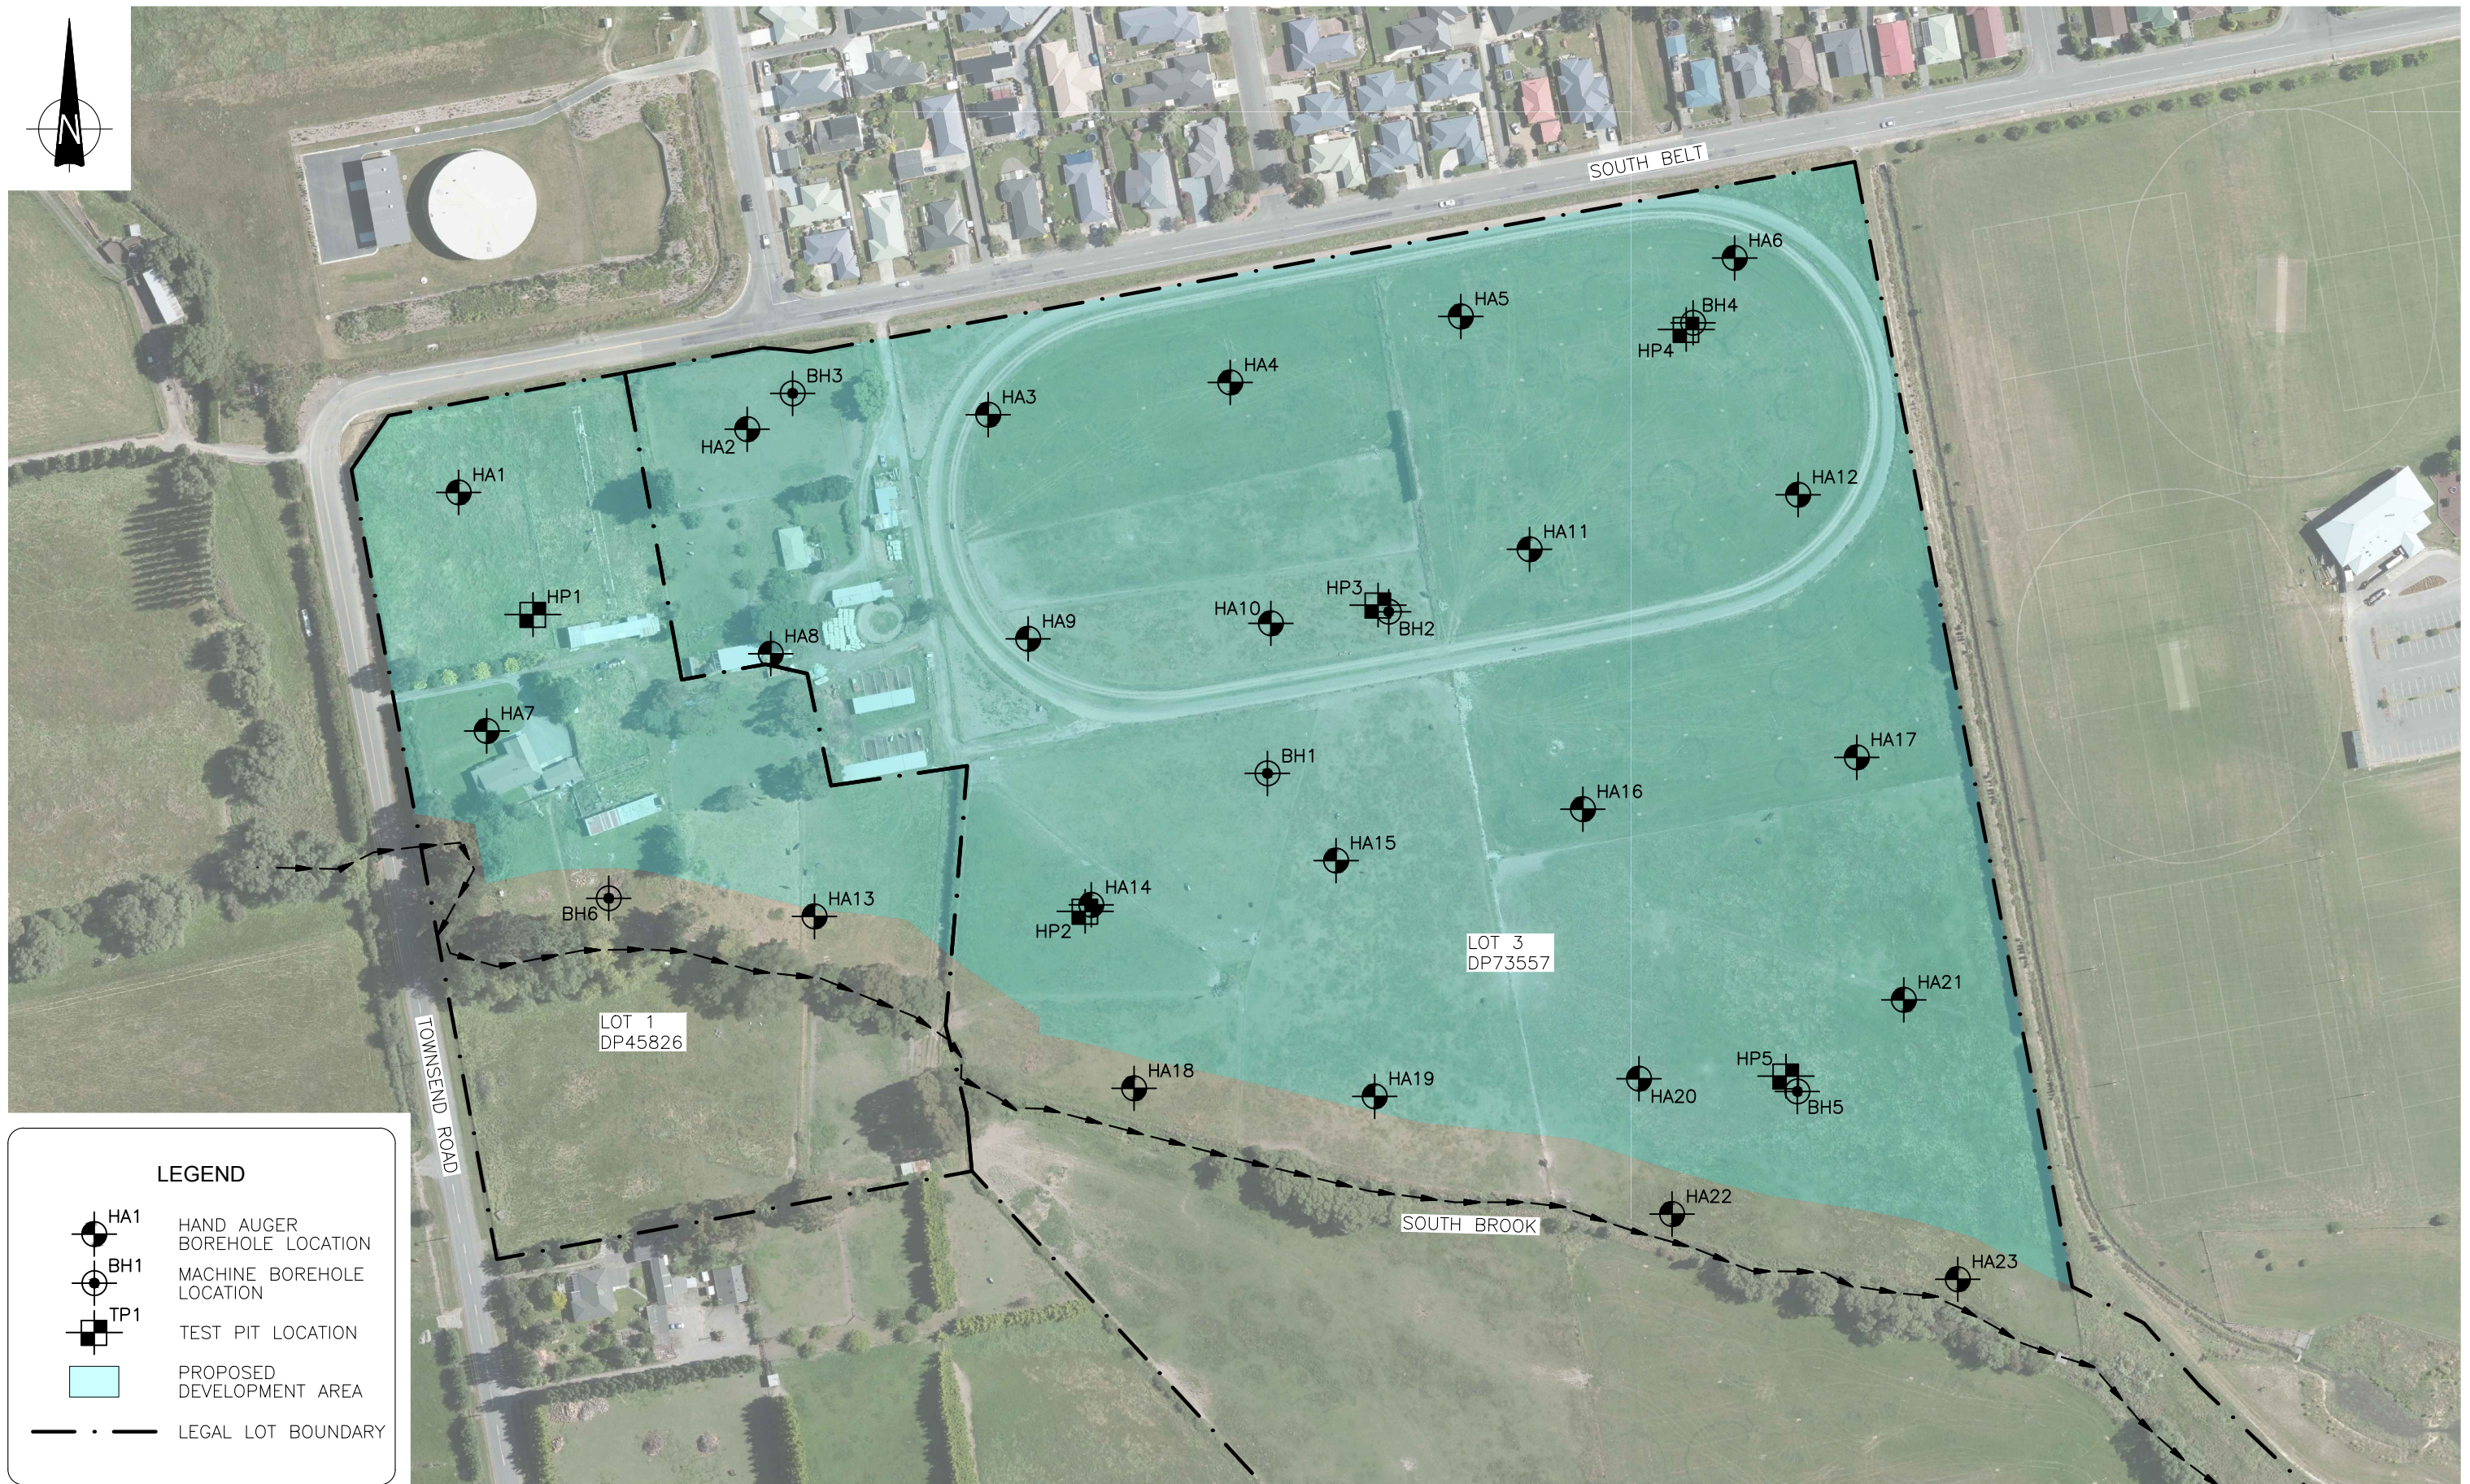
### ***Drawing***

HA1 HAND AUGER BOREHOLE LOCATION
