# Proposed Waimakariri District Plan - Submission

The Rural Lifestyle Zone proposed for our property at Mandeville, and statements of Plan objectives and policies for the rural residential area and the Large Lot Residential Zone. Please refer to the attached reports for full details of the property, the matters covered by the submission, and the reasons. The attached reports are set out at the end of the submission.

# Geotechnical Report

**81 Gressons Road and 1375 Main North  
Road, Waikuku**

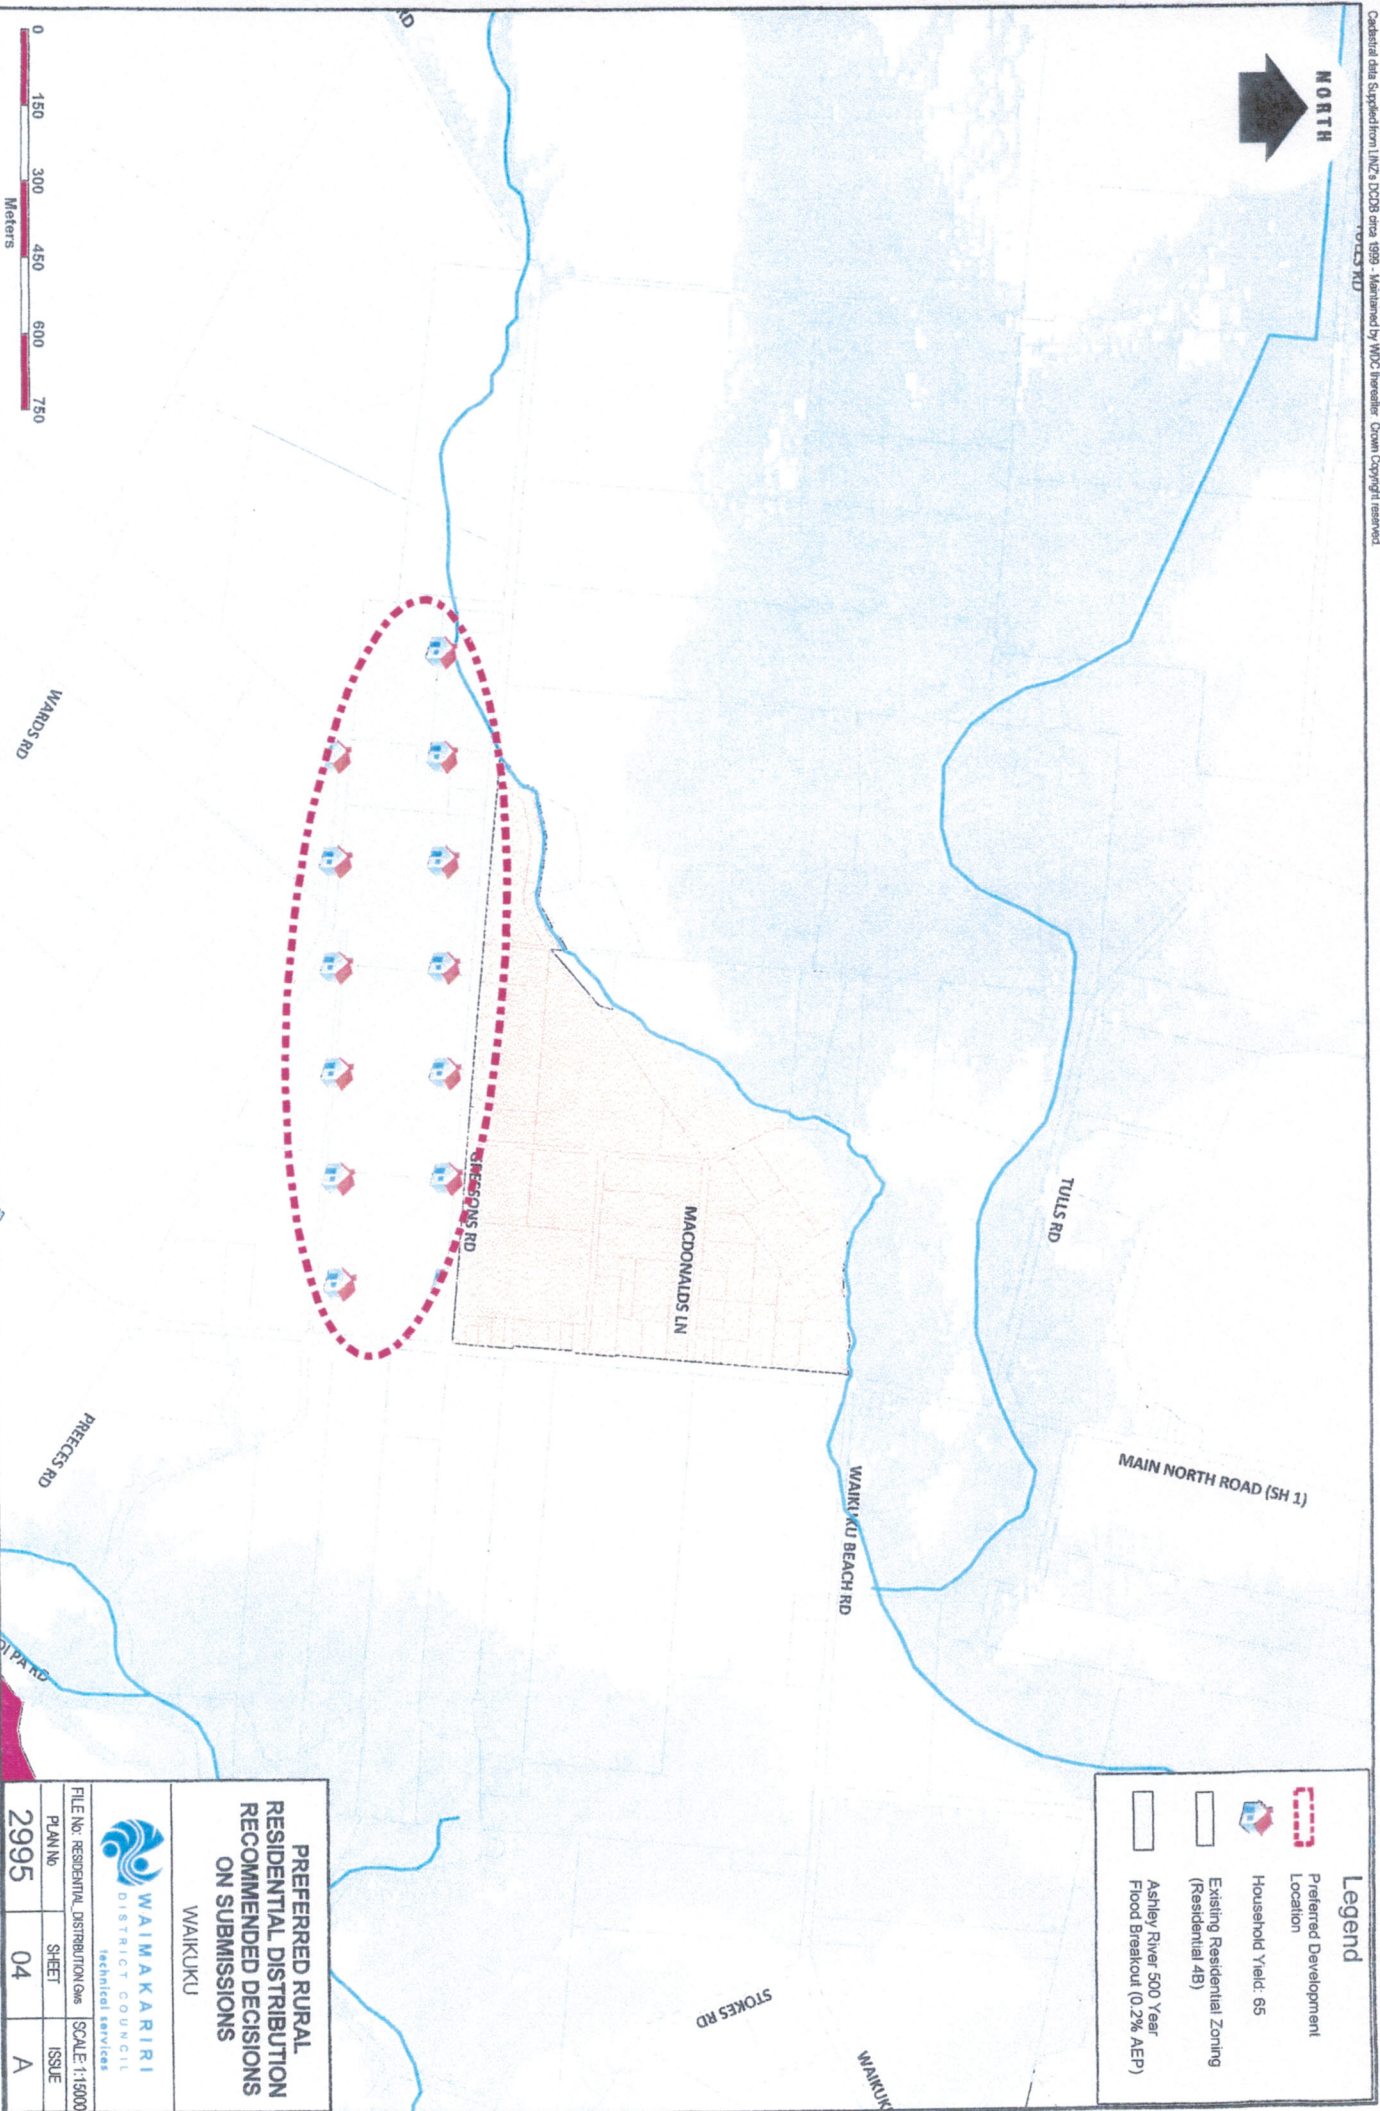
**RURAL-RESIDENTIAL DEVELOPMENT PLAN (2010)**

- Preferred Development Location
- Household Yield: 65
- Existing Residential Zoning (Residential 4B)
- Ashley River 500 Year Flood Breakout (0.2% AEP)

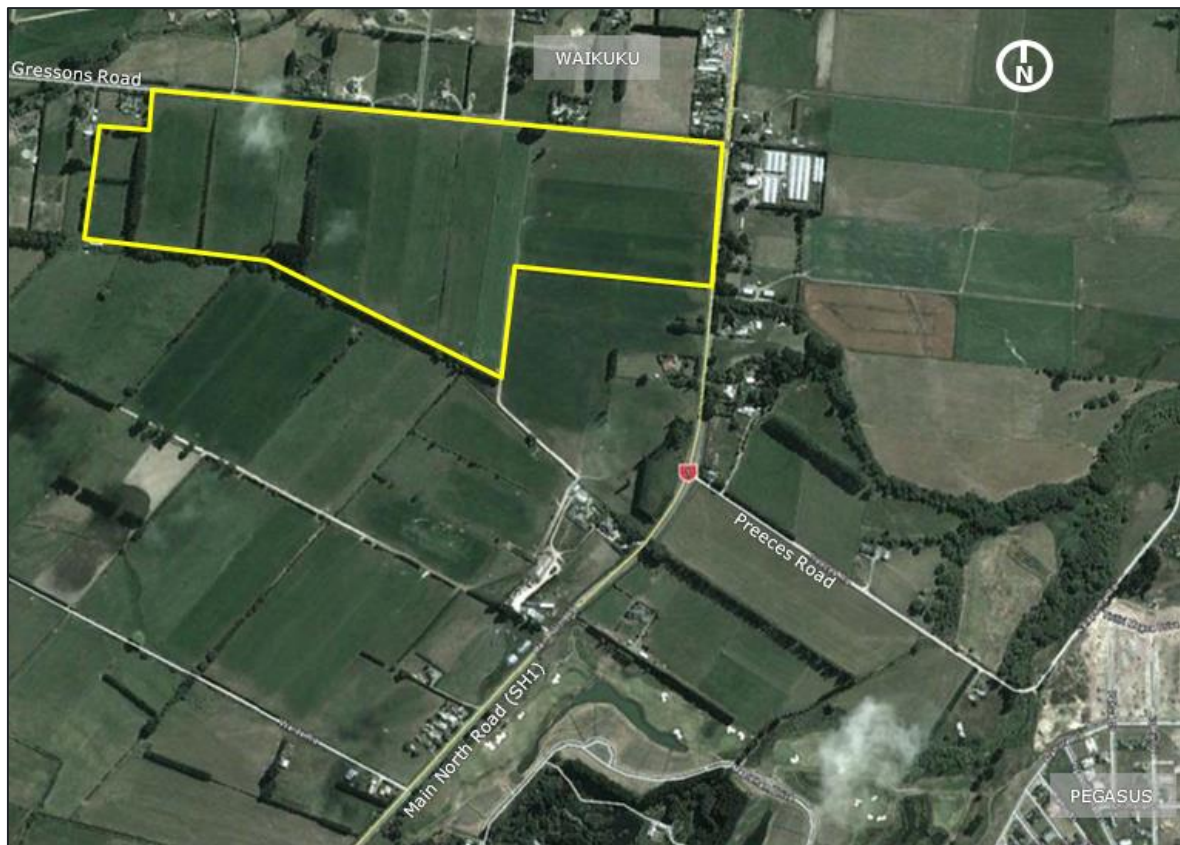
**Figure 1: Site Location (yellow outline)**

The Site is located at the corner of Gressons Road and Main North Road (SH1) and has a gross area of approximately 34 ha (refer to Figure 1).

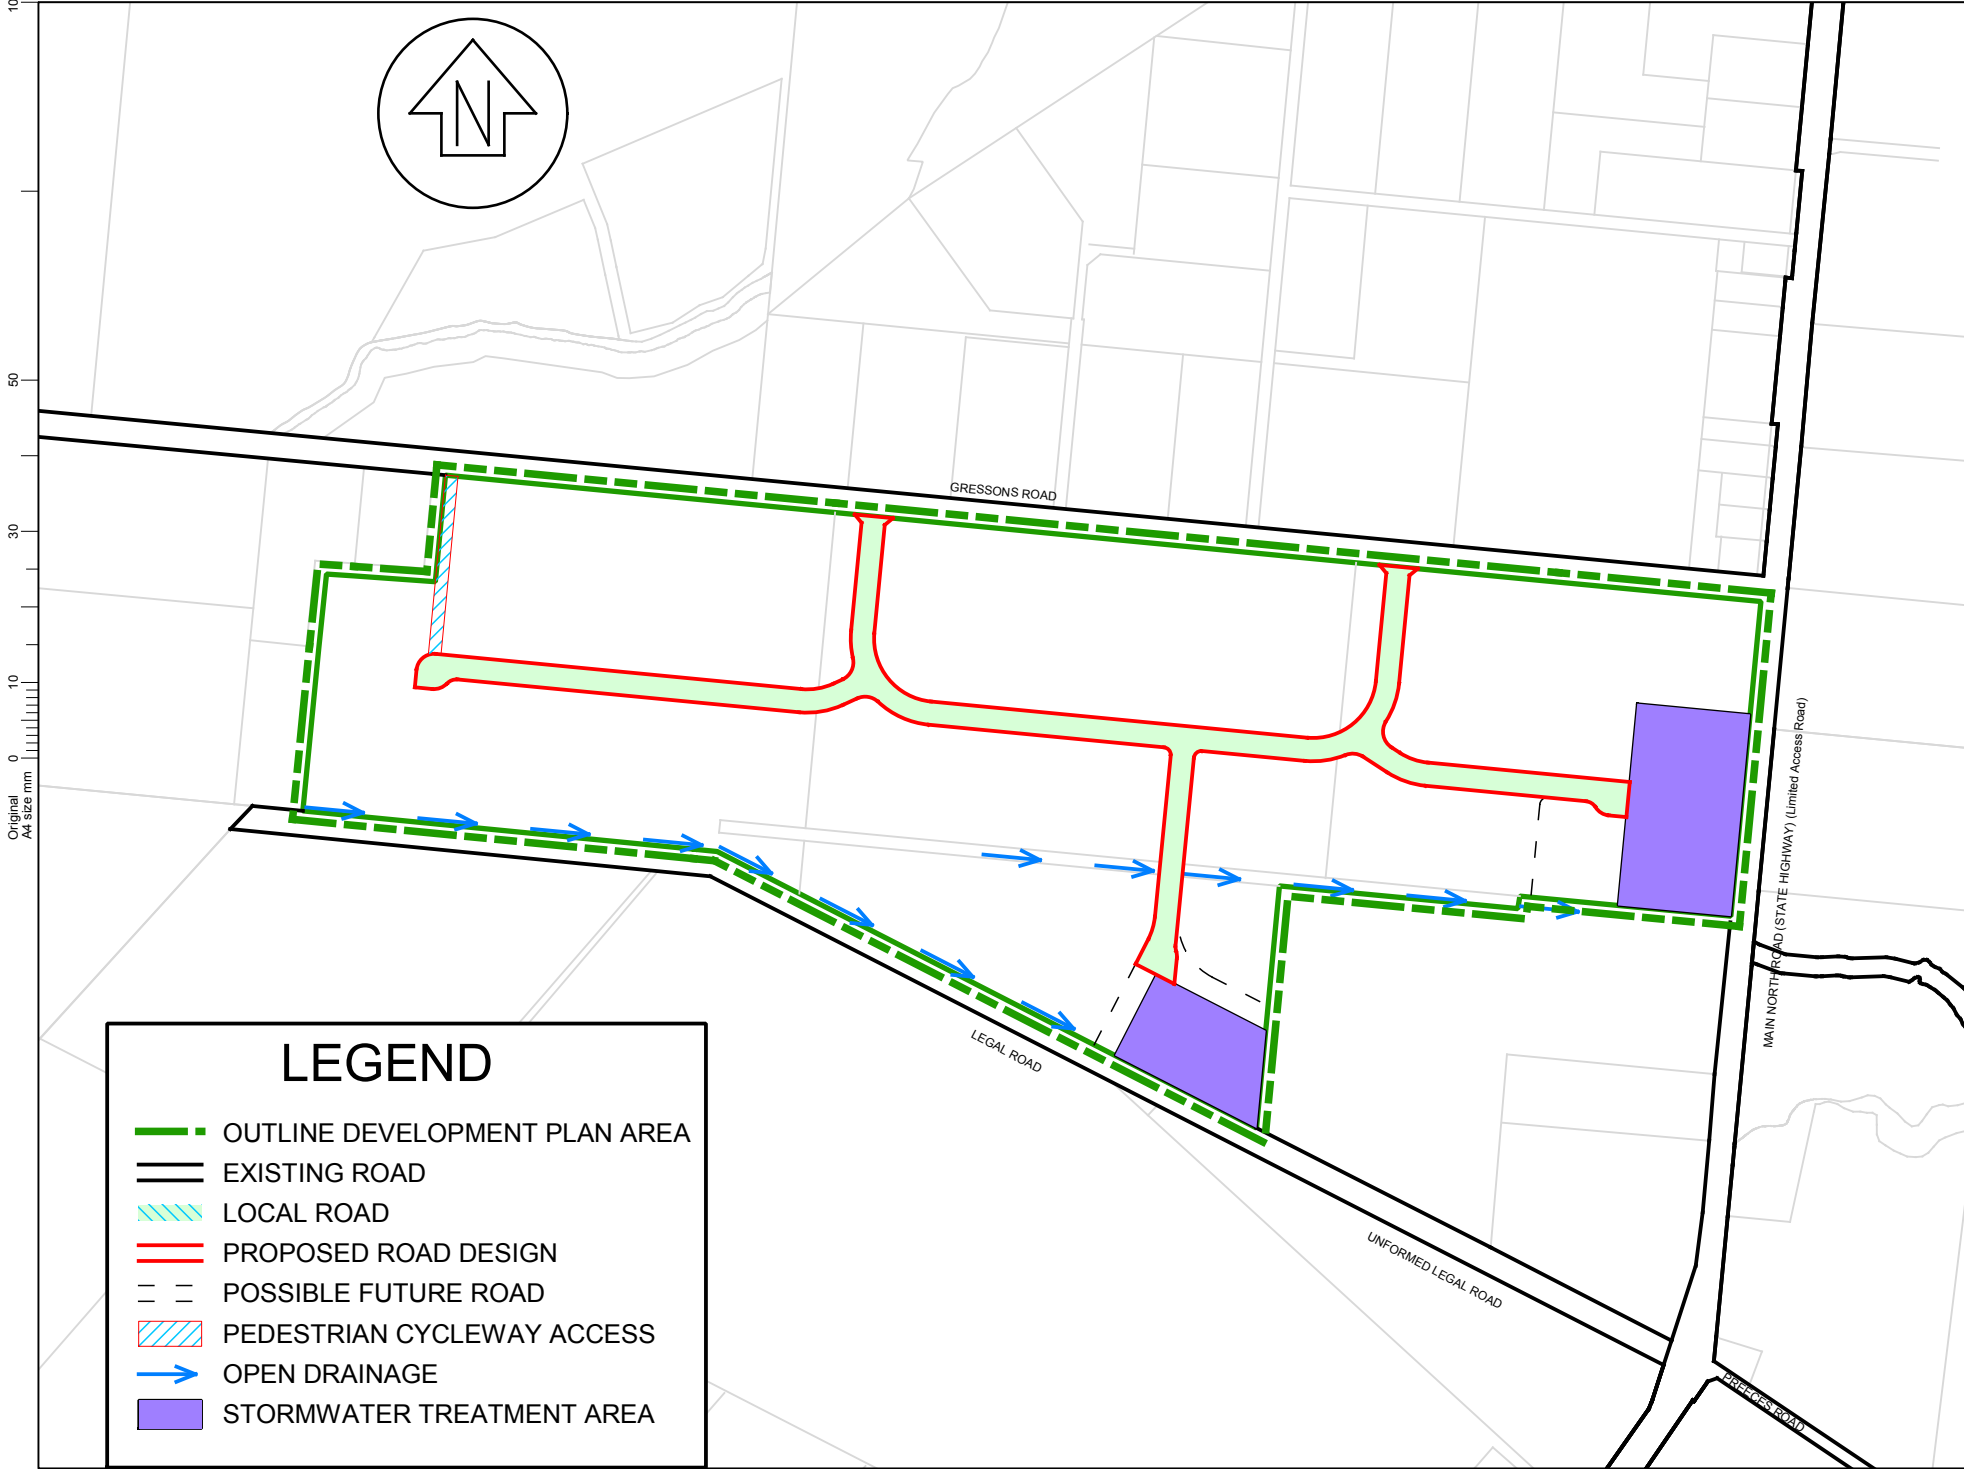
**OUTLINE DEVELOPMENT PLAN**

- OUTLINE DEVELOPMENT PLAN AREA
- EXISTING ROAD
- LOCAL ROAD
- PROPOSED ROAD DESIGN
- POSSIBLE FUTURE ROAD
- PEDESTRIAN CYCLEWAY ACCESS
- OPEN DRAINAGE
- STORMWATER TREATMENT AREA

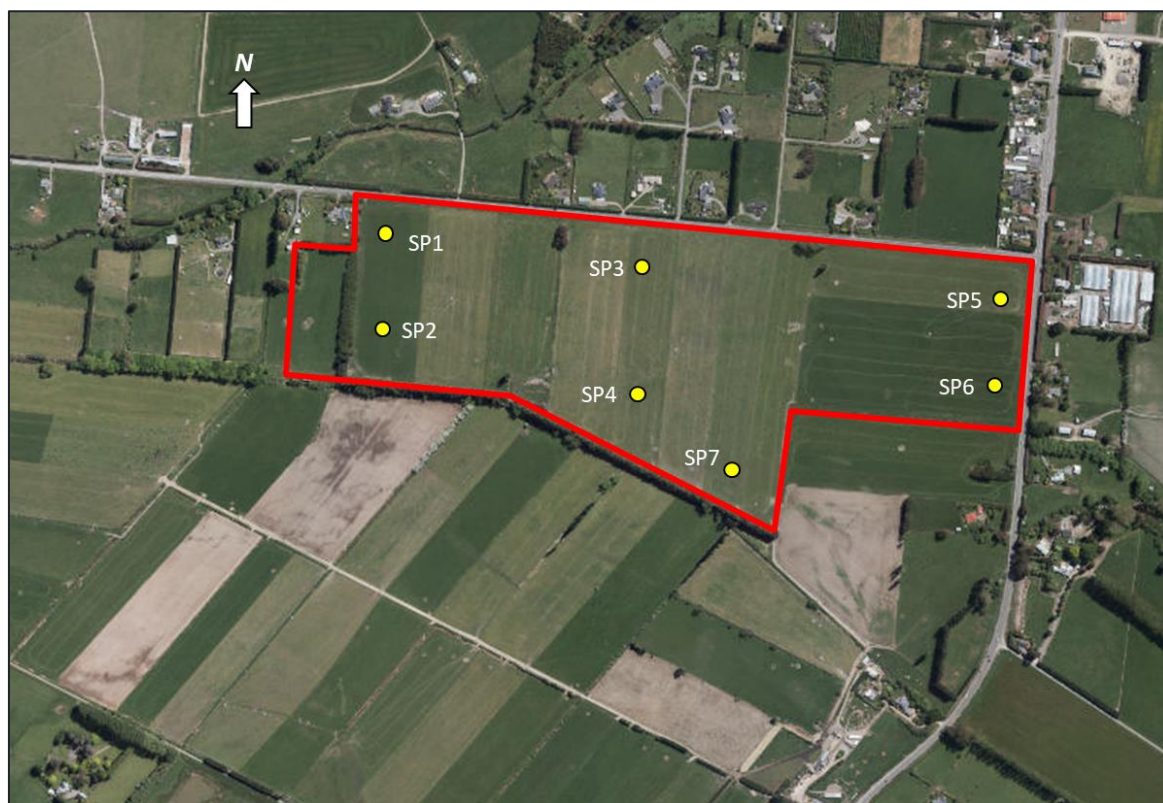
**Figure 2: Groundwater Monitoring Standpipe Locations**

Seven standpipes have been installed across the Site and groundwater levels were monitored on a monthly basis between June 2013 and October 2017. Figure 2 shows the standpipe locations and Table 1 provides an analysis of the groundwater monitoring data.

The groundwater depth across the Site fluctuates seasonally and generally the highest level was recorded in the western monitoring wells. Potentially, the highest groundwater monitoring data (shown in row 1 of the above table) is not accurate and there may have been water (or rainfall) infiltration into the standpipes giving a false result. It was noted that during some monitoring periods, especially after rainfall some wells indicated a groundwater near the surface while other suggested it was 1 m bgl. It is considered that the 15<sup>th</sup> and 85<sup>th</sup> percentile groundwater records should be used for groundwater depth measurements. The average annual groundwater depth across the full site is 1.10 m bgl.

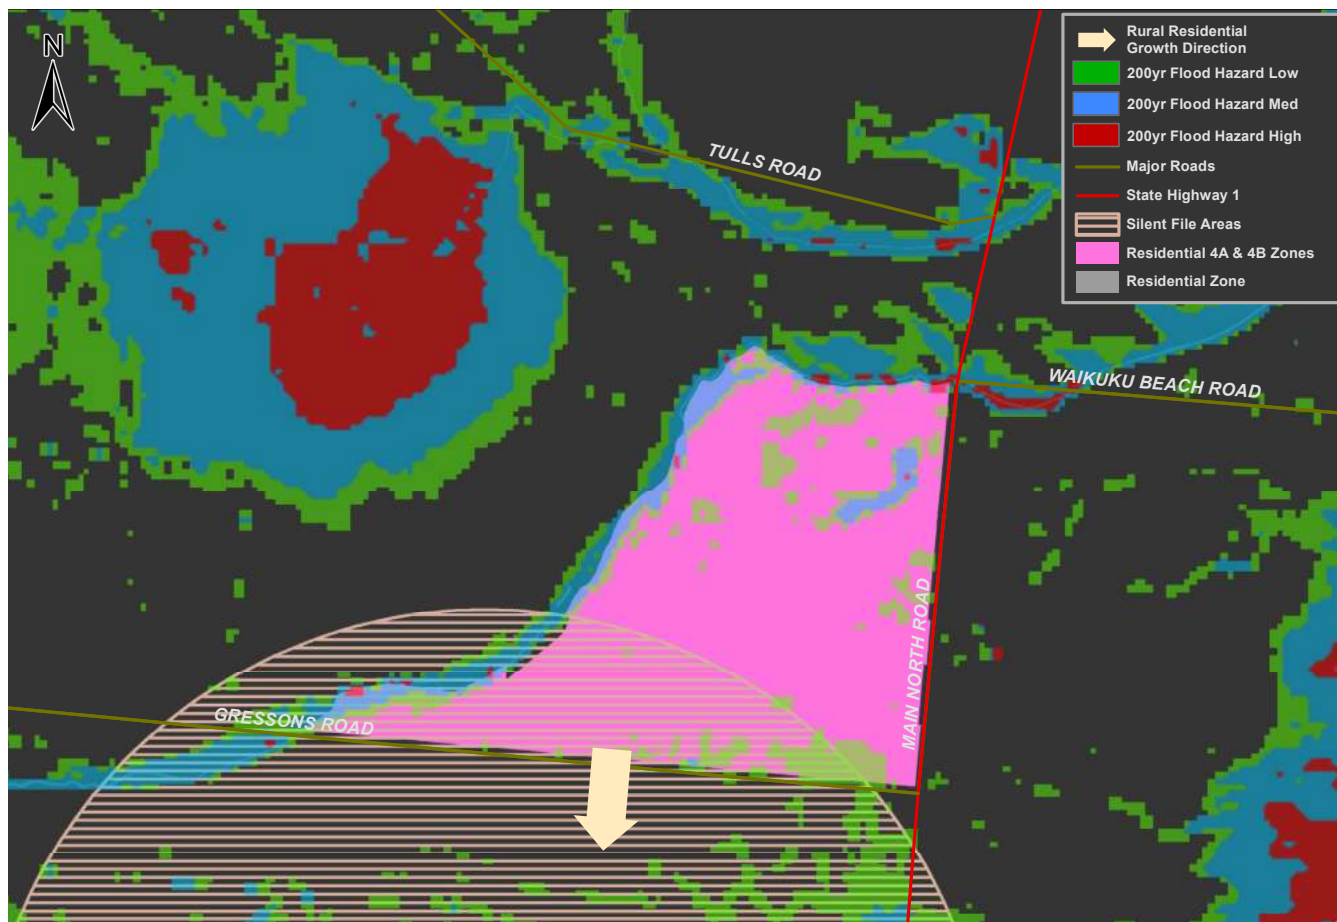
Figure 10: Gressons Road rural residential growth direction

This area is relatively free from localised flood hazard and avoids the potential community severance associated with State Highway 1. It also allows a greater level of integration with the existing settlement via Gressons Road. The key underlying landowner is in support of rural residential development at this site.

It is acknowledged the growth direction is within a Silent File Area indicating the presence of significant wāhi tapu or wāhi taonga somewhere in the area. Therefore, consultation with Ngāi Tūāhuriri is particularly important in order to identify effects of the activity and to avoid, remedy or mitigate those effects. It is also acknowledged that the growth direction does impact land with versatile soils.

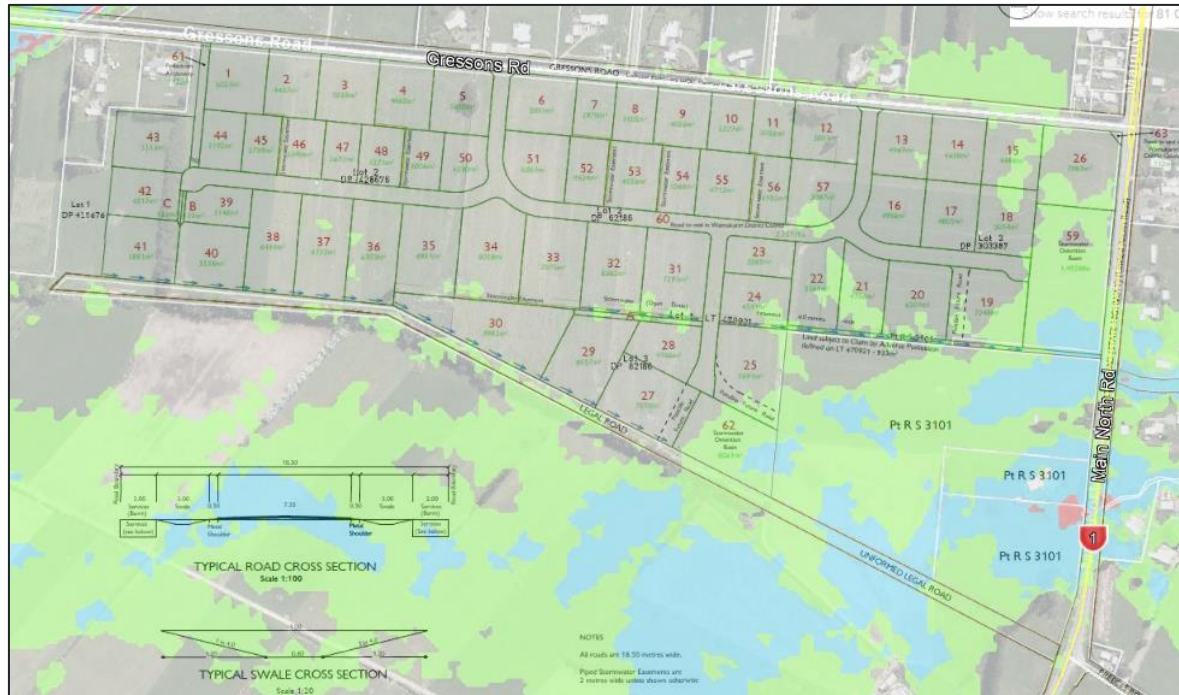
**Figure 4. 200 Year Ashley River Floodplain Mapping (WDC, 2020)**

Figure 4, shows an overlay of the proposed subdivision plan and the Waimakariri District Council (WDC or "the Council") 200 year flood hazard map (WDC 2020). The flood hazard map incorporates the combined output of the 200 year localised rainfall, Ashley River Breakout and coastal flooding. Green shaded areas indicate a low hazard flood depth of less than 0.3 m and blue shaded areas indicate medium hazard flood depths of greater than 0.3 m. There are no high hazard flood areas within the Site (indicated by red shading).

In general, there is isolated flooding within the proposed residential lots, indicative of water ponding due to rainfall, rather than flowing water. The main flooding impacts are to the southeast within the neighbouring land (Rt RS 3101) and within Lots 59 and 62, which have been set aside for stormwater management (e.g. stormwater basins).

WDC may require the proposed development to undergo 200 year flood modelling to confirm that the Site has no adverse effects on surrounding properties. If this requirement is stipulated by Council, we recommend that it be carried out as part of the subdivision consent phase.

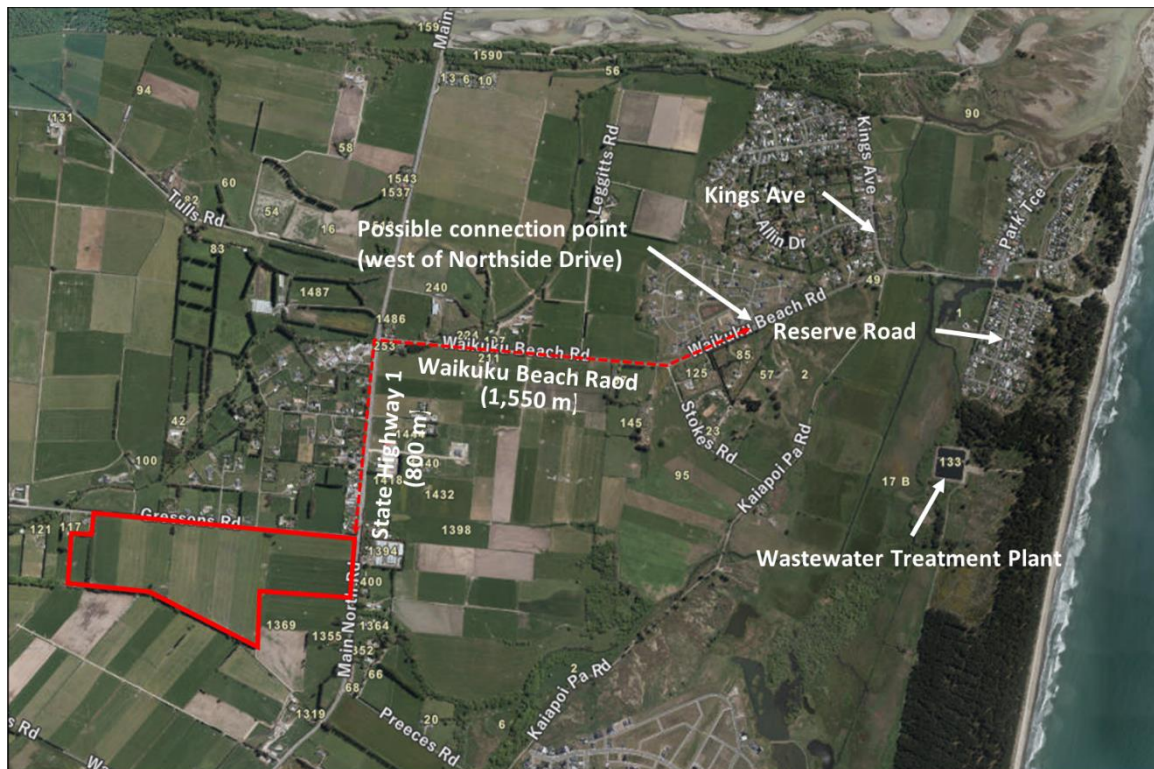
**Figure 5: Potential Sewer Pipe Route and Distances**

As shown in Figure 5, an 800 m length of pipe will need to be run down State Highway 1 and an additional 1,550 m down Waikuku Beach Road, up to Northside Drive.

Appendix C provides a concept LPS sewer design, prepared by Ecoflow in 2014. It should be noted that the design shows the discharge via Preece's Road, which is no longer feasible.

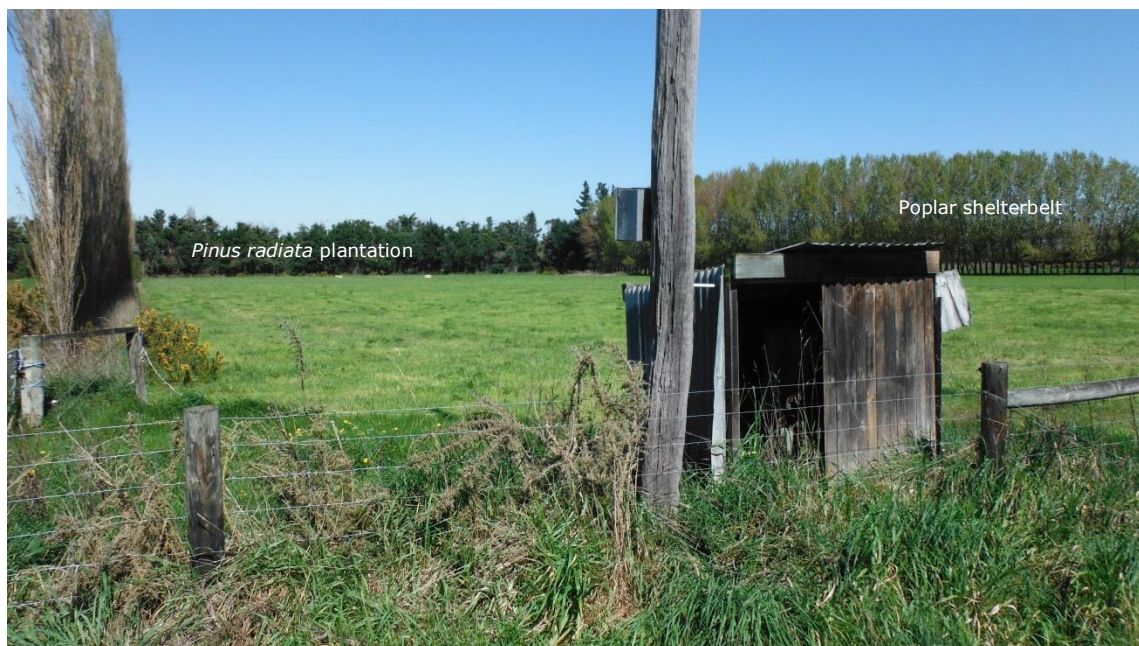
Photo 3. Power pole and disused well shed at 81 Gressons Road (looking south).

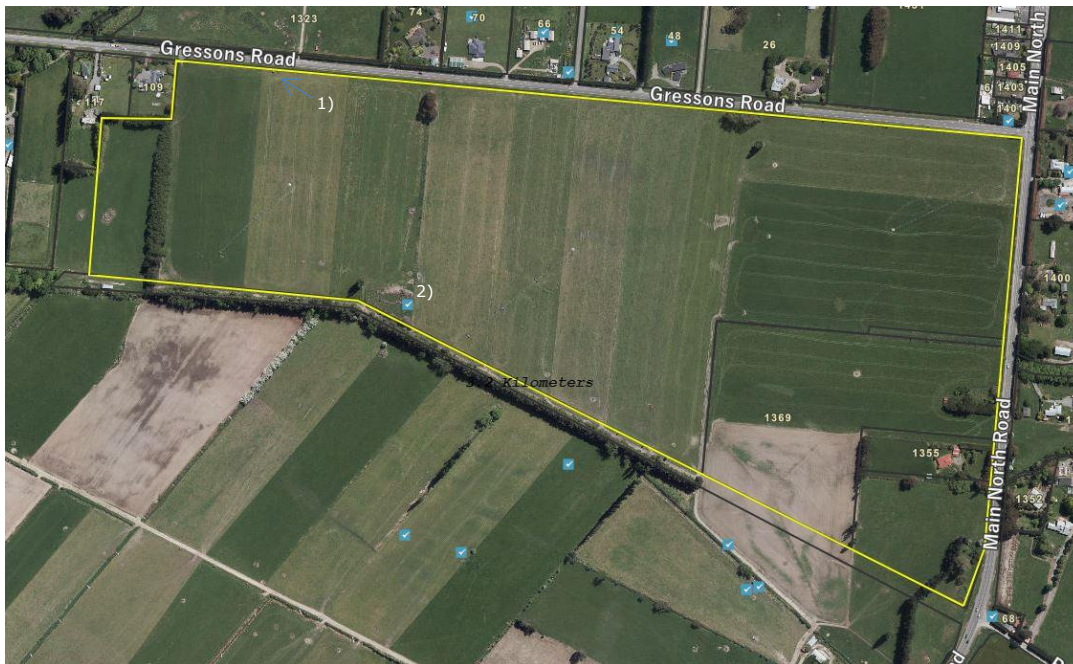
On the subject site:

- 1) Well M35/4266: 51mm well in pump shed. Well card status: 'Not used', updated in May 2016. No associated water permit. No dates in wellcard.
- 2) NCY880160: Surface water take. Expired in 1997.

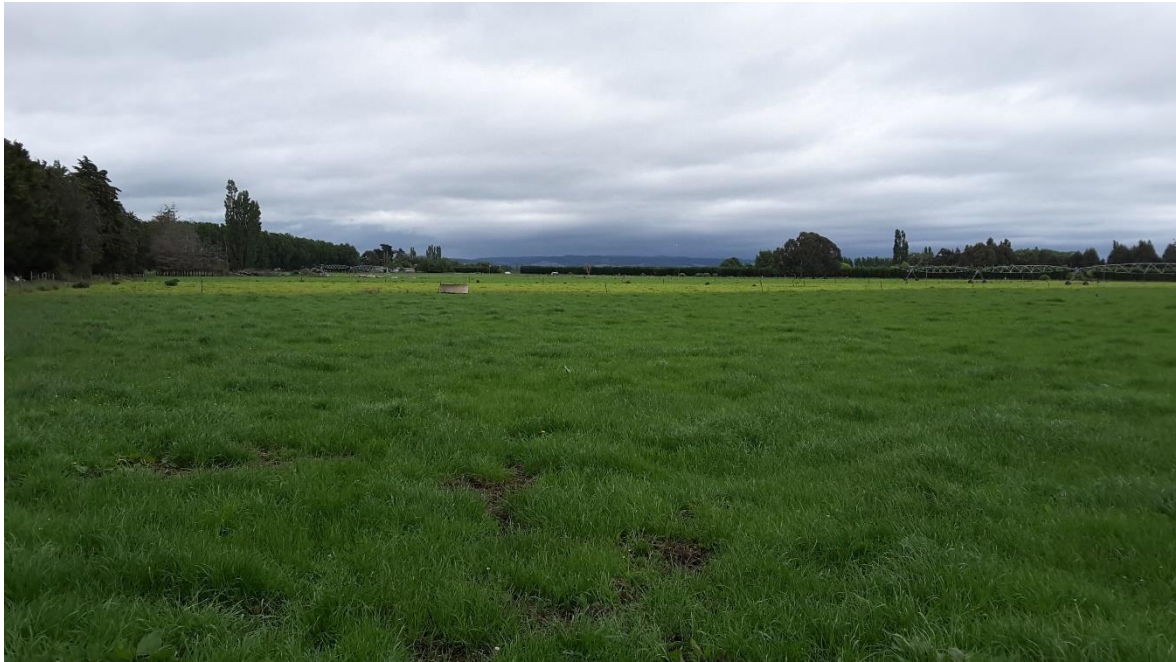
The site is located on the corner of Gressons Road and Main North Road. The site topography is flat.

Photograph 1: The southeast corner of the site looking west, showing the flat topography across the site. (November 2020)

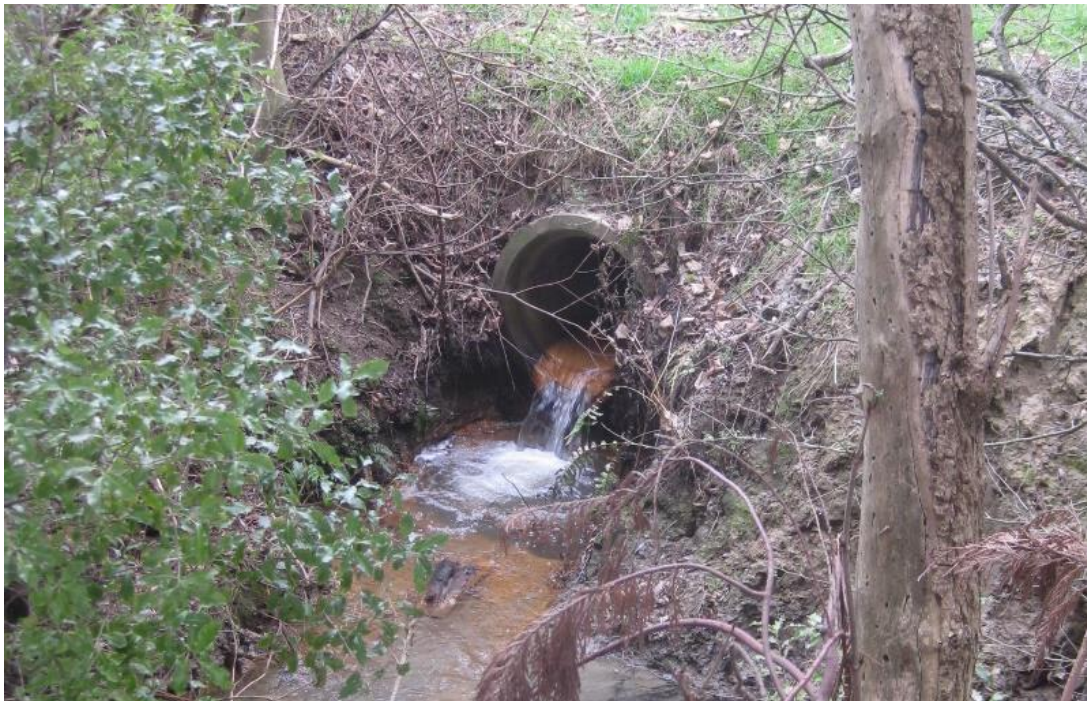
An open drain is located along the west and south boundaries of the site, and is piped in places.

Photograph 2: The large drain situated on the neighbouring property, south of the site. (July 2012)

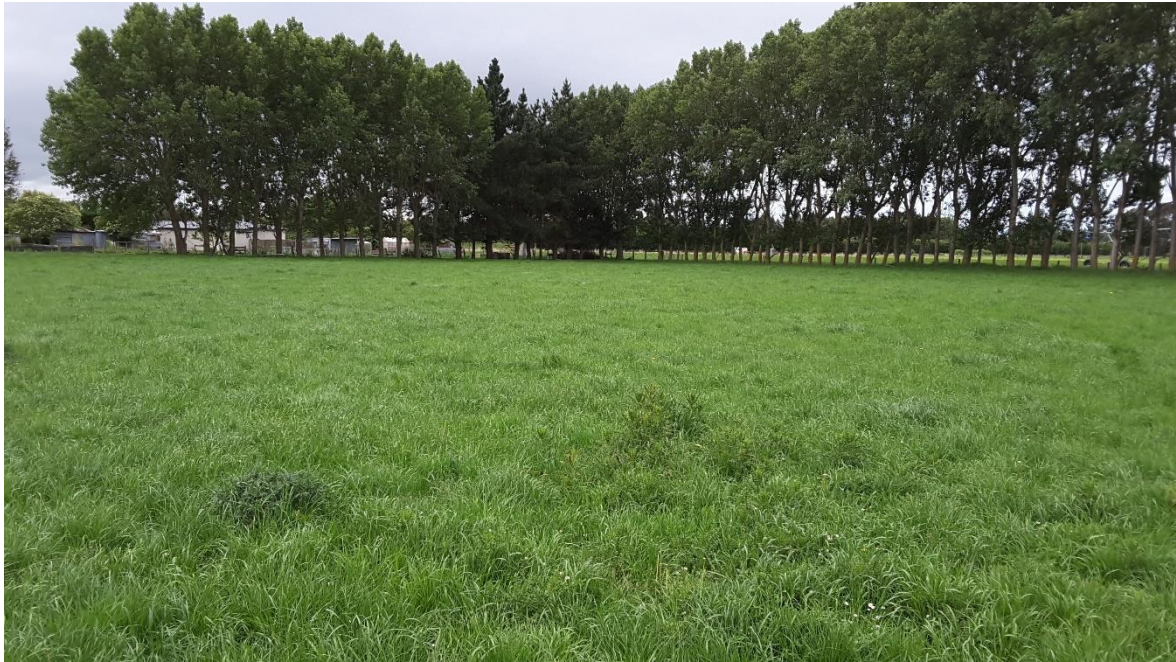
The site is vegetated in grass, with shelterbelts located in the western part of the site.

**Photograph 3: The west end of the site looking northeast. (November 2020)**

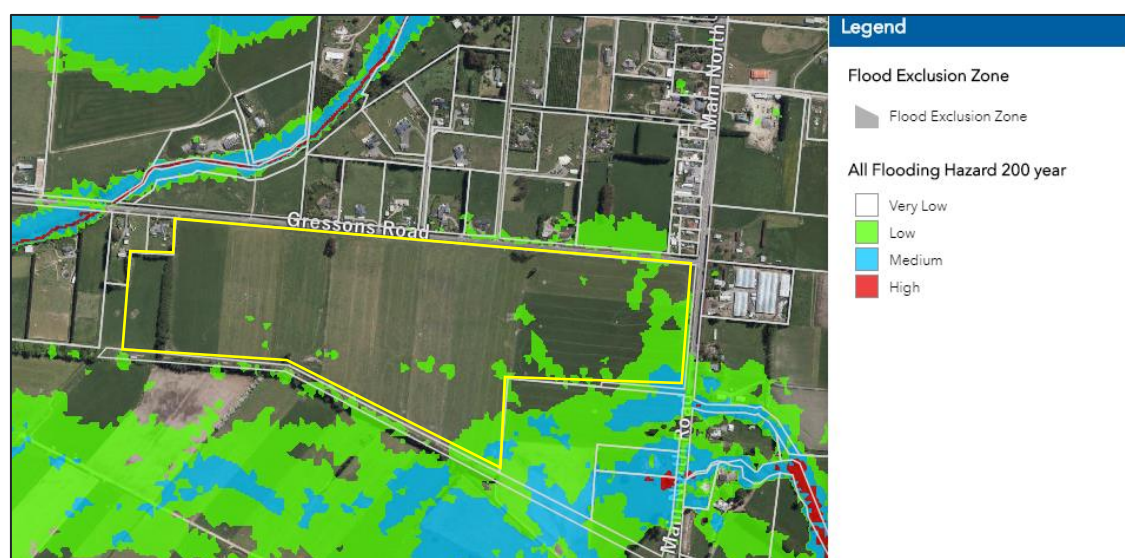
Figure 3 Waimakariri District Natural Hazards Interactive Viewer, retrieved Nov 2020.

The Waimakariri District Natural Hazards Interactive viewer shows the site is generally at very low risk of flooding for the 1 in 200 year return period. Parts of the southeast corners of the site are at low to medium risk.

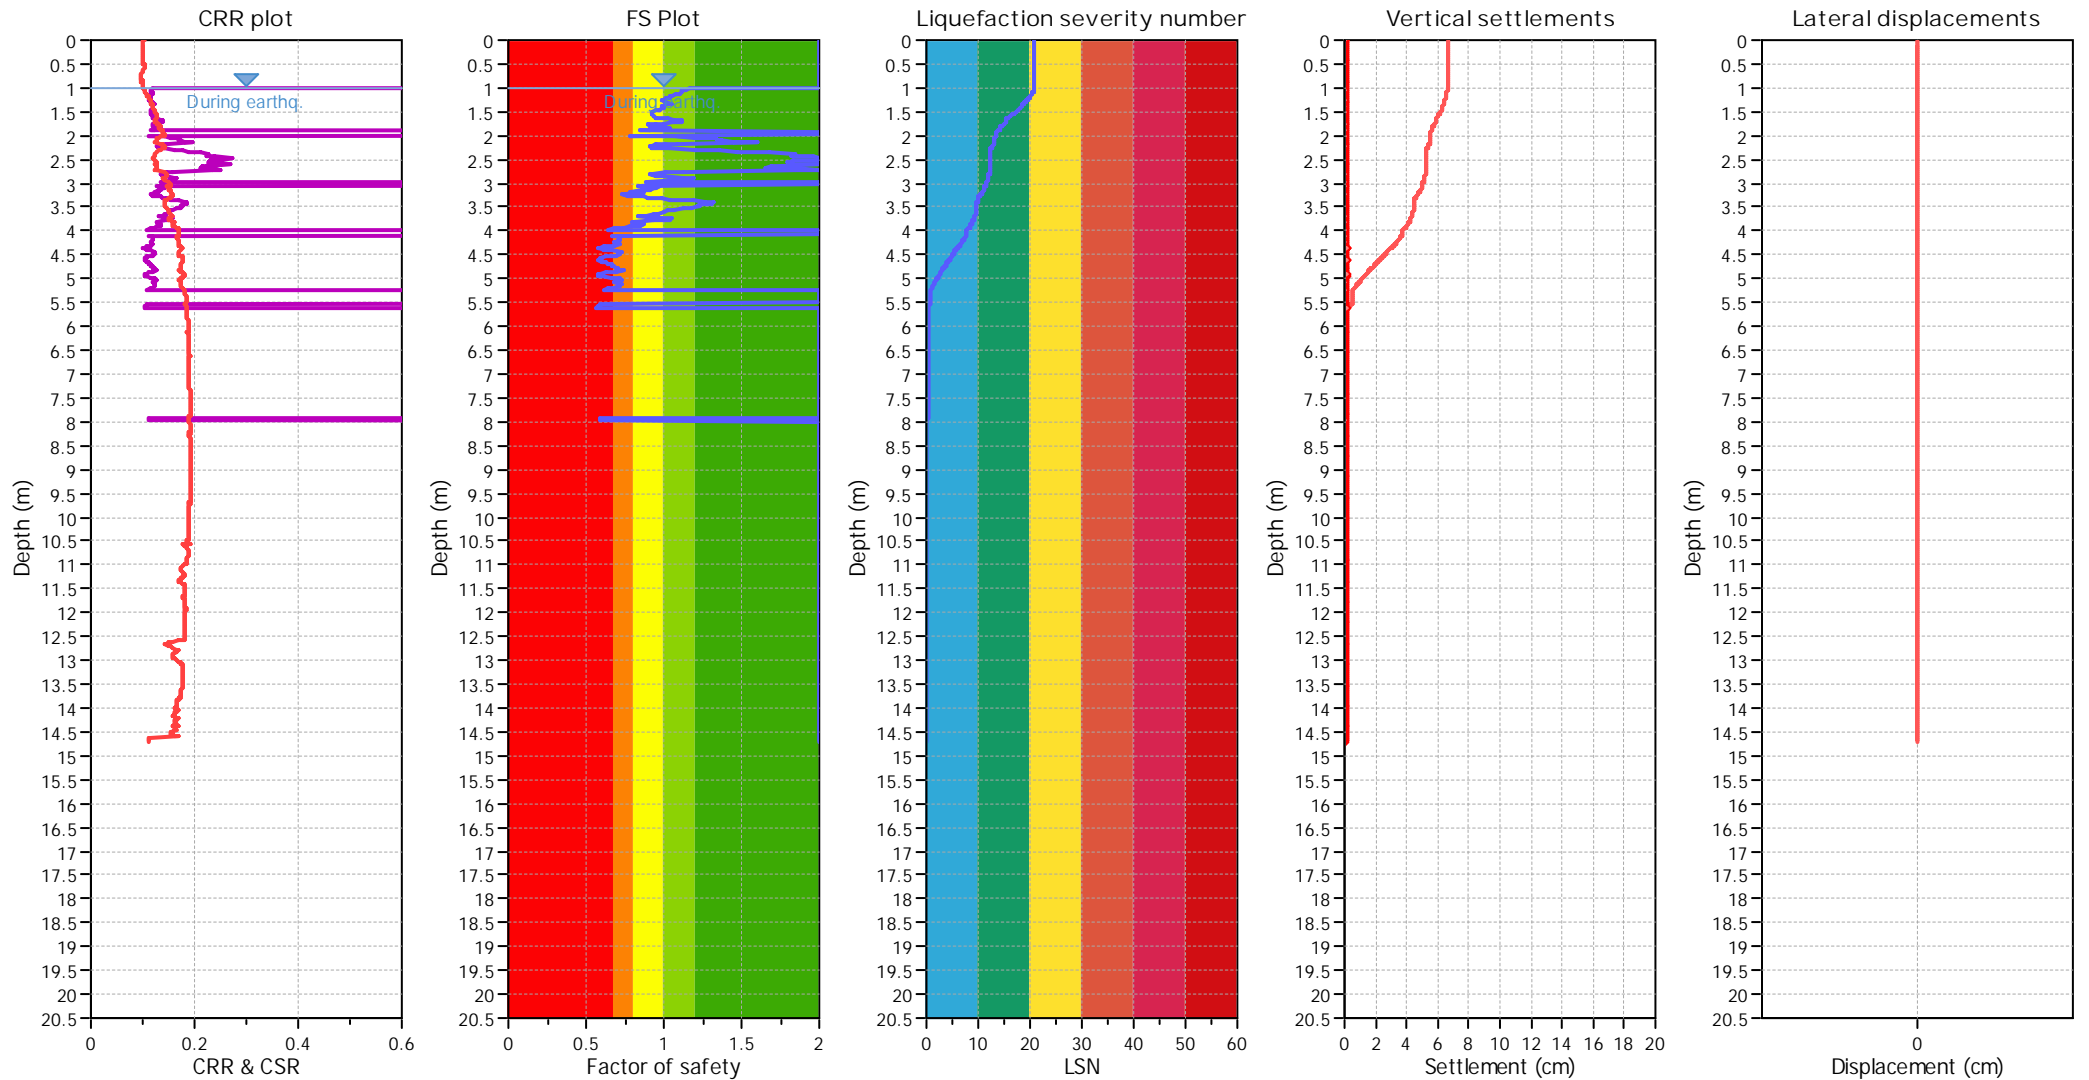
Liquefaction analysis overall plots

Analysis method:	B&I (2014)	Depth to GWT (erthq.):	1.00 m	Fill weight:	N/A	F.S. color scheme	LSN color scheme
Fines correction method:	B&I (2014)	Average results interval:	3	Transition detect. applied:	No	Almost certain it will liquefy	Severe damage
Points to test:	Based on Ic value	Ic cut-off value:	2.60	$K_0$ applied:	Yes	Very likely to liquefy	Major expression of liquefaction
Earthquake magnitude $M_w$ :	6.00	Unit weight calculation:	Based on SBT	Clay like behavior applied:	Sands only	Liquefaction and no liq. are equally likely	Moderate to severe exp. of liquefaction
Peak ground acceleration:	0.19	Use fill:	No	Limit depth applied:	Yes	Unlike to liquefy	Moderate expression of liquefaction
Depth to water table (insitu):	1.00 m	Fill height:	N/A	Limit depth:	10.00 m	Almost certain it will not liquefy	Minor expression of liquefaction
							Little to no expression of liquefaction
