DISTRICT PLAN REVIEW

Proposed Waimakariri District Plan - Submission

On-site Wastewater Treatment and Disposal at Proposed Subdivision of 2 Auckland Street, Ashley

Davis Ogilvie & Partners Ltd was engaged by Alistair Cameron to undertake a geotechnical investigation of the site at 2 Auckland Street, Ashley. The purpose of the geotechnical investigation was to investigate the underlying ground conditions, assess natural hazards, and provide recommendations regarding residential foundations and civil infrastructure to support a subdivision consent application for 28 proposed residential lots.

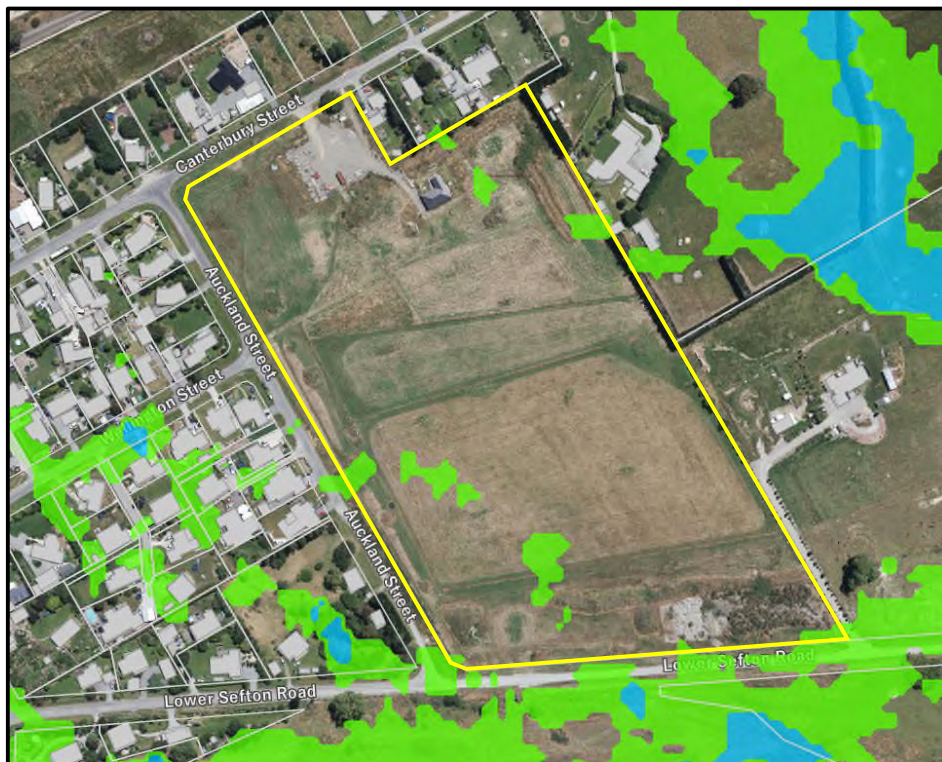
Figure 2: Waimakariri District Council Flood Modelling (Site Outlined Yellow)

23. In relation to flooding, small portions of the subject property are shown within the 'low probability' 1 in 200 year hazard overlay of the Waimakariri District Council Flood Model. Similarly, small portions of the site are located within the 'low probability' 1 in 500 year hazard overlay. The modelling shows no overland flow paths or significant flooding within the site. This is illustrated in Figure 2 below, and further discussed in the Geotechnical Report attached as **Appendix 3**.

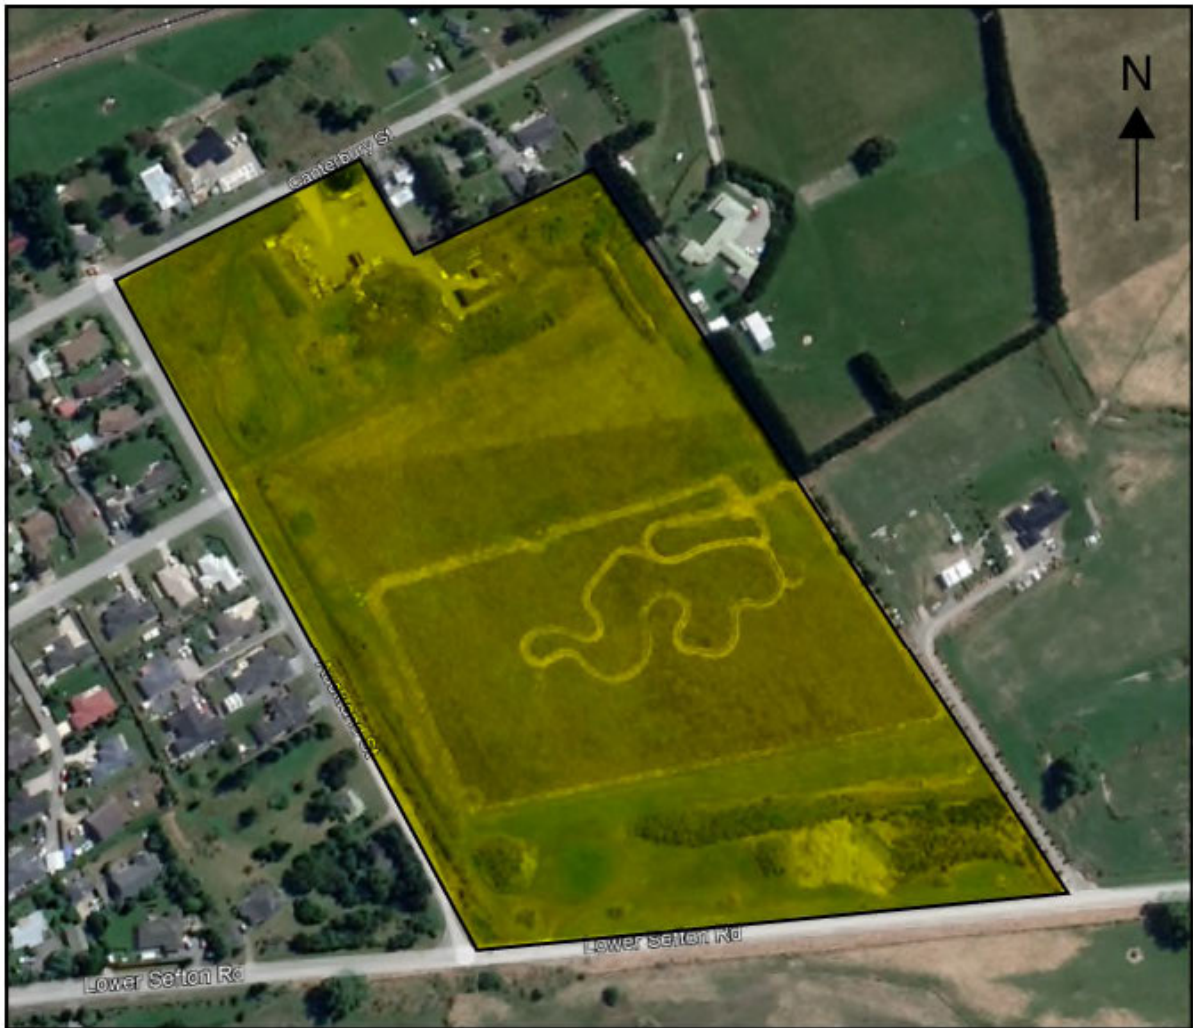
Figure 1: Proposed Development Area.

Based on a minimum lot size of 5,000 m², we have a potential yield of 16 lots if zoned LLRZ. The site is currently zoned RLZ, is rural in character and the land grades generally to the south. The site is legally known as Lot 1 DP 394101 (Title 376526).

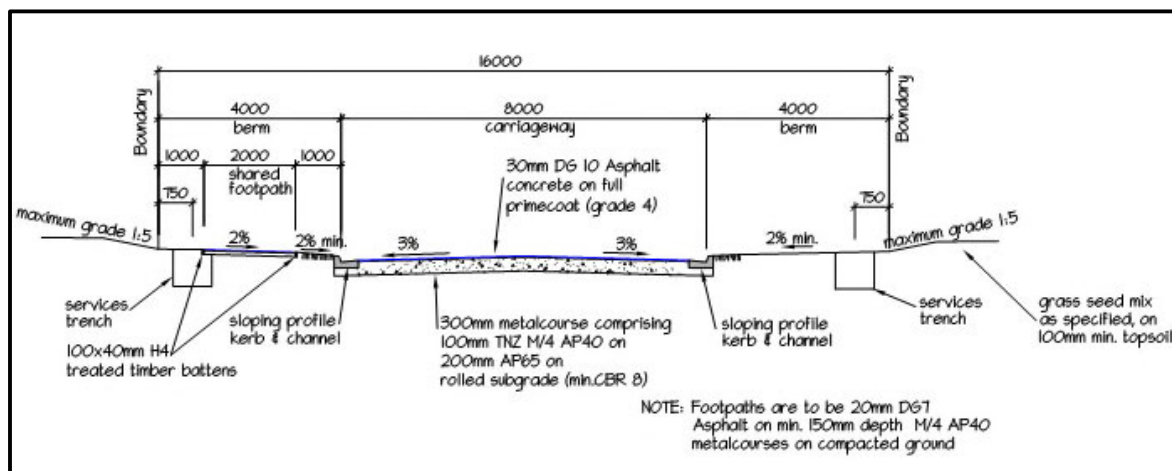
Figure 2: Typical Road Cross Section

Figure 2 below shows a typical road cross-section for the proposed development.

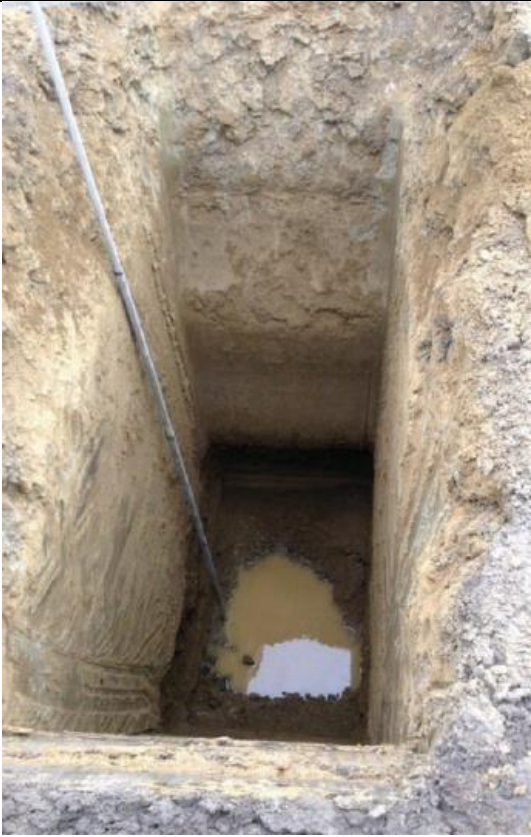
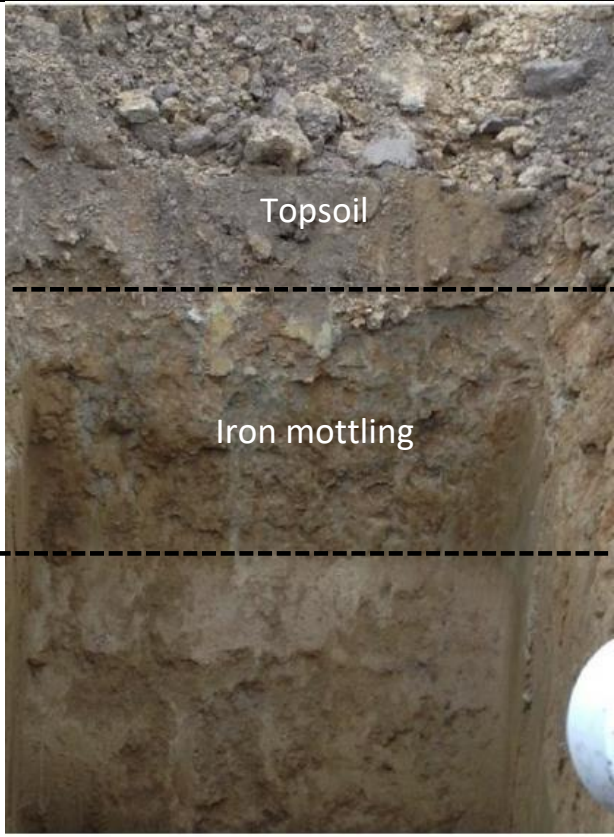
Example photos of a test pit and excavated soils are shown below.

<p>Photograph 1: Example test pit (TP8) with groundwater at 3.7 m</p>	<p>Photograph 2: Test pit showing iron mottling below topsoil</p>

Table 1: Test Pit Summary				
	Start depths (m)	End depths (m)		Comments
Topsoil	0.0	0.3 – 0.5		
Silt	0.3 – 0.5	1.5 – 4.0		Mottling present at the top of the silt layer and generally decreasing with depth. Indicates a pan or restriction in soakage within silt layer and not a seasonal high groundwater. Classified as Category 5 in accordance with AS/NZS 1547:2012
Sandy or silty gravel	1.5 - 4.0	Base of test holes		Orangey brown with dark reddish stained grey gravel. Staining could represent groundwater. Gravels had excellent soakage with respect to the discharge of wastewater. In general, the second 10 L bucket drained in less than 60 seconds. Classified as Category 1 in accordance with AS/NZS 1547:2012

Based on the test pit findings, the following disposal methods are recommended:

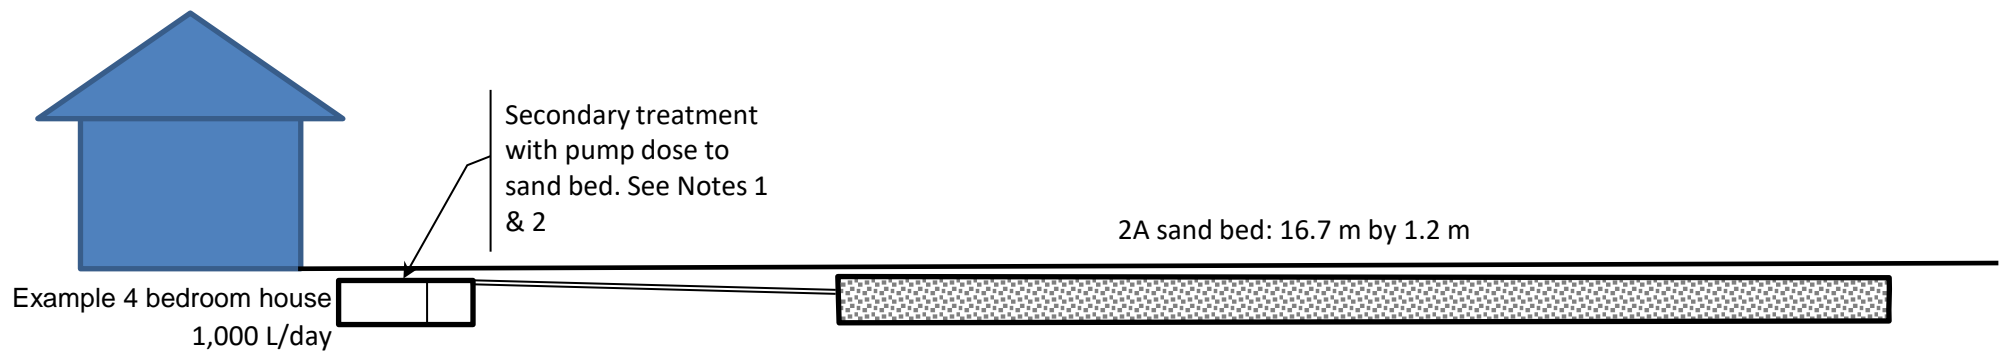
2 Auckland St
Flow Diagram

- Notes:**
- 1. Pump duty: 8 m head at a flow 85 L/min [BAV400 or alternative low head high flow pump]
 - 2. Proprietary filter is within the treatment tank. Do not include disc filter

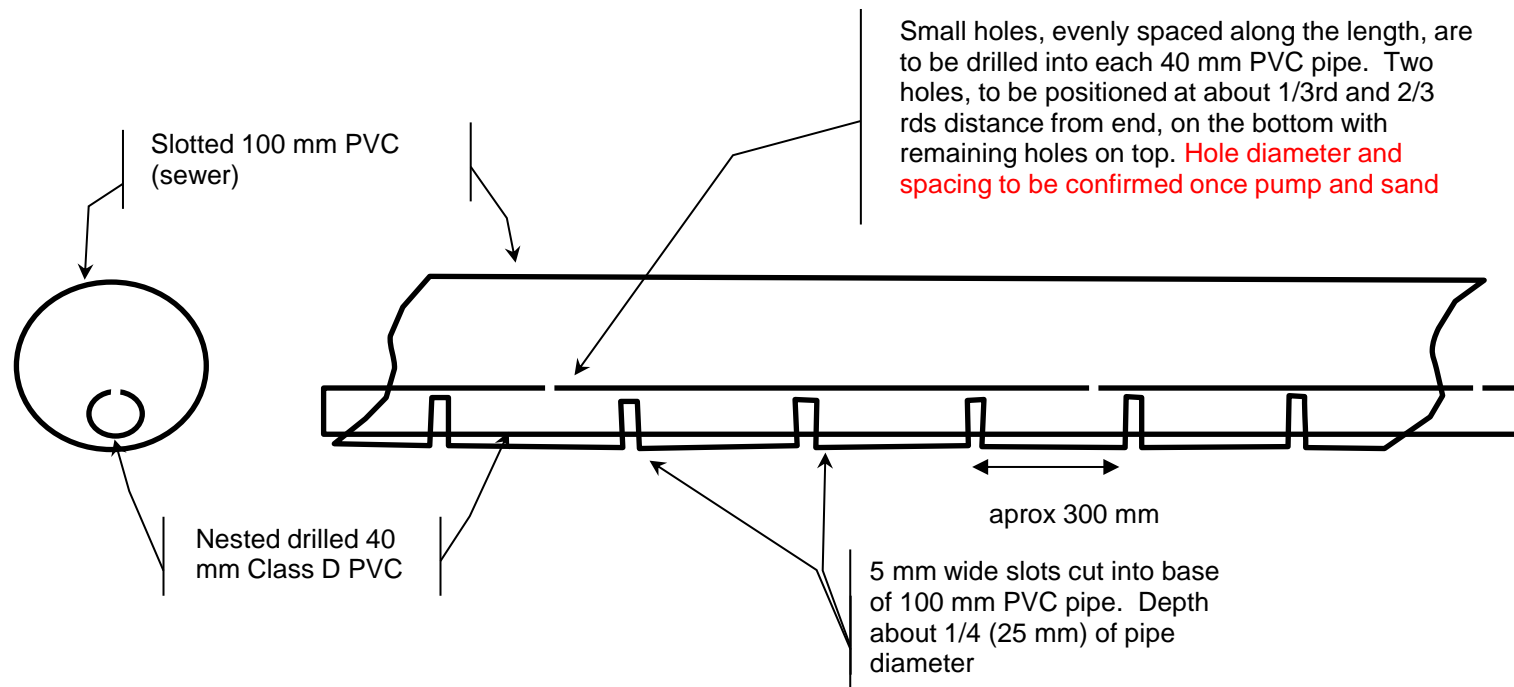
Distribution Pipe Details

- recommended diameter of delivery pipe from pump to sand trench
- hole diameter and spacing in each 40 mm distribution pipe

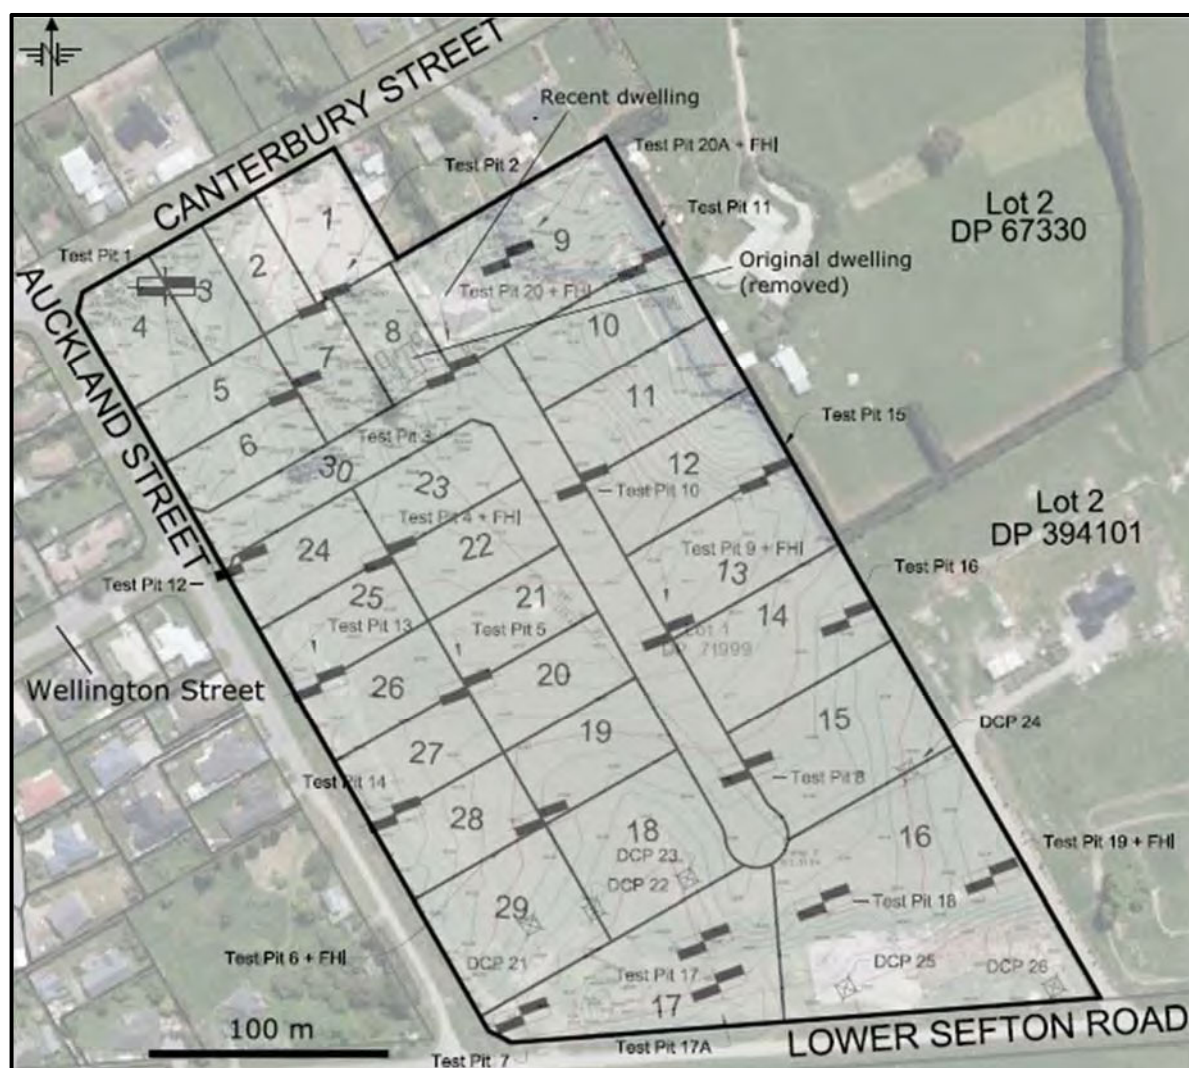
Based on the scheme plan for the site, the proposed development is to include subdividing the 8.0 ha site into approximately 28 residential lots plus a stormwater disposal area in the south (Lot 17) and access road (Lot 30), as shown in Figure 3⁴. The lots are to be served by a single cul-de-sac road proposed at the existing Wellington Street and Auckland Street intersection. The proposed residential lots range between 1,210 – 9,110 m², with most being in the order of 1,800 – 2,600 m².

Figure 3: Proposed scheme plan (dated 09/20) showing test pit locations, a recent aerial image⁵ and an overlay of existing topographical contour plan². Contour intervals are 0.2 m (blue) and 1.0 m (red). Note that the existing “original dwelling” marked on the topographical contour plan in the area of proposed Lot 8 was removed prior to this investigation.

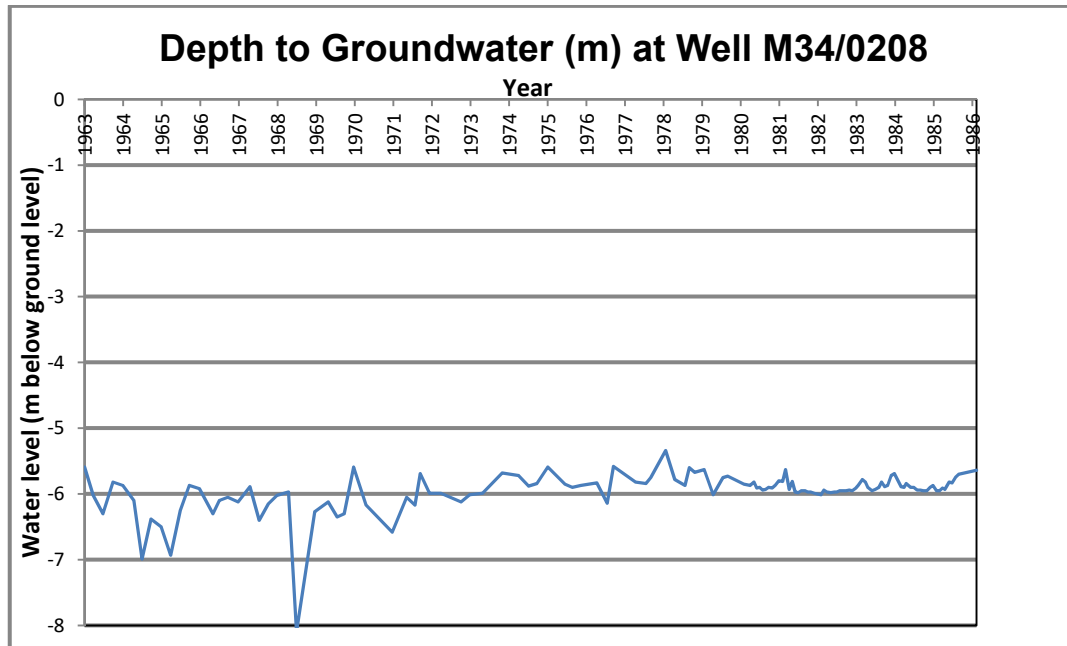
Figure 5: Groundwater monitoring data from well M34/0208 (480 m from the site) showing measured depths to groundwater below ground level (in meters) between 1963 to 1986 (generally 3 to 4 measurements recorded annually).

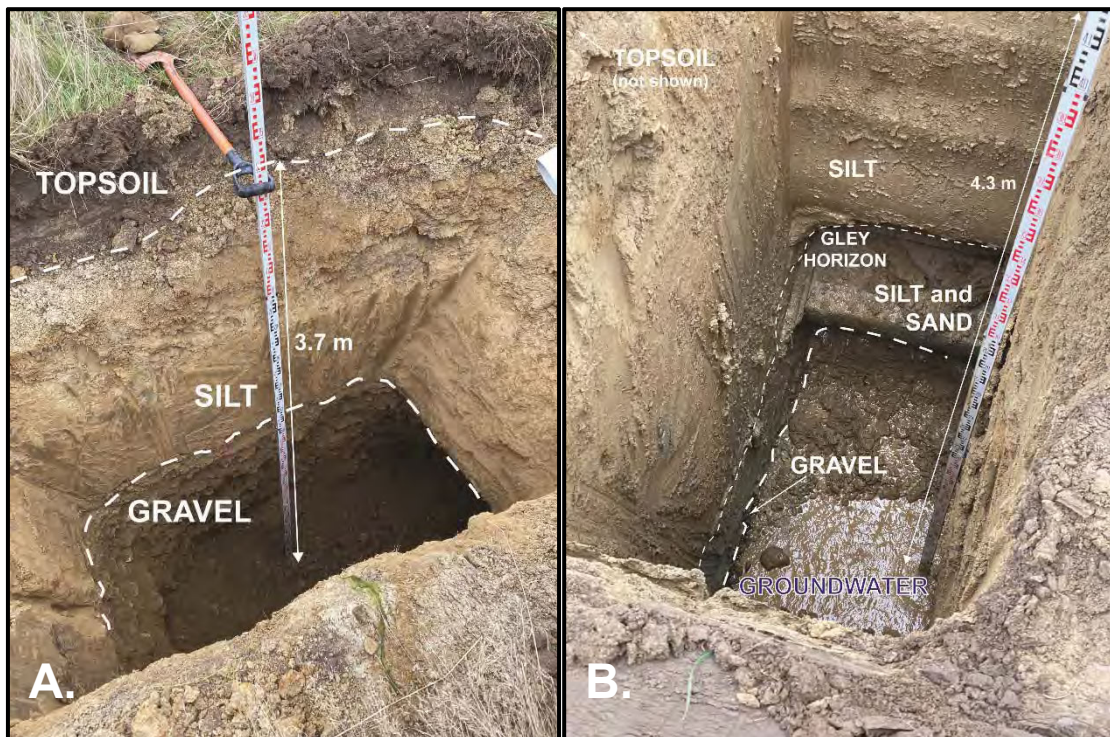
Figure 6: Examples of the soil profile encountered in the north of the site: A) TP20a, where gravel was encountered at relatively shallow depths; and south of the site: B) TP7 where gravel was encountered at greater depths beneath a saturated gley horizon.

Typical soil profiles revealed by the TPs are shown in Figure 6 and DCP profiles are presented in Figure 7. This figure shows the variation between blow counts with depth over most of the site compared to those in the south. A summary of the soil profiles encountered at each test location is provided in Table 1A-C and full logs are included in Appendix C. The depth to gravel encountered across the site is presented on a site plan in Figure 8.

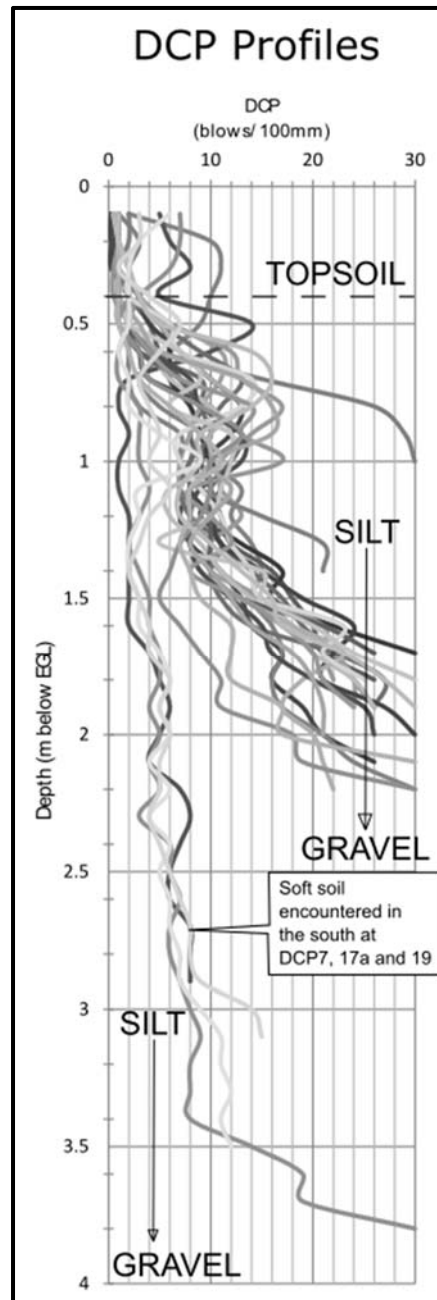
Figure 7: DCP profiles through topsoil and silt (overlying gravel, not reached by DCPs). Results show a consistent trend, except for DCP 7, 17a and 19 in the south of the site where soft, wet silt was encountered at deep.

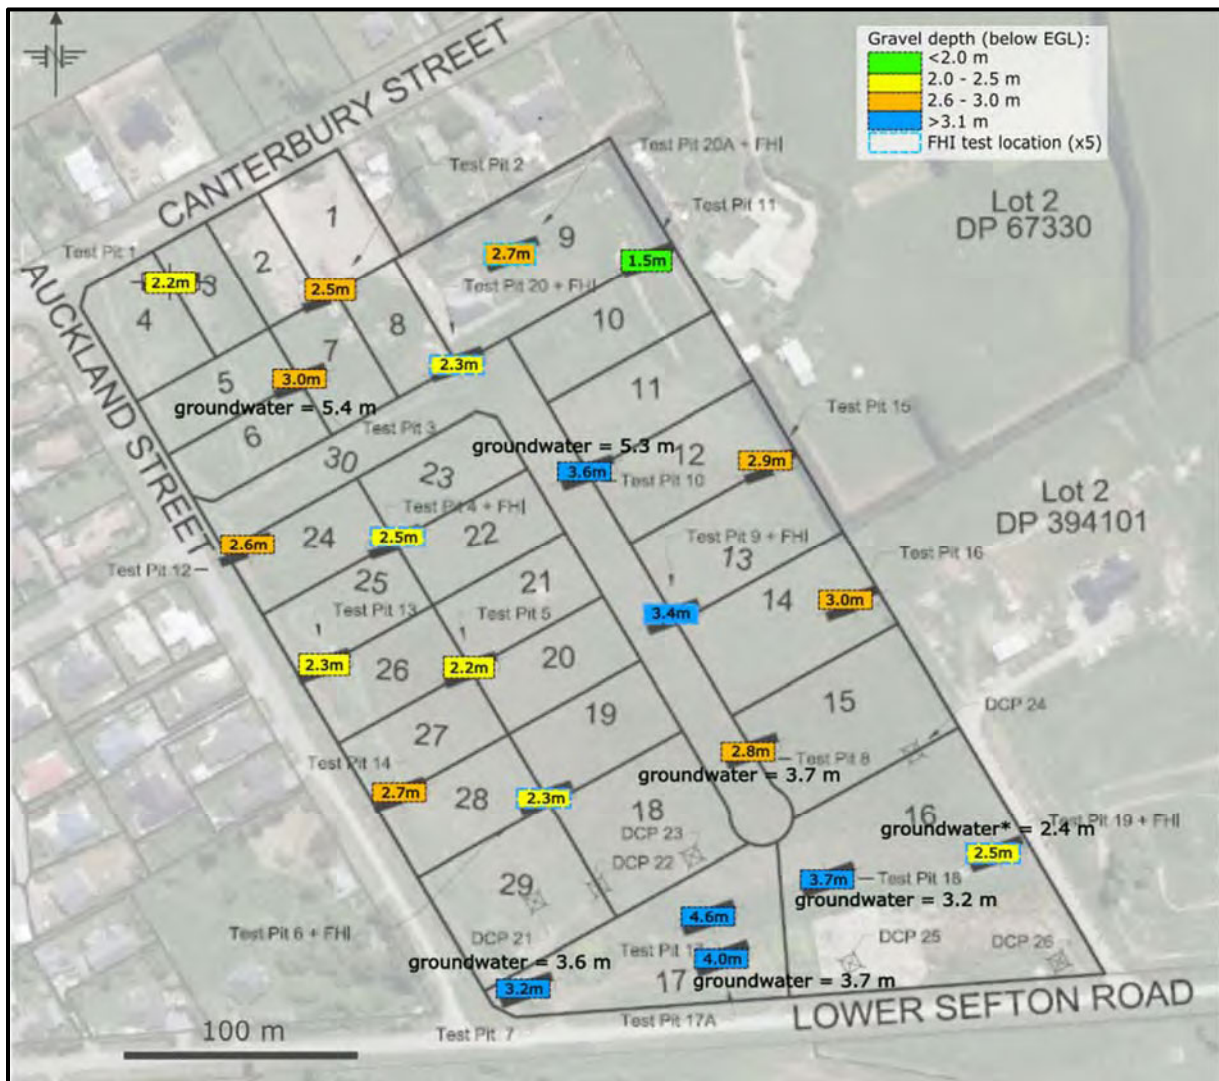
Figure 8: Proposed scheme plan annotated to show the approximate depth to gravel and groundwater (m below EGL) measured in test pit excavations during the site investigation.

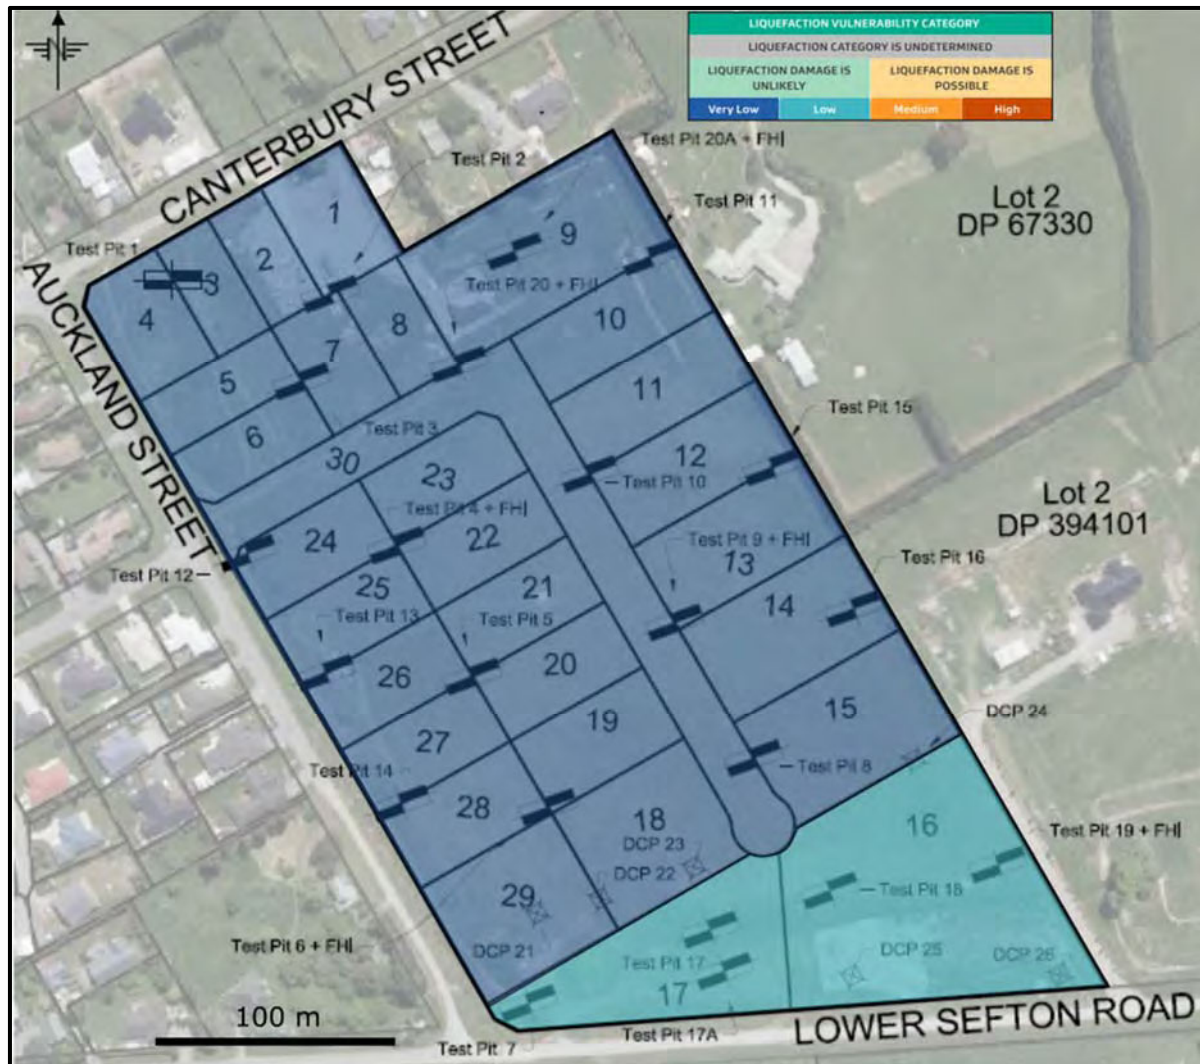
Figure 9: Expected liquefaction vulnerability categories at the site based on subsurface observations.
Category extents defined by proposed lot boundaries.
Categories based on MBIE (2017)²².

Across the 8.0 ha site, Davis Ogilvie oversaw the excavation of 22 Test Pits and 26 Dynamic Cone Penetrometers. The shallow soil profile generally consisted of a surficial topsoil layer overlying a unit of silt, which ranged from 1.1 to 3.7 m thick, then dense silty and sandy gravel. Groundwater was encountered at between 2.4 – 5.4 m below existing ground level (EGL). Observations of the soil and groundwater conditions indicate liquefaction-induced settlement is unlikely and a liquefaction vulnerability risk of ‘very low’ to ‘low’ is considered appropriate.

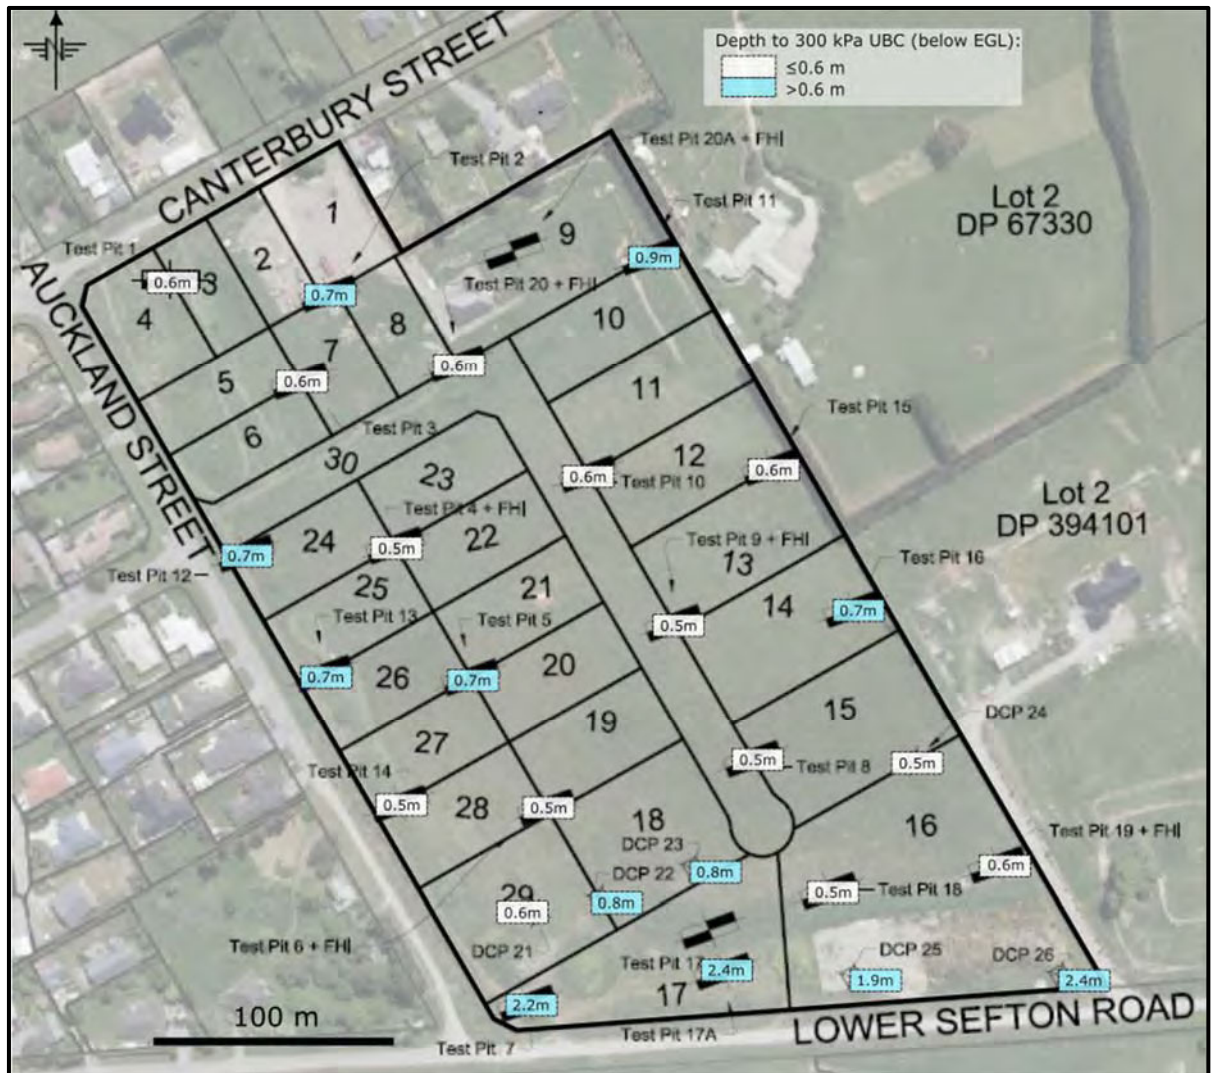
Figure 10: Map of the proposed development showing the depth 300 kPa (UBC) below EGL encountered across the site.

Based on the in-situ DCP testing, a static Ultimate Bearing Capacity (UBC) of 300 kPa was achieved at depths ranging from 0.5 – 2.4 m below EGL. The maximum depth to which ‘good ground’ has been assigned at the site is 0.6 m, above which standard (NZS 3604:2011) foundation options are considered suitable. Recommended foundation options where ‘good ground’ has been achieved include NZS 3604 concrete slab or piles for suspended floors founded at a depth where 300 kPa has been confirmed. In areas where the depth to 300 kPa UBC exceeds 0.6 m below EGL, an UBC of 200 kPa is recommended with Specific Engineering Design for foundations.

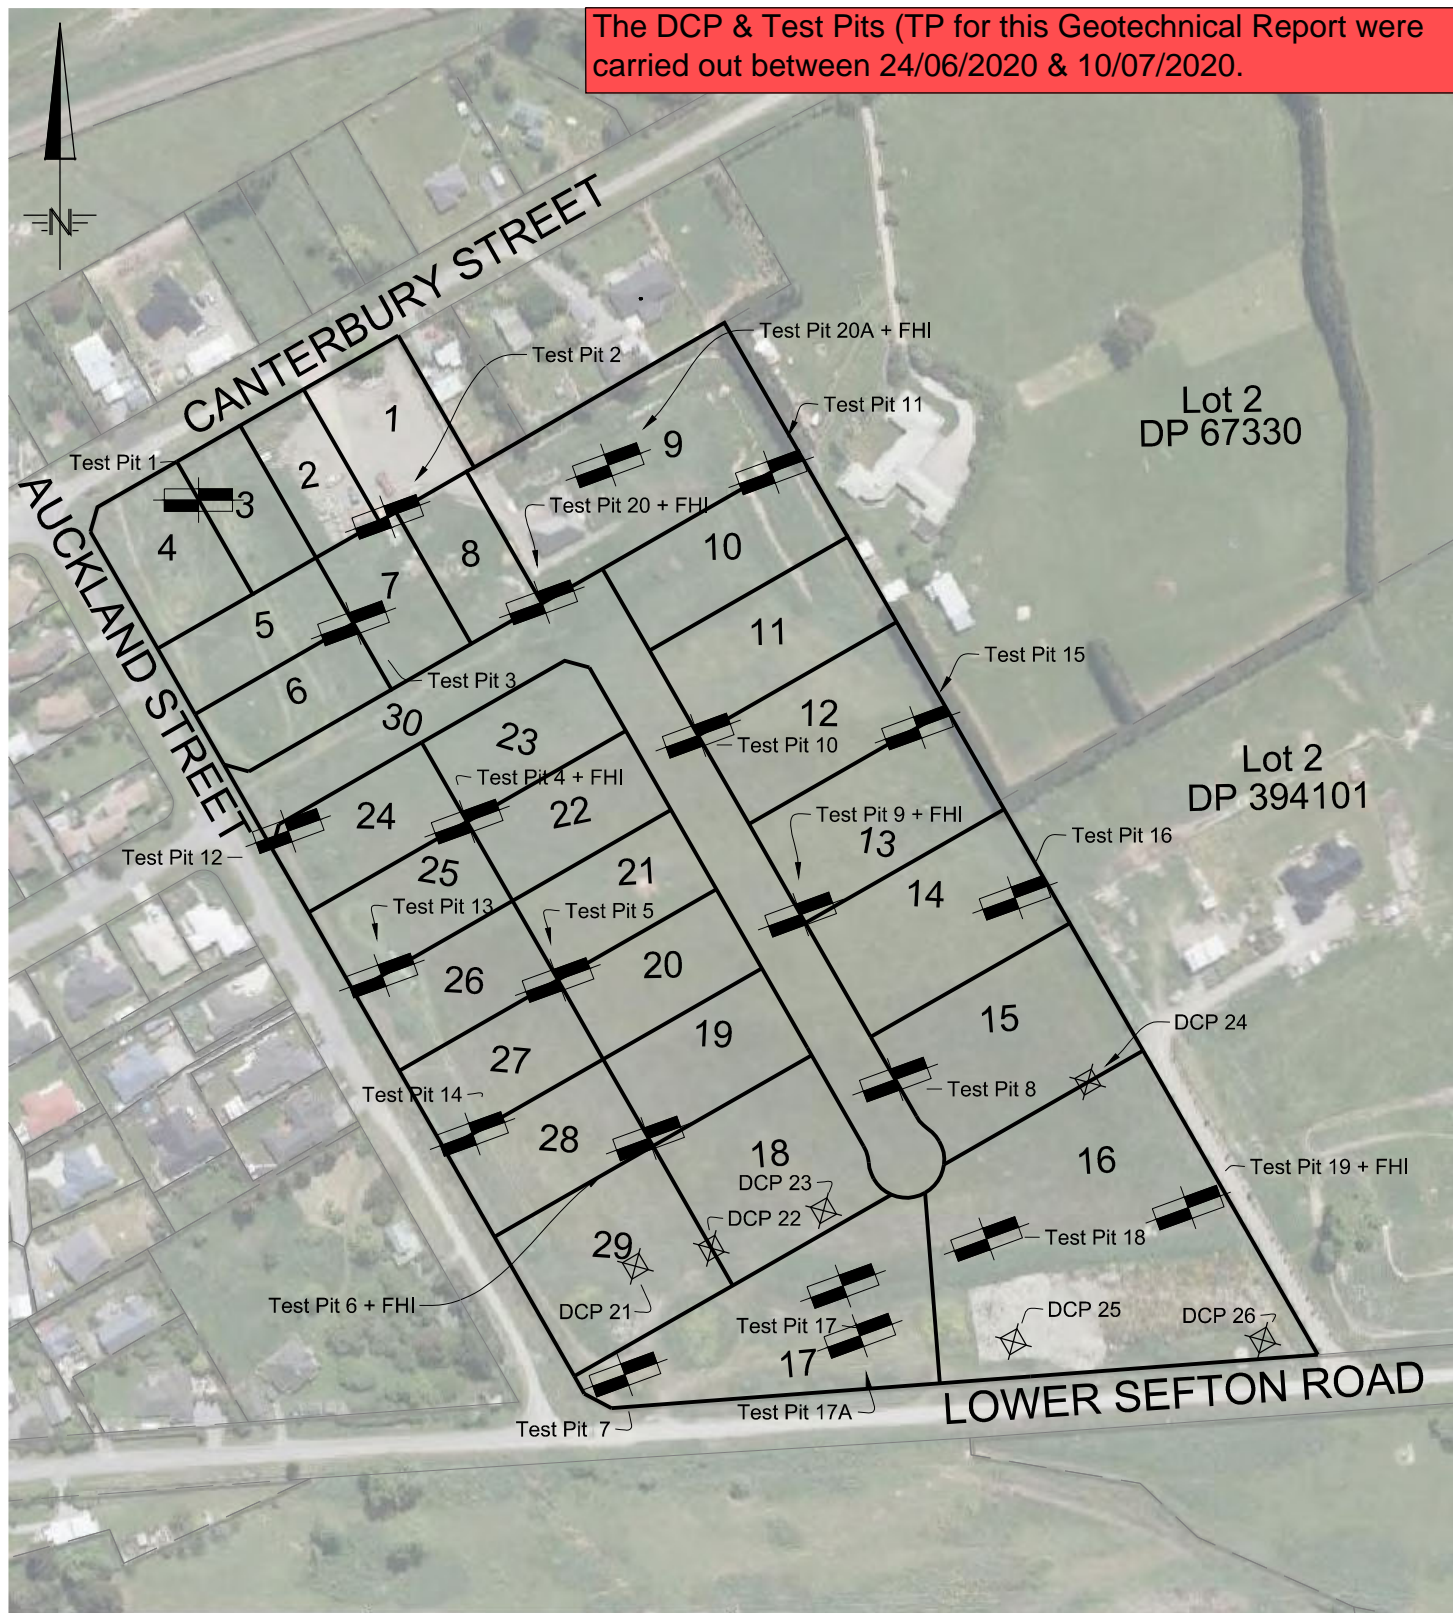
Site and Test Location Plan (DWG G01A)

Test locations are approximate (scaled and aligned using aerial imagery).
Aerial image obtained from Canterbury Maps
Boundaries are taken from Quickmap and are indicative only.
Proposed lots taken from DO drawing GM37095 101A dated 09/2020.

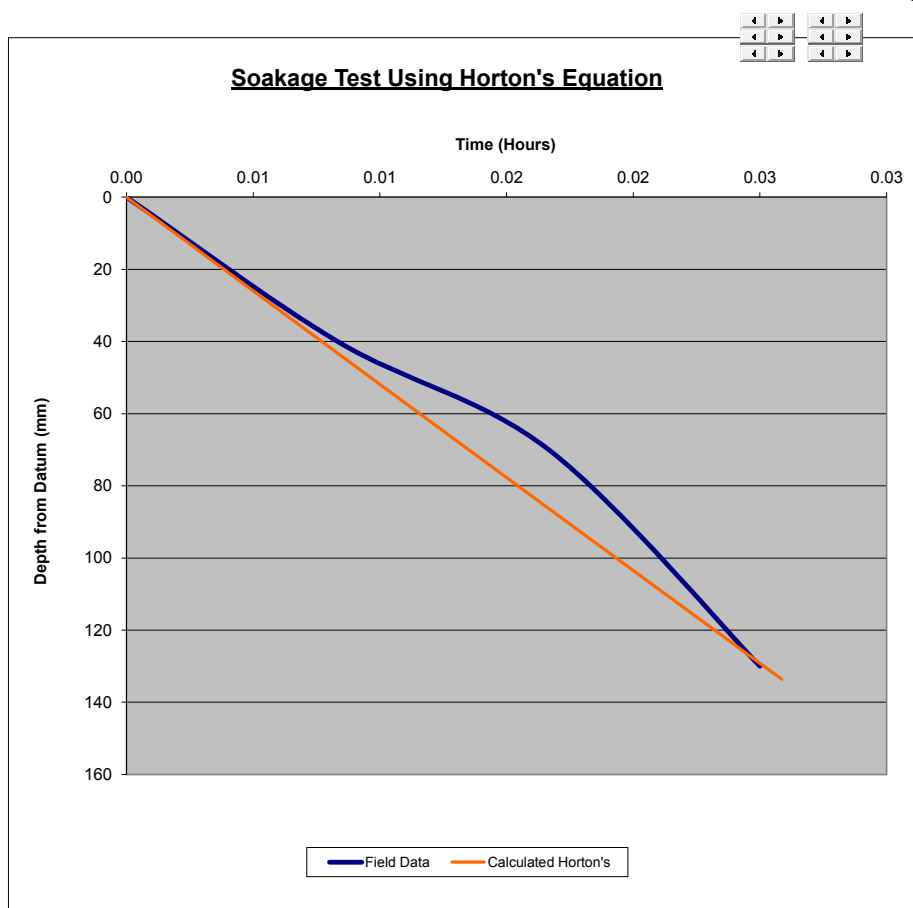
Timestep	Time (mins)	Depth from Datum (mm)
0	0.00	0
1	0.50	40
2	1.00	70
3	1.50	130
4		
5		
6		
7		
8		
9		
10		
11		
12		
13		
14		
15		
16		
17		
18		
19		
20		
21		
22		
23		
24		
25		
26		
27		
28		
29		
30

Initial Infiltration Rate:	5200.00	mm per hour
Ultimate Infiltration Rate:	255.00	mm per hour
Horton's Decay Coefficient:	0.53	per hour

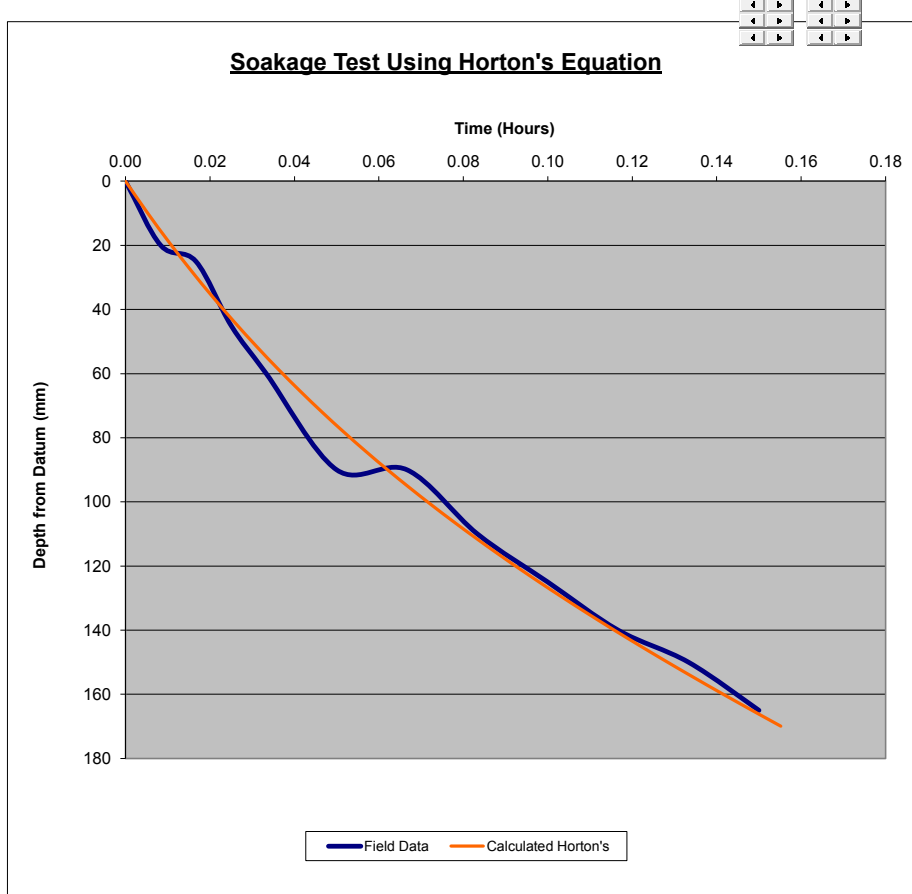
Timestep	Time (mins)	Depth from Datum (mm)
0	0.00	0
1	0.50	20
2	1.00	25
3	1.50	45
4	2.00	60
5	3.00	90
6	4.00	90
7	5.00	110
8	6.00	125
9	7.00	140
10	8.00	150
11	9.00	165
12		
13		
14		
15		
16		
17		
18		
19		
20		
21		
22		
23		
24		
25		
26		
27		
28		
29		
30

**Initial Infiltration Rate: 1953.00 mm per hour****Ultimate Infiltration Rate: 616.00 mm per hour****Horton's Decay Coefficient: 16.62 per hour**

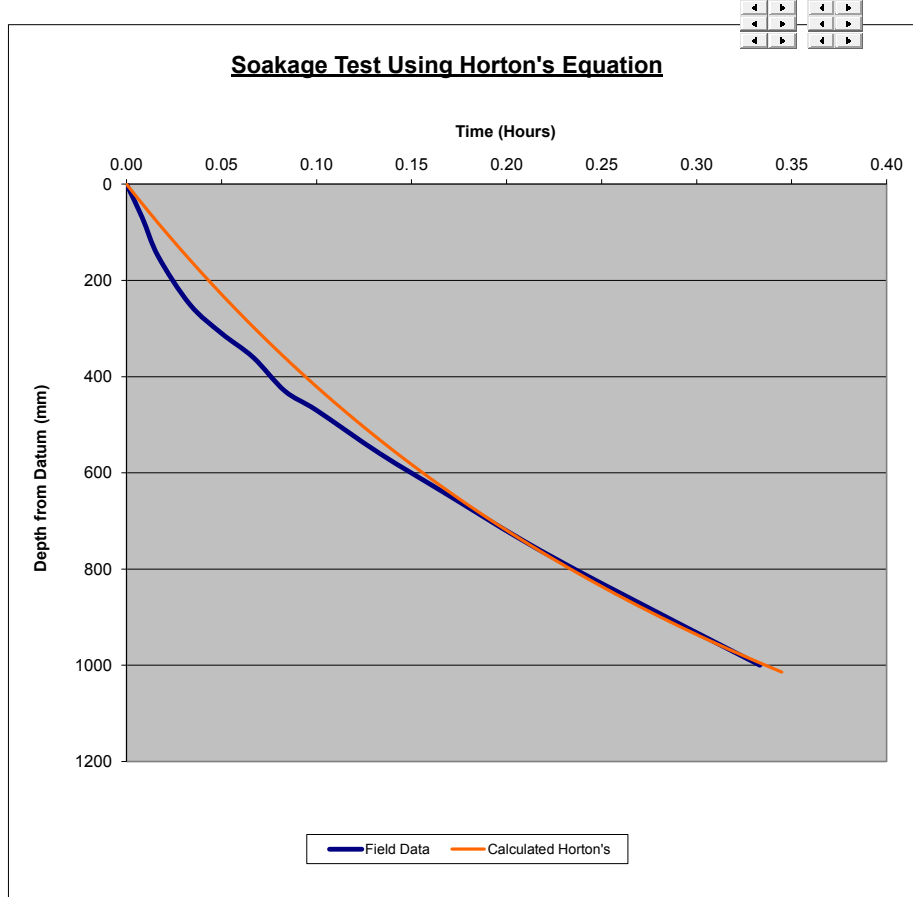
Timestep	Time (mins)	Depth from Datum (mm)
0	0.00	0
1	0.50	70
2	1.00	150
3	2.00	250
4	3.00	310
5	4.00	360
6	5.00	430
7	6.00	470
8	8.00	560
9	10.00	640
10	12.50	740
11	15.00	830
12	20.00	1000
13		
14		
15		
16		
17		
18		
19		
20		
21		
22		
23		
24		
25		
26		
27		
28		
29		
30

Initial Infiltration Rate:	5000.00	mm per hour
Ultimate Infiltration Rate:	500.00	mm per hour
Horton's Decay Coefficient:	4.00	per hour
