25 November 2021

## Risk of Natural Hazards & Soil Contamination at 163 ~ 203 Johns Rd, Rangiora

Eliot Sinclair were engaged to undertake a desktop review of the geotechnical conditions, and to comment on any obvious risk of natural hazards for 163 Johns Road, Rangiora.

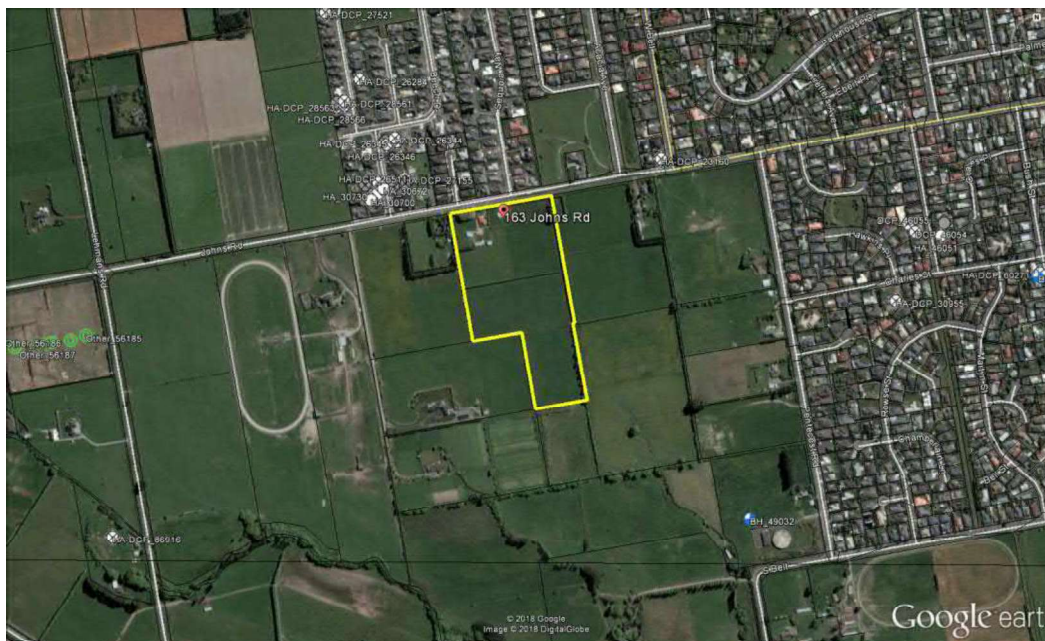
There is no nearby deep investigation undertaken within 100m from the site. The nearest shallow test that was undertaken just north of the site encountered gravels around 1.4 to 1.7m bgl. Refer to Figure 5.

**Figure 5: Plan of existing geotechnical deep investigation. Note the recent deep test is located around 400m southeast of the site.**

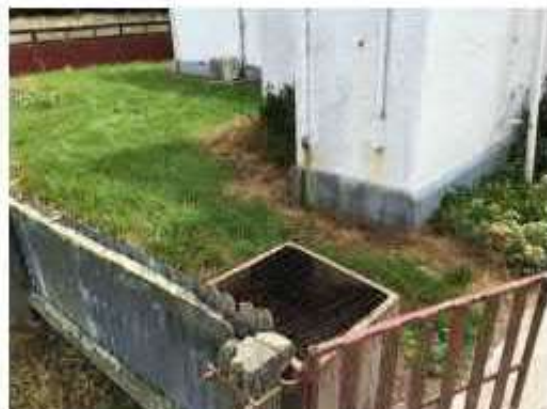
It appears that rubbish was incinerated in a concrete bin behind the original (pre-1940s) dwelling (Figure 3), however, the disposal location of ash is unknown. If it was deposited on site, then it could be the potential source of contamination (HAIL G5).

Figure 4: Concrete bin that appears to have been used to incinerate domestic rubbish. It is not known where potentially contaminated ash has been deposited.

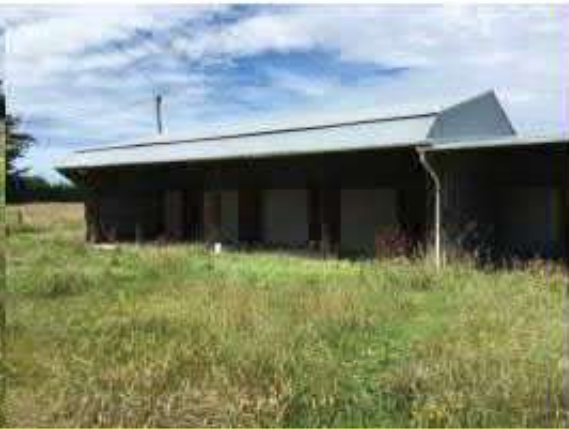
**Figure 6: Horse stables, originally constructed pre-1940s, presumably as shearing shed.**

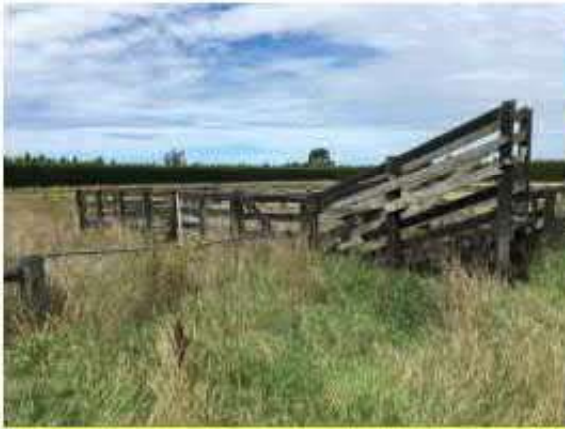
**Figure 7: Disused sheep holding pen and loading ramp (approx. 12m southeast of stockyard area).**

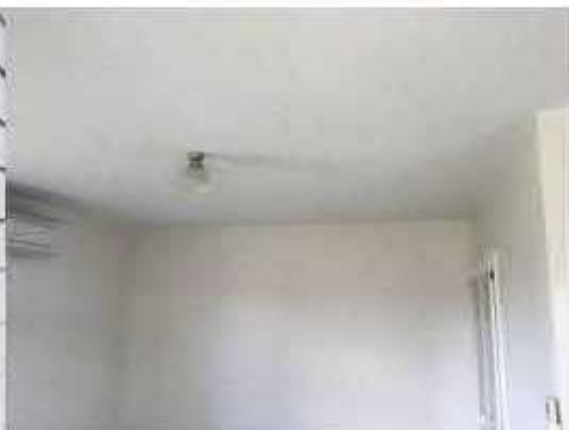
**Figure 10: Stippled ceiling plaster in the more recent residential dwelling (possibly containing asbestos).**

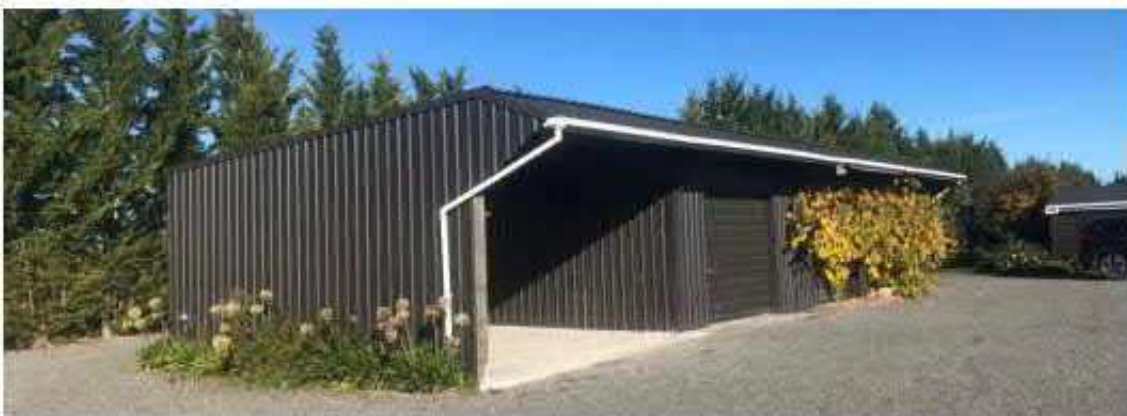
Photo 2. View of the garage and shed located to the southeast of the residential dwelling

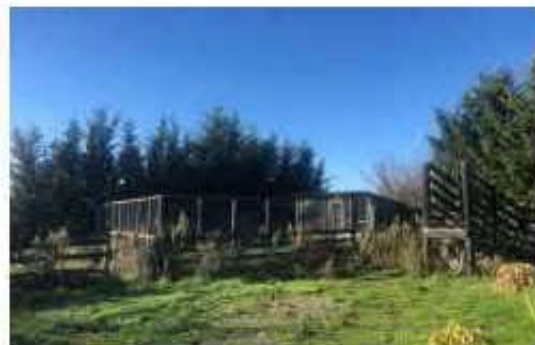
Photo 4. Cattle yards and garden shed
