Preliminary Site Investigation

518 Rangiora Woodend Road & 4 Golf Links Road, Rangiora, Canterbury

Prepared for CVI Projects Ltd

511185

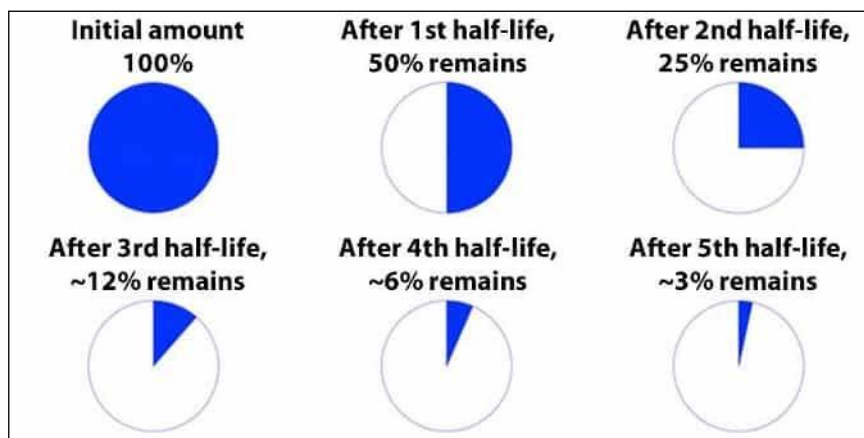
DDT is known for having a half-life ranging from 10 to 30 years in the soil (depending on the soil environment). The half-life of a pesticide in the soil gives the time it takes for the pesticide concentration to decrease to half of the initial concentration. This means that pesticide can still be largely present in the soils after that period of time as explained below.

Figure 4. Approximate amount of pesticide (shaded area) remaining at the application site over time (source: NPIC)

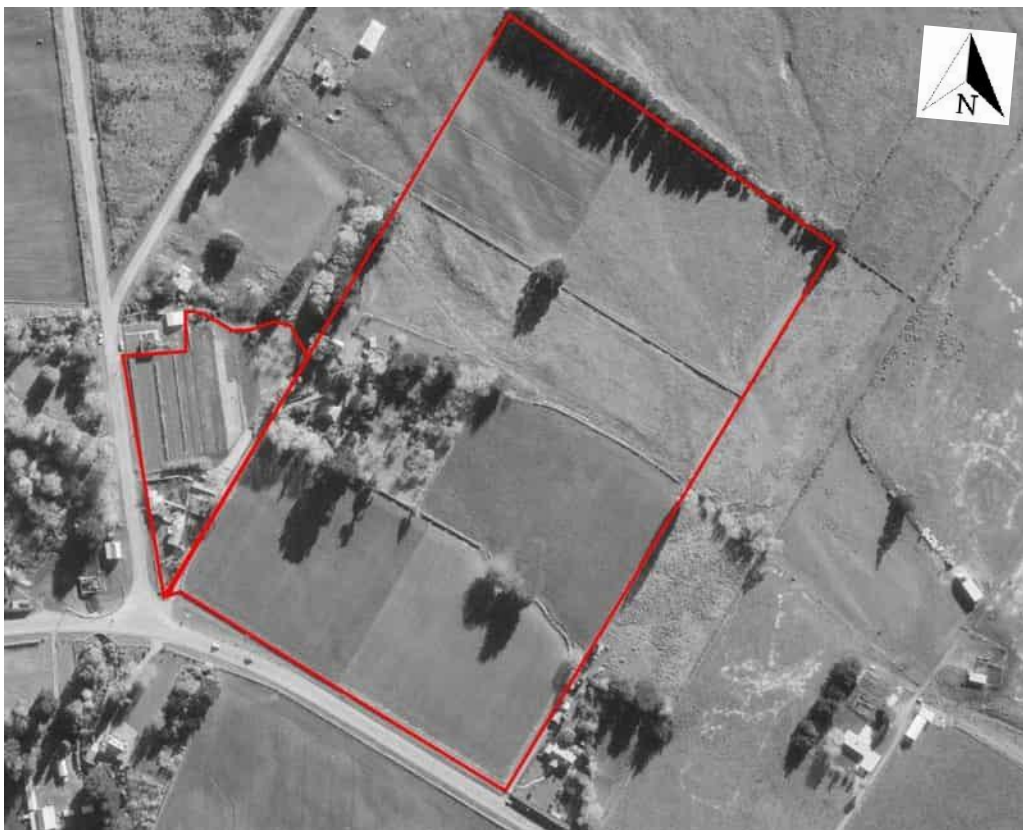
Figure 5 clearly shows market gardens on 4 Golf Links Road, indicating the likely Hail A1 0 of persistent pesticide bulk storage and use. This activity carried on for many years with its first appearance in 1963 and carrying on through till the 1990's.

Aerial imagery of 4 Golf Links Road (left) and 518 Rangiora Woodend Road (right) in 1963 (site boundary outlined in red). Retrieved from Retrolens.

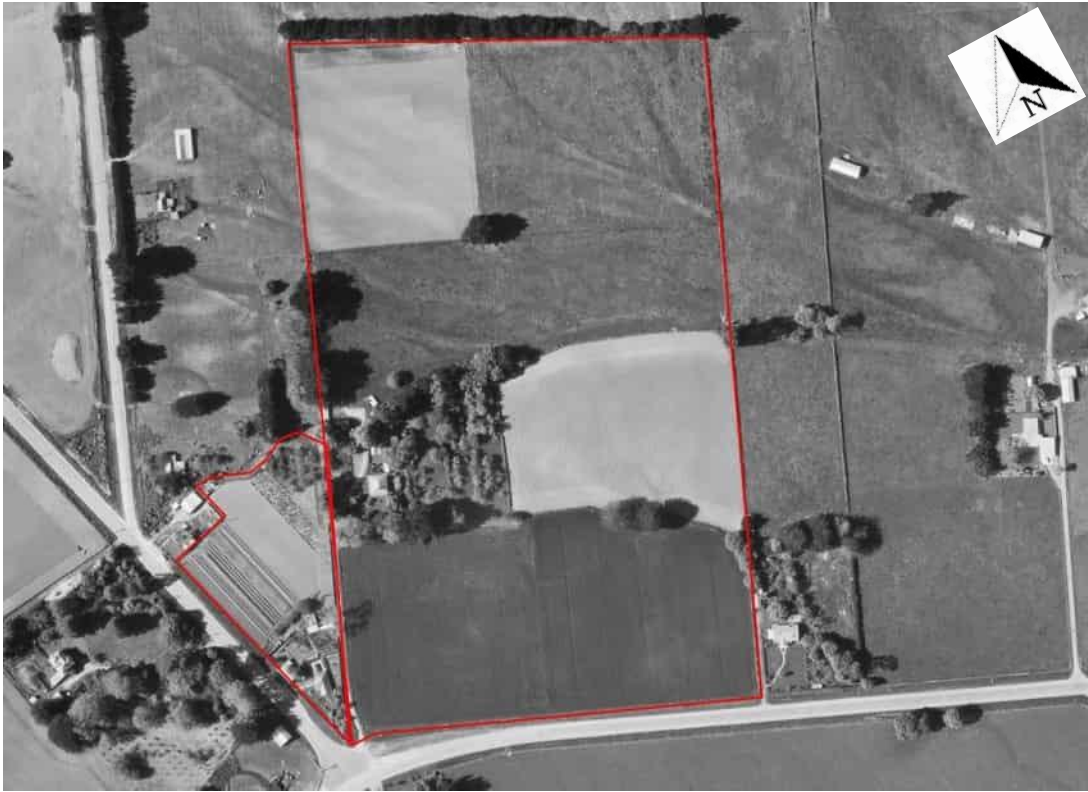
Aerial imagery of 4 Golf Links Road (left) and 518 Rangiora Woodend Road (right) in 1969 (site boundary outlined in red). Retrieved from Retrolens.
