# GEOTECHNICAL REPORT FOR SUBDIVISION

37211 / 2 AUCKLAND STREET, ASHLEY / ALISTAIR CAMERON

**Title:** Geotechnical Report for Subdivision: 2 Auckland Street, Ashley

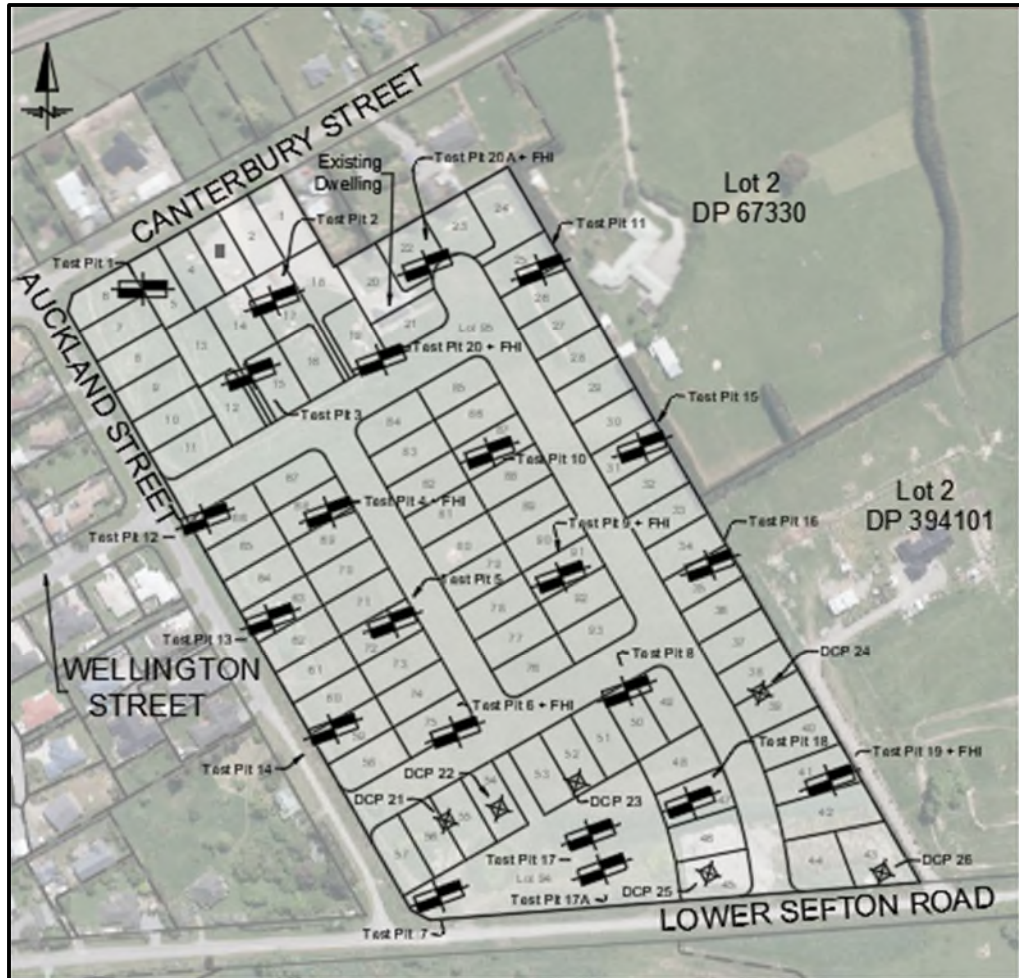
Figure 3: Proposed scheme plan showing test pit and DCP locations and recent aerial image<sup>5</sup>

Based on the scheme plan for the site, the proposed development is to include subdividing the 8.0 ha site into approximately 93 residential lots plus a stormwater disposal area in the south (Lot 94) and access road (Lot 95), as shown in Figure 3<sup>4</sup>. The lots are to be served by an internal roading network with two egresses from Auckland Street and one from Lower Sefton Road. The proposed residential lots are typically 600 m<sup>2</sup> but range from 600 m<sup>2</sup> up to 860 m<sup>2</sup>. Lot 94, the stormwater management area, will be 5600 m<sup>2</sup>,

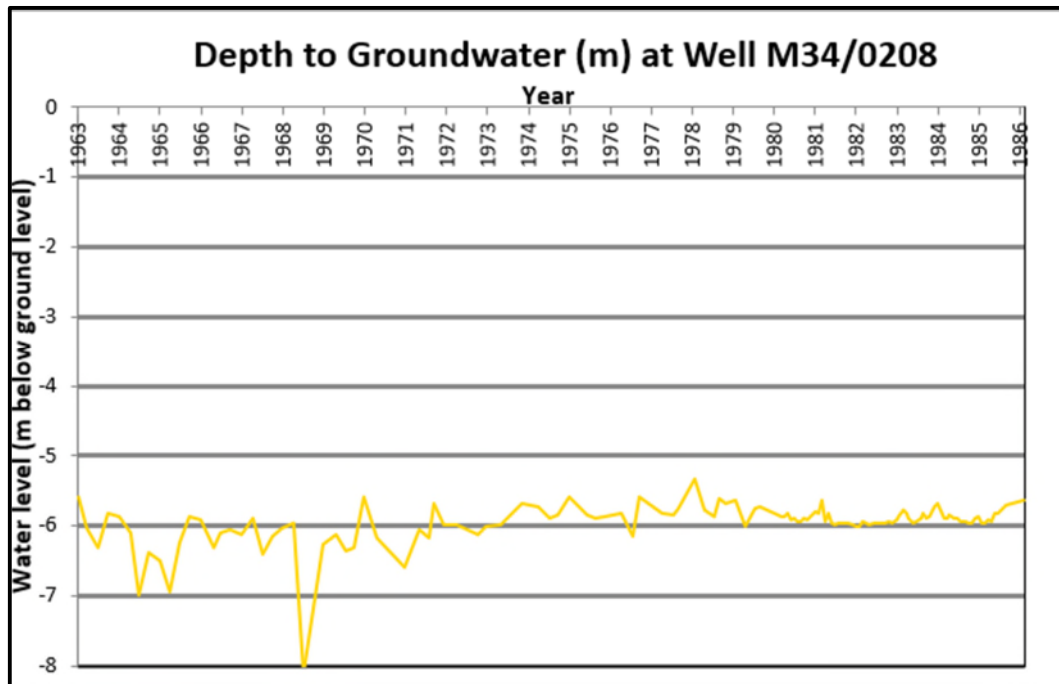
**Figure 5: Groundwater monitoring data from well M34/0208 (480 m from the site) showing measured depths to groundwater below ground level (in meters) between 1963 to 1986 (generally 3 to 4 measurements recorded annually).**

Groundwater depths in well M34/0208, 480 m west of the site near the intersection of Fawcetts and Boundary Roads, were recorded during a 23-year period between 1963 and 1986. The results are presented in Figure 5 and show a median depth to groundwater during this period of 5.9 m below ground level, and a minimum depth of 5.3 m at this location.

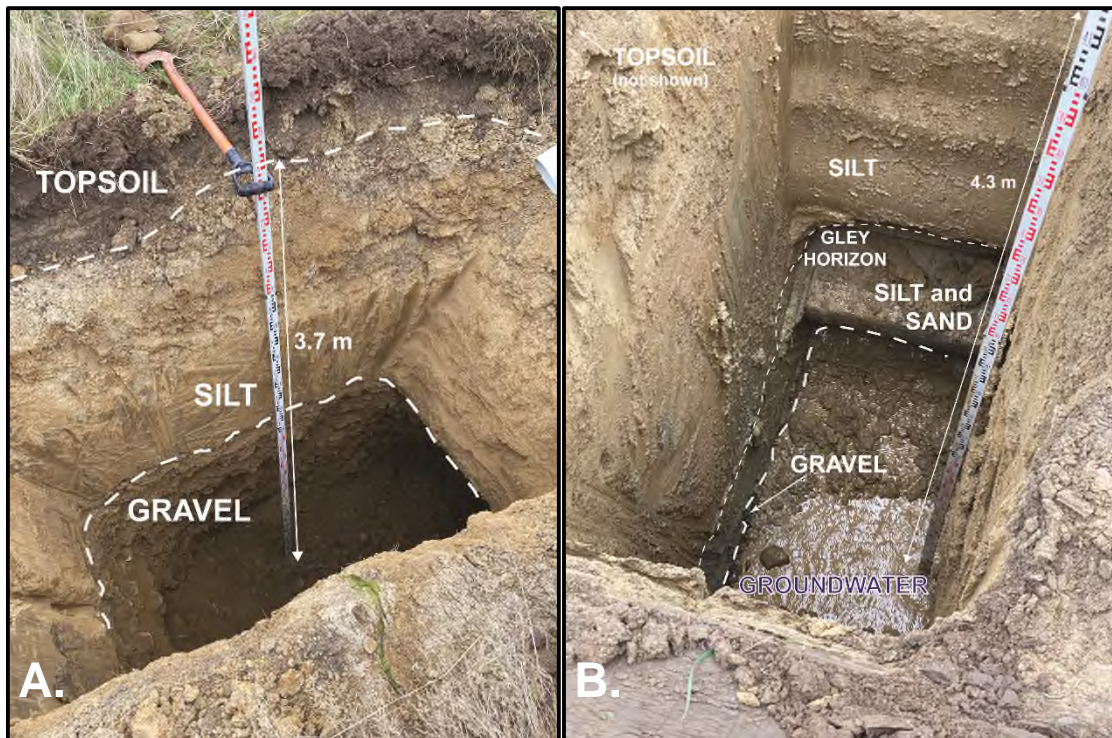
Figure 6: Examples of the soil profile encountered in the north of the site:

- A) TP20a, where gravel was encountered at relatively shallow depths; and south of the site:
- B) TP7 where gravel was encountered at greater depths beneath a saturated gley horizon.

Typical soil profiles revealed by the TPs are shown in Figure 6 and DCP profiles are presented in Figure 7. This figure shows the variation between blow counts with depth over most of the site compared to those in the south. A summary of the soil profiles encountered at each test location is provided in Table 1A-C and full logs are included in **Appendix C**. The depth to gravel encountered across the site is presented on a site plan in Figure 8.

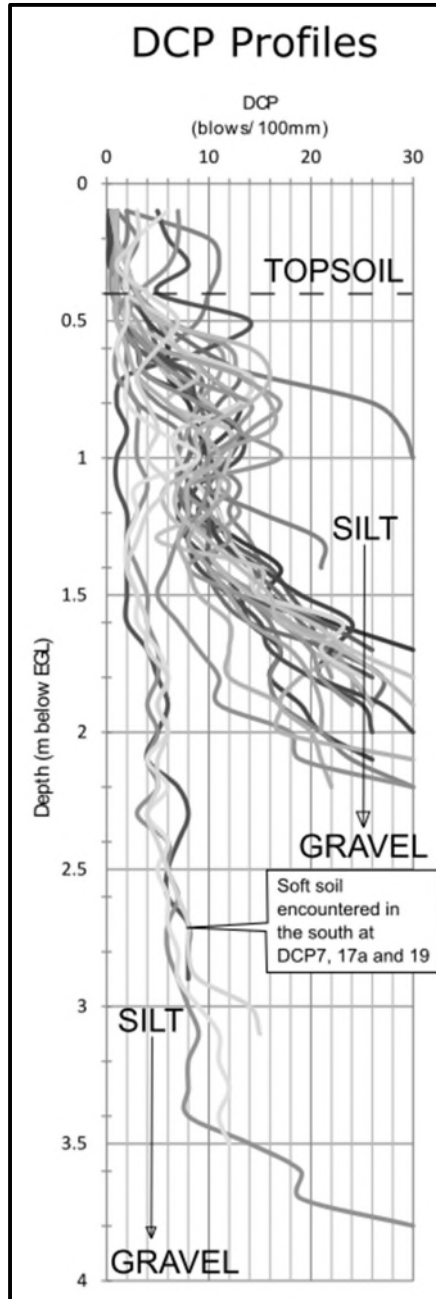
**Figure 7: DCP profiles through topsoil and silt (overlying gravel, not reached by DCPs). Results show a consistent trend, except for DCP 7, 17a and 19 in the south of the site where soft, wet silt was encountered at deep.**

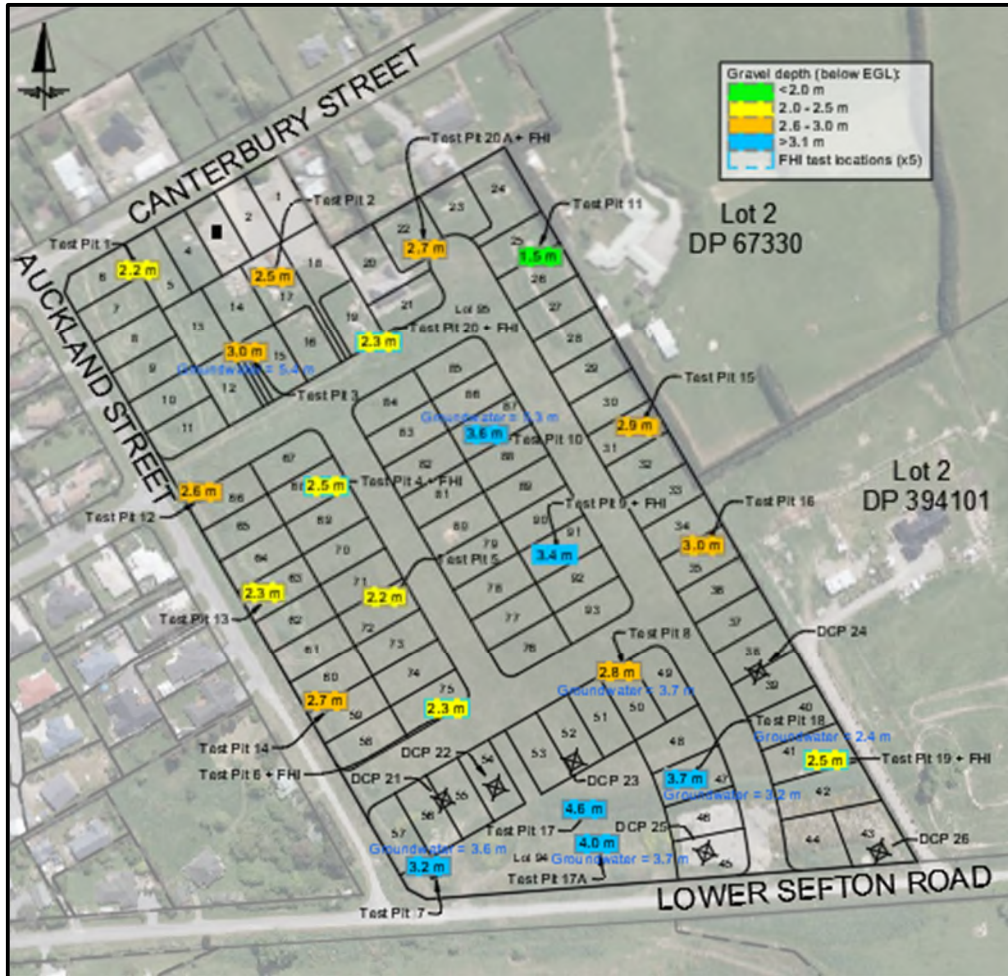
**Figure 8: Proposed scheme plan annotated to show the approximate depth to gravel and groundwater (m below EGL) measured in test pit excavations during the site investigation.**

**\*Possible seepage encountered at 2.4m depth in TP19.**

As shown in Figure 8, groundwater was encountered in some of the TP excavations at between 2.4 – 5.4 m below EGL, with the median depth being 3.7 m below EGL. Groundwater was encountered at a shallower depth in the south of the site (2.4 – 3.7 m below EGL) compared with measurement in the north (up to 5.4 m below EGL). This is, albeit broadly, consistent with groundwater wells in the area as discussed in Section 2.2. Due to the varied ground level across the site, the depth to water measured below relative ground level broadly reflected changes in topography.

Tps encountered groundwater within the gravel unit. In the south of the site, where the depth to gravel was greater, the initial level of the water strike gradually rose to the lower levels of the overlying silt (and interbedded sand) unit. This is consistent with the observed presence of a gleysol horizon overlying the gravel indicating long-term saturation of the silt.

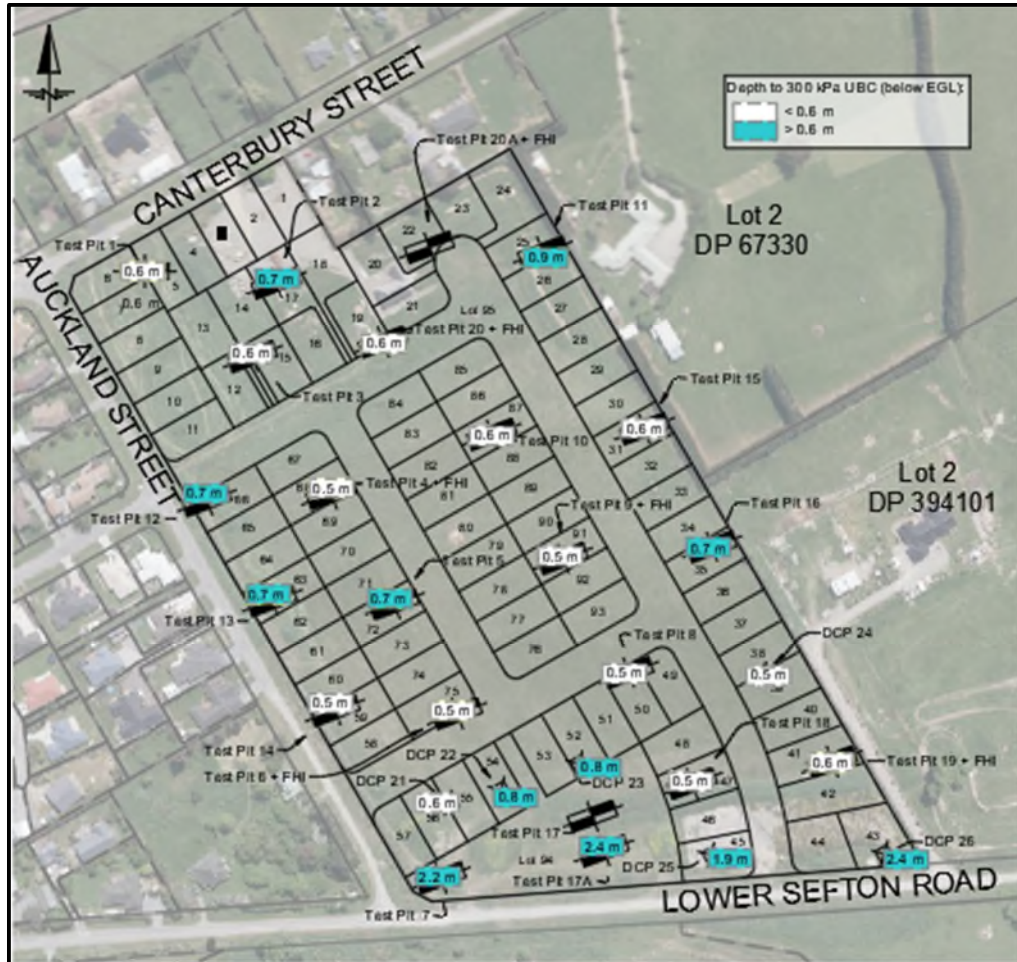
Figure 10: Map of the proposed development showing the depth 300 kPa (UBC) below EGL encountered across the site.

Based on the in-situ DCP testing, a static UBC of 300 kPa is achieved at depths ranging from 0.5 – 2.4 m below EGL, as shown on the map in Figure 10. The maximum depth at which “good ground” has been assigned at the site is  $\leq 0.6$  m relative to EGL. This is considered a maximum practical depth where standard (NZS 3604:2011) foundation options are considered suitable. In addition, NZS 3604 states that “*Specific Engineer Design (SED) foundations are required if filling is in excess of 600 mm.*” Where the depth to 300 kPa UBC exceeds a depth of 0.6 m below EGL (i.e., below normal foundation depths), an UBC of 200 kPa is recommended with SED for concrete slab foundations. Table 3 summarises the depth to 300 kPa and 200 kPa UBC encountered at the location of the DCP testing. We note, however, that the testing was undertaken during winter and the prevailing weather conditions could have increased the moisture content and softened the near-surface soils. Testing during drier seasons may encounter different results.

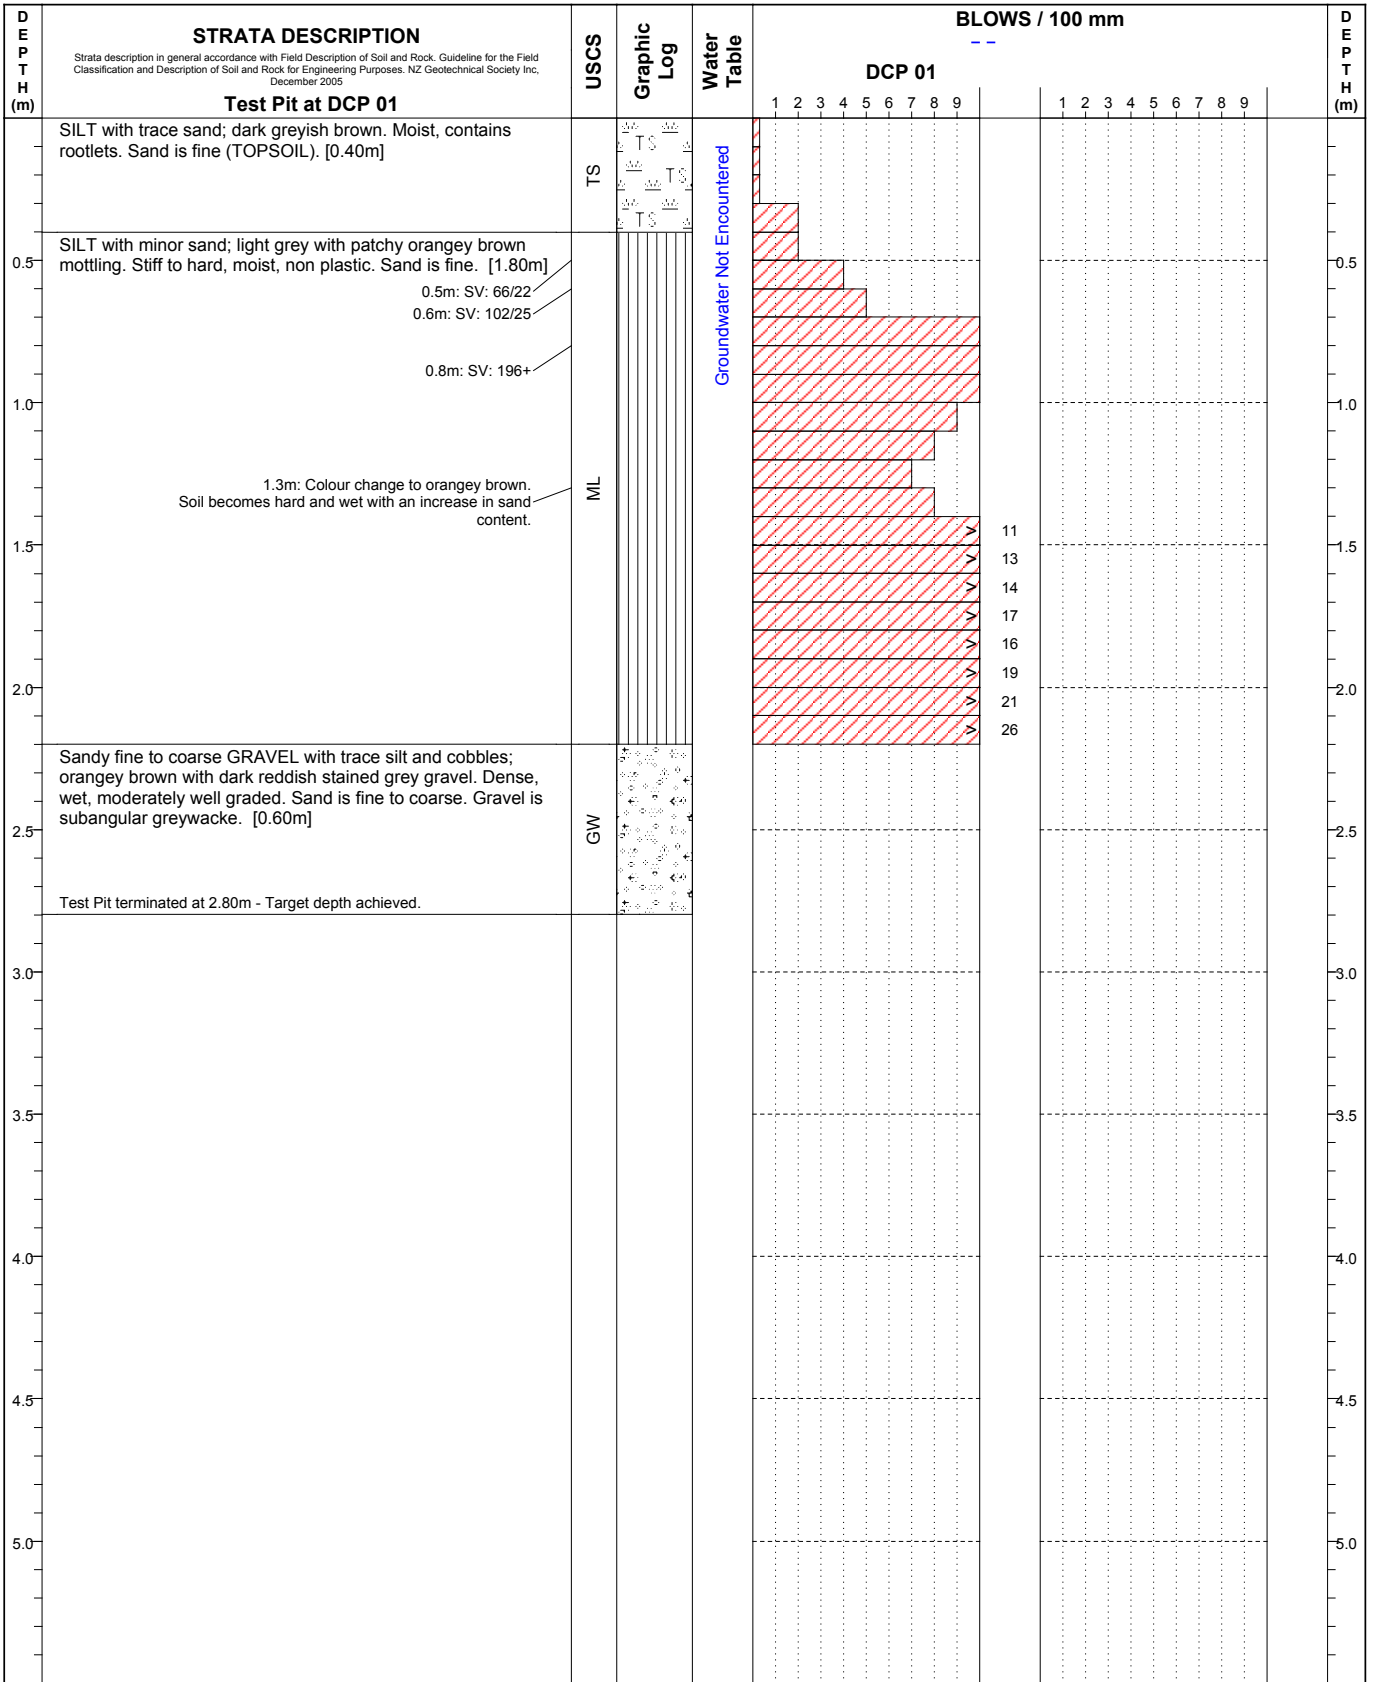
<b>Project:</b> 2 Auckland Street, Ashley (Lot 1 DP 394101) <b>Client:</b> A J Cameron <b>Test Location:</b> Refer to attached Geotechnical Site Plan (G01A).	<b>Date:</b> 24/06/20 <b>Time:</b> 10:00 a.m. <b>Excavation Method:</b> 13T Ex+DCP
---	--

<b>Logged By:</b> AB+HC <b>Plotted By:</b> KL <b>Checked By:</b> HC	<b>Notes:</b> Shear vane (SV): peak/remoulded (kPa)	Dynamic Penetrometer Test and logs give an indication of the ground condition at the location of the tests only. While they are representative of typical conditions across the site, they do not identify variations in the ground away from the test locations. This log does not cover slope stability or suitability of the site for building.  Dynamic Cone Penetrometer Test performed in accordance with NZS 4402 Test 6.5.2 (Procedure 1 and 2)
---	---	---

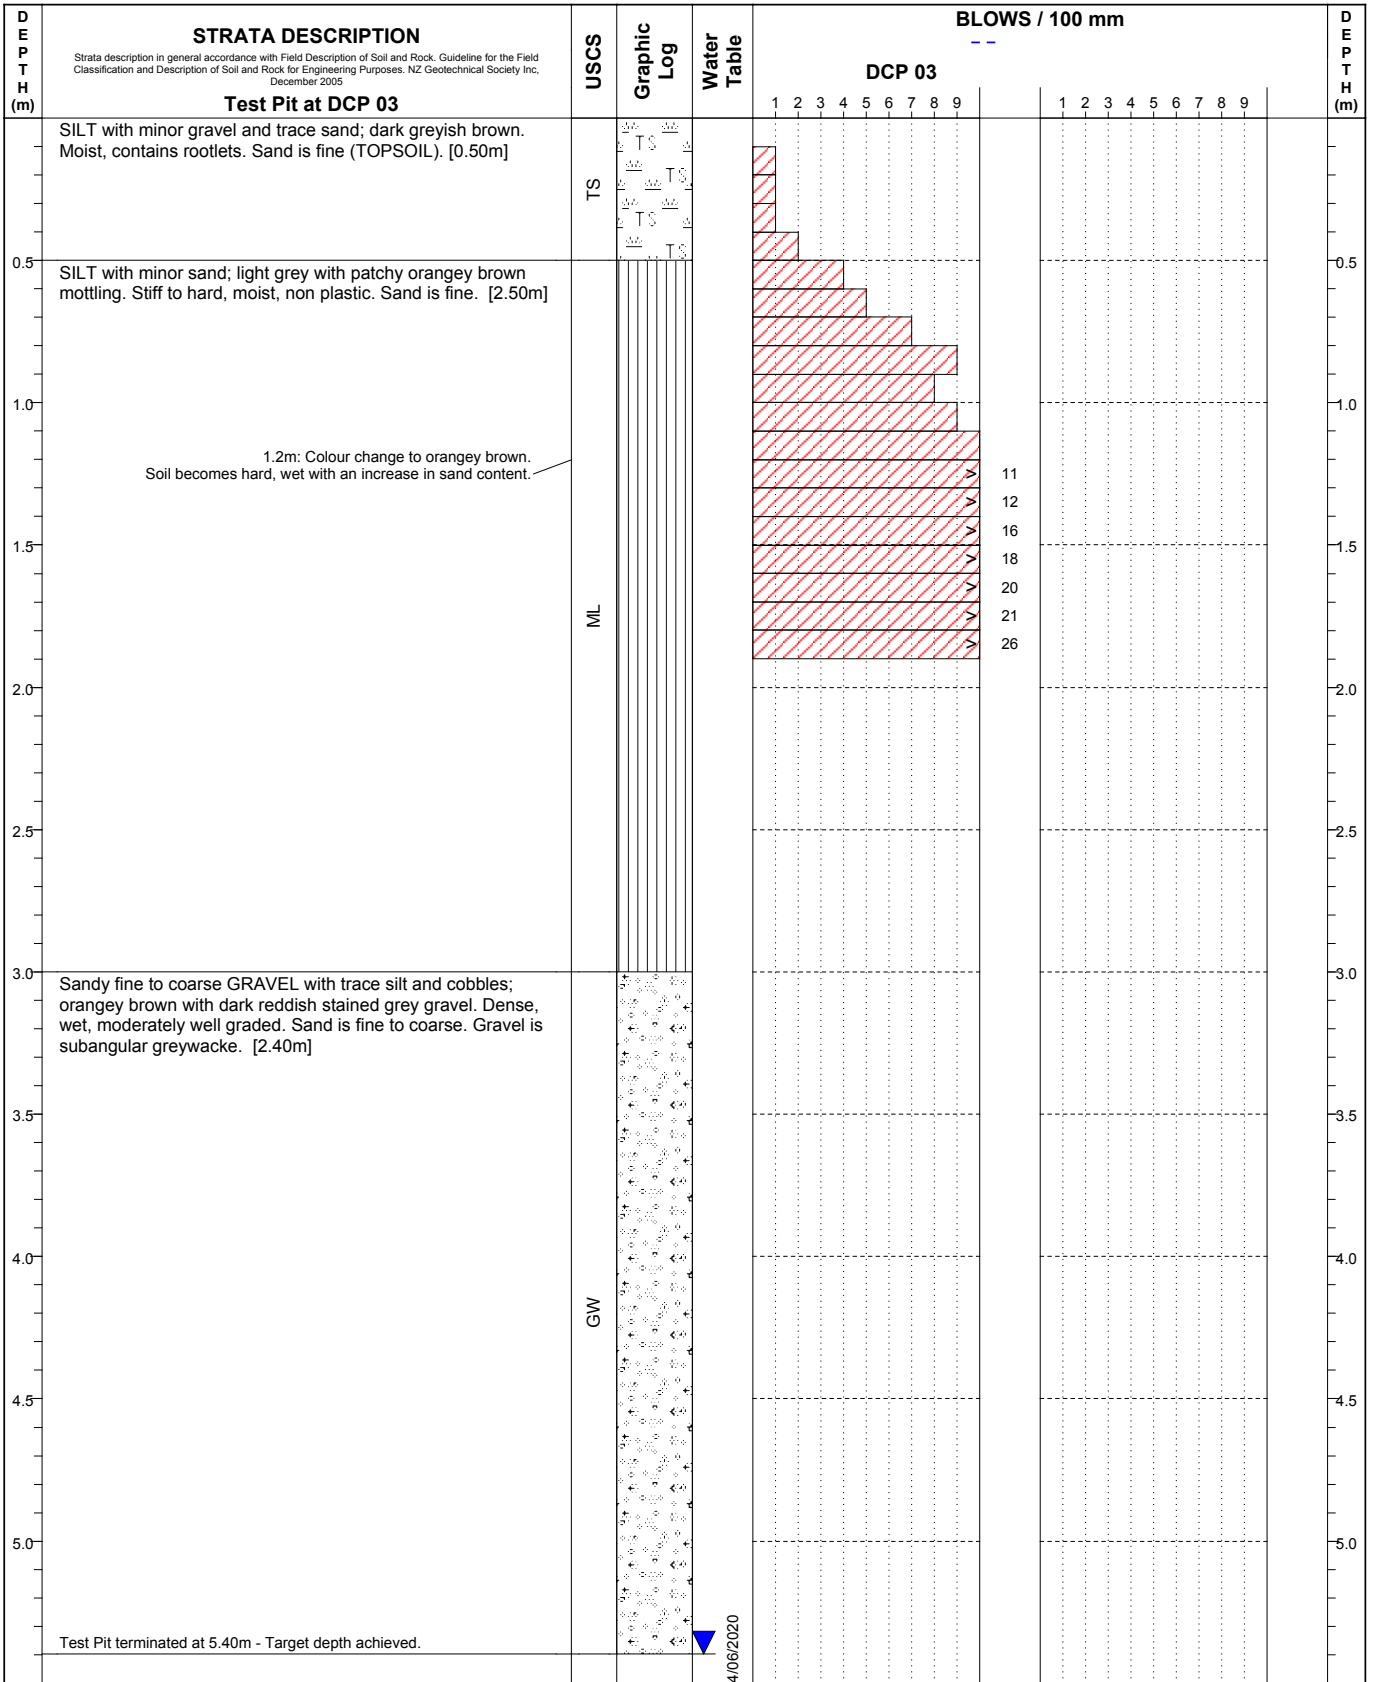
<b>Project:</b> 2 Auckland Street, Ashley (Lot 1 DP 394101) <b>Client:</b> A J Cameron <b>Test Location:</b> Refer to attached Geotechnical Site Plan (G01A).	<b>Date:</b> 24/06/20 <b>Time:</b> 10:00 a.m. <b>Excavation Method:</b> 13T Ex+DCP
---	--

<b>Logged By:</b> AB+HC <b>Plotted By:</b> KL <b>Checked By:</b> HC	<b>Notes:</b>  Dynamic Penetrometer Test and logs give an indication of the ground condition at the location of the tests only. While they are representative of typical conditions across the site, they do not identify variations in the ground away from the test locations. This log does not cover slope stability or suitability of the site for building.  Dynamic Cone Penetrometer Test performed in accordance with NZS 4402 Test 6.5.2 (Procedure 1 and 2)
---	--

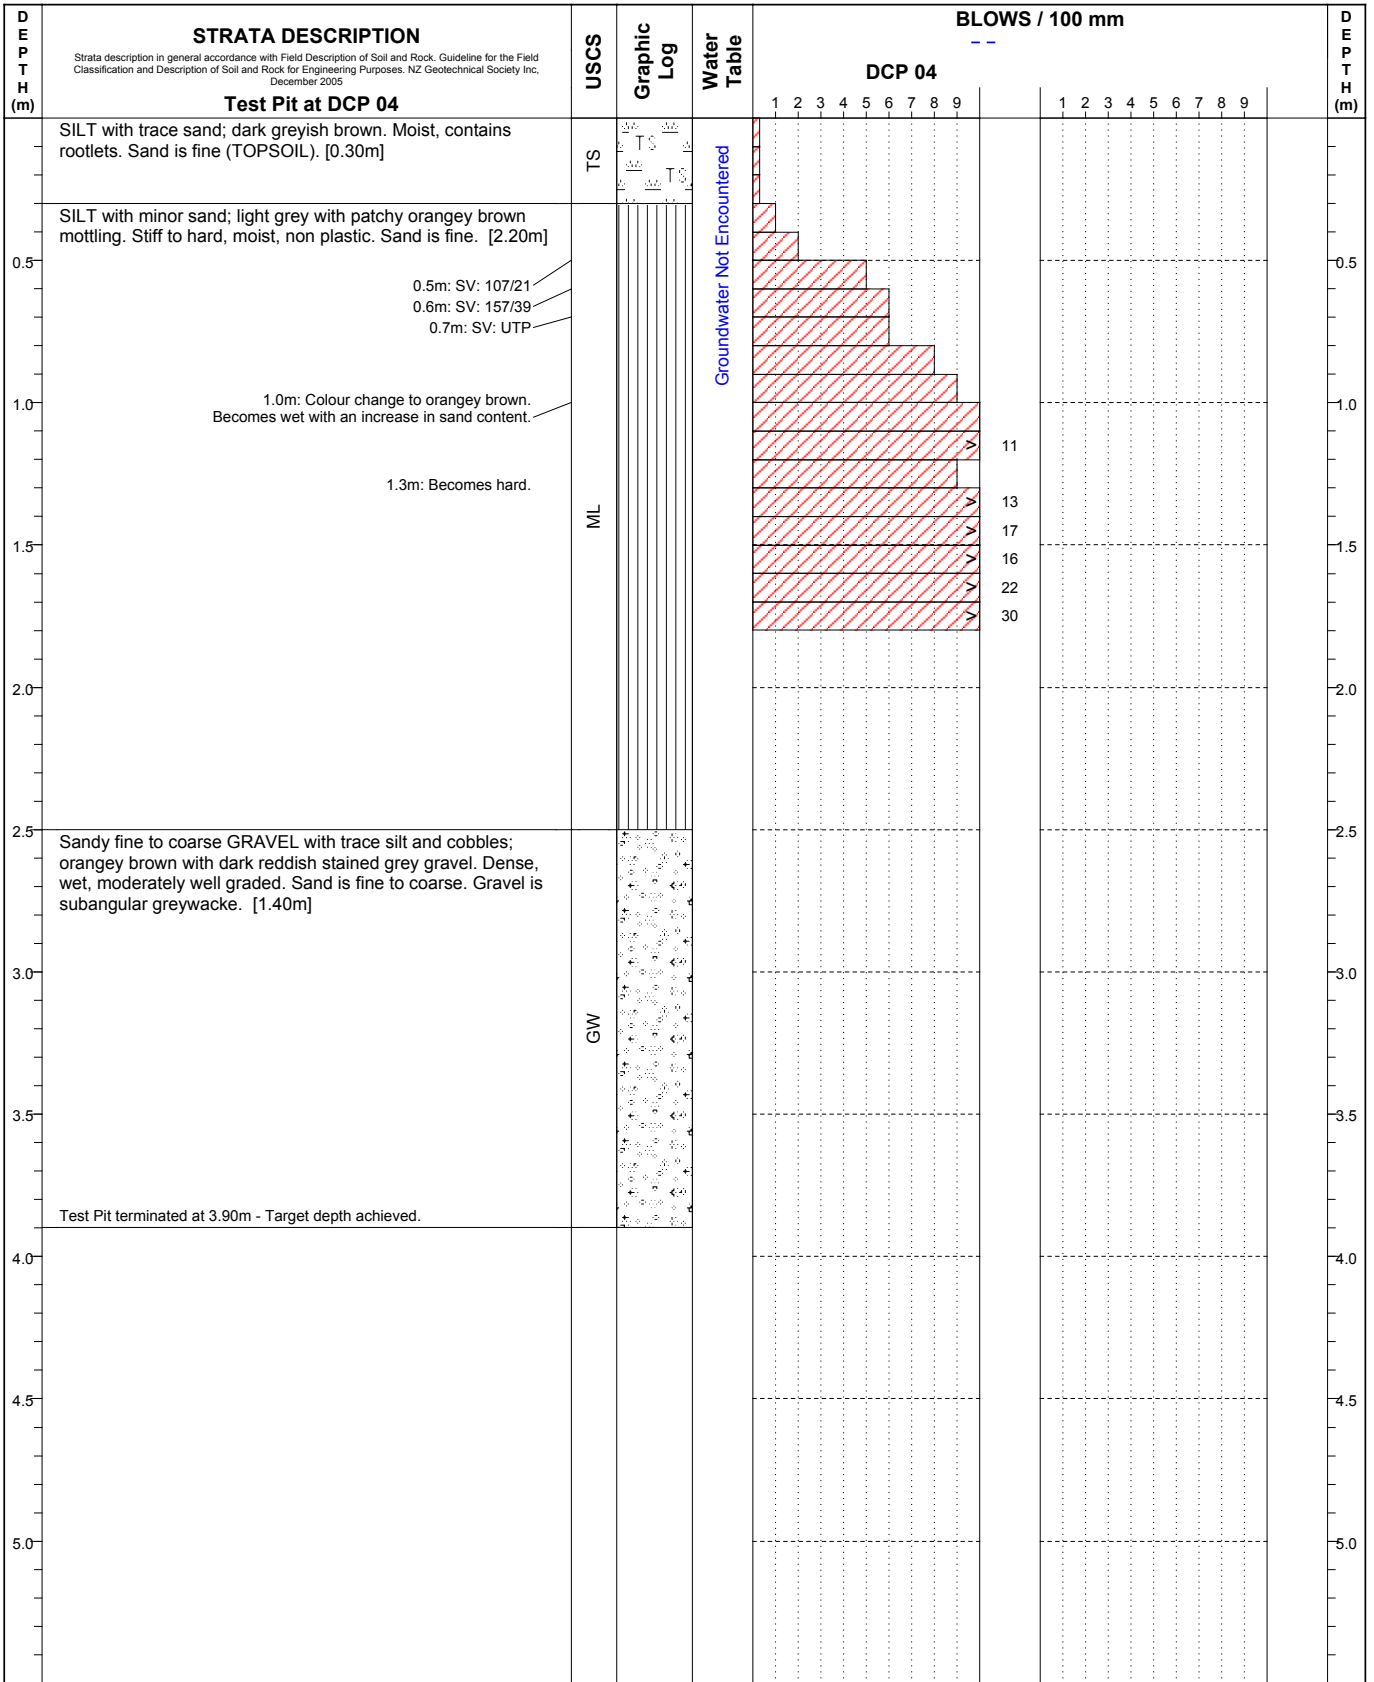
<b>Project:</b> 2 Auckland Street, Ashley (Lot 1 DP 394101) <b>Client:</b> A J Cameron <b>Test Location:</b> Refer to attached Geotechnical Site Plan (G01A).	<b>Date:</b> 25/06/20 <b>Time:</b> 10:00 a.m. <b>Excavation Method:</b> 13T Ex+DCP
---	--

<b>Logged By:</b> AB+HC <b>Plotted By:</b> KL <b>Checked By:</b> HC	<b>Notes:</b> Shear vane (SV): peak/remoulded (kPa) Unable to penetrate with SV (UTP) IT3 = TP4	Dynamic Penetrometer Test and logs give an indication of the ground condition at the location of the tests only. While they are representative of typical conditions across the site, they do not identify variations in the ground away from the test locations. This log does not cover slope stability or suitability of the site for building.  Dynamic Cone Penetrometer Test performed in accordance with NZS 4402 Test 6.5.2 (Procedure 1 and 2)
---	---	---

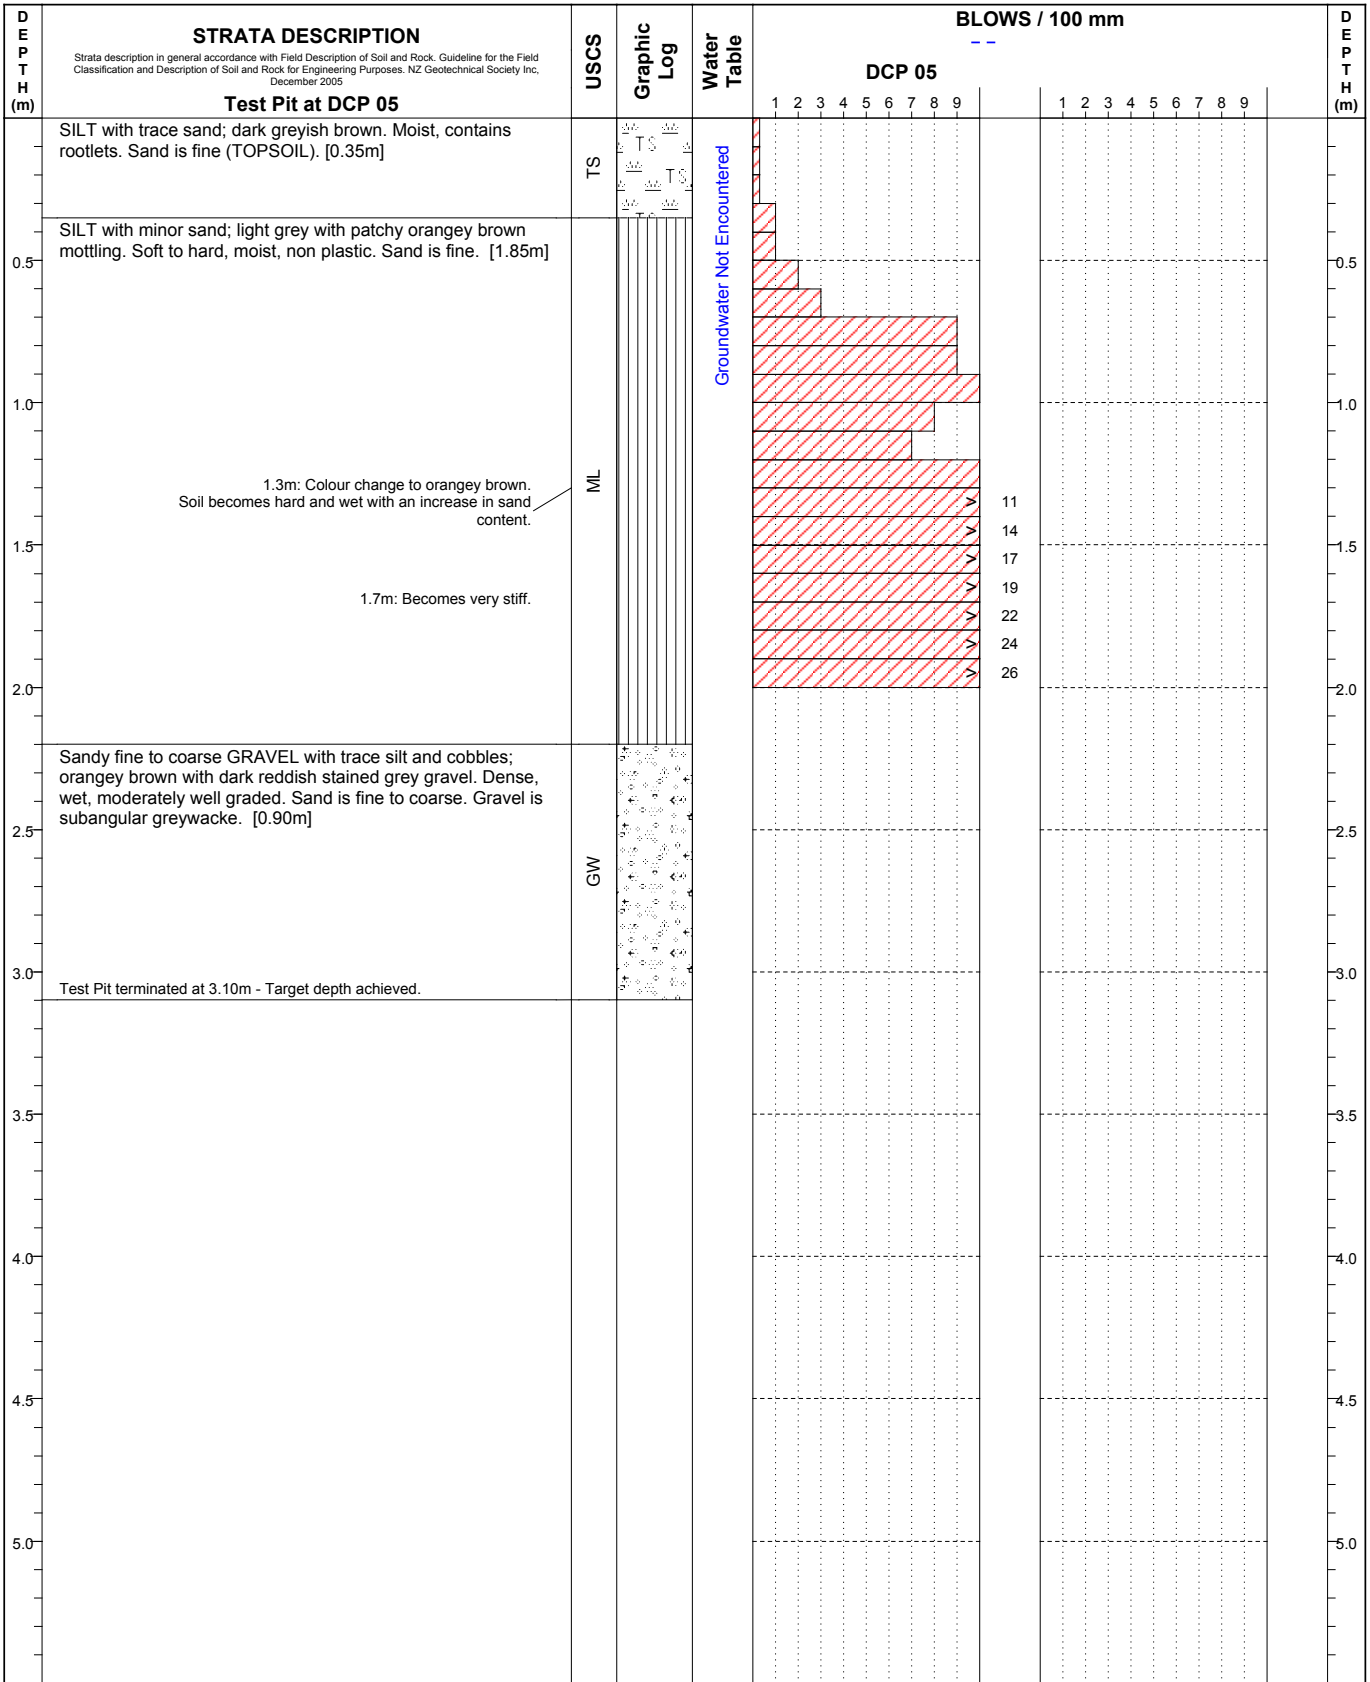
<b>Project:</b> 2 Auckland Street, Ashley (Lot 1 DP 394101)	<b>Date:</b> 25/06/20
<b>Client:</b> A J Cameron	<b>Time:</b> 10:00 a.m.
<b>Test Location:</b> Refer to attached Geotechnical Site Plan (G01A).	<b>Excavation Method:</b> 13T Ex+DCP

<b>Logged By:</b> AB+HC	<b>Notes:</b>  Dynamic Penetrometer Test and logs give an indication of the ground condition at the location of the tests only. While they are representative of typical conditions across the site, they do not identify variations in the ground away from the test locations. This log does not cover slope stability or suitability of the site for building.  Dynamic Cone Penetrometer Test performed in accordance with NZS 4402 Test 6.5.2 (Procedure 1 and 2)
<b>Plotted By:</b> KL	
<b>Checked By:</b> HC

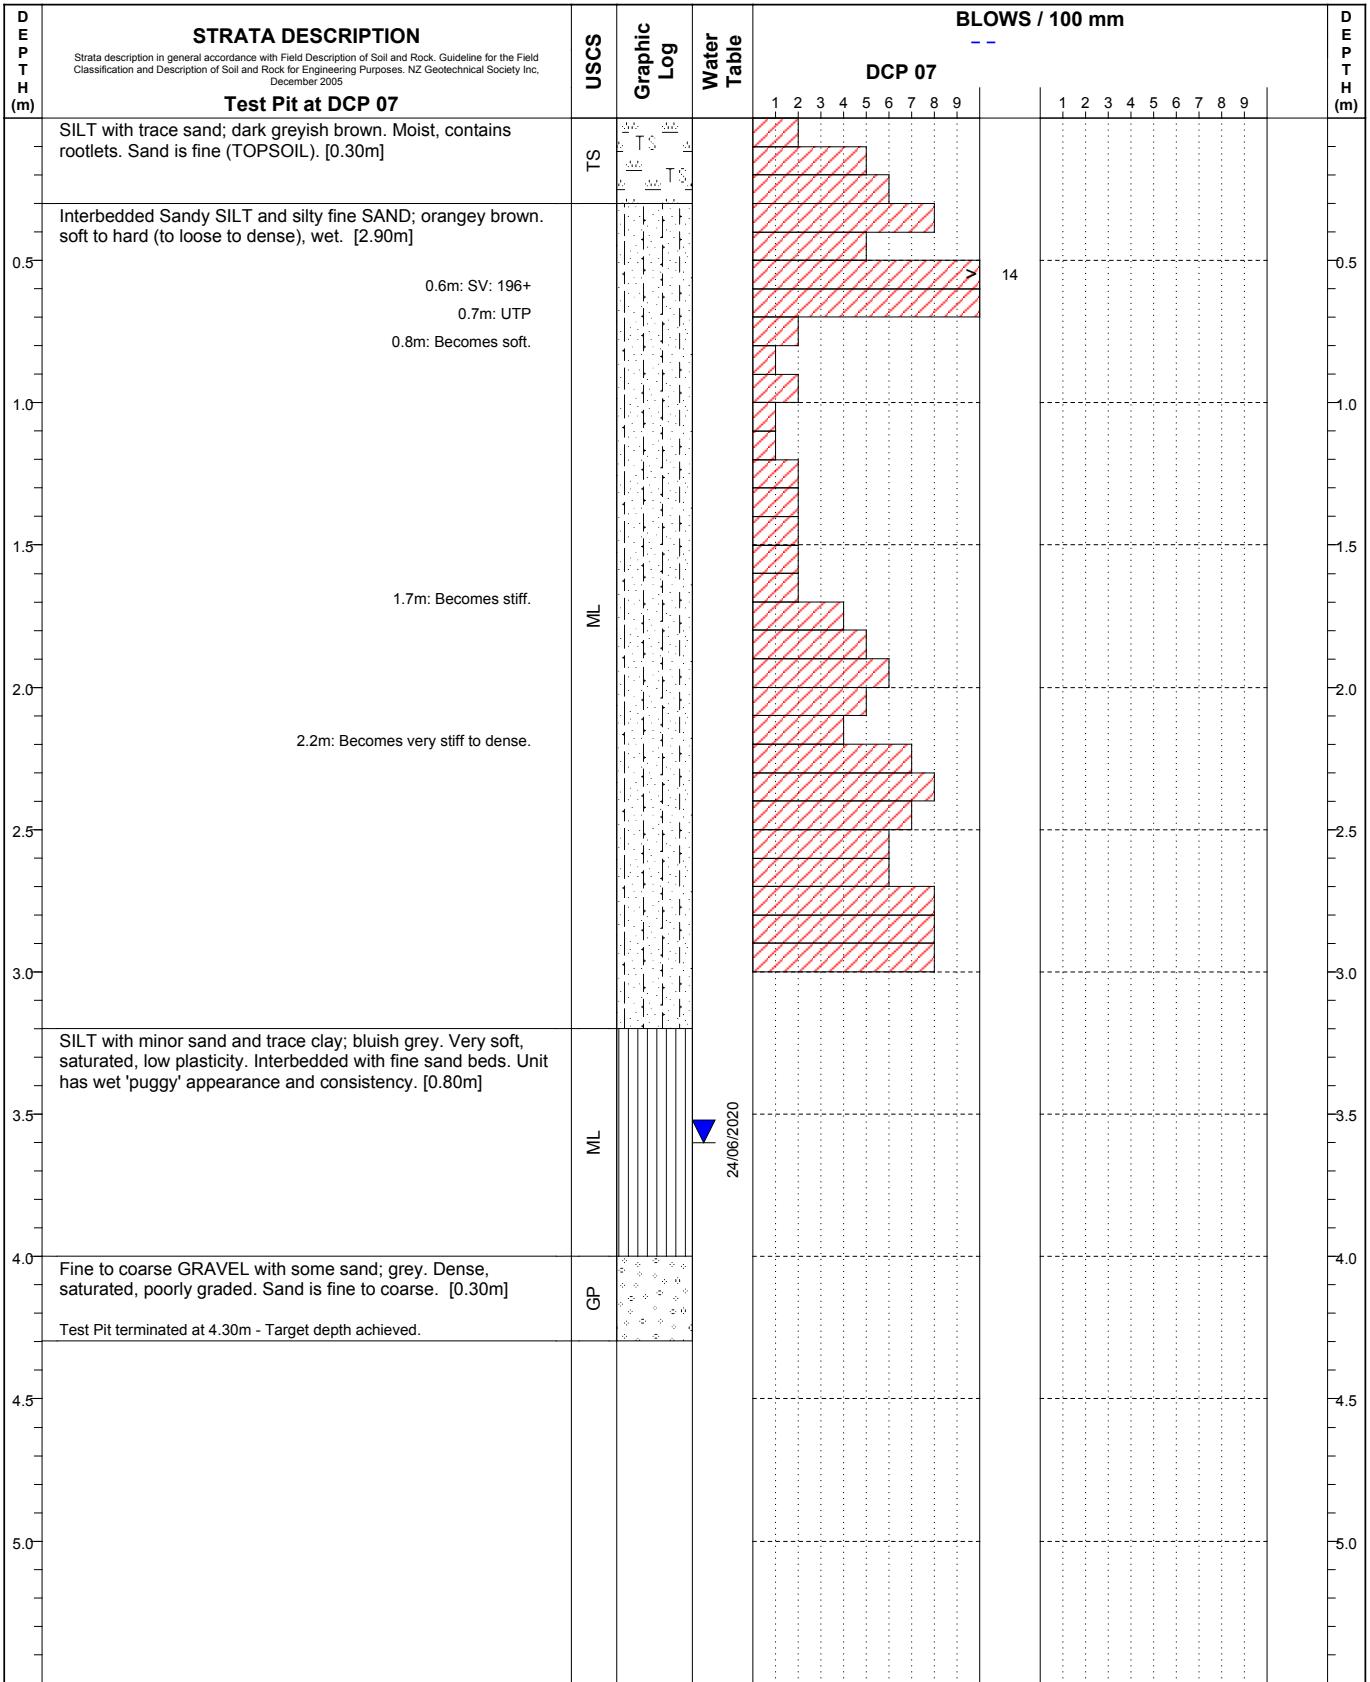
<b>Logged By:</b> AB+HC <b>Plotted By:</b> KL <b>Checked By:</b>	<b>Notes:</b>	Dynamic Penetrometer Test and logs give an indication of the ground condition at the location of the tests only. While they are representative of typical conditions across the site, they do not identify variations in the ground away from the test locations. This log does not cover slope stability or suitability of the site for building.  Dynamic Cone Penetrometer Test performed in accordance with NZS 4402 Test 6.5.2 (Procedure 1 and 2)
--	---------------	---

<b>Project:</b> 2 Auckland Street, Ashley (Lot 1 DP 394101) <b>Client:</b> A J Cameron <b>Test Location:</b> Refer to attached Geotechnical Site Plan (G01A).	<b>Date:</b> 24/06/20 <b>Time:</b> 10:00 a.m. <b>Excavation Method:</b> 13T Ex+DCP
---	--

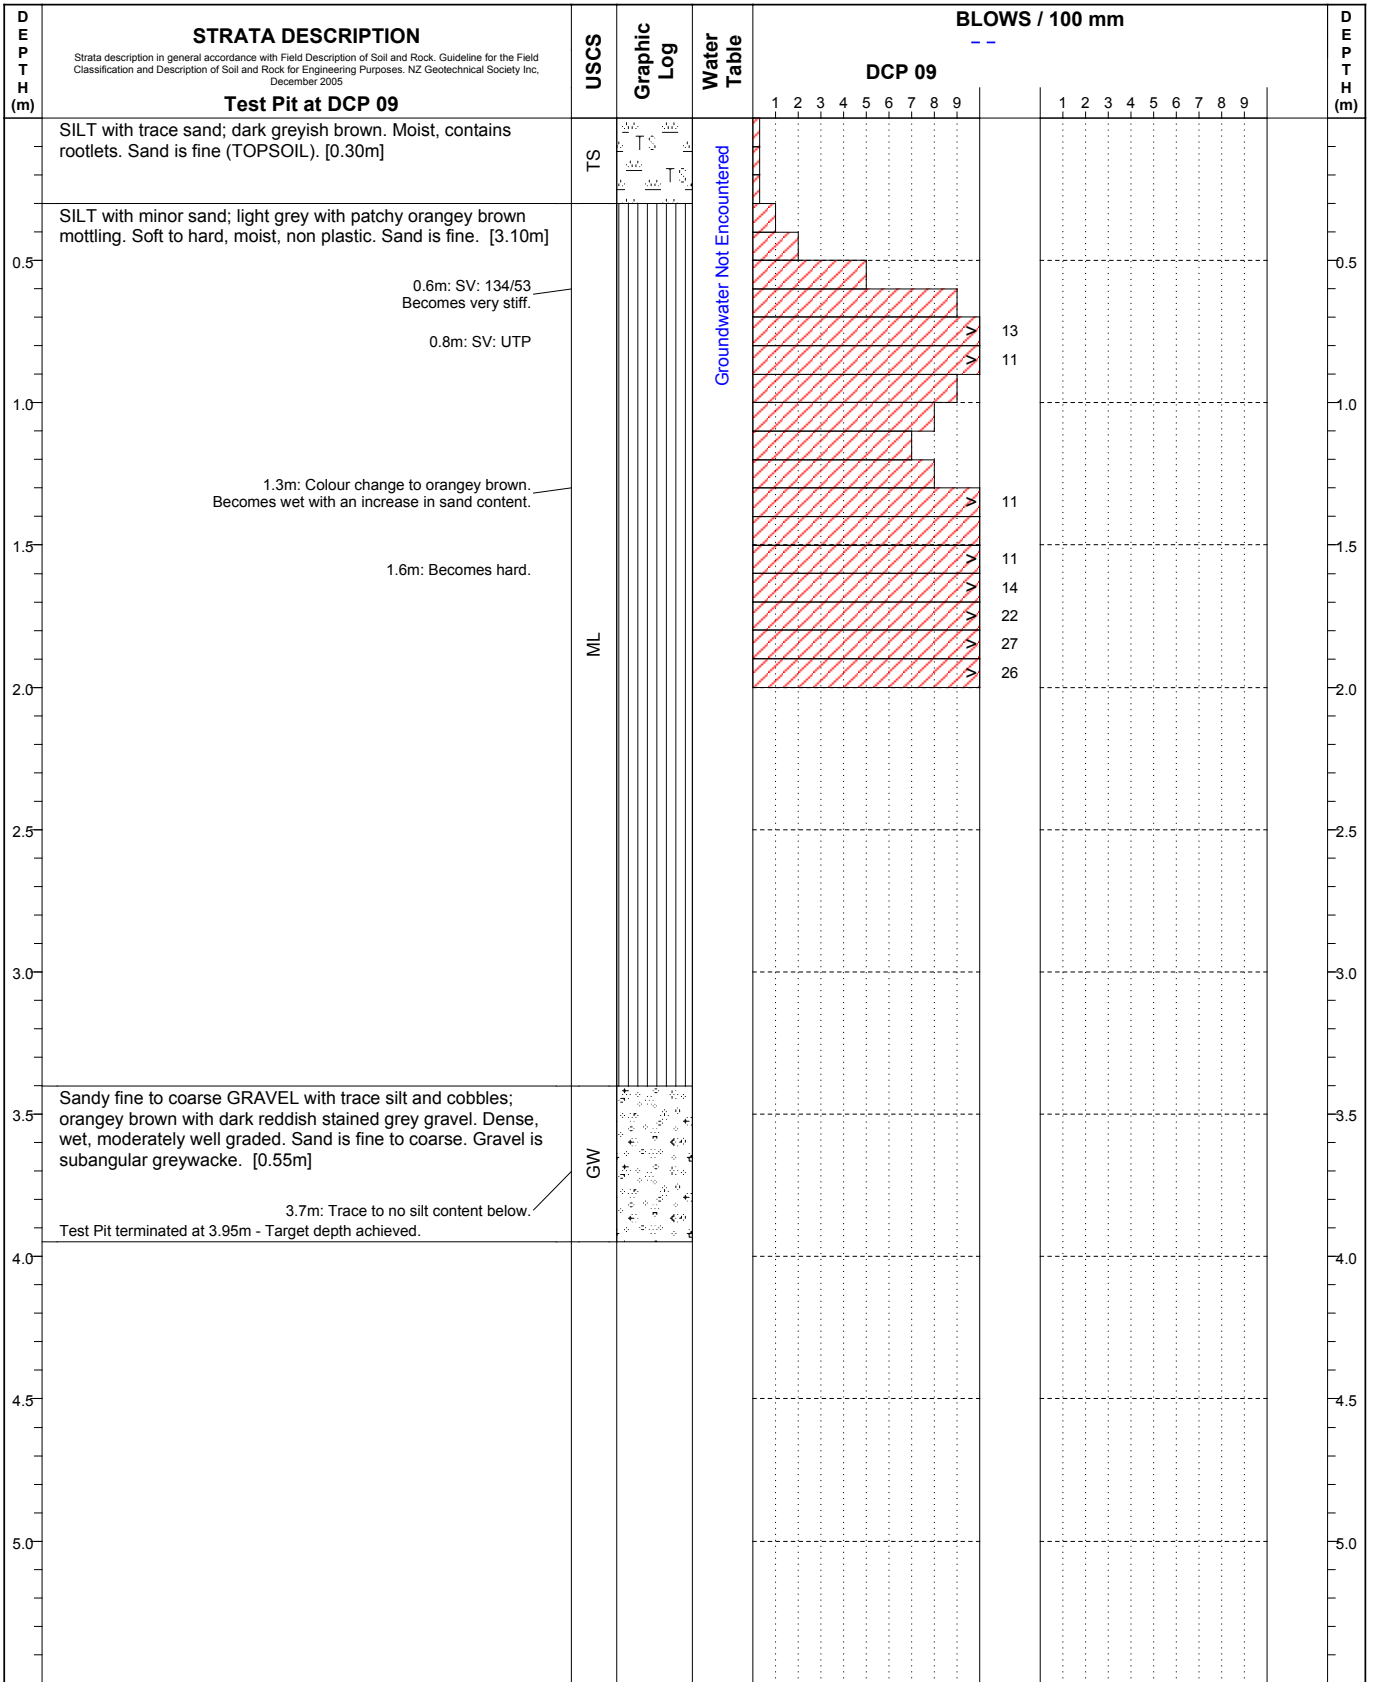
<b>Logged By:</b> AB+HC <b>Plotted By:</b> KL <b>Checked By:</b> HC	<b>Notes:</b>  Dynamic Penetrometer Test and logs give an indication of the ground condition at the location of the tests only. While they are representative of typical conditions across the site, they do not identify variations in the ground away from the test locations. This log does not cover slope stability or suitability of the site for building.  Dynamic Cone Penetrometer Test performed in accordance with NZS 4402 Test 6.5.2 (Procedure 1 and 2)
---	--

<b>Project:</b> 2 Auckland Street, Ashley (Lot 1 DP 394101) <b>Client:</b> A J Cameron <b>Test Location:</b> Refer to attached Geotechnical Site Plan (G01A).	<b>Date:</b> 25/06/20 <b>Time:</b> 10:00 a.m. <b>Excavation Method:</b> 13T Ex+DCP
---	--
