# GEOTECHNICAL REPORT FOR SUBDIVISION

37211 / 2 AUCKLAND STREET, ASHLEY / ALISTAIR CAMERON

**Title:** Geotechnical Report for Subdivision: 2 Auckland Street, Ashley

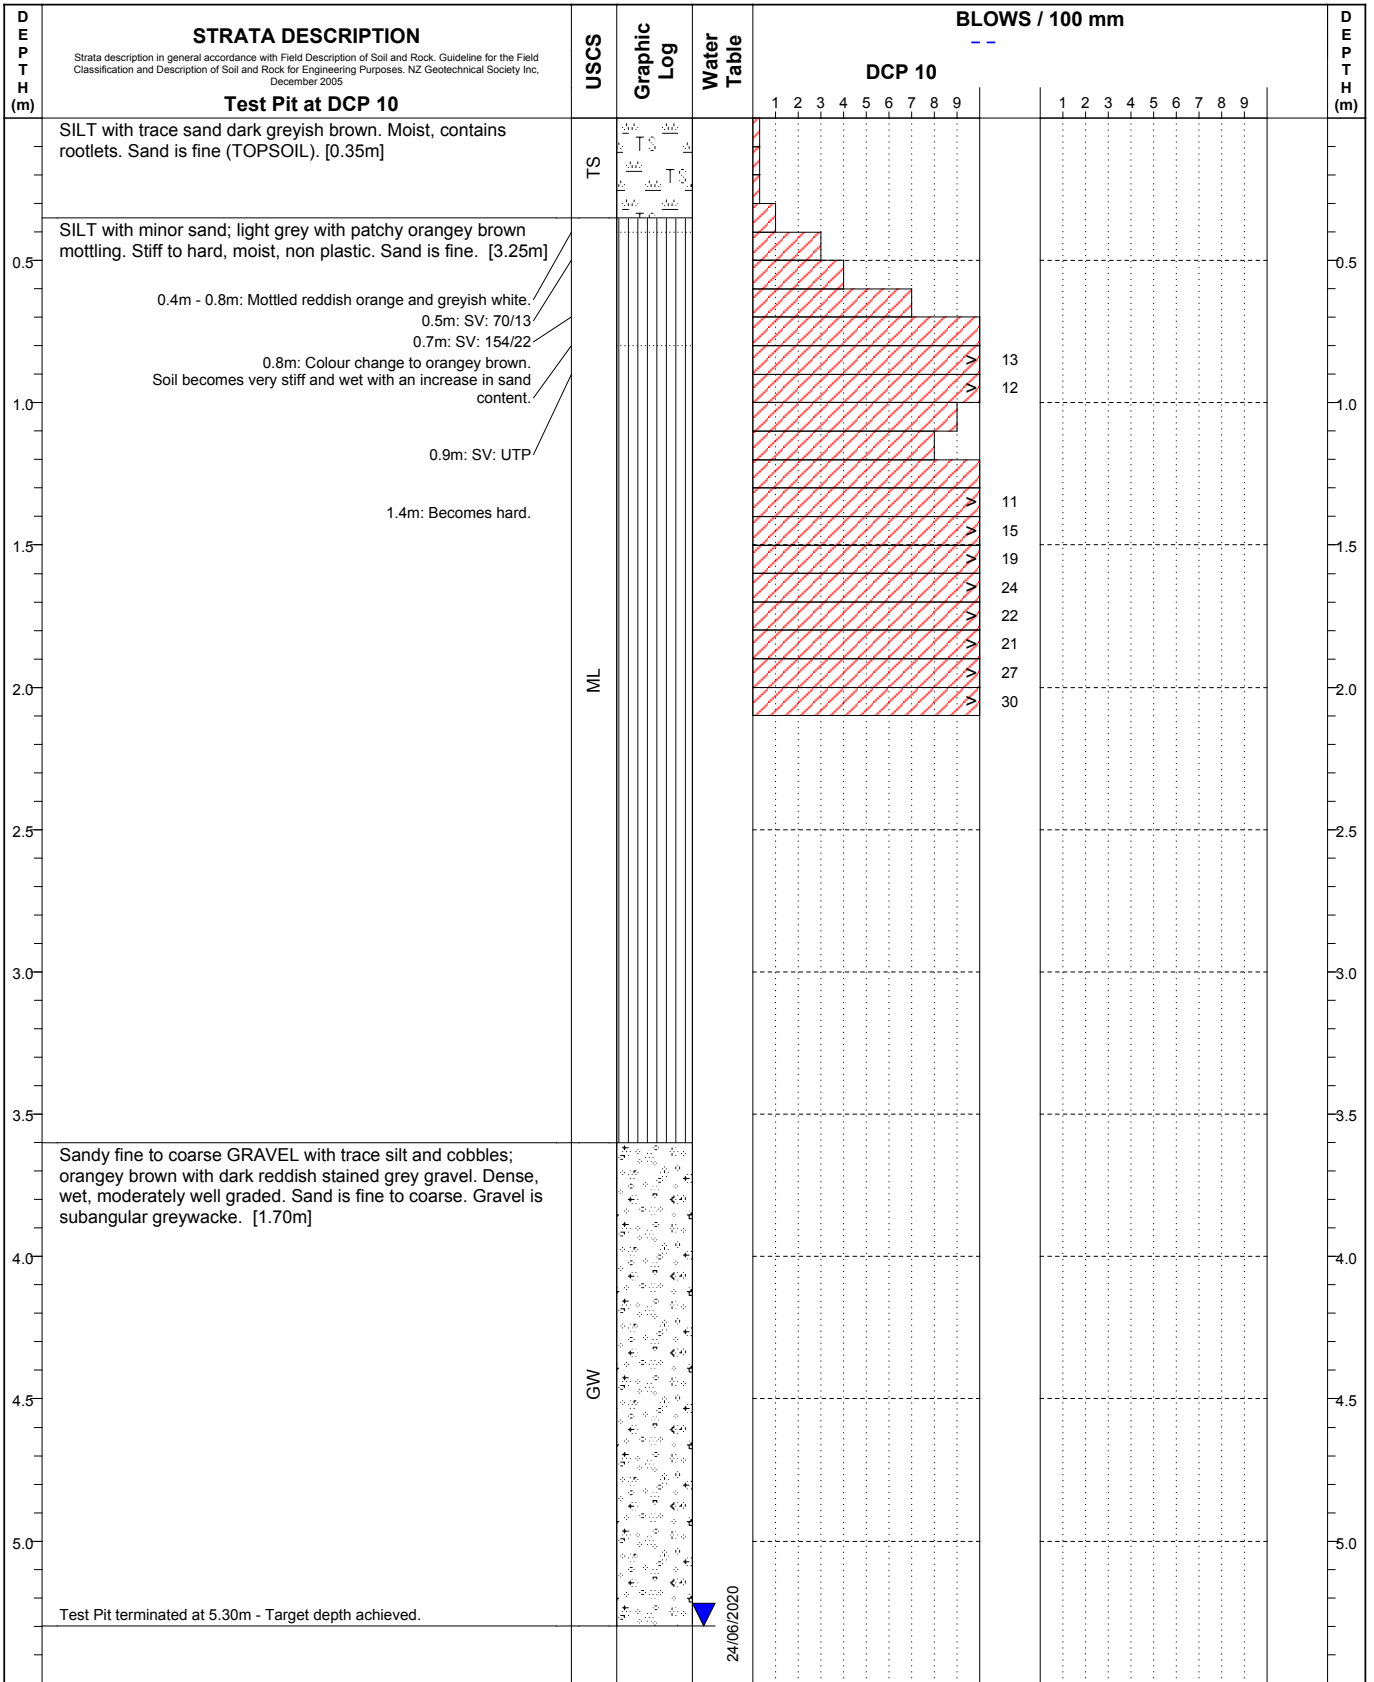
<b>Logged By:</b> AB+HC <b>Plotted By:</b> KL <b>Checked By:</b> HC	<b>Notes:</b> Shear vane (SV): peak/remoulded (kPa) Unable to penetrate with SV (UTP)	Dynamic Penetrometer Test and logs give an indication of the ground condition at the location of the tests only. While they are representative of typical conditions across the site, they do not identify variations in the ground away from the test locations. This log does not cover slope stability or suitability of the site for building.  Dynamic Cone Penetrometer Test performed in accordance with NZS 4402 Test 6.5.2 (Procedure 1 and 2)
---	--	---

<b>Project:</b> 2 Auckland Street, Ashley (Lot 1 DP 394101) <b>Client:</b> A J Cameron <b>Test Location:</b> Refer to attached Geotechnical Site Plan (G01A).	<b>Date:</b> 25/06/20 <b>Time:</b> 10:00 a.m. <b>Excavation Method:</b> 13T Ex+DCP
---	--

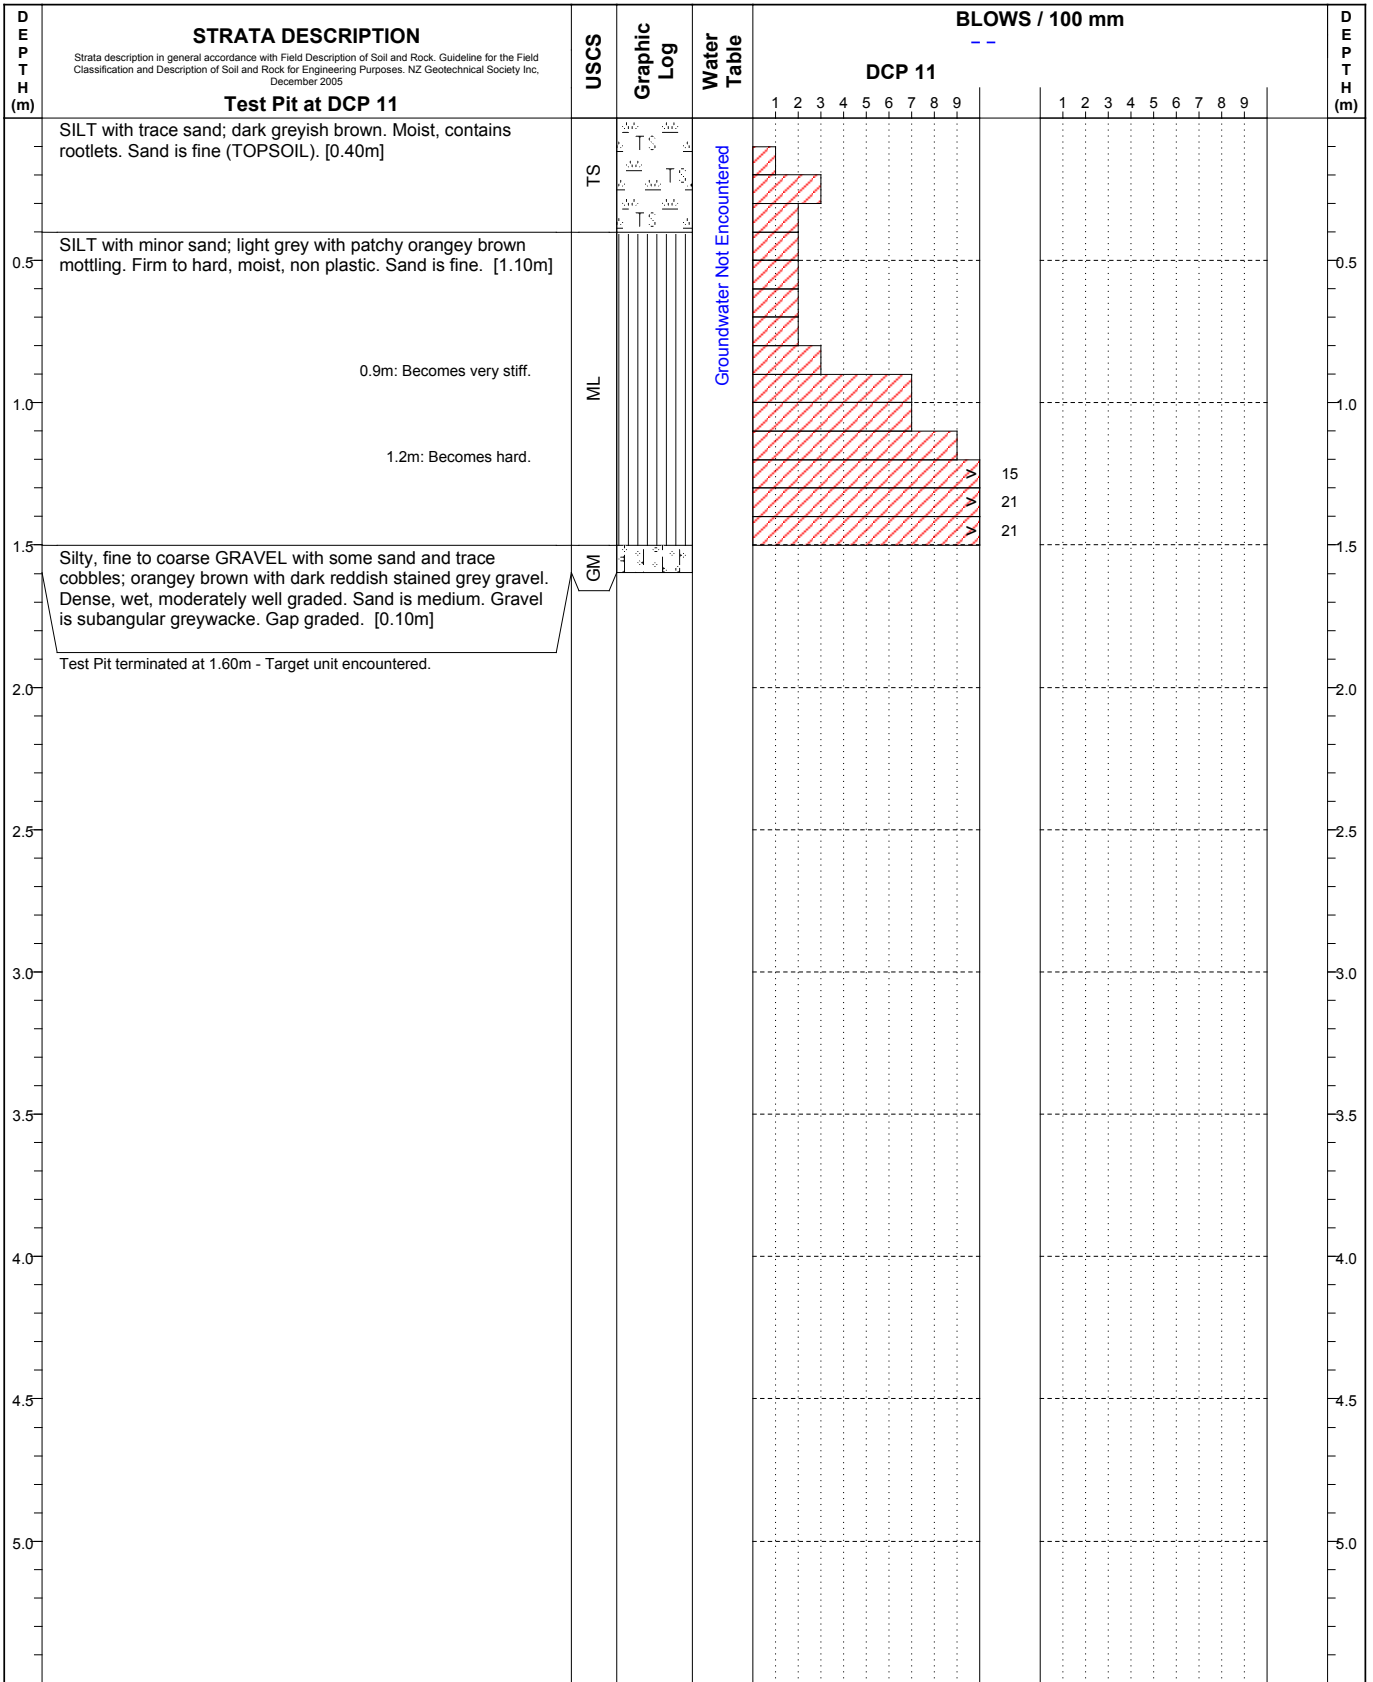
<b>Logged By:</b> AB+HC <b>Plotted By:</b> KL <b>Checked By:</b> HC	<b>Notes:</b> Shear vane (SV): peak/remoulded (kPa) Unable to penetrate with SV (UTP)	Dynamic Penetrometer Test and logs give an indication of the ground condition at the location of the tests only. While they are representative of typical conditions across the site, they do not identify variations in the ground away from the test locations. This log does not cover slope stability or suitability of the site for building.  Dynamic Cone Penetrometer Test performed in accordance with NZS 4402 Test 6.5.2 (Procedure 1 and 2)
---	--	---

<b>Project:</b> 2 Auckland Street, Ashley (Lot 1 DP 394101) <b>Client:</b> A J Cameron <b>Test Location:</b> Refer to attached Geotechnical Site Plan (G01A).	<b>Date:</b> 25/06/20 <b>Time:</b> 10:00 a.m. <b>Excavation Method:</b> 13T Ex+DCP
---	--

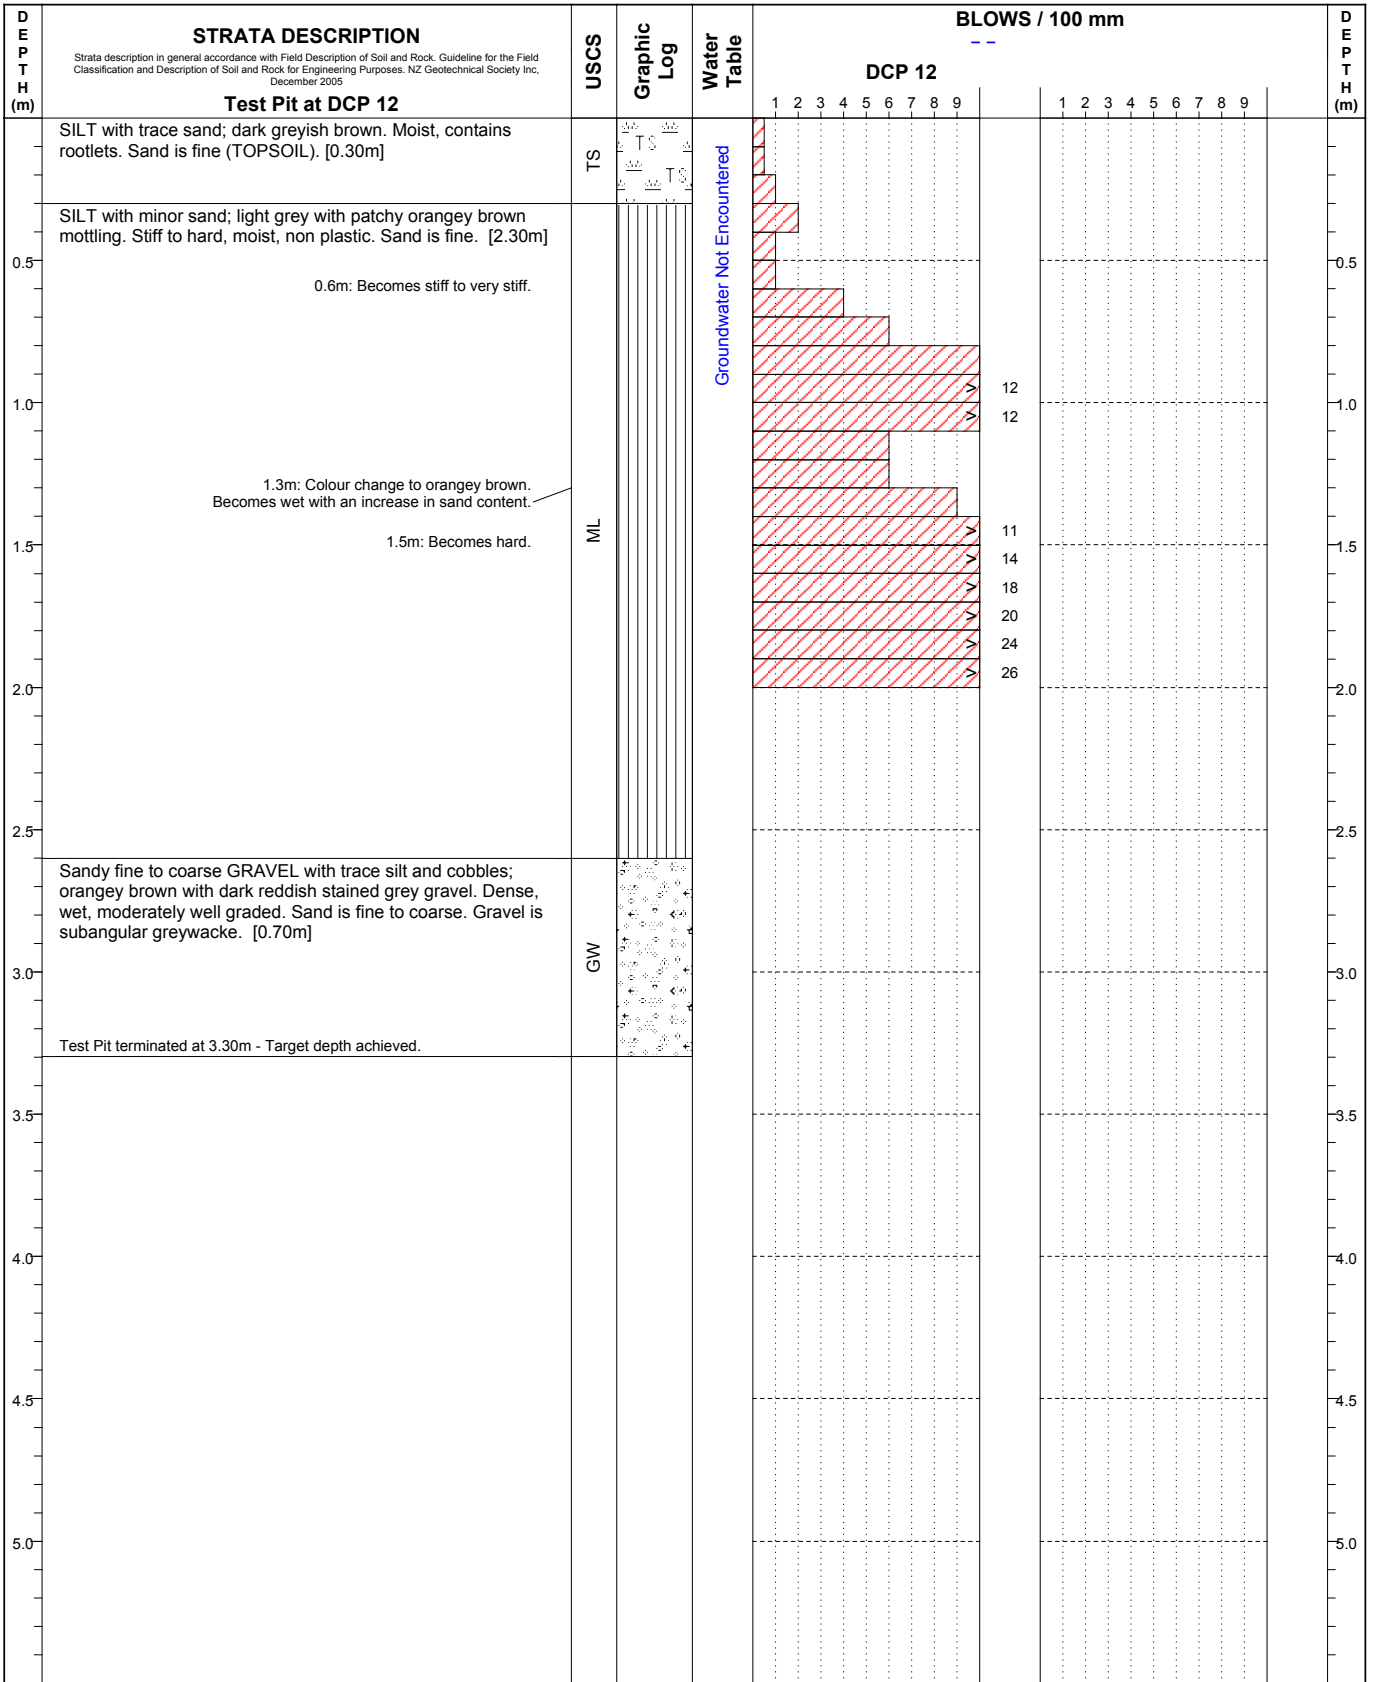
<b>Logged By:</b> AB+HC <b>Plotted By:</b> KL <b>Checked By:</b> HC	<b>Notes:</b>	Dynamic Penetrometer Test and logs give an indication of the ground condition at the location of the tests only. While they are representative of typical conditions across the site, they do not identify variations in the ground away from the test locations. This log does not cover slope stability or suitability of the site for building.  Dynamic Cone Penetrometer Test performed in accordance with NZS 4402 Test 6.5.2 (Procedure 1 and 2)
---	---------------	---

<b>Project:</b> 2 Auckland Street, Ashley (Lot 1 DP 394101) <b>Client:</b> A J Cameron <b>Test Location:</b> Refer to attached Geotechnical Site Plan (G01A).	<b>Date:</b> 25/06/20 <b>Time:</b> 10:00 a.m. <b>Excavation Method:</b> 13T Ex+DCP
---	--

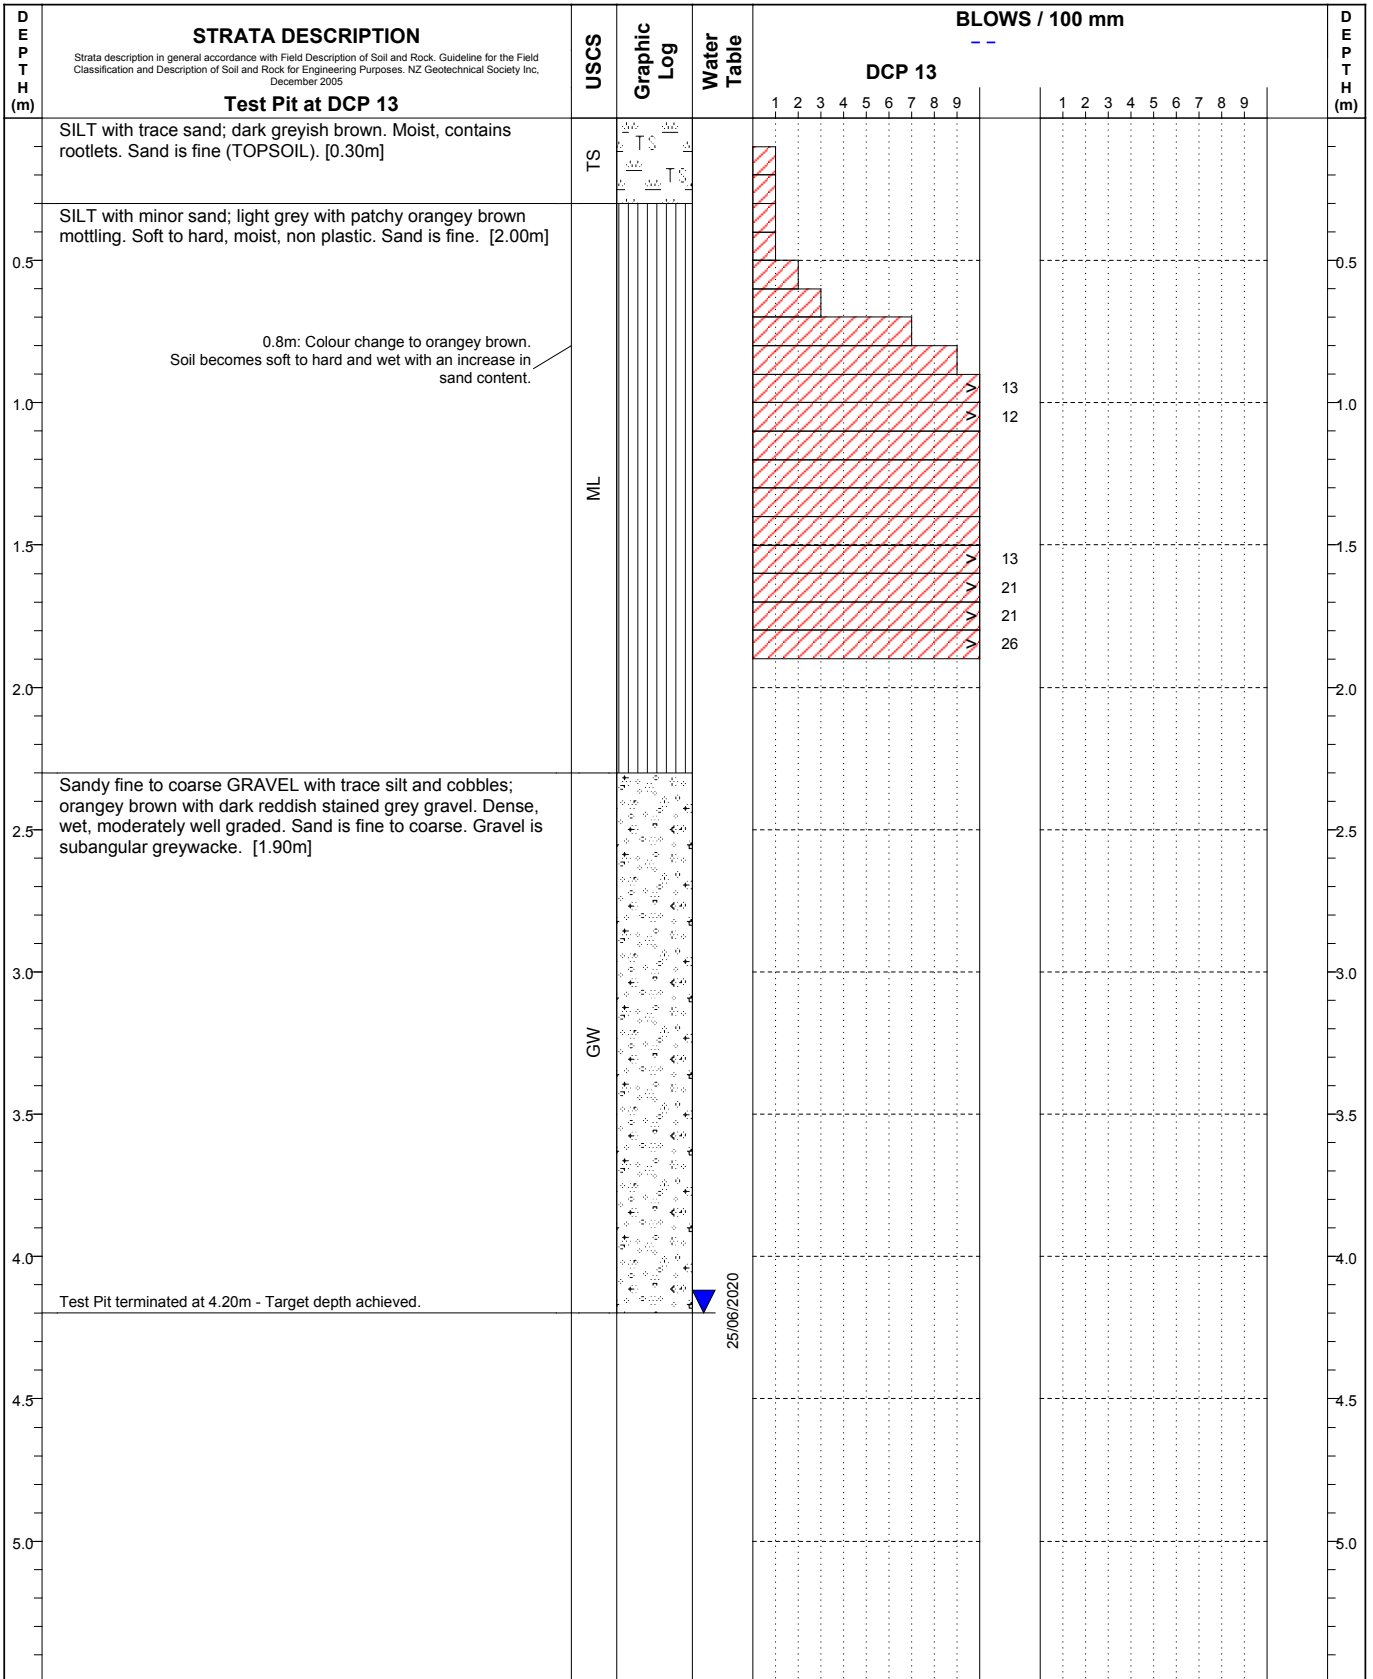
<b>Logged By:</b> AB+HC <b>Plotted By:</b> KL <b>Checked By:</b> HC	<b>Notes:</b>	Dynamic Penetrometer Test and logs give an indication of the ground condition at the location of the tests only. While they are representative of typical conditions across the site, they do not identify variations in the ground away from the test locations. This log does not cover slope stability or suitability of the site for building.  Dynamic Cone Penetrometer Test performed in accordance with NZS 4402 Test 6.5.2 (Procedure 1 and 2)
---	---------------	---

<b>Project:</b> 2 Auckland Street, Ashley (Lot 1 DP 394101) <b>Client:</b> A J Cameron <b>Test Location:</b> Refer to attached Geotechnical Site Plan (G01A).	<b>Date:</b> 25/06/20 <b>Time:</b> 10:00 a.m. <b>Excavation Method:</b> 13T Ex+DCP
---	--

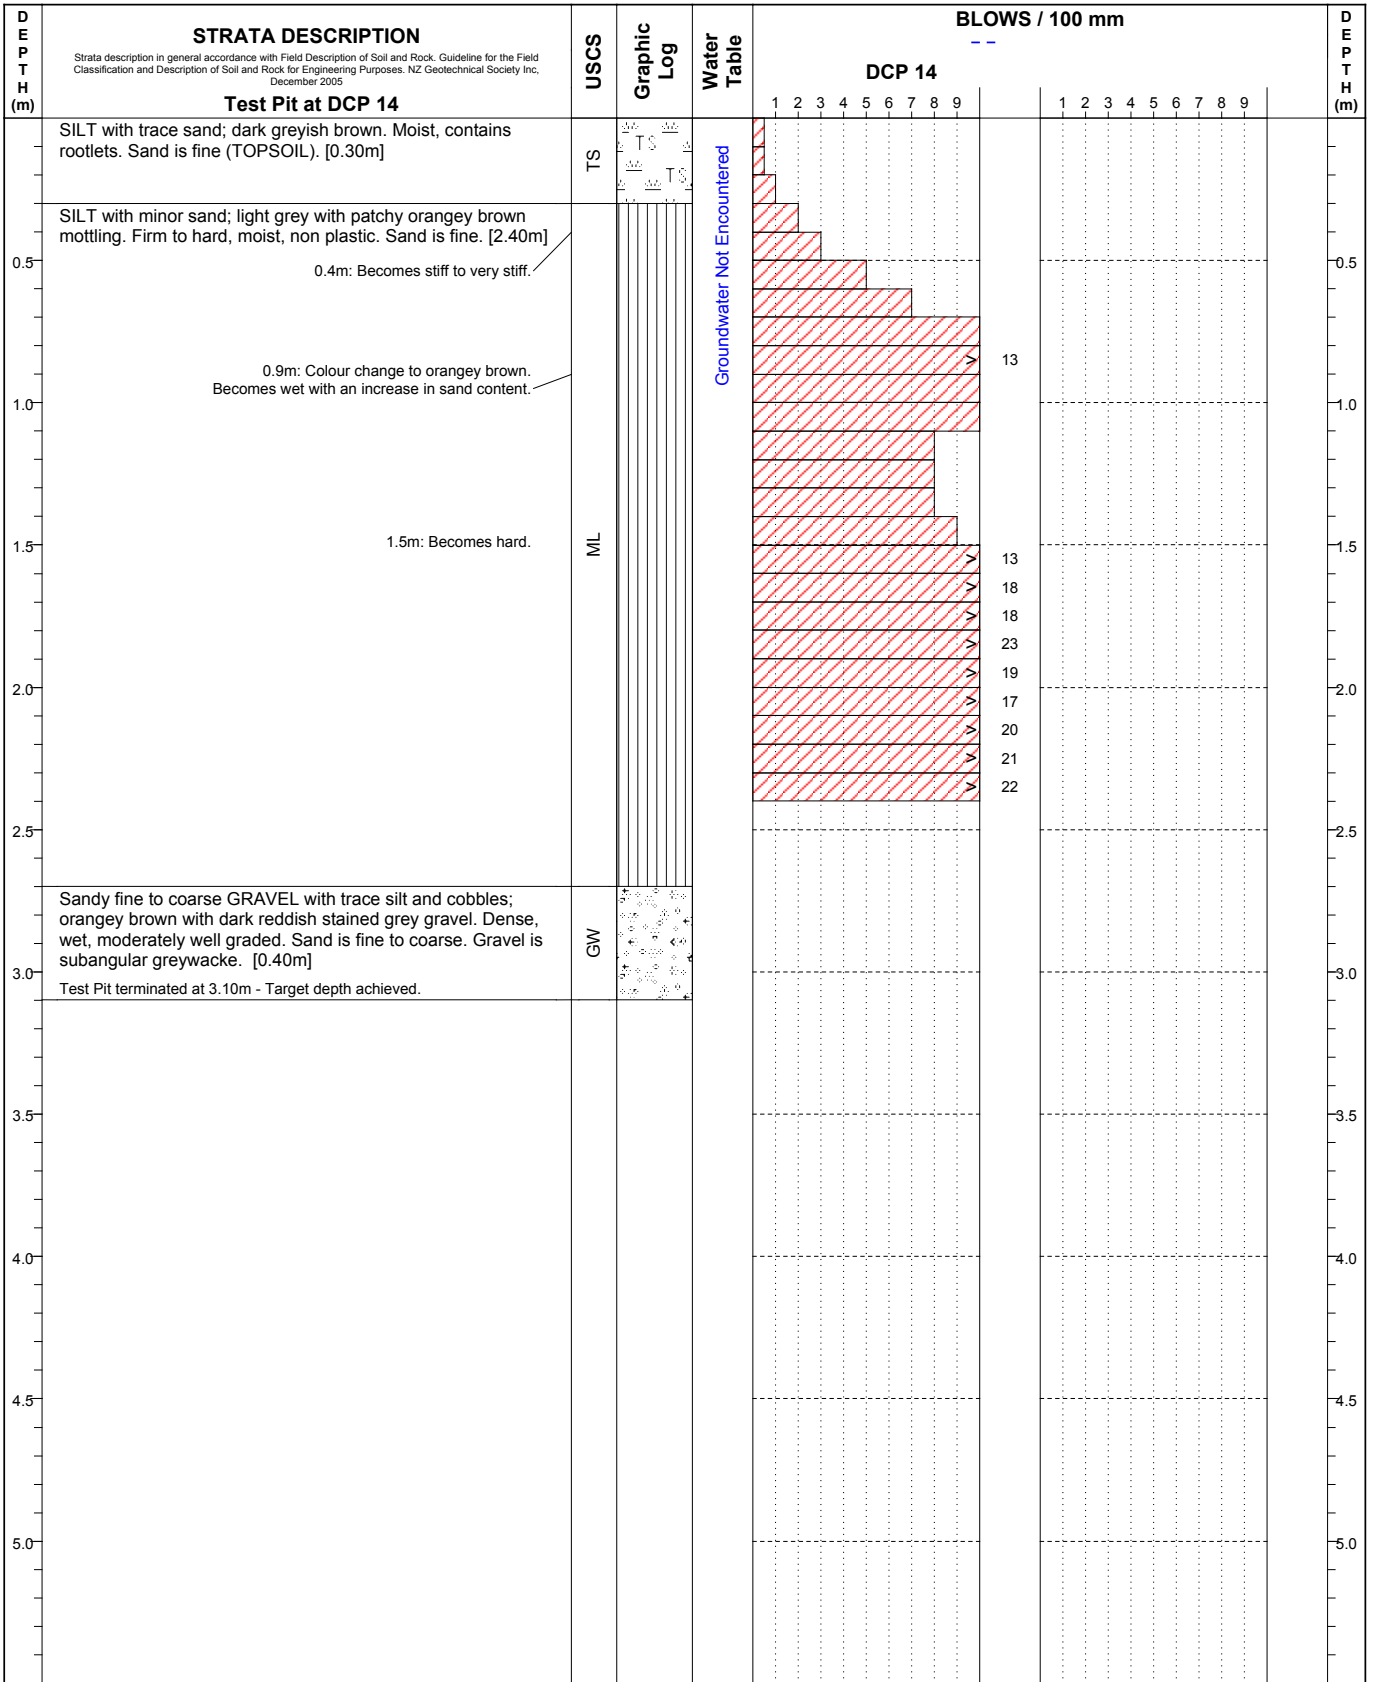
<b>Logged By:</b> AB+HC <b>Plotted By:</b> KL <b>Checked By:</b> HC	<b>Notes:</b>  Dynamic Penetrometer Test and logs give an indication of the ground condition at the location of the tests only. While they are representative of typical conditions across the site, they do not identify variations in the ground away from the test locations. This log does not cover slope stability or suitability of the site for building.  Dynamic Cone Penetrometer Test performed in accordance with NZS 4402 Test 6.5.2 (Procedure 1 and 2)
---	--

<b>Project:</b> 2 Auckland Street, Ashley (Lot 1 DP 394101) <b>Client:</b> A J Cameron <b>Test Location:</b> Refer to attached Geotechnical Site Plan (G01A).	<b>Date:</b> 25/06/20 <b>Time:</b> 10:00 a.m. <b>Excavation Method:</b> 13T Ex+DCP
---	--

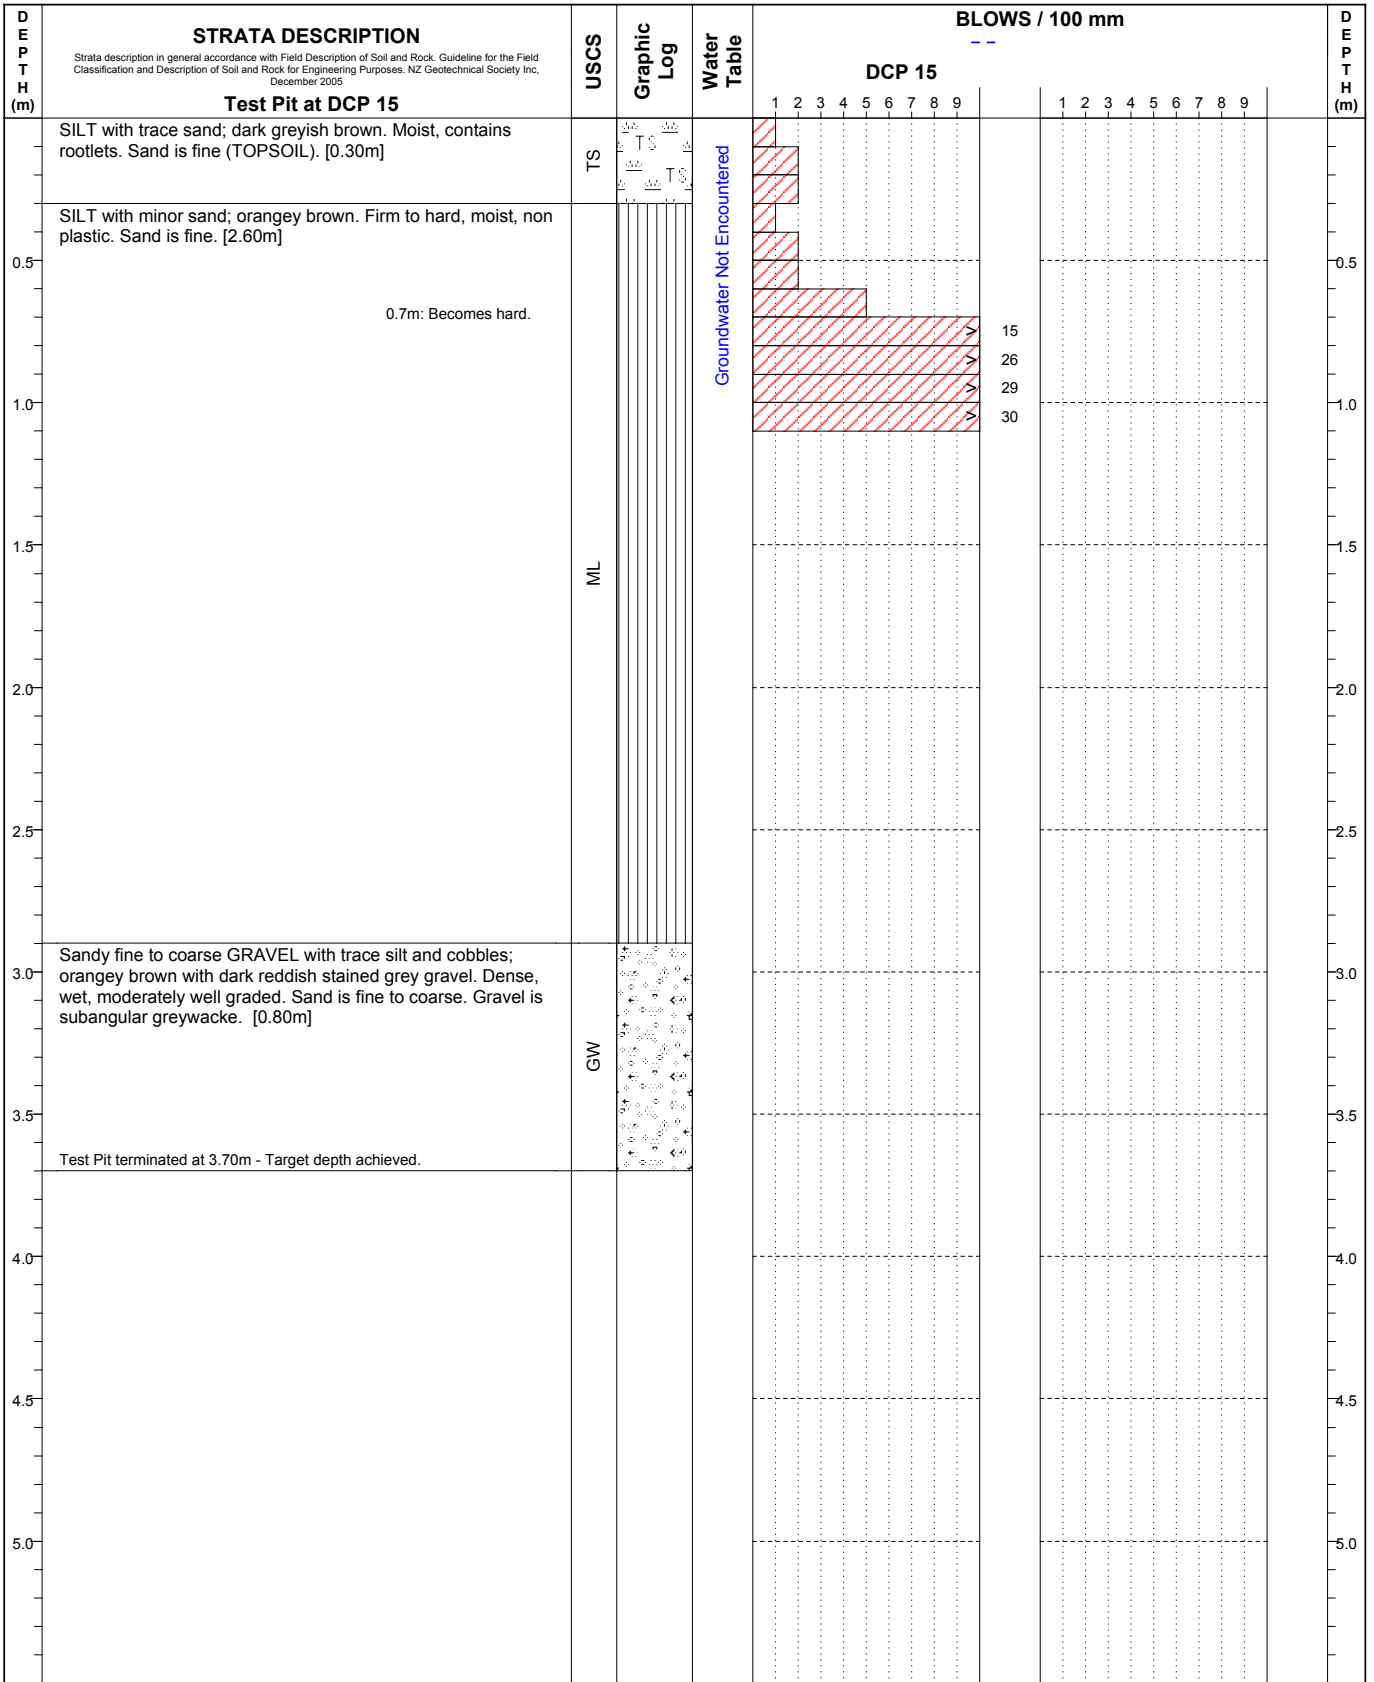
<b>Logged By:</b> AB+HC <b>Plotted By:</b> KL <b>Checked By:</b> HC	<b>Notes:</b>	Dynamic Penetrometer Test and logs give an indication of the ground condition at the location of the tests only. While they are representative of typical conditions across the site, they do not identify variations in the ground away from the test locations. This log does not cover slope stability or suitability of the site for building.  Dynamic Cone Penetrometer Test performed in accordance with NZS 4402 Test 6.5.2 (Procedure 1 and 2)
---	---------------	---

<b>Project:</b> 2 Auckland Street, Ashley (Lot 1 DP 394101) <b>Client:</b> A J Cameron <b>Test Location:</b> Refer to attached Geotechnical Site Plan (G01A).	<b>Date:</b> 25/06/20 <b>Time:</b> 10:00 a.m. <b>Excavation Method:</b> 13T Ex+DCP
---	--

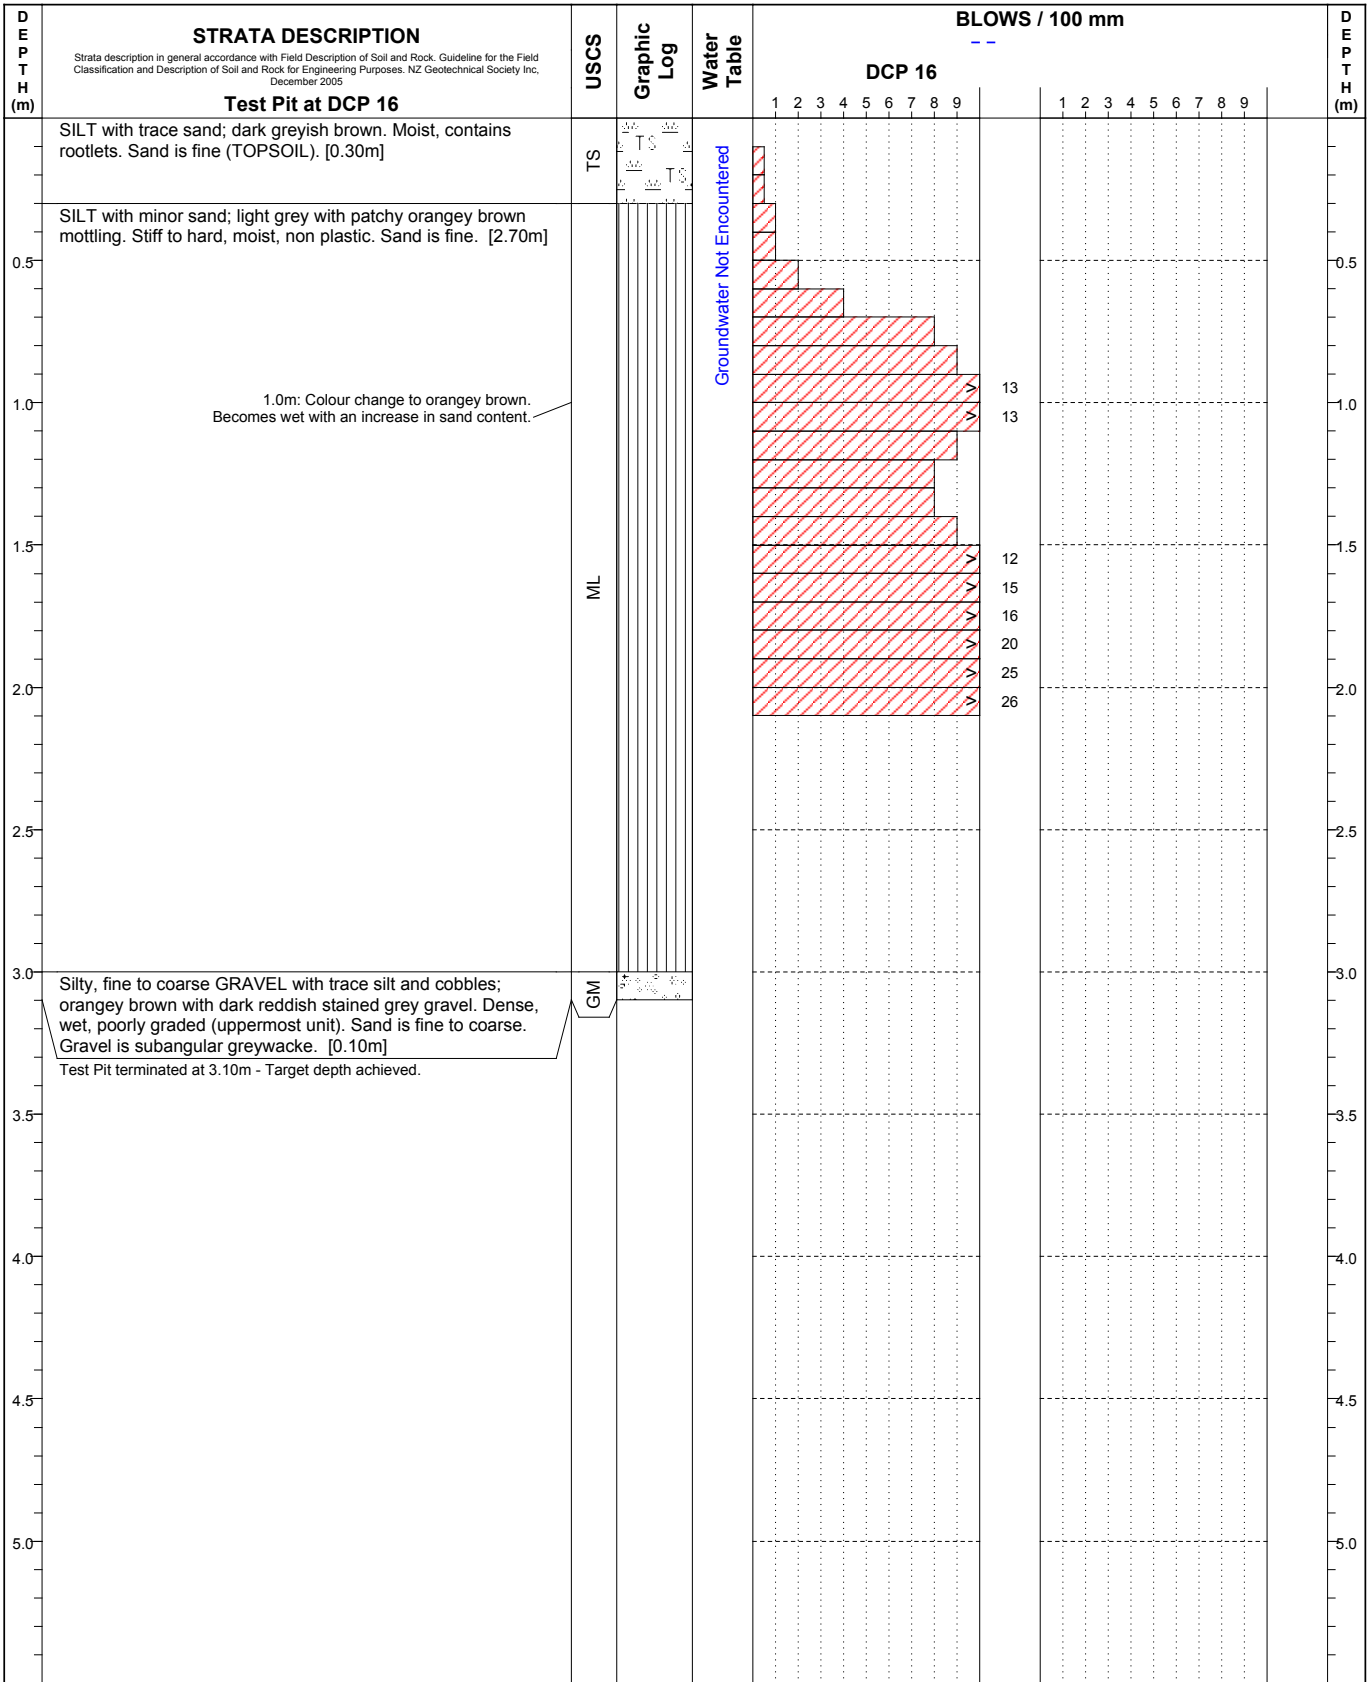
<b>Logged By:</b> AB+HC <b>Plotted By:</b> KL <b>Checked By:</b> HC	<b>Notes:</b> Shear vane (SV): peak/remoulded (kPa) Unable to penetrate with SV (UTP)	Dynamic Penetrometer Test and logs give an indication of the ground condition at the location of the tests only. While they are representative of typical conditions across the site, they do not identify variations in the ground away from the test locations. This log does not cover slope stability or suitability of the site for building.  Dynamic Cone Penetrometer Test performed in accordance with NZS 4402 Test 6.5.2 (Procedure 1 and 2)
---	--	---

<b>Project:</b> 2 Auckland Street, Ashley (Lot 1 DP 394101) <b>Client:</b> A J Cameron <b>Test Location:</b> Refer to attached Geotechnical Site Plan (G01A).	<b>Date:</b> 25/06/20 <b>Time:</b> 10:00 a.m. <b>Excavation Method:</b> 13T Ex+DCP
---	--

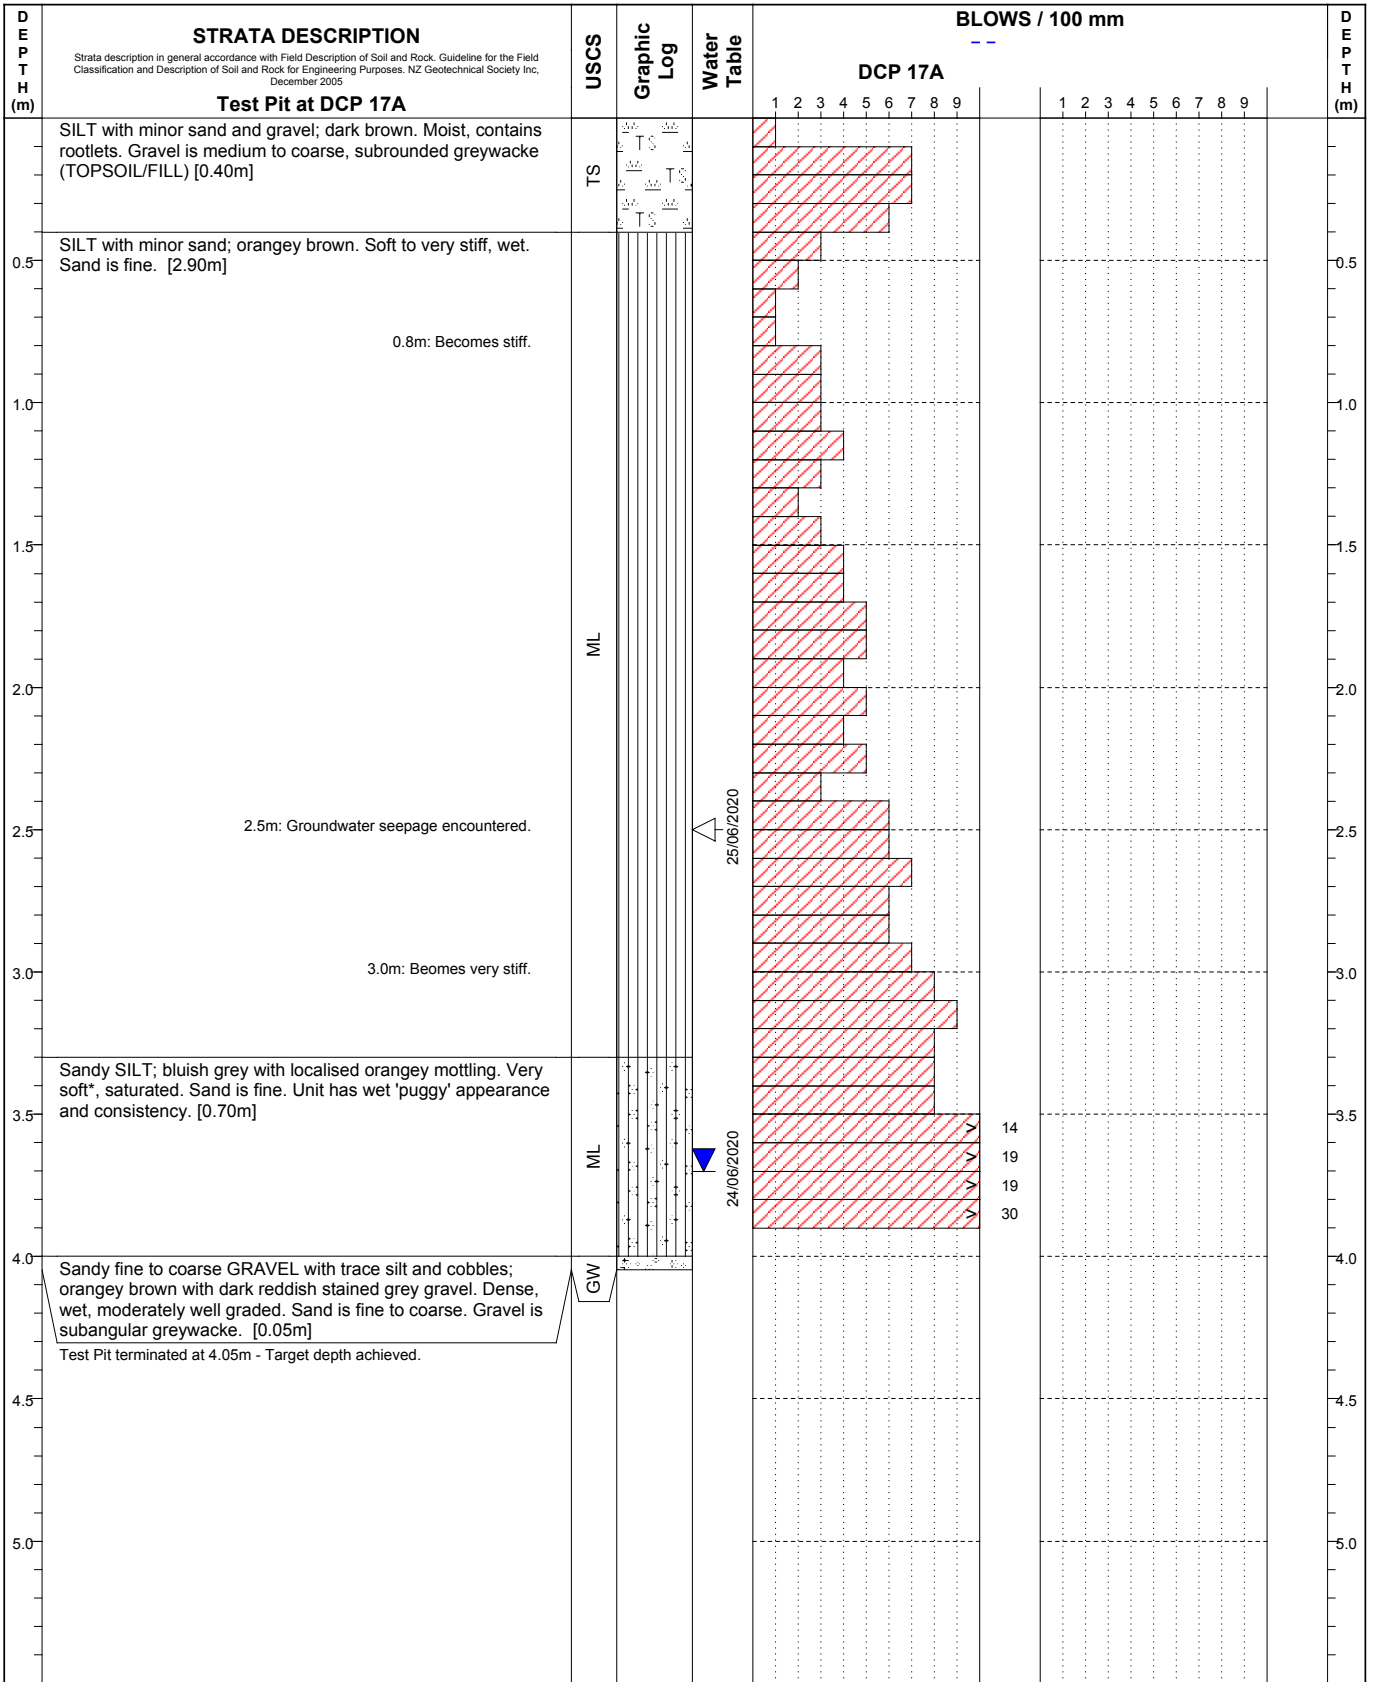
<b>Logged By:</b> AB+HC <b>Plotted By:</b> KL <b>Checked By:</b> HC	<b>Notes:</b>	Dynamic Penetrometer Test and logs give an indication of the ground condition at the location of the tests only. While they are representative of typical conditions across the site, they do not identify variations in the ground away from the test locations. This log does not cover slope stability or suitability of the site for building.  Dynamic Cone Penetrometer Test performed in accordance with NZS 4402 Test 6.5.2 (Procedure 1 and 2)
---	---------------	---

<b>Project:</b> 2 Auckland Street, Ashley (Lot 1 DP 394101) <b>Client:</b> A J Cameron <b>Test Location:</b> Refer to attached Geotechnical Site Plan (G01A).	<b>Date:</b> 24/06/20 <b>Time:</b> 10:00 a.m. <b>Excavation Method:</b> 13T Ex+DCP
---	--

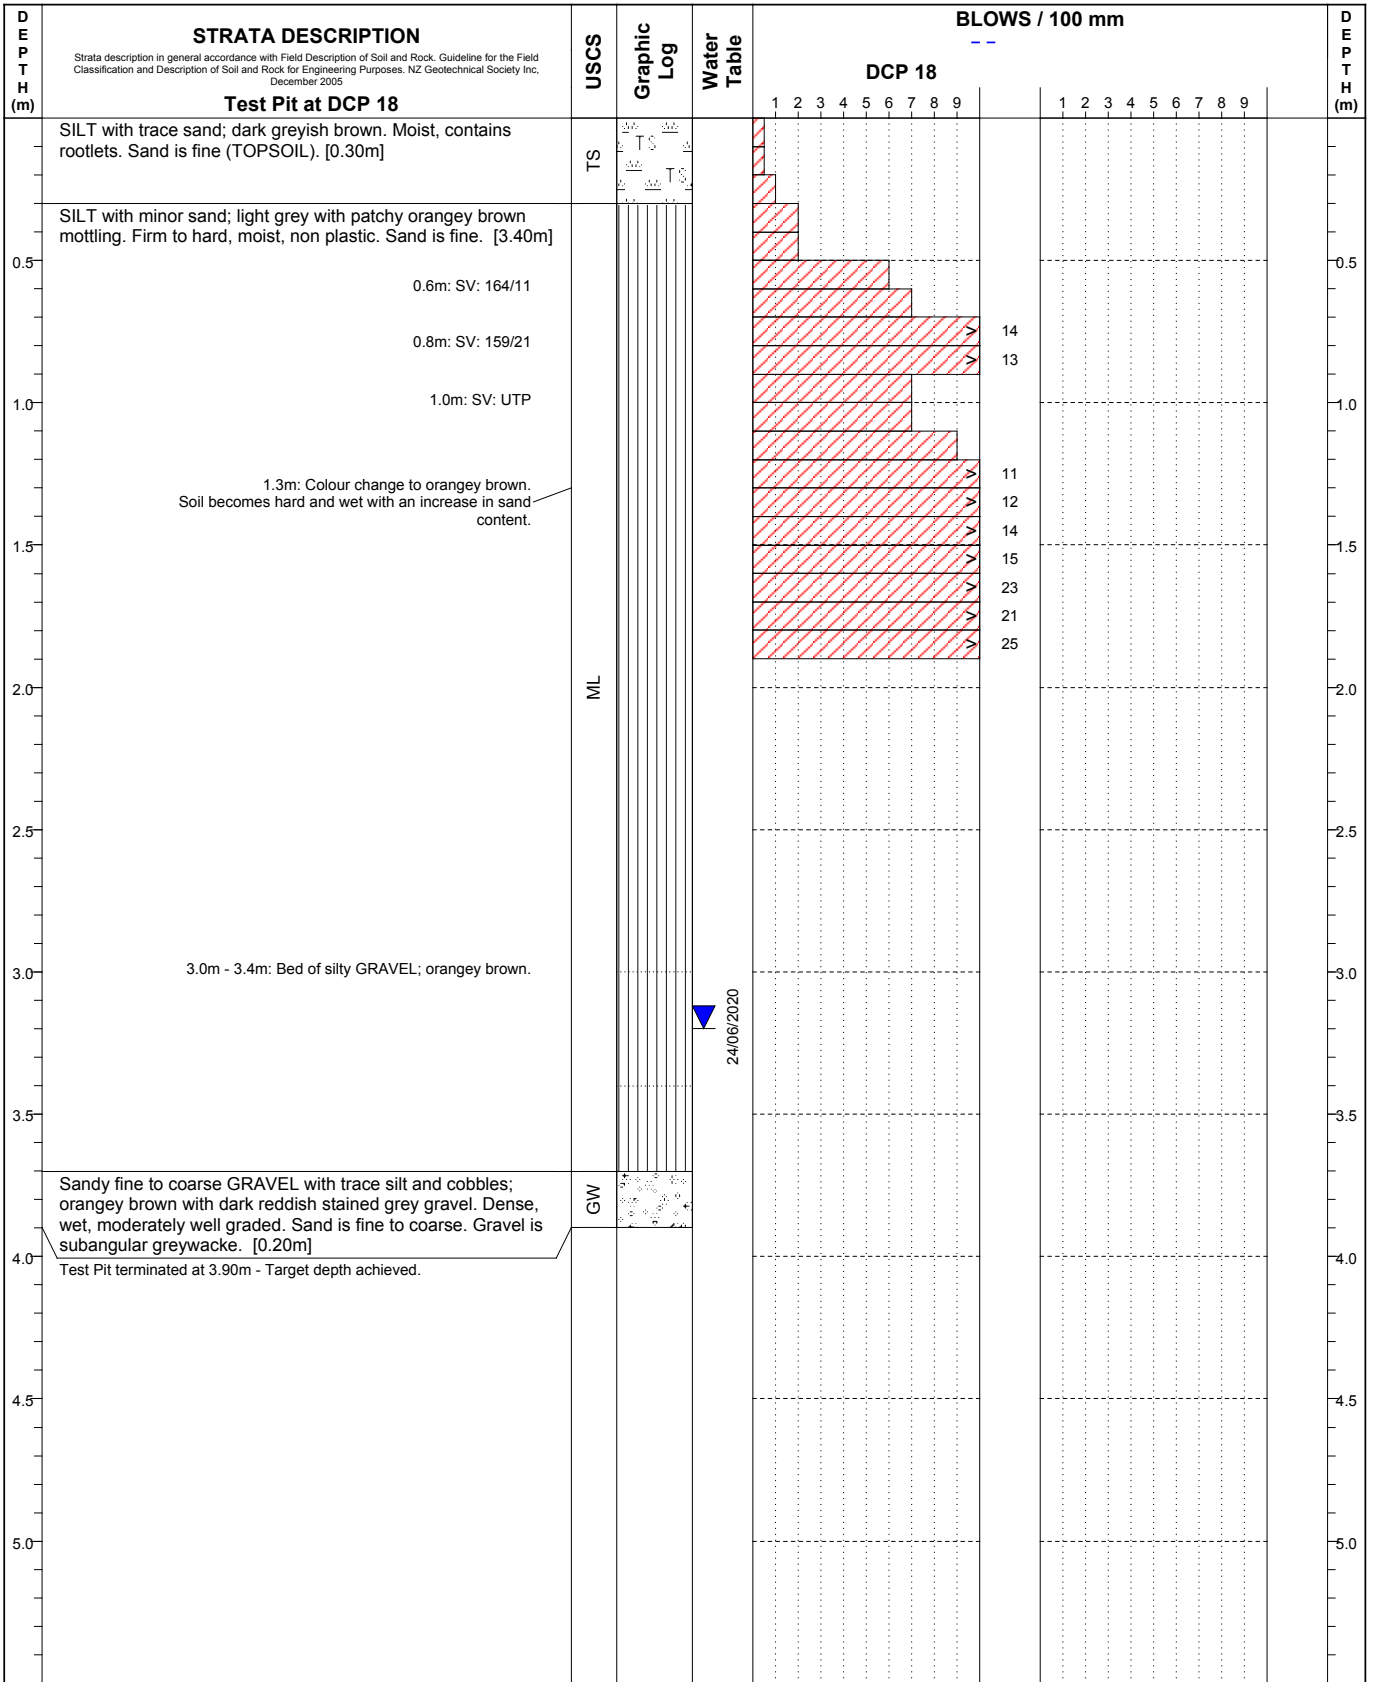
<b>Logged By:</b> AB+HC <b>Plotted By:</b> KL <b>Checked By:</b> HC	<b>Notes:</b> IT2a = TP17a  * Silt was very soft upon excavation, but DCP results indicate dense which may be attributed to high DCP rod friction at depth.	Dynamic Penetrometer Test and logs give an indication of the ground condition at the location of the tests only. While they are representative of typical conditions across the site, they do not identify variations in the ground away from the test locations. This log does not cover slope stability or suitability of the site for building.  Dynamic Cone Penetrometer Test performed in accordance with NZS 4402 Test 6.5.2 (Procedure 1 and 2)
---	---	---

<b>Project:</b> 2 Auckland Street, Ashley (Lot 1 DP 394101) <b>Client:</b> A J Cameron <b>Test Location:</b> Refer to attached Geotechnical Site Plan (G01A).	<b>Date:</b> 24/06/20 <b>Time:</b> 10:00 a.m. <b>Excavation Method:</b> 13T Ex+DCP
---	--
