# GEOTECHNICAL REPORT FOR SUBDIVISION

37211 / 2 AUCKLAND STREET, ASHLEY / ALISTAIR CAMERON

**Title:** Geotechnical Report for Subdivision: 2 Auckland Street, Ashley

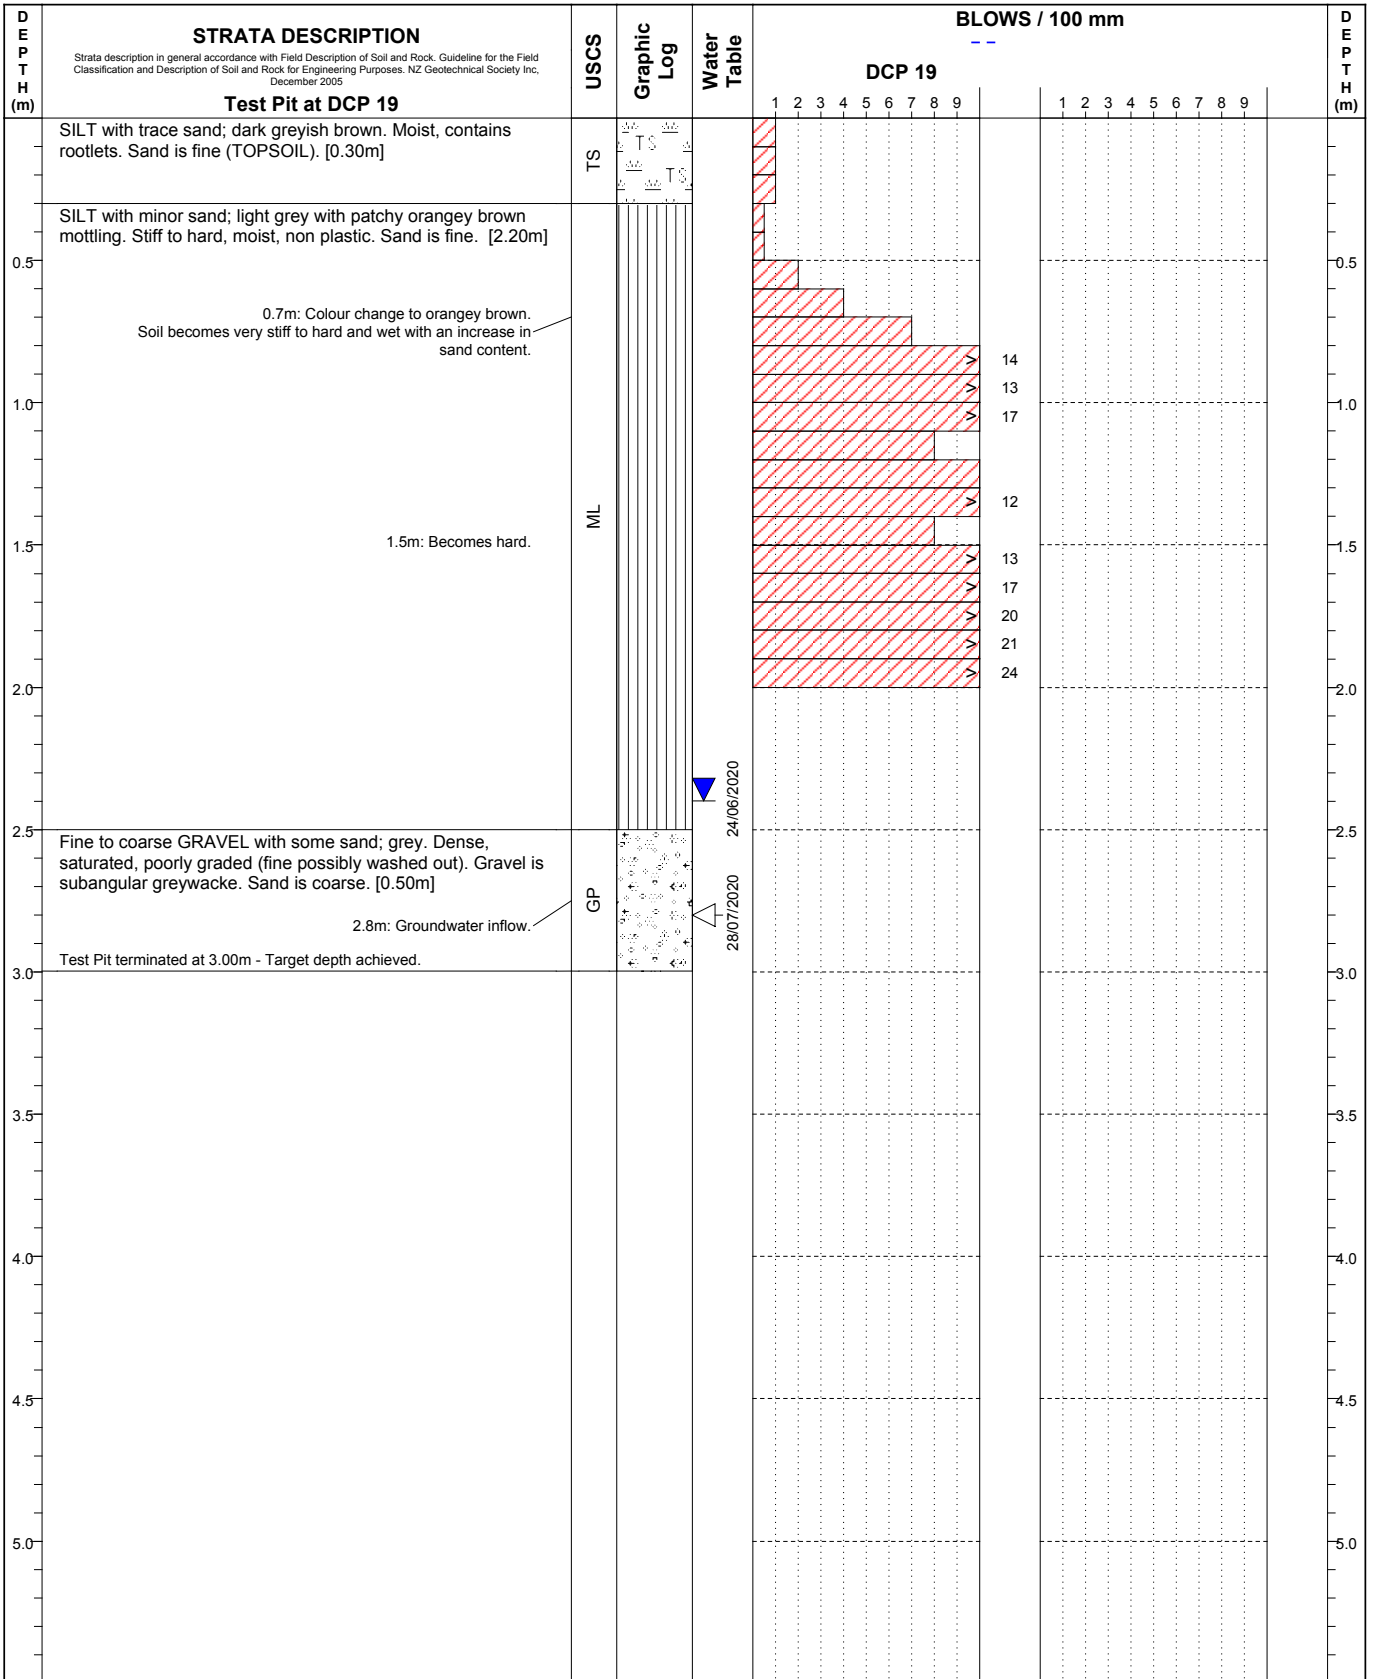
<b>Logged By:</b> AB+HC <b>Plotted By:</b> KL <b>Checked By:</b> HC	<b>Notes:</b> Shear vane (SV): peak/remoulded (kPa) Unable to penetrate with SV (UTP)	Dynamic Penetrometer Test and logs give an indication of the ground condition at the location of the tests only. While they are representative of typical conditions across the site, they do not identify variations in the ground away from the test locations. This log does not cover slope stability or suitability of the site for building.  Dynamic Cone Penetrometer Test performed in accordance with NZS 4402 Test 6.5.2 (Procedure 1 and 2)
---	--	---

<b>Project:</b> 2 Auckland Street, Ashley (Lot 1 DP 394101) <b>Client:</b> A J Cameron <b>Test Location:</b> Refer to attached Geotechnical Site Plan (G01A).	<b>Date:</b> 24/06/20 <b>Time:</b> 10:00 a.m. <b>Excavation Method:</b> 13T Ex+DCP
---	--

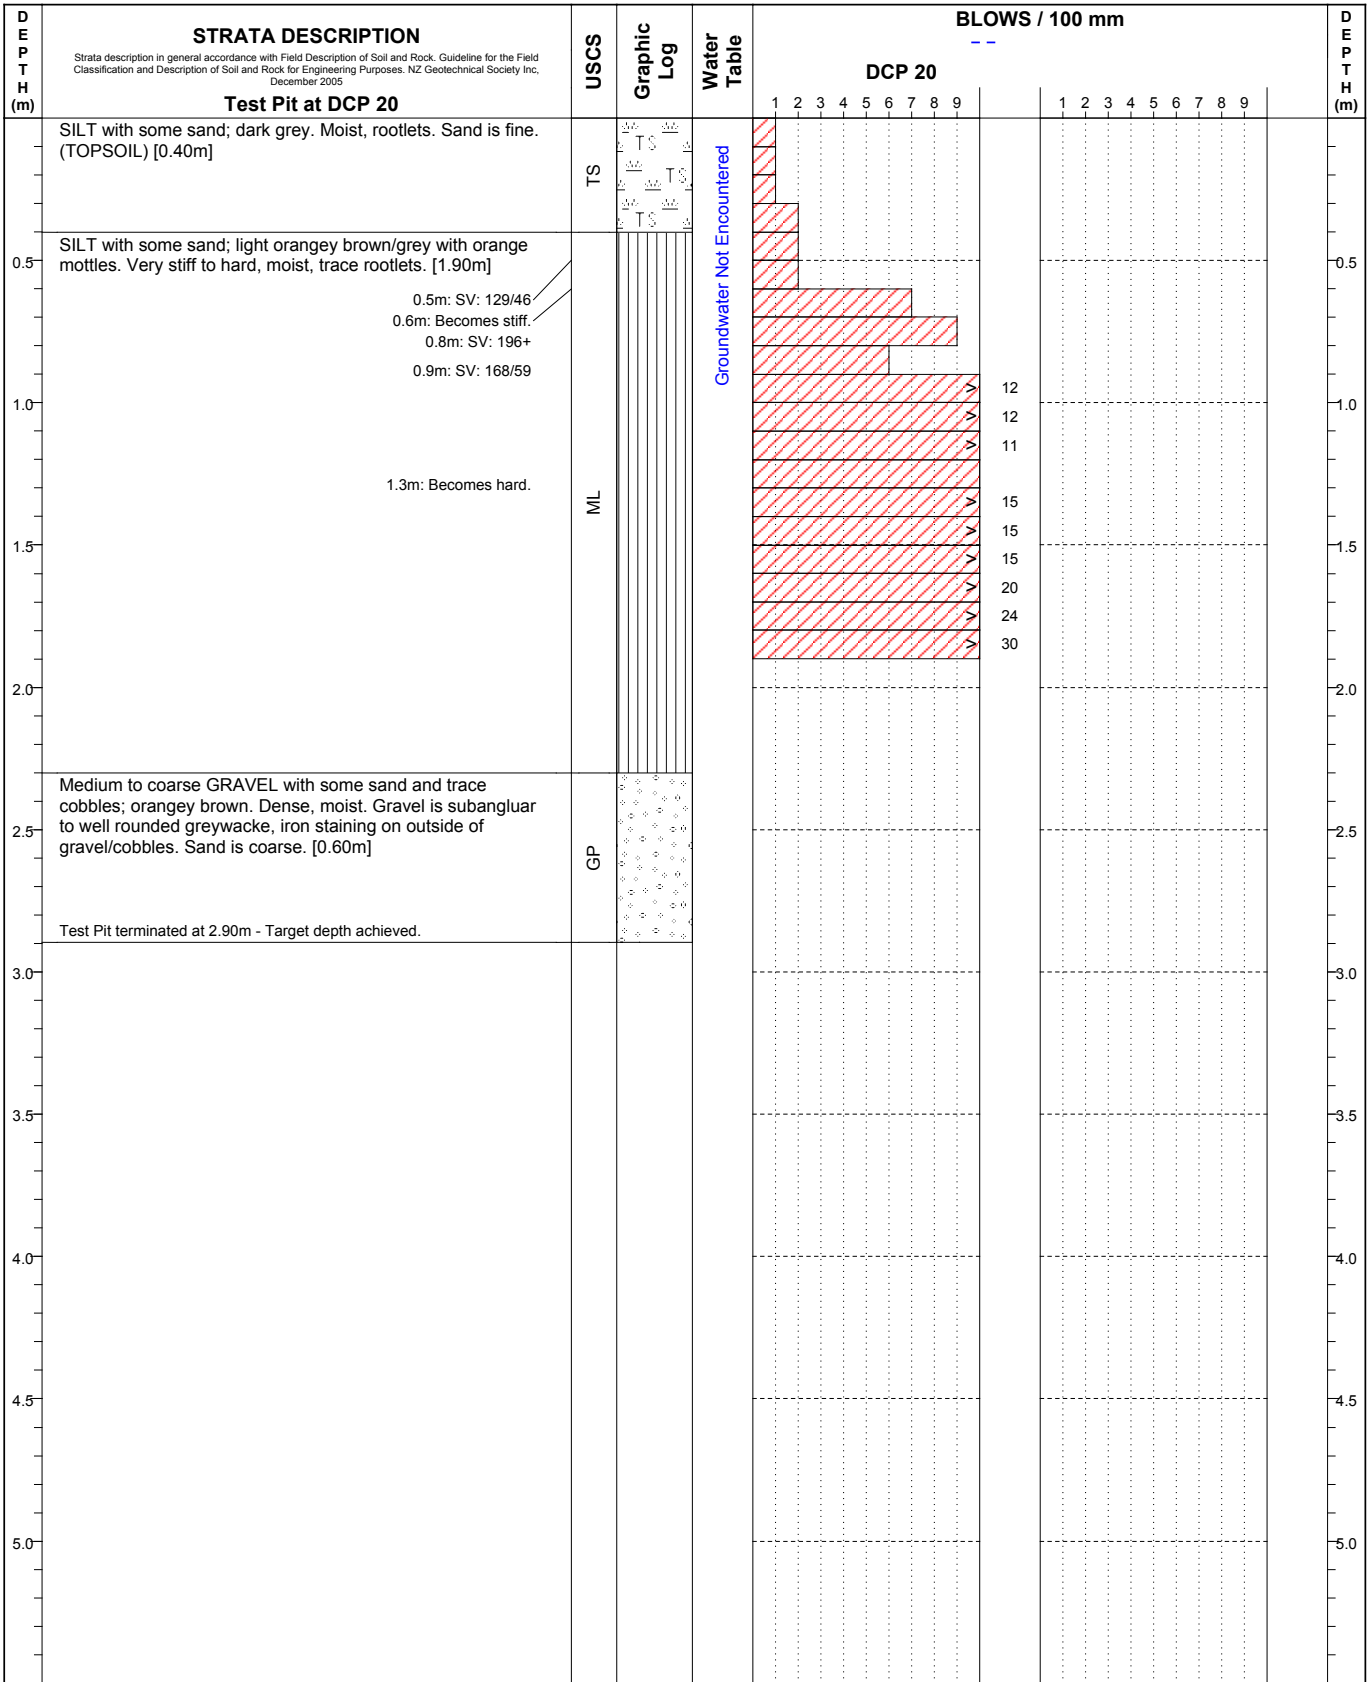
<b>Logged By:</b> AB+HC <b>Plotted By:</b> KL <b>Checked By:</b> HC	<b>Notes:</b>	Dynamic Penetrometer Test and logs give an indication of the ground condition at the location of the tests only. While they are representative of typical conditions across the site, they do not identify variations in the ground away from the test locations. This log does not cover slope stability or suitability of the site for building.  Dynamic Cone Penetrometer Test performed in accordance with NZS 4402 Test 6.5.2 (Procedure 1 and 2)
---	---------------	---

<b>Project:</b> 2 Auckland Street, Ashley (Lot 1 DP 394101) <b>Client:</b> A J Cameron <b>Test Location:</b> Refer to attached Geotechnical Site Plan (G01A).	<b>Date:</b> 25/06/20 <b>Time:</b> 10:00 a.m. <b>Excavation Method:</b> 13T Ex+DCP
---	--

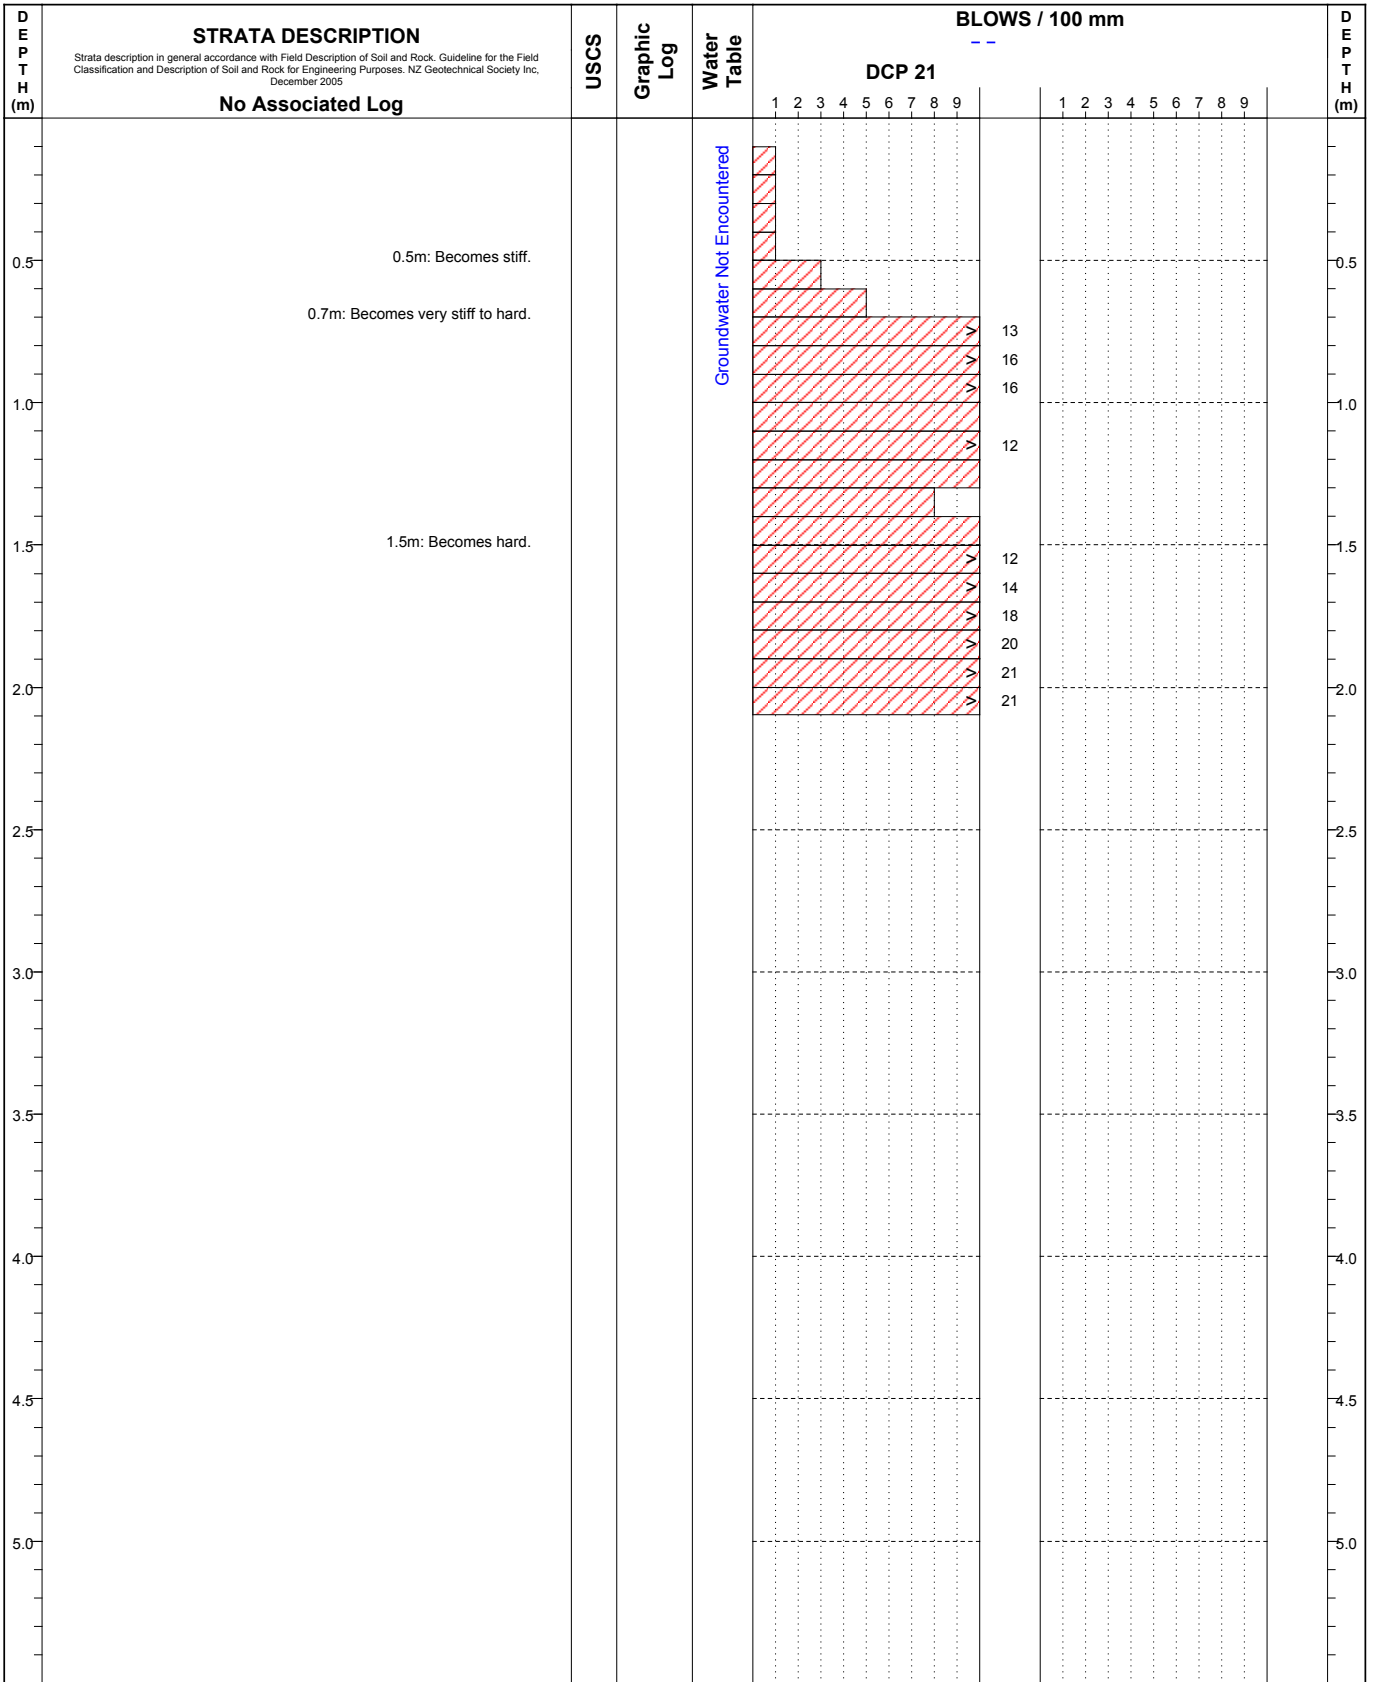
<b>Logged By:</b> JLP <b>Plotted By:</b> KL <b>Checked By:</b>	<b>Notes:</b> IT1a = TP20	Dynamic Penetrometer Test and logs give an indication of the ground condition at the location of the tests only. While they are representative of typical conditions across the site, they do not identify variations in the ground away from the test locations. This log does not cover slope stability or suitability of the site for building.  Dynamic Cone Penetrometer Test performed in accordance with NZS 4402 Test 6.5.2 (Procedure 1 and 2)
--	---------------------------	---

<b>Project:</b> 2 Auckland Street, Ashley (Lot 1 DP 394101)	<b>Date:</b> 10/07/20
<b>Client:</b> A J Cameron	<b>Time:</b> 10:00 a.m.
<b>Test Location:</b> Refer to attached Geotechnical Site Plan (G01A).	<b>Excavation Method:</b> DCP

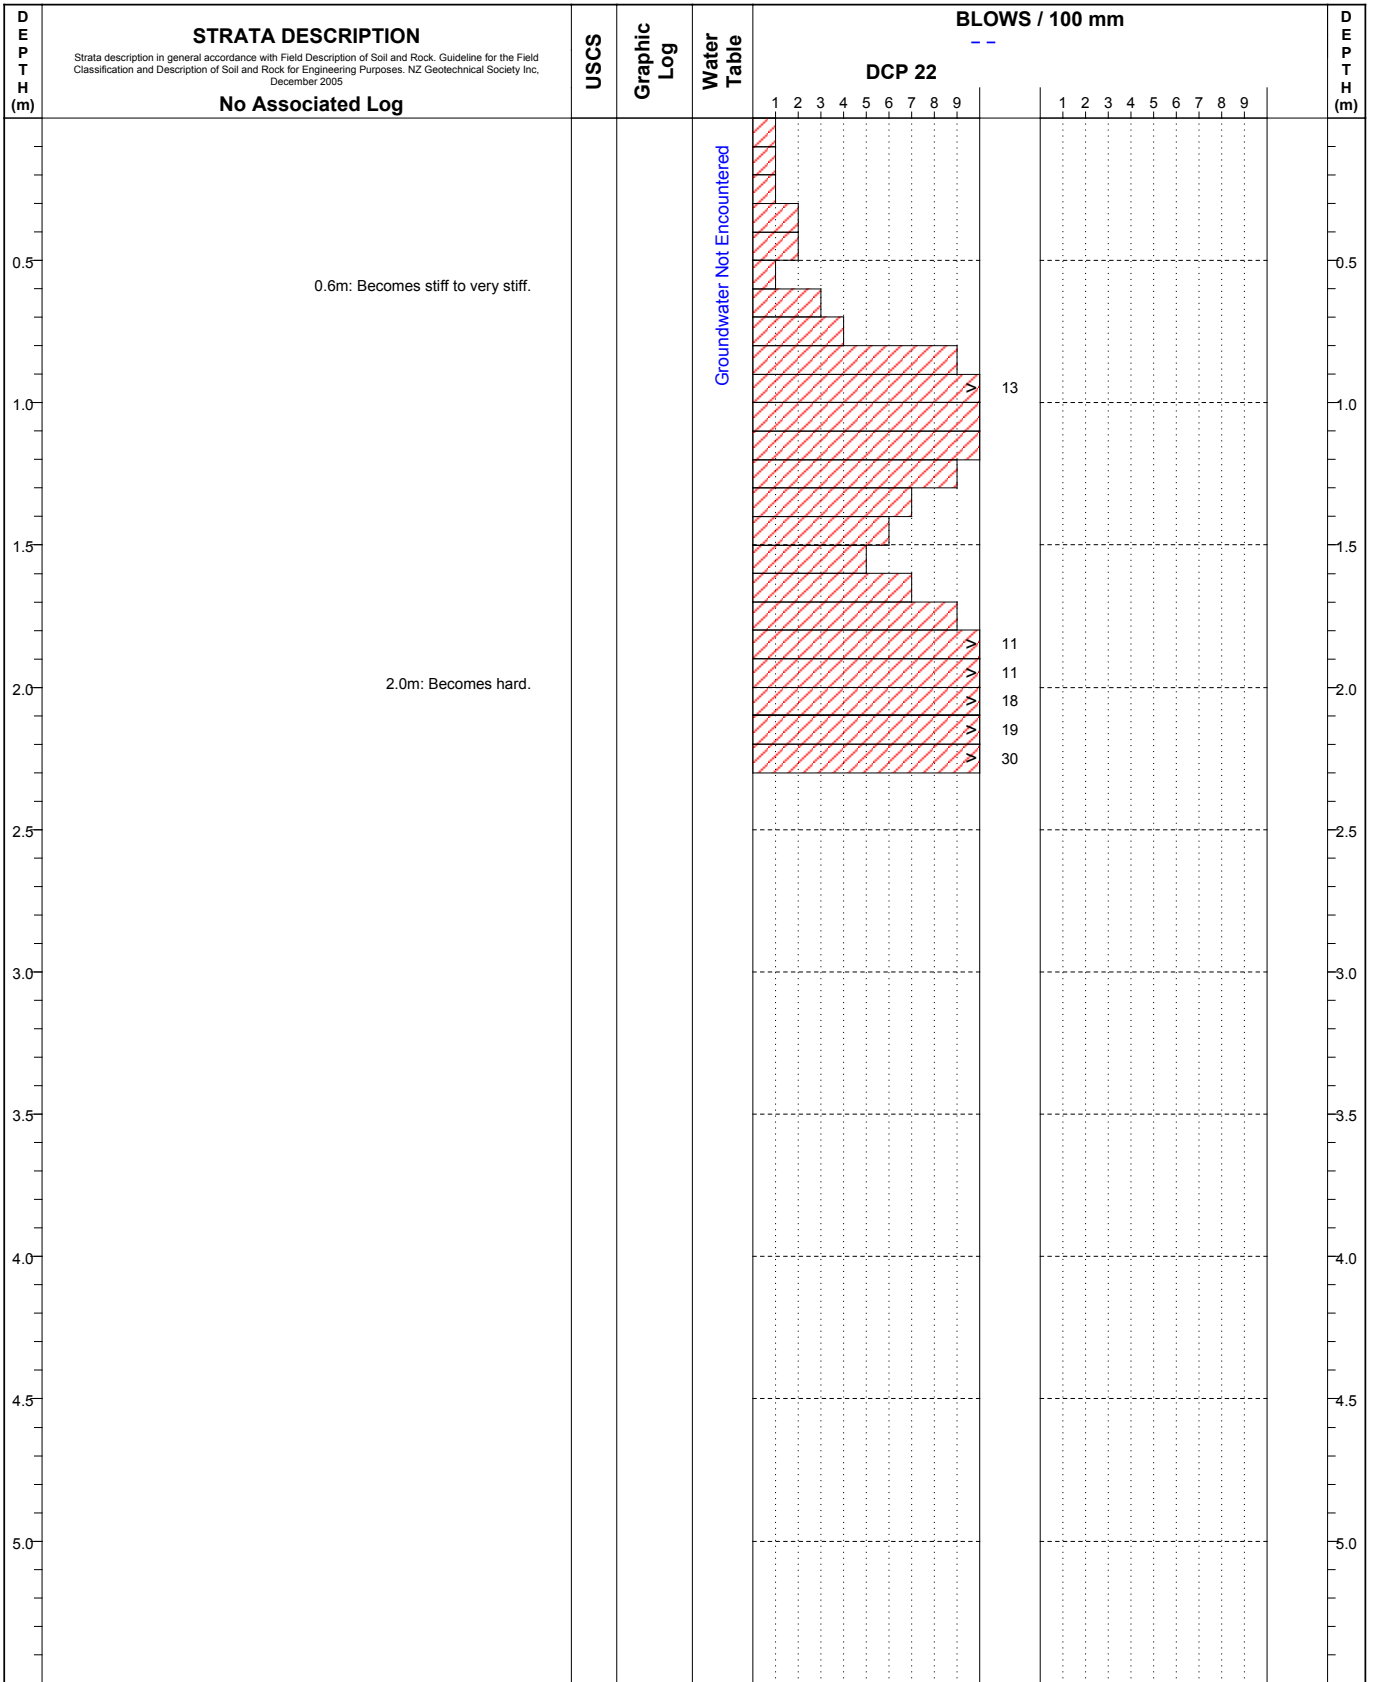
<b>Logged By:</b> AB+HC	<b>Notes:</b> No test pit undertaken at DCP 21.	Dynamic Penetrometer Test and logs give an indication of the ground condition at the location of the tests only. While they are representative of typical conditions across the site, they do not identify variations in the ground away from the test locations. This log does not cover slope stability or suitability of the site for building.  Dynamic Cone Penetrometer Test performed in accordance with NZS 4402 Test 6.5.2 (Procedure 1 and 2)
<b>Plotted By:</b> HC		
<b>Checked By:</b> HC

<b>Project:</b> 2 Auckland Street, Ashley (Lot 1 DP 394101)	<b>Date:</b> 10/07/20
<b>Client:</b> A J Cameron	<b>Time:</b> 10:00 a.m.
<b>Test Location:</b> Refer to attached Geotechnical Site Plan (G01A).	<b>Excavation Method:</b> DCP

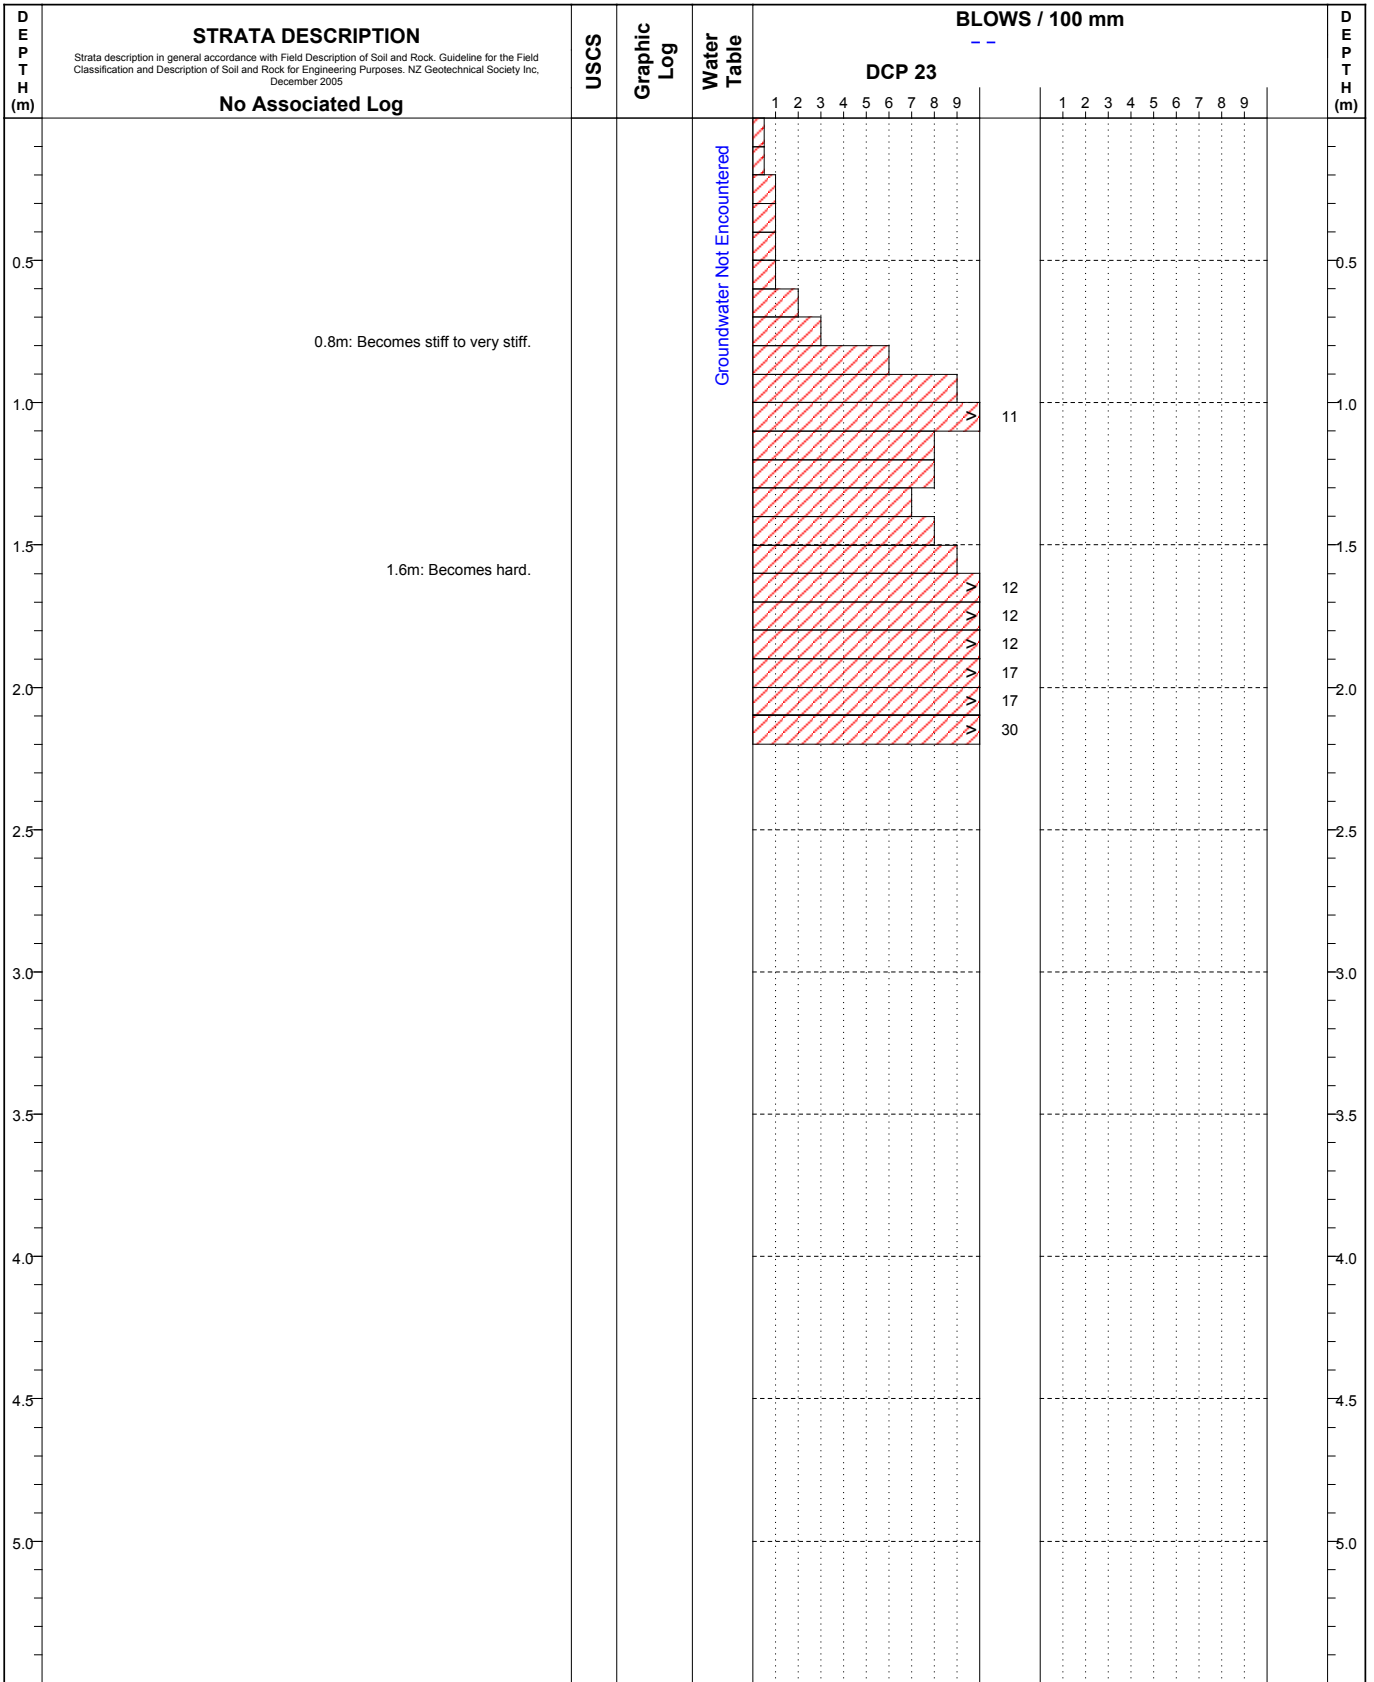
<b>Logged By:</b> AB+HC	<b>Notes:</b> No test pit undertaken at DCP 22.	Dynamic Penetrometer Test and logs give an indication of the ground condition at the location of the tests only. While they are representative of typical conditions across the site, they do not identify variations in the ground away from the test locations. This log does not cover slope stability or suitability of the site for building.  Dynamic Cone Penetrometer Test performed in accordance with NZS 4402 Test 6.5.2 (Procedure 1 and 2)
<b>Plotted By:</b> HC		
<b>Checked By:</b> HC

<b>Project:</b> 2 Auckland Street, Ashley (Lot 1 DP 394101) <b>Client:</b> A J Cameron <b>Test Location:</b> Refer to attached Geotechnical Site Plan (G01A).	<b>Date:</b> 10/07/20 <b>Time:</b> 10:00 a.m. <b>Excavation Method:</b> DCP
---	---

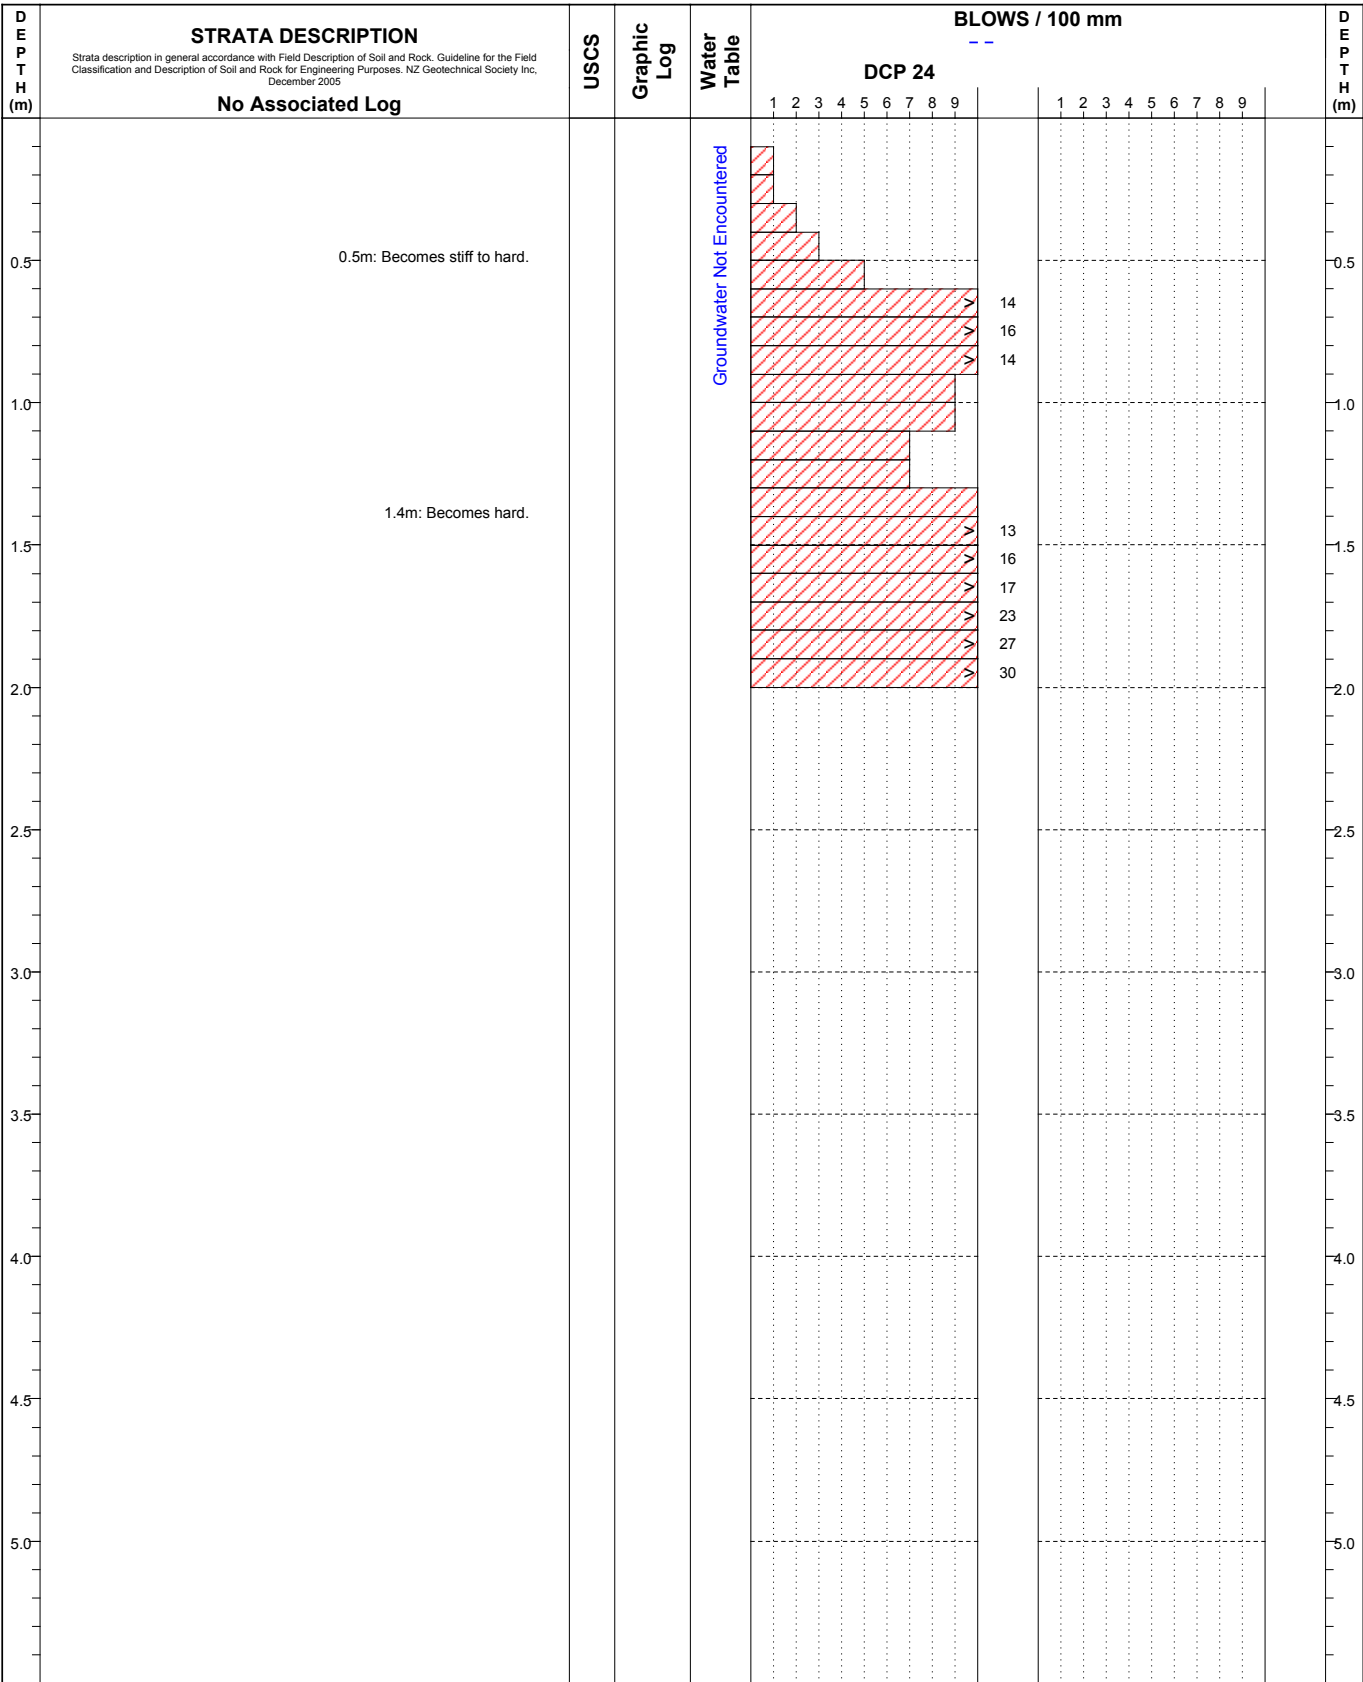
<b>Logged By:</b> AB+HC <b>Plotted By:</b> HC <b>Checked By:</b> HC	<b>Notes:</b> No test pit undertaken at DCP 23.	Dynamic Penetrometer Test and logs give an indication of the ground condition at the location of the tests only. While they are representative of typical conditions across the site, they do not identify variations in the ground away from the test locations. This log does not cover slope stability or suitability of the site for building.  Dynamic Cone Penetrometer Test performed in accordance with NZS 4402 Test 6.5.2 (Procedure 1 and 2)
---	---	---

<b>Project:</b> 2 Auckland Street, Ashley (Lot 1 DP 394101) <b>Client:</b> A J Cameron <b>Test Location:</b> Refer to attached Geotechnical Site Plan (G01A).	<b>Date:</b> 10/07/20 <b>Time:</b> 10:00 a.m. <b>Excavation Method:</b> DCP
---	---

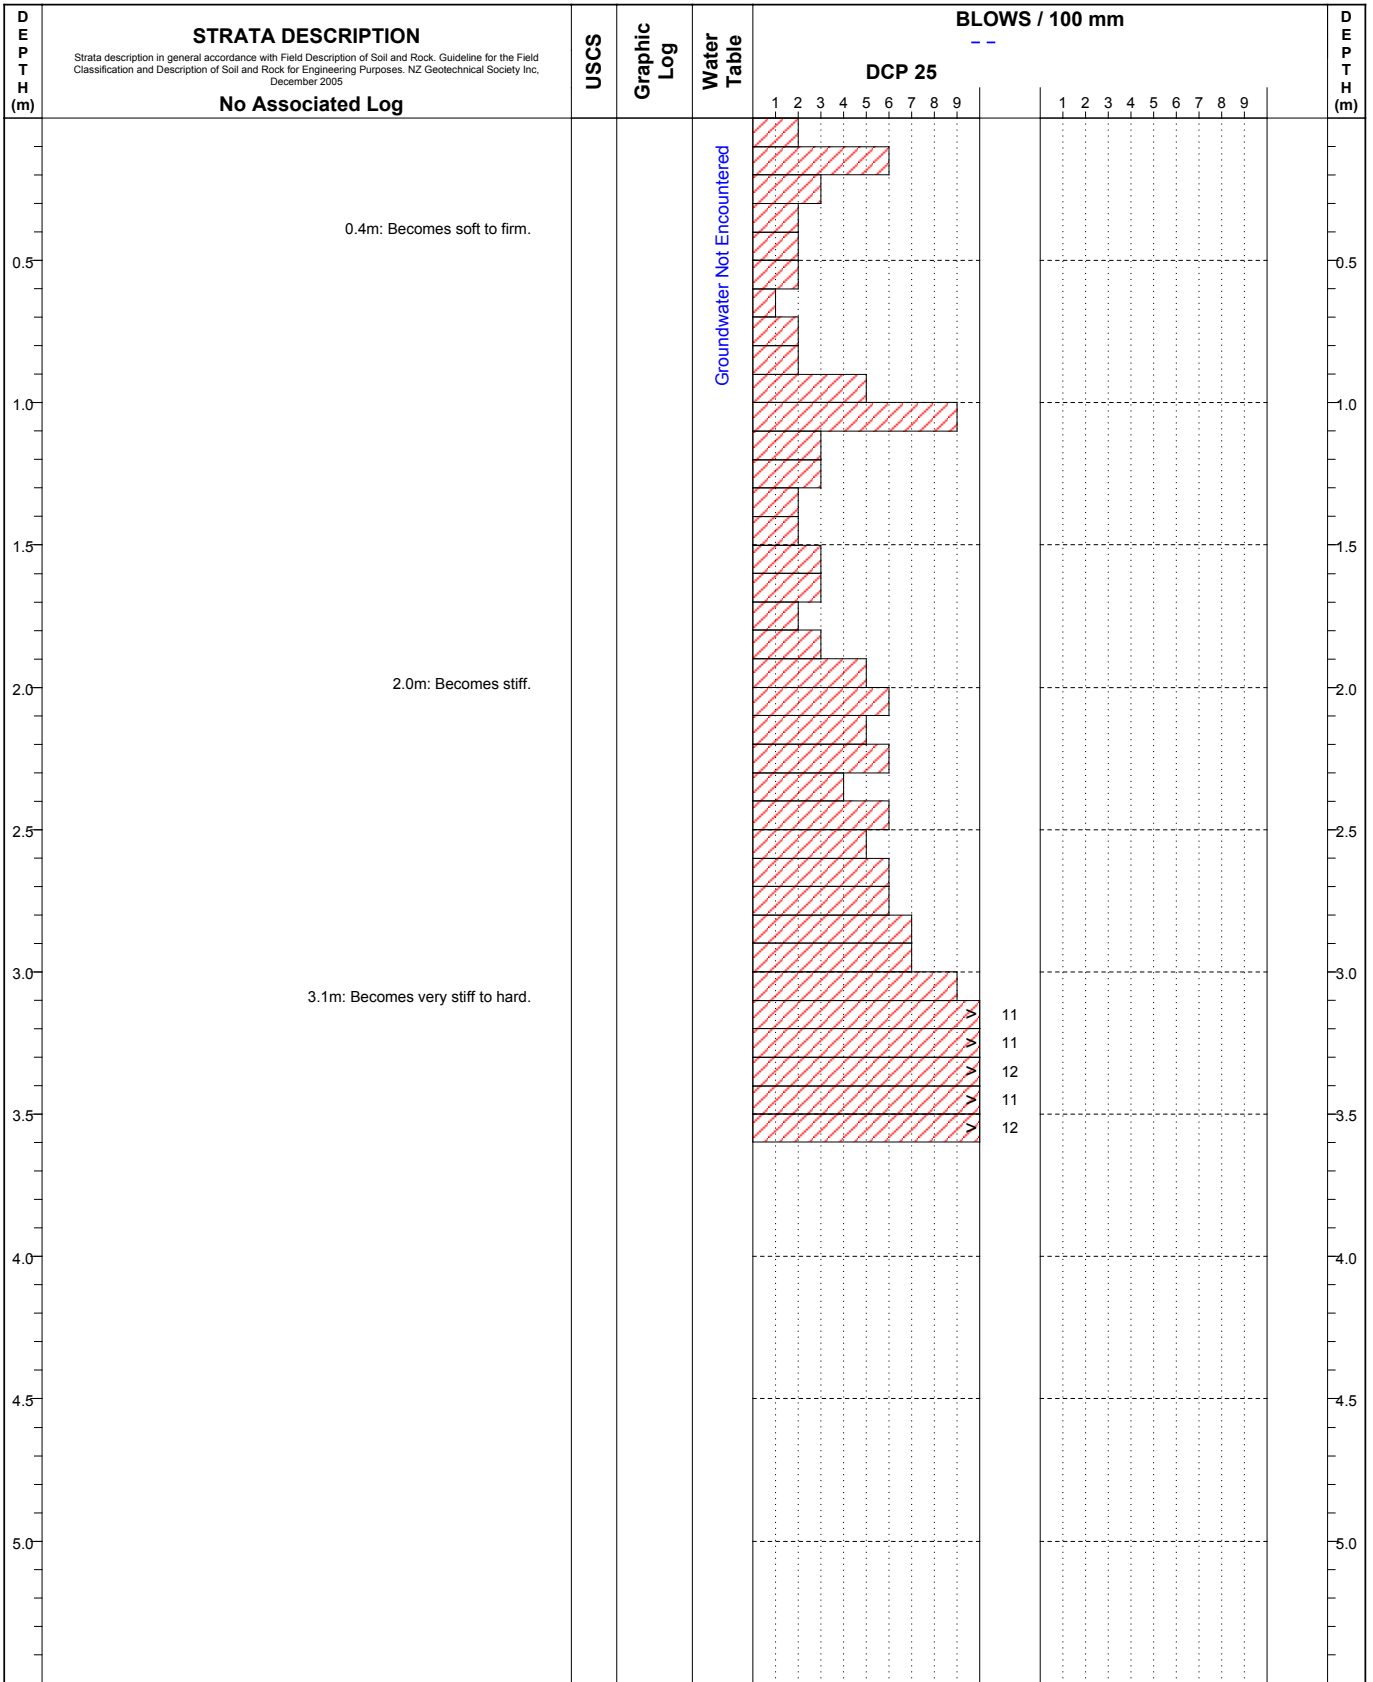
<b>Project:</b> 2 Auckland Street, Ashley (Lot 1 DP 394101)	<b>Date:</b> 10/07/20
<b>Client:</b> A J Cameron	<b>Time:</b> 10:00 a.m.
<b>Test Location:</b> Refer to attached Geotechnical Site Plan (G01A).	<b>Excavation Method:</b> DCP

<b>Logged By:</b> AB+HC	<b>Notes:</b> No test pit undertaken at DCP 25. Fill inferred to ~0.3 m.	Dynamic Penetrometer Test and logs give an indication of the ground condition at the location of the tests only. While they are representative of typical conditions across the site, they do not identify variations in the ground away from the test locations. This log does not cover slope stability or suitability of the site for building.  Dynamic Cone Penetrometer Test performed in accordance with NZS 4402 Test 6.5.2 (Procedure 1 and 2)
<b>Plotted By:</b> HC		
<b>Checked By:</b> HC

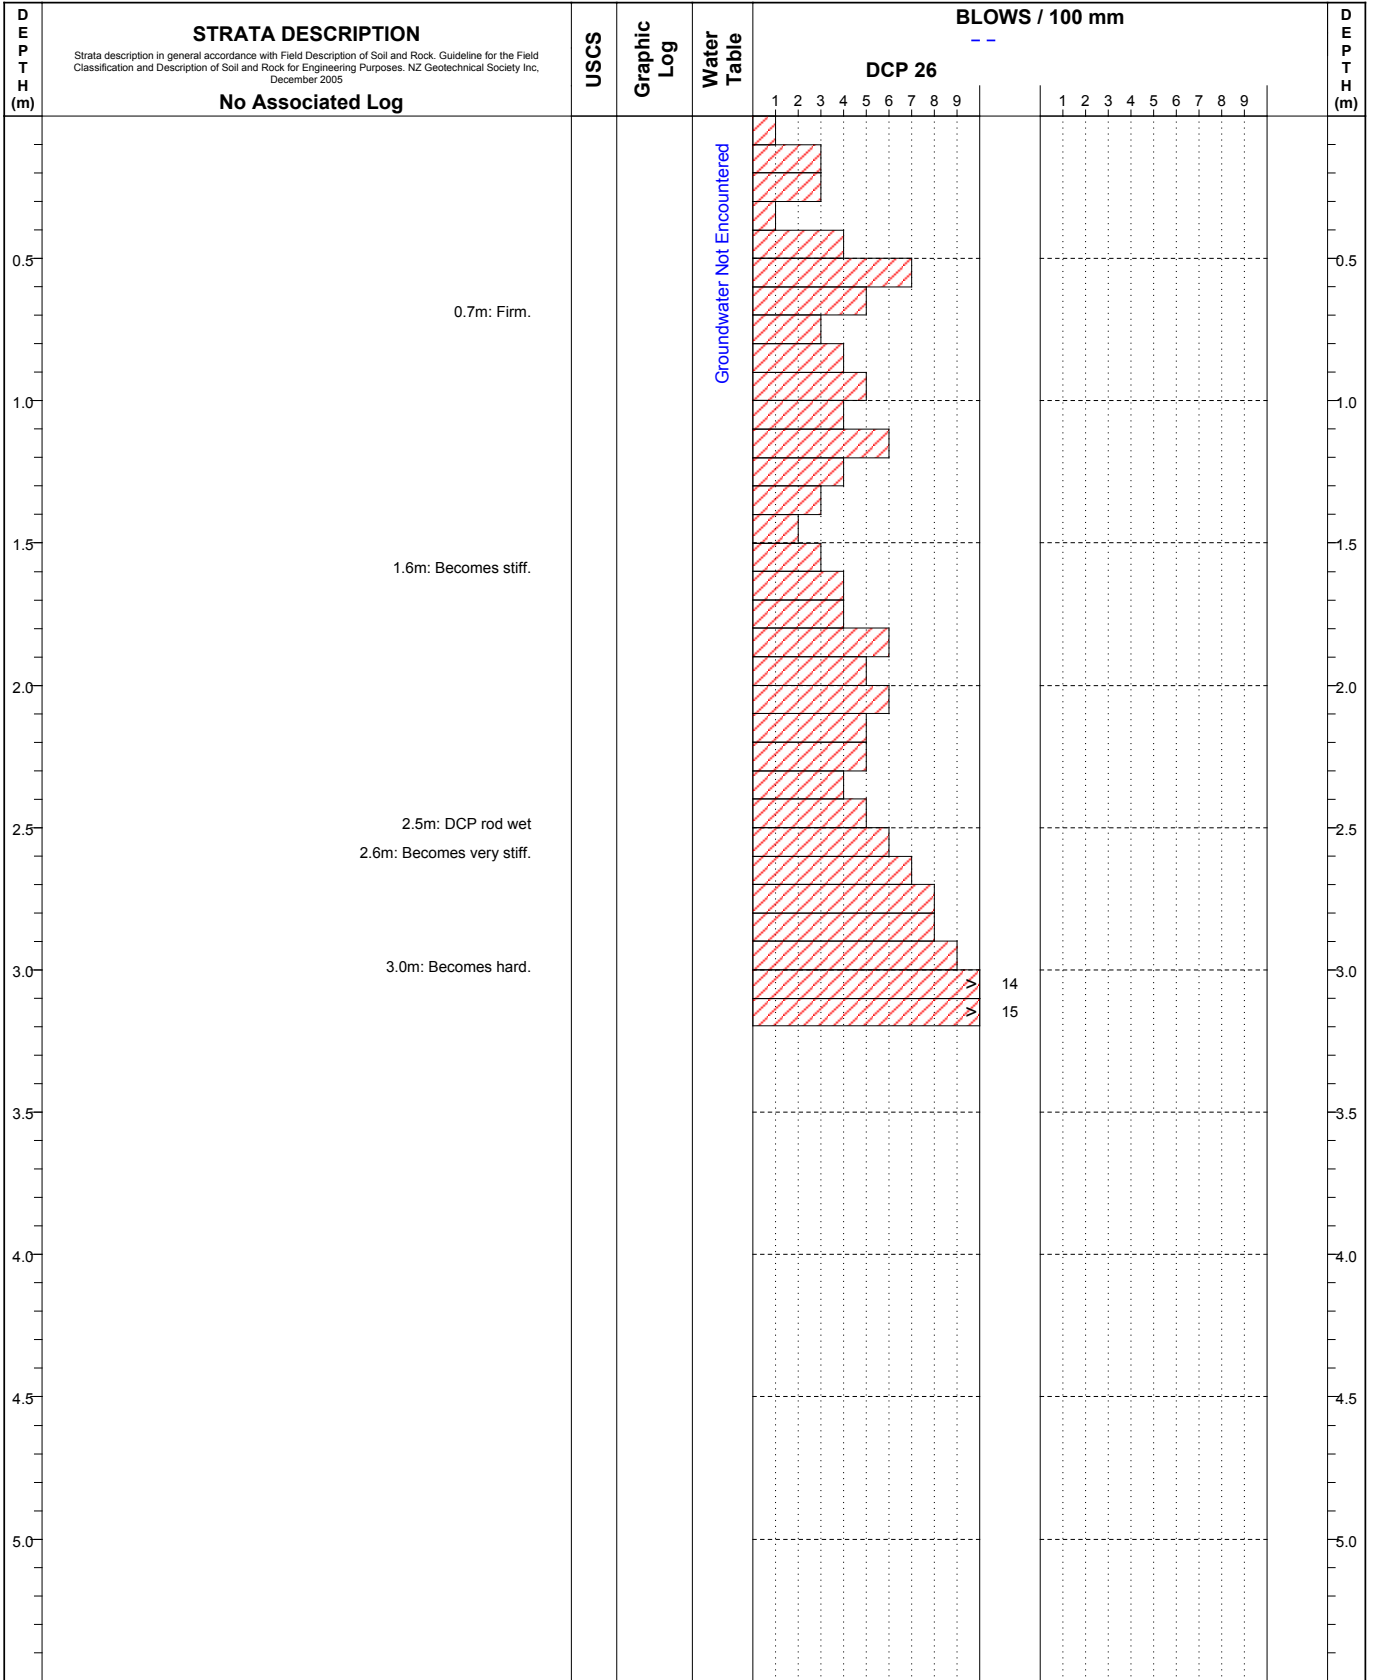
<b>Project:</b> 2 Auckland Street, Ashley (Lot 1 DP 394101) <b>Client:</b> A J Cameron <b>Test Location:</b> Refer to attached Geotechnical Site Plan (G01A).	<b>Date:</b> 10/07/20 <b>Time:</b> 10:00 a.m. <b>Excavation Method:</b> DCP
---	---

<b>Logged By:</b> AB+HC <b>Plotted By:</b> HC <b>Checked By:</b> HC	<b>Notes:</b> No test pit undertaken at DCP 26. Fill interred to ~0.5 m.	Dynamic Penetrometer Test and logs give an indication of the ground condition at the location of the tests only. While they are representative of typical conditions across the site, they do not identify variations in the ground away from the test locations. This log does not cover slope stability or suitability of the site for building.  Dynamic Cone Penetrometer Test performed in accordance with NZS 4402 Test 6.5.2 (Procedure 1 and 2)
---	---	---

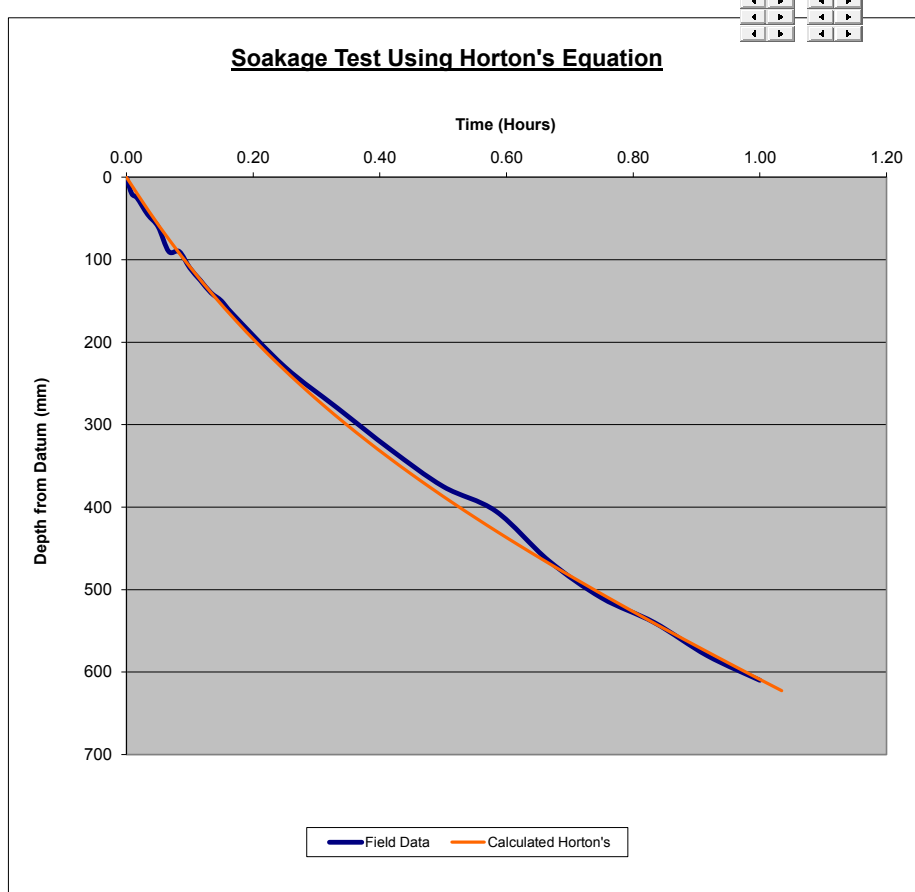
Issued to:	<b>File</b>	Job name:	<b>2 Auckland Street, Ashley</b>	Test Pit:	<b>FHI1</b>
Date:	<b>24 June 2020</b>	Job no:	<b>37441</b>		
Time:		People/equipment/materials on site:	<b>HC AB JLP</b>		
Weather/ground conditions:			<b>Wet</b>		
Test/photographs taken:			<b>Falling head infiltration test</b>		
Location Information:					
Pit size:			<b>2500 x 1000 x 2800 (L x W x D)</b>

Timestep	Time (mins)	Depth from Datum (mm)
0	0.00	0
1	0.50	20
2	1.00	25
3	2.00	45
4	3.00	60
5	4.00	90
6	5.00	90
7	6.00	110
8	7.00	125
9	8.00	140
10	9.00	150
11	10.00	165
12	15.00	230
13	20.00	280
14	25.00	330
15	30.00	375
16	35.00	405
17	40.00	465
18	45.00	510
19	50.00	540
20	55.00	580
21	60.00	610
22		
23		
24		
25		
26		
27		
28		
29		
30

**Initial Infiltration Rate: 1214.00 mm per hour**  
**Ultimate Infiltration Rate: 372.00 mm per hour**  
**Horton's Decay Coefficient: 3.44 per hour**

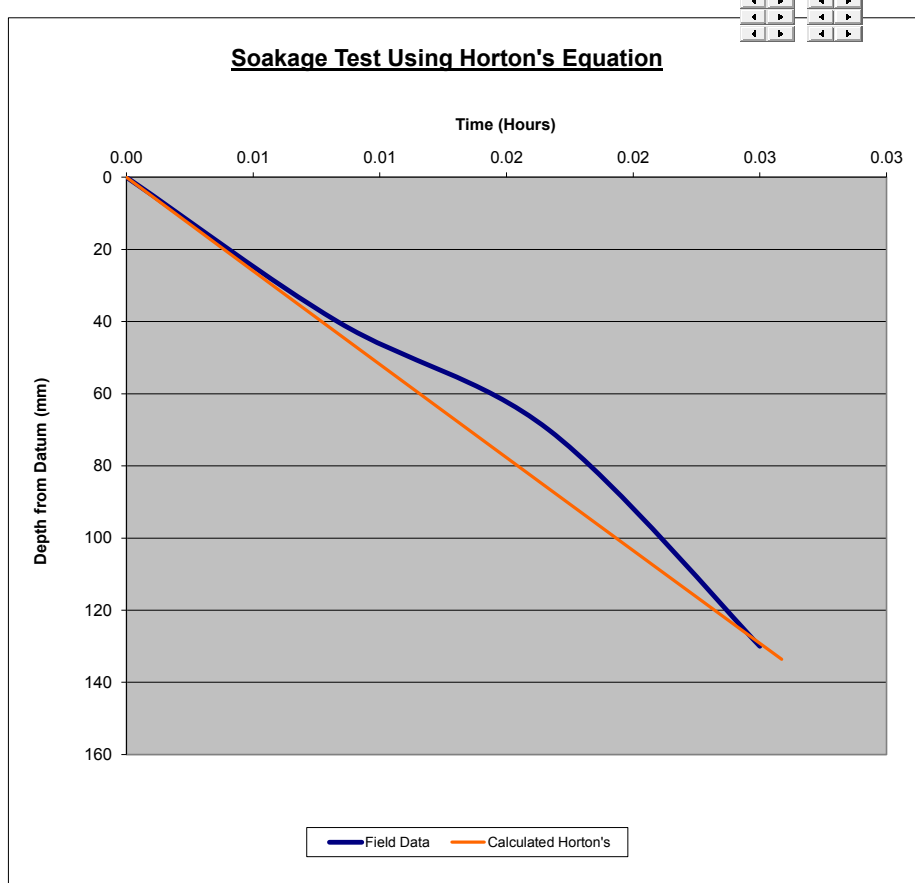
Issued to:	<u>File</u>		
Date:	<u>24 June 2020</u>	Job name:	<u>2 Auckland Street, Ashley</u>
Time:		Job no:	<u>37441</u>
People/equipment/materials on site:	<u>HC AB JLP</u>		
Weather/ground conditions:	<u>Wet</u>		
Test/photographs taken:	<u>Falling head infiltration test</u>		
Location Information:			
Pit size:	<u>1100 x 1500 x 3700 (L x W x D)</u>

Timestep	Time (mins)	Depth from Datum (mm)
0	0.00	0
1	0.50	40
2	1.00	70
3	1.50	130
4		
5		
6		
7		
8		
9		
10		
11		
12		
13		
14		
15		
16		
17		
18		
19		
20		
21		
22		
23		
24		
25		
26		
27		
28		
29		
30

**Initial Infiltration Rate: 5200.00 mm per hour**

**Ultimate Infiltration Rate: 255.00 mm per hour**

**Horton's Decay Coefficient: 0.53 per hour**
