# GEOTECHNICAL REPORT FOR SUBDIVISION

37211 / 2 AUCKLAND STREET, ASHLEY / ALISTAIR CAMERON

**Title:** Geotechnical Report for Subdivision: 2 Auckland Street, Ashley

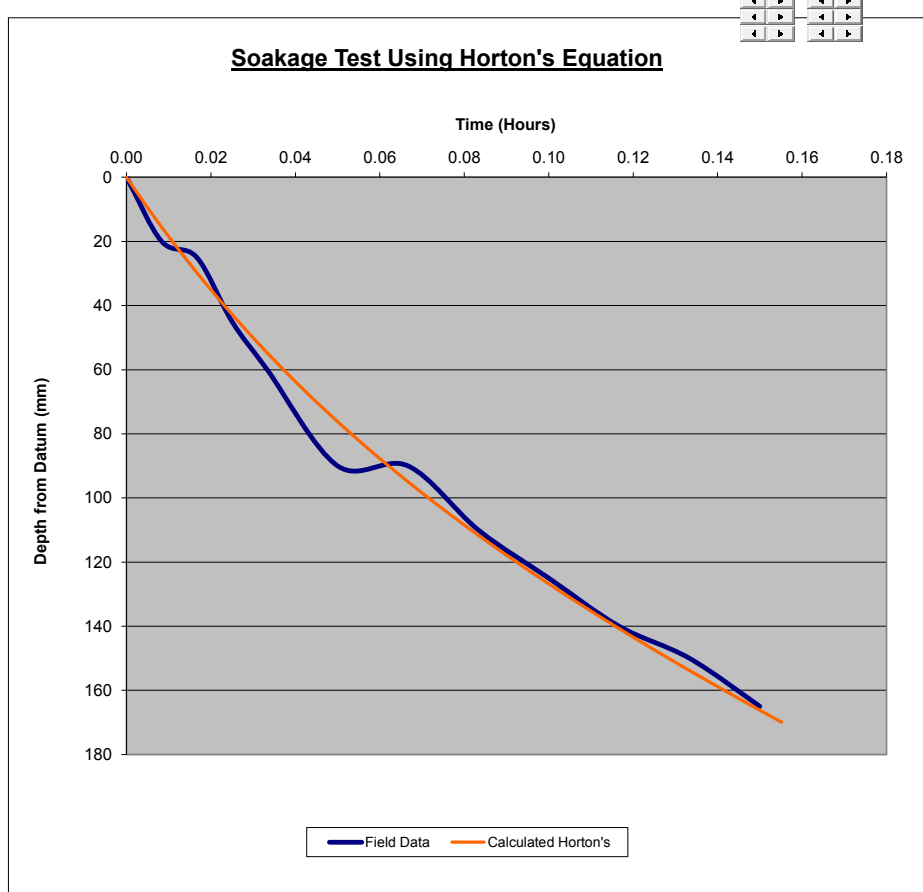
Issued to:	<u>File</u>		
Date:	<u>24 June 2020</u>	Job name:	<u>2 Auckland Street, Ashley</u>
Time:		Job no:	<u>37441</u>
People/equipment/materials on site:	<u>HC AB</u>		
Weather/ground conditions:	<u>Wet</u>		
Test/photographs taken:	<u>Falling head infiltration test</u>		
Location Information:			
Pit size:	<u>2500 x 1000 x 2800 (L x W x D)</u>

Timestep	Time (mins)	Depth from Datum (mm)
0	0.00	0
1	0.50	20
2	1.00	25
3	1.50	45
4	2.00	60
5	3.00	90
6	4.00	90
7	5.00	110
8	6.00	125
9	7.00	140
10	8.00	150
11	9.00	165
12		
13		
14		
15		
16		
17		
18		
19		
20		
21		
22		
23		
24		
25		
26		
27		
28		
29		
30

**Initial Infiltration Rate: 1953.00 mm per hour**  
**Ultimate Infiltration Rate: 616.00 mm per hour**  
**Horton's Decay Coefficient: 16.62 per hour**

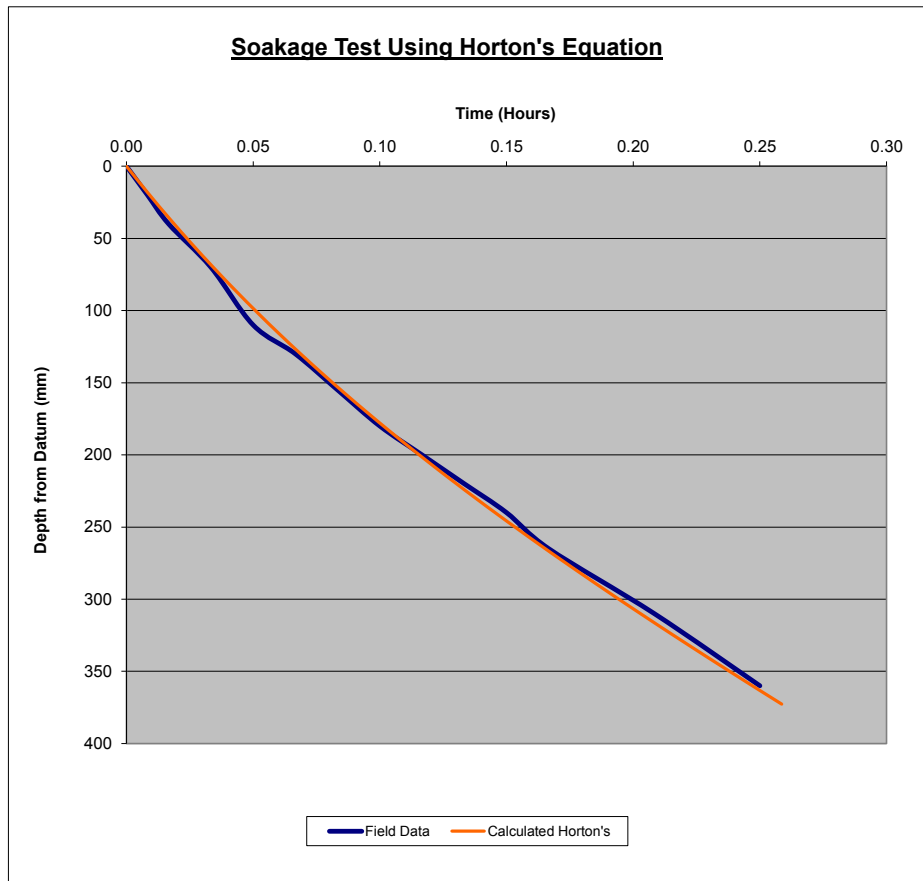
Issued to:	<b>File</b>		
Date:	<b>24 June 2020</b>	Job name:	<b>2 Auckland Street, Ashley</b>
Time:		Job no:	<b>37441</b>
People/equipment/materials on site:	<b>HC AB</b>		
Weather/ground conditions:	<b>Wet</b>		
Test/photographs taken:	<b>Falling head infiltration test</b>		
Location Information:			
Pit size:	<b>2500 x 1000 x 2800 (L x W x D)</b>		
Test Pit:	<b>FHI1A-3</b>

Timestep	Time (mins)	Depth from Datum (mm)
0	0.00	0
1	0.50	20
2	1.00	40
3	2.00	70
4	3.00	110
5	4.00	130
6	5.00	155
7	6.00	180
8	7.00	200
9	8.00	220
10	9.00	240
11	10.00	265
12	12.50	310
13	15.00	360
14		
15		
16		
17		
18		
19		
20		
21		
22		
23		
24		
25		
26		
27		
28		
29		
30

**Initial Infiltration Rate: 2232.00 mm per hour**  
**Ultimate Infiltration Rate: 1001.00 mm per hour**  
**Horton's Decay Coefficient: 10.00 per hour**

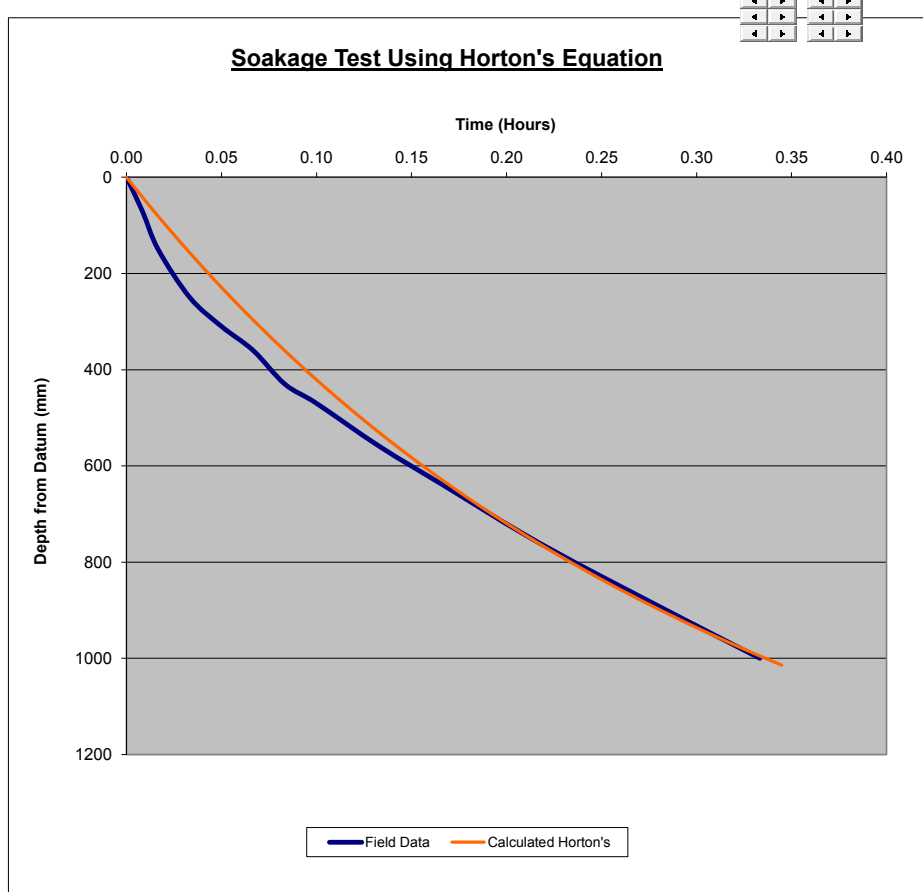
Issued to:	<u>File</u>	Job name:	<u>2 Auckland Street, Ashley</u>	Test Pit:	<u>TP4-1</u>
Date:	<u>24 June 2020</u>	Job no:	<u>37441</u>		
Time:		People/equipment/materials on site:	<u>HC AB TR</u>		
Weather/ground conditions:			<u>Wet</u>		
Test/photographs taken:			<u>Falling head infiltration test</u>		
Location Information:					
Pit size:			<u>2500 x 1000 x 2800 (L x W x D)</u>

Timestep	Time (mins)	Depth from Datum (mm)
0	0.00	0
1	0.50	70
2	1.00	150
3	2.00	250
4	3.00	310
5	4.00	360
6	5.00	430
7	6.00	470
8	8.00	560
9	10.00	640
10	12.50	740
11	15.00	830
12	20.00	1000
13		
14		
15		
16		
17		
18		
19		
20		
21		
22		
23		
24		
25		
26		
27		
28		
29		
30

**Initial Infiltration Rate: 5000.00 mm per hour**

**Ultimate Infiltration Rate: 500.00 mm per hour**

**Horton's Decay Coefficient: 4.00 per hour**

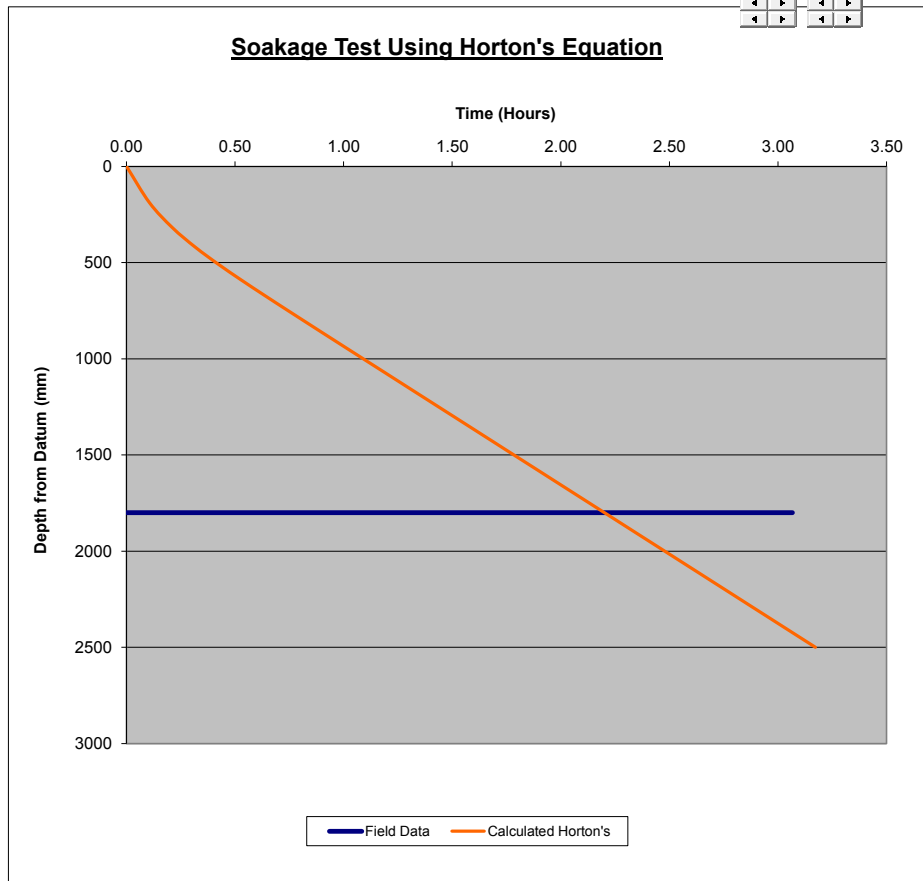
Issued to:	<u>File</u>		
Date:	<u>24 June 2020</u>	Job name:	<u>2 Auckland Street, Ashley</u>
Time:		Test Pit:	<u>FHI19</u>
People/equipment/materials on site:	<u>HC AB TR</u>		
Weather/ground conditions:	<u>Wet</u>		
Test/photographs taken:	<u>Falling head infiltration test</u>		
Location Information:			
Pit size:	<u>2300 x 1100 x 1600 (L x W x D)</u>

Timestep	Time (mins)	Depth from Datum (mm)
0	0.00	1800
1	33.00	1800
2	110.00	1800
3	184.00	1800
4		
5		
6		
7		
8		
9		
10		
11		
12		
13		
14		
15		
16		
17		
18		
19		
20		
21		
22		
23		
24		
25		
26		
27		
28		
29		
30

Cannot model 'no change' in field data water level

**Initial Infiltration Rate: 2228.00 mm per hour**

**Ultimate Infiltration Rate: 720.00 mm per hour**

**Horton's Decay Coefficient: 7.00 per hour**

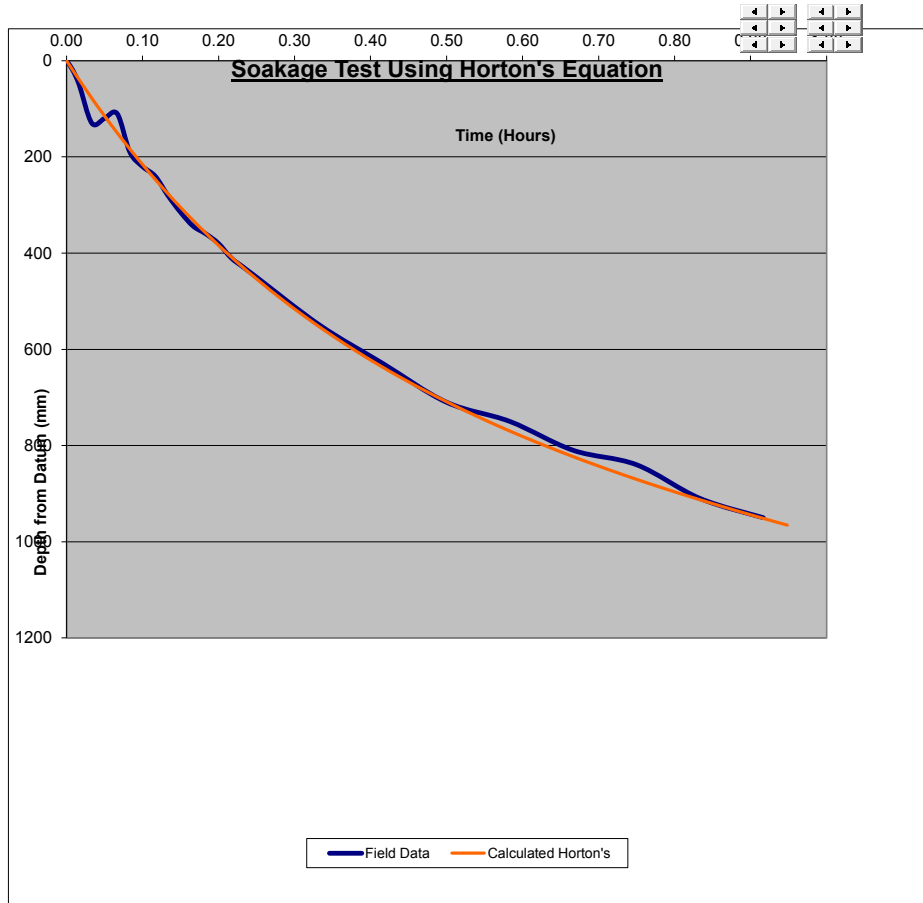
Issued to:	<b>File</b>		
Date:	<b>24 June 2020</b>	Job name:	<b>2 Auckland Street, Ashley</b>
Time:		Job no:	<b>37441</b>
People/equipment/materials on site:	<b>HC AB TR</b>		
Weather/ground conditions:	<b>Wet</b>		
Test/photographs taken:	<b>Falling head infiltration test</b>		
Location Information:			
Pit size:	<b>3900 x 1100 x 2600 (L x W x D)</b>

Timestep	Time (mins)	Depth from Datum (mm)
0	0.00	0
1	0.50	20
2	1.00	50
3	2.00	130
4	3.00	120
5	4.00	110
6	5.00	190
7	6.00	220
8	7.00	240
9	8.00	280
10	9.00	315
11	10.00	344
12	11.00	360
13	12.00	380
14	13.00	410
15	14.00	430
16	15.00	450
17	20.00	550
18	25.00	630
19	30.00	710
20	35.00	750
21	40.00	810
22	45.00	840
23	50.00	910
24	55.00	950
25		
26		
27		
28		
29		
30

**Initial Infiltration Rate: 2449.00 mm per hour**

**Ultimate Infiltration Rate: 310.00 mm per hour**

**Horton's Decay Coefficient: 3.00 per hour**

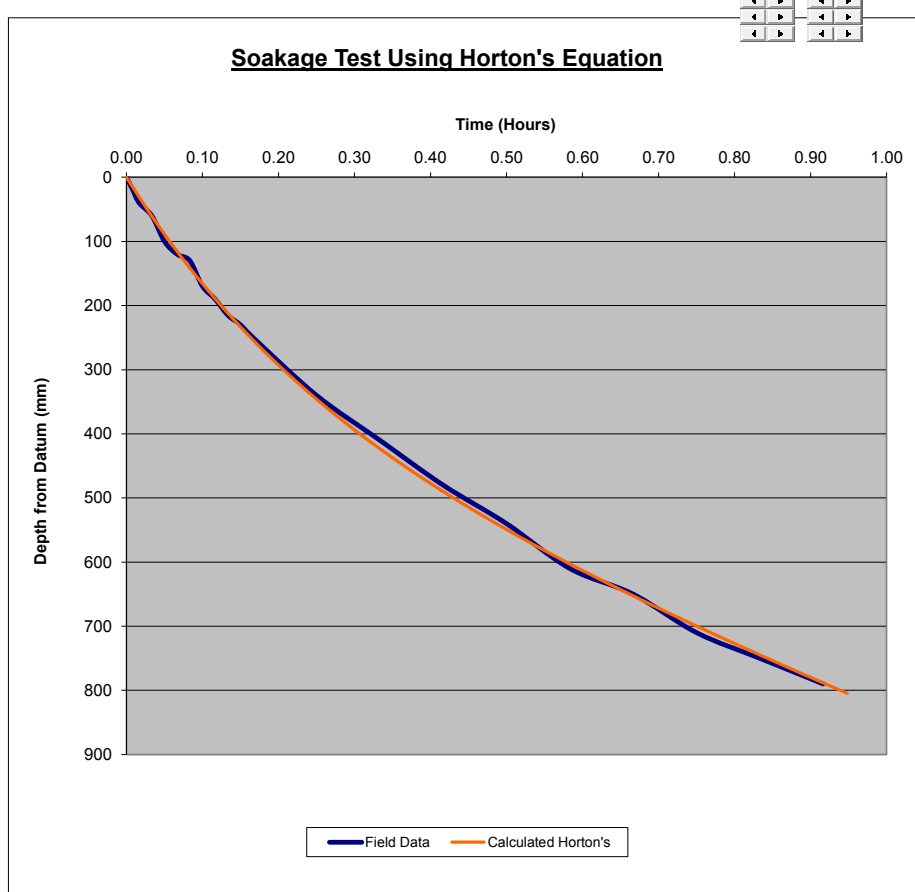
Issued to:	<u>File</u>	Job name:	<u>2 Auckland Street, Ashley</u>	Test Pit:	<u>TP 9-2</u>
Date:	<u>24 June 2020</u>	Job no:	<u>37441</u>		
Time:		People/equipment/materials on site:	<u>HC AB TR</u>		
Weather/ground conditions:			<u>Wet</u>		
Test/photographs taken:			<u>Falling head infiltration test</u>		
Location Information:					
Pit size:			<u>3900 x 1100 x 2600 (L x W x D)</u>

Timestep	Time (mins)	Depth from Datum (mm)
0	0.00	0
1	0.50	20
2	1.00	40
3	2.00	60
4	3.00	100
5	4.00	120
6	5.00	130
7	6.00	170
8	7.00	190
9	8.00	215
10	9.00	230
11	10.00	250
12	15.00	340
13	20.00	410
14	25.00	480
15	30.00	540
16	35.00	610
17	40.00	650
18	45.00	710
19	50.00	750
20	55.00	790
21		
22		
23		
24		
25		
26		
27		
28		
29		
30

**Initial Infiltration Rate: 1910.00 mm per hour**  
**Ultimate Infiltration Rate: 480.00 mm per hour**  
**Horton's Decay Coefficient: 4.00 per hour**

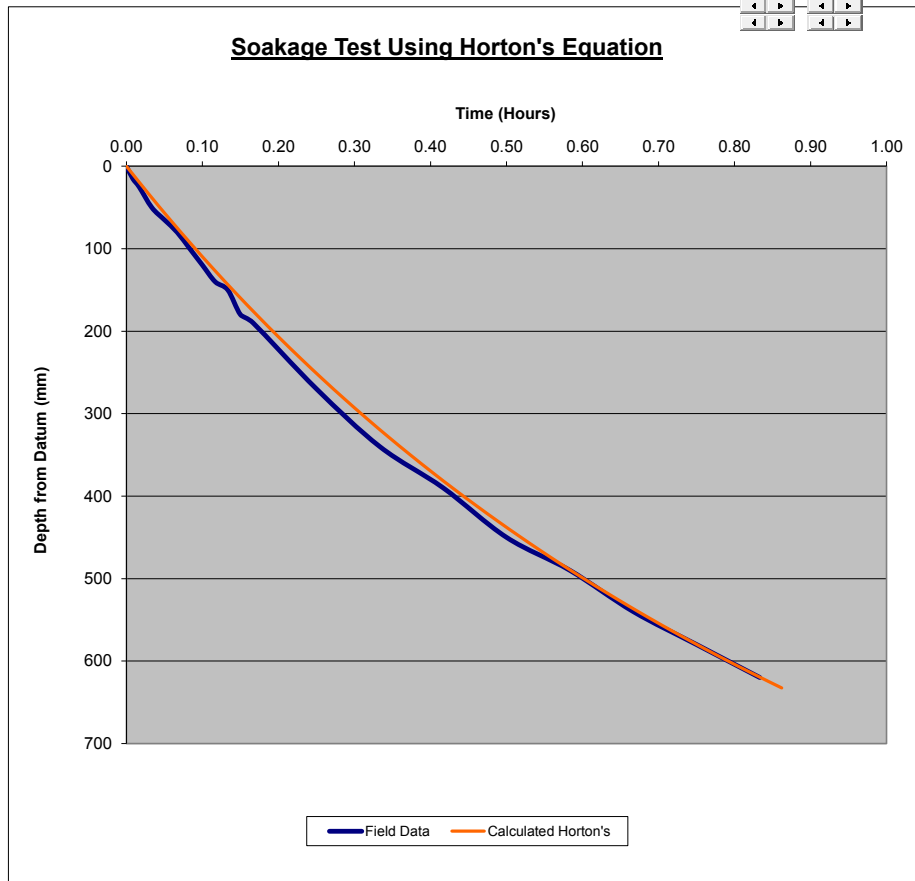
Issued to:	<u>File</u>	Job name:	<u>2 Auckland Street, Ashley</u>	Test Pit:	<u>TP 9-3</u>
Date:	<u>24 June 2020</u>	Job no.:	<u>37441</u>		
Time:		People/equipment/materials on site:	<u>HC AB TR</u>		
Weather/ground conditions:			<u>Wet</u>		
Test/photographs taken:			<u>Falling head infiltration test</u>		
Location Information:					
Pit size:			<u>3900 x 1100 x 2600 (L x W x D)</u>

Timestep	Time (mins)	Depth from Datum (mm)
0	0.00	0
1	0.50	15
2	1.00	25
3	2.00	50
4	3.00	65
5	4.00	80
6	5.00	100
7	6.00	120
8	7.00	140
9	8.00	150
10	9.00	180
11	10.00	190
12	15.00	270
13	20.00	340
14	25.00	390
15	30.00	450
16	35.00	490
17	40.00	540
18	45.00	580
19	50.00	620
20		
21		
22		
23		
24		
25		
26		
27		
28		
29		
30

**Initial Infiltration Rate:    1168.00    mm per hour**  
**Ultimate Infiltration Rate:    161.00    mm per hour**  
**Horton's Decay Coefficient:    1.46    per hour**

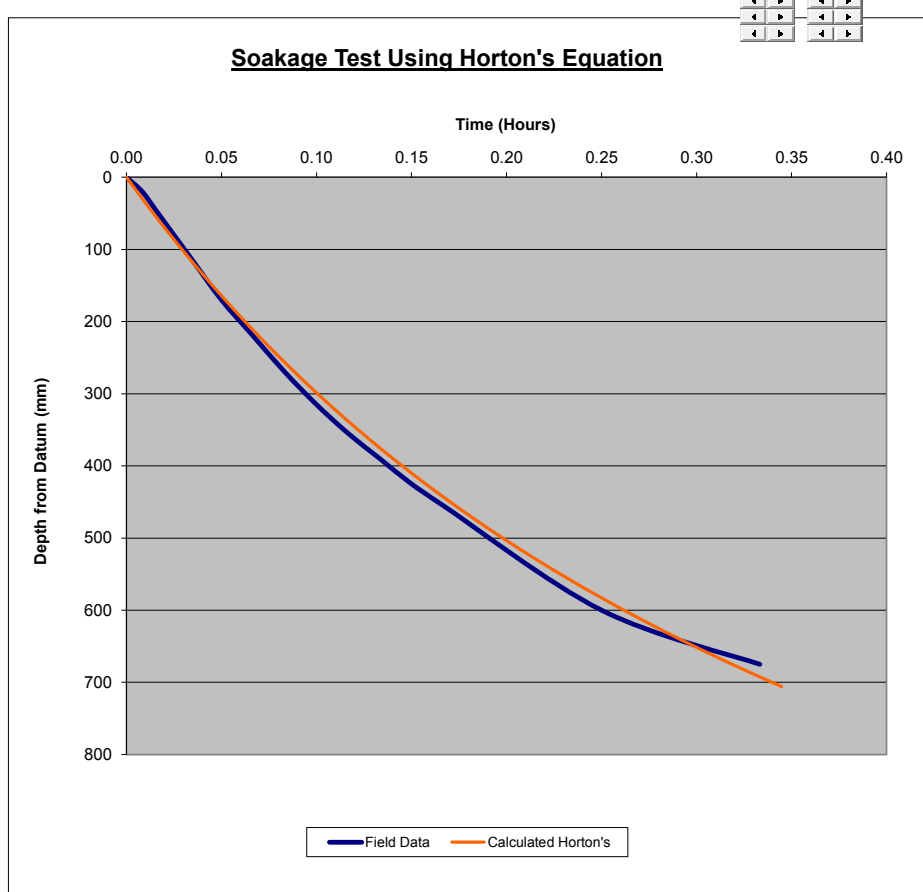
Issued to:	<u>File</u>	Job name:	<u>2 Auckland Street, Ashley</u>	Test Pit:	<u>TP 6-1</u>
Date:	<u>24 June 2020</u>	Job no:	<u>37441</u>		
Time:		People/equipment/materials on site:	<u>HC AB TR</u>		
Weather/ground conditions:			<u>Wet</u>		
Test/photographs taken:			<u>Falling head infiltration test</u>		
Location Information:					
Pit size:			<u>2500 x 1100 x 2700 (L x W x D)</u>

Timestep	Time (mins)	Depth from Datum (mm)
0	0.00	0
1	0.50	20
2	1.00	50
3	2.00	110
4	3.00	170
5	4.00	220
6	5.00	270
7	6.00	315
8	7.00	355
9	8.00	390
10	9.00	425
11	10.00	455
12	15.00	600
13	20.00	675
14		
15		
16		
17		
18		
19		
20		
21		
22		
23		
24		
25		
26		
27		
28		
29		
30

**Initial Infiltration Rate: 3633.00 mm per hour**

**Ultimate Infiltration Rate: 613.00 mm per hour**

**Horton's Decay Coefficient: 5.03 per hour**

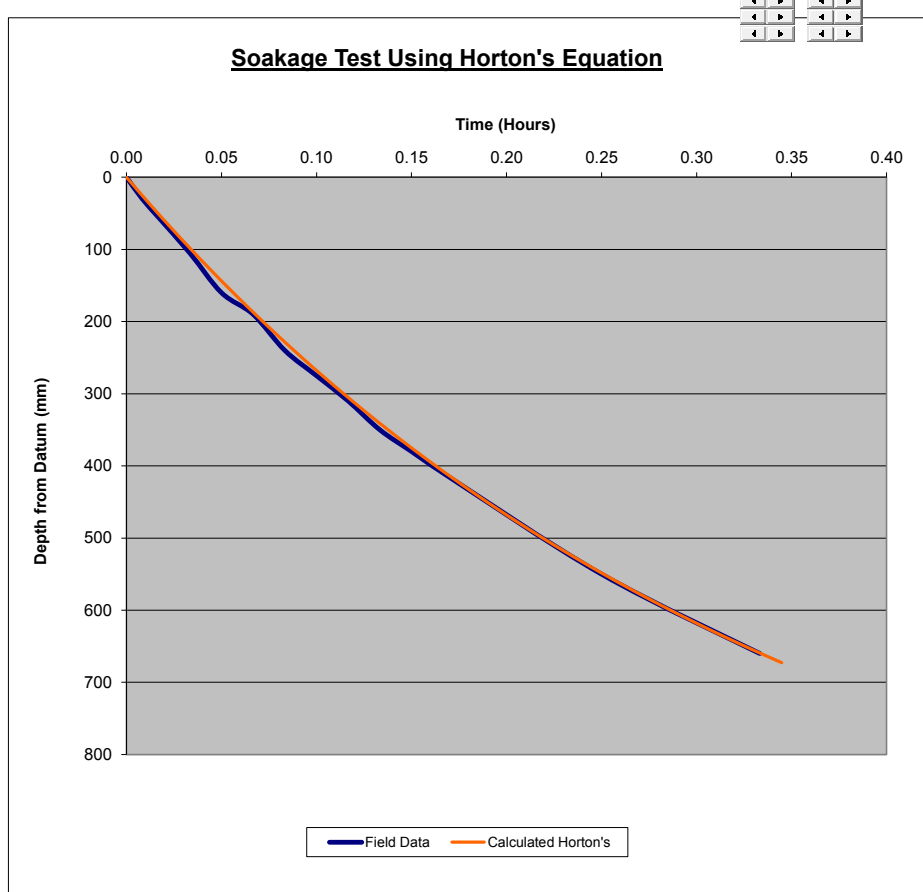
Issued to:	<u>File</u>	Job name:	<u>2 Auckland Street, Ashley</u>	Test Pit:	<u>TP 6-2</u>
Date:	<u>24 June 2020</u>	Job no:	<u>37441</u>		
Time:		People/equipment/materials on site:	<u>HC AB TR</u>		
Weather/ground conditions:			<u>Wet</u>		
Test/photographs taken:			<u>Falling head infiltration test</u>		
Location Information:					
Pit size:			<u>2500 x 1100 x 2700 (L x W x D)</u>

Timestep	Time (mins)	Depth from Datum (mm)
0	0.00	0
1	0.50	30
2	1.00	55
3	2.00	105
4	3.00	160
5	4.00	190
6	5.00	240
7	6.00	275
8	7.00	310
9	8.00	350
10	9.00	380
11	10.00	410
12	15.00	550
13	20.00	660
14		
15		
16		
17		
18		
19		
20		
21		
22		
23		
24		
25		
26		
27		
28		
29		
30

**Initial Infiltration Rate: 3088.00 mm per hour**

**Ultimate Infiltration Rate: 71.00 mm per hour**

**Horton's Decay Coefficient: 3.00 per hour**

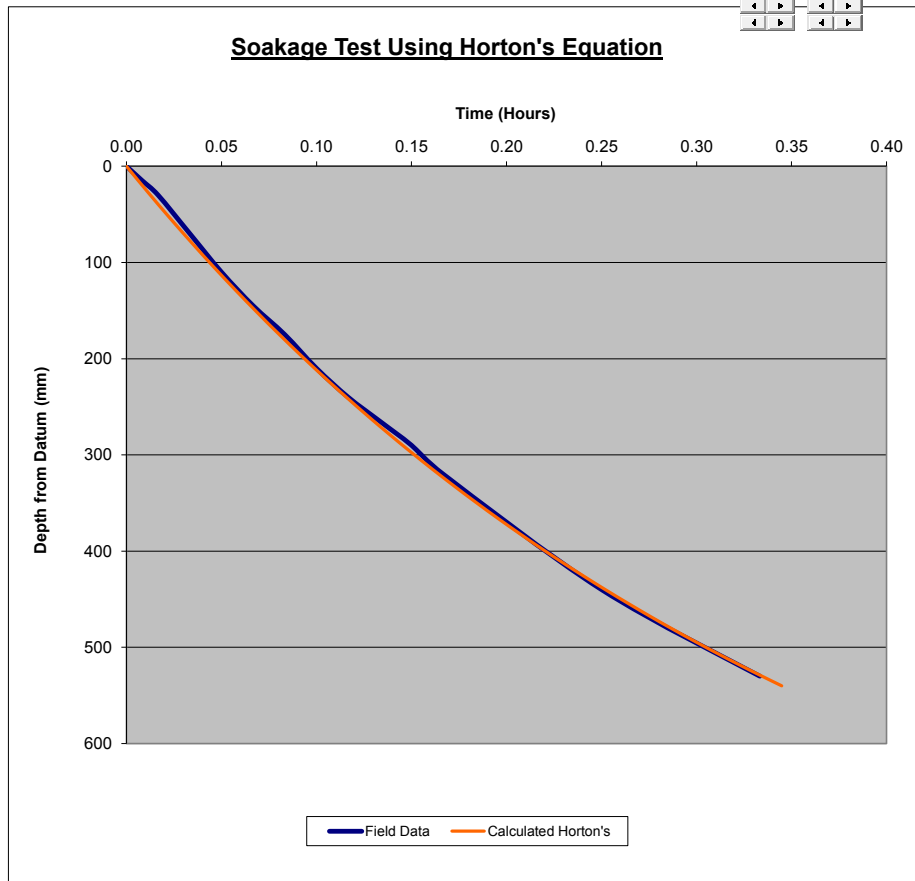
Issued to:	<u>File</u>	Job name:	<u>2 Auckland Street, Ashley</u>	Test Pit:	<u>TP 6-3</u>
Date:	<u>24 June 2020</u>	Job no:	<u>37441</u>		
Time:		People/equipment/materials on site:	<u>HC AB TR</u>		
Weather/ground conditions:			<u>Wet</u>		
Test/photographs taken:			<u>Falling head infiltration test</u>		
Location Information:					
Pit size:			<u>2500 x 1100 x 2700 (L x W x D)</u>

Timestep	Time (mins)	Depth from Datum (mm)
0	0.00	0
1	0.50	15
2	1.00	30
3	2.00	70
4	3.00	110
5	4.00	145
6	5.00	175
7	6.00	210
8	7.00	240
9	8.00	265
10	9.00	290
11	10.00	320
12	15.00	440
13	20.00	530
14		
15		
16		
17		
18		
19		
20		
21		
22		
23		
24		
25		
26		
27		
28		
29		
30

**Initial Infiltration Rate: 2430.00 mm per hour**

**Ultimate Infiltration Rate: 138.00 mm per hour**

**Horton's Decay Coefficient: 3.00 per hour**
