MCCRACKEN & ASSOCIATES RFI RESPONSE

Re: Request for Information – RC235259 – Energy Bay Limited, 87 Upper Sefton Road, Sefton

Proposed Solar Farm - 87 Upper Sefton Road, Ashley, Canterbury Graphic Attachment to Landscape Assessment Report

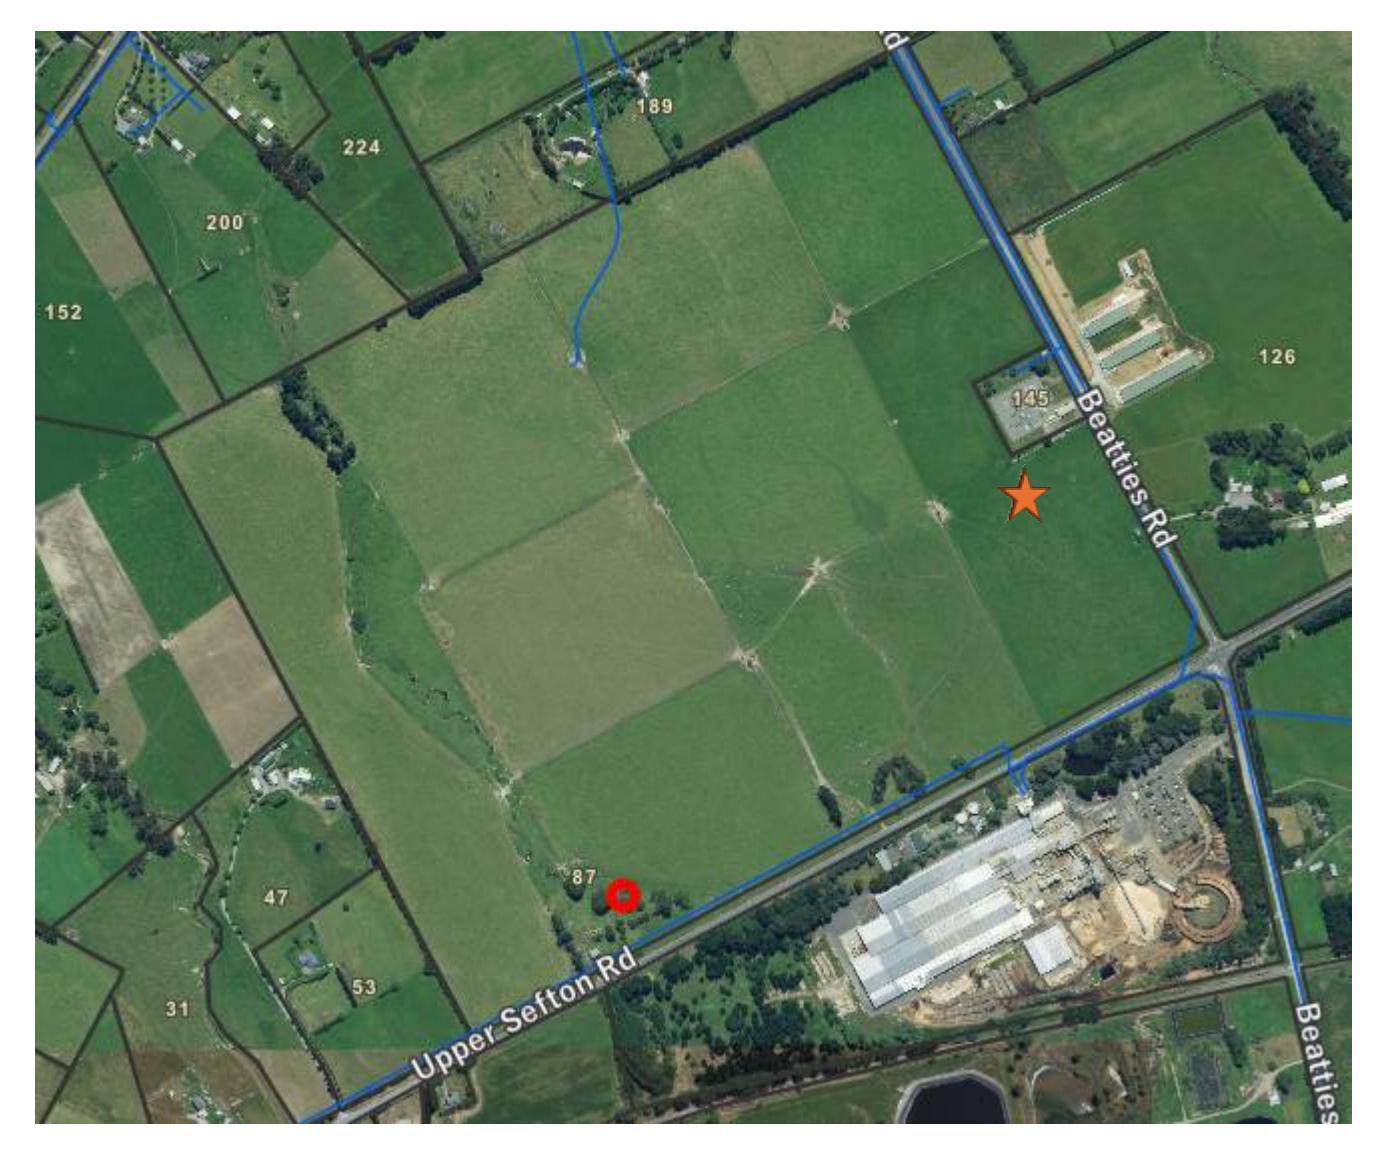
I see on Canterbury Maps that there appears to be a service connection into the site from the northern boundary. I'm checking how many units the site is rated for and if this connection can be relocated to supply a new tanks at the approximate location shown by the star on the figure below?

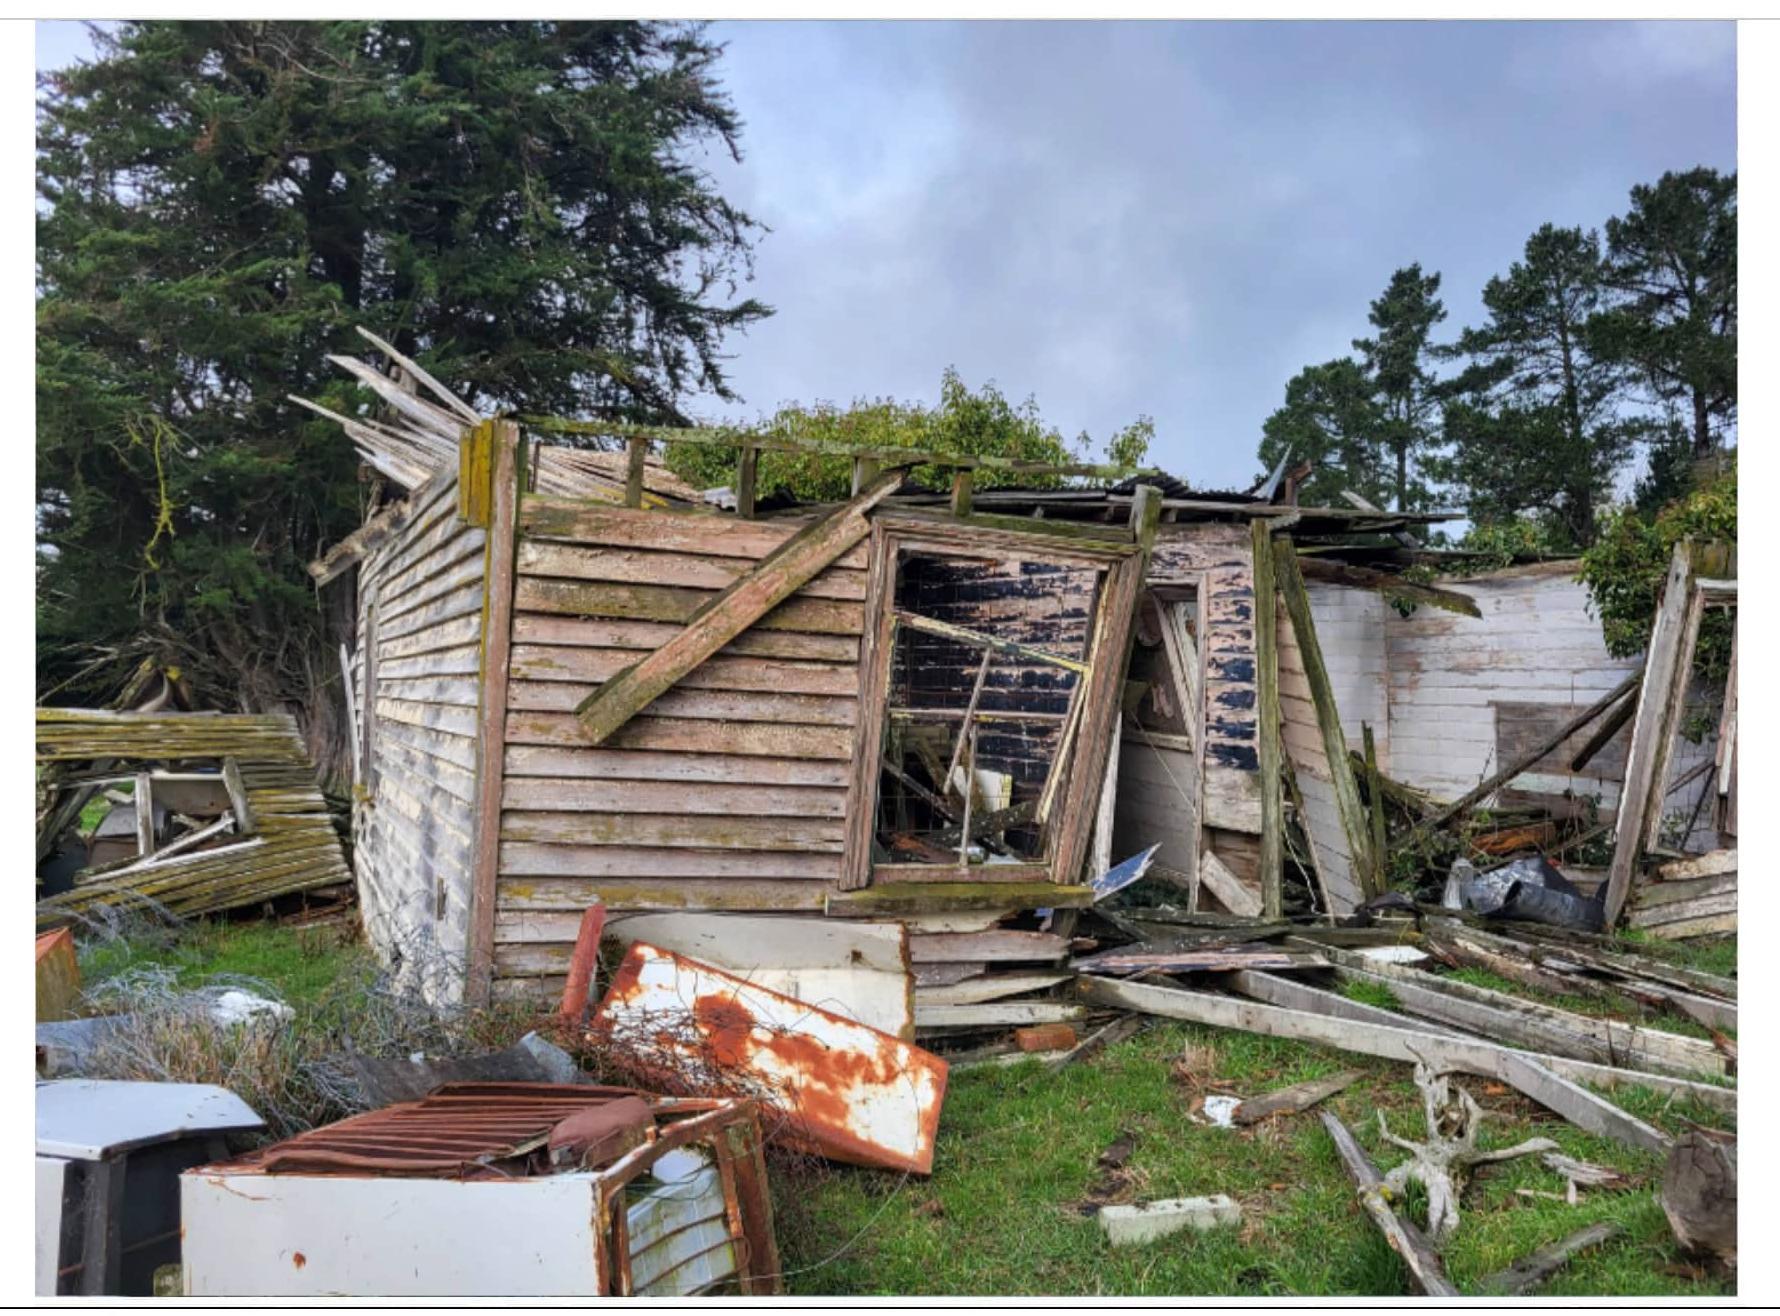
Main dwelling (fire damage) at South West entrance to 87 Upper Sefton Road. Potential Lead paints on timber cladding. No PACM visually Identified.

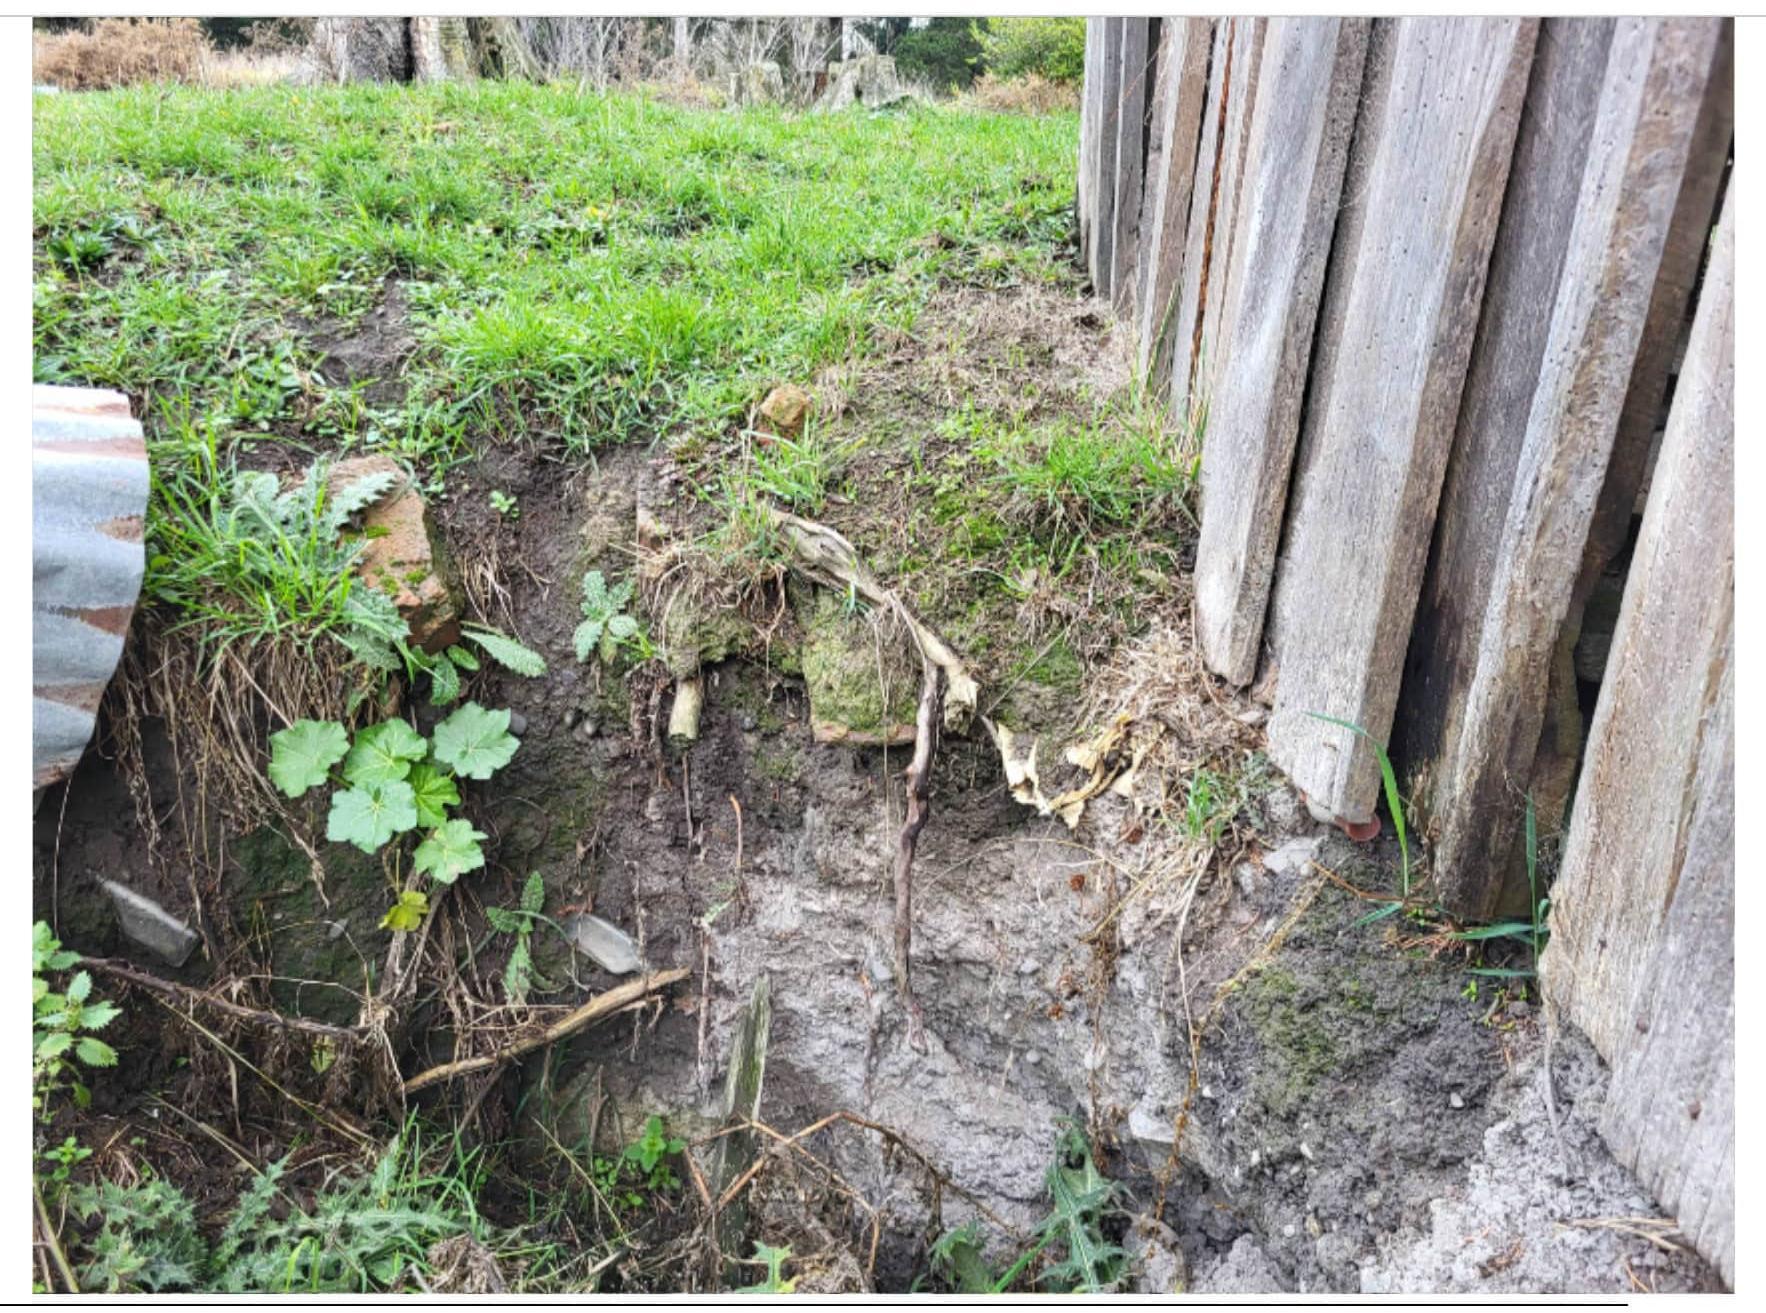
Waste hole to east of small shed. East of main dwelling within South West entrance to 87 Upper Sefton Road.

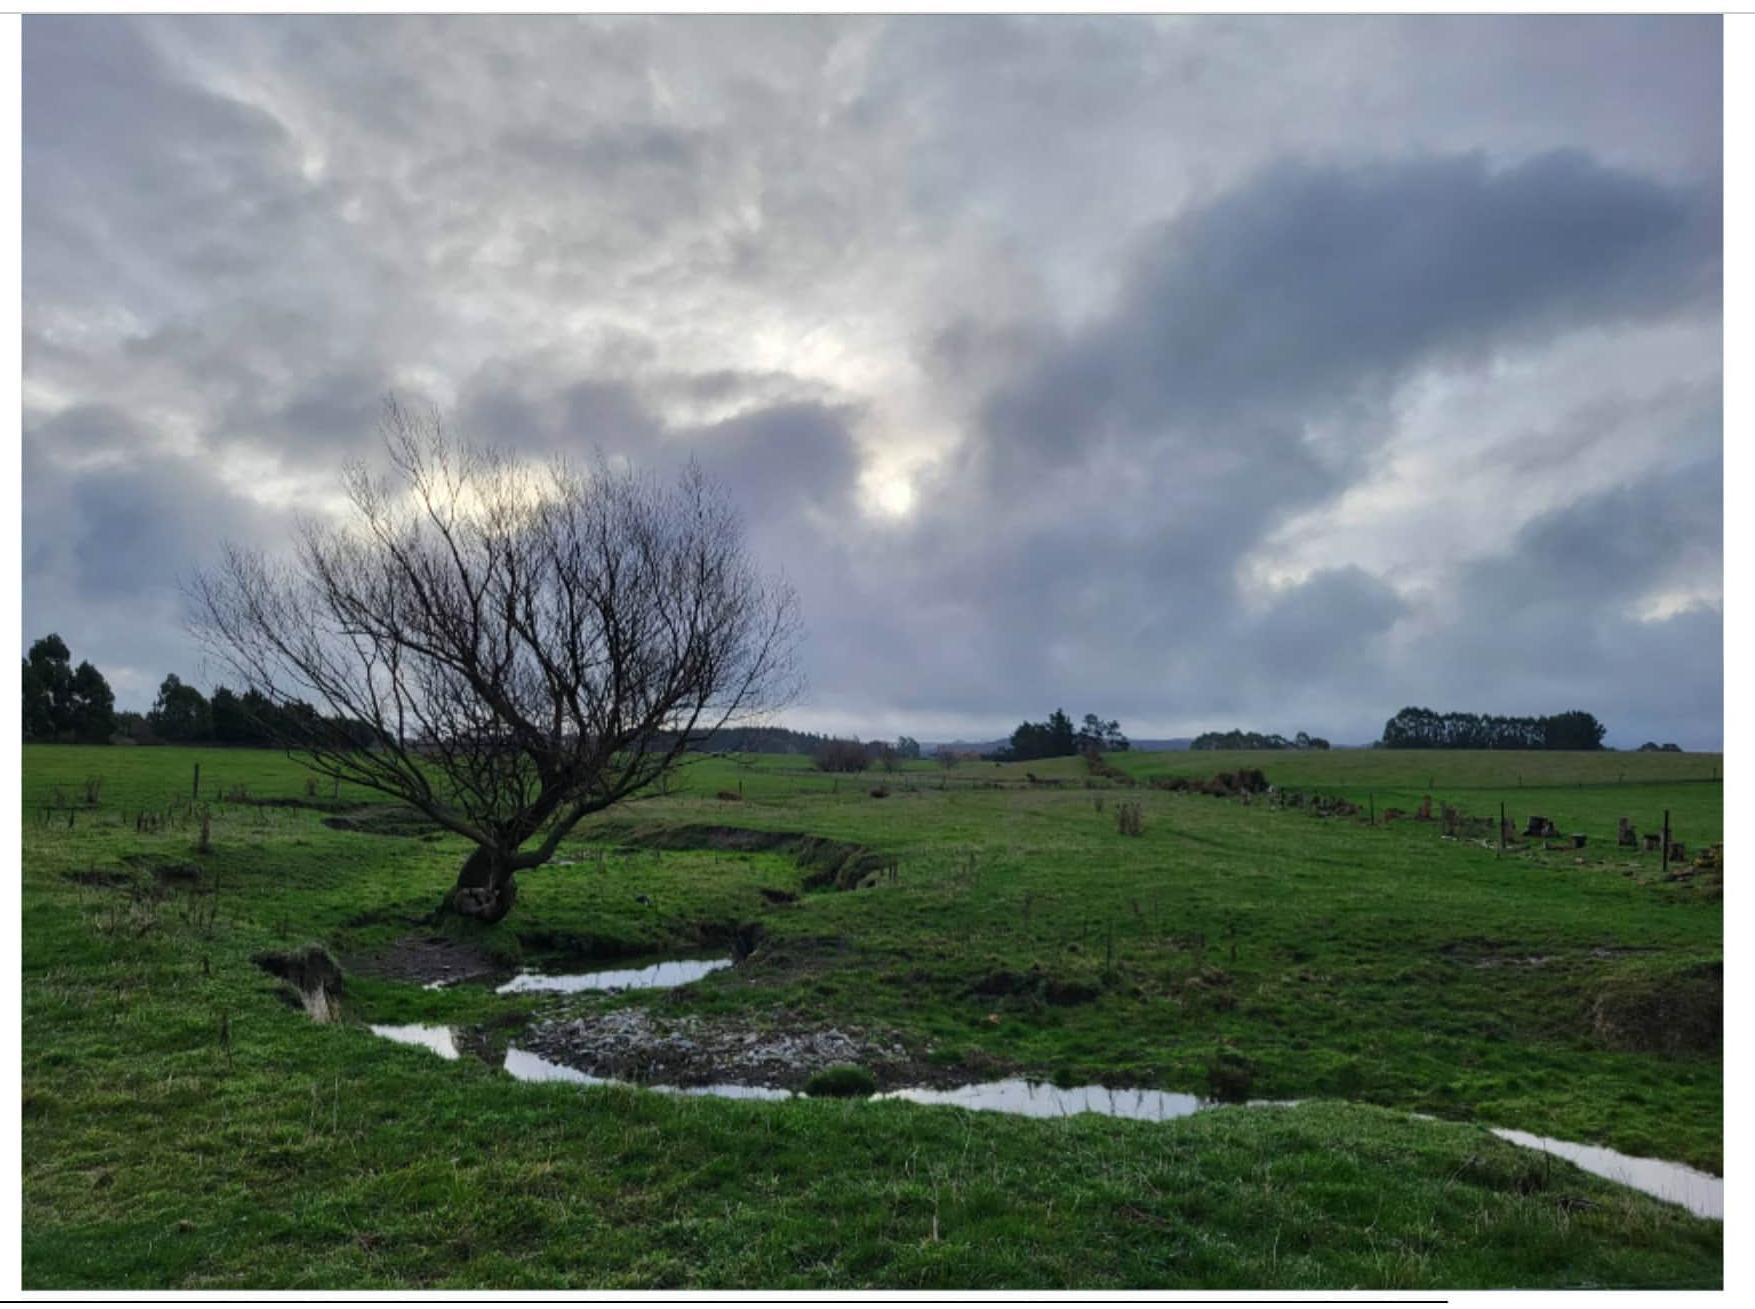
Standing water (slow moving) in stream to north of main dwelling. Photo facing north (upstream).

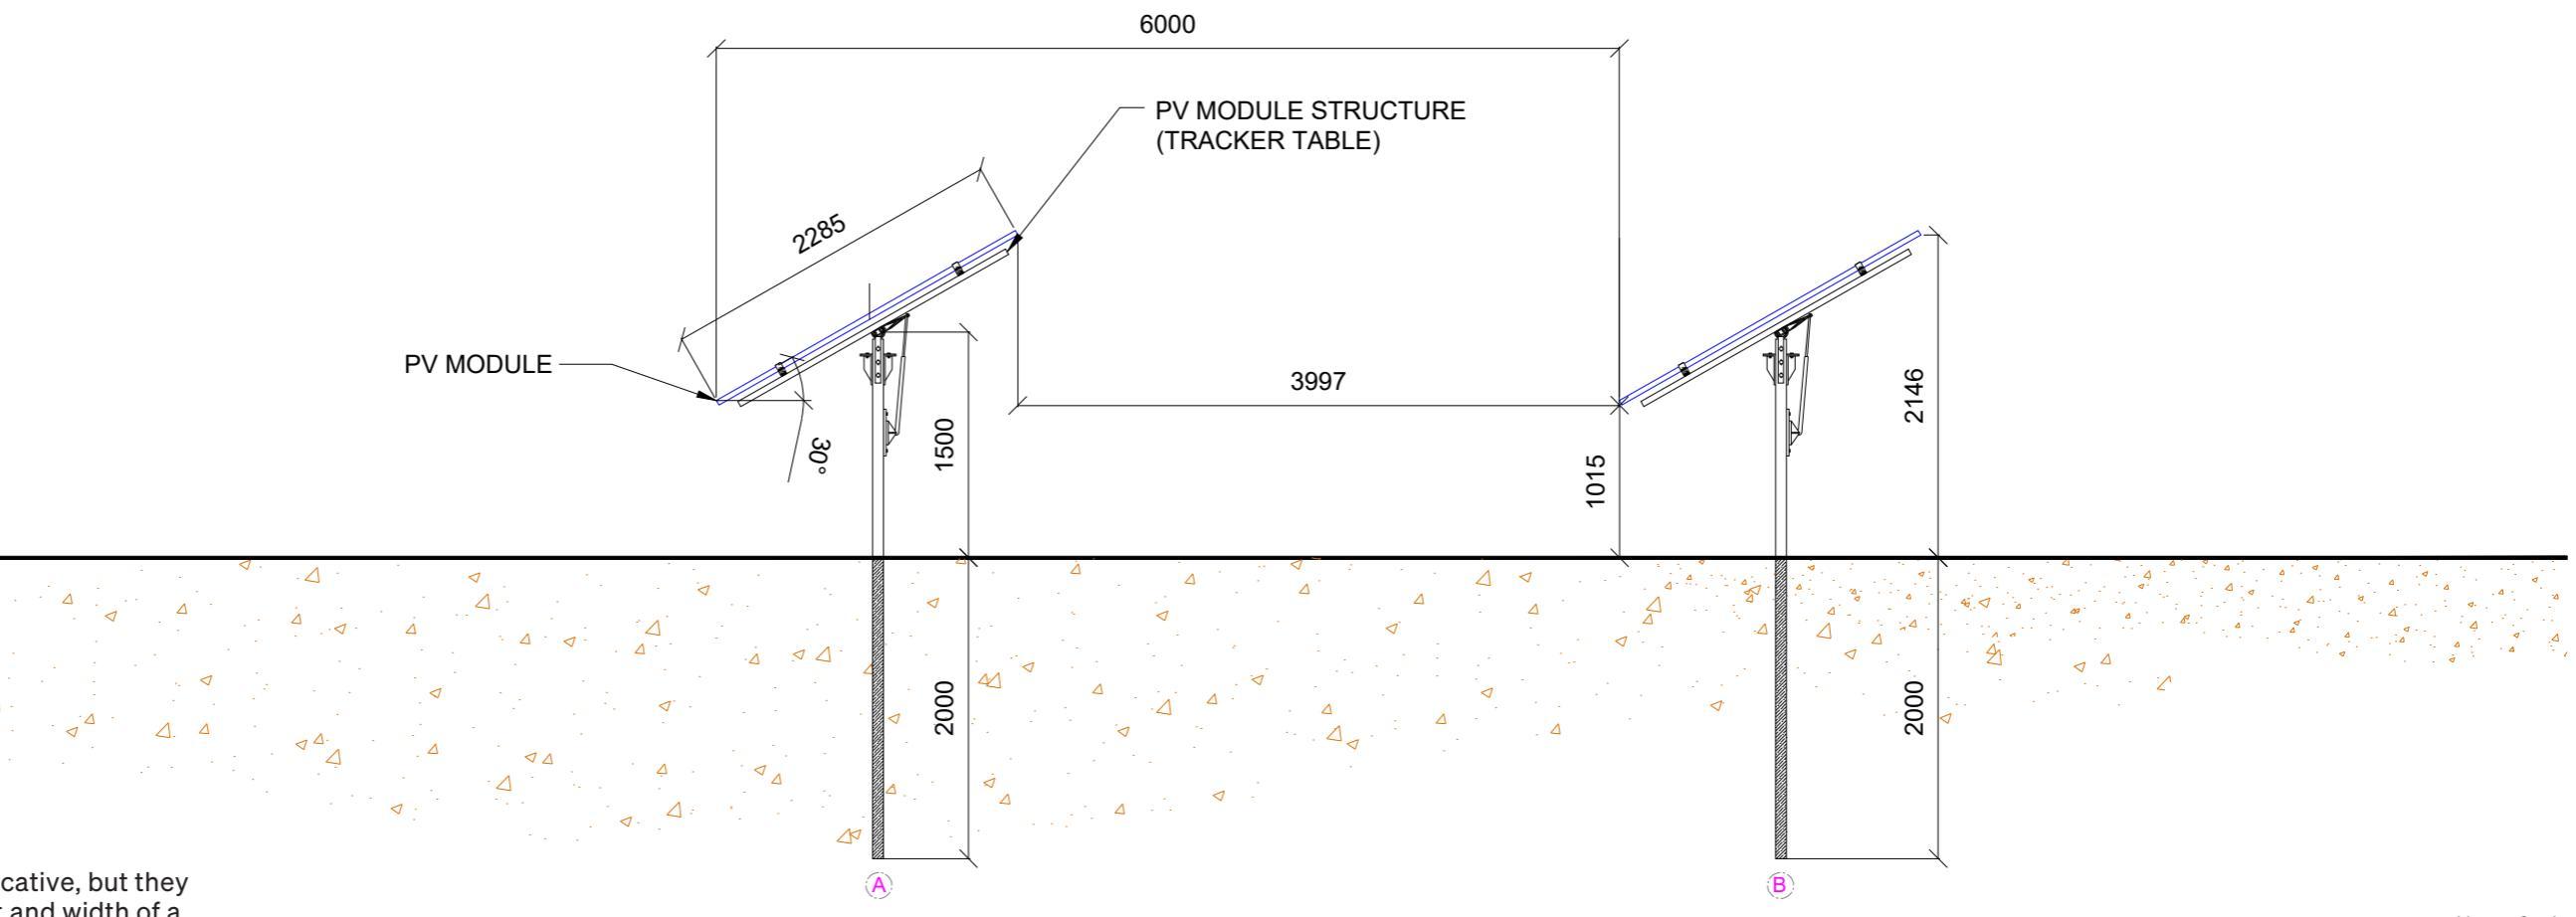
Typical Cross Section Detail for Tracker Table (Side View)

Note: These cross sections are indicative, but they generally illustrate the height and width of a one panel single axis tracking solar table.

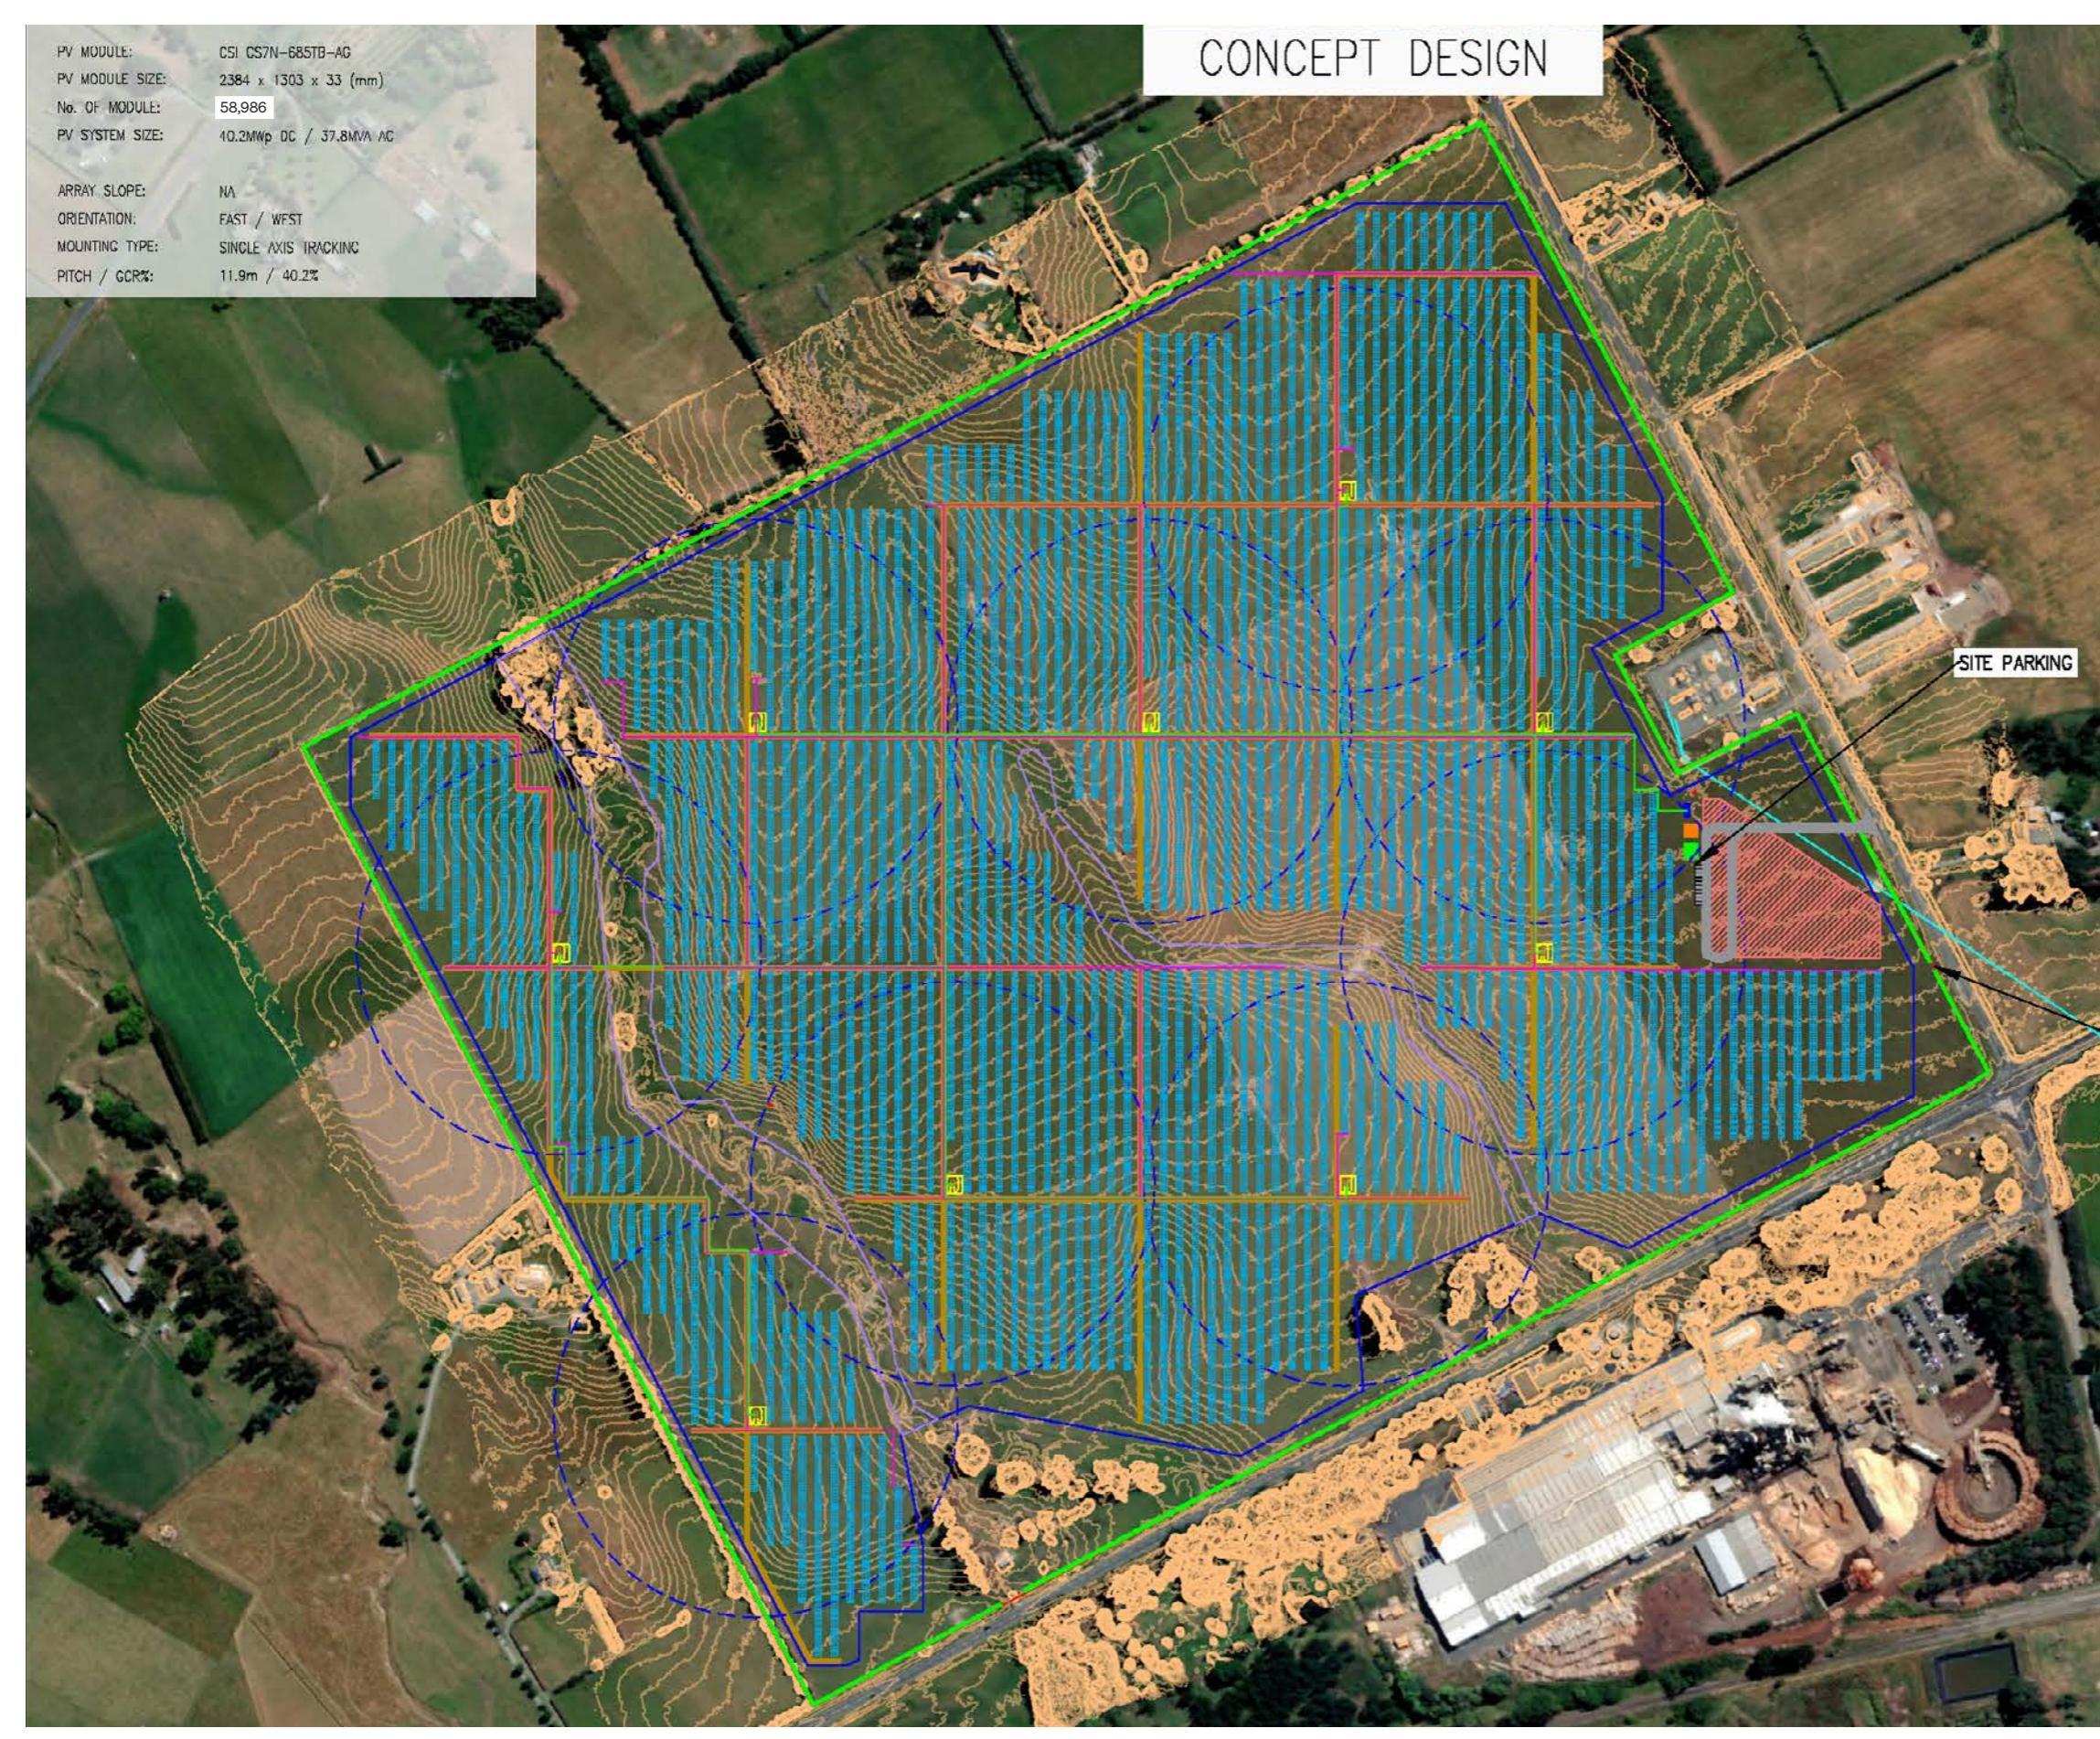
Two Panel Tilting Solar Table - General Arrangement Plan

- Two Panel Tilting options: 129 short tables (58 panels), 444 long tables (116 panels), 573 total.

LEGEND	
	SITE BOUNDARY + POST-AND-WRE FENCE
	2 x (29 OR 58) TRACKING TABLES OF BIFACIAL SOLAR MODULES
	PROPOSED GRASS ROADS (4m WIDTH)
	PROPOSED ACCESS ROADS (6m WIDTH)
	4200kW CENTRAL INVERTER + SERVICE SETBACKS
0	TRANSFORMER STATION ACOUSTIC/EMF SETBACK RADIUS (150m)
	LV CABLE TRENCHING
	MV CABLE TRENCHING
10117	SWITCHING STATION BUILDING (40m ²)
	O&M BUILDING (100m ²)
	STORAGE BUILDING (100m ²)
	SECURITY FENCE
· · · · · · · · · · · · · · · · · · ·	TRANSMISSION LINES
•	WEATHER STATION
111-14	LAYDOWN AREA
	POST-AND-WIRE FENCE AROUND EPHEMERAL STREAMS
	SHELTERBELT
	SHELTERBELT 0.5m CONTOUR LINES
SITE ACCESS	SHELTERBELT 0.5m CONTOUR LINES
SITE ACCESS	SHELTERBELT 0.5m CONTOUR LINES
-SITE ACCESS	SHELTERBELT 0.5m CONTOUR LINES
-SITE ACCESS	SHELTERBELT 0.5m CONTOUR LINES
SITE ACCESS	SHELTERBELT 0.5m CONTOUR LINES

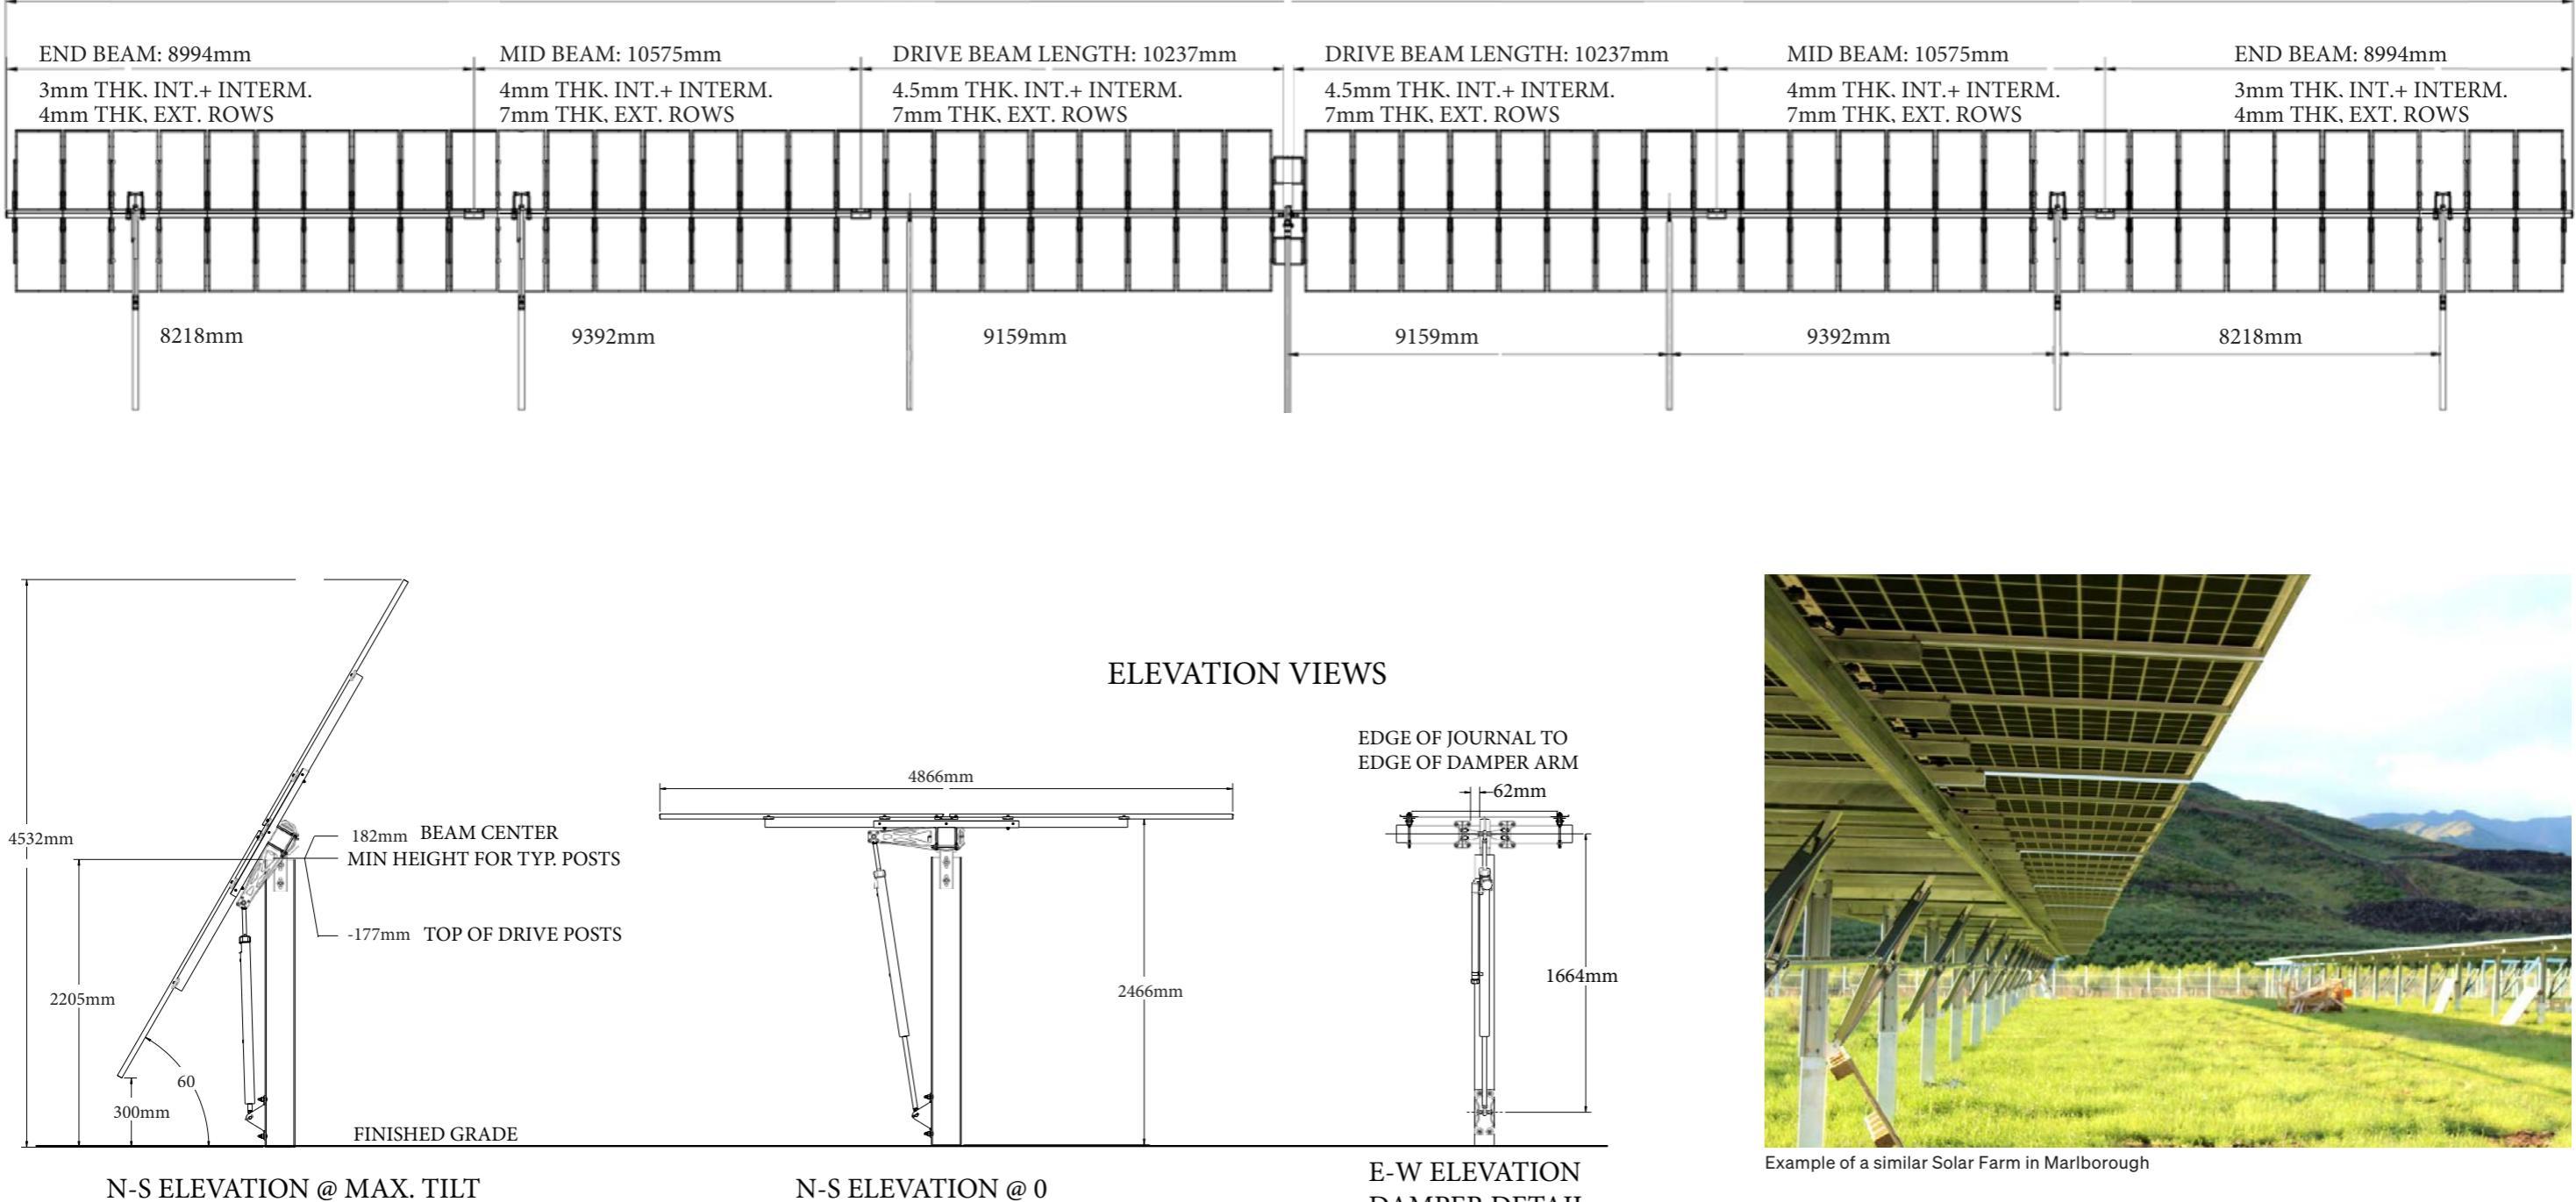
Two Panel Tilting Solar Table - Indicative Cross Sections

59861mm OVERALL WIDTH

Note: These cross sections are indicative, but they generally illustrate the height and width of a two panel single axis tracking solar table.

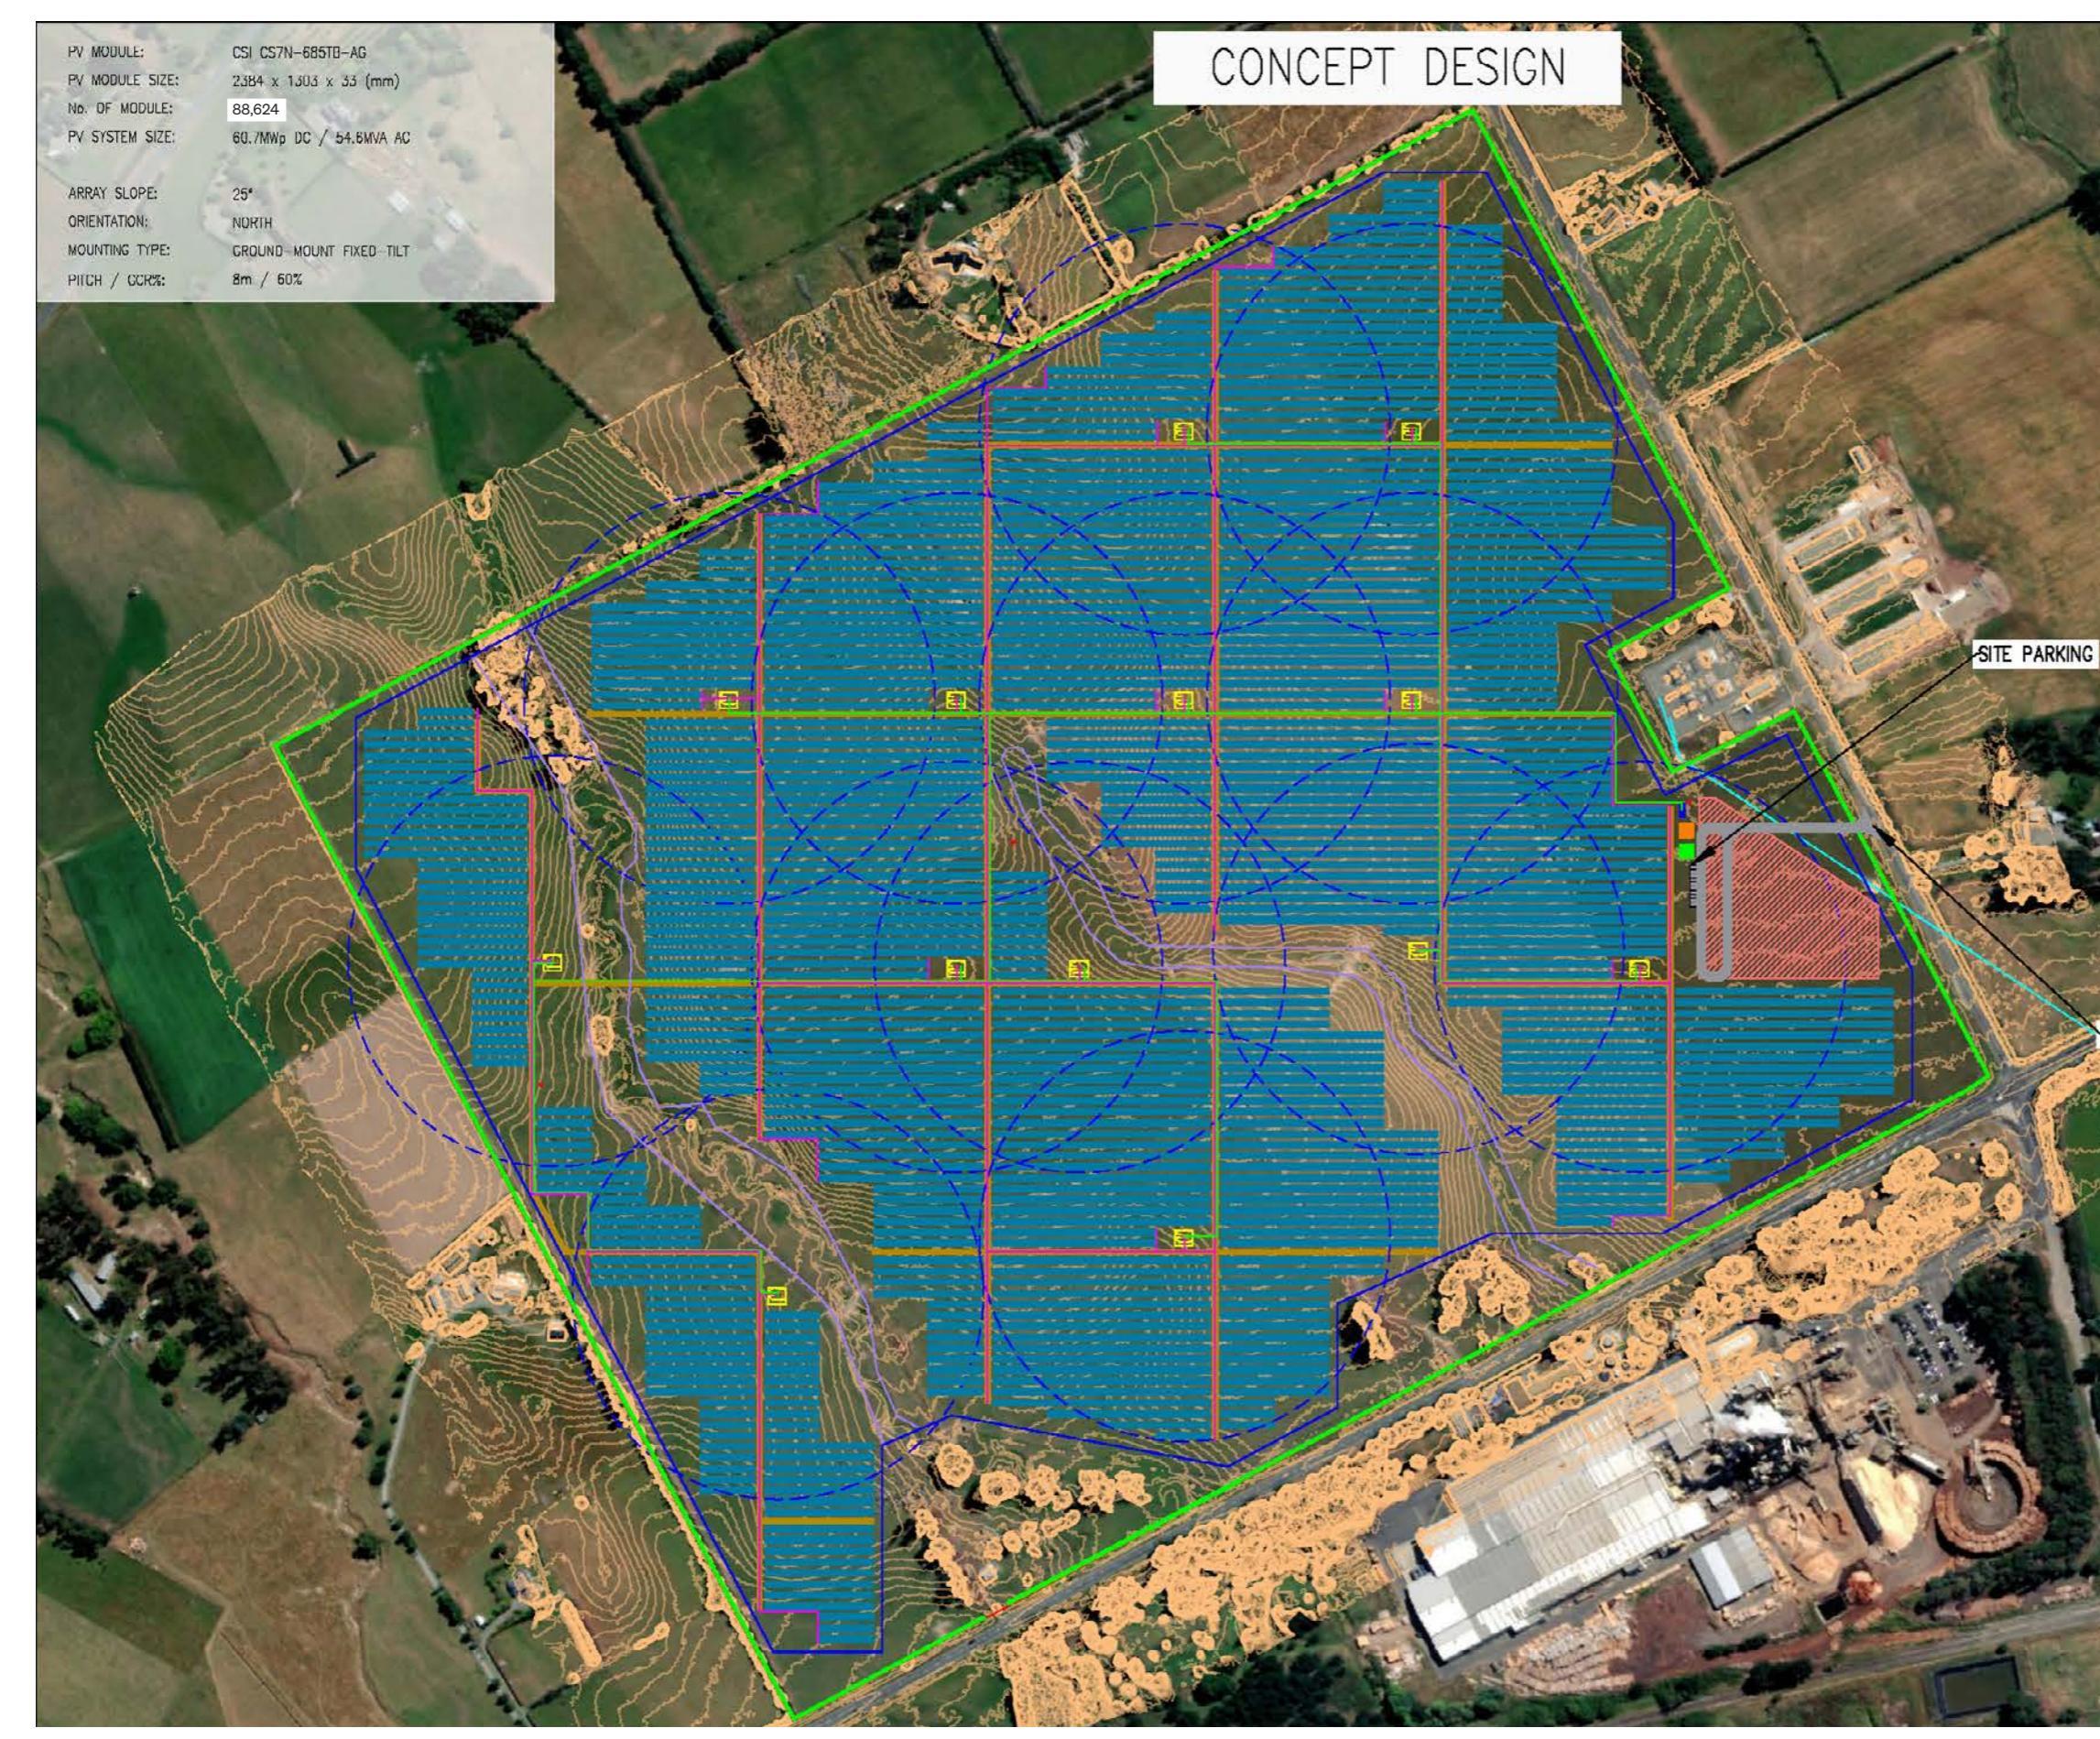
Fixed Solar Table - General Arrangement Plan

LEGEND		
	SITE BOUNDARY + POST-AND-WIRE FENCE	
	2 x 29 TABLES OF BIFACIAL SOLAR MODULES	
	PROPOSED GRASS ROADS (4m WIDTH)	
4	PROPOSED ACCESS ROADS (6m WIDTH)	
	4200kw CENTRAL INVERTER + SERVICE SETBACKS	
0	TRANSFORMER STATION ACOUSTIC/EMF SETBACK RADIUS (150m)	
	LV CABLE TRENCHING	
	MV CABLE TRENCHING	
	SWITCHING STATION BUILDING (40m²)	
	O&M BUILDING (100m ²)	
	STORAGE BUILDING (100m ²)	
	SECURITY FENCE	
	TRANSMISSION LINES	
	WEATHER STATION	
CALLO.	LAYDOWN AREA	
· · · · · ·	POST-AND-WIRE FENCE AROUND EPHEMERAL STREAMS	
1 N	SHELTERBELT	
	0.5m CONTOUR LINES	
SITE ACCESS		
Fixed Solar Table - Indicative Cross Sections
