MCCRACKEN & ASSOCIATES RFI RESPONSE

Re: Request for Information – RC235259 – Energy Bay Limited, 87 Upper Sefton Road, Sefton

Proposed Solar Farm - 87 Upper Sefton Road, Ashley, Canterbury Graphic Attachment to Landscape Assessment Report

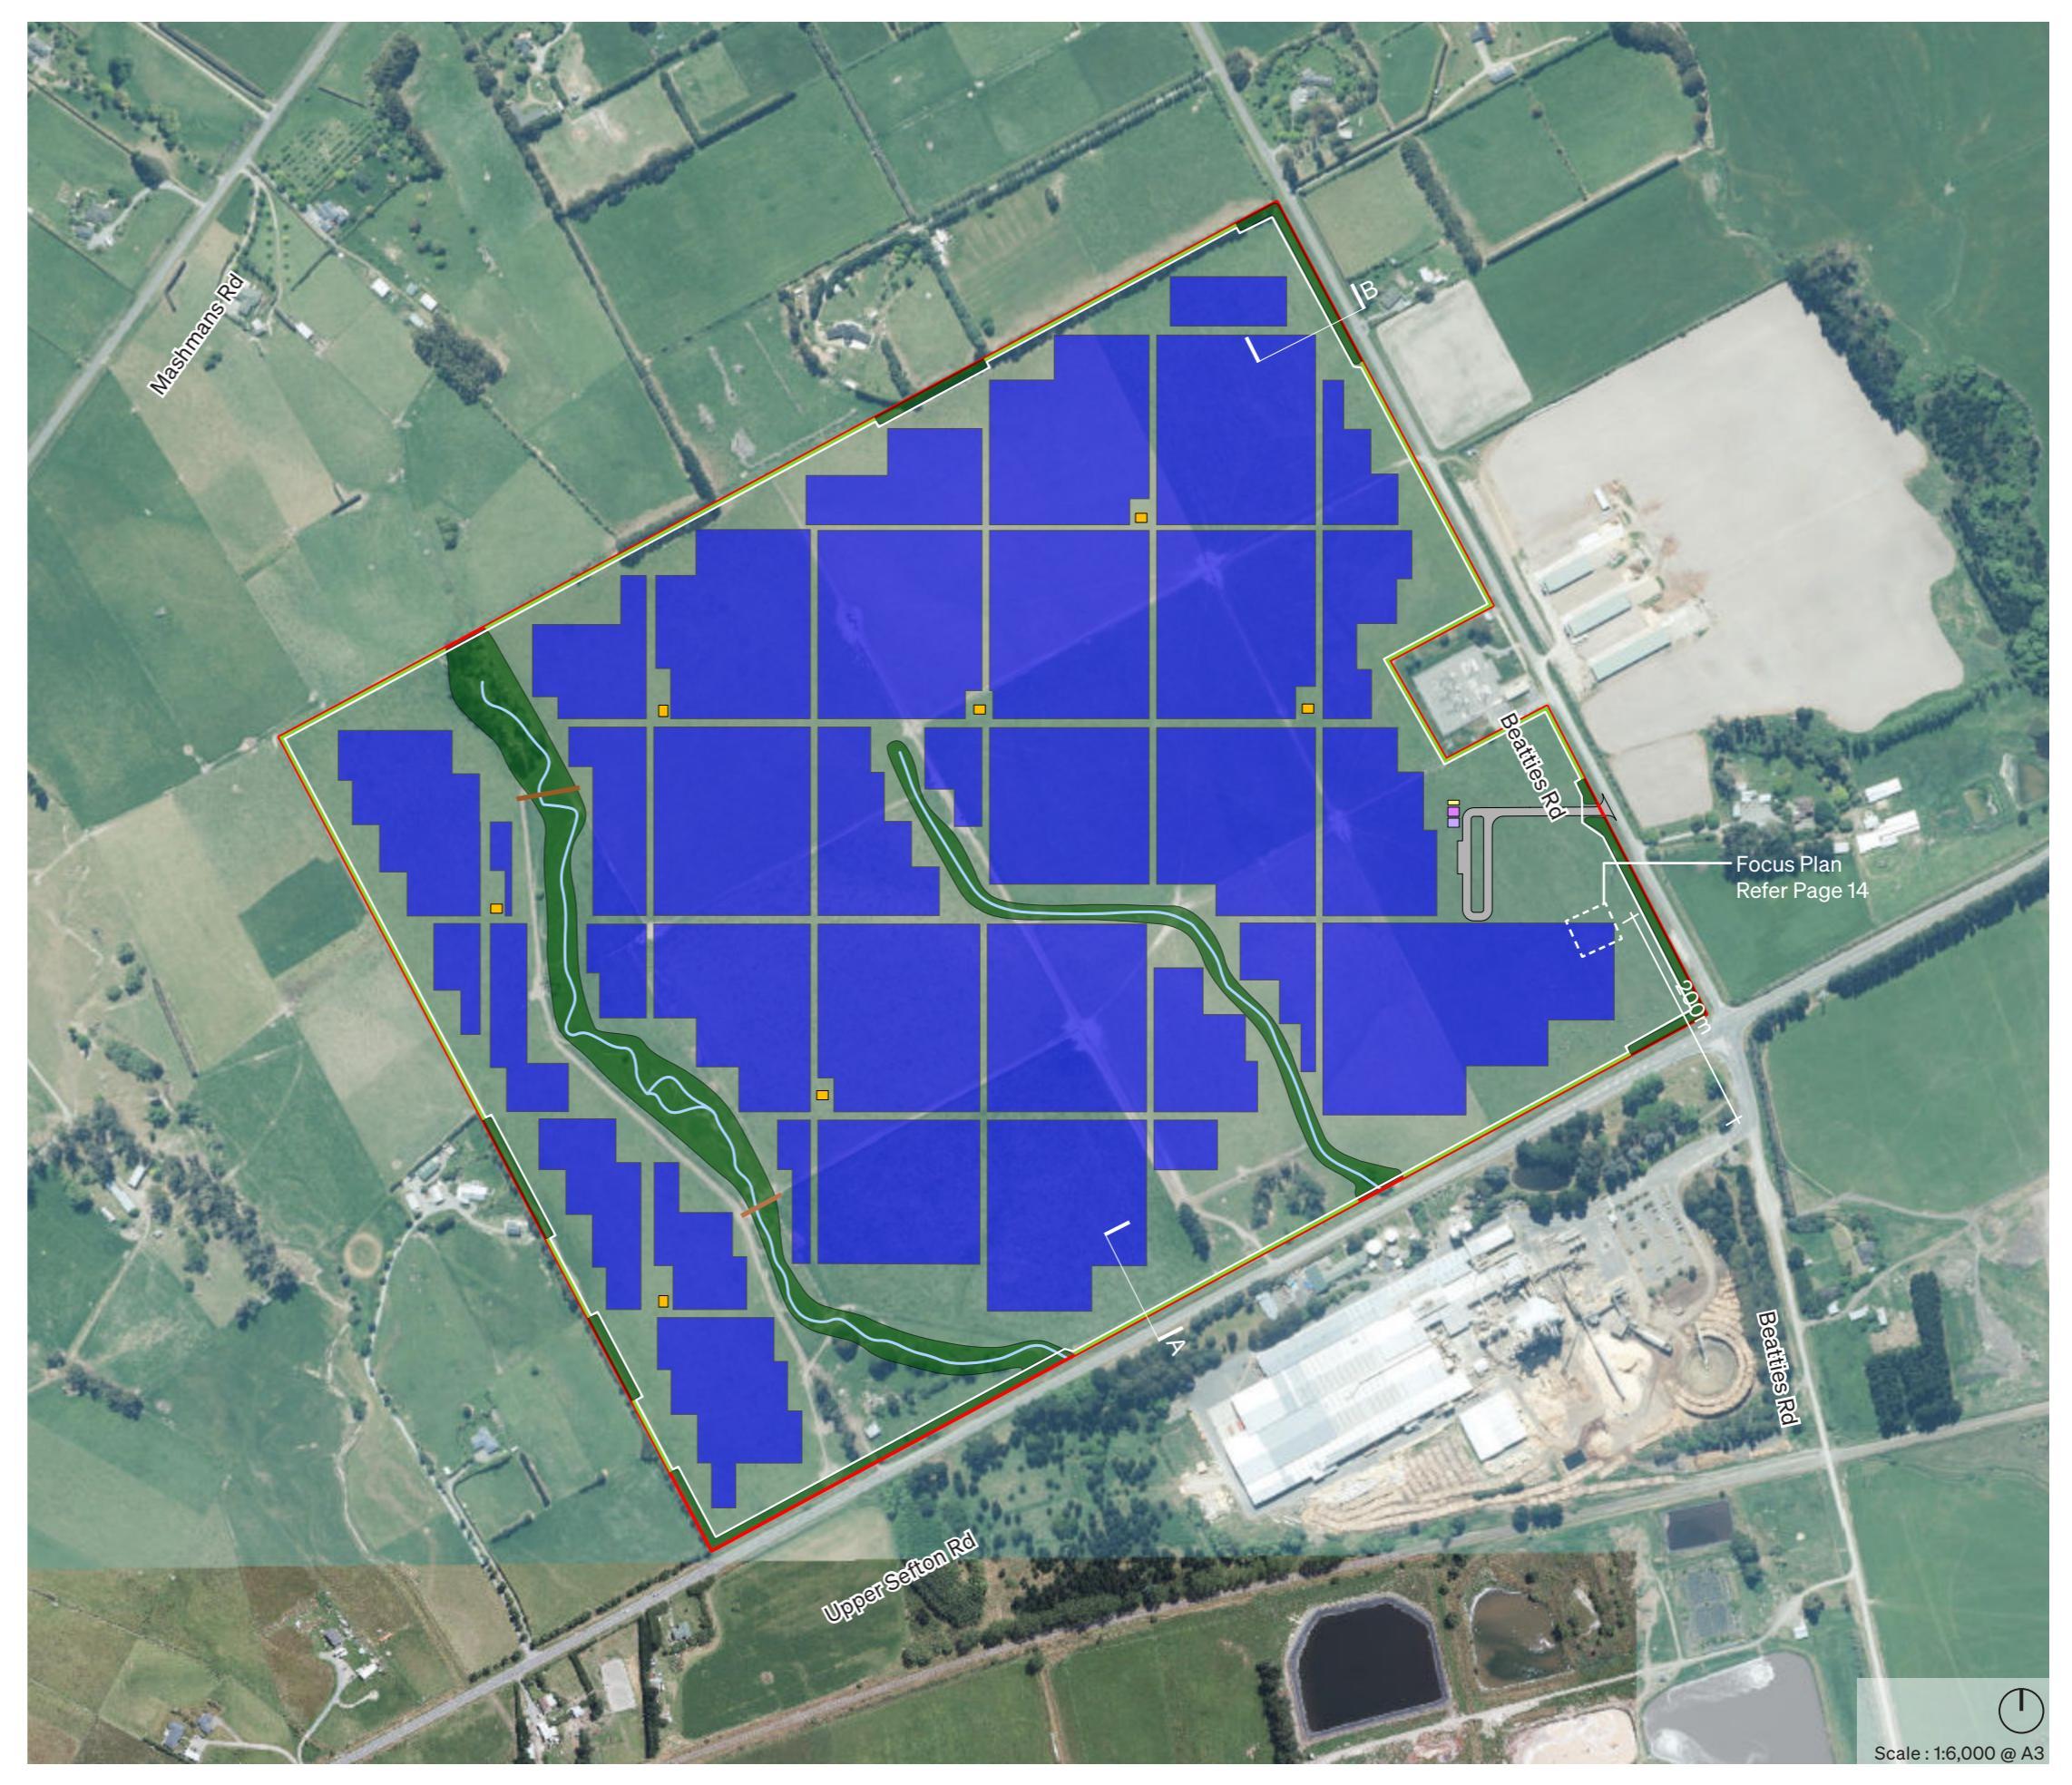
Landscape Mitigation Plan - Focus Plan

Solar panel layout based on two panel tilting solar table option.

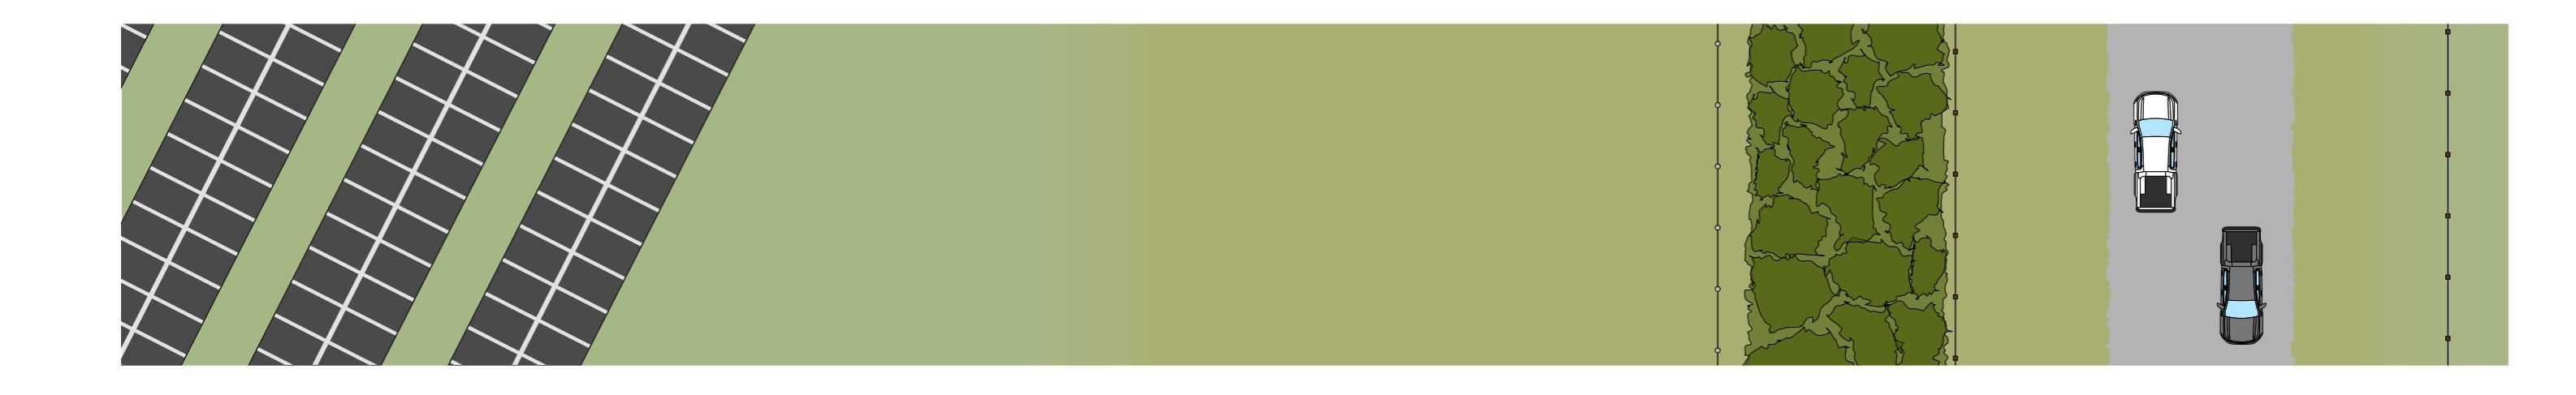
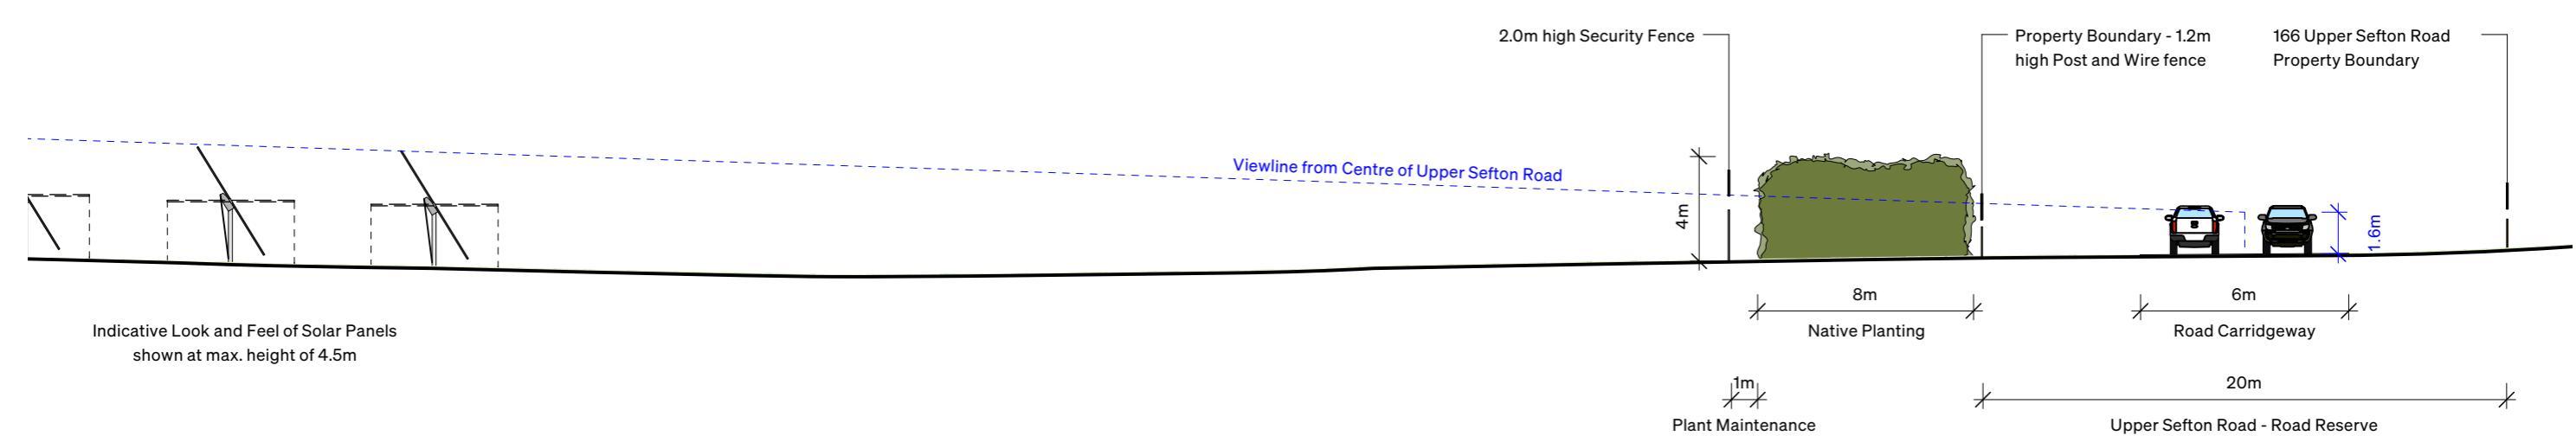
Landscape Mitigation Plan - Cross Section B

Plant Maintenance Access

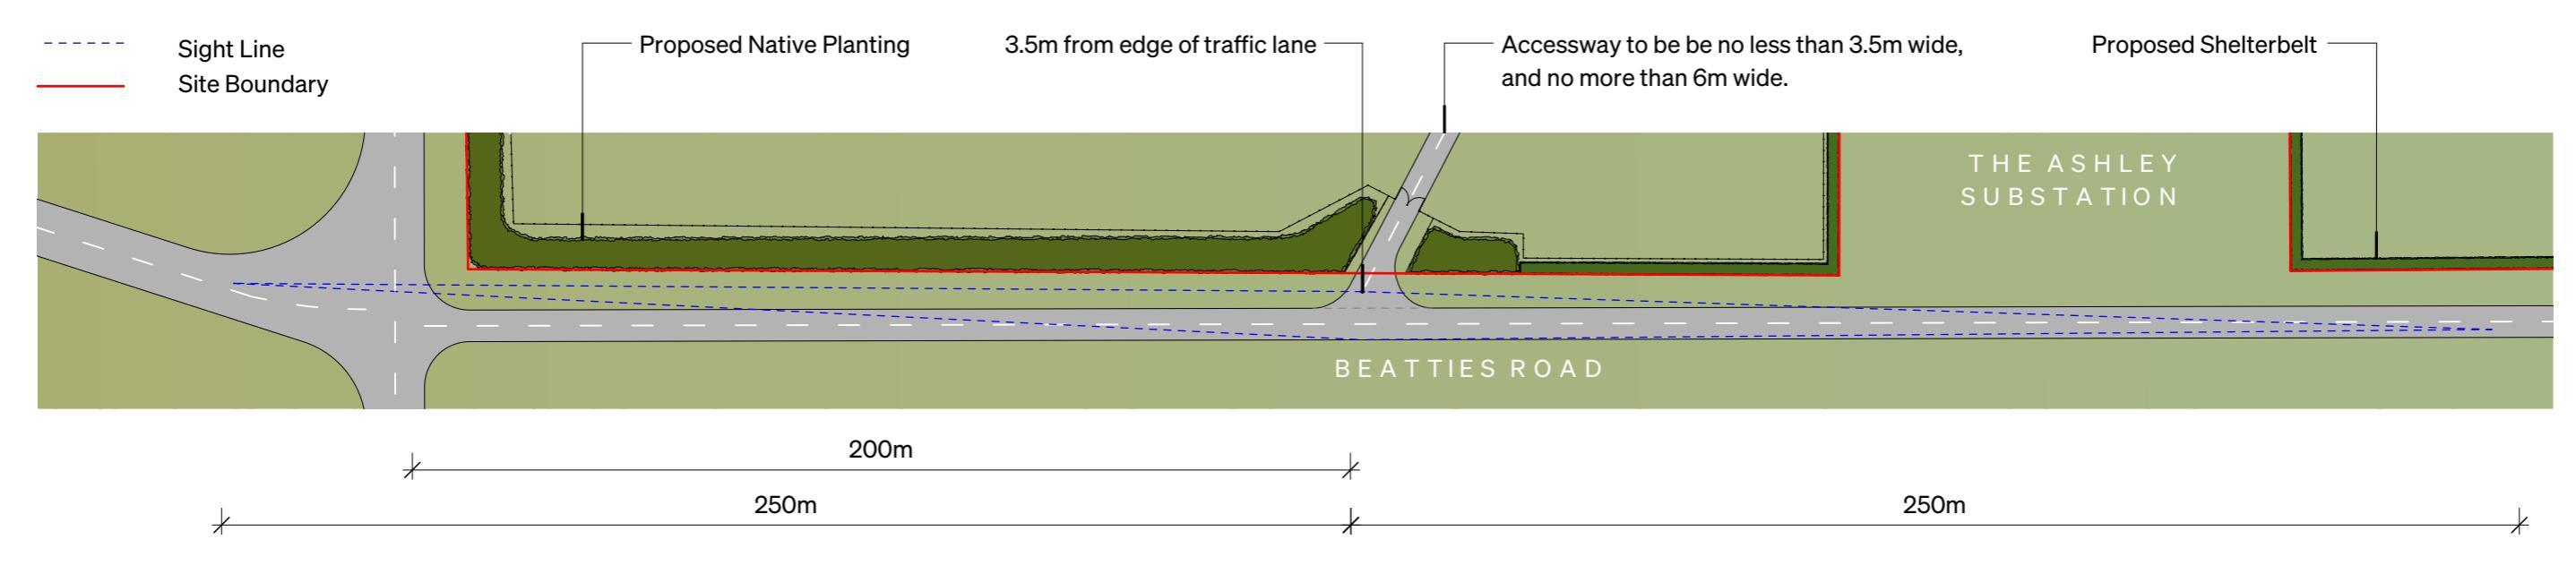
Landscape Mitigation Plan - Accessway Sight Lines

Beatties Road Accessway - Sight Distances and Sight Lines for Vehicles Crossings

Scale 1:1500

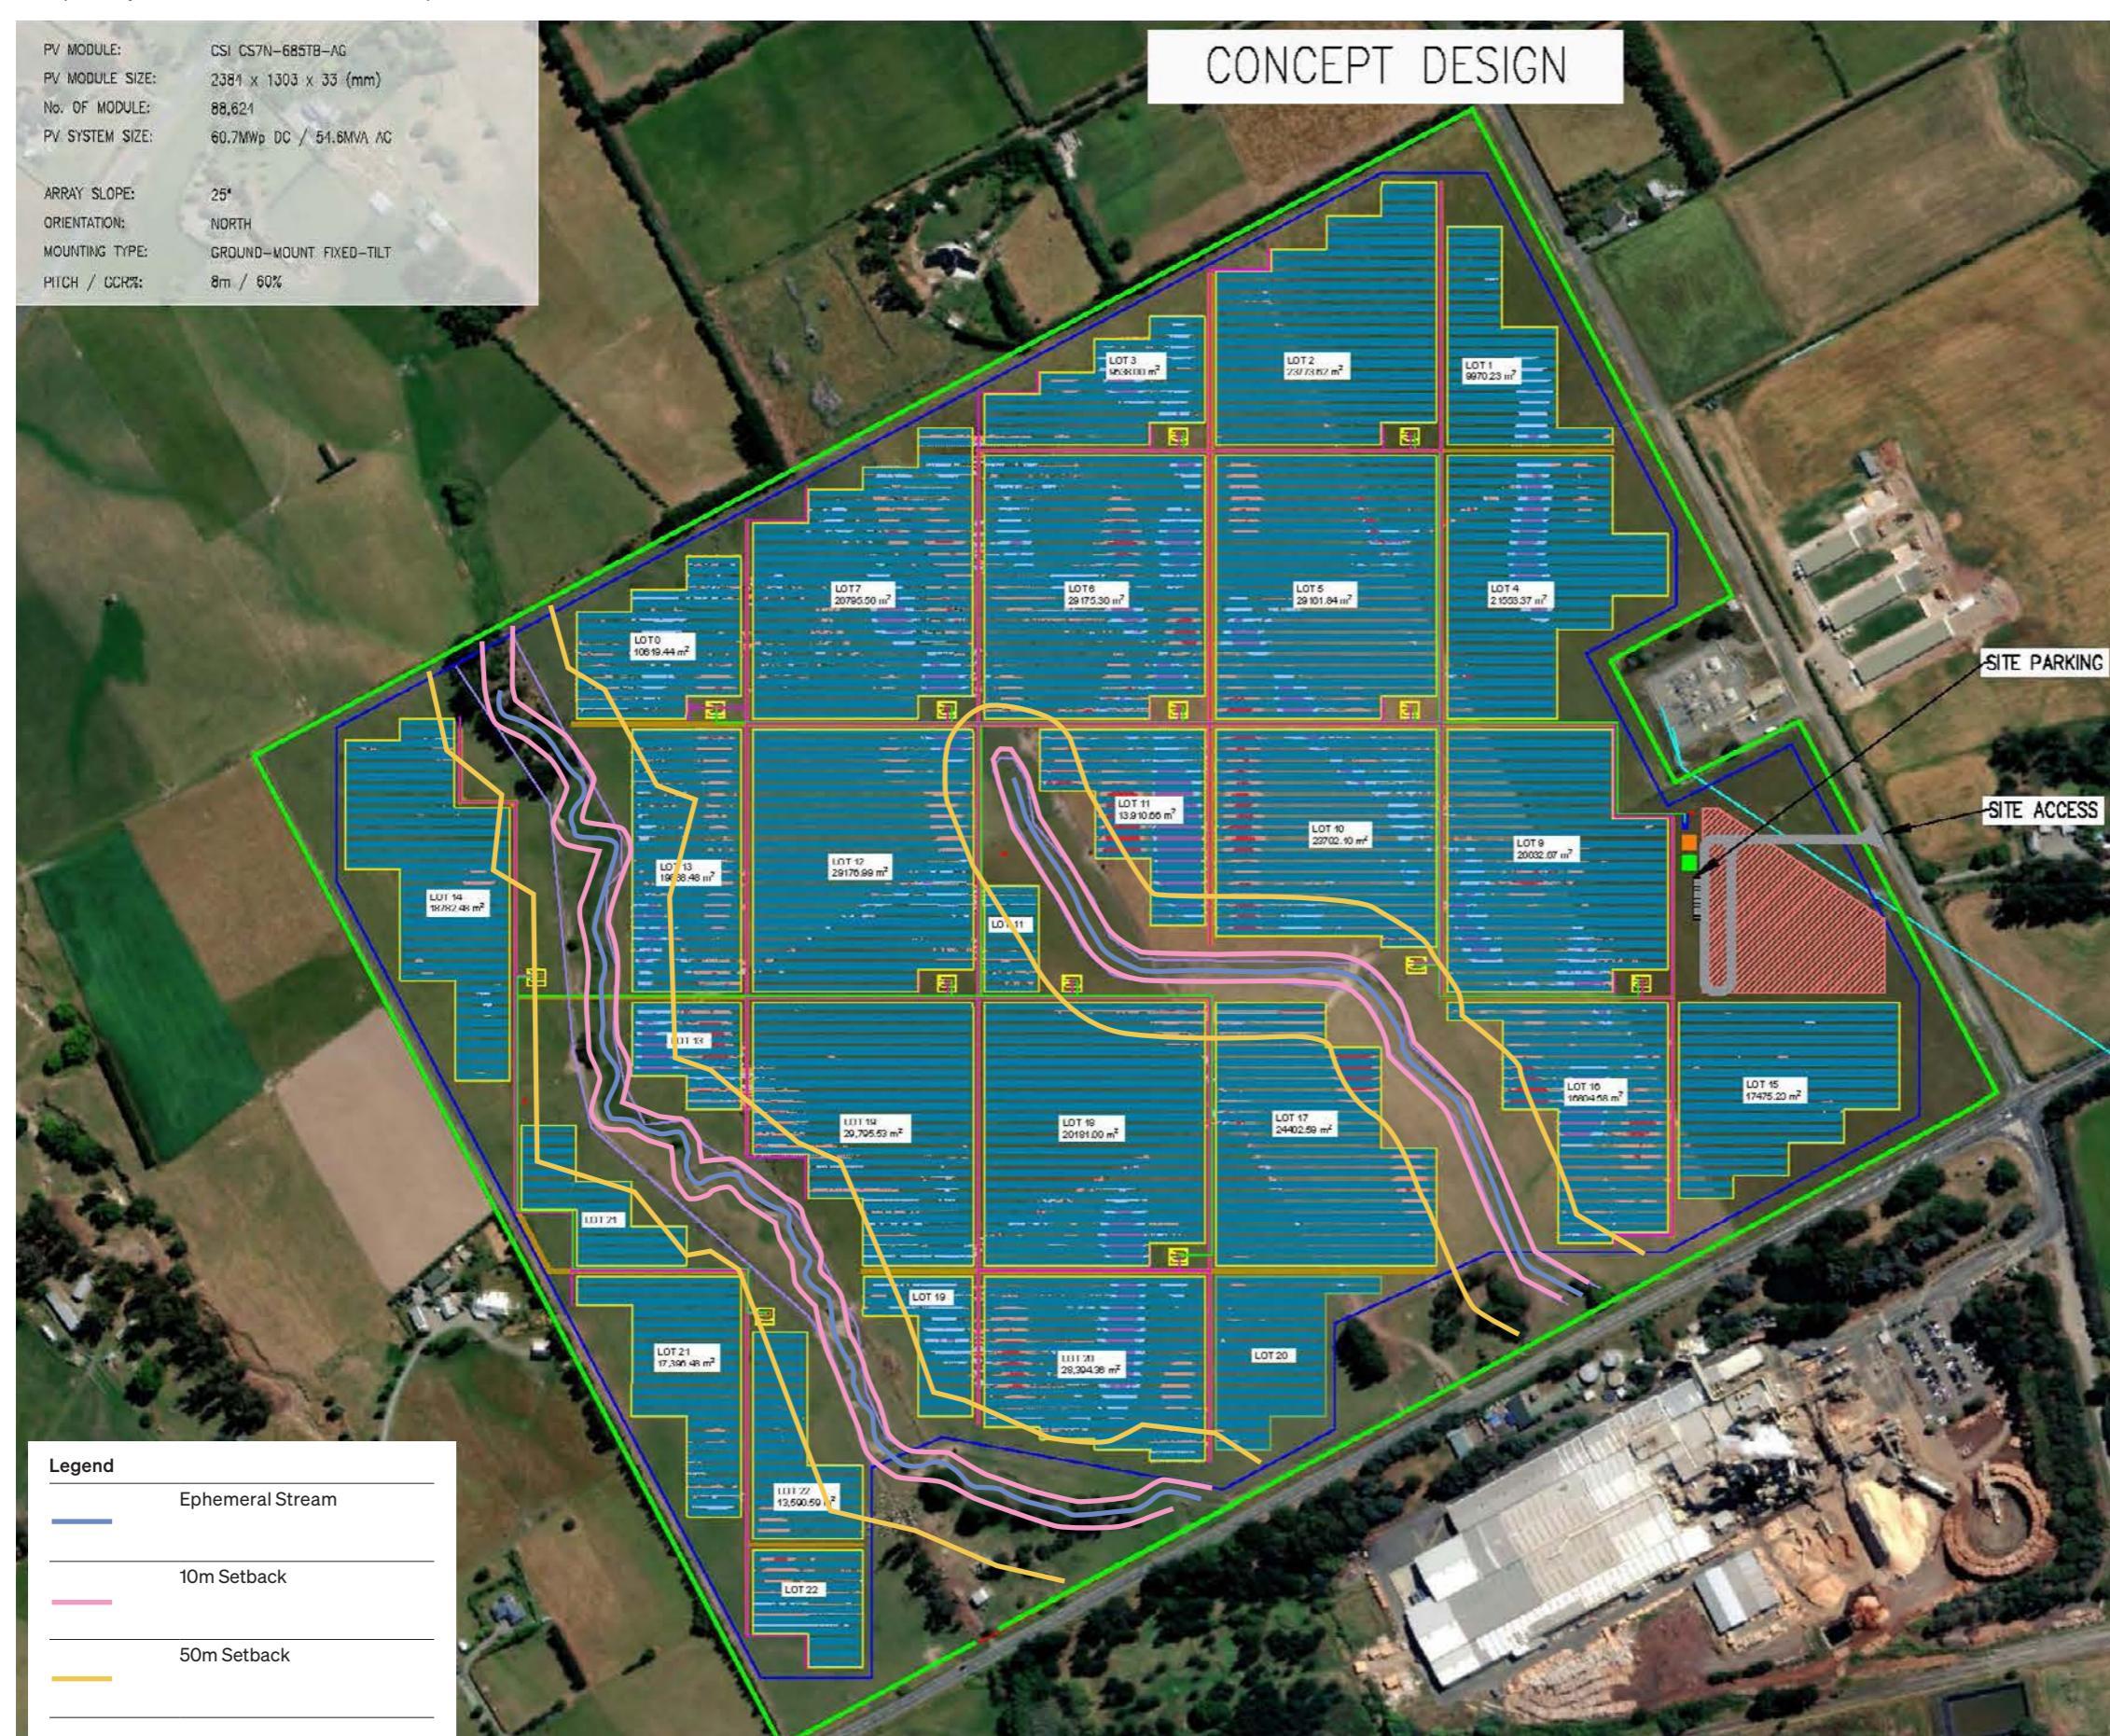
Solar panel layout based on the fixed solar table option.
