Rangiora Eastern Road Connections

Ecological Report Prepared for Waimakariri District Council

3 May 2021

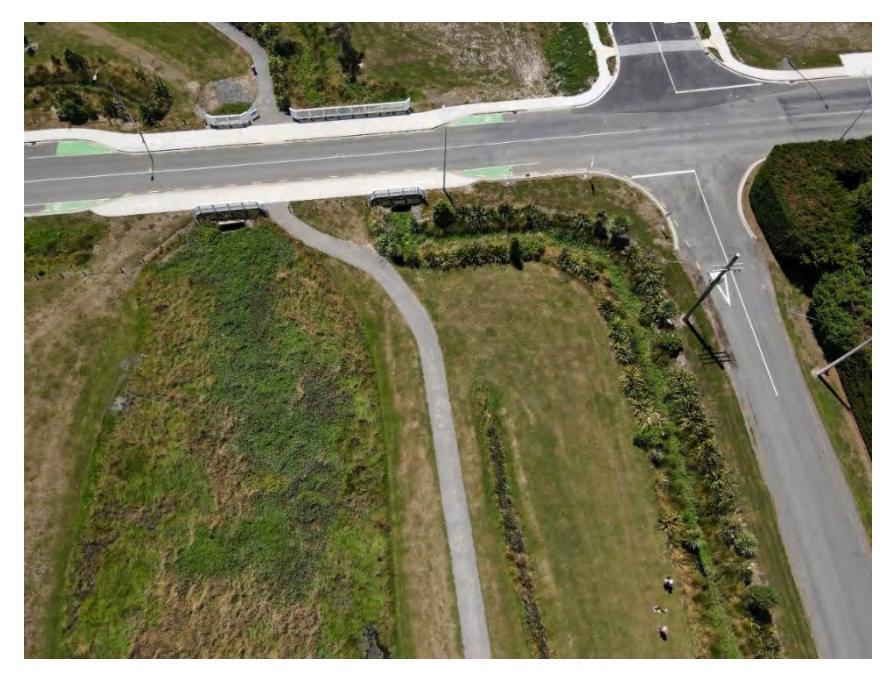
Figure 2. Koura Creek flowing under Northbrook Road (top) and alongside Spark Lane (right). Photo taken looking upstream (north).

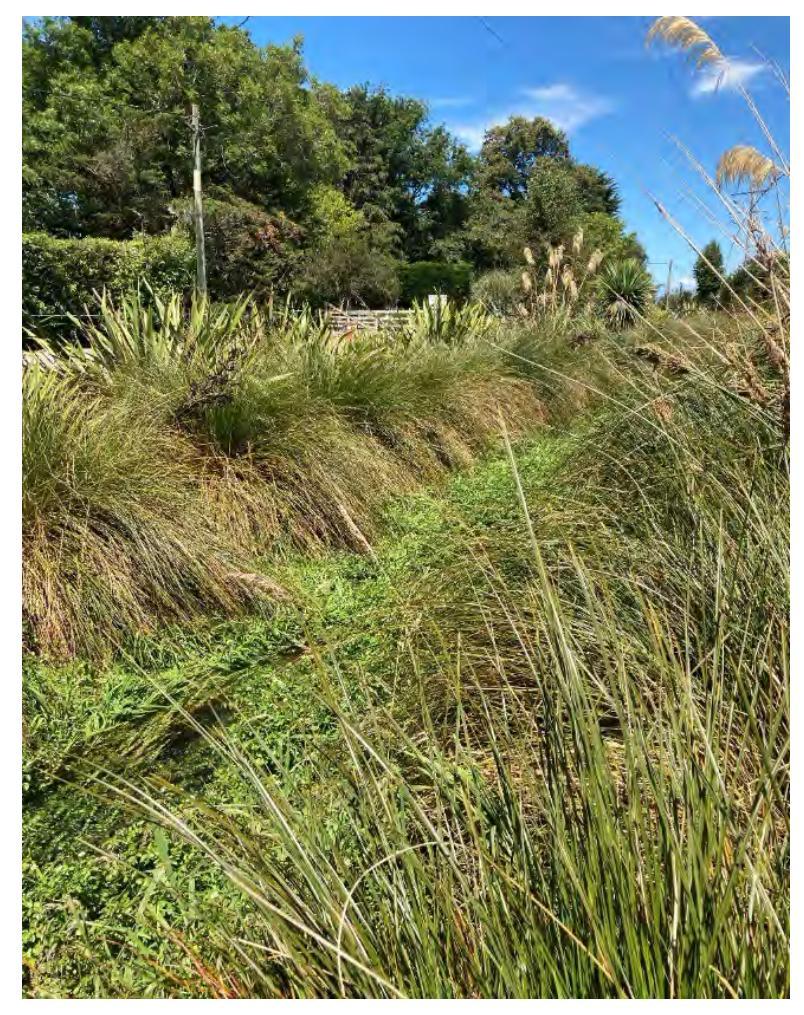
Figure 3. Koura Creek with riparian plantings, such as harakeke, pūrei, tī kouka.

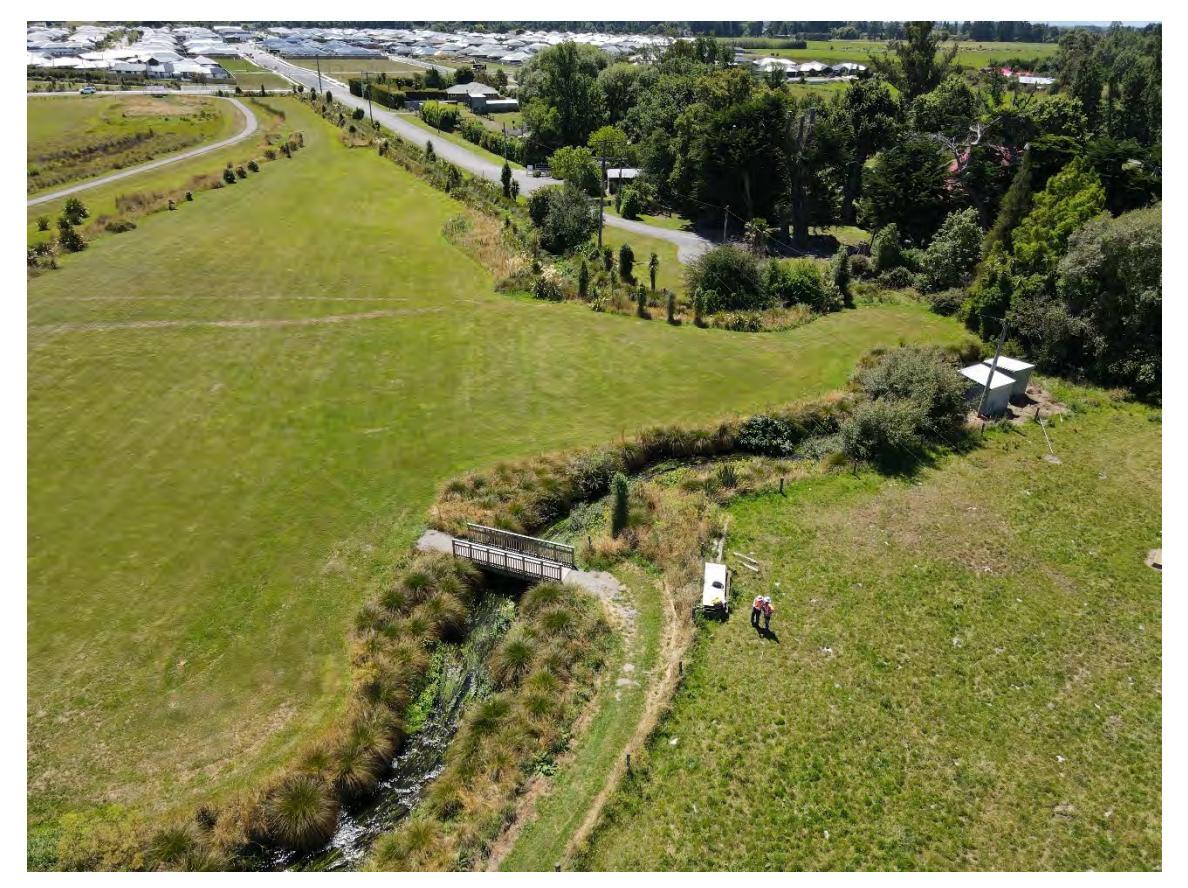
Figure 4. North Brook near the confluence with Kōura Creek where the proposed RERC alignment crosses. Photo taken looking downstream (northeast).

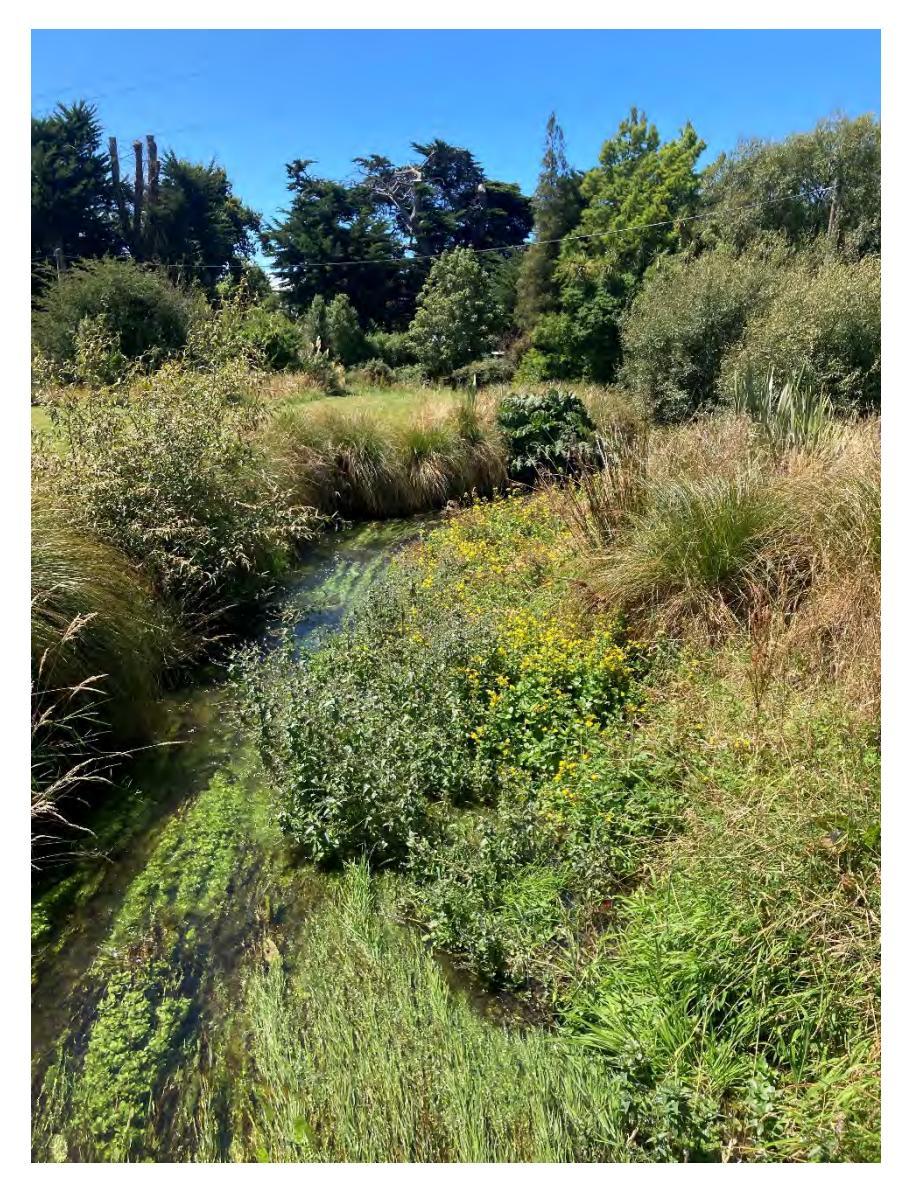
There is abundant cover of macrophytes (as shown in Figure 5), and the stream health is noted to be fair to poor (based on the Macroinvertebrate Community Index (MCI) measures from EOS Ecology 2005).

Figure 5. North Brook with deep, clear spring-fed water and abundant macrophytes (creeping bent, monkey musk, water speedwell, and cape pondweed).

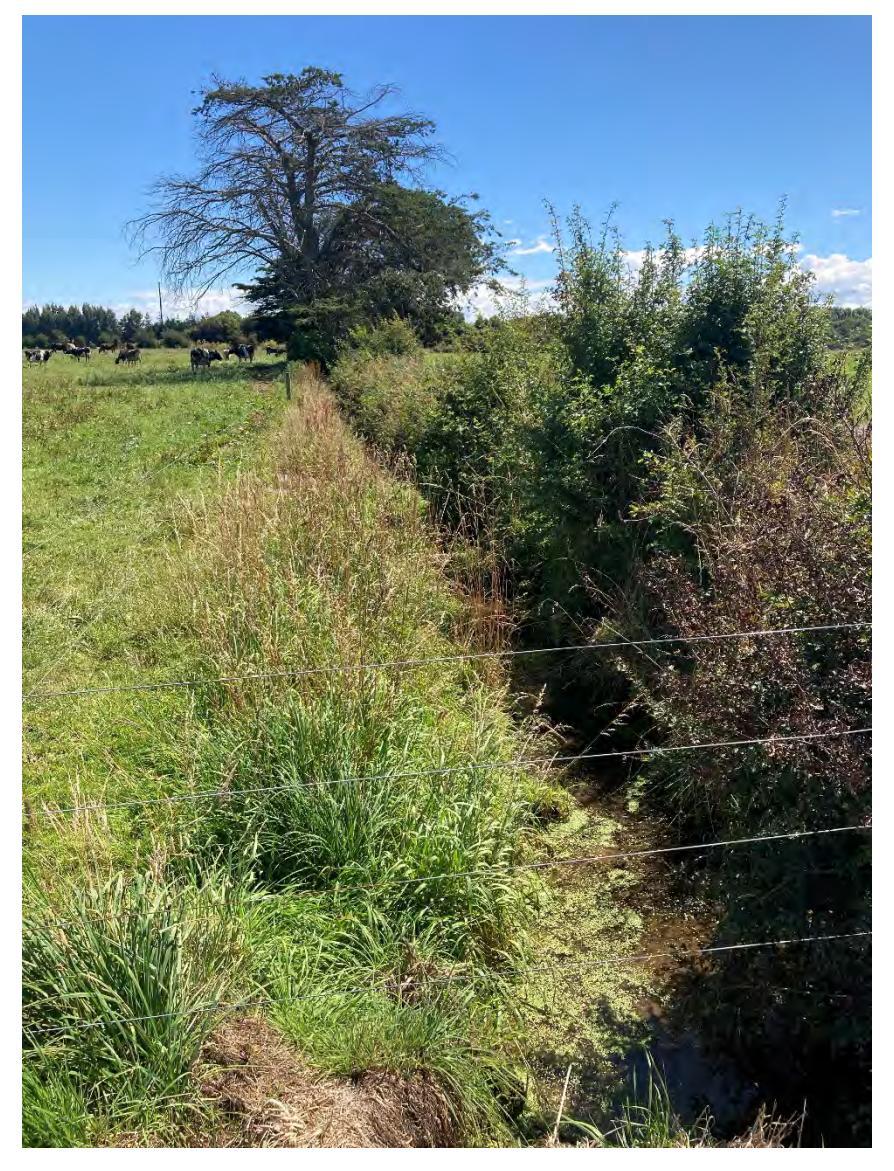
The channel is approx. 1.5 m and had c.10 cm of surface water present on the day of our site walkover.

The channel is straight and incised, with soft sediments dominating the bed; the waterway appears to be regularly maintained for drainage purposes (Figure 6). The vegetation is predominantly rank pasture grasses with some exotic shrubs, which together provide a reasonable amount of shade to the waterway. Given there is surface water present and due to its proximity to and connection with North Brook, it's possible that this waterway provides habitat for more tolerant fish and macroinvertebrate species, including shortfin eels.

Figure 6. Farm drain (photo taken c.80 m downstream of the proposed RERC alignment where surface water was present).

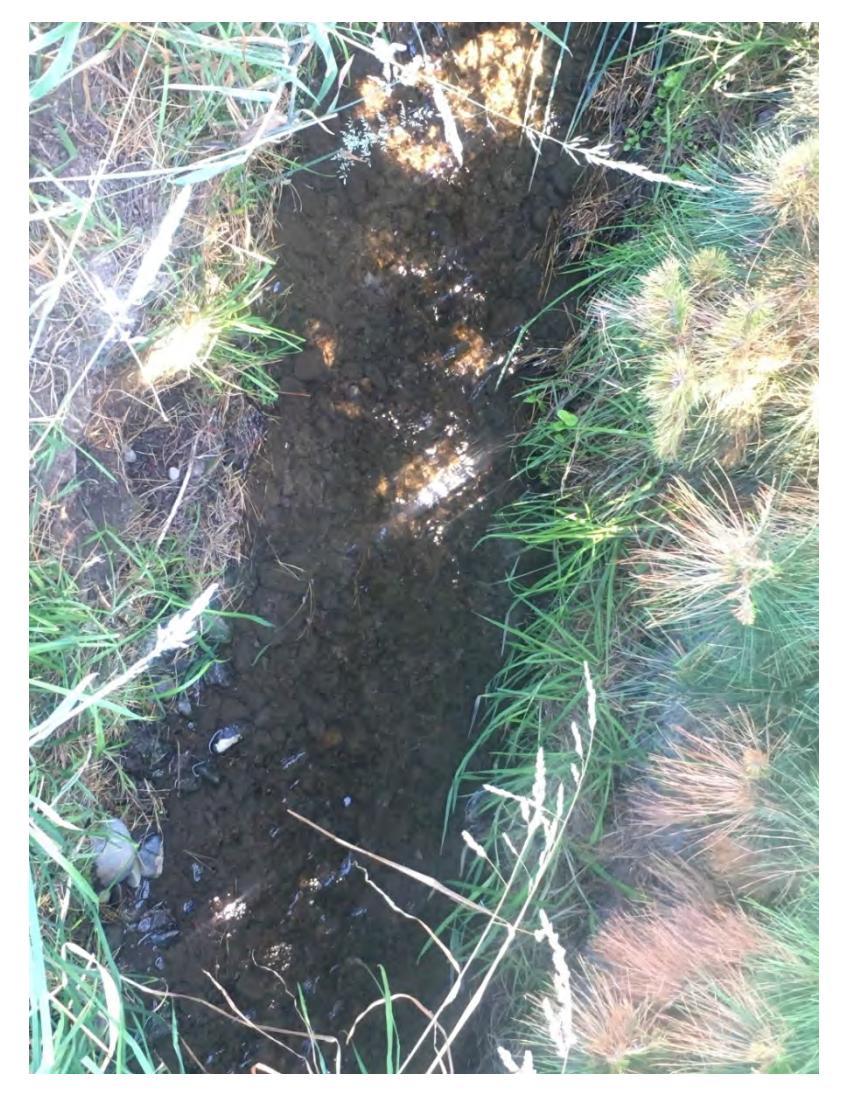
The vegetation is predominantly rank pasture grasses with a shelter belt on the northern bank at the RERC crossing location, which provides high shading to the stream.

Given the perennial and reasonable flows, presence of cobbles and gravels, and the proximity to and connection with North Brook, this waterway is likely to support a reasonably representative assemblage of macroinvertebrate and fish species, including eels and bullies.

Figure 7. Roadside waterway tributary of North Brook, on the north side of Boys Road.

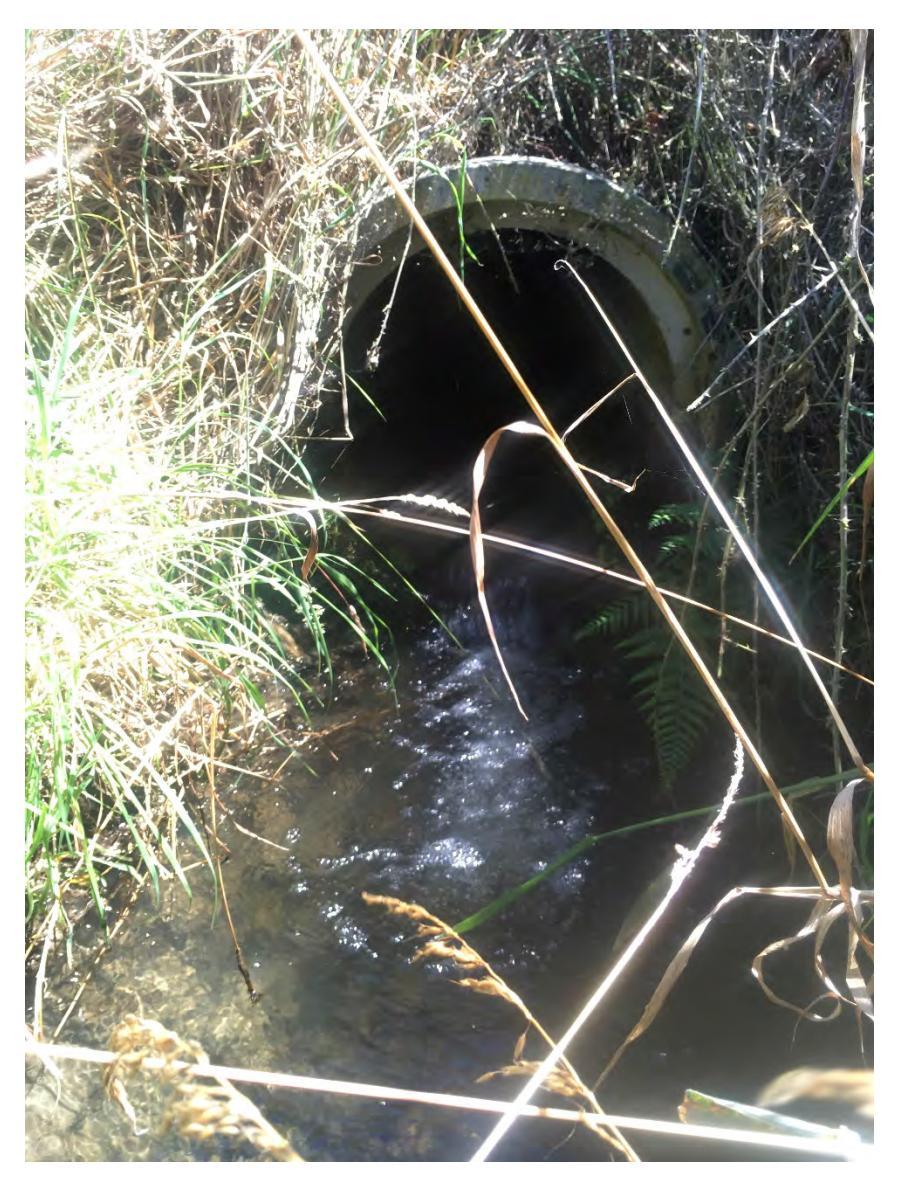
Figure 8. Perched culvert in the roadside waterway and tributary of North Brook.

- It is essential that a suitably qualified and experienced freshwater ecologist provides advice into the design and build stages for the road.
- Avoiding the installation of culverts is recommended as a first principle. Bridges will certainly have a better ecological outcome; and may be more cost-effective in the long term given the requirements to monitor and maintain fish passage for the life of a culvert.
- Where avoidance is not possible, mitigation for stream loss is likely to be required, which may include enhancement of adjacent sections of waterway.

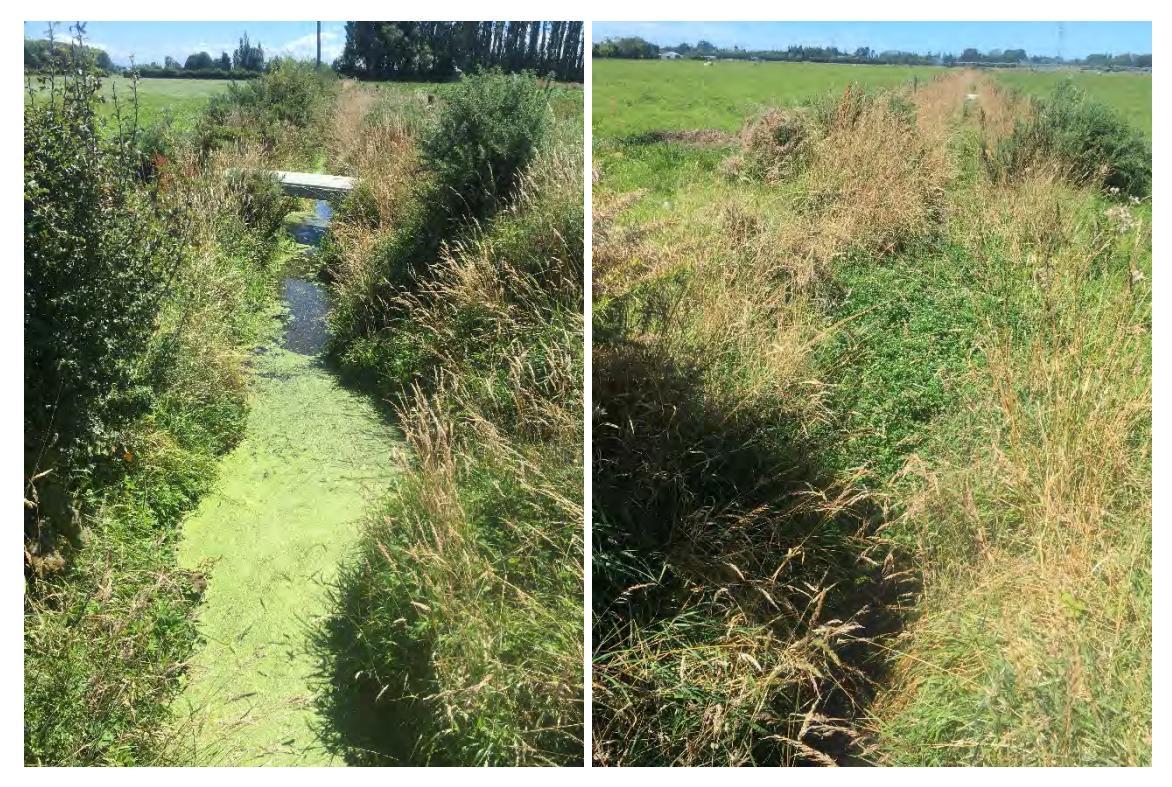
Figure 9. Waterway at Crossing 5: a tributary of North Brook (left: looking upstream; right: looking downstream). Abundant duckweed and dense, emergent creeping bent, watercress and monkey musk indicate high nutrient loads and slow flow.

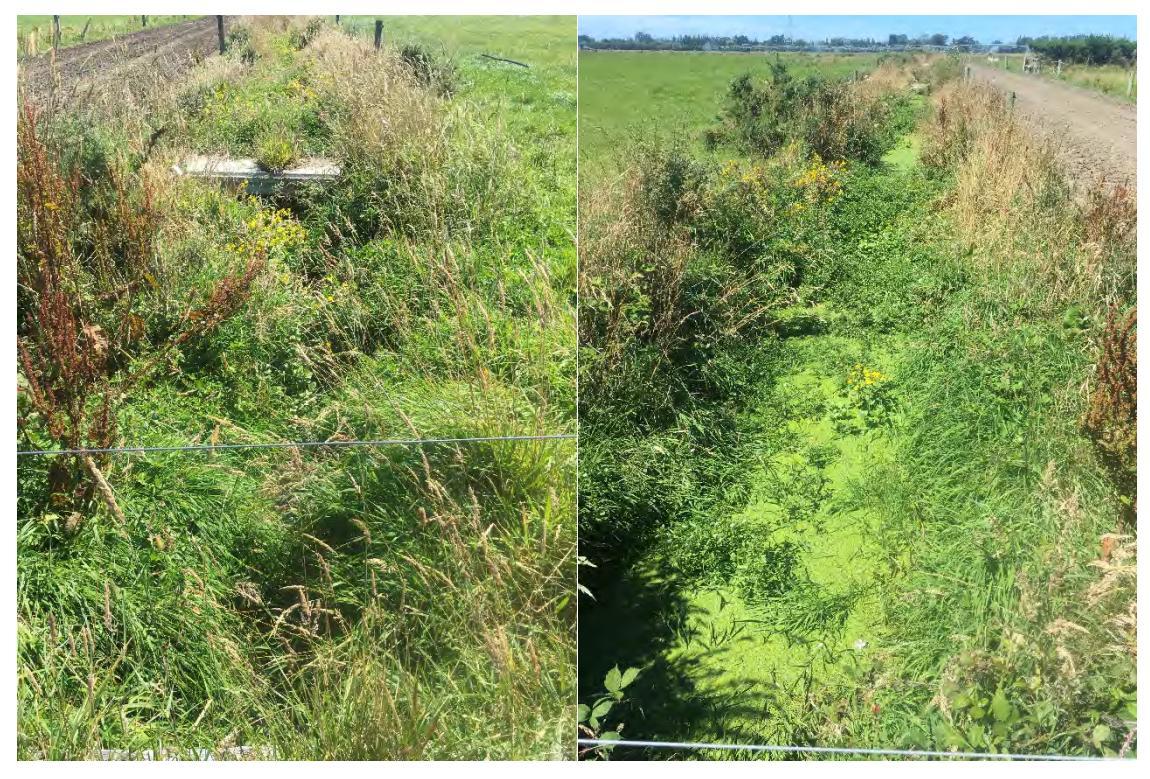
The waterway at Crossing 6 (Figure 10) is approx. 2 m wide and also had c. 20 cm of surface water present on the day of our site walkover.

The channels of both waterways are straight and incised, with soft sediments dominating the bed; the waterways appear to be regularly maintained for drainage purposes. The vegetation is predominantly rank pasture grasses with some exotic shrubs, but these provide little shade to the waterways. However, as with the other farm waterways, given the presence of surface water and the proximity and connectedness to North Brook, these waterways may provide habitat for more tolerant fish and macroinvertebrate species, including shortfin eels.

Figure 10. Waterway at Crossing 6: a tributary of North Brook (left: looking upstream; right: looking downstream). A similar waterway to that at Crossing 5.

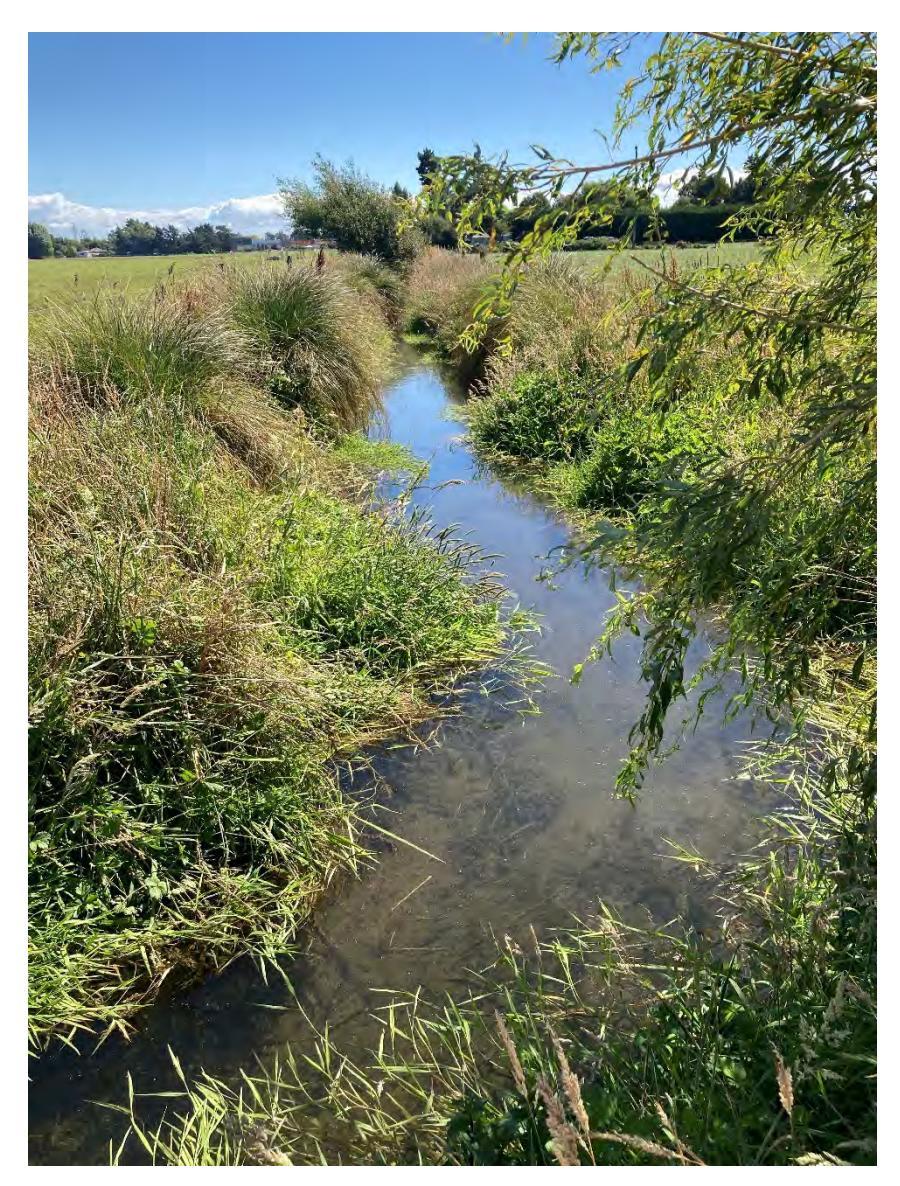
Figure 11. Middle Brook (looking upstream). A deeper, slow-flowing pool is impounded by a vehicle crossing point and water intake structure.

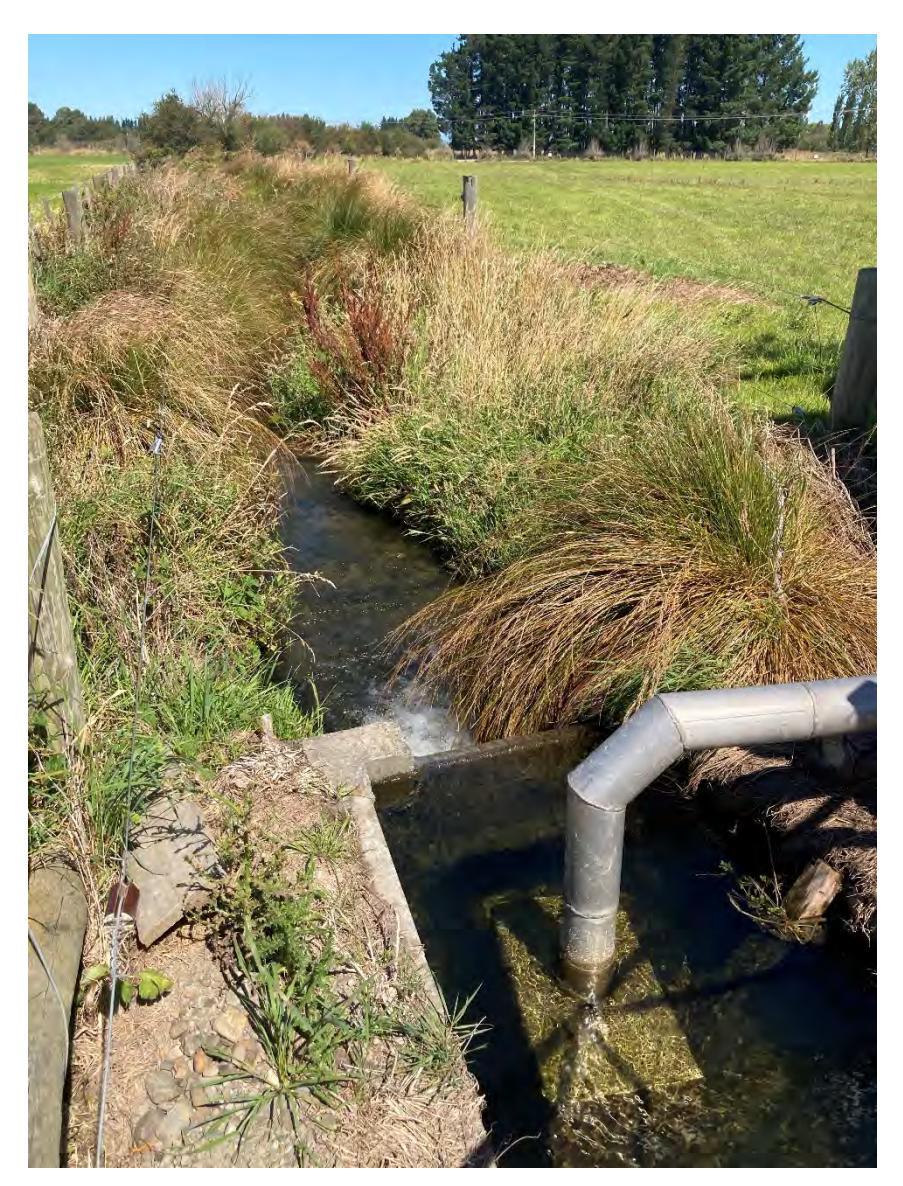
There is an irrigation intake and pumphouse located generally within the proposed crossing location (Figure 12). The irrigation intake consists of a concrete weir that impounds the flow to allow sufficient depth for a pump to take water. This is likely to impede passage of most, if not all, freshwater fish species that migrate and move along Middle Brook.

Figure 12. Middle Brook (looking downstream). An irrigation intake is located immediately upstream of a c.40 cm weir that likely prevents upstream and downstream fish passage.

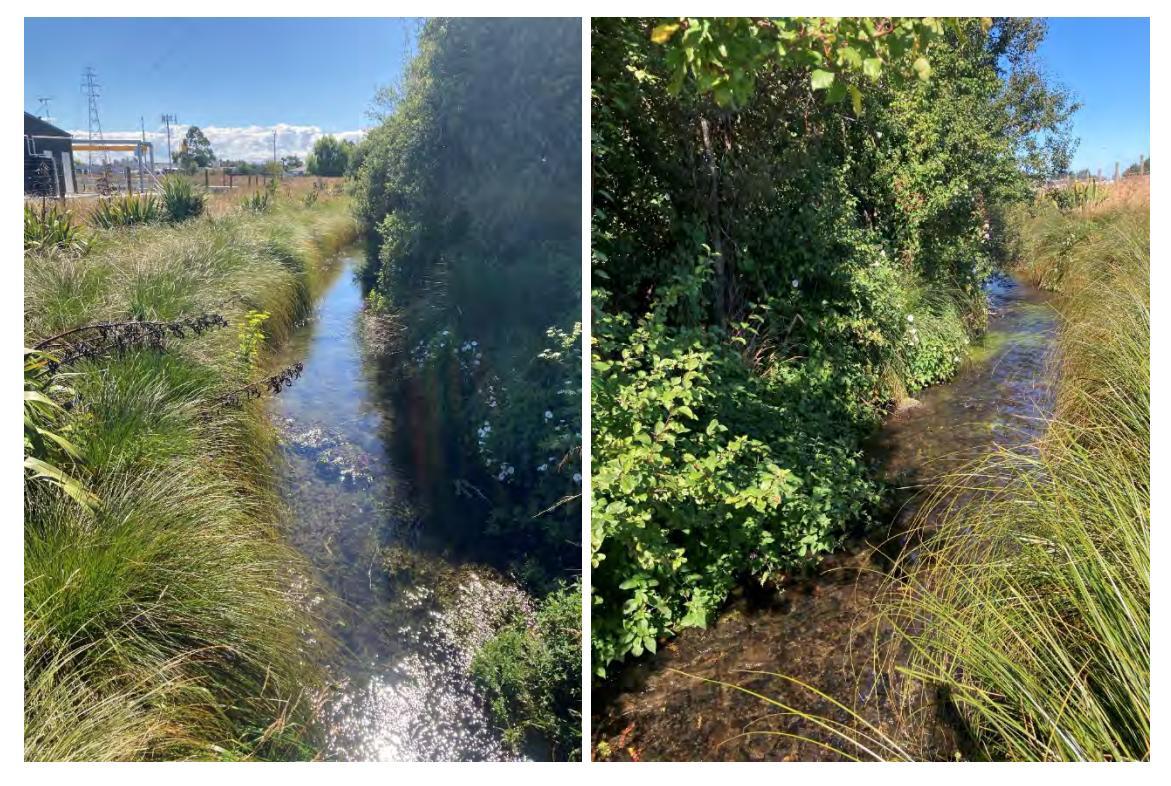
The riparian margins are planted with pūrei (predominantly on the south or true right side) with kōhūhū trees (*Pittosporum tenuifolium*) on the north or true left side (Figure 13). The kōhūhū are particularly important for providing substantial shade and leaf litter inputs to the stream; essential components of the freshwater ecosystem for good stream health.

The stream health is noted to be good to poor (based on the Macroinvertebrate Community Index (MCI) measures from EOS Ecology 2005). As with North and Middle Brooks, South Brook has been found to have trout redds throughout, owing to the cobble-bottom bed. The waterway also supports kēkēwai, and longfin and shortfin eels, upland and common bullies, and brown trout. The WDC Wastewater Treatment Plant (WWTP) staff noted they often feed large longfin eels under the bridge within the site. A large (>1 m long) longfin eel was visible during the day, presumably habituated to vibrations from humans and being fed. The bridge and stable undercut banks likely provide good habitat for these large eel/s.

Figure 13. South Brook (left: looking upstream; right looking downstream) at the proposed RERC crossing point, within the Rangiora Wastewater Treatment Plant.

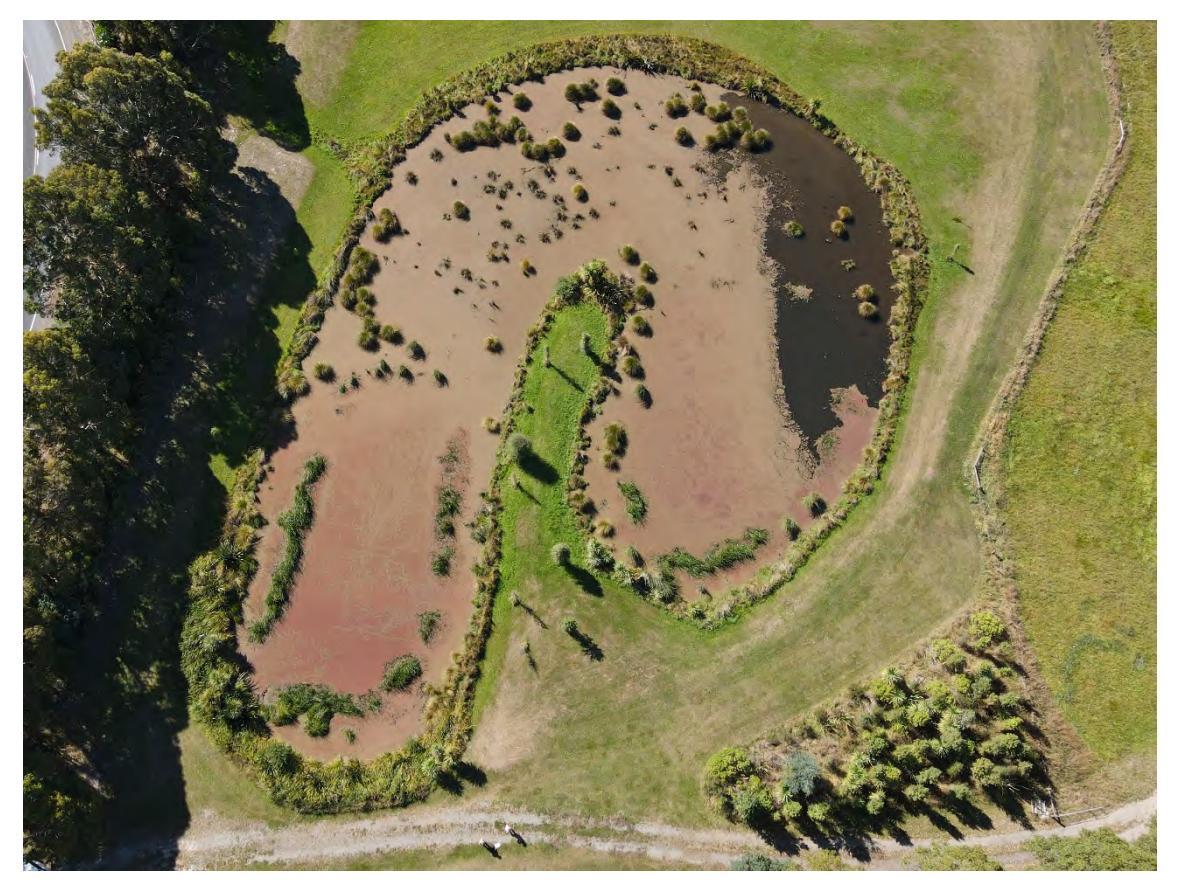
This waterbody is a constructed wetland with mature plantings of pūrei, Juncus spp. rushes, and tī kōuka. The native floating red fern (*Azolla*) is also abundant, which can be seen in the aerial image (Figure 14 and Figure 15). This constructed wetland provides important habitat for waterfowl and while it is not connected to adjacent waterways via surface water, there is an apparent input via a swale to the north. The wetland habitat appears to be suitable for freshwater fish species such as shortfin eels, although as this is a migratory species the presence of this fish would require connection to other waterways at some point.

Figure 14. Constructed wetland at south end of proposed RERC alignment.

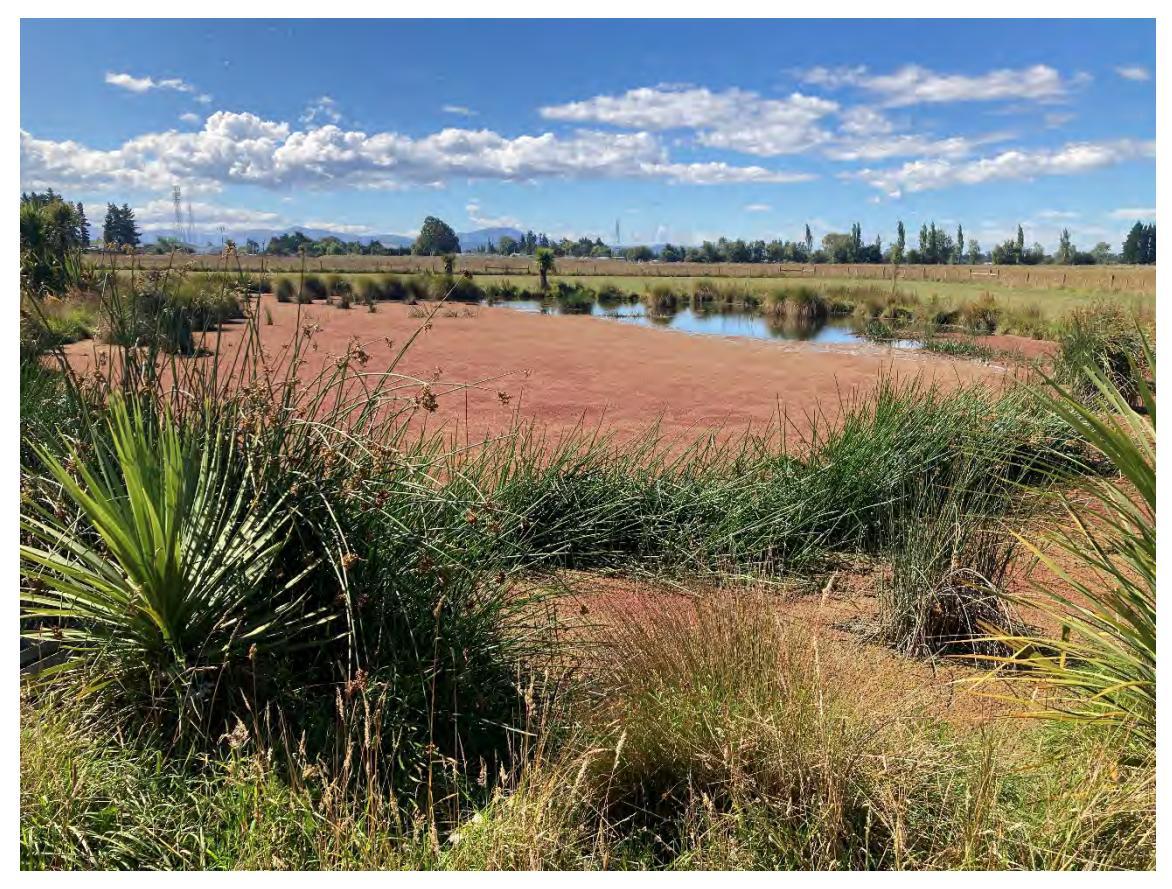
Figure 15. Constructed wetland at south end of proposed RERC alignment.
